**Correctional Services Canada (CSC) – Drumheller Institution No. 530  
Landfill Remediation**

**Environmental Assessment Report  
*Submitted to the Public Works and Government Services Canada (PWGSC)*  
Pursuant to the *Canadian Environmental Assessment Act (CEA Act)***

Project No. 2026-1102  
May 2012

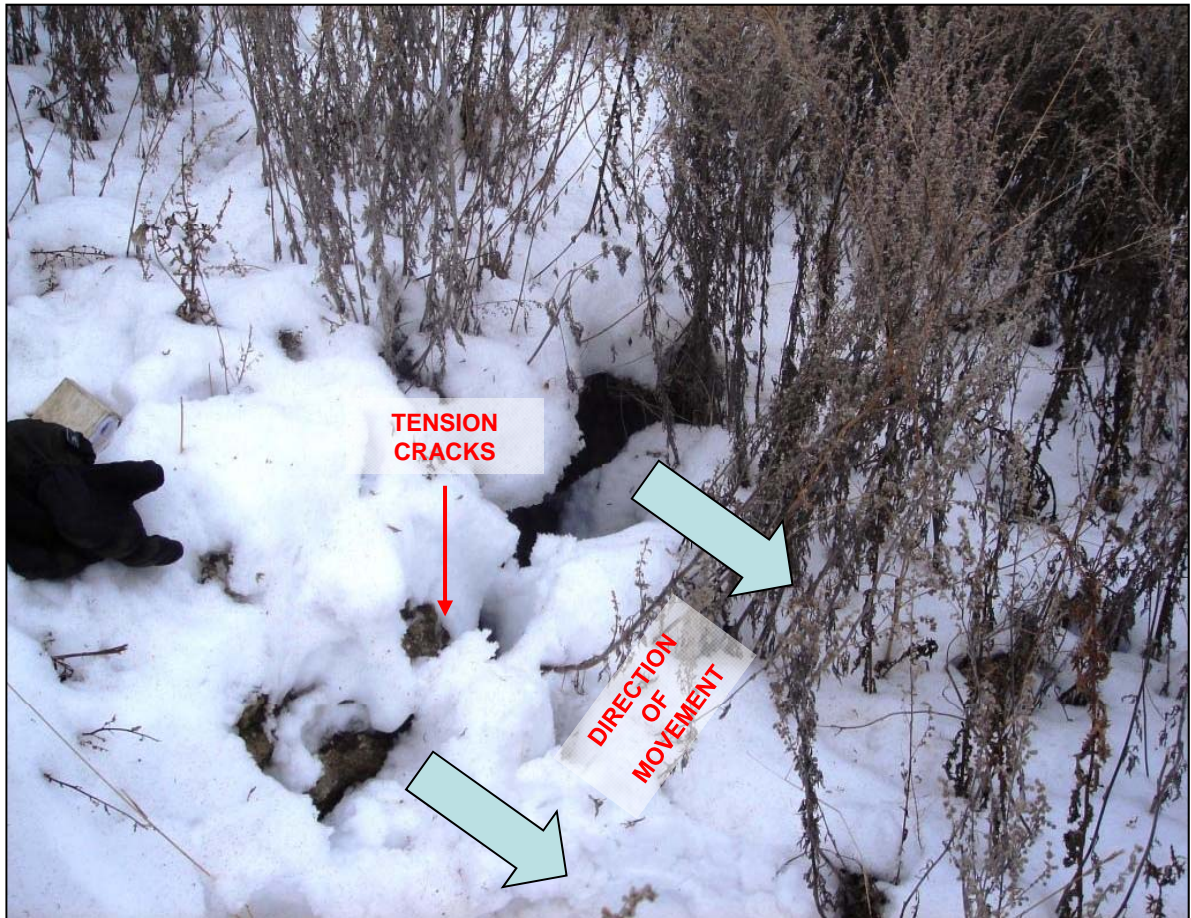
Some signs of slope instability were observed at the subject site, as indicated by tension cracks on the table lands along the east side of the landfill. The fissures were observed to extend to a depth of at least 1 to 2 metres below ground surface and were about 300 millimetres wide at the ground surface. It was noted that the cracks may extend beyond this depth (FRANZ, 2011a).

VIEW OF TENSION CRACK ALONG CREST OF SLOPE

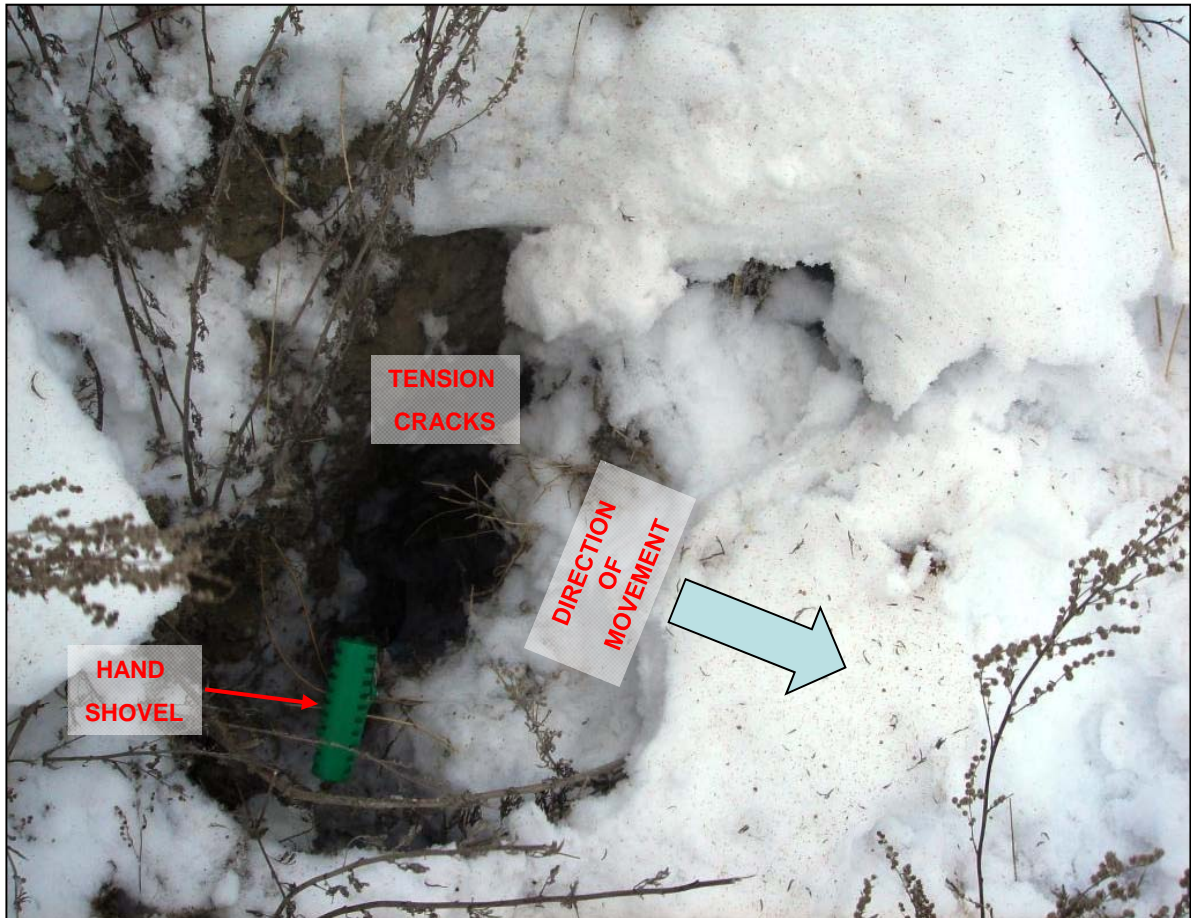
VIEW OF TENSION CRACK ALONG CREST OF SLOPE

Note: Hand shovel placed in tension crack, depth exceeding 1 – 2 metres.

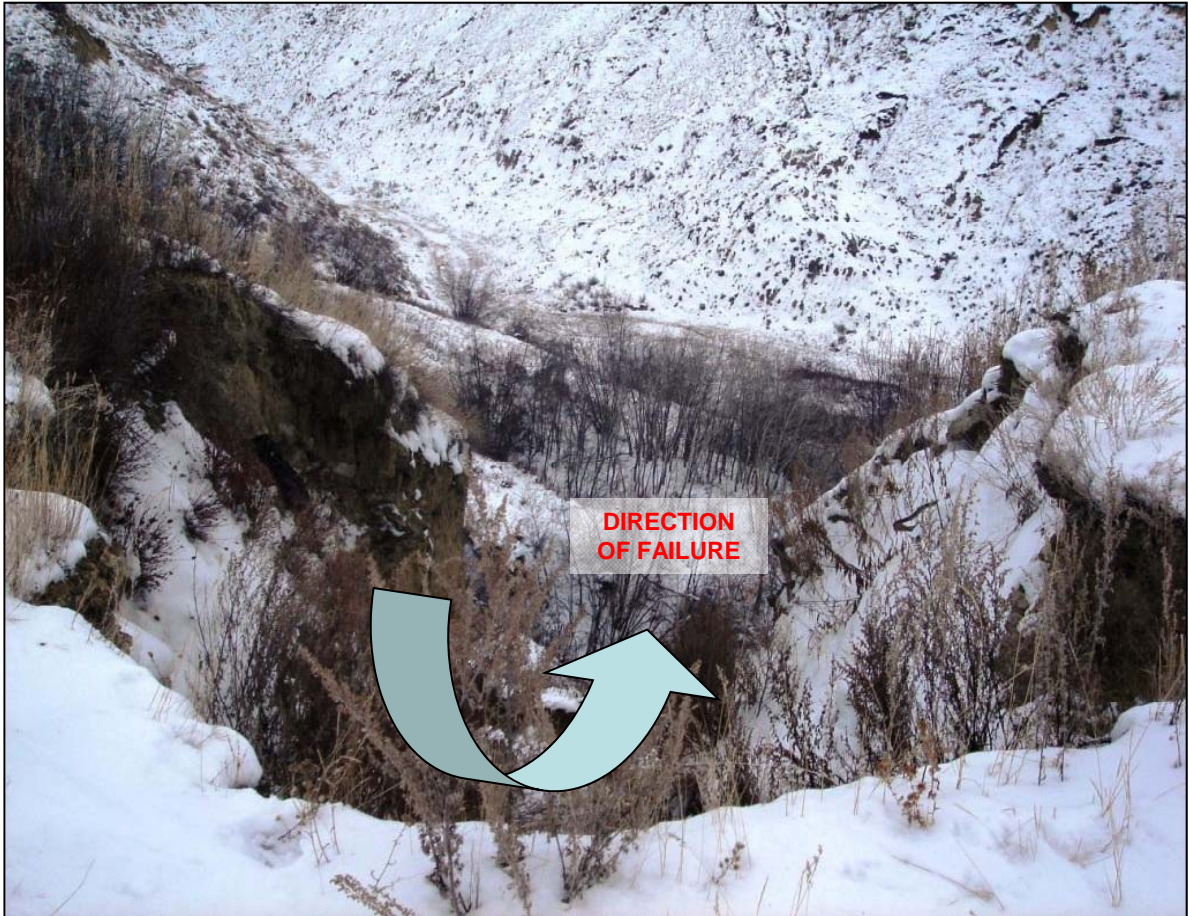
VIEW OF TO EAST FROM CREST OF SLOPE

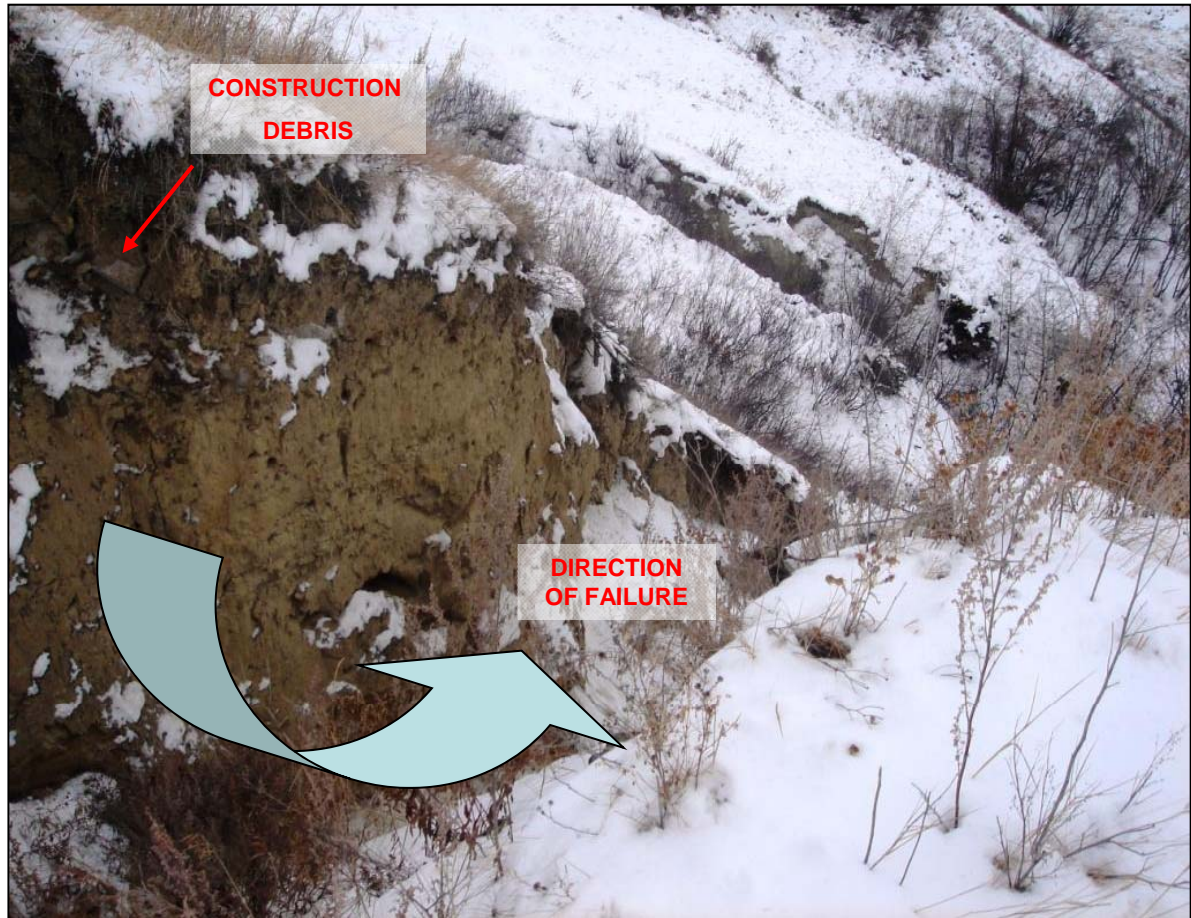
An existing deep failure zone was observed at the northeast end of the landfill. In the vicinity of the failure the slope has a height of about 19 metres and is generally inclined at about 40 degrees from the horizontal. The failure zone extends about 4 to 5 metres back from the original crest of the slope and has a width of about 3 to 4 metres at the top of the failure zone. At time of the site reconnaissance, a near vertical failure scarp several metres in depth was observed at the location of the failure. A small frozen spring was observed at the base of failure zone, indicating that the failure may have occurred as a result of concentrated groundwater/surface runoff from the tableland to this portion of the landfill (FRANZ, 2011a).

VIEW OF FILL MATERIAL IN EXISTING FAILURE

Note: Exposed construction debris on north face of failure scarp.

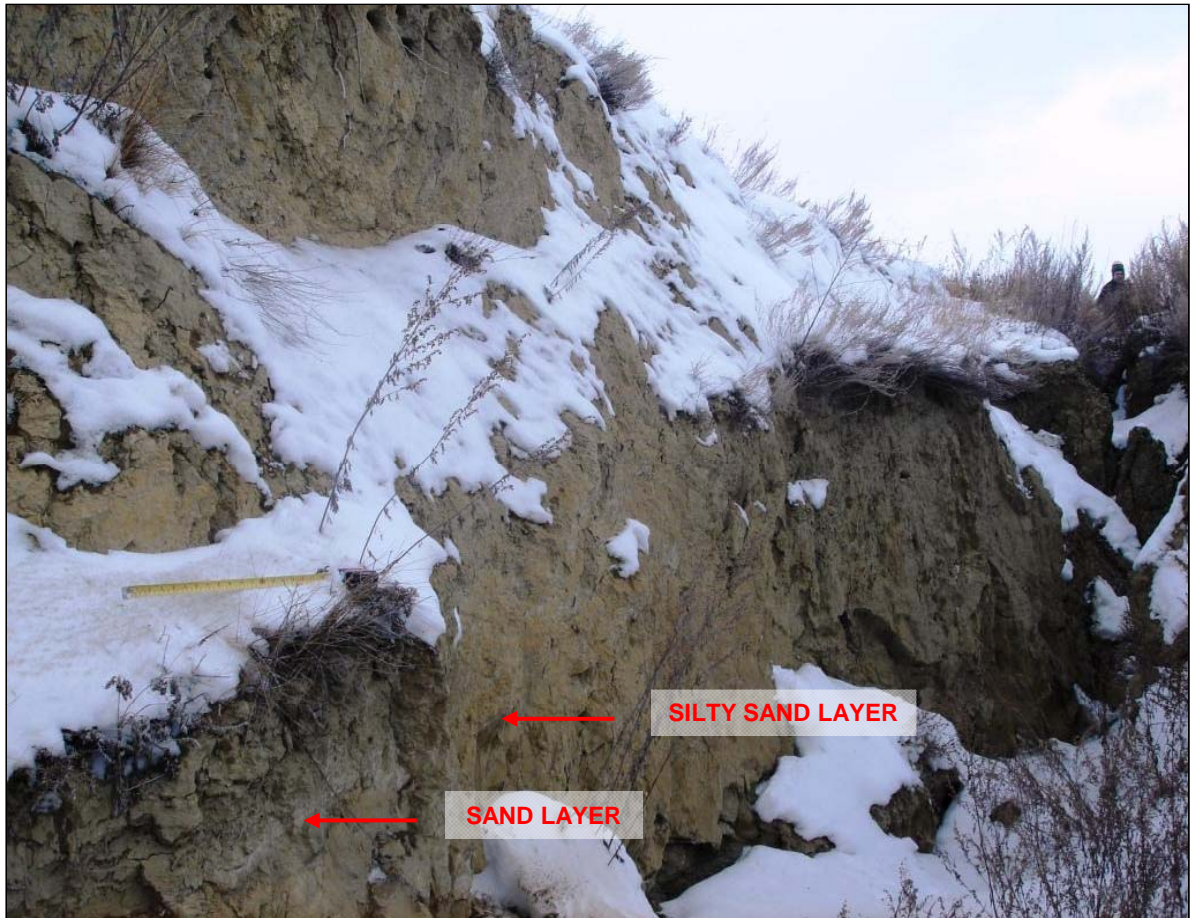
VIEW OF EXPOSED SOIL WEST SIDE OF ACCESS RAMP

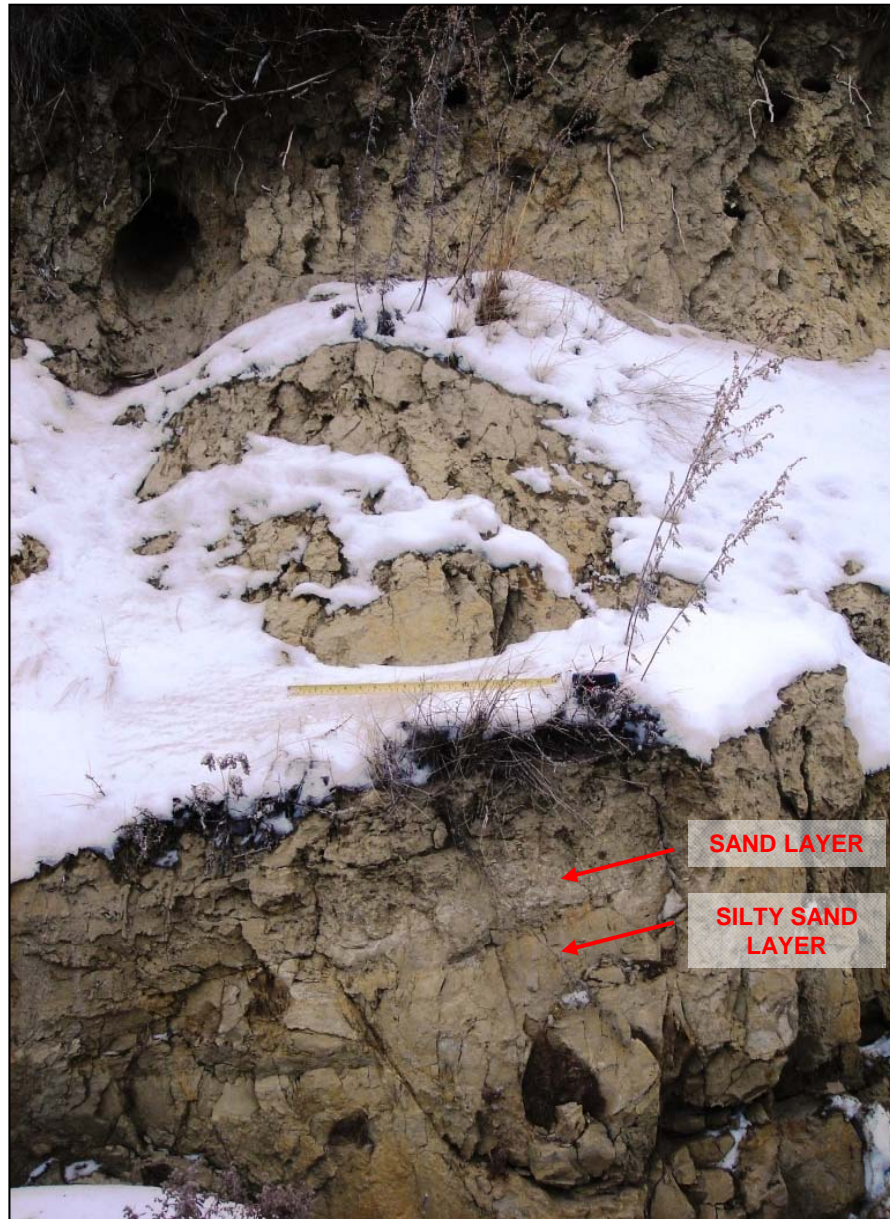
VIEW OF EXPOSED SOIL WEST SIDE OF ACCESS RAMP

Note: Interbedded layers of sand and silty sand

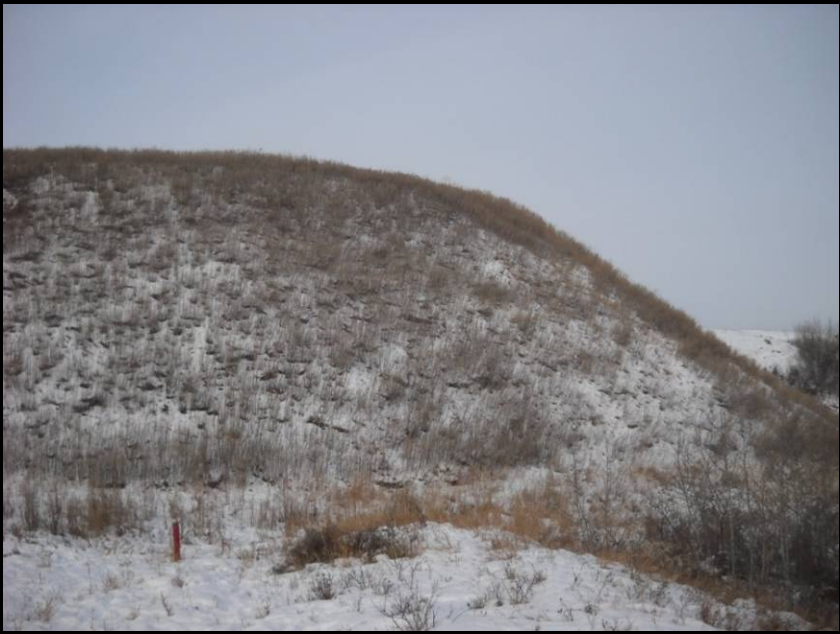
Environmental Investigation and Slope Stability Study, Drumheller Institution		Project No: 2026-1001
Photo ID 8

<b>Description</b> North westerly facing photograph. Landfill visible as hill in background. Red groundwater stick-up MW-05-3 visible in foreground.

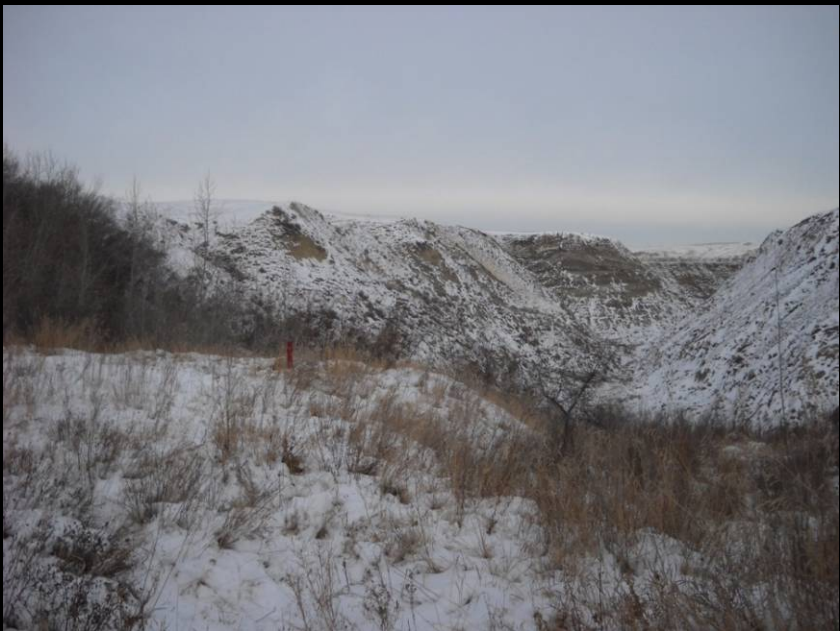
Environmental Investigation and Slope Stability Study, Drumheller Institution		Project No: 2026-1001
Photo ID 9

<b>Description:</b> North facing photograph. Coulee visible in background. Red groundwater stick-up MW-05-1 visible in foreground.

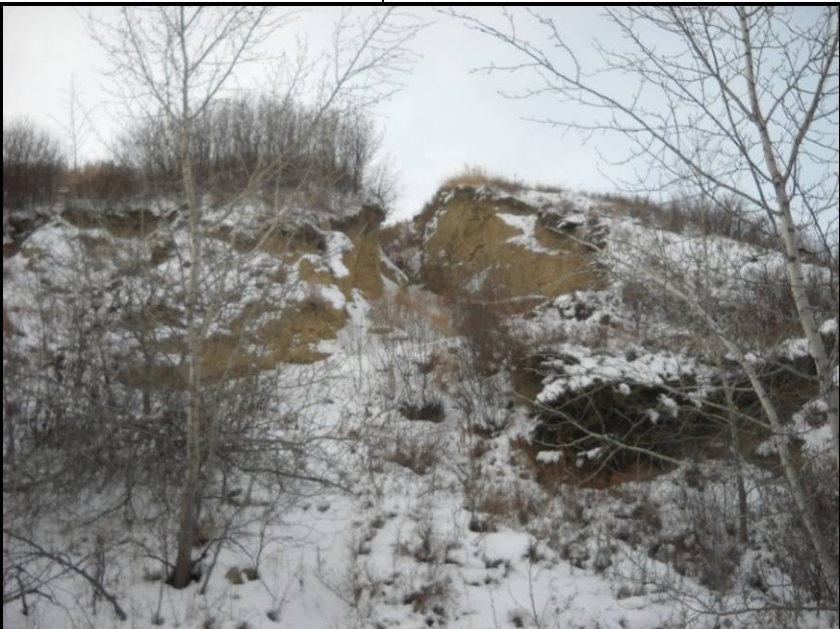
Environmental Investigation and Slope Stability Study, Drumheller Institution		Project No: 2026-1001
Photo ID 10

<b>Description:</b> Westerly facing photograph. Eroded face of landfill visible in centre. Collapsed landfill material resting on slope.

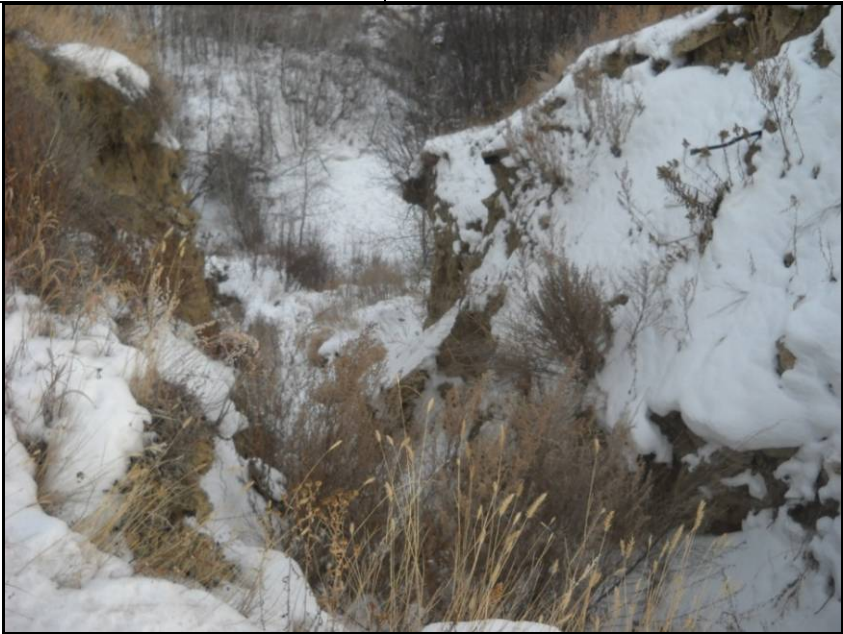
Environmental Investigation and Slope Stability Study, Drumheller Institution		Project No: 2026-1001
Photo ID 11

<p><b>Description:</b> Easterly facing photograph through area of collapsed landfill material.</p>

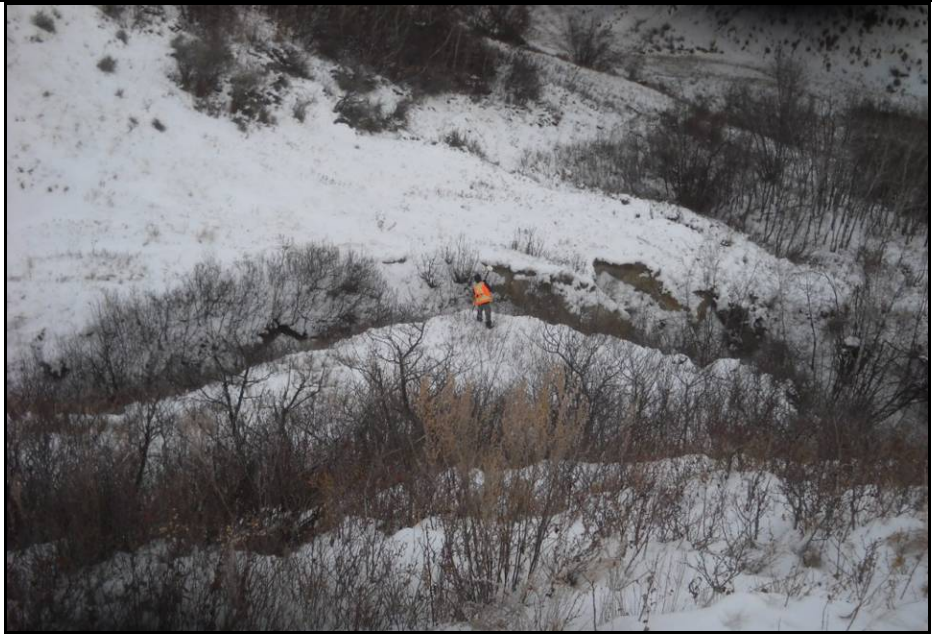
Environmental Investigation and Slope Stability Study, Drumheller Institution		Project No: 2026-1001
Photo ID 12

<b>Description:</b> North facing photo of Erosion channel, formed on north east side of landfill.

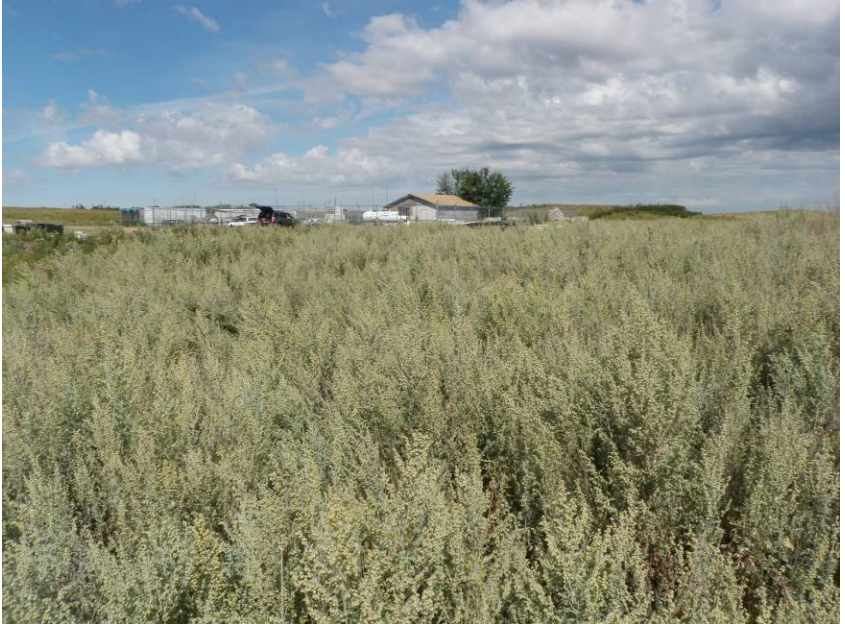
Supplemental Environmental Site Investigation and Data Gap Analysis, Former Landfill, Drumheller Institution		Project No: 2026-1101
Photo ID 1

Direction: NW		
Description: Top of Former Landfill looking NW towards fence line.

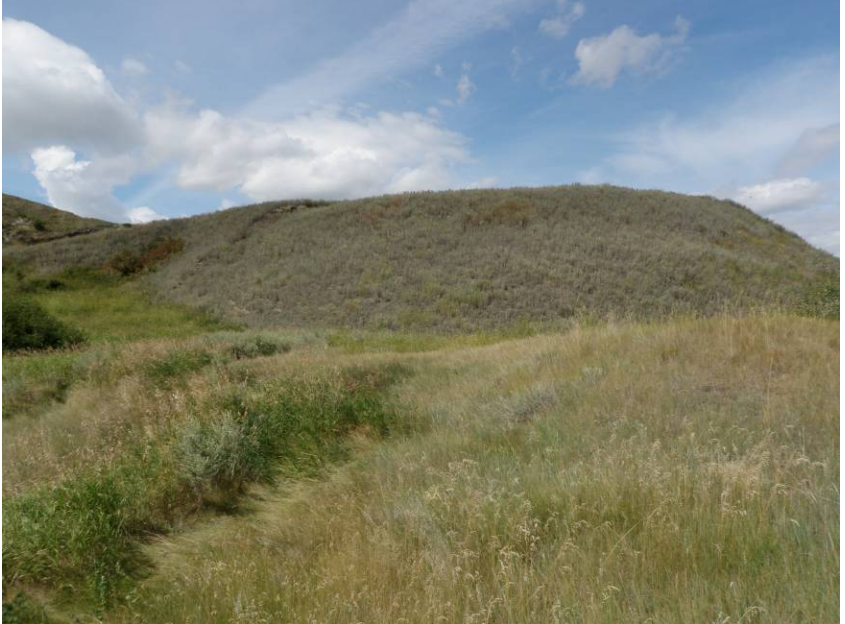
Supplemental Environmental Site Investigation and Data Gap Analysis, Former Landfill, Drumheller Institution		Project No: 2026-1101
Photo ID 2

Direction: NW		
Description: View of the Former Landfill looking NW.

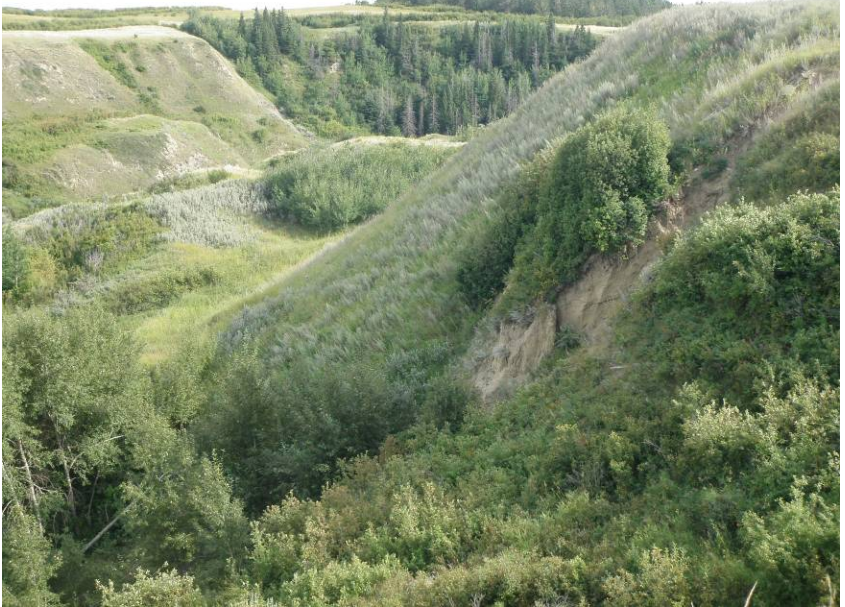
Supplemental Environmental Site Investigation and Data Gap Analysis, Former Landfill, Drumheller Institution		Project No: 2026-1101
Photo ID 3

Direction: SE		
<b>Description:</b> View of Former Landfill looking SE. Note slope failure on the right hand side of photo.

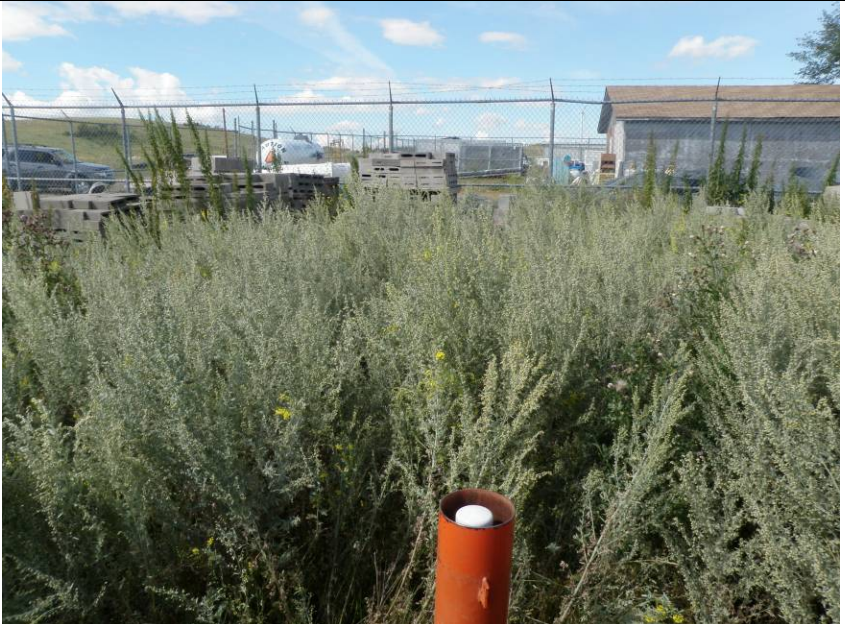
Supplemental Environmental Site Investigation and Data Gap Analysis, Former Landfill, Drumheller Institution		Project No: 2026-1101
Photo ID 4

Direction: W		
<b>Description:</b> View of MW99-03 on top of Landfill. Well located adjacent to Landfill fence line.

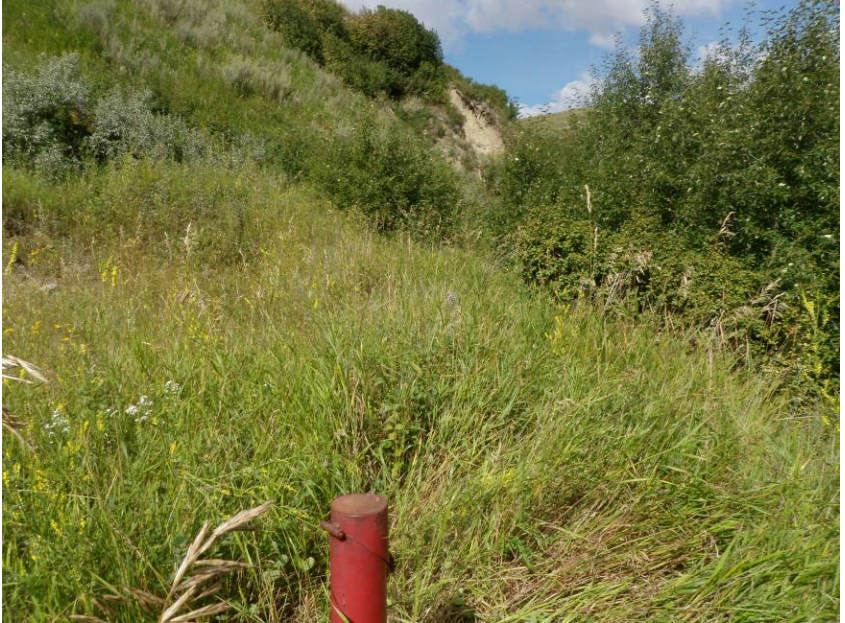
Supplemental Environmental Site Investigation and Data Gap Analysis, Former Landfill, Drumheller Institution		Project No: 2026-1101
Photo ID 5

Direction: NW		
<b>Description:</b> View of MW05-1. Wetland area is located just beyond trees at the top right hand corner of photo. Slope failure area located in top background of photo.

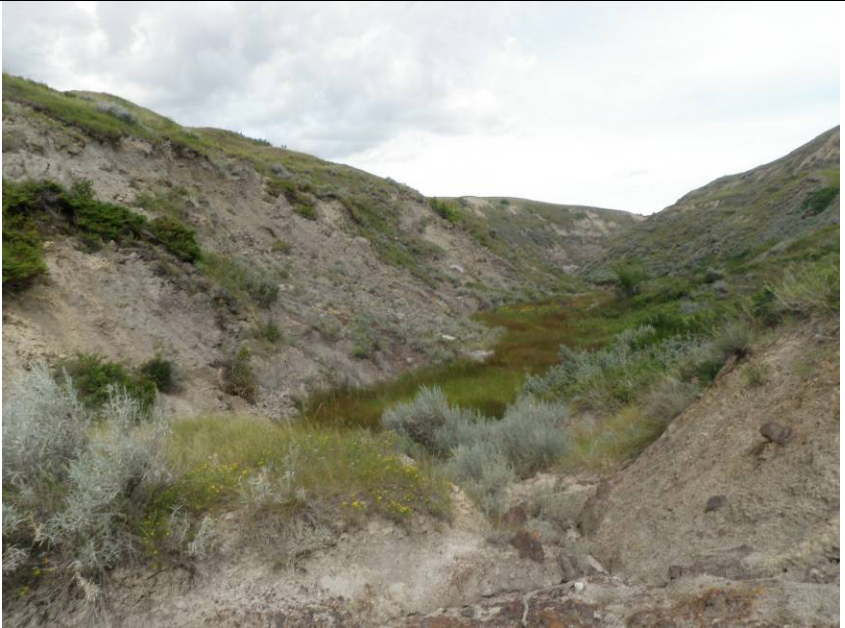
Supplemental Environmental Site Investigation and Data Gap Analysis, Former Landfill, Drumheller Institution		Project No: 2026-1101
Photo ID 7

Direction: S		
<b>Description:</b> Stream bed at bottom of coulee. View looking south towards background sample location.

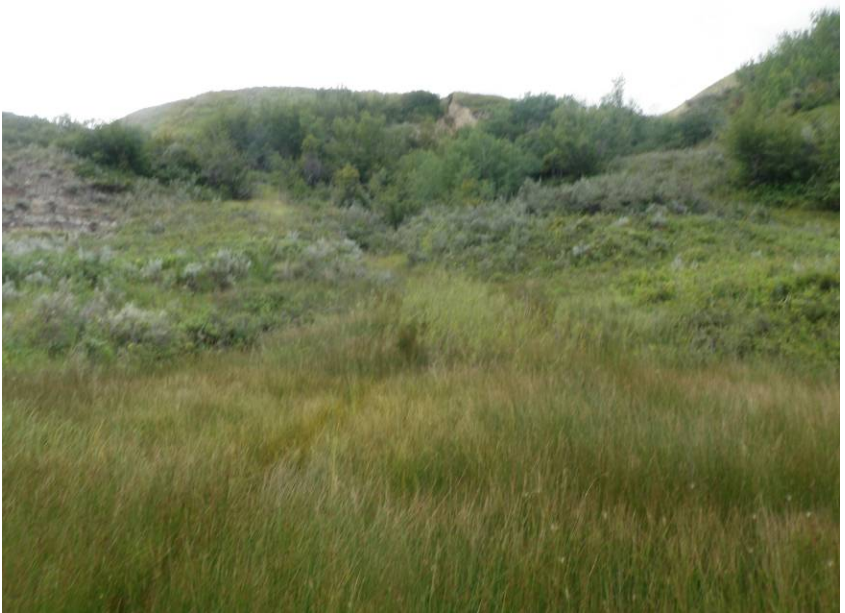
Supplemental Environmental Site Investigation and Data Gap Analysis, Former Landfill, Drumheller Institution		Project No: 2026-1101
Photo ID 8

Direction: W		
<b>Description:</b> Looking west up at Former Landfill. Standing where seepage meets the stream bed (DRUM-SW/SED-4). Note slope failure on right side of Landfill.

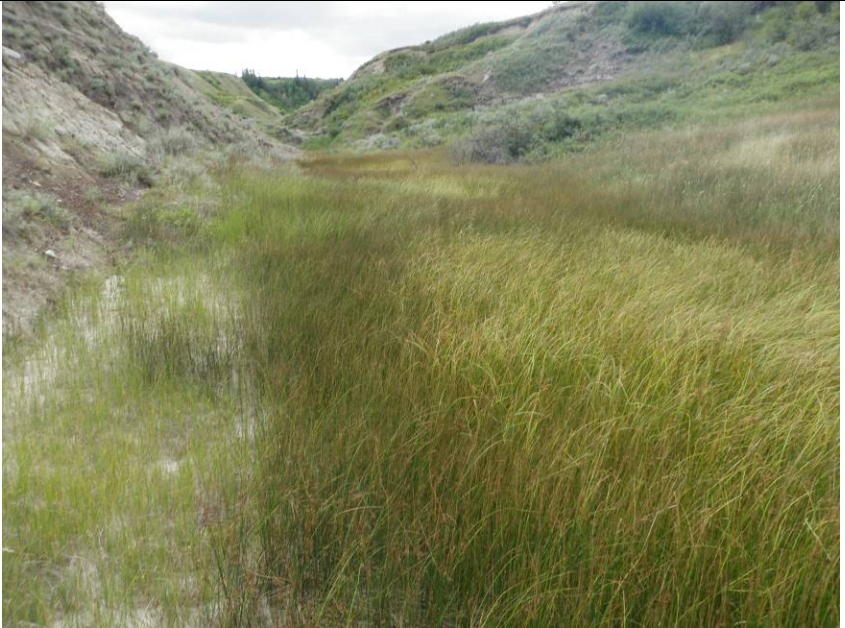
Supplemental Environmental Site Investigation and Data Gap Analysis, Former Landfill, Drumheller Institution		Project No: 2026-1101
Photo ID 9

Direction: S		
<b>Description:</b> Stream bed at bottom of coulee. Looking south towards Landfill.

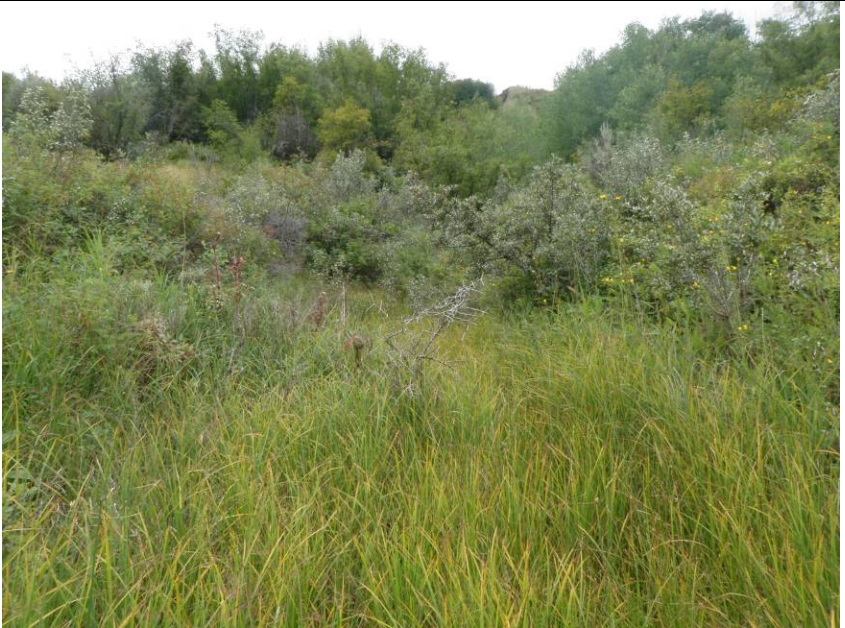
Supplemental Environmental Site Investigation and Data Gap Analysis, Former Landfill, Drumheller Institution		Project No: 2026-1101
Photo ID 10

Direction: W		
<b>Description:</b> View of seepage drainage pathway looking west towards Landfill. Drainage pathway is heavily vegetated.

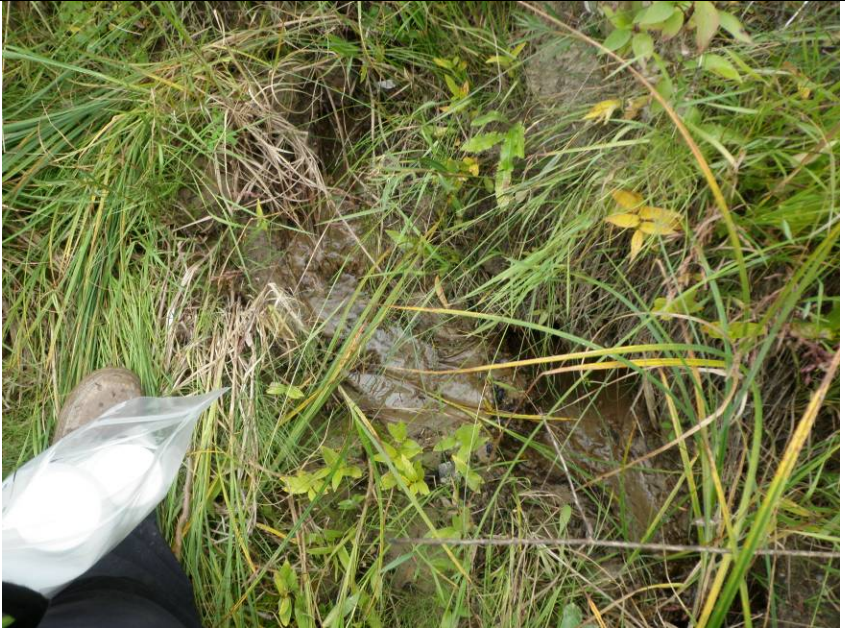
Supplemental Environmental Site Investigation and Data Gap Analysis, Former Landfill, Drumheller Institution		Project No: 2026-1101
Photo ID 11

Direction: N/A		
<b>Description:</b> Seepage drainage pathway. Flow is minimal.

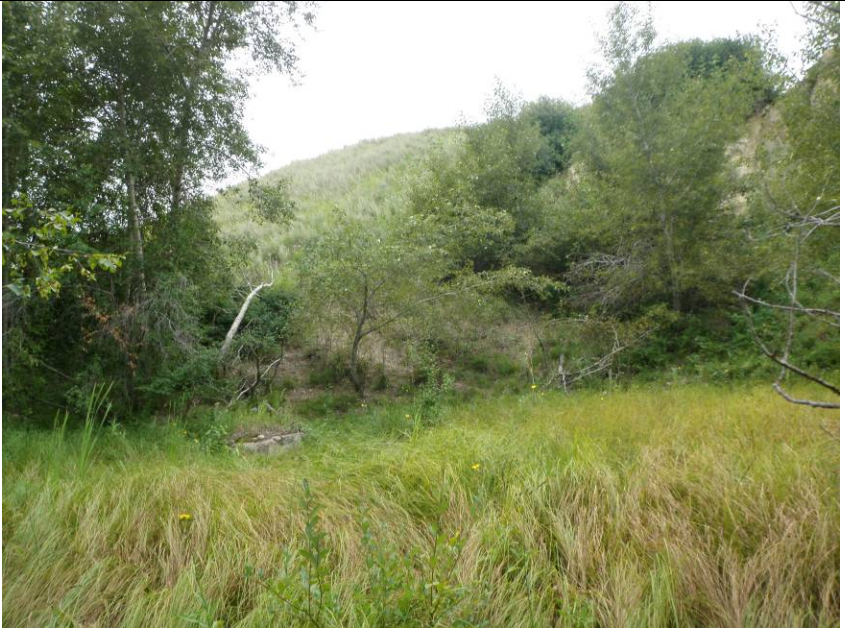
Supplemental Environmental Site Investigation and Data Gap Analysis, Former Landfill, Drumheller Institution		Project No: 2026-1101
Photo ID 12

Direction: SW		
<b>Description:</b> Wetland area located at toe of Landfill. View towards SW up at Landfill. This area is a low lying depression.

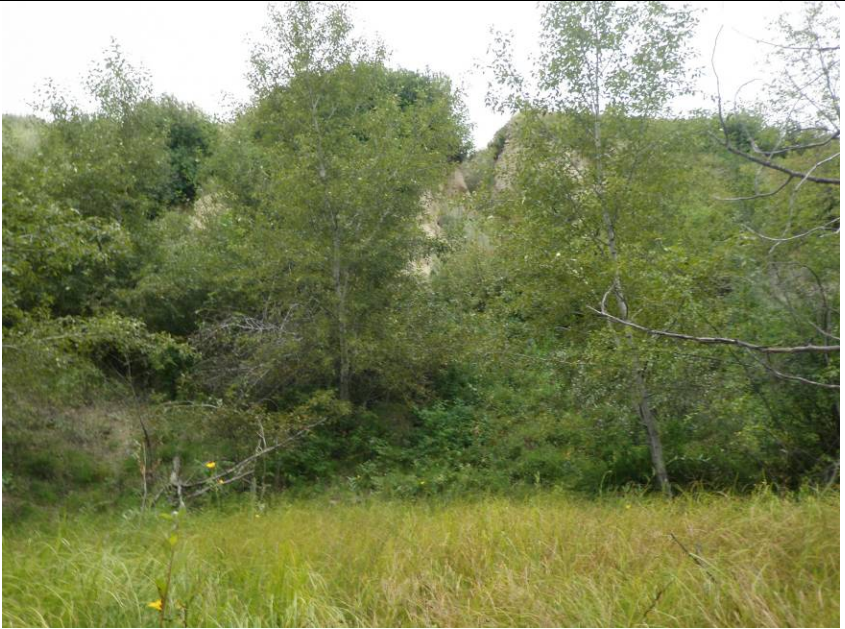
Supplemental Environmental Site Investigation and Data Gap Analysis, Former Landfill, Drumheller Institution		Project No: 2026-1101
Photo ID 13

Direction: W		
<b>Description:</b> Wetland area. View towards the west and the slope failure.

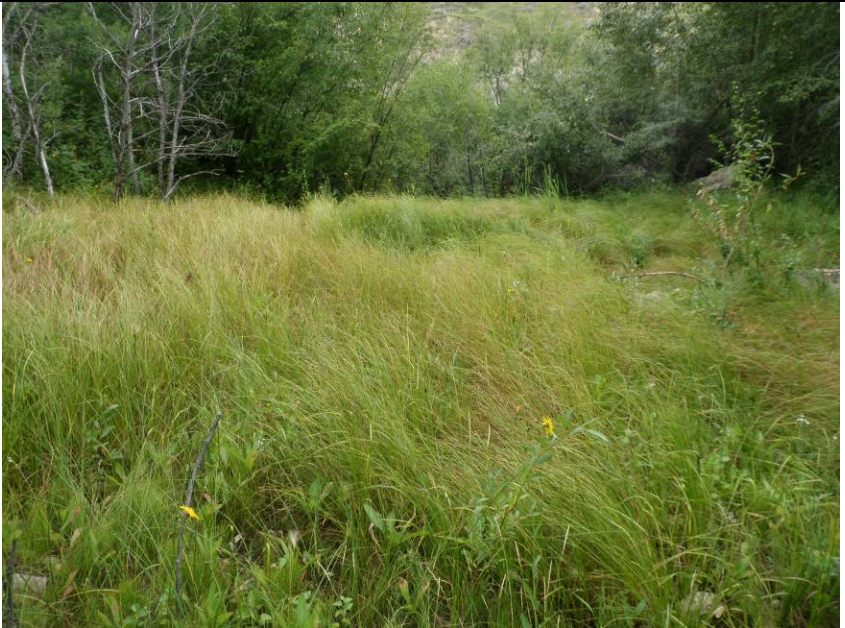
Supplemental Environmental Site Investigation and Data Gap Analysis, Former Landfill, Drumheller Institution		Project No: 2026-1101
Photo ID 14

Groundwater seepage was observed in a steep gully on the north side of the landfill. At the toe of the landfill a depression was observed containing peaty materials with grasses, sedges and cat tails, similar to a small wetland (see Photo 14, Appendix C). The surface sediments observed had a visible surface film that appeared reddish in color (see Photo 18). It was observed during the site reconnaissance that the seepage water originated from this depression and then flowed down slope into the creek/stream located at the base of the coulee, approximately 50 to 60 m below the landfill. The water in the creek eventually discharges into the Red Deer River at a distance of approximately 4.5 km downstream. At the time of the site visit, the stream bed was dry. Additionally, while on site, the CSC commissioner stated that

Direction: E		
<b>Description:</b> View of wetland area towards E. The seepage drainage pathway exits wetland and flows down slope towards stream bed from here.

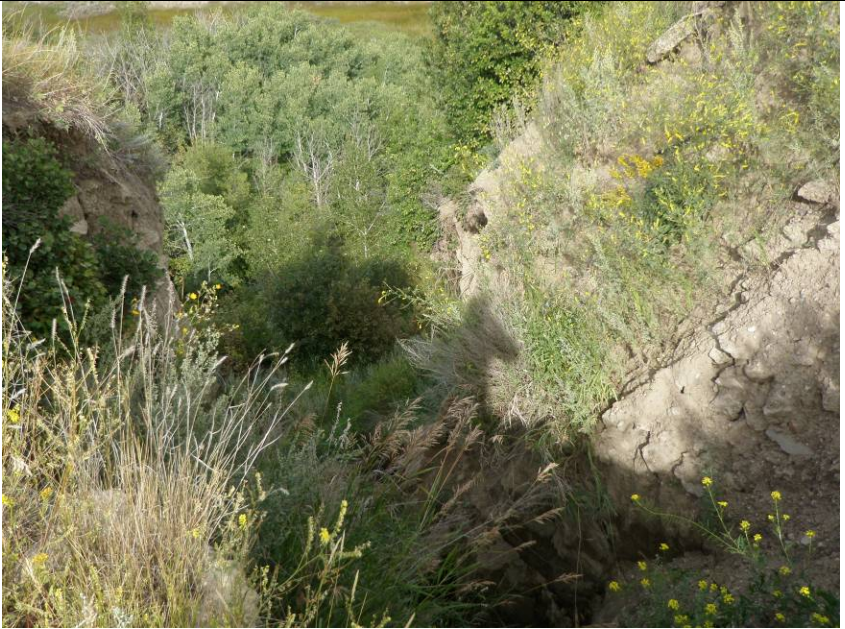
Supplemental Environmental Site Investigation and Data Gap Analysis, Former Landfill, Drumheller Institution		Project No: 2026-1101
Photo ID 15

Direction: E		
<b>Description:</b> Standing at top of the Former Landfill at the slope failure looking E.

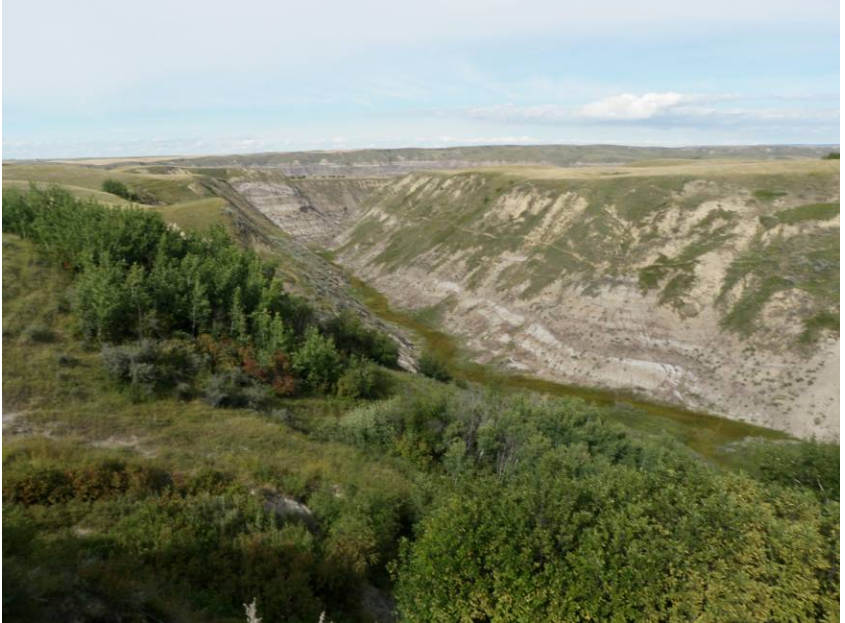
Supplemental Environmental Site Investigation and Data Gap Analysis, Former Landfill, Drumheller Institution		Project No: 2026-1101
Photo ID 16

Direction: N		
<b>Description:</b> View towards the north from top of Landfill.

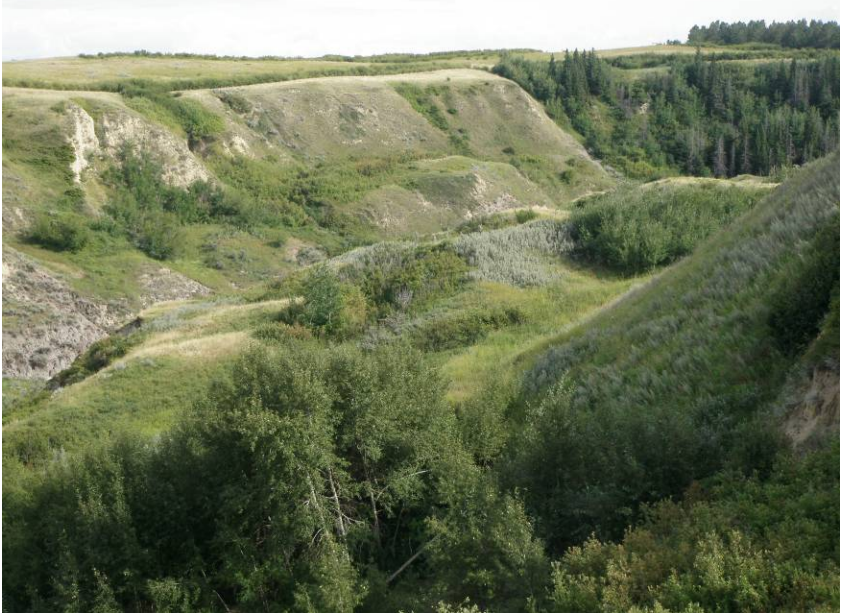
Supplemental Environmental Site Investigation and Data Gap Analysis, Former Landfill, Drumheller Institution		Project No: 2026-1101
Photo ID 17

Direction: S		
<b>Description:</b> View south from top of coulee. Former Landfill on right hand side.

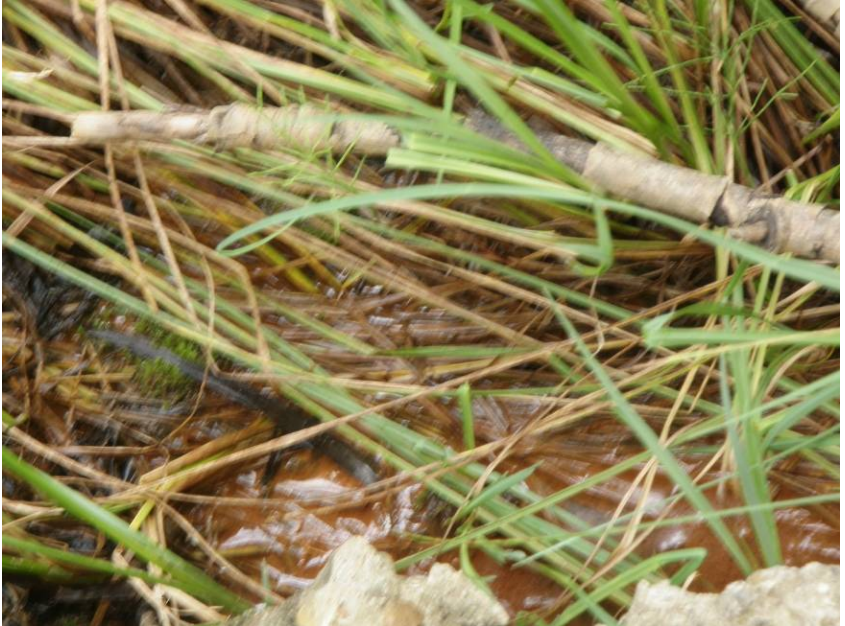
Supplemental Environmental Site Investigation and Data Gap Analysis, Former Landfill, Drumheller Institution		Project No: 2026-1101
Photo ID 18

Direction: N/A		
<b>Description:</b> View of the bright orange colour of colloidal iron oxides at the DRUM-SEEP1A sampling location. Note the biofilm ("sheen"-like appearance, with angular edges) of iron-reducing bacteria on the surface.

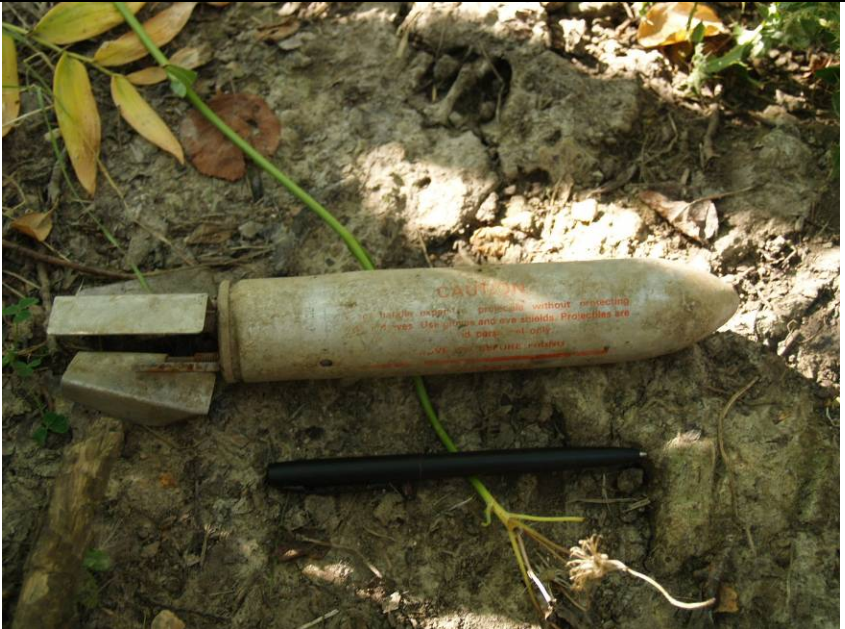
Supplemental Environmental Site Investigation and Data Gap Analysis, Former Landfill, Drumheller Institution		Project No: 2026-1101
Photo ID 19

Direction: N/A		
<b>Description:</b> Canister found during site reconnaissance. Confirmed to be tear gas, but has been decommissioned prior to disposal.

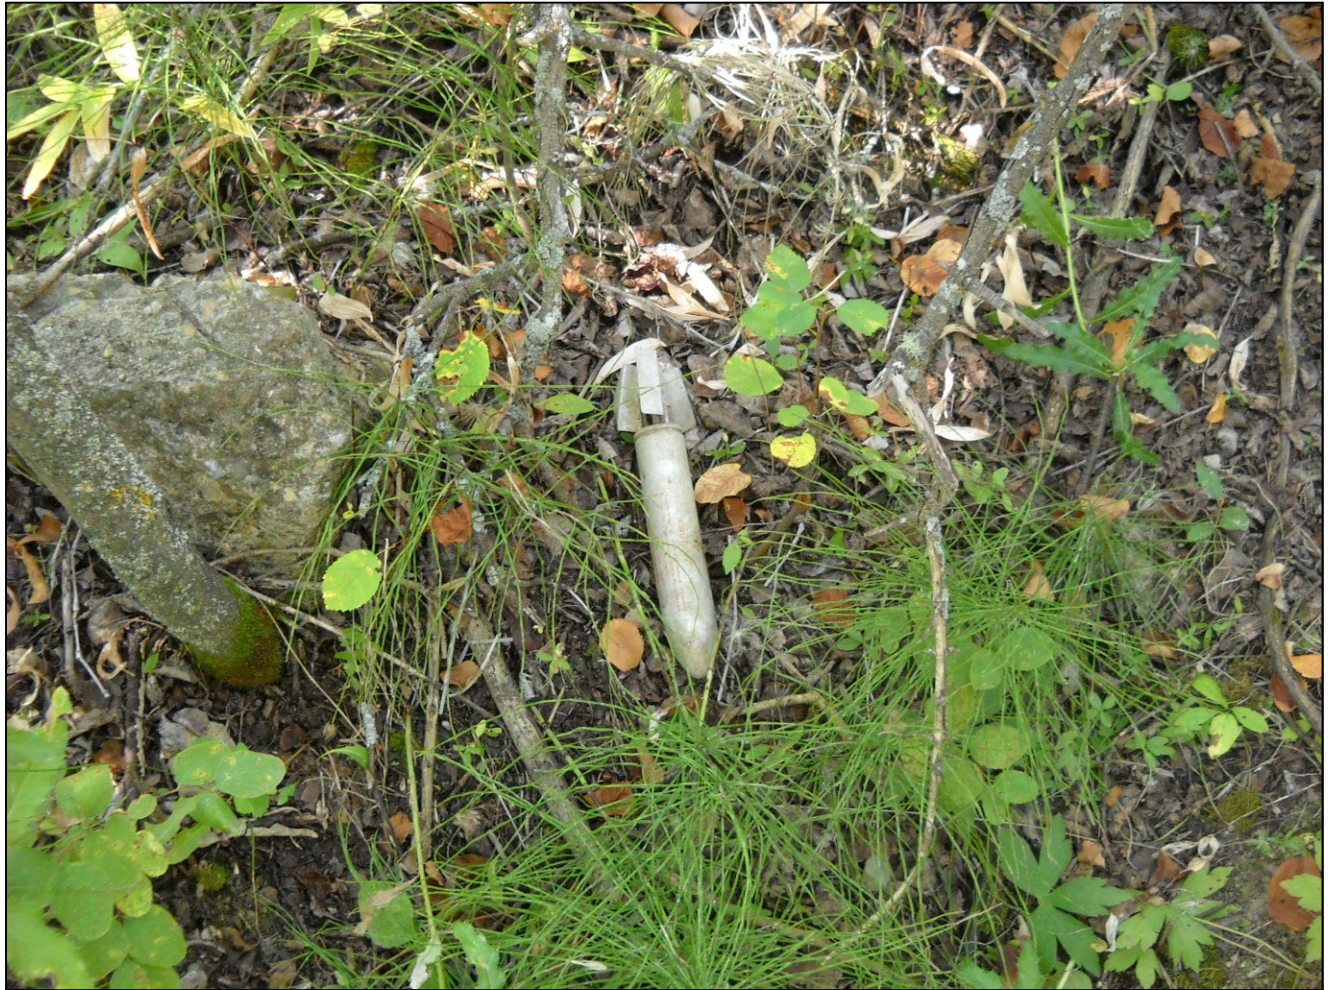
VIEW OF ORDNANCE AT BASE OF NORTH SECTION OF  
LANDFILL

Note: Item was recovered from the landfill and retained by  
personnel of the correctional facility

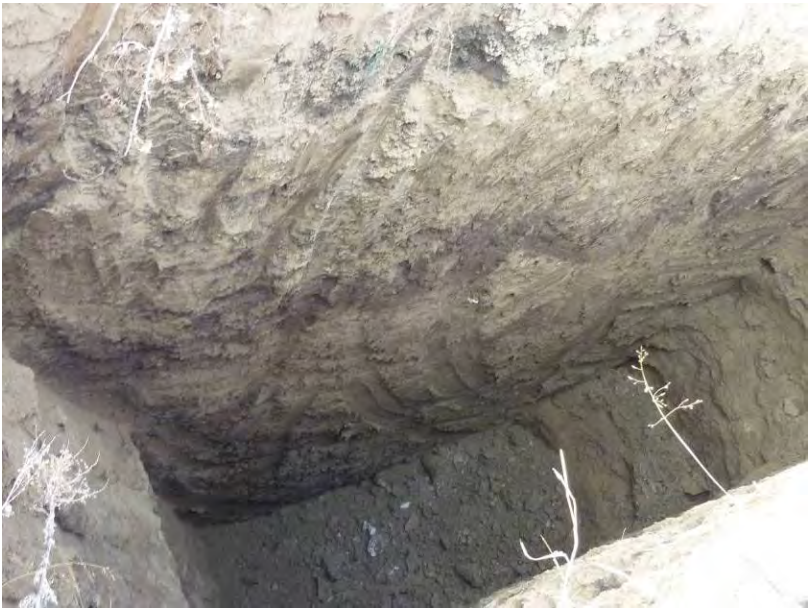
<b>Client Name: Public Works and Government Services Canada</b>		<b>Site Location: Drumheller Institution, Drumheller Alberta</b>	<b>Project No. 2026-1103</b>
<b>Photo No. 1</b>

<b>Date: November 29, 2011</b>			
<b>Direction Photo taken: N/A</b>			
<b>Description:</b>  <b>TP1: View of test pit walls and floor from surface. Test pit excavated to 6 m bgs.</b>
