**Correctional Services Canada (CSC) – Drumheller Institution No. 530  
Landfill Remediation**

**Environmental Assessment Report  
*Submitted to the Public Works and Government Services Canada (PWGSC)*  
Pursuant to the *Canadian Environmental Assessment Act (CEA Act)***

Project No. 2026-1102  
May 2012

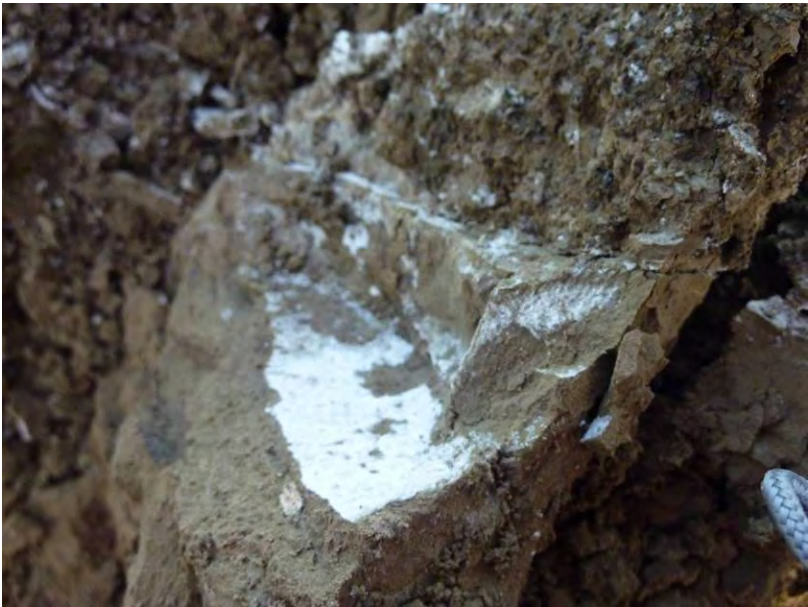
<b>Client Name: Public Works and Government Services Canada</b>		<b>Site Location: Drumheller Institution, Drumheller Alberta</b>	<b>Project No. 2026-1103</b>
<b>Photo No. 2</b>

<b>Date: November 29, 2011</b>			
<b>Direction Photo taken: N/A</b>			
<b>Description:</b>  <b>TP1: Native soil sample with white (possibly alkali), fine material layered in bands.</b>

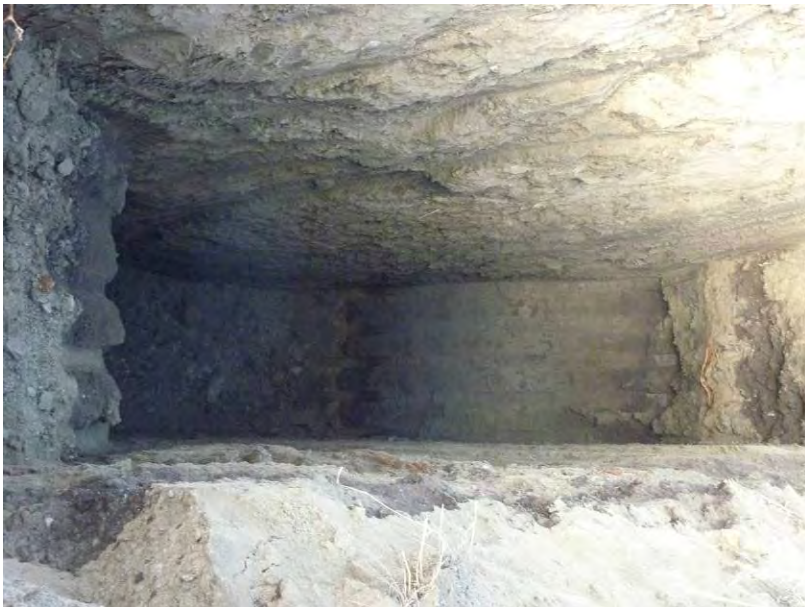
<b>Client Name:</b> Public Works and Government Services Canada	<b>Site Location:</b> Drumheller Institution, Drumheller Alberta	<b>Project No.</b> 2026-1103
<b>Photo No. 3</b>

<b>Date:</b> November 29, 2011		
<b>Direction Photo taken:</b> N/A		
<b>Description:</b>  TP2: Test pit walls and floor (6 m bgs)

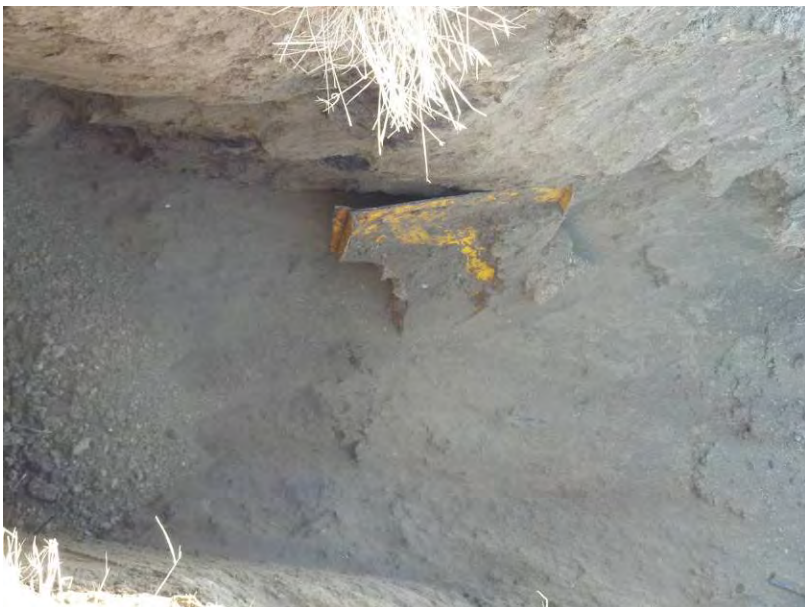
<b>Client Name:</b> Public Works and Government Services Canada	<b>Site Location:</b> Drumheller Institution, Drumheller Alberta	<b>Project No.</b> 2026-1103
<b>Photo No. 4</b>

<b>Date:</b> November 29, 2011		
<b>Direction Photo taken:</b> N/A		
<b>Description:</b>  TP3: Metal sheet painted yellow visible at a depth of 2-3 m bgs.

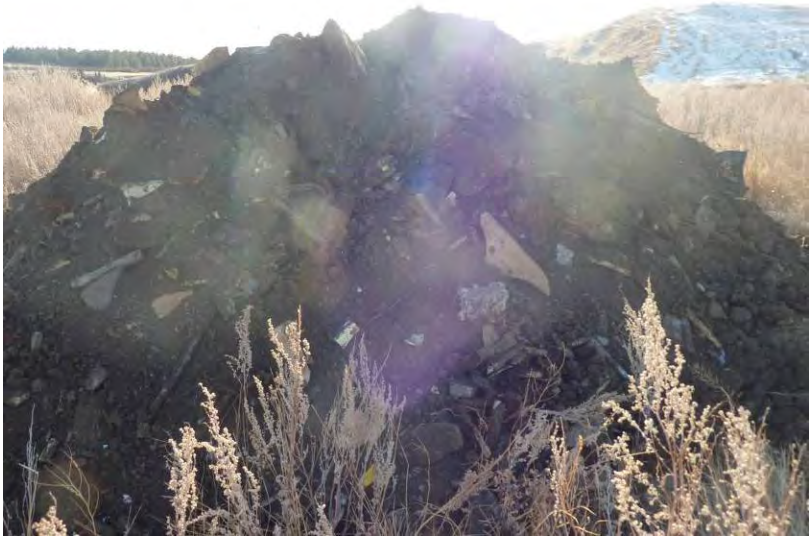
<b>Client Name: Public Works and Government Services Canada</b>	<b>Site Location: Drumheller Institution, Drumheller Alberta</b>	<b>Project No. 2026-1103</b>
<b>Photo No. 5</b>

<b>Date: November 29, 2011</b>		
<b>Direction Photo taken: S</b>		
<b>Description:</b>  <b>TP3: Material excavated from test pit 3. Waste pictured is irregular shaped (rock, concrete etc.).</b>

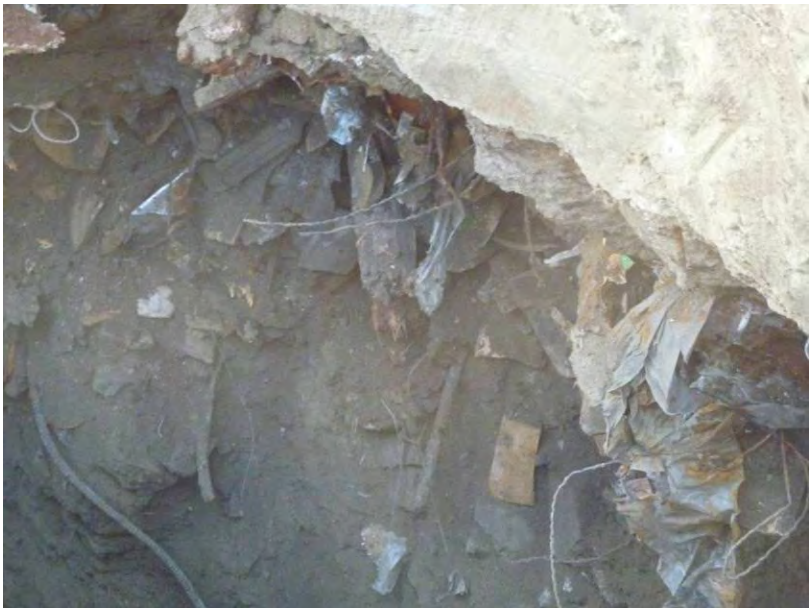
<b>Client Name: Public Works and Government Services Canada</b>	<b>Site Location: Drumheller Institution, Drumheller Alberta</b>	<b>Project No. 2026-1103</b>
<b>Photo No. 6</b>

<b>Date: November 29, 2011</b>		
<b>Direction Photo taken: N/A</b>		
<b>Description:</b>  <b>TP3: In situ waste.</b>

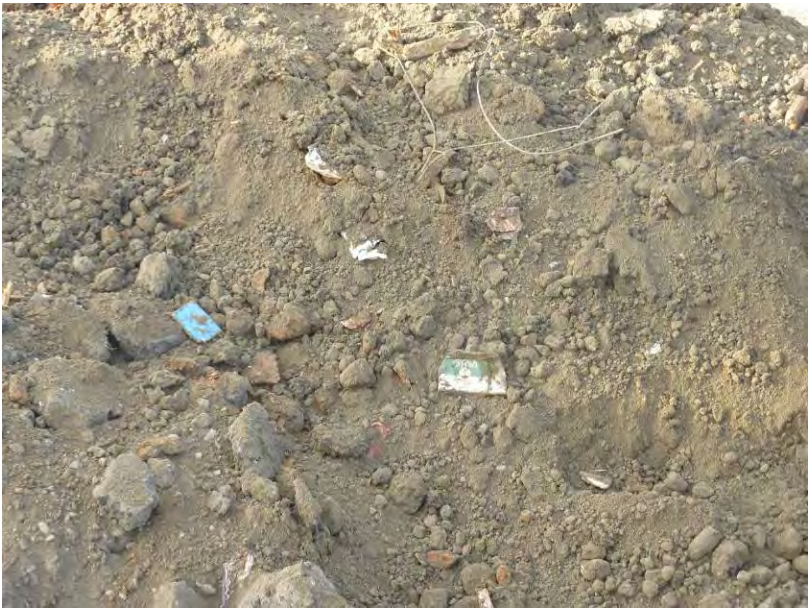
<b>Client Name: Public Works and Government Services Canada</b>		<b>Site Location: Drumheller Institution, Drumheller Alberta</b>	<b>Project No. 2026-1103</b>
<b>Photo No. 7</b>

<b>Date: November 29, 2011</b>			
<b>Direction Photo taken: N/A</b>			
<b>Description:</b>  <b>TP4: In situ waste.</b>

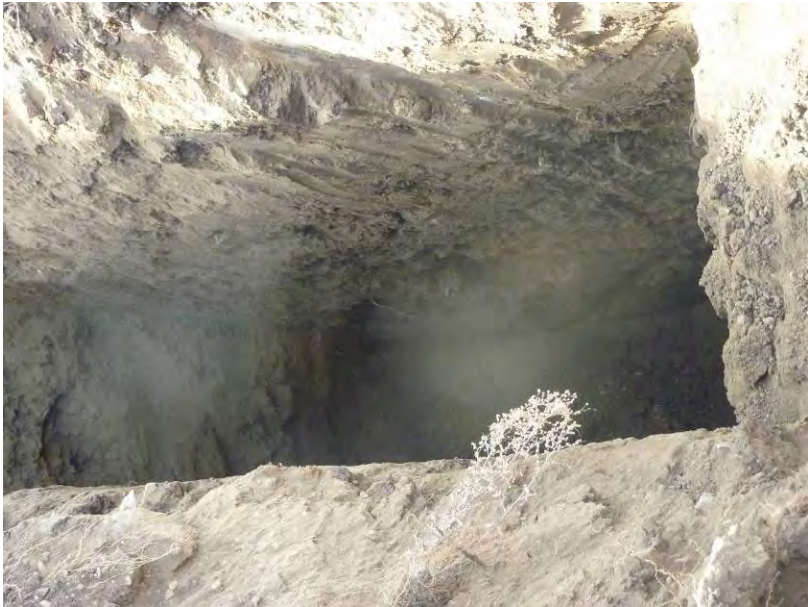
<b>Client Name: Public Works and Government Services Canada</b>		<b>Site Location: Drumheller Institution, Drumheller Alberta</b>	<b>Project No. 2026-1103</b>
<b>Photo No. 8</b>

<b>Date: November 29, 2011</b>			
<b>Direction Photo taken: N/A</b>			
<b>Description:</b>  <b>TP4: View of test pit walls and floor from surface. Test pit excavated to 6 m bgs.</b>

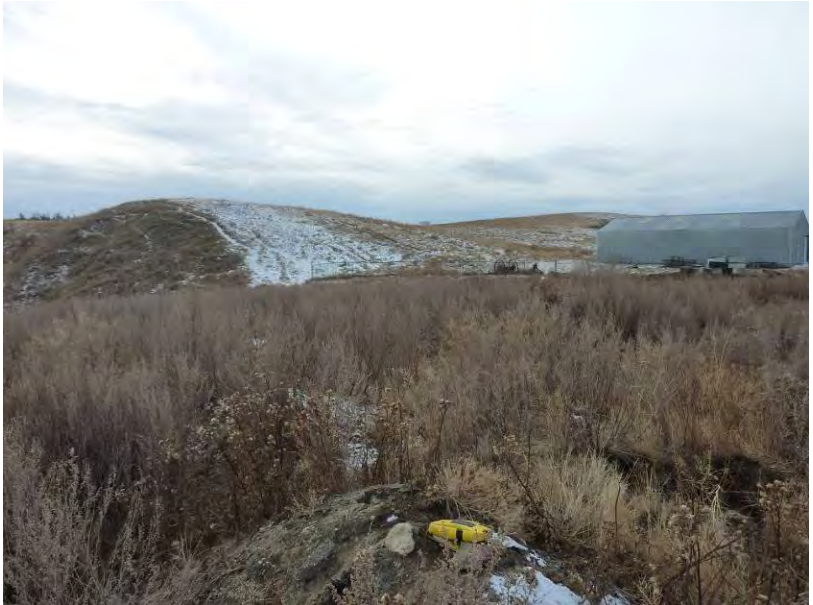
<b>Client Name: Public Works and Government Services Canada</b>	<b>Site Location: Drumheller Institution, Drumheller Alberta</b>	<b>Project No. 2026-1103</b>
<b>Photo No. 9</b>

<b>Date: November 29, 2011</b>		
<b>Direction Photo taken: SW</b>		
<b>Description:</b>  <b>TP5: View of top of landfill looking towards the south. Native undisturbed land is visible in background adjacent and beyond metal shed.</b>

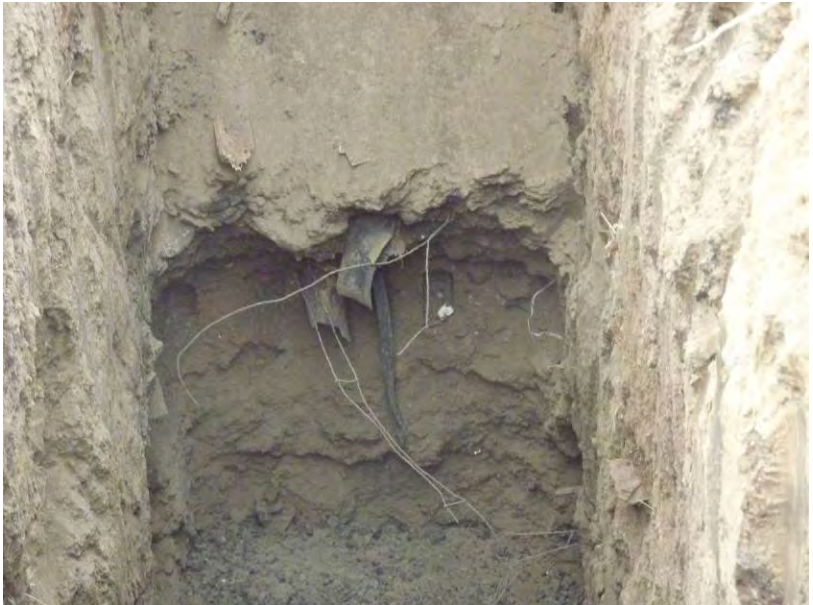
<b>Client Name: Public Works and Government Services Canada</b>	<b>Site Location: Drumheller Institution, Drumheller Alberta</b>	<b>Project No. 2026-1103</b>
<b>Photo No. 10</b>

<b>Date: November 29, 2011</b>		
<b>Direction Photo taken: N/A</b>		
<b>Description:</b>  <b>TP5: In situ waste.</b>

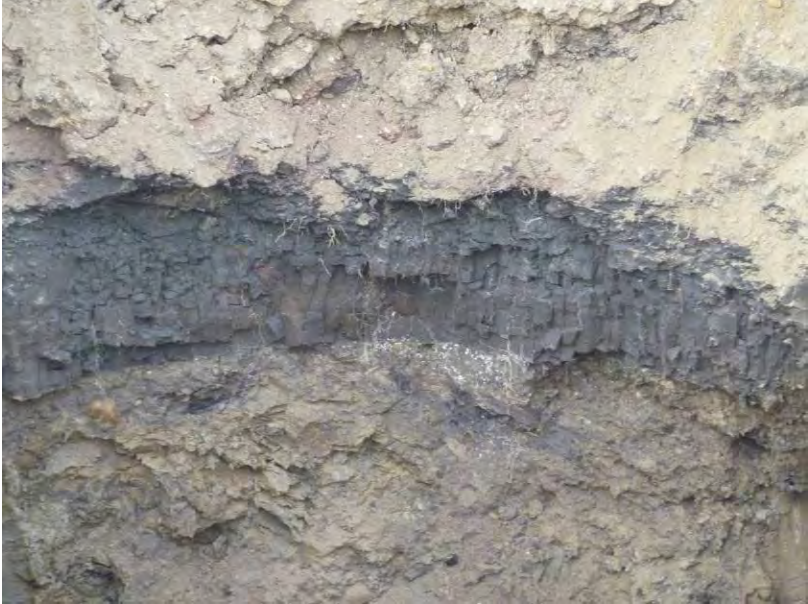
<b>Client Name: Public Works and Government Services Canada</b>	<b>Site Location: Drumheller Institution, Drumheller Alberta</b>	<b>Project No. 2026-1103</b>
<b>Photo No. 11</b>

<b>Date: November 29, 2011</b>		
<b>Direction Photo taken: N/A</b>		
<b>Description:</b>  <b>TP5: Clay fill material visible as a darker band. Clay fill extends approximately from 0.5 to 2.0 m bgs.</b>

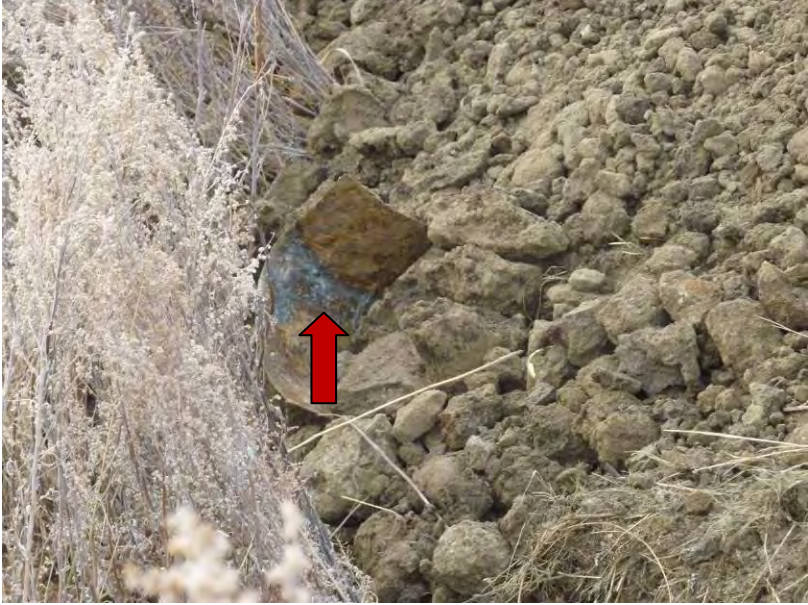
<b>Client Name: Public Works and Government Services Canada</b>	<b>Site Location: Drumheller Institution, Drumheller Alberta</b>	<b>Project No. 2026-1103</b>
<b>Photo No. 12</b>

<b>Date: November 29, 2011</b>		
<b>Direction Photo taken: N/A</b>		
<b>Description:</b>  <b>TP5: Metal waste removed from test pit (indicated by red arrow).</b>

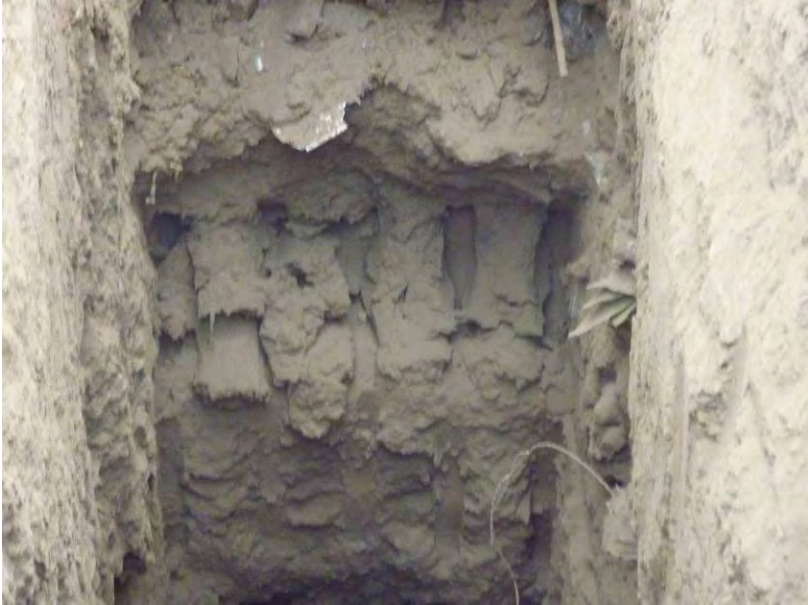
<b>Client Name: Public Works and Government Services Canada</b>		<b>Site Location: Drumheller Institution, Drumheller Alberta</b>	<b>Project No. 2026-1103</b>
<b>Photo No. 13</b>

<b>Date: November 29, 2011</b>			
<b>Direction Photo taken: N/A</b>			
<b>Description:</b>  <b>TP6: Test pit wall (note visible waste fragments).</b>

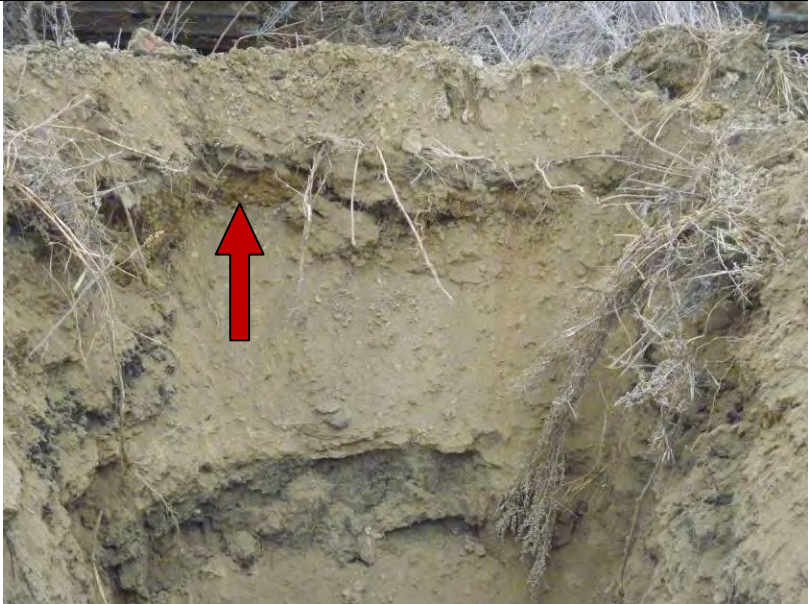
<b>Date: November 29, 2011</b>			
<b>Direction Photo taken: N/A</b>			
<b>Description:</b>  <b>TP6: Rust colored band visible below humic level. Possible red shale or brick fill type material.</b>

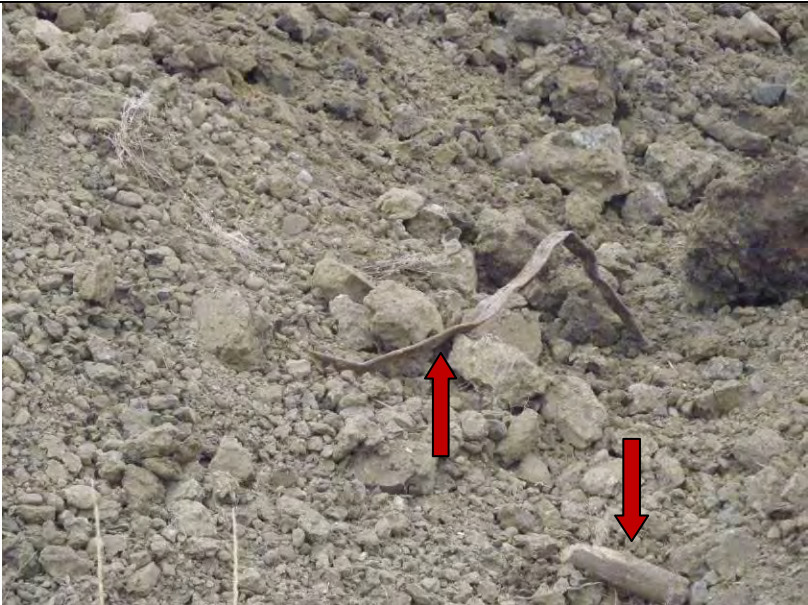
<b>Client Name:</b> Public Works and Government Services Canada	<b>Site Location:</b> Drumheller Institution, Drumheller Alberta	<b>Project No.</b> 2026-1103
<b>Photo No. 16</b>

<b>Date:</b> November 29, 2011		
<b>Direction Photo taken:</b> N/A		
<b>Description:</b>  TP7: Metal and wood present in excavated material.

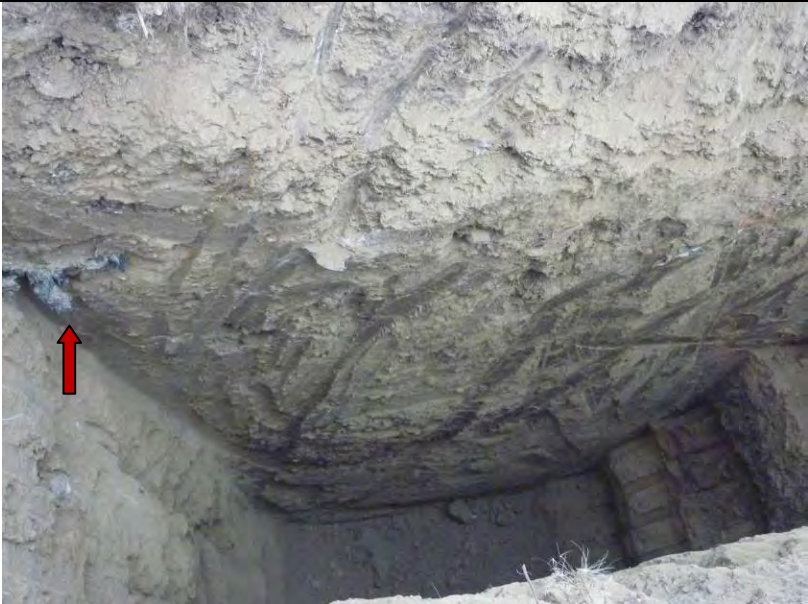
Client Name: Public Works and Government Services Canada		Site Location: Drumheller Institution, Drumheller Alberta	Project No. 2026-1103
<b>Photo No. 17</b>

Date: November 29, 2011			
Direction Photo taken: N/A			
<b>Description:</b>  TP7: View of walls and floor from surface. Test pit extends to 6 m bgs. Note the plastic waste visible at 2-3 m bgs.

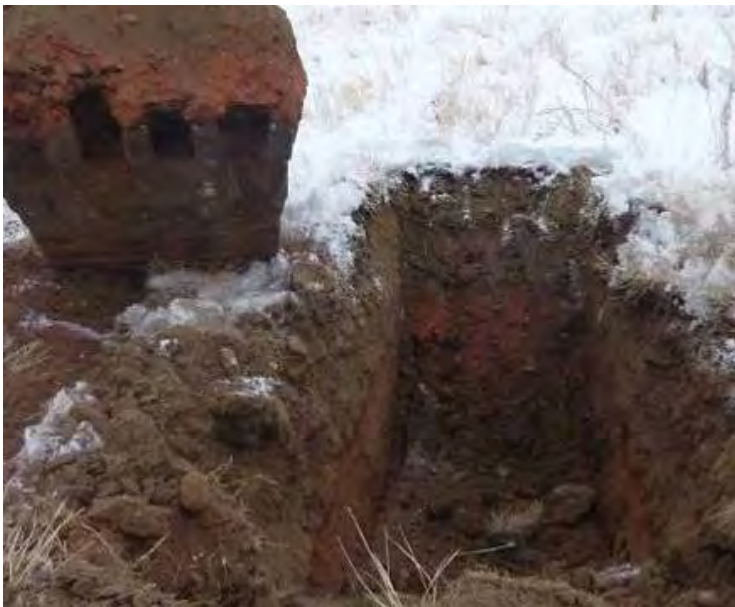
Client Name: Public Works and Government Services Canada		Site Location: Drumheller Institution, Drumheller Alberta	Project No. 2026-1103
<b>Photo No. 18</b>

Date: November 30, 2011			
Direction Photo taken: W			
<b>Description:</b>  TP9: Red shale type material visible in situ.

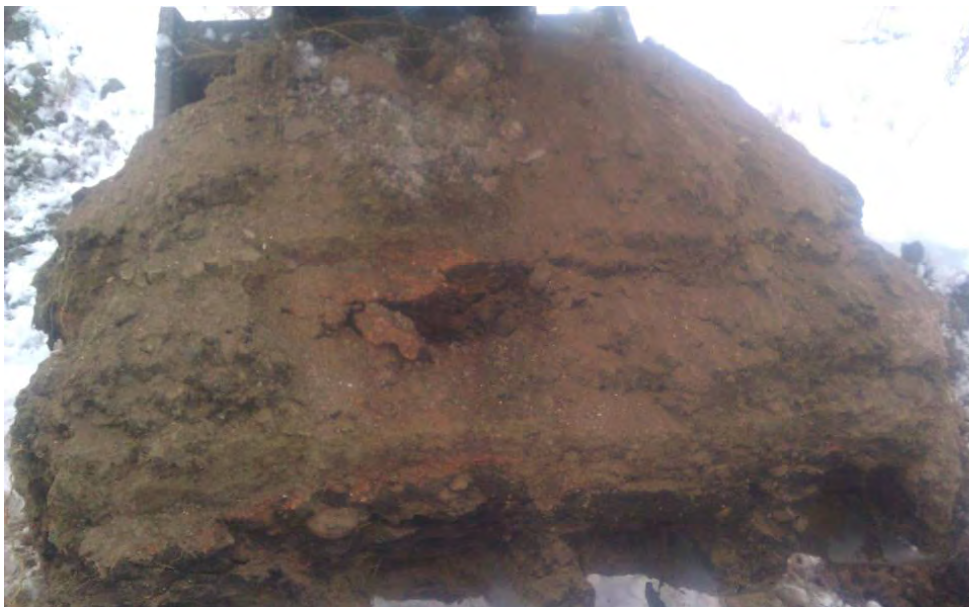
Client Name: Public Works and Government Services Canada		Site Location: Drumheller Institution, Drumheller Alberta	Project No. 2026-1103
Photo No. 19

Date: November 30, 2011			
Direction Photo taken: N/A			
Description:  TP9: Red shale type material visible in situ.

- Contents of former landfill – although indicated to be comprised of domestic and general construction waste, former tear gas canisters were found at the landfill during the September 2011 test pitting program (Franz, 2011 – see Photo 19, Appendix C). In addition, the type, location and extent of waste(s) potentially encountered during excavation/construction to implement the selected “cut and fill” approach needed to be ascertained (i.e. would planned construction work disturb buried waste(s)).
- Potential Impacted Soil by the Landfill – soils at the top of the Landfill slope maybe impacted by petroleum hydrocarbons and PAHs based on historical activities conducted at the site. The location(s), extent(s) and volume(s) of impacted soil potentially

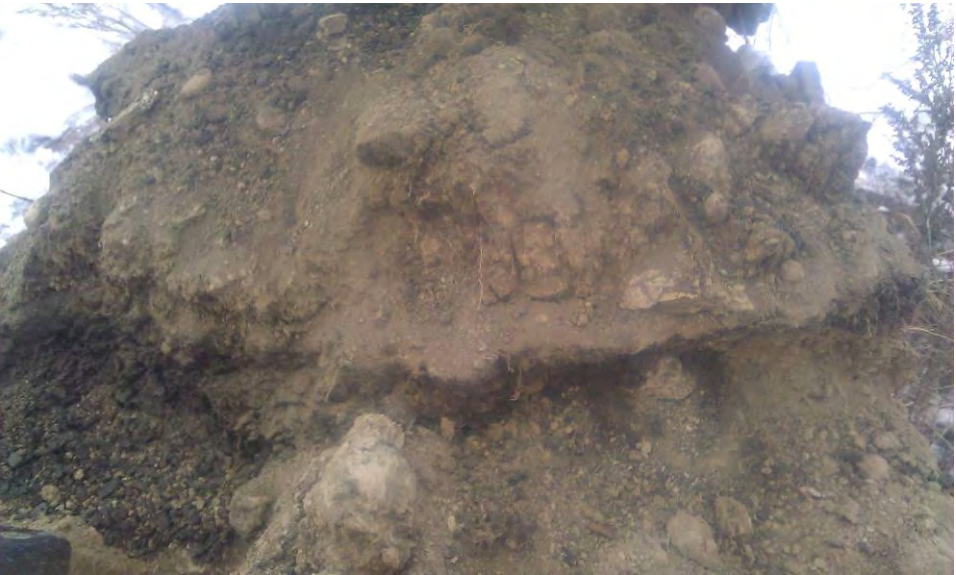
Client Name: Public Works and Government Services Canada		Site Location: Drumheller Institution, Drumheller Alberta	Project No. 2026-1103
Photo No. 20

Date: November 30, 2011			
Direction Photo taken: N/A			
Description:  TP11: Excavated fill materials.

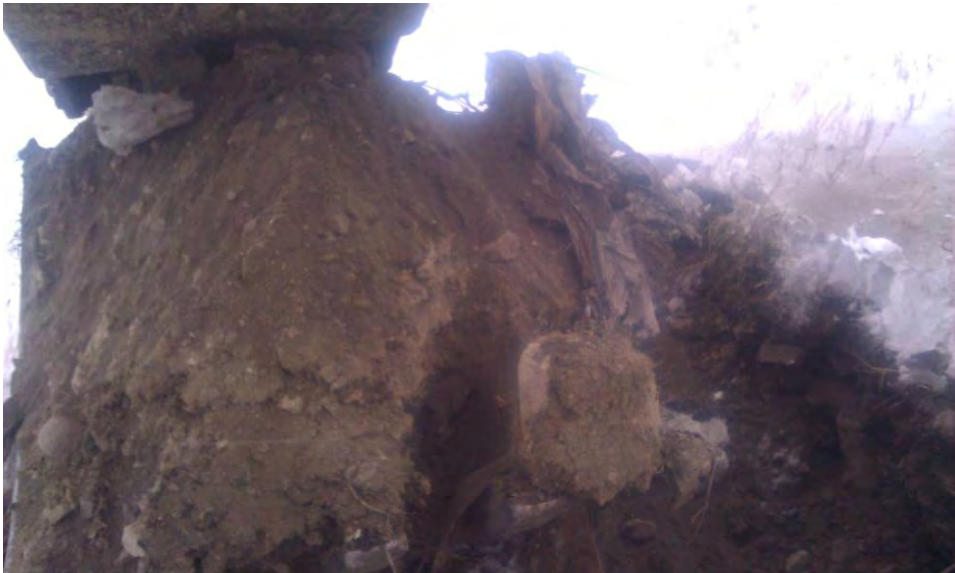
Client Name: Public Works and Government Services Canada		Site Location: Drumheller Institution, Drumheller Alberta	Project No. 2026-1103
Photo No. 21

Date: November 30, 2011			
Direction Photo taken: N/A			
Description:  TP12: Building and metal waste present in excavated materials.

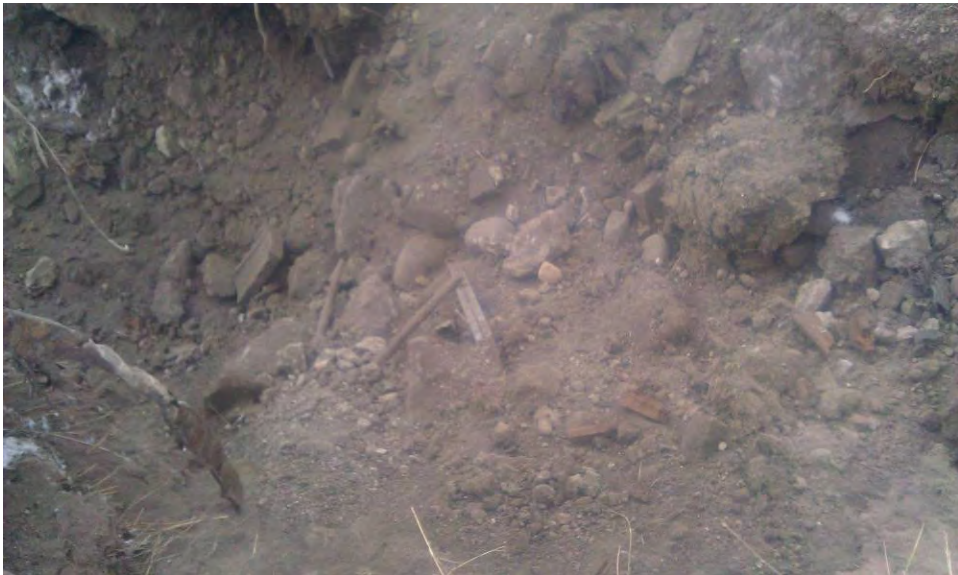
Client Name: Public Works and Government Services Canada		Site Location: Drumheller Institution, Drumheller Alberta	Project No. 2026-1103
Photo No. 22

Date: November 30, 2011			
Direction Photo taken: N/A			
Description:  TP12: In situ fill material. Waste materials visible.

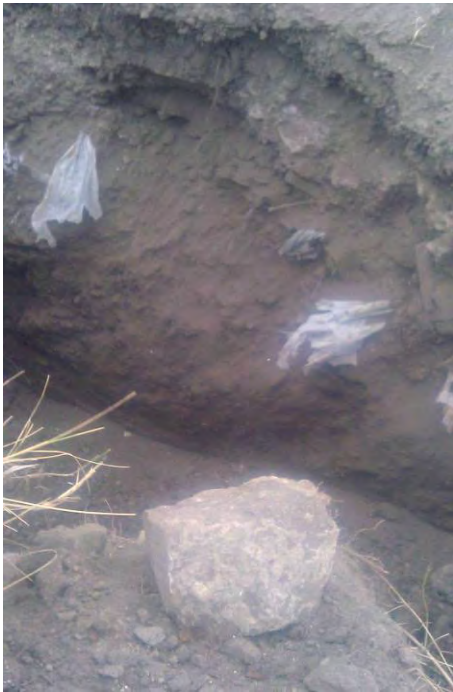
<b>Client Name: Public Works and Government Services Canada</b>		<b>Site Location: Drumheller Institution, Drumheller Alberta</b>	<b>Project No. 2026-1103</b>
<b>Photo No. 23</b>

<b>Date: November 30, 2011</b>			
<b>Direction Photo taken: N/A</b>			
<b>Description:</b>  <b>TP12: View of plastic material and boulder size concrete wastes within fill on wall of test pit.</b>

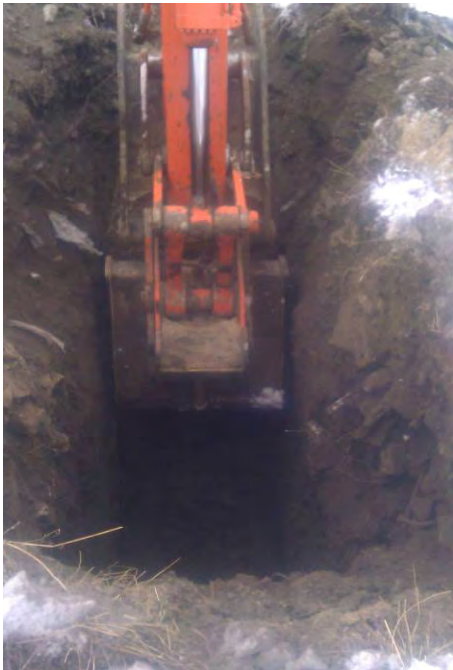
<b>Client Name: Public Works and Government Services Canada</b>		<b>Site Location: Drumheller Institution, Drumheller Alberta</b>	<b>Project No. 2026-1103</b>
<b>Photo No. 24</b>

<b>Date: November 30, 2011</b>			
<b>Direction Photo taken: N/A</b>			
<b>Description:</b>  <b>TP12: View of excavations side and floor at approximately 5 m bgs. In situ waste visible in test pit.</b>

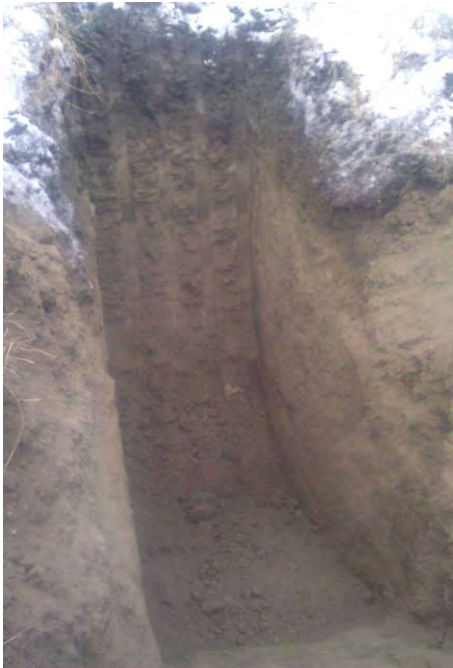
<b>Client Name: Public Works and Government Services Canada</b>		<b>Site Location: Drumheller Institution, Drumheller Alberta</b>	<b>Project No. 2026-1101</b>
<b>Photo No. 25</b>

<b>Date: November 30, 2011</b>			
<b>Direction Photo taken: N/A</b>			
<b>Description:</b>  <b>TP13: "Gumbo" topsoil visible at surface of test pit.</b>

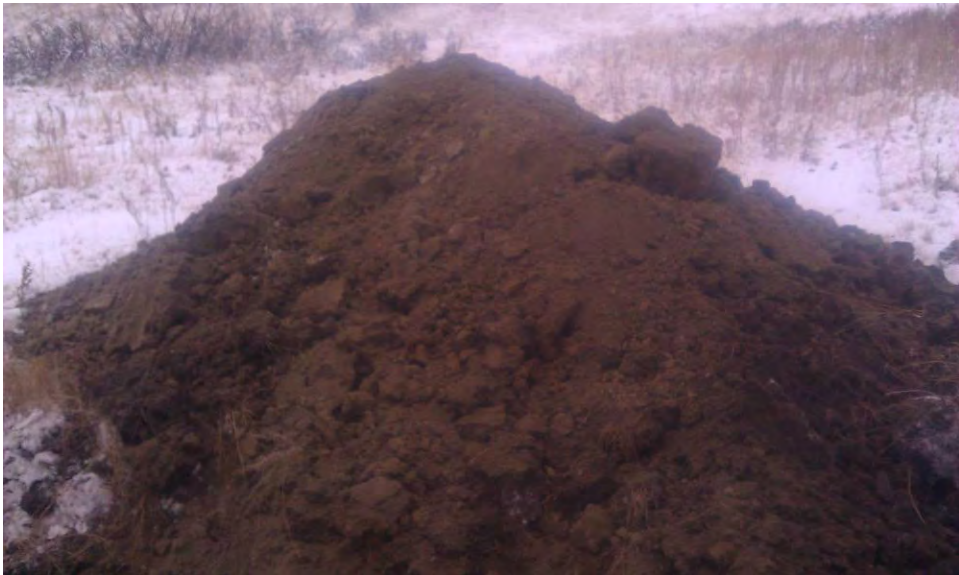
<b>Client Name: Public Works and Government Services Canada</b>		<b>Site Location: Drumheller Institution, Drumheller Alberta</b>	<b>Project No. 2026-1101</b>
<b>Photo No. 26</b>

<b>Date: November 30, 2011</b>			
<b>Direction Photo taken: N/A</b>			
<b>Description:</b>  <b>TP14: Excavated native material.</b>

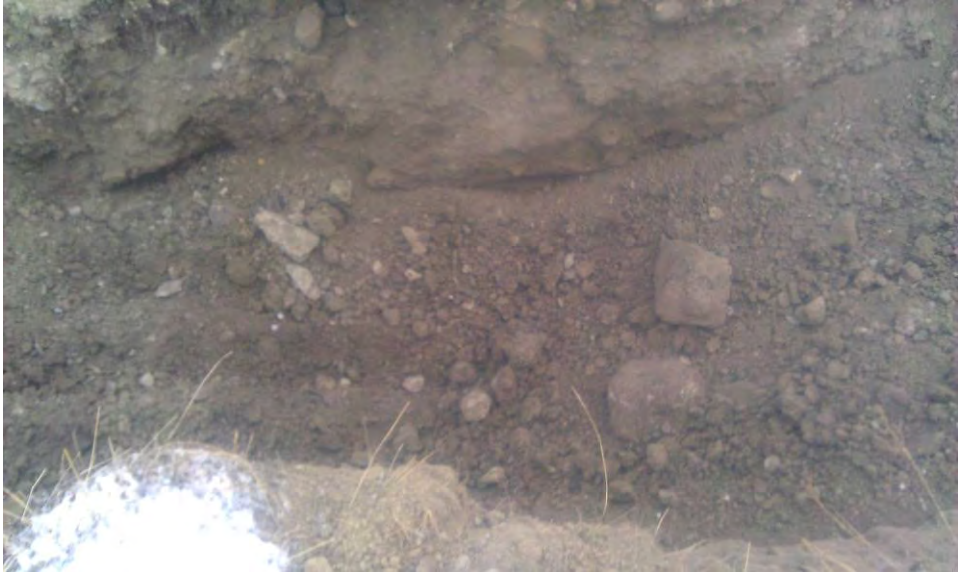
<b>Client Name: Public Works and Government Services Canada</b>		<b>Site Location: Drumheller Institution, Drumheller Alberta</b>	<b>Project No. 2026-1101</b>
<b>Photo No. 27</b>

<b>Date: November 30, 2011</b>			
<b>Direction Photo taken: N/A</b>			
<b>Description:</b>  <b>TP15: Pieces of concrete waste visible in test pit.</b>

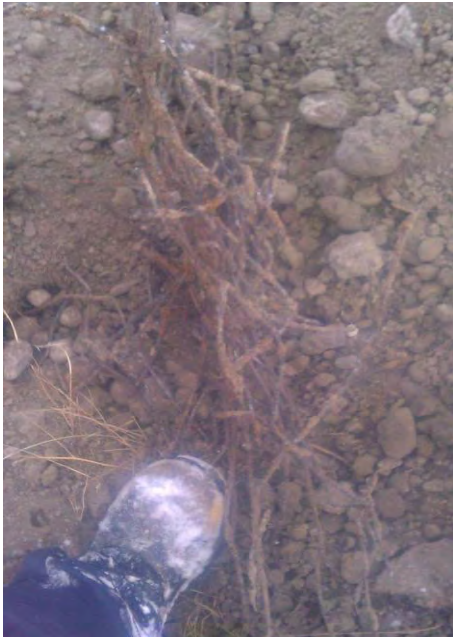
<b>Client Name: Public Works and Government Services Canada</b>		<b>Site Location: Drumheller Institution, Drumheller Alberta</b>	<b>Project No. 2026-1101</b>
<b>Photo No. 28</b>

<b>Date: November 30, 2011</b>			
<b>Direction Photo taken: N/A</b>			
<b>Description:</b>  <b>TP15: Metal wire mesh excavated from test pit.</b>

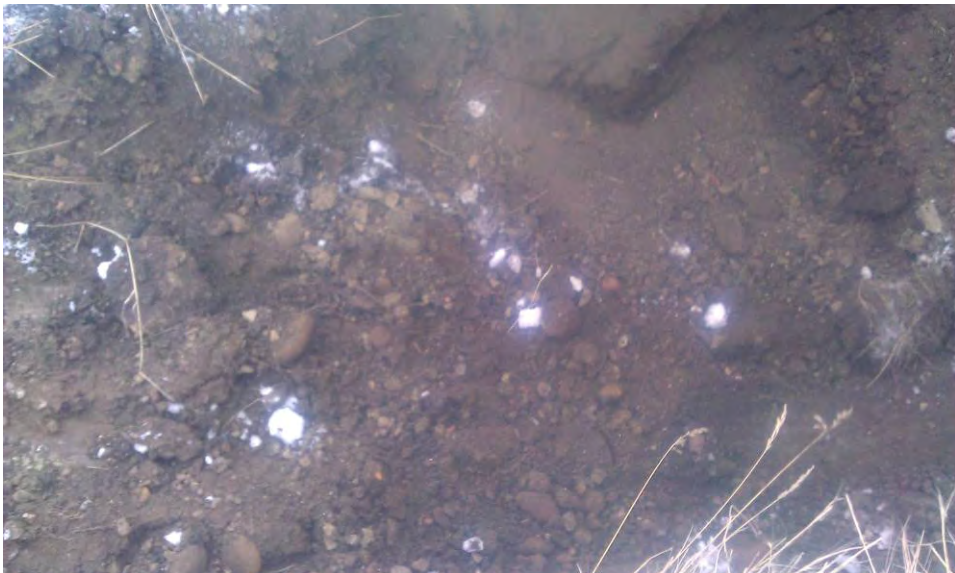
Client Name: Public Works and Government Services Canada		Site Location: Drumheller Institution, Drumheller Alberta	Project No. 2026-1101
Photo No. 29

Date: November 30, 2011			
Direction Photo taken: N/A			
Description:  TP16: Red shale type material encountered at 0-1.0 m bgs.

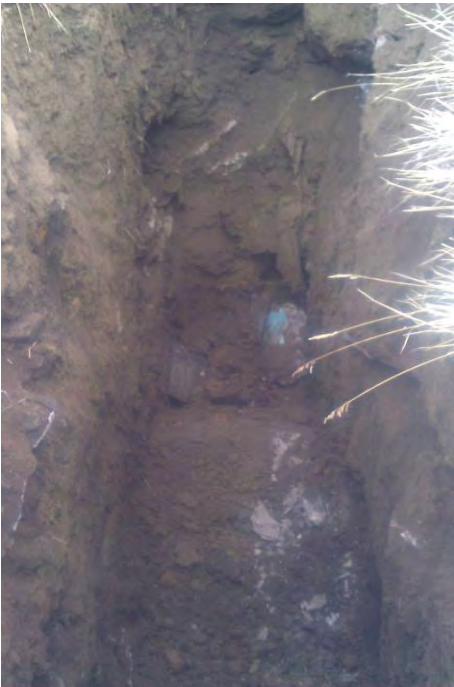
Client Name: Public Works and Government Services Canada		Site Location: Drumheller Institution, Drumheller Alberta	Project No. 2026-1101
Photo No. 30

Date: November 30, 2011			
Direction Photo taken: N/A			
Description:  TP16: Large piece of concrete (>300 mm) encountered between 2.0 and 6.0 m bgs.

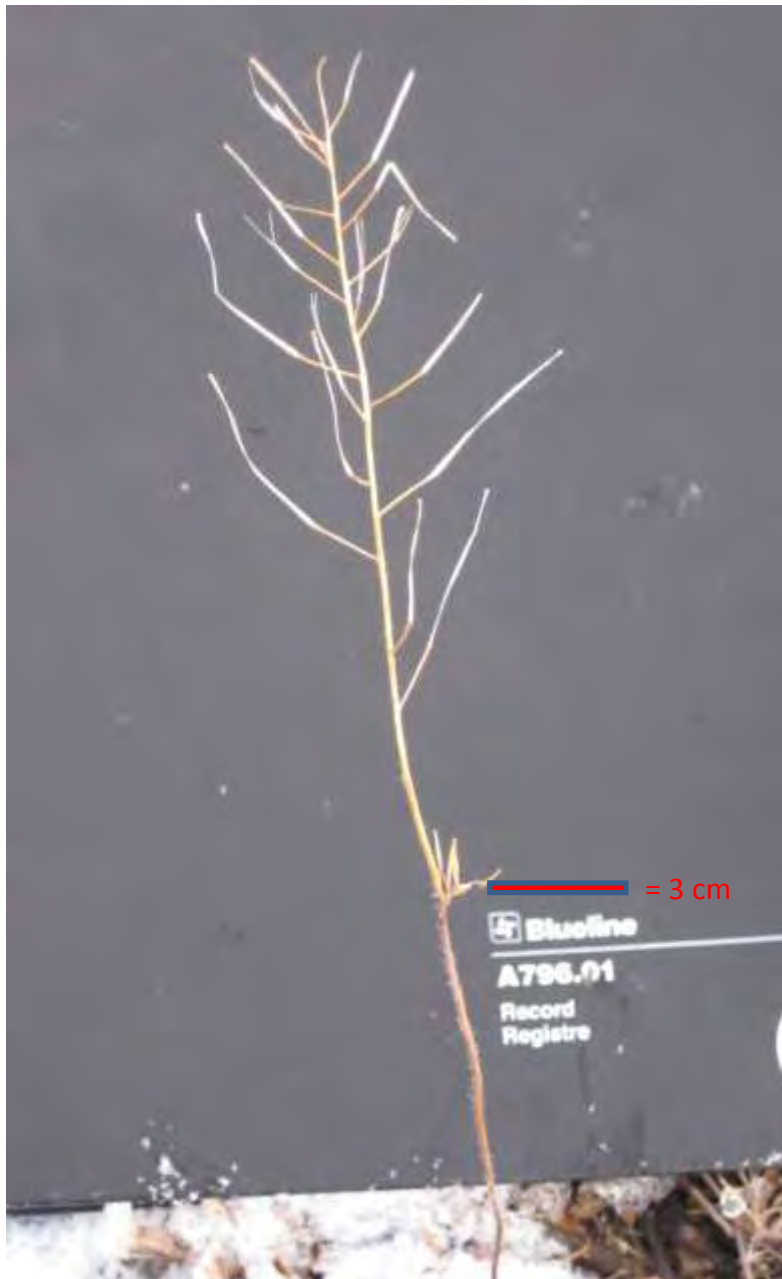
**Figure 4.** Photograph of stem of putatively identified *Halimolobos virgata* found in quadrat 92. This was the only individual found throughout the study area.
