**REQUEST FOR PROPOSALS FOR ARCHITECTURAL MULTIDISCIPLINARY SERVICES
AS PART OF THE PROJECT OF MANSORY REPAIRS OF THE CUSTOMS BUILDING**

REQUEST FOR PROPOSALS FOR ARCHITECTURAL MULTIDISCIPLINARY SERVICES
AS PART OF THE PROJECT OF MANSORY REPAIRS OF THE CUSTOMS BUILDING
105 McGill Street / 400 place d'Youville
Montréal, Quebec

- 1.1 PWGSC Project Title:** Customs Building Masonry Repairs
- 1.2 Location of the Project:** 105 McGill Street / 400 place d’Youville, Montréal
- 1.3 PWGSC Project Number:** R.021798.100
- 1.4 Client / User:** Public Works and Government Services Canada (PWGSC)
- 1.5 PWGSC Project Manager:** Pierre-Hugues Mathieu

Preliminary Masonry Condition Assessment

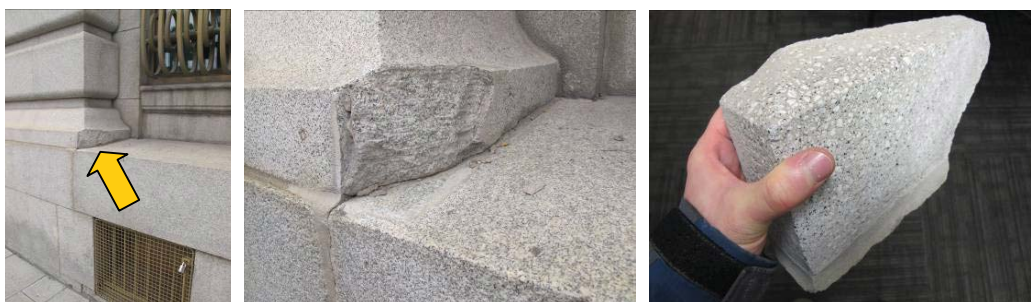
Figures 1, 2 and 3 Fractured corner, at ground floor level from a 105 McGill west façade pilaster, which fell in 2007 (spall currently kept in SNC-Lavalin's offices located in the basement).

After the fall of a previously repaired corner of a granite pilaster located below one of the 105 McGill ground floor windows (*figures 1 to 3*), a third report was prepared in 2007-2008 by Régis Côté et associés architectes to assess the risk for public safety. Following this assessment, urgent repointing work was conducted by the masons of Atwill-Morin. Approaches were then made to initiate a new repair project but the latter came to a halt in 2008, at the Investment Analysis Report (IAR) stage. No masonry intervention has been performed between 2008 and 2012.

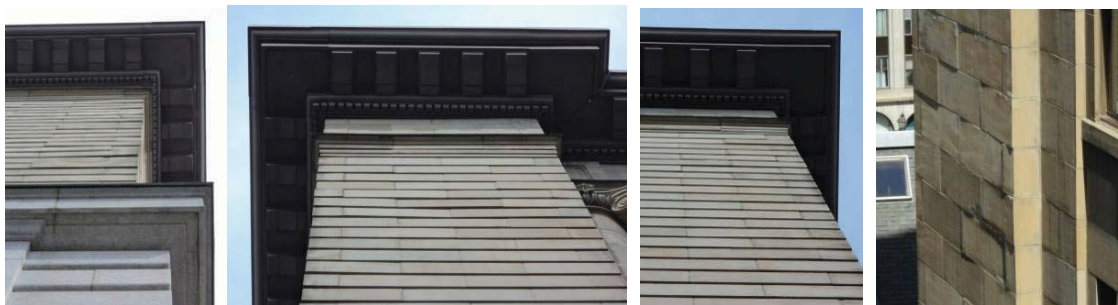
Figures 4, 5, 6 and 7 South and east façades of the southeast corner avant-corps, east façade of northeast corner avant-corps, west façade of northwest corner avant-corps (September 2011).

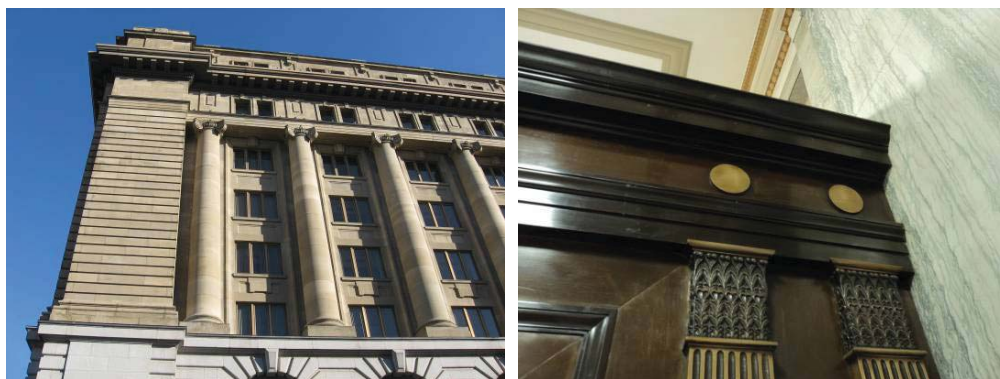
Figures 9 and 10 Façade along McGill Street and details of bronze vestibule inside the entrance lobby (400 place d'Youville).

Outside, the ensemble maintains a highly consistent style thanks to the seamless treatment of the façades, and the use of identical materials (*figure 9*). Inside, notwithstanding significant modifications to the layout, the distribution of original functions is still noticeable and, above all, the entrance lobby (*figure 10*) and the long room remain relatively intact.

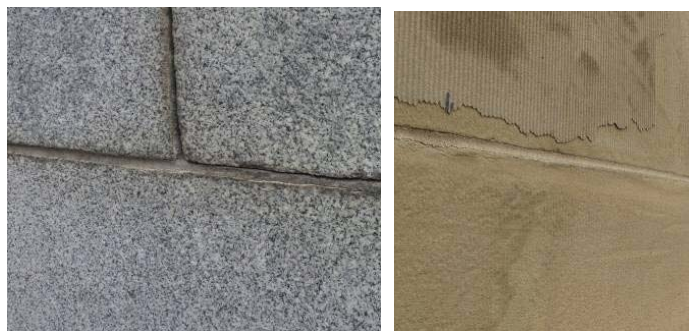
Figures 11 and 12 Existing granite and sandstone claddings.

The Customs Building exterior cladding is made of two different types of stone: Grey granite on the two lower storeys (*figure 11*), and buff sandstone on the upper storeys (2nd to 7th floor, as well as for the original penthouses, *figure 12*). In both cases, the sourcing of the stone raises some questions.

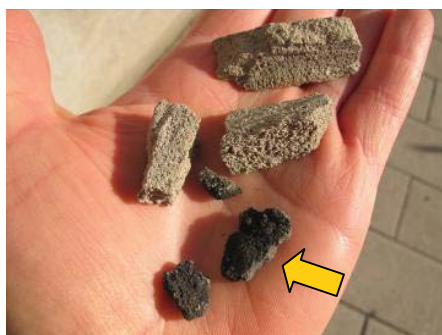
Figure 15 Black mortar scraps collected behind the more recent grey joints of the ground floor granite cladding.

- a. The stones must be set in their natural or quarry bed, and “well flushed up with Portland cement mortar, composed of three measures of clear grit sand and one of cement mixed with pure water on a boarded floor” (p. 12);
- b. Upon completion, “clean down the entire stonework with wire brushes, muriatic acid and clean water and all external joints to be cleaned out to an average depth of $\frac{3}{4}$ -inch, and then neatly flush pointed in white non-staining cement mortar” (p. 12). Based on the mortar scraps collected on November 22, 2011, on the ground floor of the 105 McGill south façade, close to the central avant-corps, the surface mortar, presumably put in place in 1997-1999, is grey. However, the mortar located deeper behind is black (*figure 15*), which raises questions with regards to the colour of the original joints;

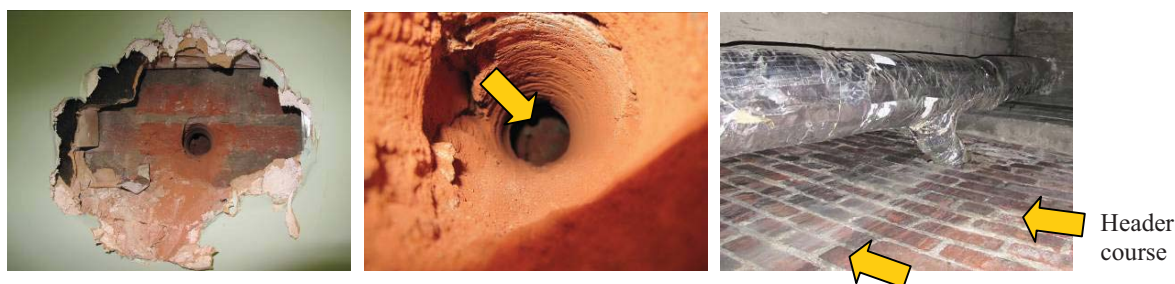
Figures 16, 17 and 18 Boring on the south face of the southeast corner of 105 McGill, on the 5th floor, cavity between the first 12 inches thick wall and the next one (with the boring shrinking to $\frac{1}{2}$ inch), one header course every four stretcher courses, on the 6th floor of 400 place d'Youville.

- g. "All brickwork to be executed in approved bond, four courses of stretchers and one course of headers" (p. 13). Finally, "all brickwork [is] to be built in best quality of cement mortar composed of one of Portland cement to three of clean sharp sand mixed with measure" (p. 14). The alternating brick pattern could not be confirmed for 105 McGill. However, it was observed inside 400 place d'Youville, this time between the concrete beams, as confirmed thanks to two services spaces on the 6th floor, one on the south façade (*figure 18*) and the other on the north façade.

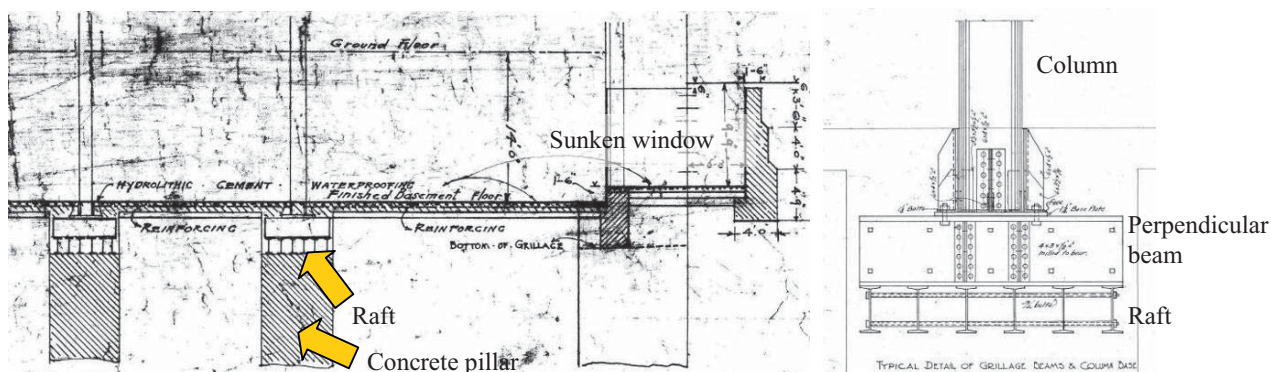
Figures 20 and 21 Cross section (excerpt, p. 18), connection of column and raft foundation of steel beams (p. 27).

Based on the original drawings, the foundations are thus composed of 67 concrete piers¹⁹ resting on bed rock, likely put in place thanks to pneumatic boxes, and connected with a raft foundation made of steel beams embedded in concrete (“grillage beams”, *figure 20*), on which a perpendicular beam distributes the load coming from the columns attached above (*figure 21*). As for the sunken windows planned for the basement, they were apparently never installed.

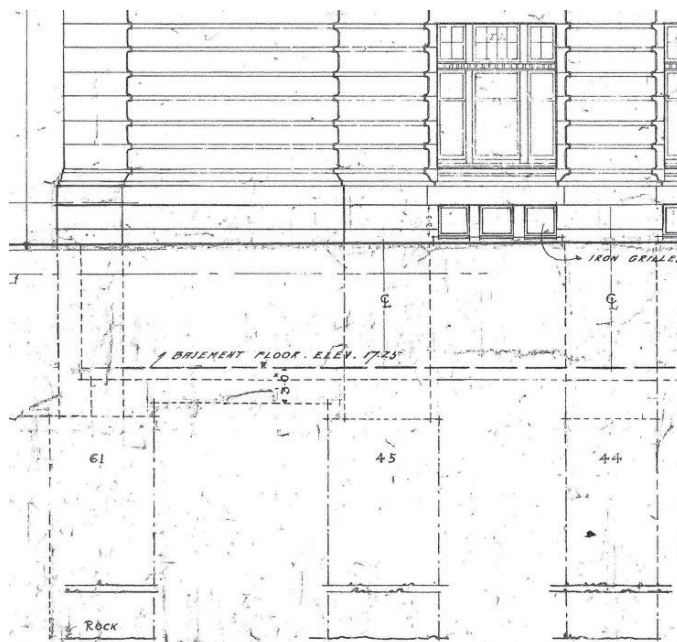
Figure 22 Piers down to bed rock below the north façade (excerpt from the original drawings, p. 13).

In the absence of structural drawings and again according to Guy Pinard, the foundations of 400 place d'Youville and of the central avant-corps have apparently been erected using the same method as for 105 McGill, which would be consistent considering that this portion of the building is located even closer to the small Saint-Martin river. As confirmed, "The managers decided to build the northern [western] portion as soon as possible, and the contractor Lyall was awarded the contract on May 1st, 1919. However, construction work was stopped as soon as the construction of the piers was completed, due to the lack of funding."²⁰ The use of massive piers is also apparently confirmed in the architectural drawings (*figure 22*).

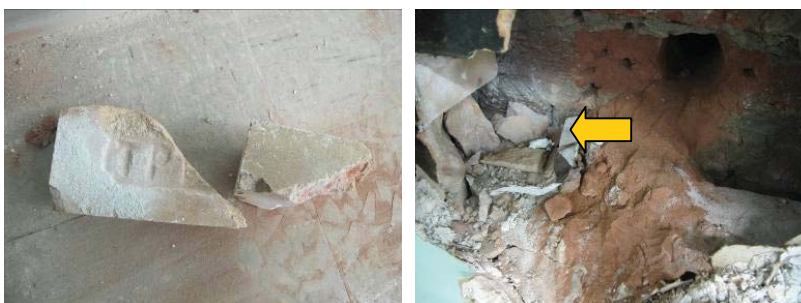
Figures 37 and 38 Brick fragments from the boring drilled on the 5th floor in the southeast corner of 105 McGill, metal tie between the solid wall and the interior facing in the same location.

However, an item of the specifications requesting that the facing “be well bonded to the backing every fifth course by a stretcher and header alternating [...]” (p. 16) could have been replaced with the installation of metal ties, between the solid wall and interior brick facing (*figure 38*).

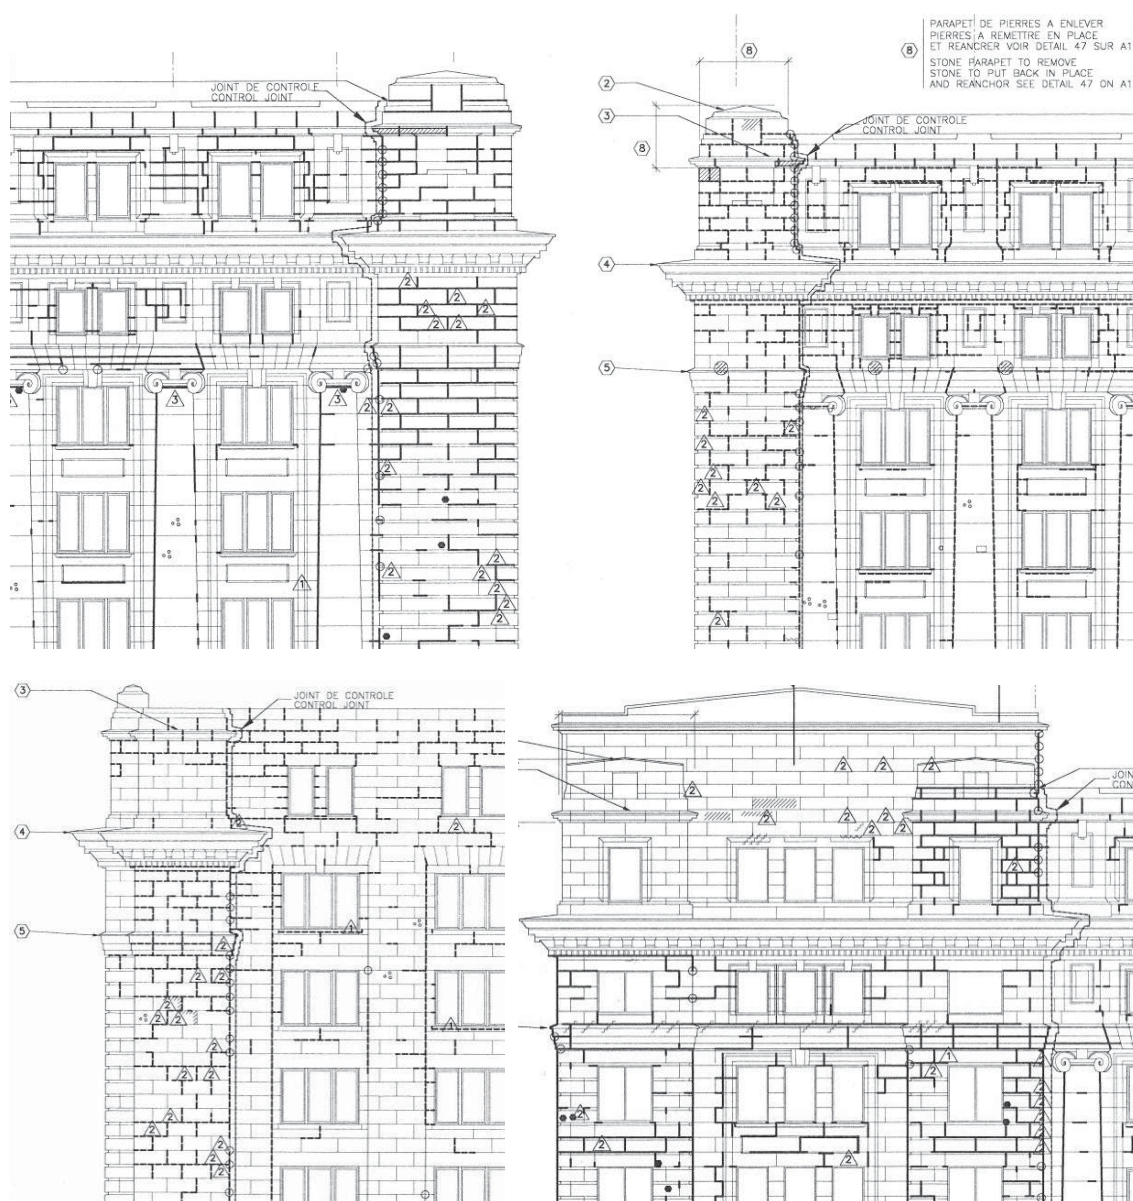
Figures 67, 68, 69 and 70 South and east façades of 105 McGill (excerpts from pages A09 and A08), west façade and central avant-corps south façade of 105 McGill (excerpts from pages A07 and A09).

- d. To stabilize the numerous displaced stones of 105 McGill corner avant-corps, installing anchors is the only intervention planned (no dismantling or reassembling), and is limited to the southeast corner (17 on the west face, *figure 67*, and 9 on the east face, *figure 68*)²⁴, and to the northwest corner (14 on the west face, *figure 69*). No anchors are planned in the northeast corner avant-corps;
- e. Ten (10) anchors are planned to stabilize stones of the central avant-corps, primarily in the upper portion of the southeast corner, and ten (10) additional anchors are planned at parapet level (*figure 70*);

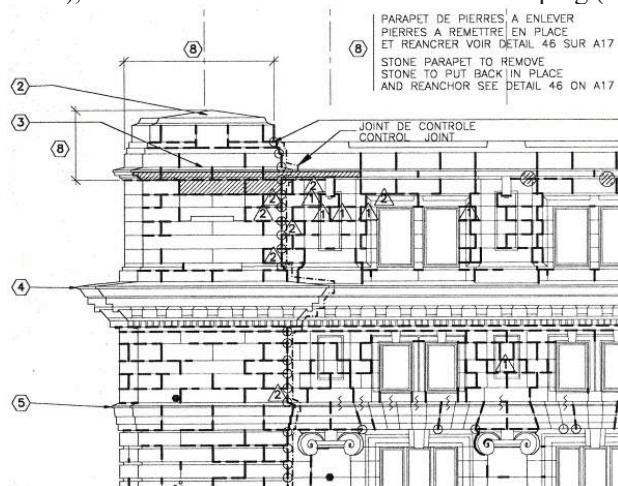
Figure 71 Parapet to be dismantled on the southwest corner of 400 place d'Youville south façade (from page A01).

- f. It is planned to entirely dismantle and reassemble the corner avant-corps parapet stones, by attaching them with anchor plates, following the construction of a new concrete block backing (cells filled with concrete mixture), and the installation of a new concrete coping (see note 8, *figure 71*);

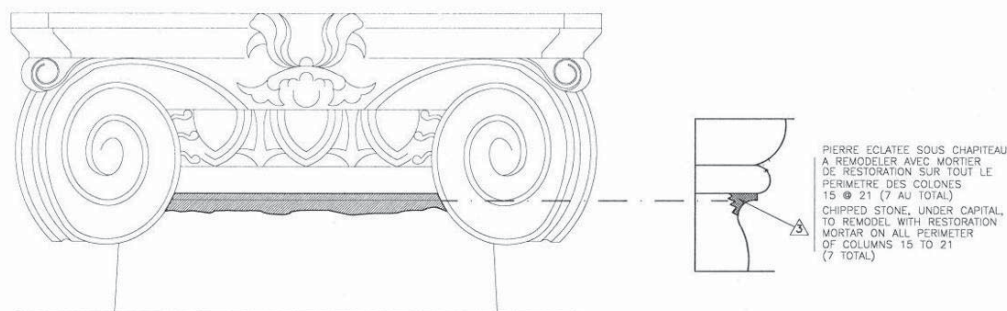
Figure 72 Remodelling of the flare below the capitals (detail 25, page A09).

- l. The copper flashings of the penthouses are kept in place;
- m. At the top of each column, the flare below the capital is remodelled using restoration mortar (*figure 72*);

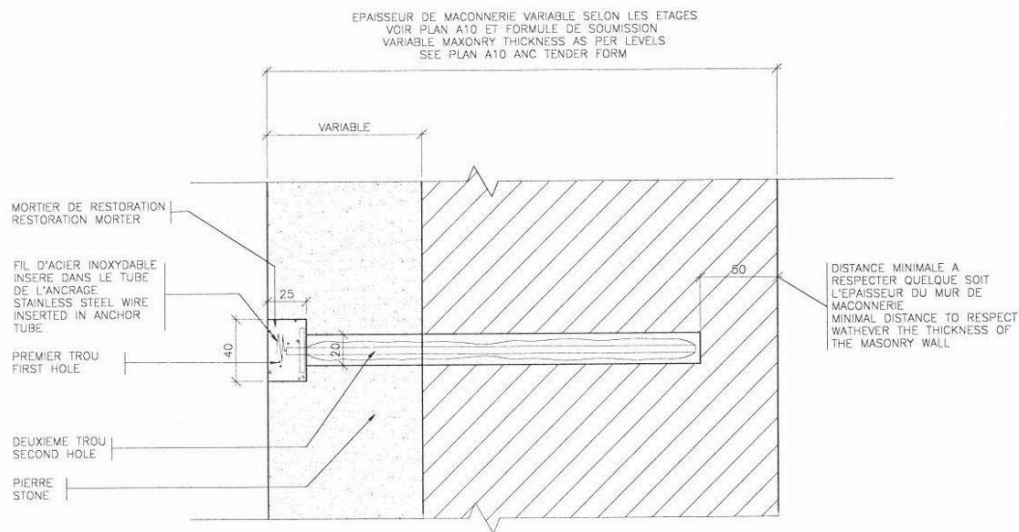
Figure 73 Typical anchor (detail 53, page A17).

n. Based on the planned detail for the anchors, the latter were of the injectable type or Cintec (*figure 73*);

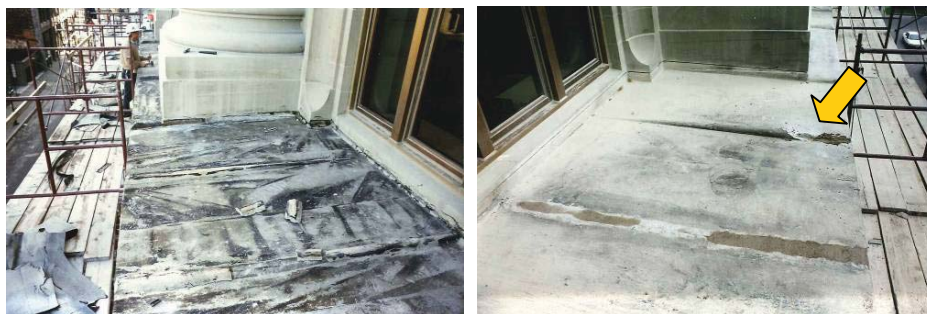
Figures 76 and 77 Removal of the stone “strips” on the deep cornice at the base of the columns, patching the surfaces damaged in the process, here along Normand Street.

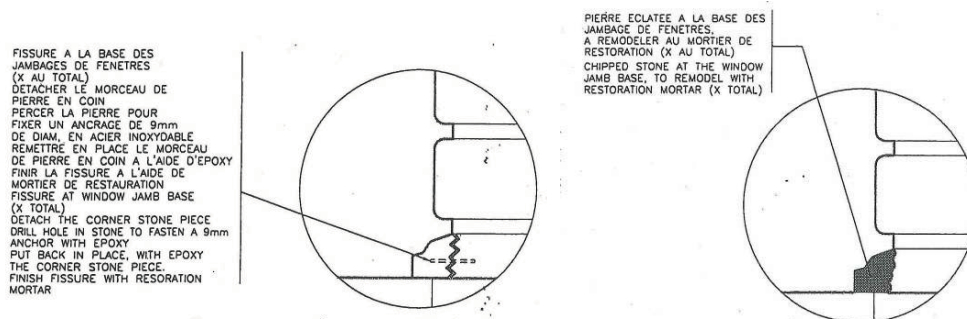
Figures 80 and 81 Details showing the proposed repair of the lower corners of the pilasters (drawing no 27 and 26 taken from the drawings for tenders, 1996).

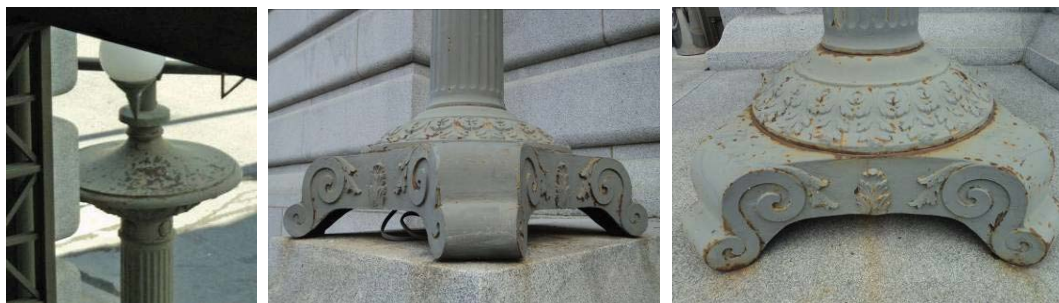
- Stones are rust stained in every location where the handrails are attached to the exterior wall;
- Some stones located above are also rust stained, but the reason is less clear.

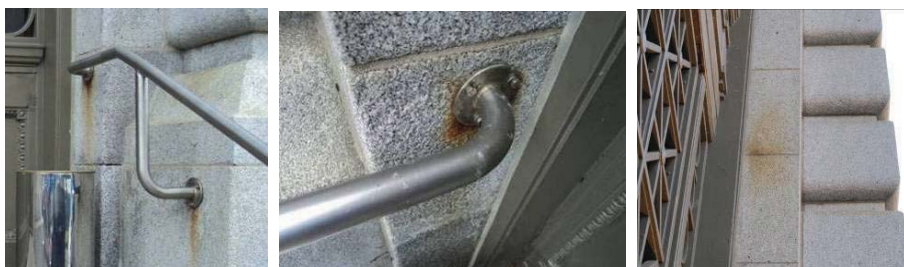
PORTICO / 400 PLACE D'YOUVILLE

- Along the semicircular arches that crown each of the three openings of the portico, several stones are displaced and the width of the mortar joints increases near the top;
- Outside, the stones are sagging and slightly protruding;
- Similar displacements are visible inside the portico.

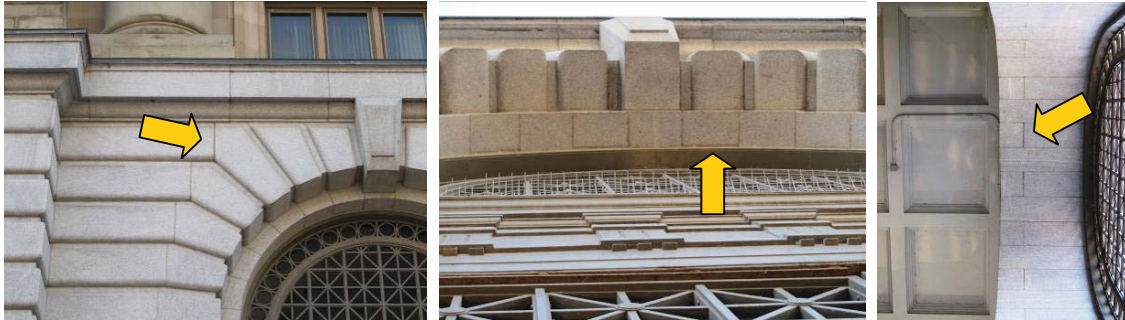
- Behind the pillars of the portico, several mortar joints are de-bonded or opened, some stones are deeply cracked and others are slightly displaced;
- Based on the original drawings (pages 1 et 2), the foundations do not entirely support the pillars above. Also, each pillar is made of a concrete column embedded on three faces with a brick backing, and clad with granite. However, behind the pillars, the cladding is apparently directly in contact with the concrete column.

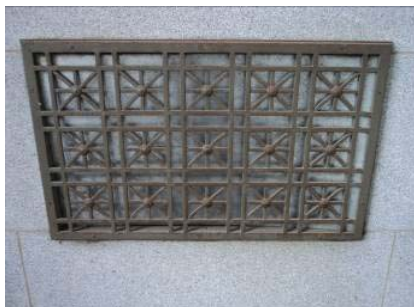
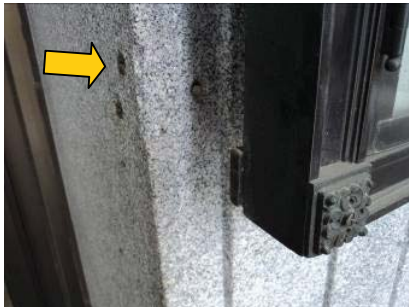
PLINTH

- At the southeast corner of 105 McGill, the mortar joints are de-bonded, and the corner stone at the base of the wall is displaced (eastward);
- At the northeast corner of 105 McGill, two stones are fractured.

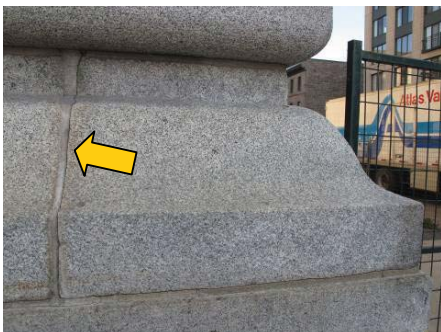
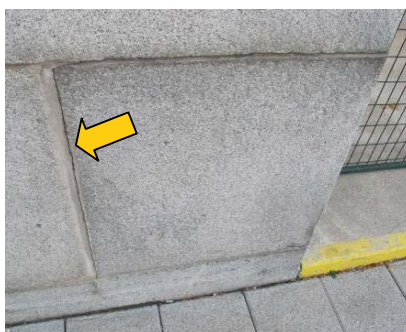
- Stones located along the plinth, especially on Normand Street, are eroded by de-icing salt, striped, rust stained and fractured in some places, likely due to snow removal along the sidewalk;
- Several stones peel and many mortar joints are opened, especially along McGill Street.

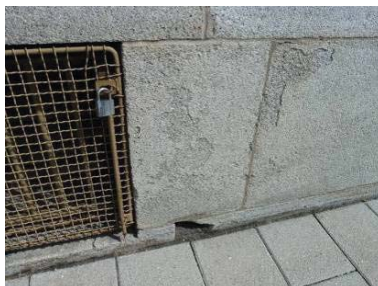
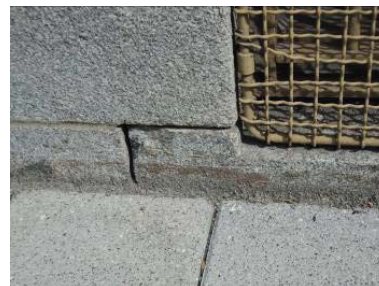
- Stones located close to the ground are also splashed by rain and melting snow dripping from the cornice that separates the two lower storeys from the upper portion of the building, and which bounces back against the wall after reaching the sidewalk.

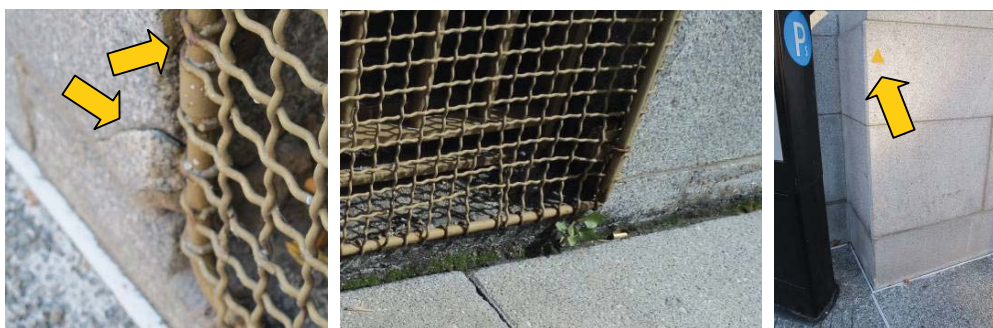
PILASTERS

- With its cyma reversa profile, the base stone extends outside the axis of the pilasters, and the pressure difference thus created weakens this flare and incidentally the corners. Moreover, the mortar joints perpendicular to the façade are spalled, facilitating water infiltrations, which results, in the long term, in the fracturing of most corners, notwithstanding the repairs made during the 1997-1999 campaign.

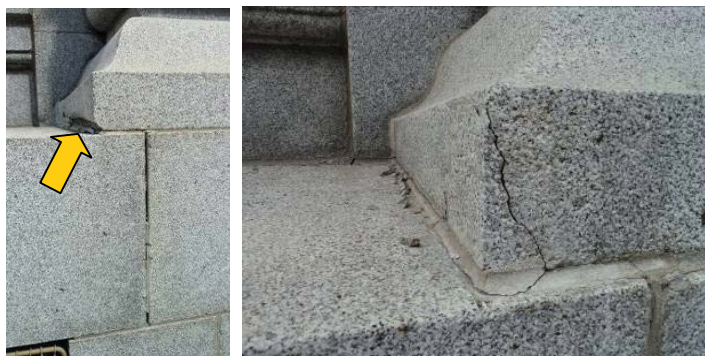
- Some castings have held adequately, but several mortar joints have been replaced with sealant;
- Right below, some vertical mortar joints are backed with a compressible filler, here on the 105 McGill south façade.

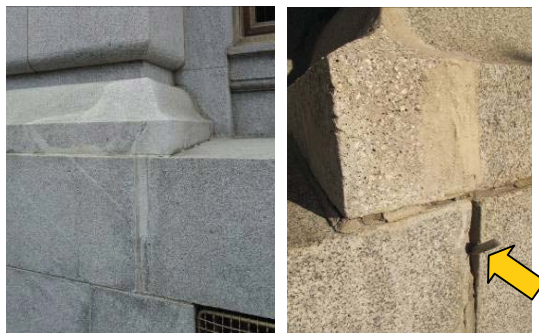
CORNER AVANT-CORPS

- With their numerous inside corners, the corner avant-corps are apparently more subject to snow build-up. Also, stones located below the cornice that separates the two lower storeys from the upper portion of the building are more exposed to dripping melting snow and the resulting ice build-up.

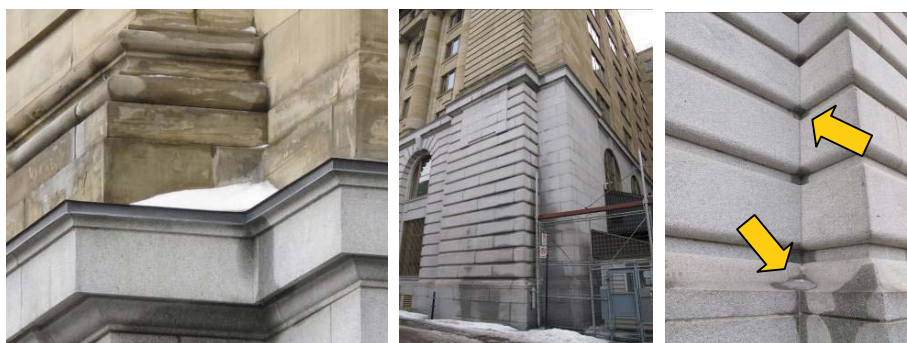
CLADDING

- Several vertical mortar joints are opened where the south façade meets the central avant-corps, among others;
- Elsewhere, all vertical mortar joints located along inside corners have been replaced with sealant;
- Several mortar joints are also opened around the bases that support the original lampposts, at the entrance of 400 place d'Youville.

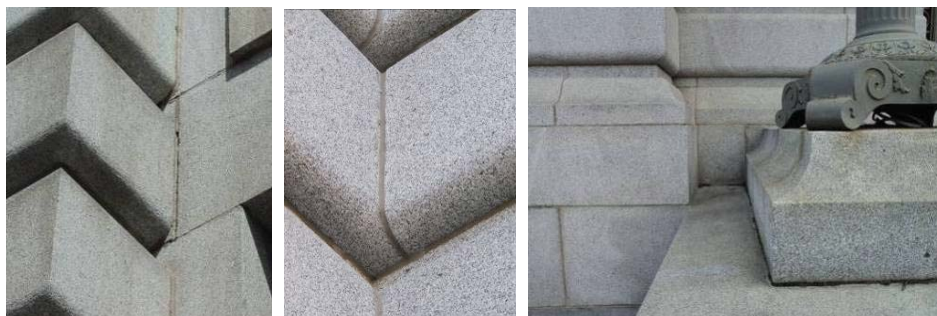
- Several stone lintels located above the ground floor windows, especially on the south façade of 400 place d'Youville, are deeply fractured. The vertical mortar joint above the crack is de-bonded along the pattern protruding below the window sill;
- Several stones are moisture or soil stained.

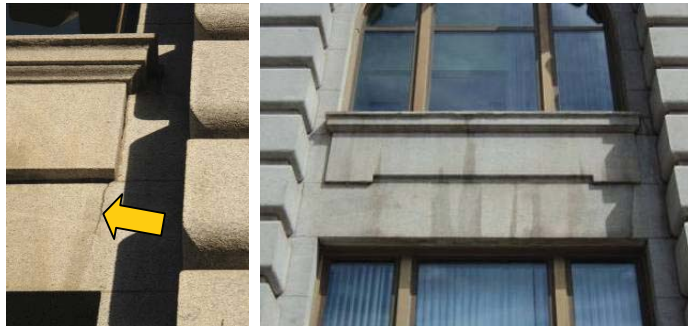
- Some stones are stained and bear drill holes where former signs where, such as at the corner of Normand Street and place d'Youville among others;
- Some letters are almost erased, but remain visible on a stone located inside the courtyard, at the northwest corner of 105 McGill.

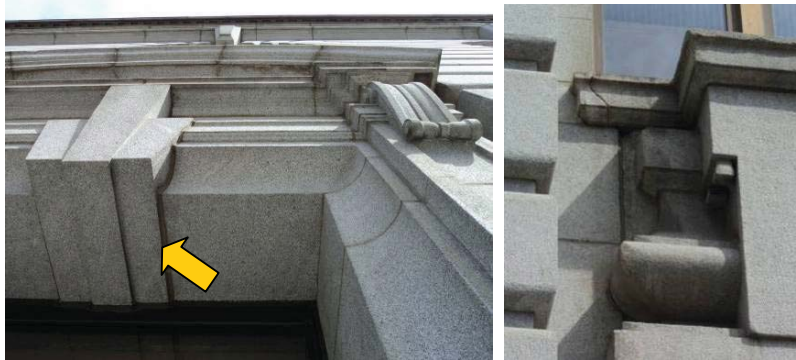
- Some keys are displaced at the top of the semicircular arches that crown the large openings framing the ground floor and first floor windows (here on the north façade of 400 place d'Youville);
- Some keys are eroded (here on the south façade 105 McGill).

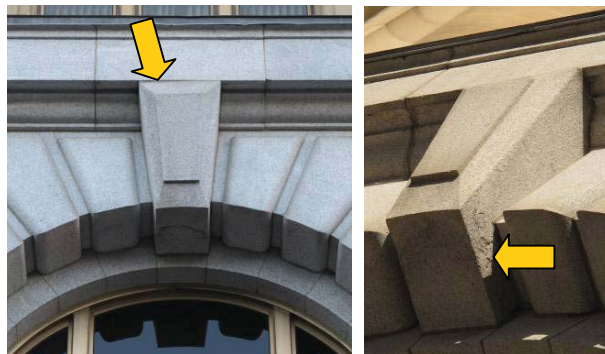
- Most keys are moisture and soil stained, a phenomenon accentuated, among others, by rain and melting snow dripping from the cornice above.

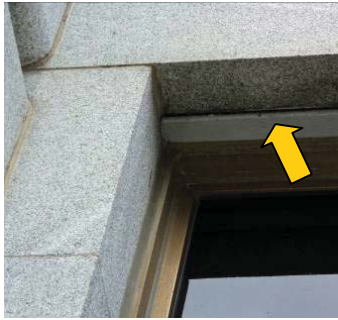
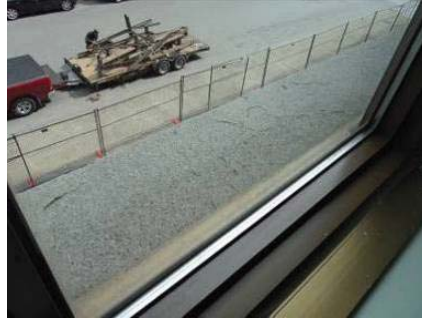
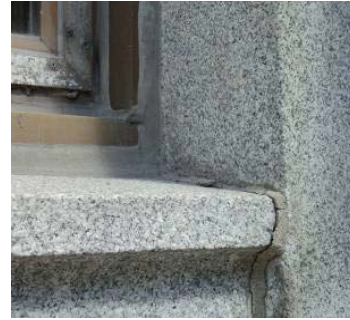
- The edges of several window sills are eroded and/or cracked (the lamp brackets are attached to the lower window mullion and not into the stone).

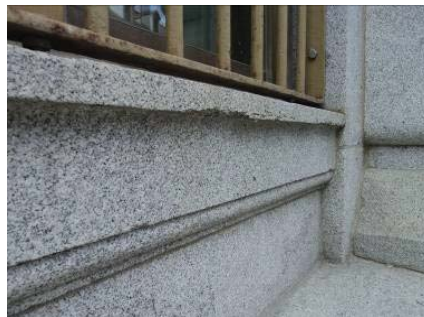
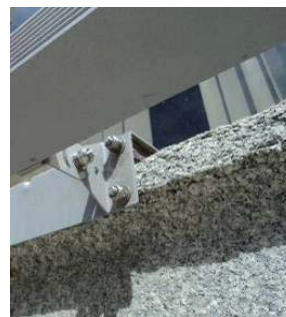
- Below the ground floor window sills, several stones are disaggregated along the deep shelf that crowns the plinth;
- If many stones have indeed a substantial size, some of them are no more than four (4) or five (5) inches thick, as it is the case on each side of the delivery platforms inside the courtyard.

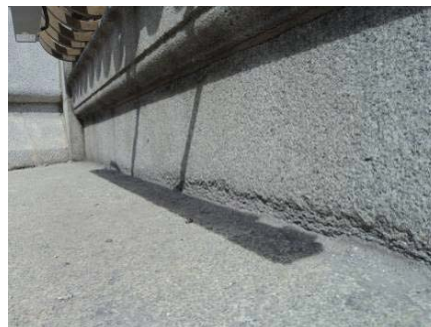
CORNICE

- Some stones are cracked along the cornice that separates the 1st floor from the 2nd floor.

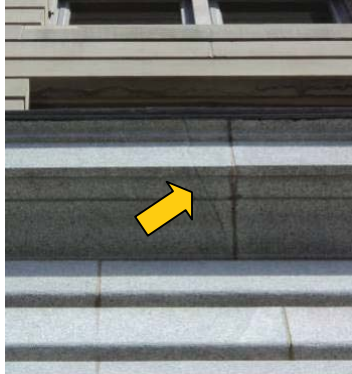
CENTRAL AVANT-CORPS

- At the base of the central avant-corps corners, the mortar joints are de-bonded and opened;
- Where the central avant-corps meets the 105 McGill building, several stones are fractured.

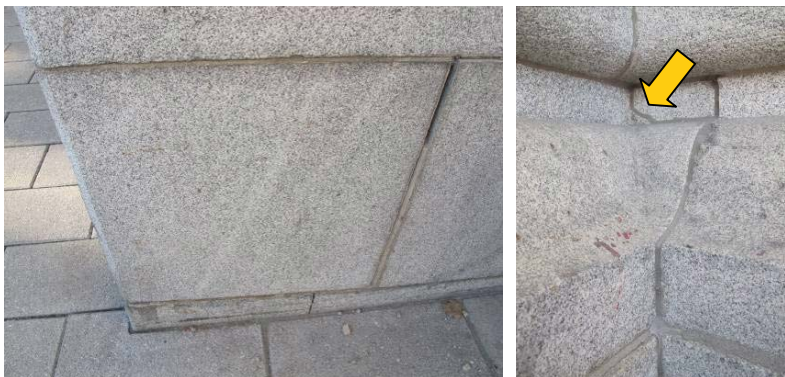
- On each side of the carriage entrance, several mortar joints are opened;
- The lower corners of the pilasters are fractured, close to the opening of the carriage entrance.

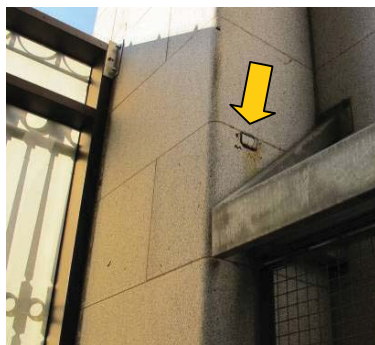
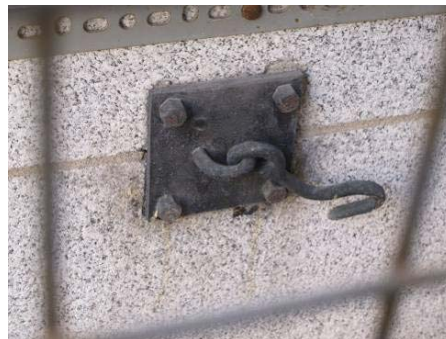
- On each side of the semicircular arch of the carriage entrance, close to McGill Street, clipped and rusted anchors indicate the original location of the large cast iron grills, now fixed in place in front of a curtain wall that blocks the mouth of the passage;
- The original hooks of the grills remain in place, here on the west wall.

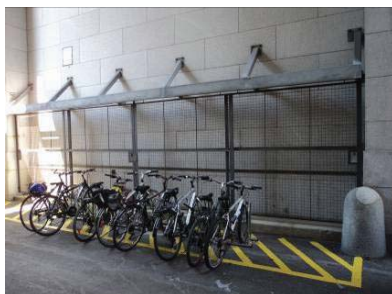
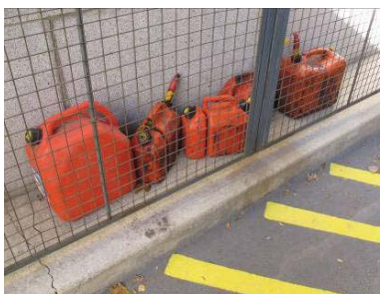
- On the western side of the carriage entrance, an enclosed area made of wire mesh doors suspended from a massive steel beam is used to store fuel.

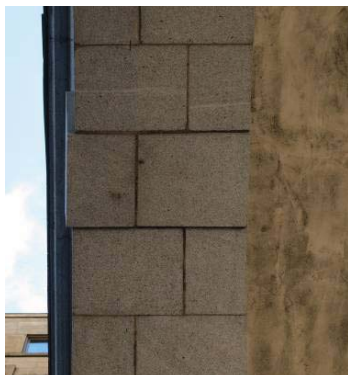
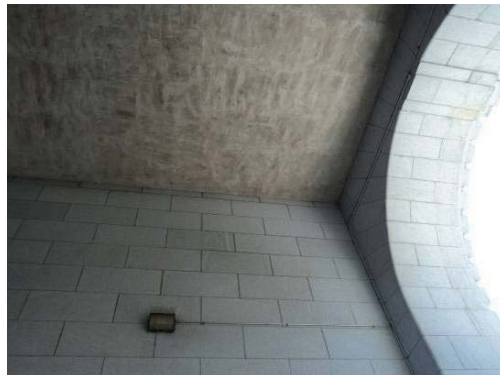
- At the northern end of the carriage entrance, mortar joints around the key of the semicircular arch are larger than elsewhere;
- As for the ceiling of the carriage entrance, the uniform coat of parging is different from the pattern created by the concrete cofferings shown on the original drawings, which could be an indication that the original ceiling underneath is in bad condition and/or has been insulated and covered.

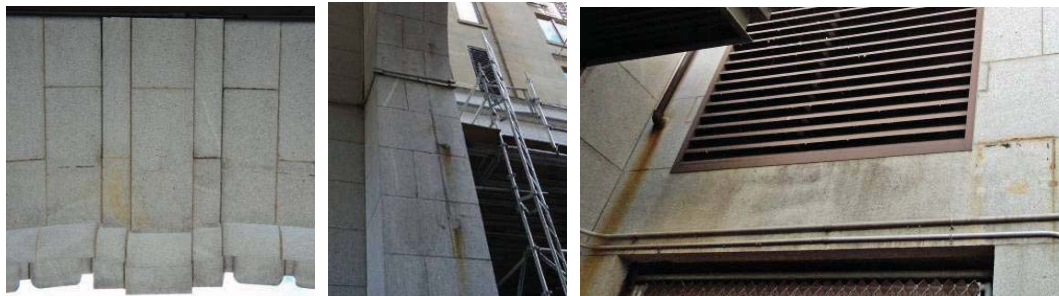
- At the base of the semicircular arch close to the courtyard, bollards show signs of impact (one of them has been repaired), and are stained. Cleaning tests made during the summer of 2011 proved unsuccessful.

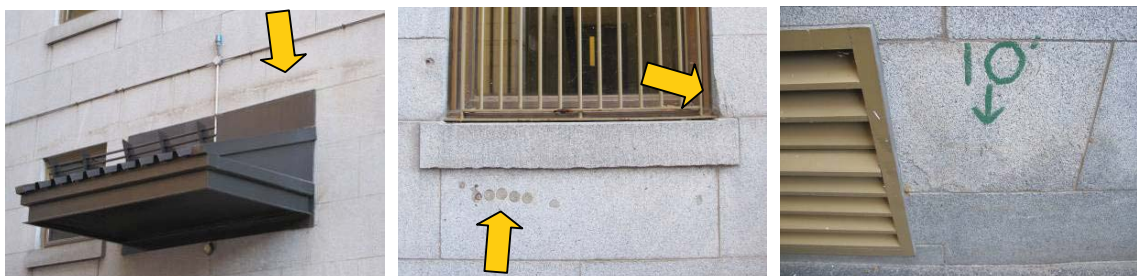
COURTYARD

- Stones are stained above the small marquee that protects the exterior door of 400 place d'Youville (the marquee is not shown on the original drawings);
- All stones to which conduits or wiring are attached are rust stained around the anchors;
- Several holes have been filled under the stairwell window (east façade of 400 place d'Youville), and the lower north corner of the latter is fractured;
- Close to the ground, stones are eroded by de-icing salt, and numbers have been painted in some locations.

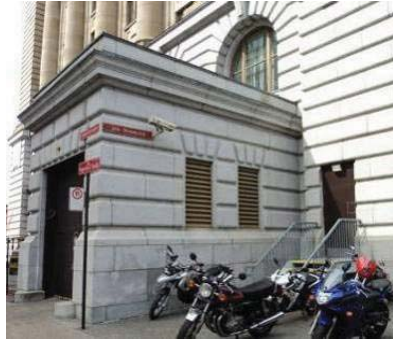
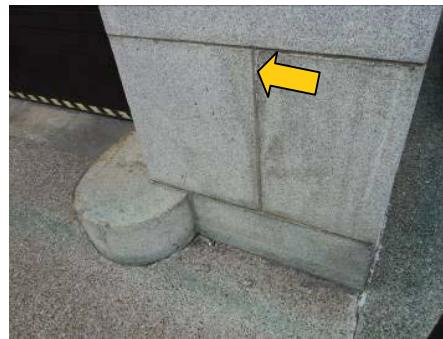
LEAN-TO ON MARGUERITE D'YOUVILLE STREET

- The lean-to located at the northeast corner of 105 McGill and which gives access to the underground parking was added in 1934-1936, along with the construction of 400 place d'Youville. When this modification was made, and in order to create “a bulkhead over the ramp, a portion of the first floor was removed and raised about 2 feet.”²⁹;
- One of the stones of the northeast corner is fractured along the mortar joints.

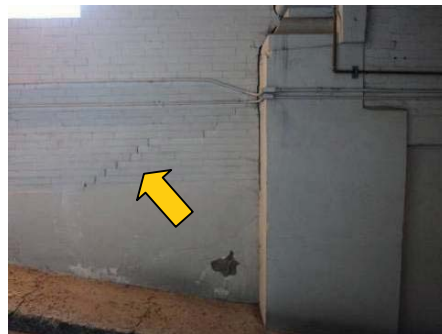
- Inside, cracks in the concrete foundations and brick walls indicate a displacement;
- And this displacement apparently ripples through outside, where the north wall of the lean-to meets the eastern façade of the 105 McGill, as at least one stone is fractured and disaggregated.

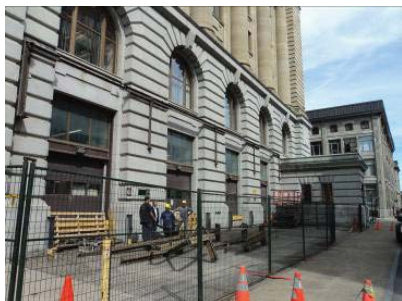
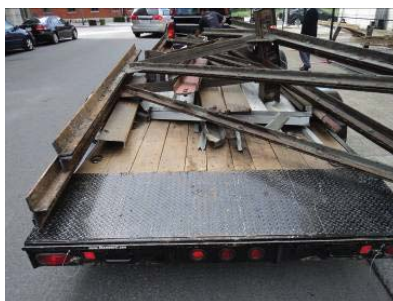
- In anticipation of the warehouse spaces conversion and roof repairs of 105 McGill, the marquee located along Marguerite-D'Youville Street was demolished in August 2011 (under its corrugated metal cladding, the identical one located in the courtyard remains in place).

- The ends of the steel trusses, which are embedded into the wall and connected to the steel columns inside, remain in place (excerpts from the original drawings, p. 4 and 11).

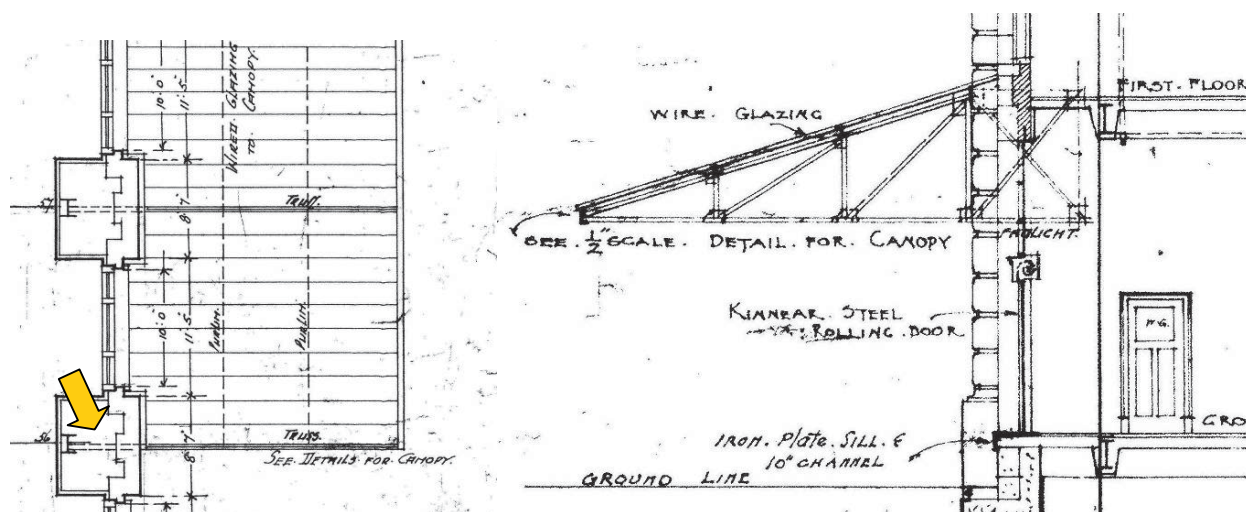
- The junctions between the steel structure and the stone cladding are no longer protected;
- Around the marquee, stones are stained by soil and bird droppings.

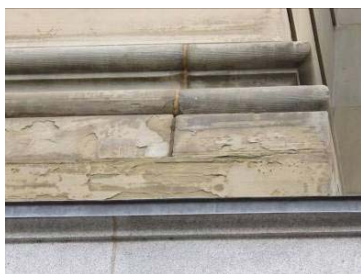
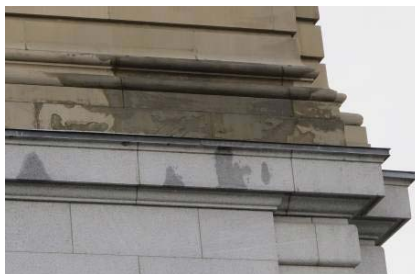
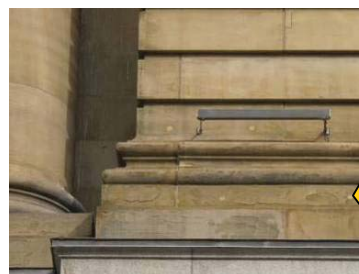
- Above the cornice that separates the two lower storeys from the upper portion of the building, almost every stone that forms the base of the pilasters is significantly exfoliated;
- These stones are splashed by rain and melting snow dripping down from the cornice above;
- In some locations, plugs betray the presence of anchors.

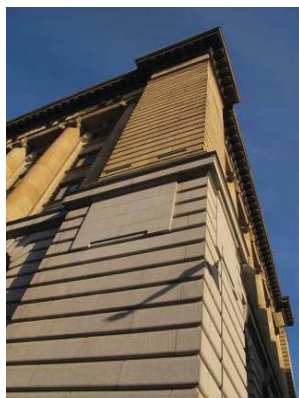
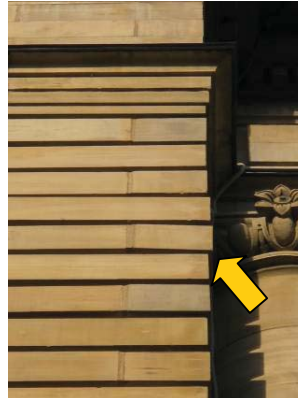
- Several stones are displaced along the southeast, northeast and northwest corner avant-corps of the building, meaning that they protrude from the face of the wall by a few inches, and that, in some cases, they rotate outwardly. These displacements suggest the presence of cavities between the stone cladding and the brick backing;

- Plugs betray the fact that many stones have been anchored, here on the south façade of the southeast corner avant-corps of 105 McGill;
- Although most mortar joints are de-bonded from the stones, they follow the direction of the displacements, which indicates that the latter did not occur recently. For now, the stones above are apparently heavy enough to refrain displaced stones from protruding farther. The displacements are nonetheless more accentuated in the upper portion of the pilasters (shown by the larger width of the mortar joints), where there is less weight above.

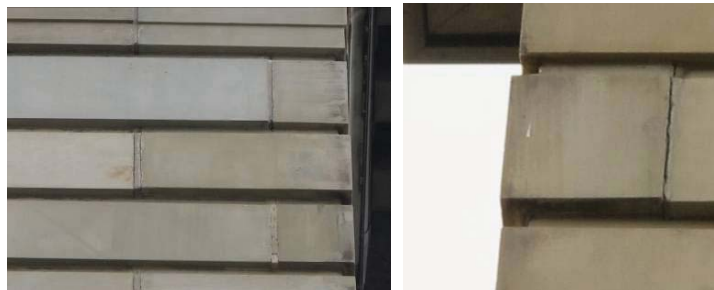
- When comparing observations made on October 27, 2001, with those made on February 16, 2012, stone displacements are apparently ongoing, considering that the gap between some of them has increased (here on the east façade of the northeast corner avant-corps);
- At fifth floor level on the southeast corner avant-corps, one stone is completely detached from the adjacent ones.

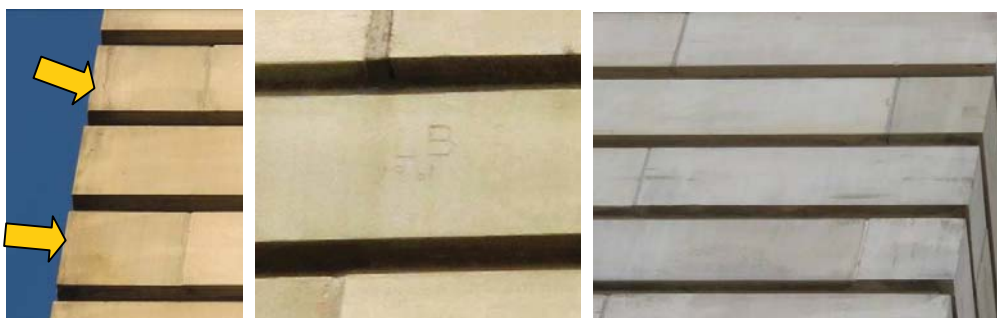
- Higher, above the small cornice that separates the 5th from the 6th floor, several stones are also displaced (here on the southwest inside corner of the southeast corner avant-corps of 105 McGill);
- Plugs indicate that many stones have been anchored, here on the south façade of the southeast corner avant-corps of 105 McGill. In the same location, the width of the mortar joints increases with height, and several of them are de-bonded, here following a steplike pattern matching the displaced stones.

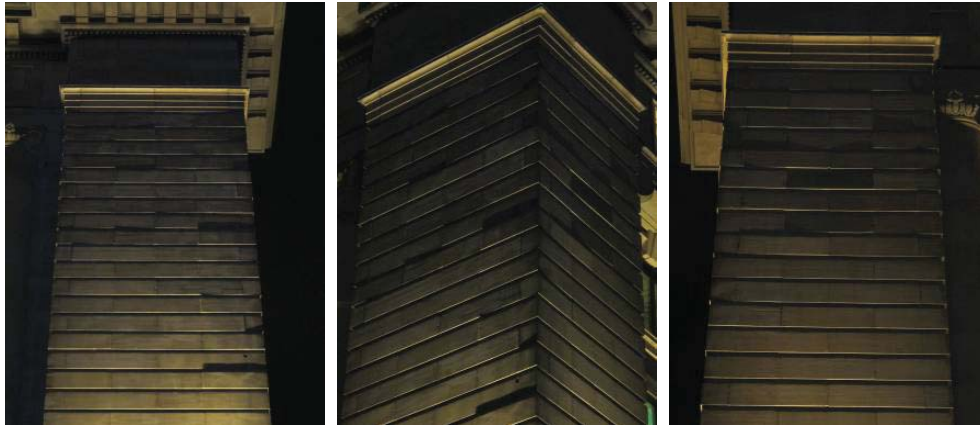
- The displacement of several corner avant-corps stones is especially dramatic at night at the southeast corner of the building, when the illumination emphasizes cast shadows (here in October 2012).

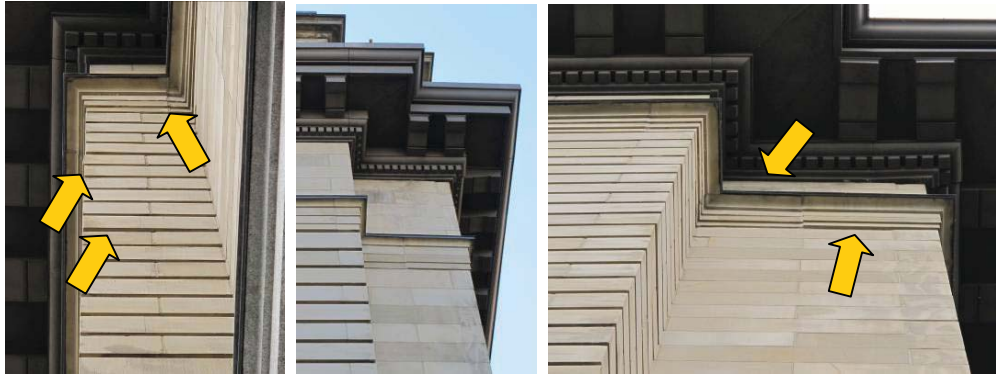
- On the north face of the northwest corner avant-corps of 105 McGill, some stones are moisture stained;
- On the north face of the northwest corner avant-corps of 400 place d'Youville, water likely infiltrated through the top of the main cornice was running down along the 6th floor wall on February 16, 2012.

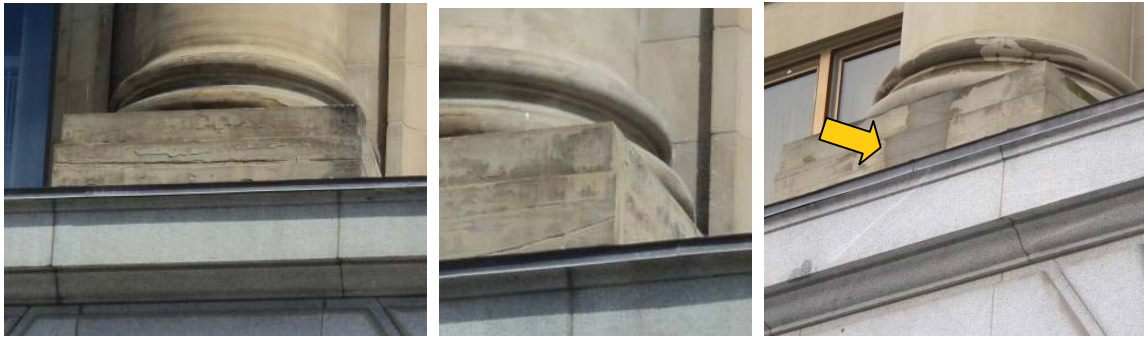
- Only one fractured corner, along McGill Street, is detached and rests on top of the column's base.

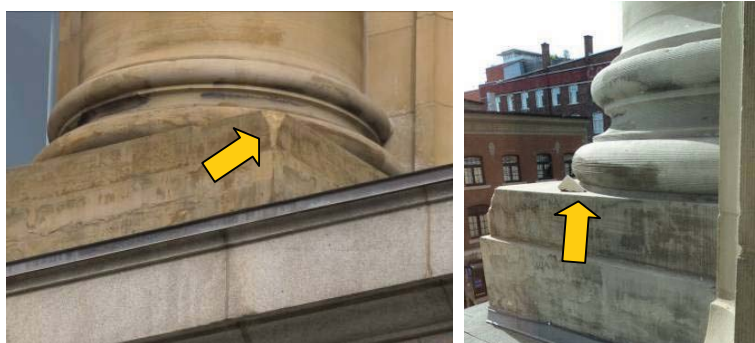
- Several window sills, some stones located between the columns and the corner avant-corps, as well as at the base of some columns, are stained by birds droppings.

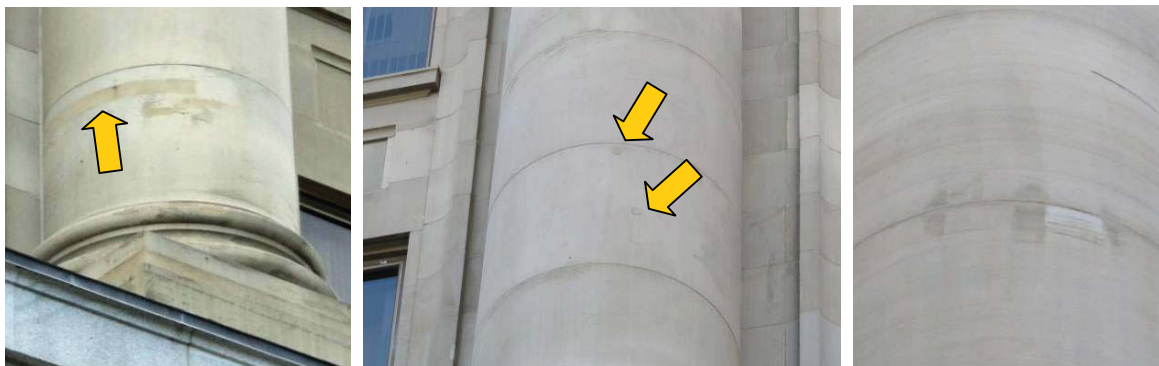
- Some capitals are cracked where they meet the architrave;
- Immediately above the flare at the top of the columns, the edges of a lighter colour indicate that they have all been remodelled using restoration mortar.

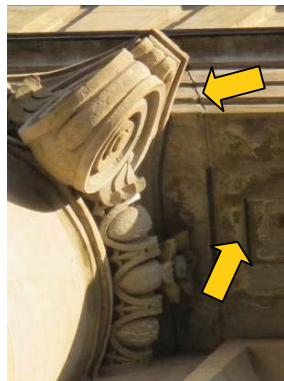
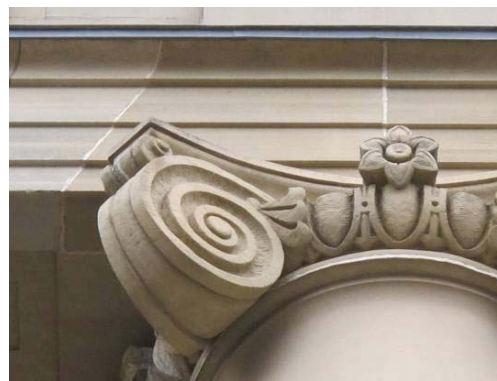
- Above the columns, the architrave is stained with moisture and efflorescence, and several mortar joints are opened, here on the northern and southern façades of 105 McGill;
- On the western façade of 400 place d'Youville, the mortar joints of the architrave have been replaced with sealant above the capitals.

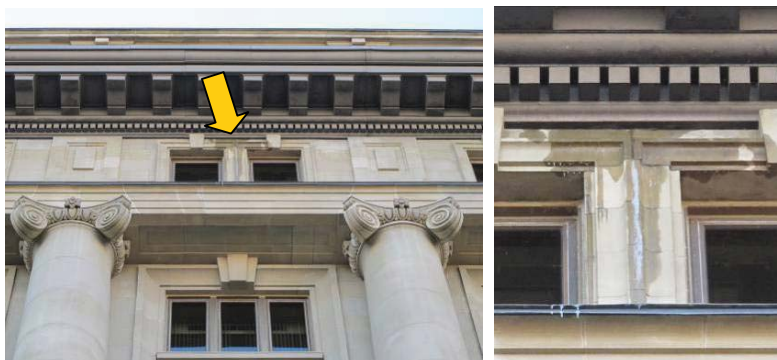
- Along the northern façade of 105 McGill, stones are stained with irregular patterns, which could indicate the presence of a coating, or of a previous cleaning intervention that would not have carefully maintained a constant distance between the nozzle and the wall, and that would have been conducted randomly;
- Rosy stains are visible close to the northeast corner avant-corps of 105 McGill, as well as some paint drops.
