**REQUEST FOR PROPOSALS FOR ARCHITECTURAL MULTIDISCIPLINARY SERVICES
AS PART OF THE PROJECT OF MANSORY REPAIRS OF THE CUSTOMS BUILDING**

REQUEST FOR PROPOSALS FOR ARCHITECTURAL MULTIDISCIPLINARY SERVICES
AS PART OF THE PROJECT OF MANSORY REPAIRS OF THE CUSTOMS BUILDING
105 McGill Street / 400 place d'Youville
Montréal, Quebec

- 1.1 PWGSC Project Title:** Customs Building Masonry Repairs
- 1.2 Location of the Project:** 105 McGill Street / 400 place d’Youville, Montréal
- 1.3 PWGSC Project Number:** R.021798.100
- 1.4 Client / User:** Public Works and Government Services Canada (PWGSC)
- 1.5 PWGSC Project Manager:** Pierre-Hugues Mathieu

Preliminary Masonry Condition Assessment

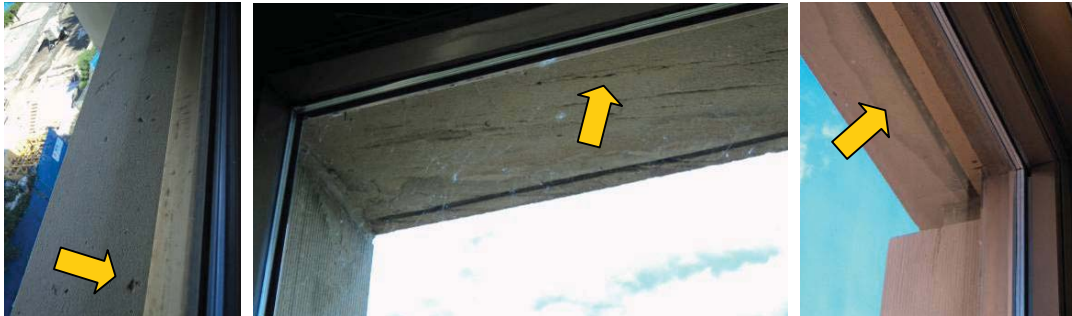
- Almost all mortar joints located in the lower corners of the openings, on all façades, are de-bonded, disaggregated and/or opened;
- Some sealant joints are also de-bonded around windows;
- The mortar is sometimes entirely disappeared from the joint, but scraps remain on the window sill;
- Several joints have been filled using sealant;
- In many locations, the portion of the stone located between the window sill and the first joint above has been repaired with mortar, but is now disaggregated.

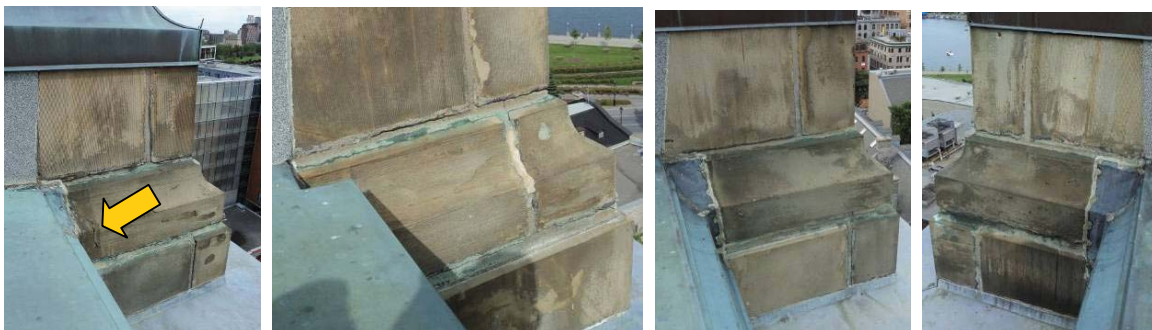
- Some mortar joints are especially deteriorated and/or opened, indicating that some stones could eventually entirely de-bond and slide outwardly. Simultaneously, in most of these worst cases, plugs indicate the presence of anchors;
- In the case of 400 place d'Youville, the upper portion of the parapets is apparently vented, as indicated by the presence of small air intakes.

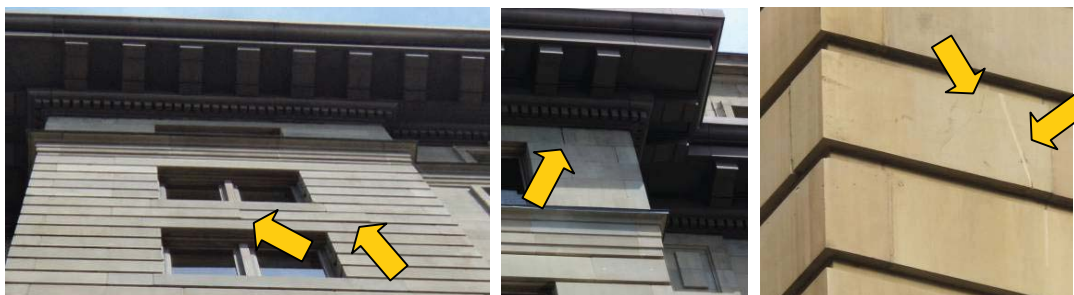
- At least two stones are displaced between the 4th and the 5th floor;
- At least one vertical joint is entirely opened below the main cornice;
- Some corner stones are cracked, and some have been repaired.

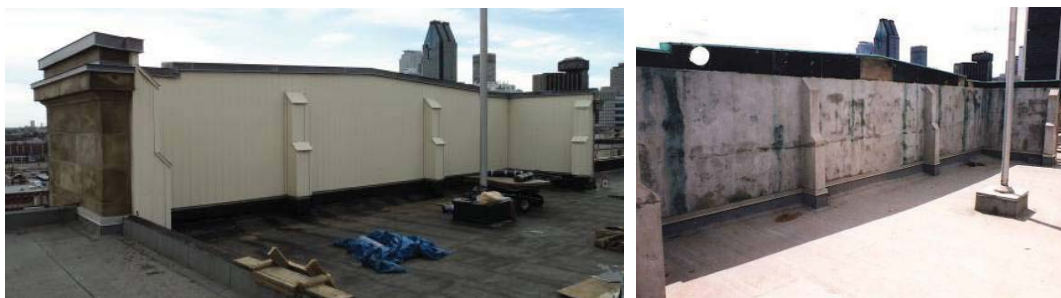
- Almost all parapet stones are significantly exfoliated, on all three outward façades, resulting in the loss of the original combed finish;
- Almost all mortar joints are de-bonded, disaggregated and/or opened.

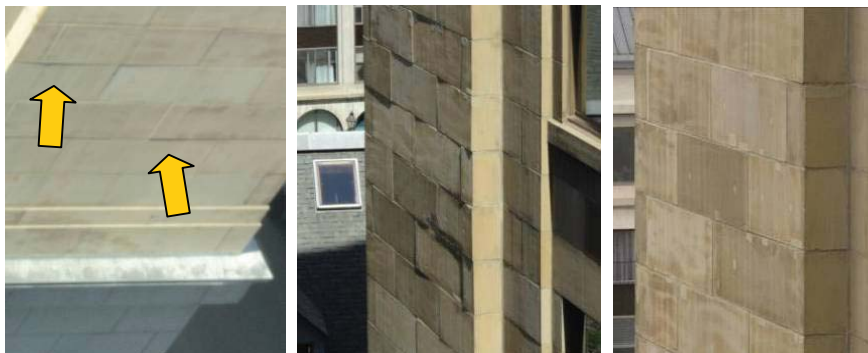
- Some stones are slightly displaced on the eastern façade of the northeast corner avant corps of 400 place d'Youville and, in a significantly more accentuated manner, on the northwest corner avant-corps of 105 McGill, both at mid-height and at the level of the cornice that separates the 5th from the 6th floor. These displacements suggest the presence of cavities between the stone cladding and the brick backing;
- On the western façade of the northwest corner avant-corps of 105 McGill, regularly placed plugs (two per stone, neatly centered) indicate the presence of anchors, but several others smaller repairs along the joints are more enigmatic.

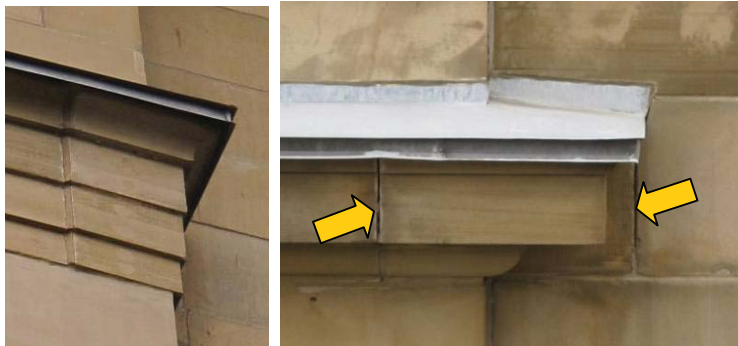
- Some stones are also displaced below the cornice that separates the 5th from the 6th floor. However, plugs indicate the presence of double-stacked anchors (two per stone);
- Several mortar joints are opened at the level of the cornice located at the base of the parapet.

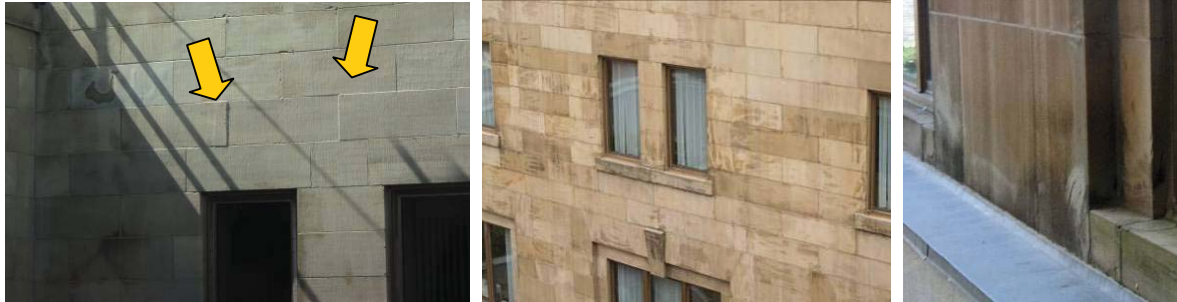
- On the eastern façade of 400 place d'Youville, stones show signs of repairs where an elevating work platform was anchored during the late summer of 2011.

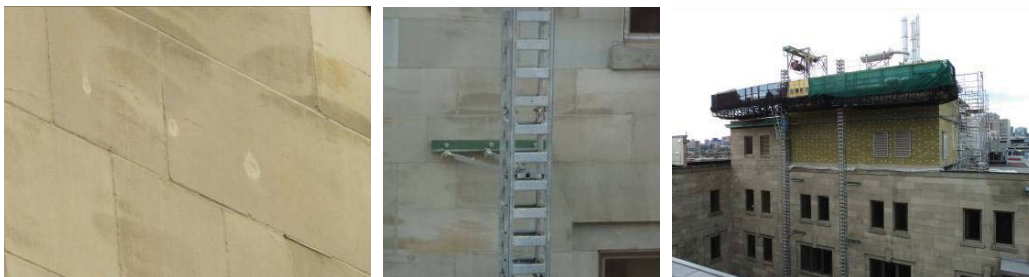
- On the eastern façade of 400 place d'Youville, at least one stone is significantly exfoliated.

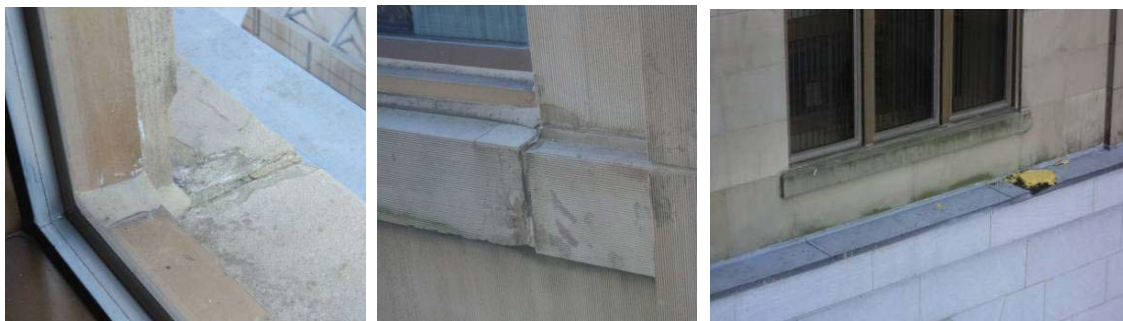
- Some stones bear black stains, especially above or close to the windows;

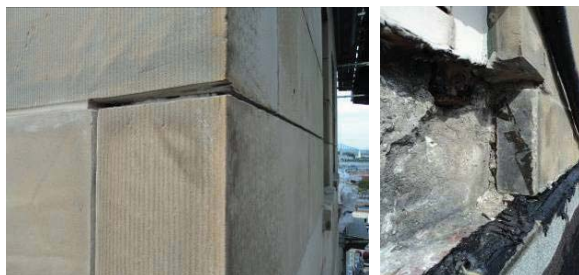
- Over the years, the concrete penthouses of 105 McGill (above the elevators and the now blocked off skylight which originally lit naturally the freight elevators mechanical room) have been absorbed into the construction of new penthouses clad with corrugated steel. However, notwithstanding the construction of a similar penthouse on the roof of 400 place d'Youville, the two original penthouses remain clearly visible;
- If some stones have a combed finish, especially along the eastern façade that faces the courtyard (repointing work was carried out in this location in August 2011, unfortunately damaging the edges of the stones), the majority of the other stones have a smooth finish;
- If corner stones are apparently thicker, others are no more than four (4) inches thick.

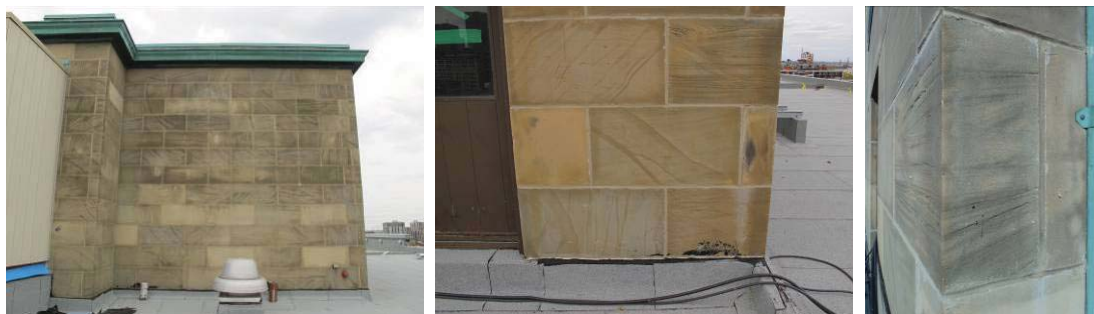
- Several stones have been damaged when holes were drilled to run various cables.

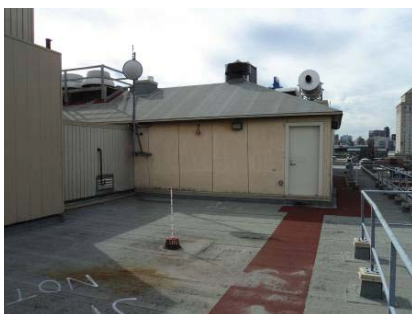
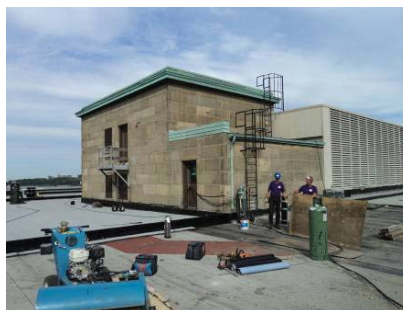
- The original roofing (six plies of roofing felt, saturated with bitumen, and covered with coal tar pitch and lake or river gravel) has been replaced with an elastomeric membrane (repair work underway), including on the roof of the skylight that lit the mechanical room above the freight elevators;
- All basins were modified following the construction of several additions around the original penthouses.

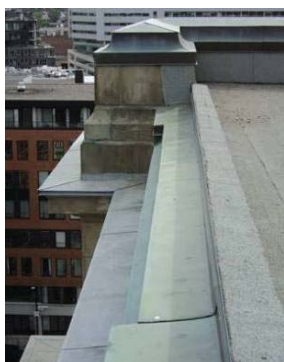
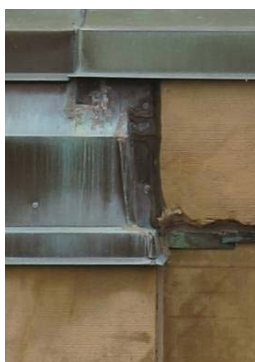
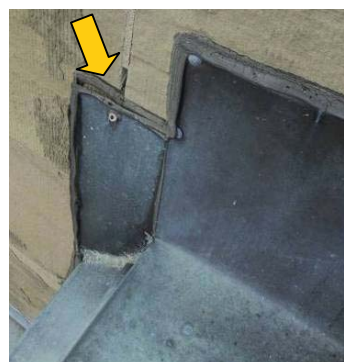
- Many sealant joints along copper flashings, recently replaced in the case of the corner avant-corps, are dry and perforated;
- Notwithstanding attempts to generously seal the flashings covering the parapets of the corner avant-corps or to mechanically fasten the flashings to the central avant-corps parapet, openings are visible in some locations, and opened mortar joints above allow infiltrations behind the sheet metal.

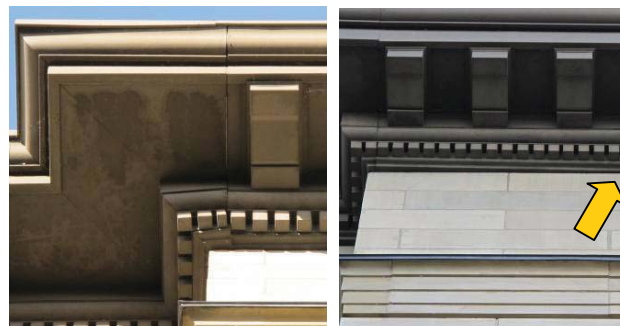
- The main cast iron cornice and the one located at the base of the parapet appear to be in good condition, but were not thoroughly assessed due to lack of access;
- Attached to the 7th floor edge beam (8th floor on the drawings), the imposing main cornice, which divides the 6th from the 7th floor, shows some distortions, primarily where joints in the sheet metal are immediately above the edge of a corner avant-corps;
- Everywhere, a slot separates the stone cladding upper course from the lower quarter round of the cornice. On the northern façade of the northwest corner avant-corps of 105 McGill, the quarter round seems to disappear behind the cladding.

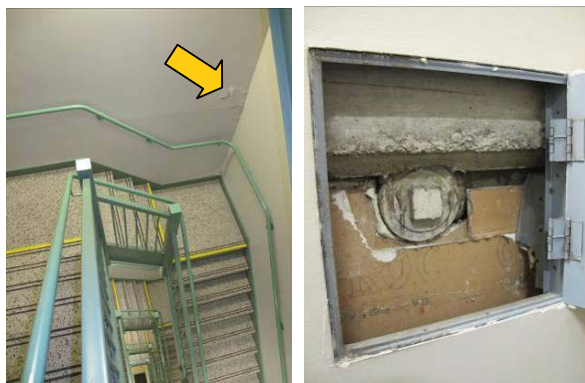
- Inside the stairwell located in the eastern portion of the central avant-corps, the interior gypsum plasterboard finish is deteriorated on several storeys, likely due to water infiltration behind the main cornice that divides the 6th from the 7th floor. An access door located on the same axis gives access to a roof drain.

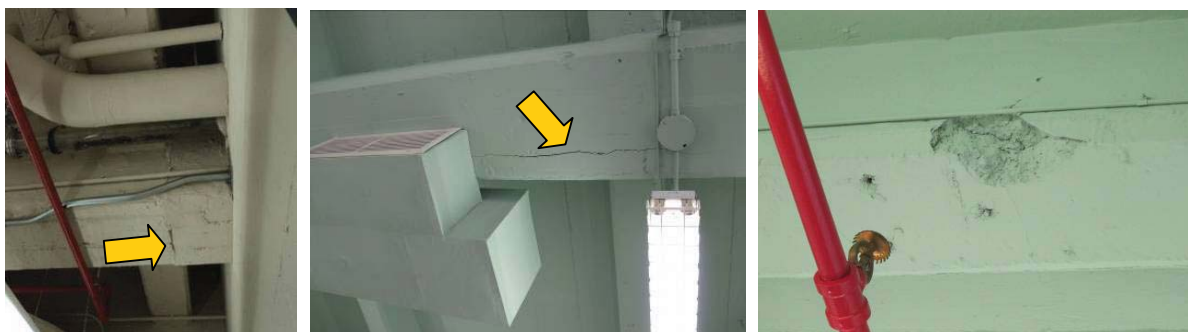
- In the southeast corner of the 5th floor, a membrane apparently joins, where the walls meet the ceiling, the vapour barrier which covers the « buff pressed bricks » finish and the concrete structure above. Rust stains are visible along the entire joint between the membrane and the concrete;
- Some concrete floor slabs of the 105 McGill have significant cracks.

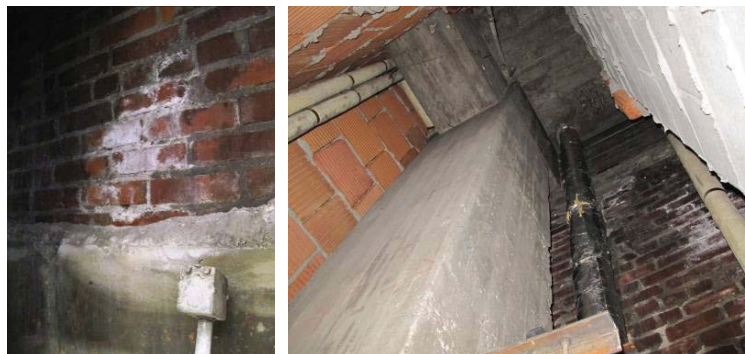
- On the 5th floor of the southeast corner of 105 McGill, there is significant air movement between the brick backing walls of the exterior wall, and this air enters the room, as the building is apparently under high negative pressure due to the Environment Canada laboratory hoods;
- On the north side of 400 place d'Youville, an opening drilled into the 6th floor concrete slab, to run drainage and heating pipes, shows that at least two floor slabs below also have openings. There is no air movement in this service space.

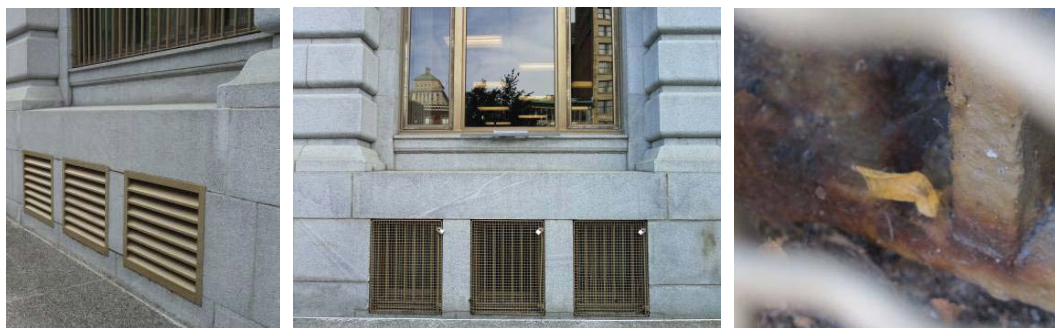
CAST IRON GRILLS IN THE BASEMENT WINDOWS / ENTIRE BUILDING

- Several basement windows have been replaced with ventilation louvers;
- The remaining windows, all protected with original cast iron grills, have been overlaid with an additional wire mesh grill, which hides the condition of the elements behind, and makes it difficult to assess their condition;
- It is nonetheless possible to see, in some places, that the original cast iron grills are severely rusted where they meet the stone cladding.

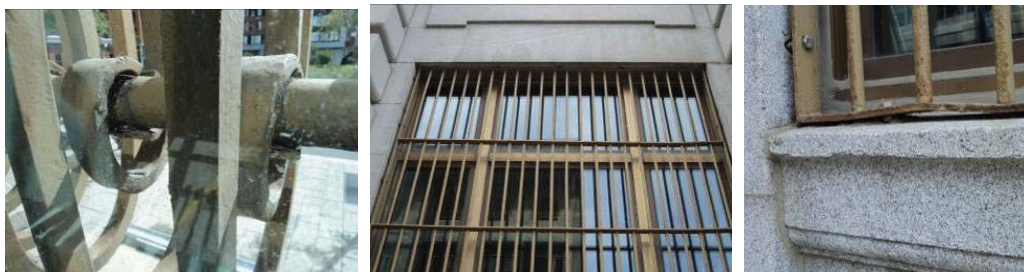
CAST IRON GRILLS IN GROUND FLOOR WINDOWS / 105 MCGILL

- The original cast iron grills, which protect the basement and ground floor windows of 105 McGill (and the stair window of 400 place d'Youville facing the courtyard), are undermined by rust, and are no longer firmly anchored into the stone.

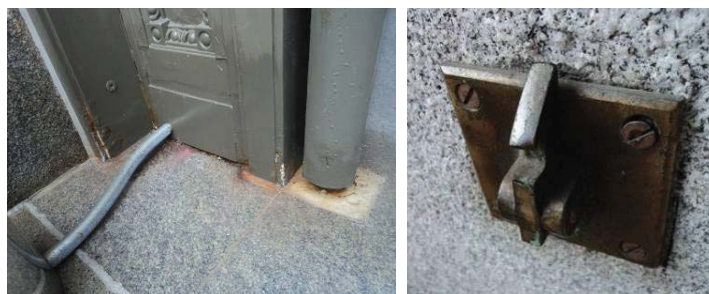
CAST IRON GRILLS OF MAIN ENTRANCE PORTICO / 400 PLACE D'YOUVILLE

- Notwithstanding recent paint touch ups in the lower portion of the grill doors of the portico, these doors are rusted and stones below are stained;
- The original bronze hooks remain in good condition.

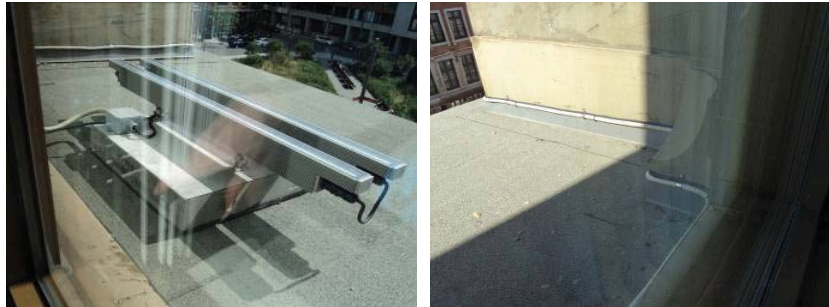
LIGHTING

- Considerable efforts were deployed to integrate and conceal electrical wiring and lamps when the building was illuminated in 2010-2011. However, this nonetheless resulted in façades along place d'Youville, as well as along McGill and Marguerite-D'Youville streets, being drilled with hundreds of holes, and clustered with all these elements, which are an obstacle to future masonry and cornice repairs.

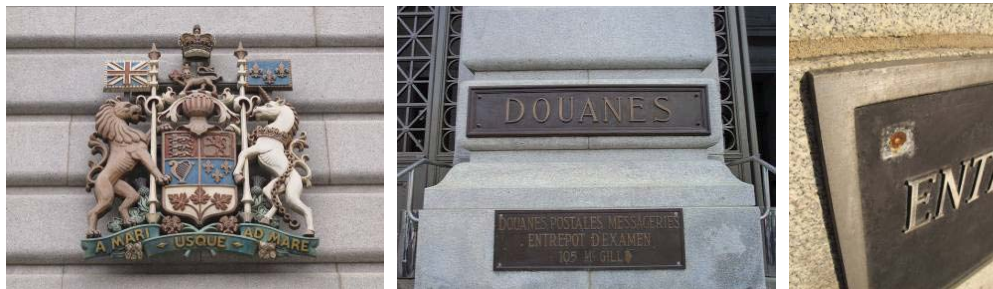
COAT OF ARMS AND PLAQUES

- The coat of arms located southwest of the main entrance of 400 place d'Youville, as well as several bronze plaques are all in good condition, although they may have to be temporarily removed during future repointing work;
- Some plaques have rusted screws, such as here at the entrance of 105 McGill.

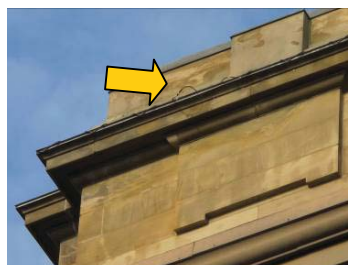
HEATING CABLES

- One or more heating cables run along half of the length of the cornice located at the base of the parapet of the southern façade of 400 place d'Youville, meaning from the southwest corner of the building up to the middle of the colonnade;
- On the southwest corner avant-corps, one of these cables is apparently detached.
