**Parking Lot Expansion and Secondary Fire Route Access,
Millhaven Institution, 5775 Bath Road, Loyalist, Ontario
PWGSC Project #: R.043010.001 & R.043010.002**

Geotechnical Investigation Report

Date: 2011-04-28
Ref. N°:038-P037950-0100-GE-0001-00

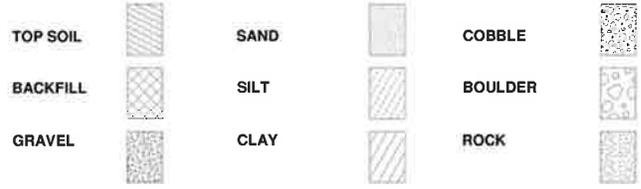
SYMBOLS

Description of the stratigraphic units: Every geological formation is detailed. The proportion of the different elements of the soil, defined according to the size of the particles, is given following the classification hereafter. The relative compactness of cohesionless soils is defined by the "N" index of the Standard Penetration Test. The consistency of cohesive soils is defined by their shear resistance.

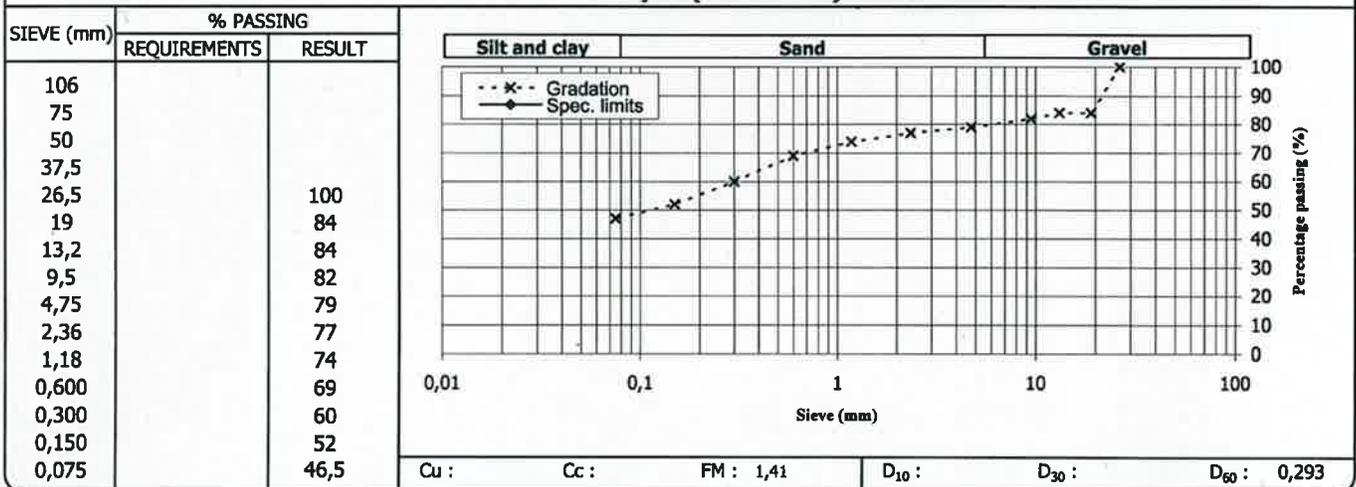
Sieve analysis (ASTM C136)

Proportions from sieve analysis (%)	
Cobble : 0,0	Sand : 31,9
Gravel : 21,2	Silt and clay : 46,9

A fill constituted of silt was intercepted on surface at the location of boreholes BH-01-11 and BH-02-11. The thickness of this fill is approximately 0.76 m. One (1) sieve analysis was done based on a representative sample. Table 5 shows the results of the analysis.

Borehole n°	Depth (m)	Gravel > 4.75 mm (%)	Sand < 4.75 mm et > 75 µm (%)	Silt and Clay < 75 µm (%)
BH-01-11	0.00 – 0.61	21	32	47

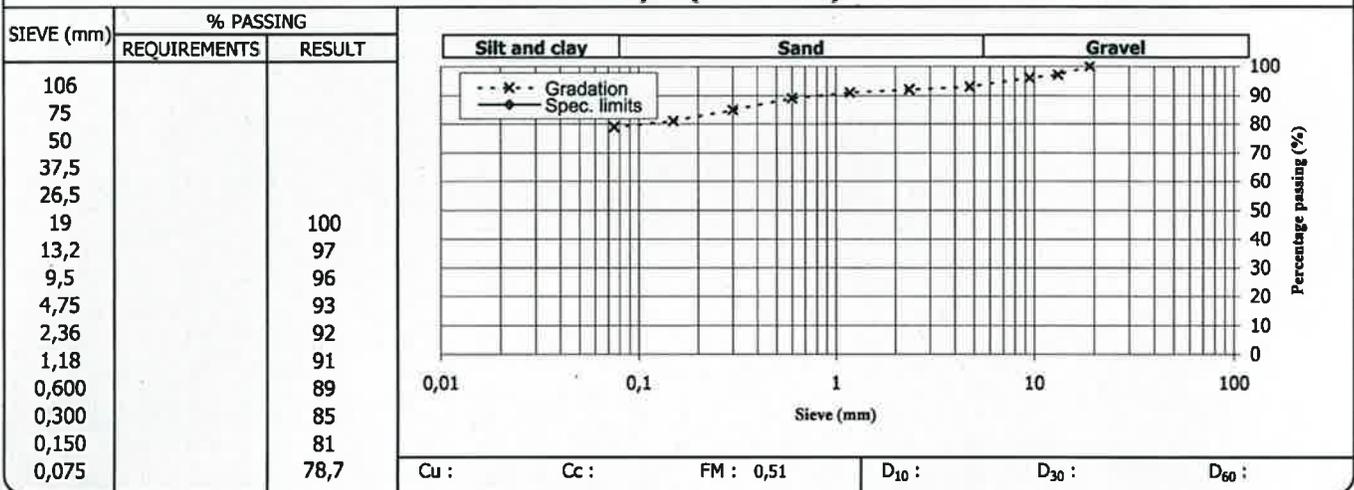
Sieve analysis (ASTM C136)

Proportions from sieve analysis (%)	
Cobble : 0,0	Sand : 13,9
Gravel : 7,2	Silt and clay : 78,9

One (1) sieve analysis was done based on a representative sample. Table 6 shows the results of the analysis.

Borehole n°	Depth (m)	Gravel > 4.75 mm (%)	Sand < 4.75 mm et > 75 µm (%)	Silt and Clay < 75 µm (%)
BH-02-11	0.76	7	14	79

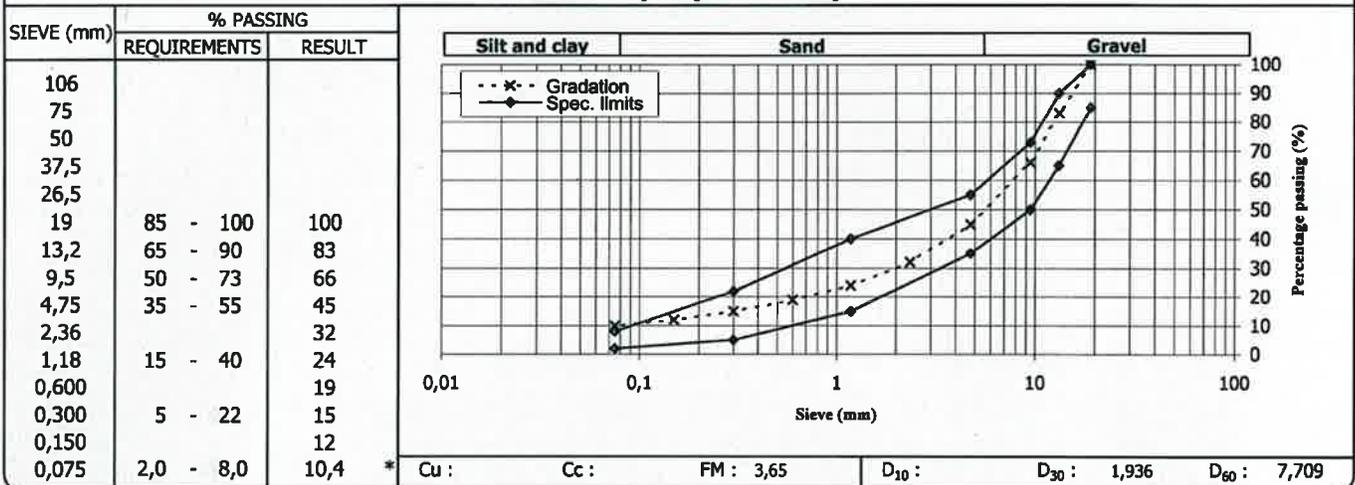
Sieve analysis (ASTM C136)

Proportions from sieve analysis (%)	
Cobble : 0,0	Sand : 36,0
Gravel : 53,5	Silt and clay : 10,5

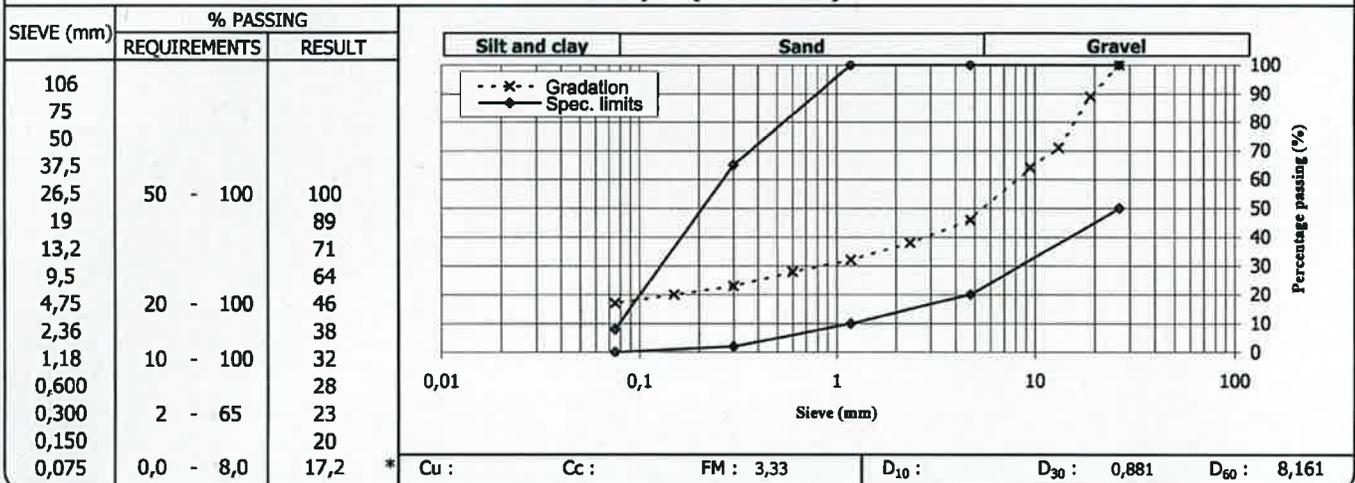
Sieve analysis (ASTM C136)

Proportions from sieve analysis (%)	
Cobble : 0,0	Sand : 29,7
Gravel : 53,0	Silt and clay : 17,4

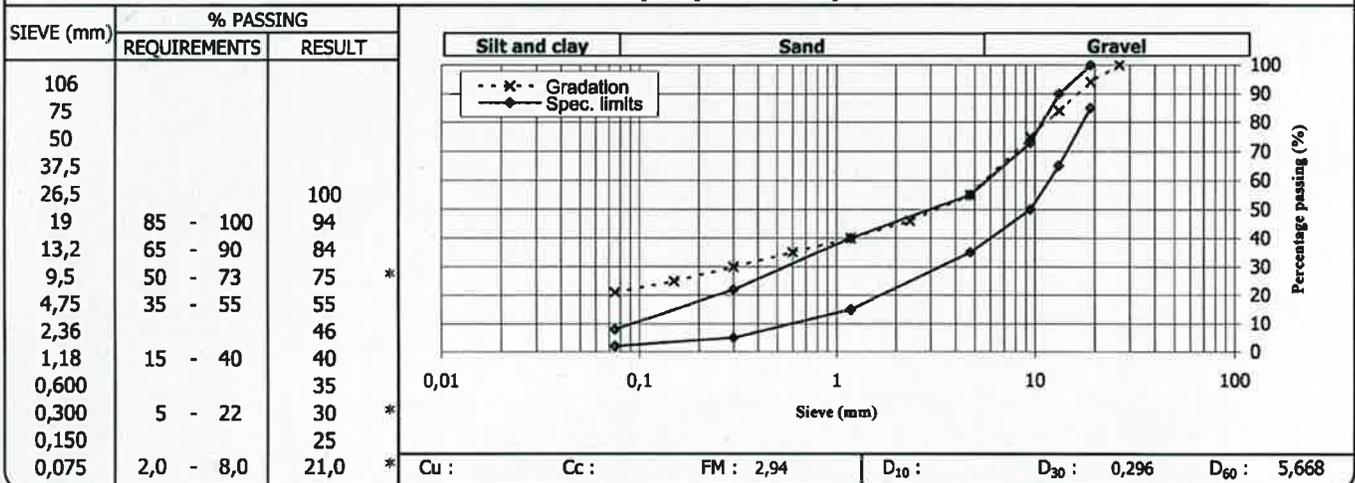
Sieve analysis (ASTM C136)

Proportions from sieve analysis (%)	
Cobble : 0,0	Sand : 34,6
Gravel : 44,1	Silt and clay : 21,3

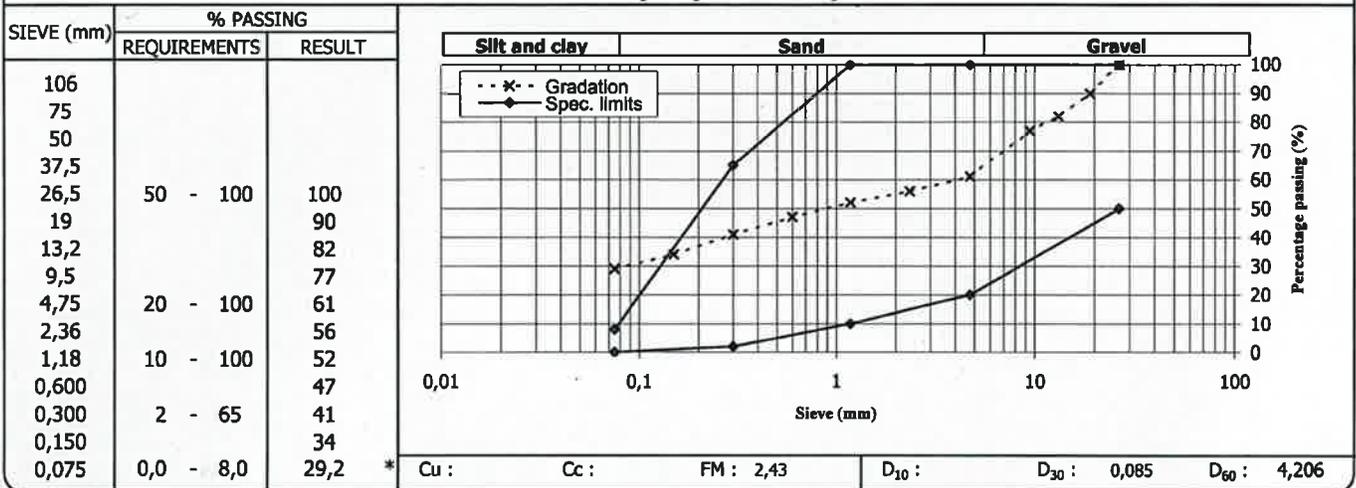
Sieve analysis (ASTM C136)

Cobble : 0,0	Sand : 32,2
Gravel : 38,3	Silt and clay : 29,5

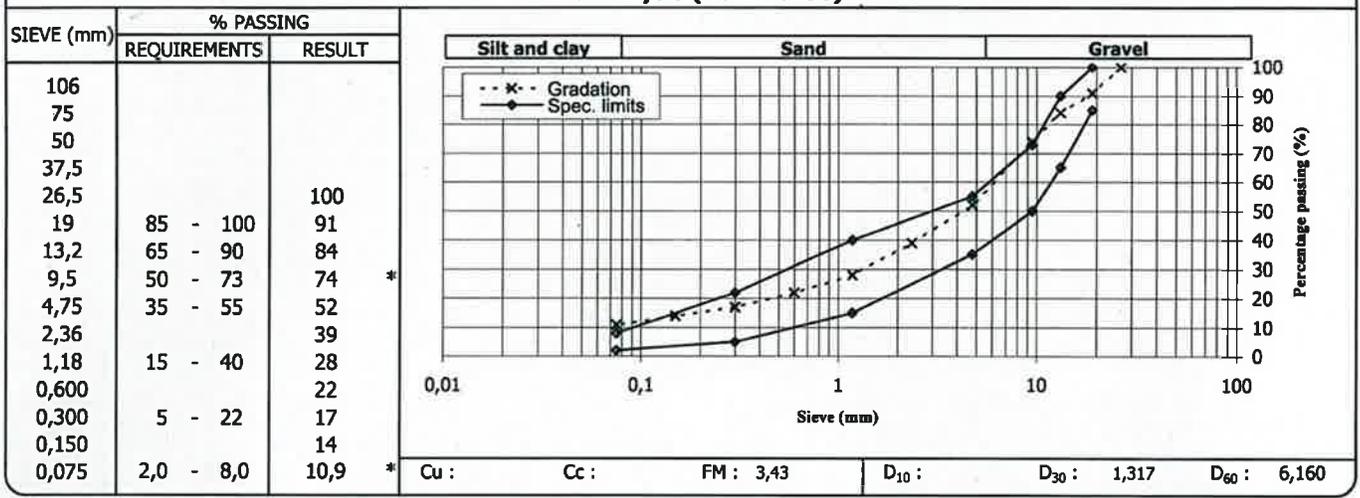
Sieve analysis (ASTM C136)

Reference : OPSS
 Use : Granular base
 Calibre : Granular A
 Class :
 Sampling date : 2011-03-21
 By : Kuljit Sodhi
 Date received : 2011-04-06
