Geotechnical Survey and Utilities Capacity Study

PWGSC Reference: R.058448.002

DATE: FEBRUARY 26, 2013

Stantec Architecture Ltd.
905 Waverley Street Winnipeg MB R3T 5P4
Tel: (204) 489-5900, Fax: (204) 453-9012

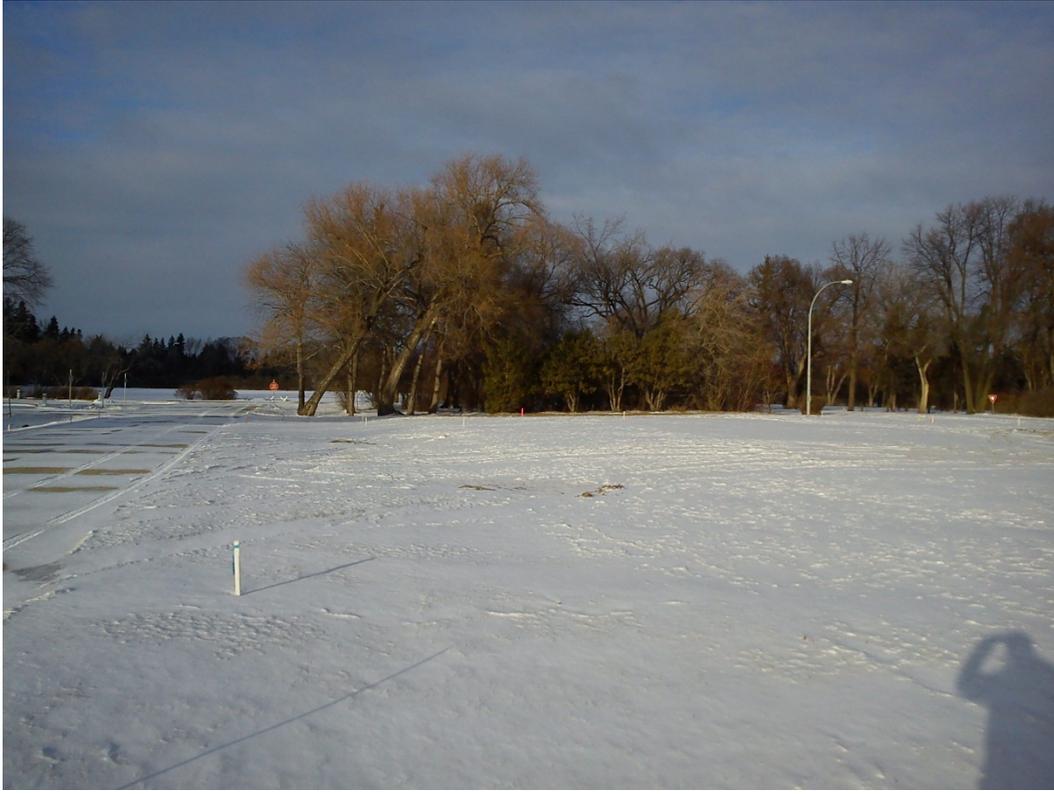
Photo 1 - Project site looking north from southwest corner

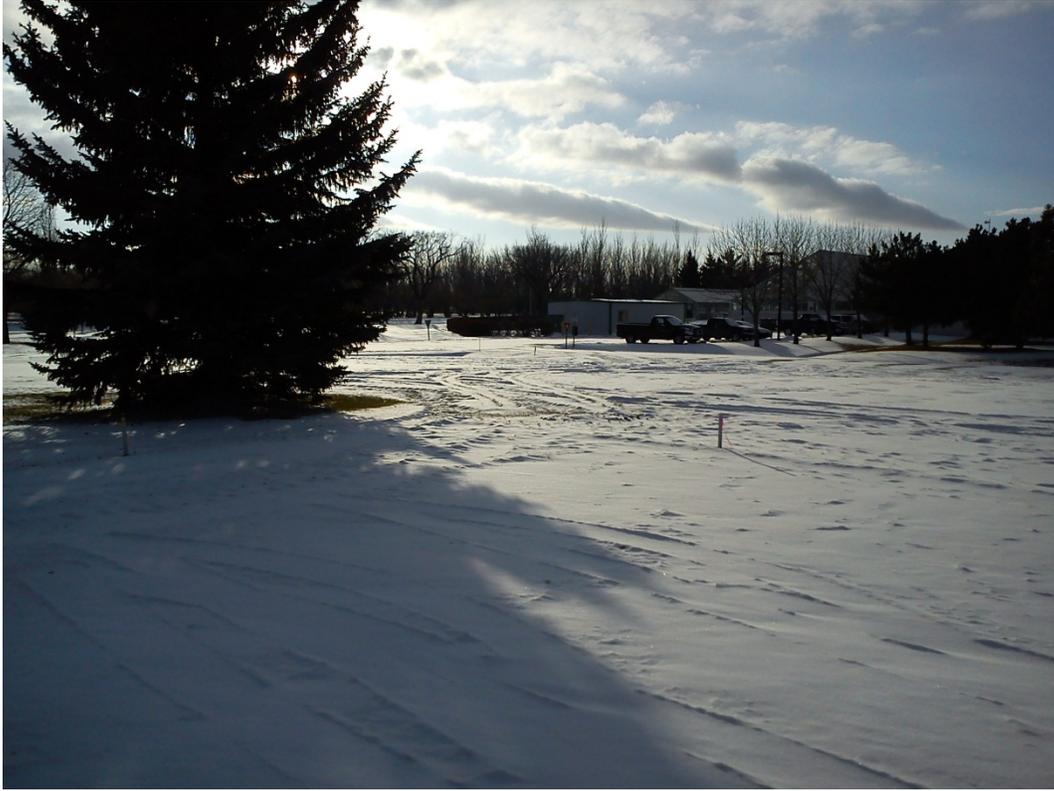
Photo 2 - Project site looking southwest from northeast corner

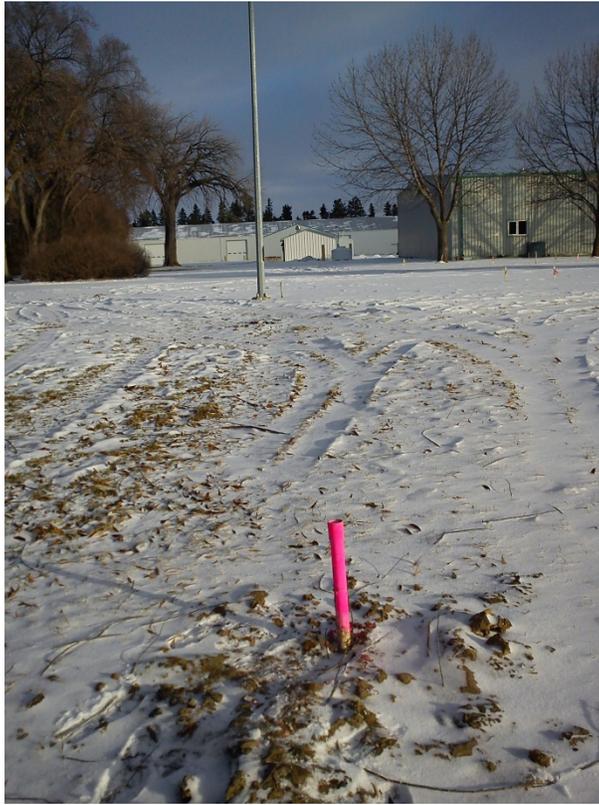
Photo 3 - Standpipe piezometer installed in Testhole TH 04

Groundwater conditions were observed immediately after completion of drilling of the testholes. Minor to moderate groundwater seepage and sloughing was observed in the sand layers in the testholes at depths between 3.0 to 4.7 m. All observations of groundwater conditions are shown in the testhole logs provided in Appendix C. It should be noted that only short-term seepage and sloughing conditions were observed in the testholes. Groundwater levels will normally fluctuate during the year and will be dependent on precipitation and surface drainage. Groundwater seepage and soil sloughing should be expected from the sand and silt layer encountered in the testholes during periods of snow melt and heavy precipitation.

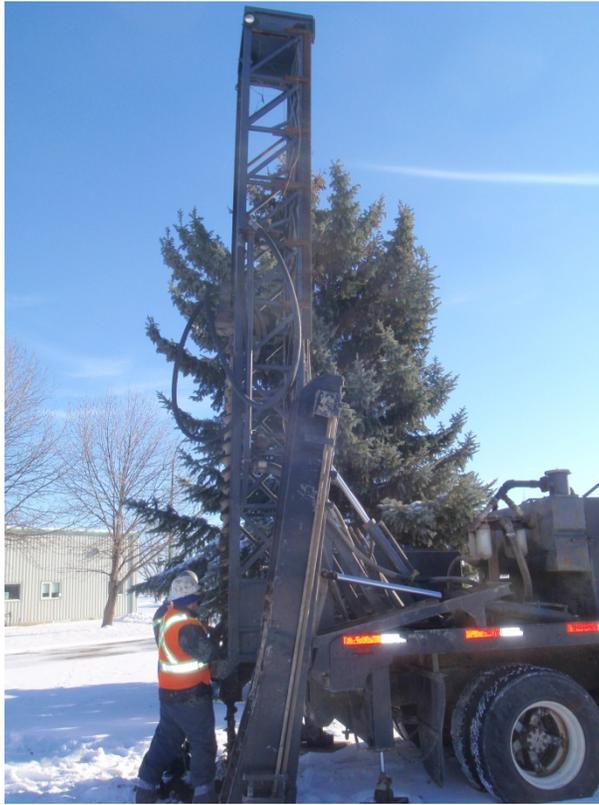
Photo 4 - Drilling Testhole TH 08

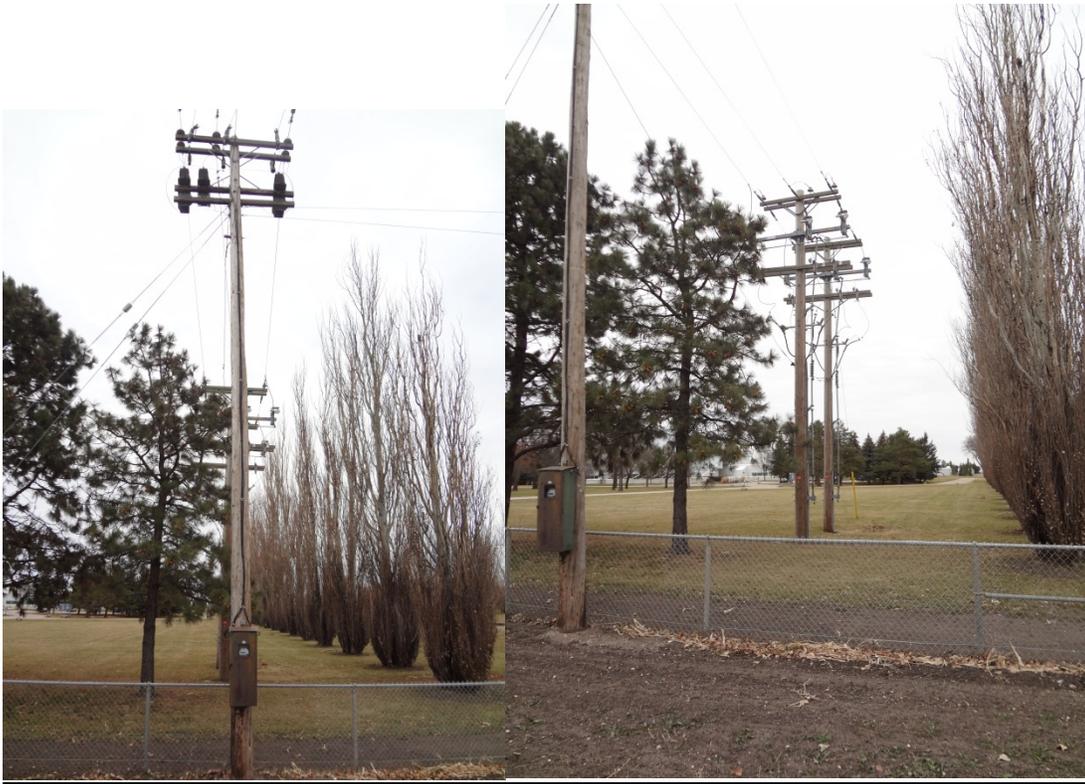
Photo 5 - Electrical main service entrance

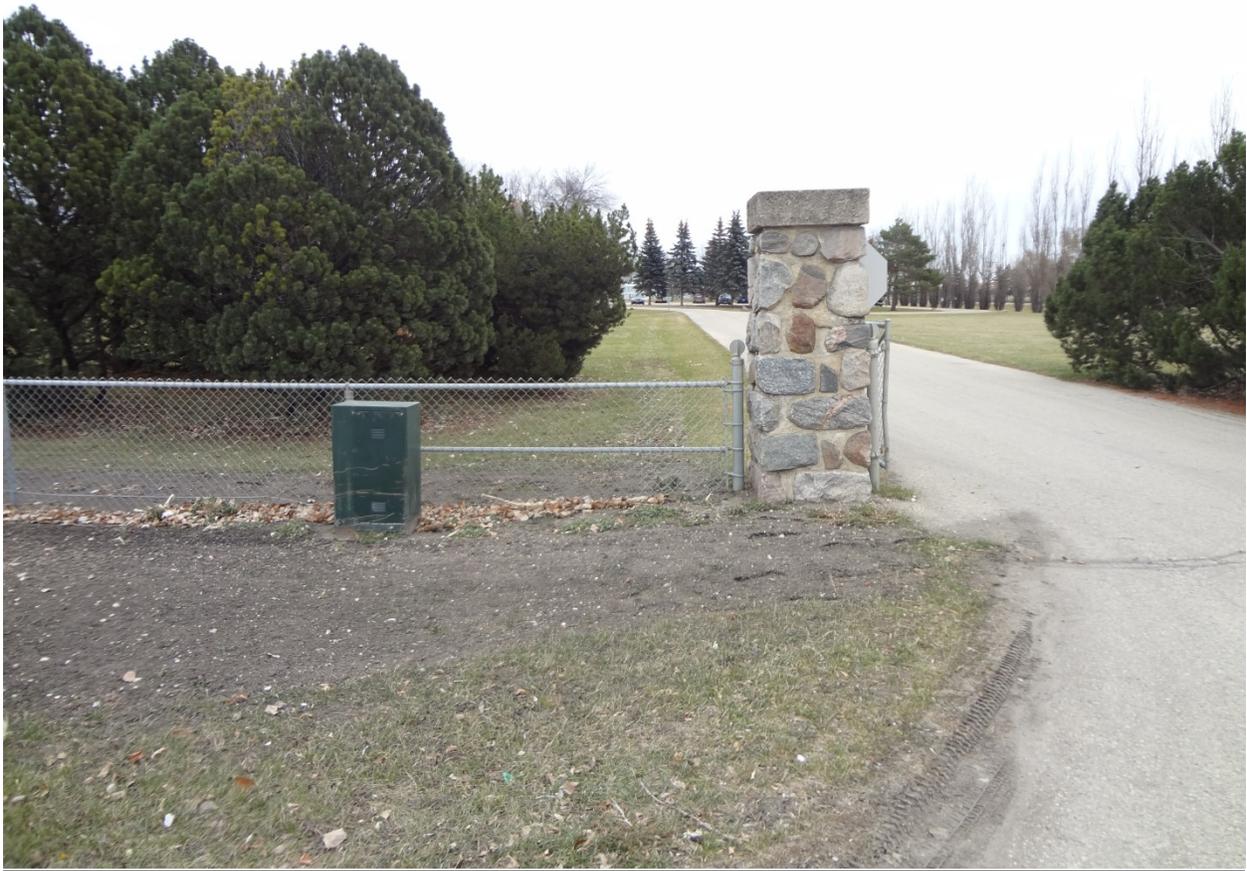
Photo – 6 Telephone main service entrance

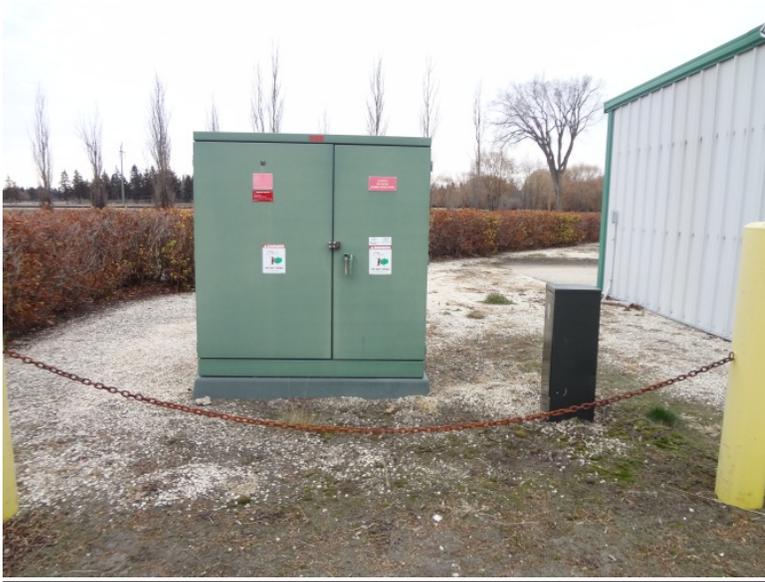
All of the customer-owned transformers, complete with their associated primary and secondary conductors, were installed in the year 2003 and appear to be in good condition.

Photo – 7 Transformer TR#1 – 750Kva 12470-347/600V

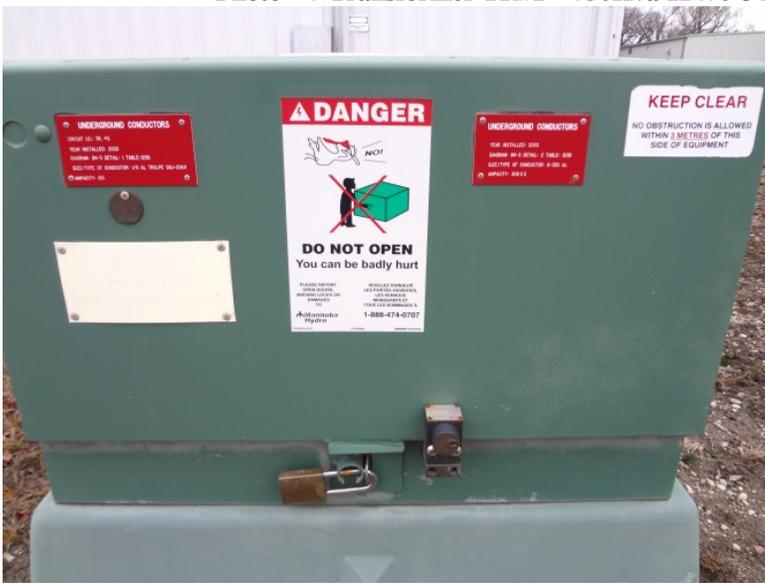
Photo – 8 Transformer TR#2 – 300Kva 12470-347/600V

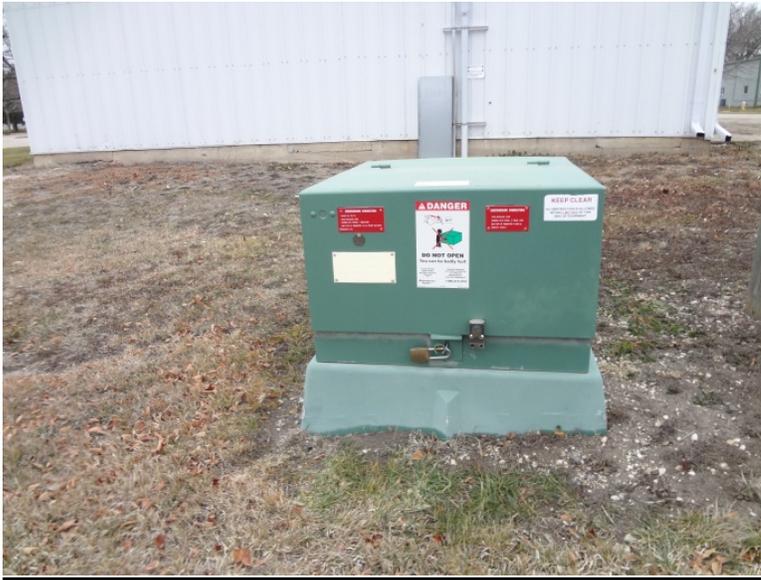
Photo – 9 Transformer TR#4 – 50Kva 7200-347/600V (Identical to transformer TR#3)
