PARKS CANADA AGENCY

ENVIRONMENTAL IMPACT ANALYSIS FOR ROCK SCALING AND REMEDIATION WORK IN MOUNT REVELSTOKE NATIONAL PARK, TRANSCANADA HIGHWAY, MEADOWS IN THE SKY PARKWAY, NELS NELSEN ROAD

REPORT

MAY 2013
ISSUED FOR USE
EBA FILE: 704-V23203109-01

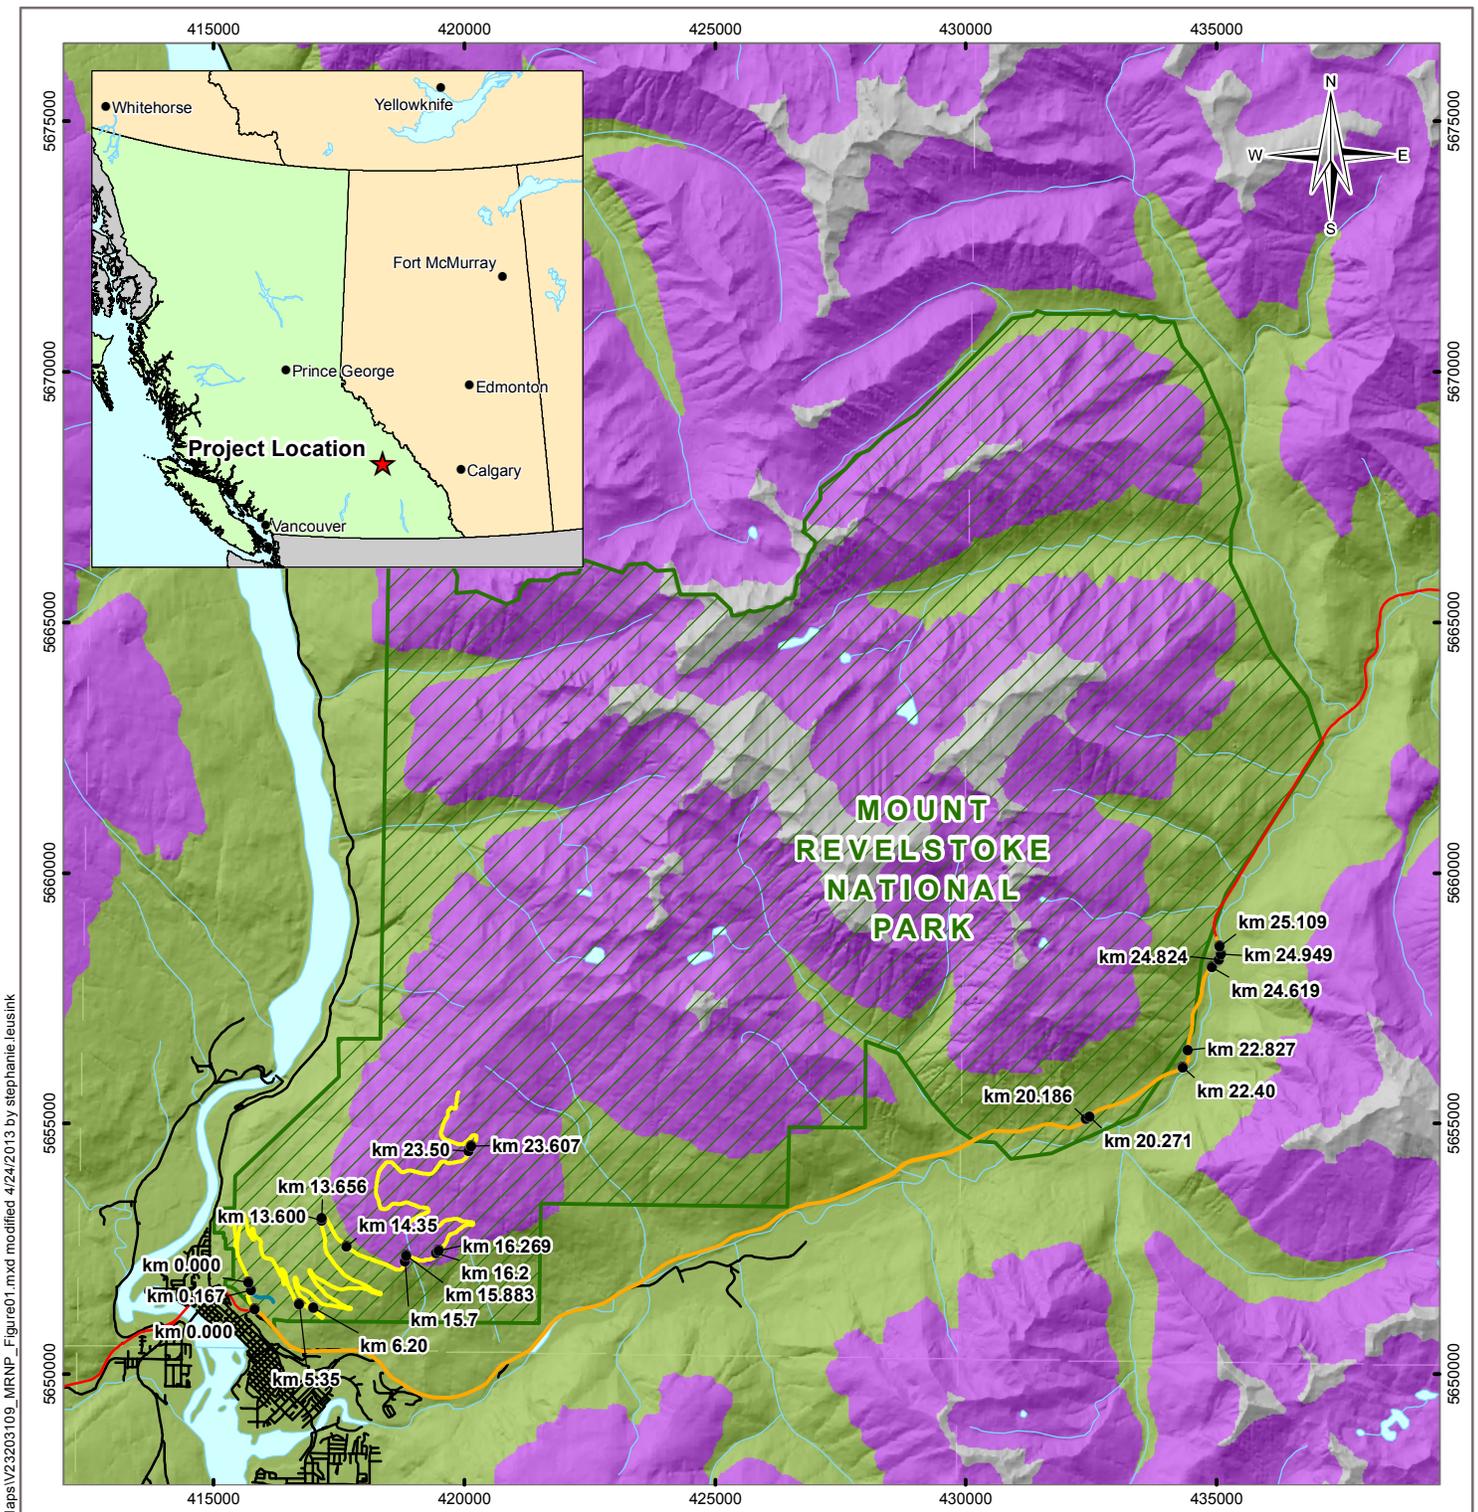
Figure 1

As shown in Figure 1, the majority of the Project Area falls within the Interior Cedar Hemlock biogeoclimatic zone (ICH), specifically ICHmw3 (Thompson moist-warm variant) and ICHwk1 (Wells Gray wet-cool variant). In southeastern BC this zone occupies the lower elevations (400 – 1500 m) of the Columbia Mountains. At higher elevations, sites along the MISP fall within the Engelmann Spruce Subalpine Fir biogeoclimatic zone (ESSF); specifically within the ESSFvc (very wet cold variant) (Braumandl and Curran 2002).

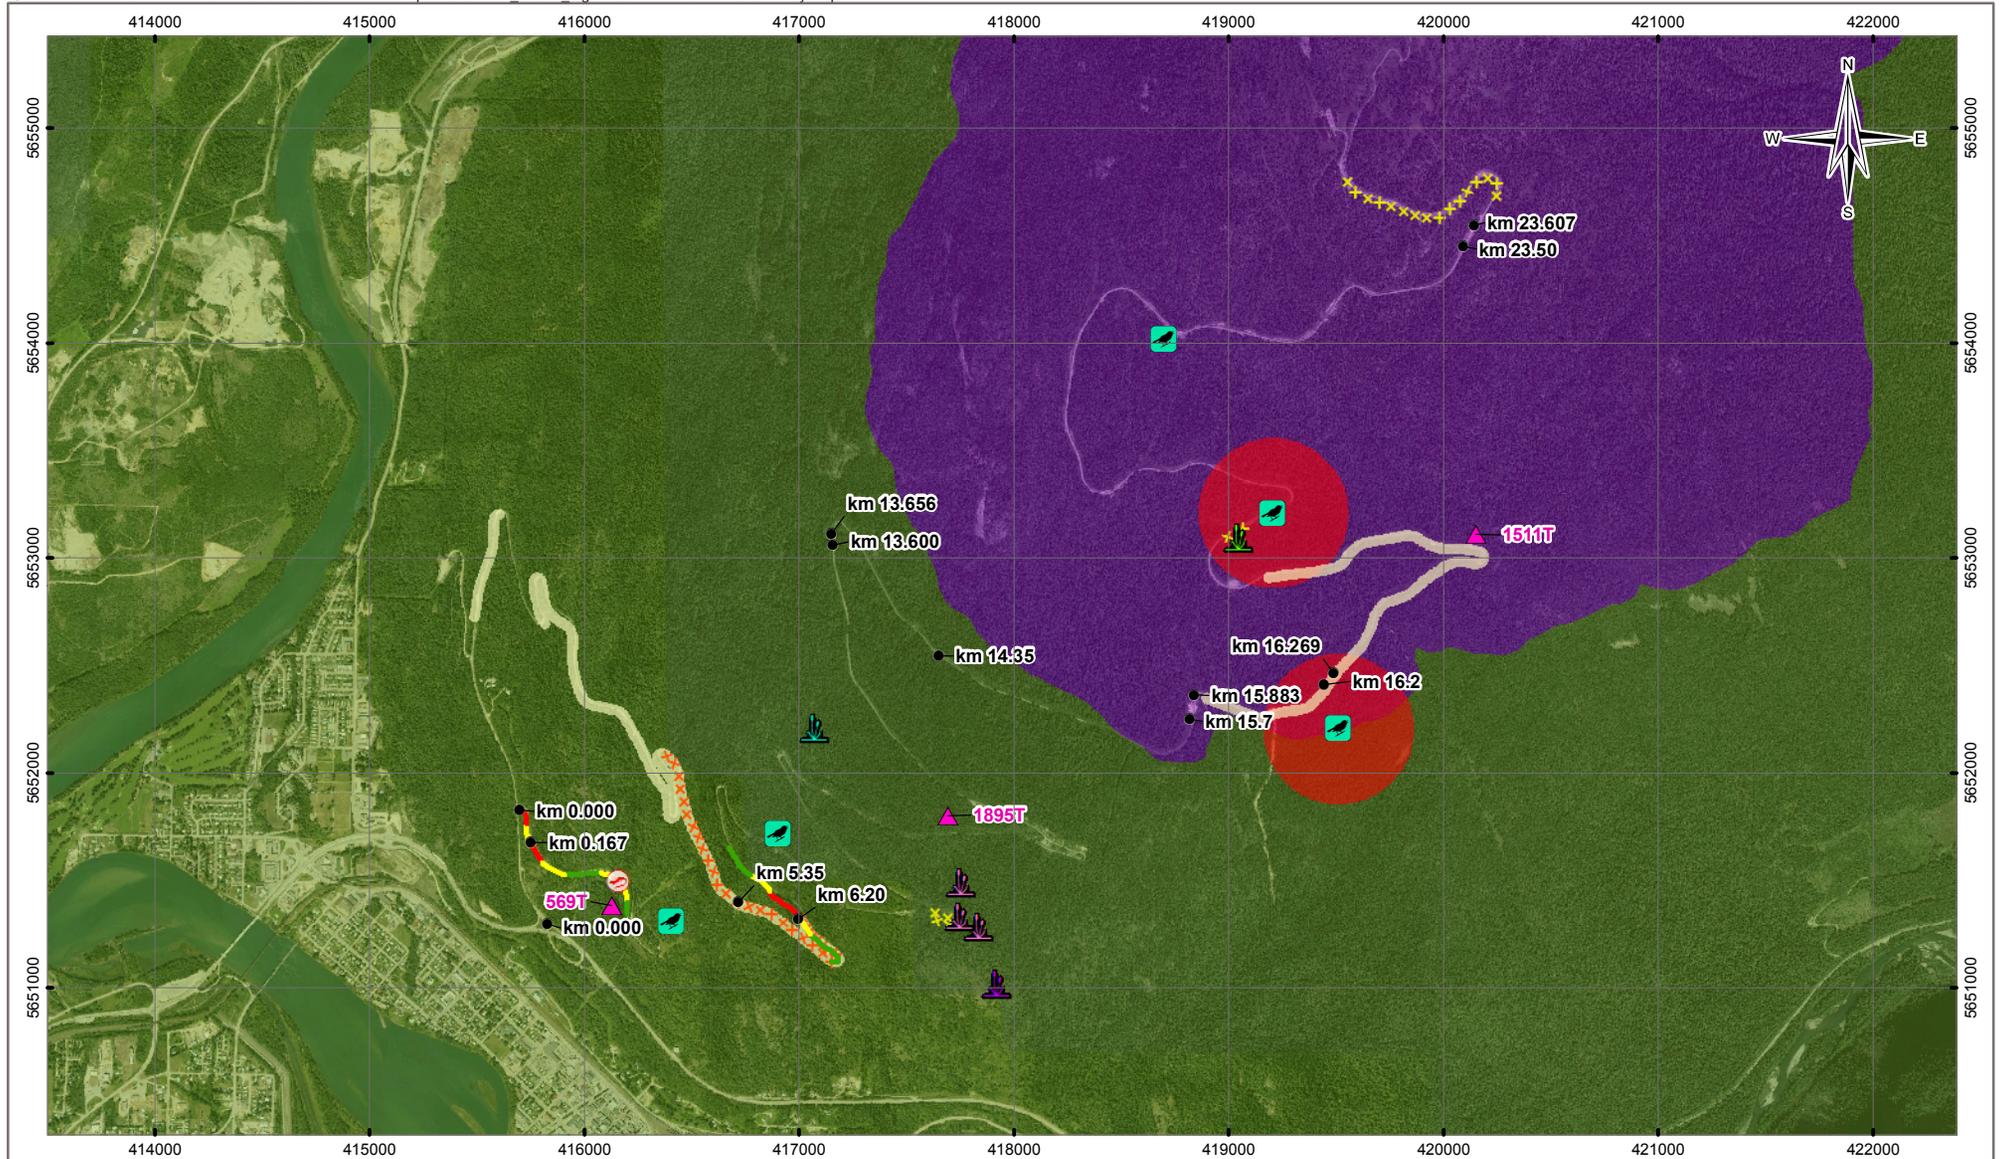
The Coeur d'Alene salamander (*Plethodon idahoensis*) has been documented at sites km 0.0 – 0.167 along the NNR and km 5.35 – 6.20 along the MISP (Figure 2). The Coeur d'Alene Salamander is a blue-listed S3S5 species in BC and ranked as a species of Special Concern under SARA. This species lacks lungs and breathes through its skin, and therefore requires moist, shady habitat which could include rockwalls with flowing seepages or streams, waterfall splash zones, caves, streams with exposed bedrock, avalanche paths and moist talus. They are very unlikely to occur if rocky areas are devoid of moisture (Environment Canada, 2012).

The Western Toad (*Anaxyrus boreas*) is known to occur at lower elevations along the MISP and along the TCH where breeding habitat exists, but can also be found at higher elevations (Figure 2). The Western Toad is a blue-listed S3S4 species in BC and ranked as a species of Special Concern under the SARA. This species spend a large majority of their time in terrestrial habitats including forested areas, moist shrublands, meadows and avalanche slopes. A wide variety of habitats are used by this species for breeding ranging from natural lakes to roadside ditches (Environment of Canada, 2012).

The Olive-sided Flycatcher (*Contopus cooperi*) has been documented at site km 16.20 – 16.269 along the MISP (Figure 2). The Olive-sided Flycatcher is a blue-listed S3S4B species in BC and is ranked as Threatened under SARA. Habitat for this species generally constitutes open areas with tall trees or snags for perching including forest clearings, openings near water bodies or cut-blocks. Foraging occurs from high vantage points targeting flying insects (Environment of Canada, 2012). There are approximately 183 species of birds found within Glacier and Mount Revelstoke National Parks. The diversity of bird species increases from April to August during the breeding season (Parks Canada, 2012a).

A small creek occurs above and falls adjacent to the NNR which is not fish bearing but provides significant potential for salamanders (Figure 2). No other water bodies were observed within 300 m of the NNR restoration site.

There is potential for impact/mortality to Coeur d'Alene salamanders as a result of the proposed works on rock faces (scaling) which may change climatic (moisture, temperature) and hydrological habitat conditions due to vegetation and rock removal and potential shifts to water source patterns. The clearing of catchment ditches composed of fine gravels and organics will not likely result in salamander mortality, however, clearing of ditches composed of talus and broken rock may. The particular population identified in the small creek along the NNR will not likely be affected by scaling activities but could be affected by removal of fallen rock from catchment (Figure 2).
