Project No.: 205.03639.00000
Client Purchase Order No.: 700260580

RE: INUVIK FFTA RECONNAISSANCE SUMMER

SLR is pleased to provide this summary letter that outlines the results of site visit conducted at the Inuvik Airport fire fighter training area (FFTA). Work was conducted under the Public Works and Government Services Canada (PWGSC) Multidisciplinary Environmental Consultant Services Task Authorization Contract EW699-121587/005/NCS.

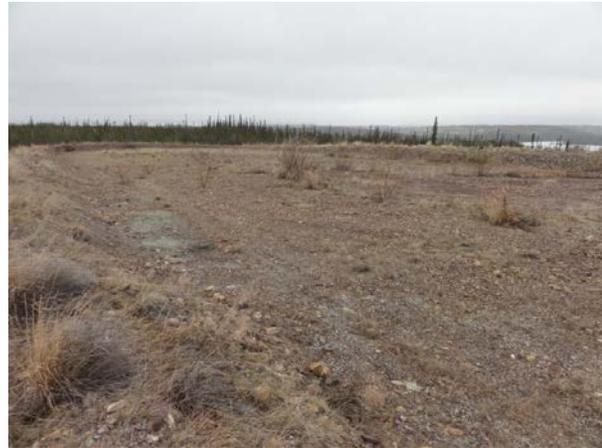
Photograph 1 - East LTF (looking east)

The eastern LTF has already been constructed but will require some additional work in order to get it ready for the liner and receipt of contaminated soil from the adjacent excavation. The base and berms around the LTF will require some material grading and vegetation removal (see Photograph 1).

The base of the east LTF has a natural slope that extends towards the northeast. Granular soil from the bottom of the site can be graded to the natural low point and/or used to increase the height of the existing berms.

A sump should be constructed in the natural low point for collection of drainage water, which will be captured and pumped back onto the soil in the LTF.

Additionally, soil from the berms of the decommissioned west LTF can be used for preparation of the east LTF.

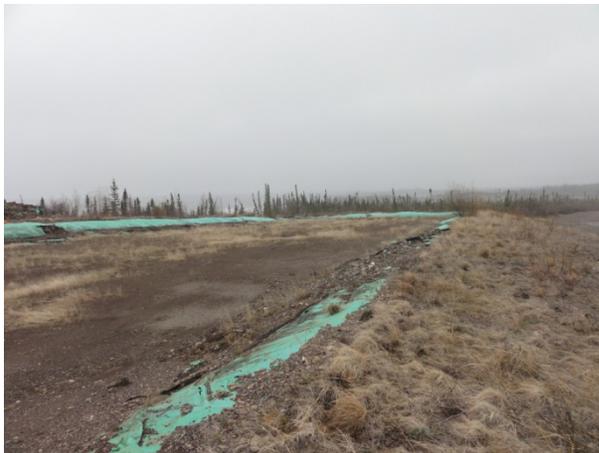
Photograph 2 - West LTF (looking west)

The western LTF (Photograph 2) was decommissioned during the fall of 2011 and the soil removed and stockpiled adjacent to the site. The artic liner was frozen to the ground and was removed along with the soil and is currently mixed in the stockpiles (Photograph 3). The side slope of the berms in this LTF are currently covered with the remains of the Artic Liner.

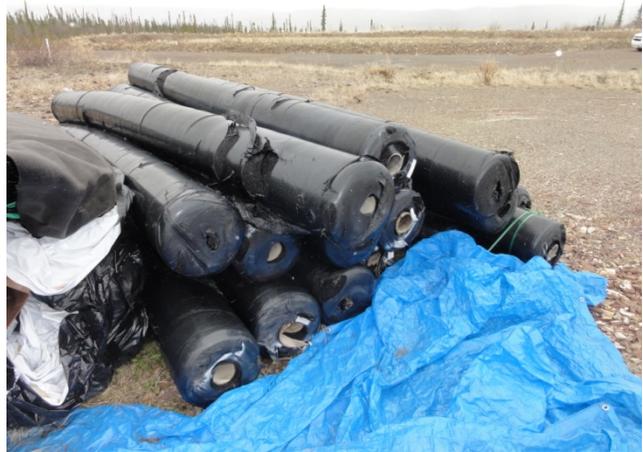
Photograph 4 - Rolls of geotextile

1. Sixteen rolls of 180 X 300 geo-textile (Photograph 4). There has been some damage to the outer parts of the geo-textile but it can be removed.

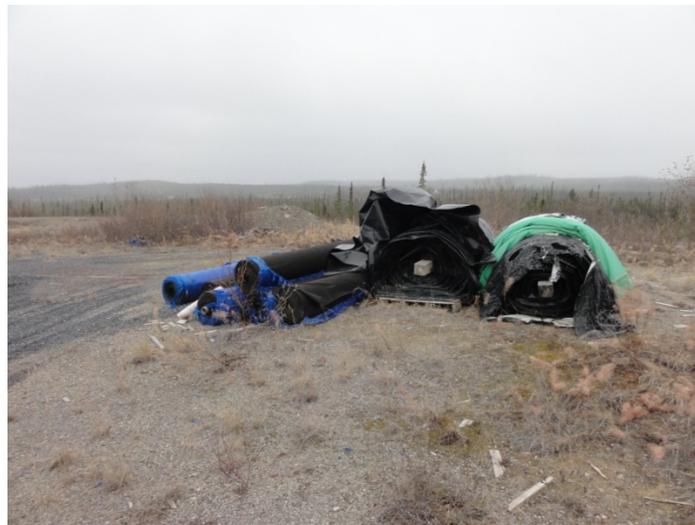
Photograph 5 - Rolls of Enviro-liner and thicker geotextile

2. Six rolls of an unknown type of geotextile (Photograph 5). It is thicker than the other rolls of geotextile on the site and should be usable in the east LTF.
3. Four rolls of Layfield 6030 High Density PolyEthylene (HDPE) Enviro-liner (Photograph 5). This gauge of this liner is 0.75 mm. It is covered and stored on palletes and appears to be in good shape.
4. Three rolls of Artic liner. The Artic Liner is the green liner on the site and is spooled on metal beams while the Enviro-liner is spooled on wooden beams. This cannot be used in the east LTF and should be moved out of the active project area.
