PROJECT-SPECIFIC DESIGNATED SUBSTANCE AND HAZARDOUS MATERIALS SURVEY REPORT

Burlington Lift Bridge, PWGSC Engineering Asset Properties

PWGSC Project R.012641.002

Re: Project-Specific Designated Substances and Hazardous Materials Survey (DSHMS) for the Controls, Drives and Cables Replacement Project of the Burlington Lift Bridge located at 1157 Beach Boulevard in Hamilton, ON

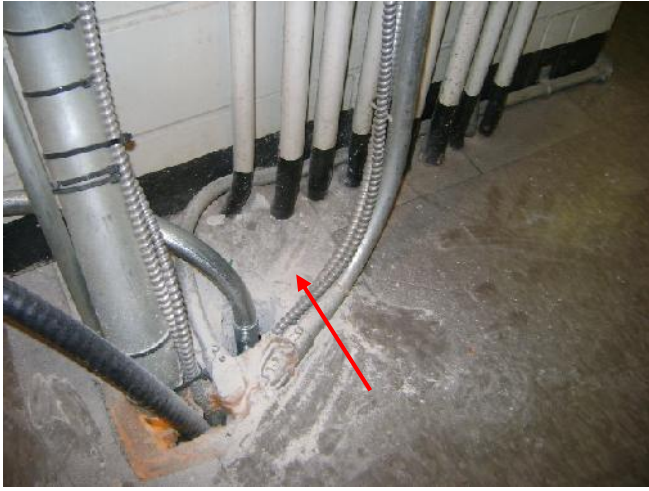
Photograph 1: [Control House Electrical Room - 2nd Floor] Asbestos-containing grey 9"x9" vinyl floor tile observed to be in fair condition around pipe conduit penetration.

- Asbestos-containing vinyl floor tiles (as confirmed by the previous reports) were identified to contain concentrations of 20-30% Chrysotile asbestos. The asbestos-containing vinyl floor tiles (9"x9" grey vinyl floor tiles) were observed to be in mainly good condition with a few tiles observed to be in fair condition. It is recommended that the vinyl floor tiles which require removal to facilitate the work, including those observed in fair condition, are removed and replaced following **Type 1 asbestos removal** procedures as prescribed by *O.Reg.278/05*.

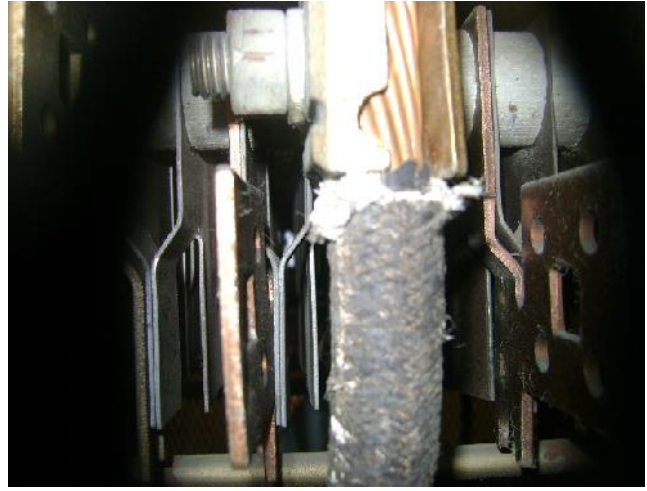
Photograph 2: [Control House Electrical Room (2nd Floor)] Presumed asbestos-containing electrical cable sheathing observed to be in fair condition.

- Electrical cable sheathing is presumed to be asbestos-containing due to inaccessibility for sampling. If the upcoming controls, drives and cables replacement project has the potential of disturbing this material, **Type 1 asbestos removal** procedures as prescribed by *O.Reg.278/05* should be followed if the material is removed using non-powered hand tools, otherwise, dispose of the entire cable as asbestos-waste.

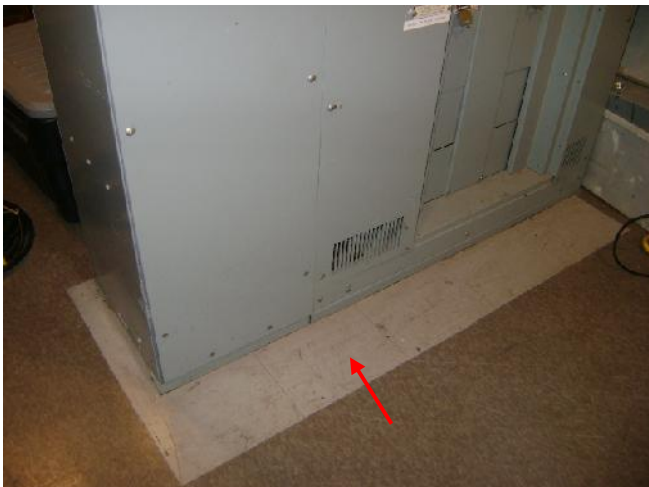
Photograph 3: [Control House Electrical Room - 2nd Floor] Non-asbestos-containing 12"x12" off-white vinyl floor tile with faint streaks (Sample Set BLB-1).

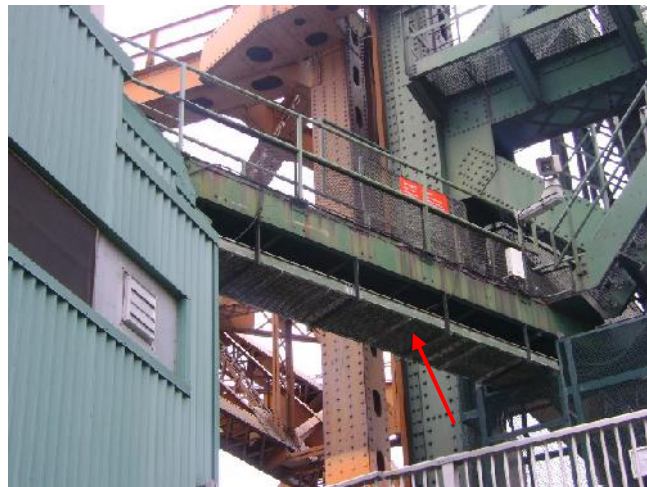
Photograph 4: [Catwalk] Lead-containing green paint application observed to be in poor condition.

- Work that will disrupt and/or pulverize (including drilling, cutting, grinding or abrading) lead-containing materials must follow the recommendations provided in the *Ministry of Labour Guideline for Lead on Construction Projects*, dated September 2004.

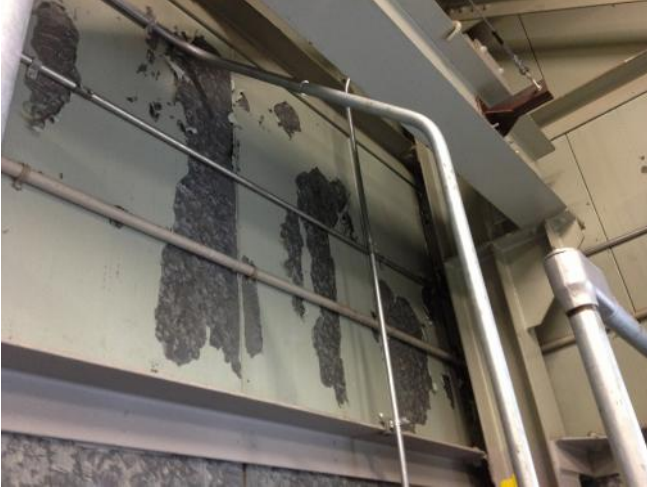
Photograph 5: [North / South Bridge Towers] Lead-containing grey wall paint application in the mechanical room observed to be in poor condition.

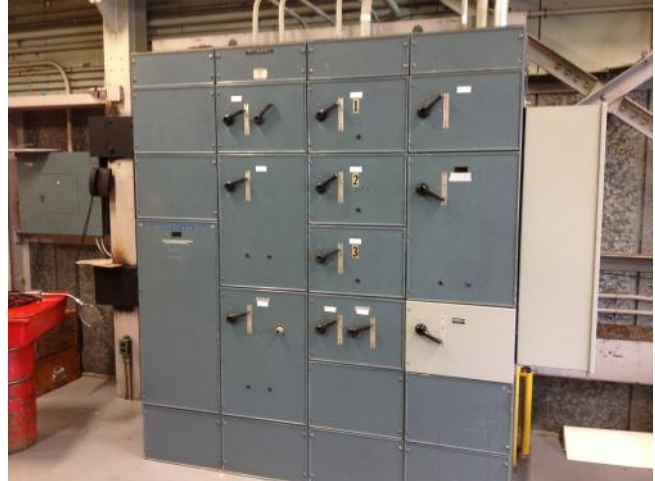
Photograph 6: [North / South Bridge Towers] “MCC” unit to be moved within the mechanical rooms.

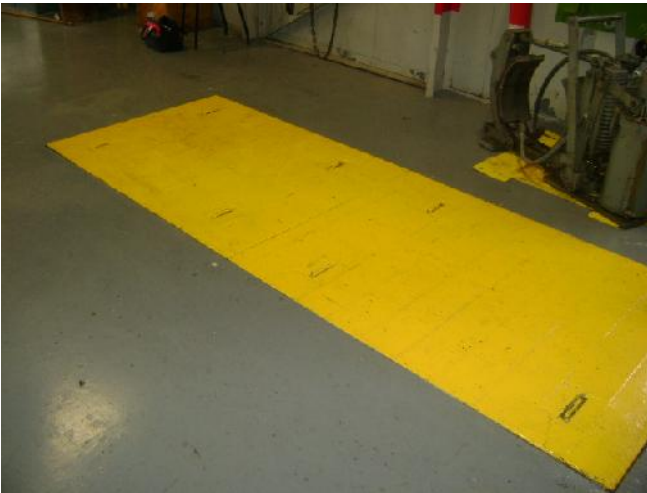
Photograph 7: [North/South Towers Mechanical Room] Lead-containing grey floor paint application observed to be in good condition.

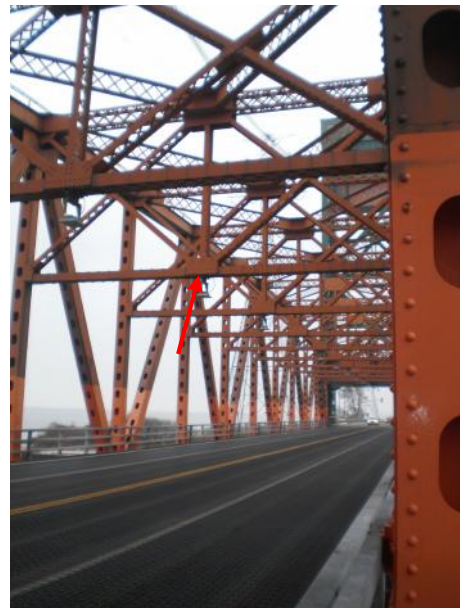
Photograph 8: [Lift Bridge Structure] Lead-containing red primer paint application observed to be in fair condition.

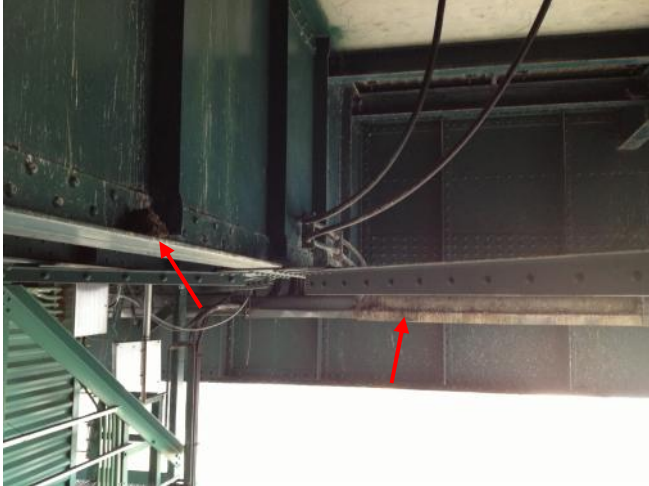
Approximately 20 m² of guano was observed on the bridge structure beneath the mechanical and sheave rooms on both of the North and South towers.

Photograph 9: [Bridge Tower, below Sheave Room]
Guano observed on the bridge tower structure.

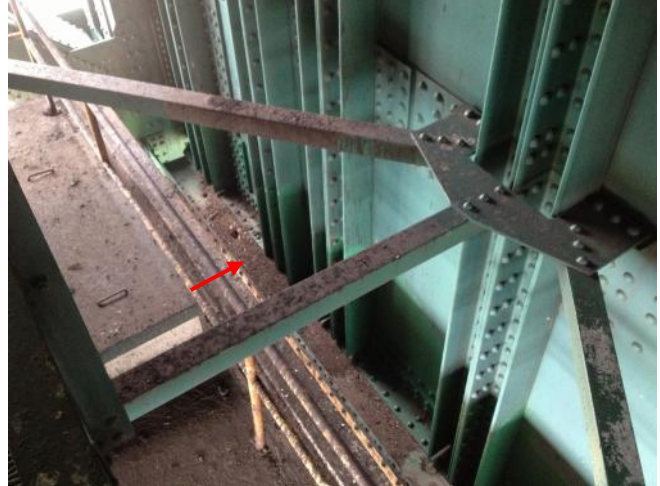
Photograph 10: [Bridge Tower, below Sheave Room]
Guano observed on the bridge tower structure.

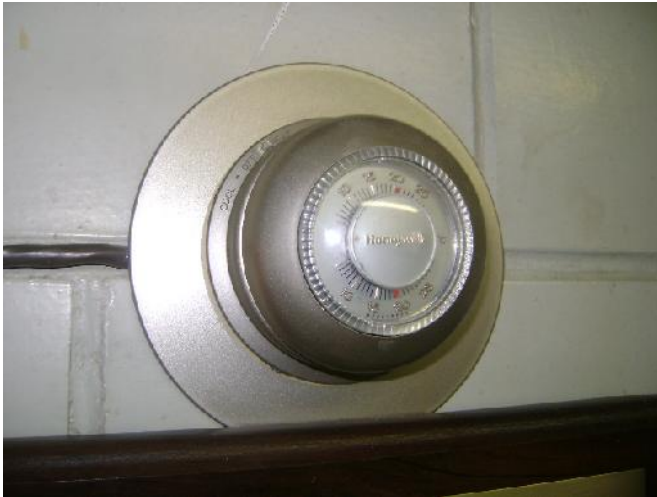
A mercury-containing thermostat was observed within the Control House (Photograph 11, Appendix C).

Photograph 11: [Control House – Electrical Room]
Mercury-containing thermostat.
