APPENDIX 4

SITE PHOTOGRAPHS – INTERIOR

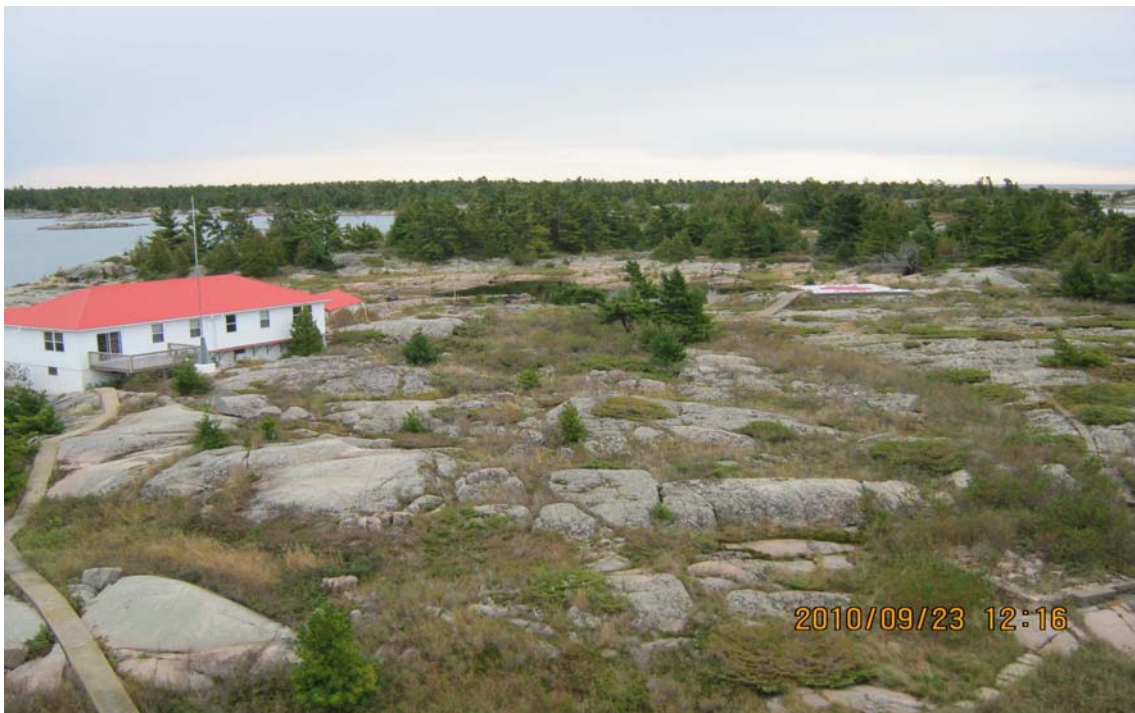
Photo 2: View from top of lighthouse facing south, residence building, helicopter pad, and boathouse visible.

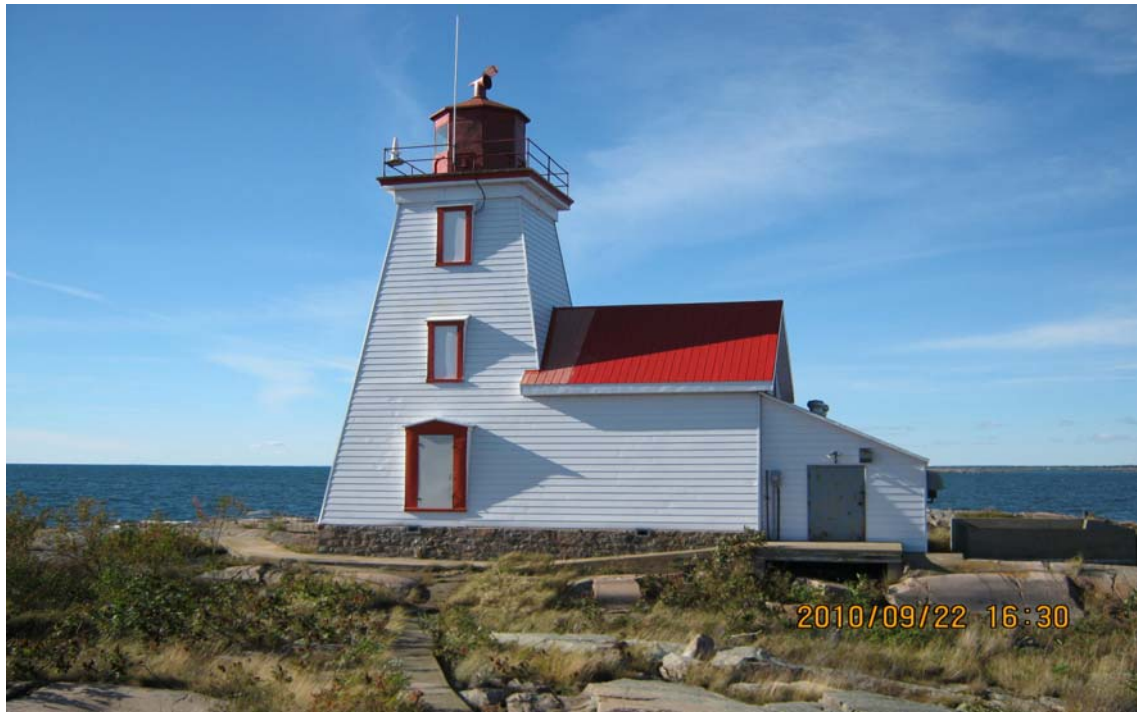
Photo 3: View of lighthouse facing north.

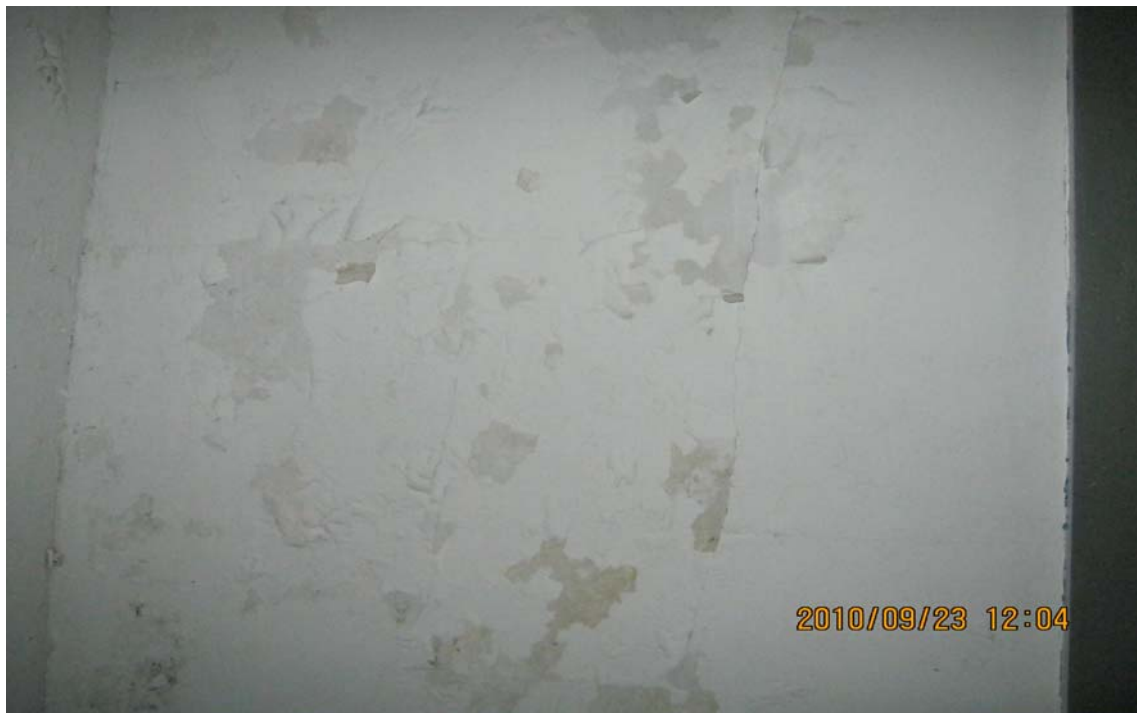
Photo 4: View L.H LS-6 sample location from lighthouse third floor interior wall. Sample was found to be above criteria and is considered lead based.

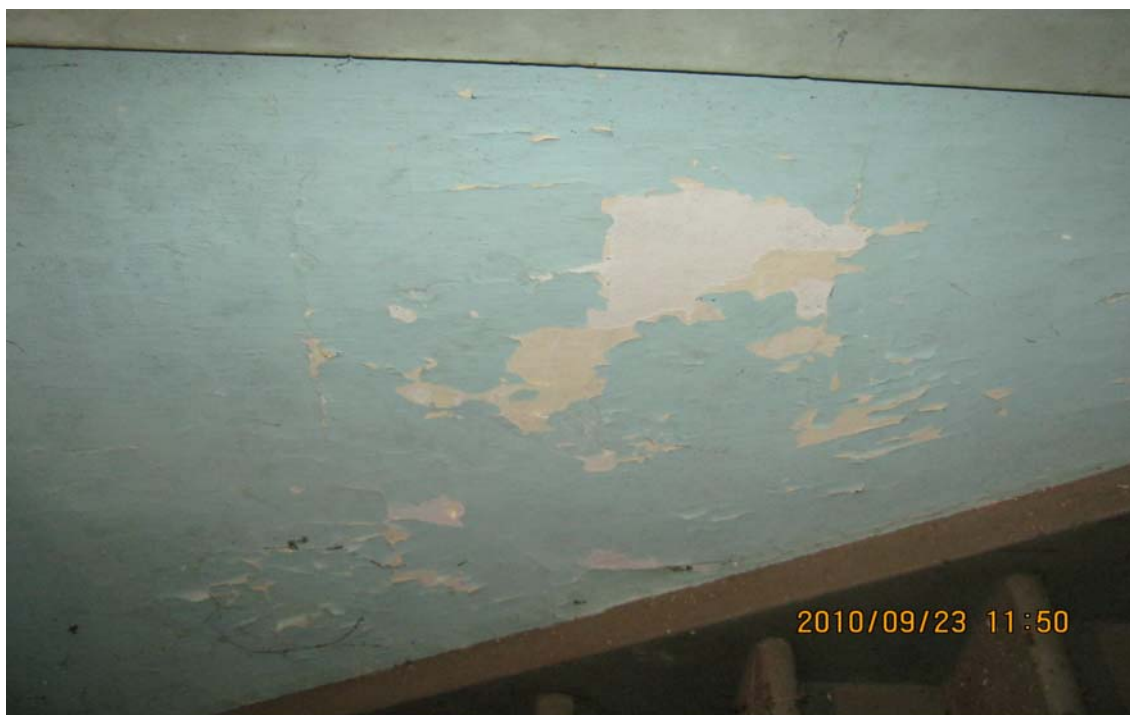
Photo 5: View of teal paint in main floor stairwell, sample L.H LS-3 was found to be above criteria and is considered lead based.

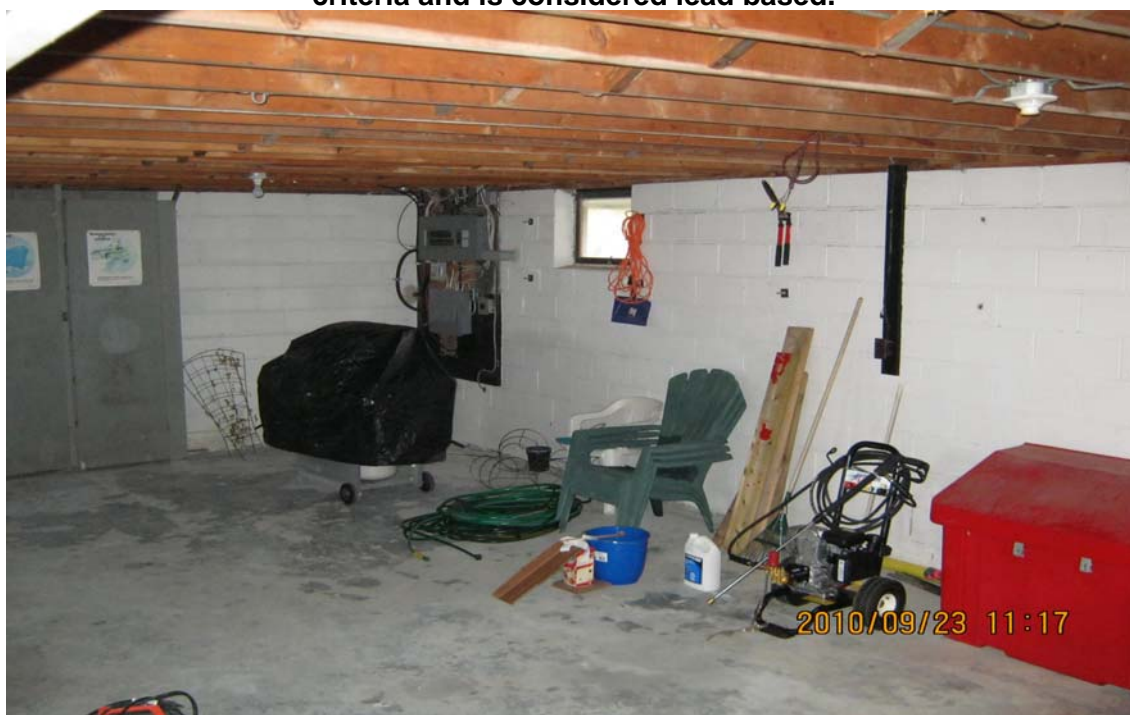
Photo 6: View of residence building basement, sample R.B LS-5 (battleship grey floor paint) was found to be above criteria and is considered lead based.

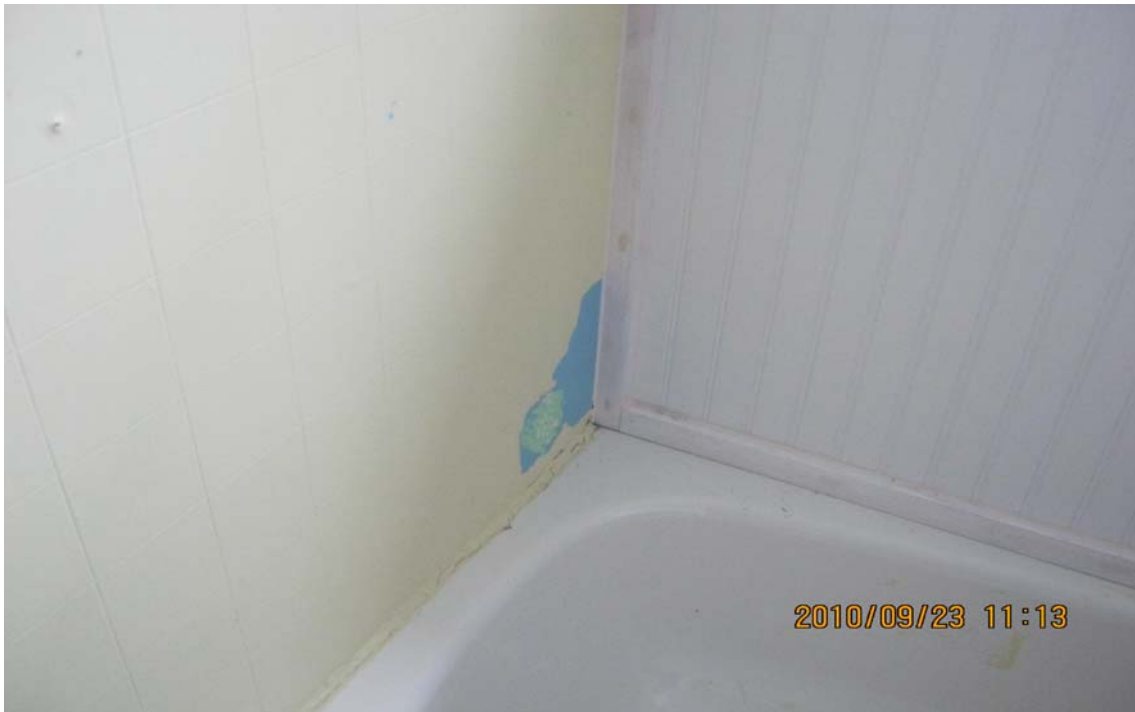
Photo 7: View of peeling paint in bathroom in residence building, sample R.B LS-8 was found to be below criteria and is considered non-lead based.
