PROJECT		WIKWEMIKONG UNCEDED INDIAN RESERVE #26 MANITOULIN ISLAND, ONTARIO		
TITLE		<b>LOCATION PLAN</b>		
<p><b>Golder Associates</b> LONDON, ONTARIO</p>	PROJECT No.	12-1134-0194	FILE No.	1211340194A01001
	CADD	L1MKDCH	SCALE	AS SHOWN   REV
	CHECK		DATE	27/12
			<b>FIGURE 1</b>

**APPENDIX A**  
**Site Photographs**

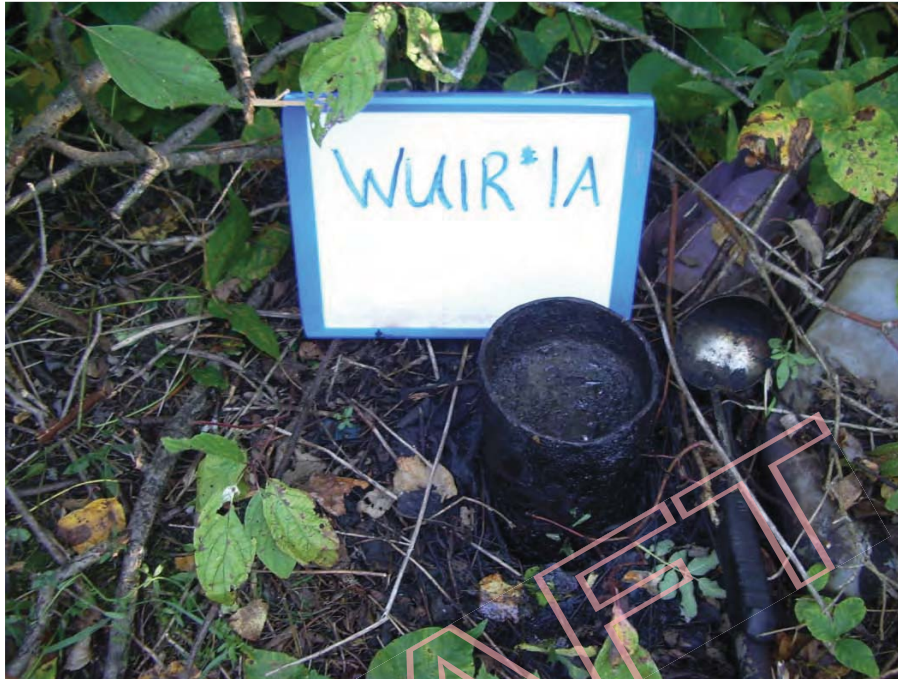
**Photograph 1:** Well 1A – Looking south-east. Photograph taken September 13, 2012. See accompanying text for description of the well and site conditions.

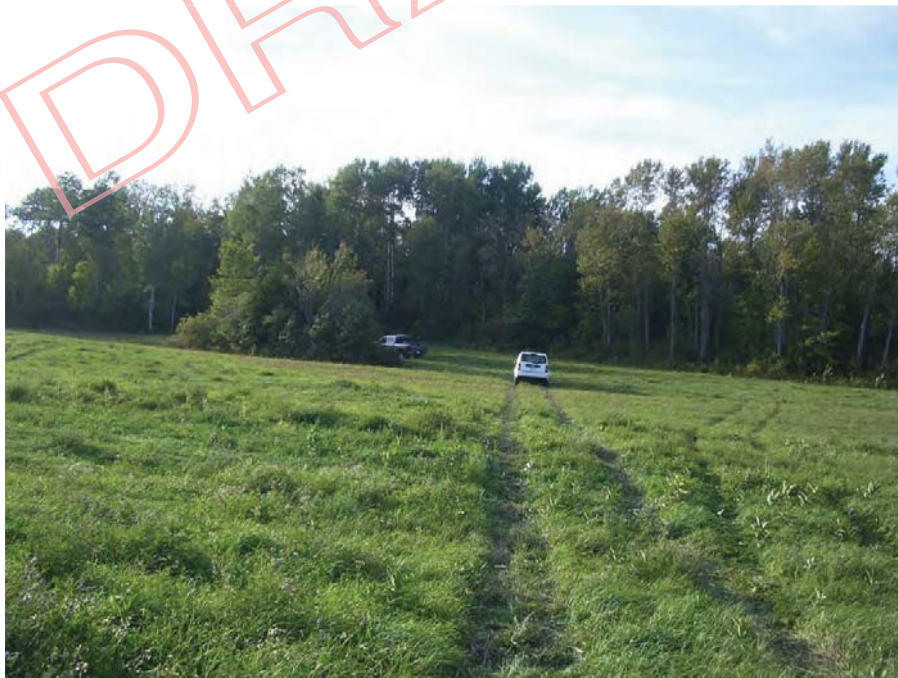
**Photograph 2:** Well 1A – Looking north-west from Kaboni Road. Well is located near stand of trees, approximately 185 m from roadway. Photograph taken September 13, 2012. See accompanying text for description of the well and site conditions.

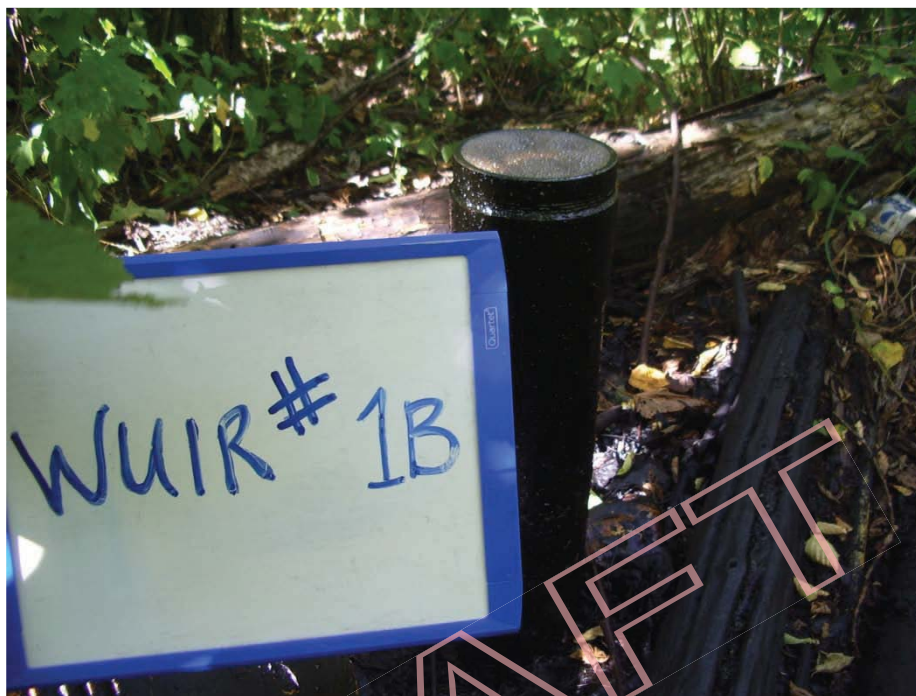
**Photograph 3:** Well 1B – Looking north-east. Photograph taken September 13, 2012. See accompanying text for description of the well and site conditions.

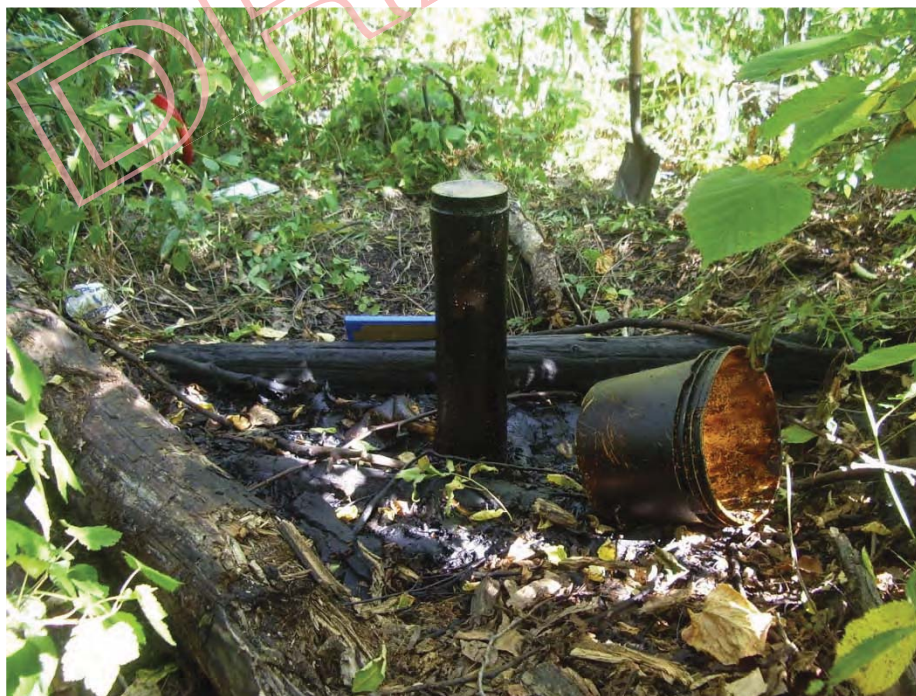
**Photograph 4:** Well 1B – Looking south-east. Photograph taken September 13, 2012. See accompanying text for description of the well and site conditions.

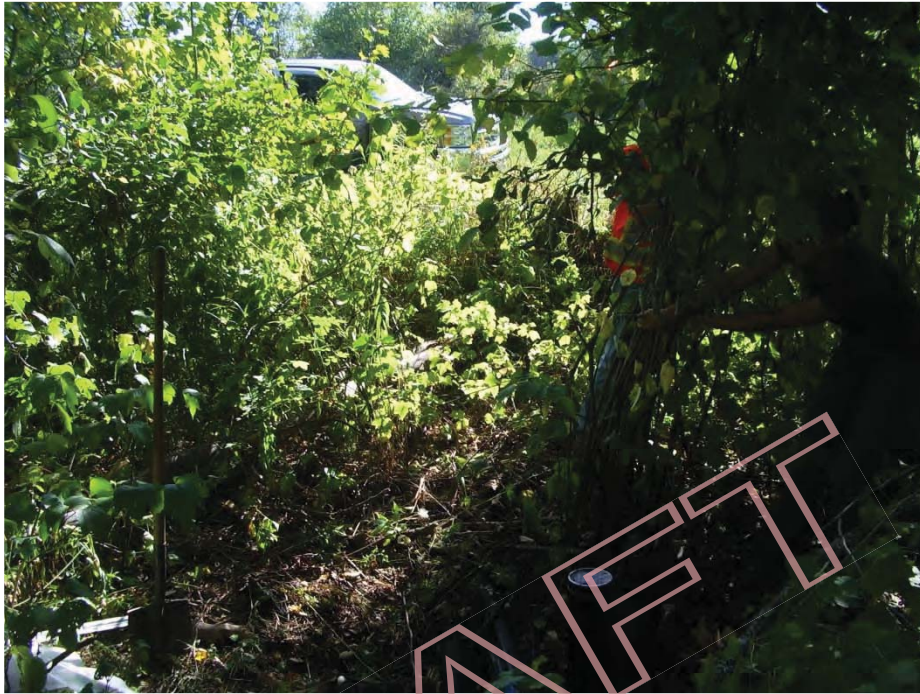
**Photograph 5:** Well 1B – Looking south-west. Well is located approximately 5 m north-east of clearing. See accompanying text for description of the well and site conditions.

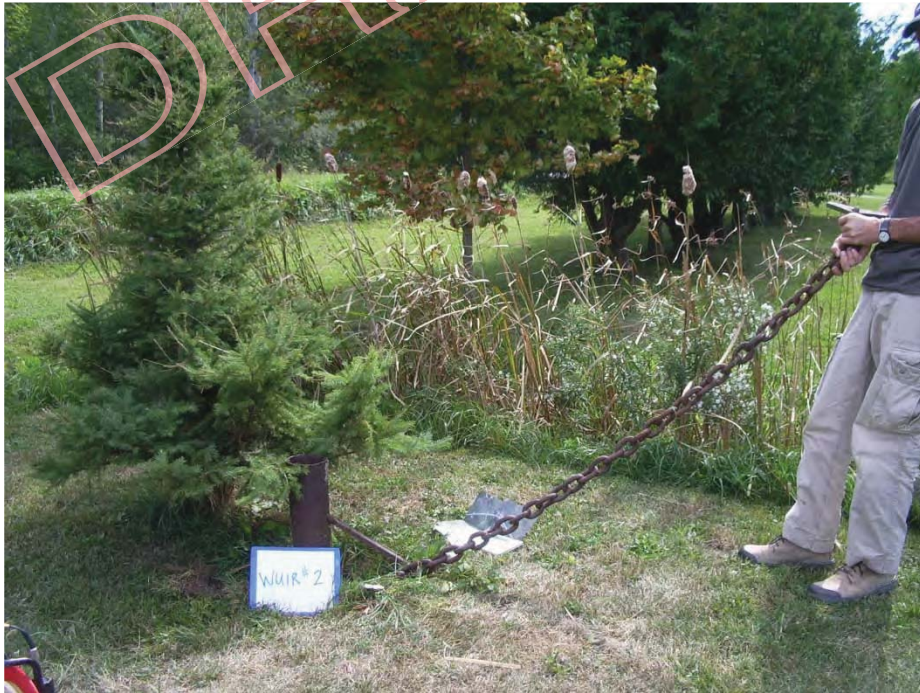
**Photograph 6:** Well 2 – Looking south. Well is located 8 m from road adjacent to small evergreen tree. There is a shallow drainage ditch south of the well. Photograph taken September 13, 2012. See accompanying text for description of the well and site conditions.

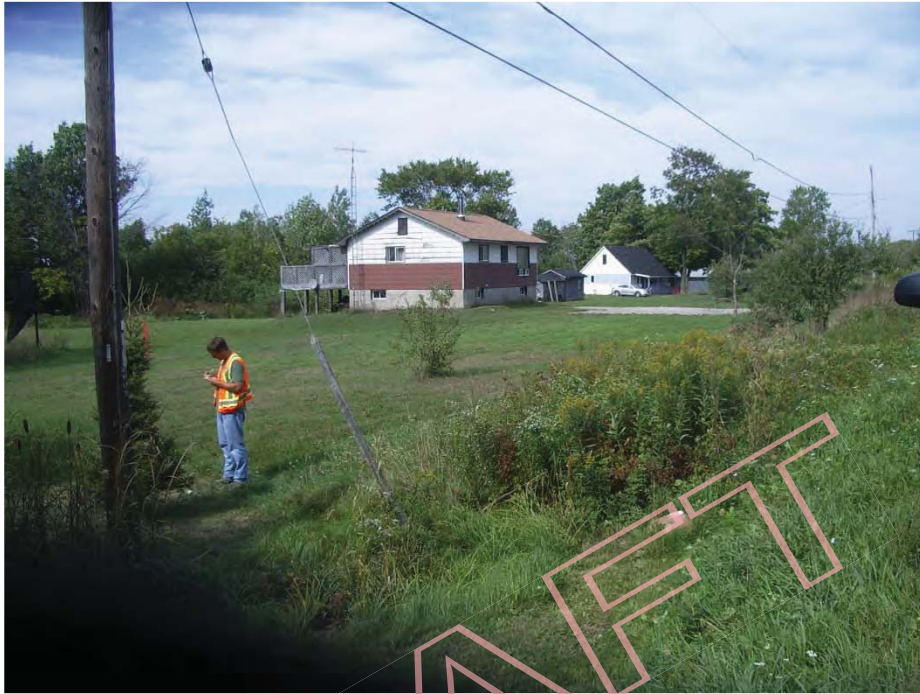
**Photograph 7:** Well 2 – Looking north. Well is located in south-west corner of MN 780 Kaboni Road, approximately 2 m west of overhead wires. See accompanying text for description of the well and site conditions.

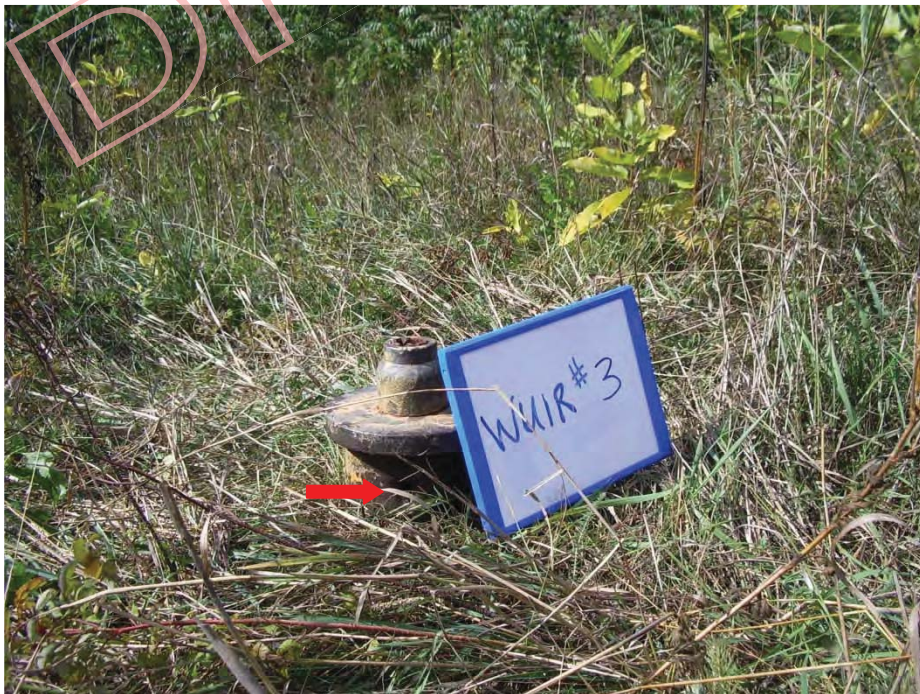
**Photograph 8:** Well 3 – Looking north. Well is sealed with a metal plate and casing is perforated (red arrow). Photograph taken September 13, 2012. See accompanying text for description of the well and site conditions.

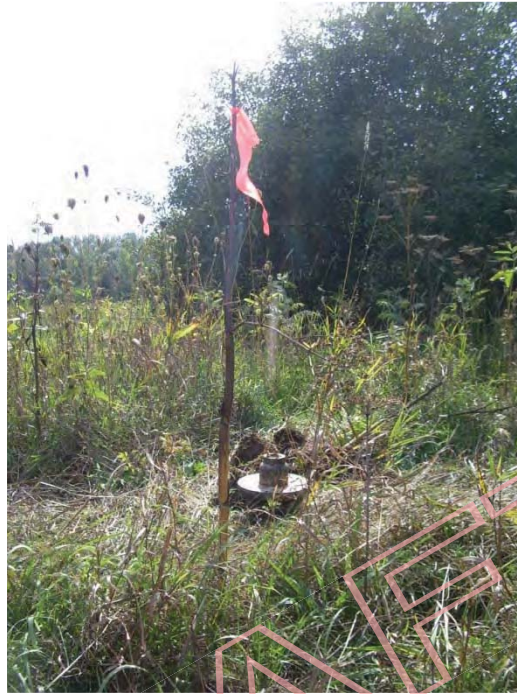
**Photograph 9:** Well 3 – Looking south. Photograph taken September 13, 2012. See accompanying text for description of the well and site conditions.

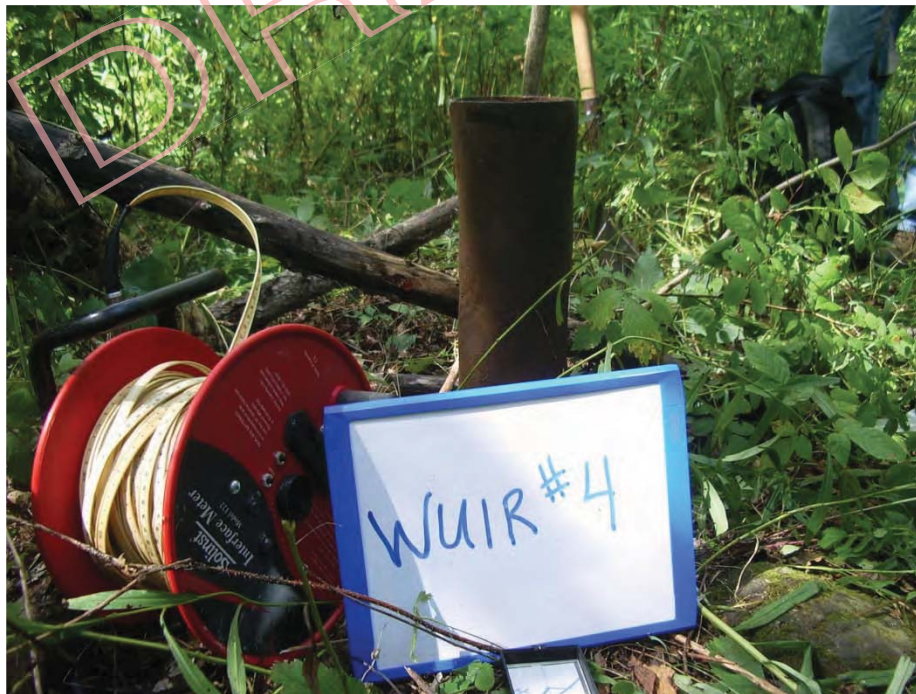
**Photograph 10:** Well 4 – Looking south. Photograph taken September 13, 2012. See accompanying text for description of the well and site conditions.

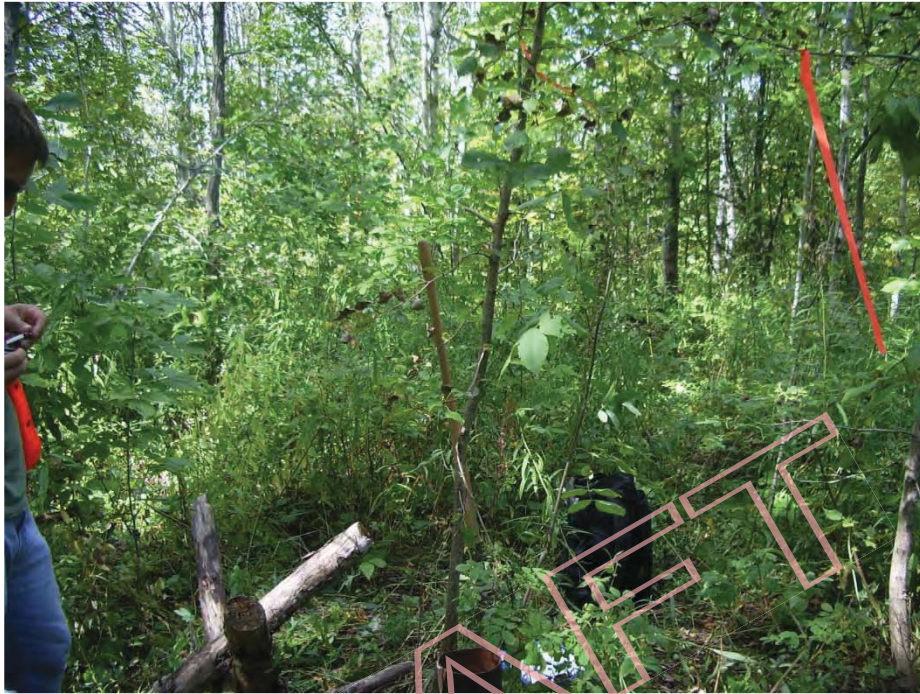
**Photograph 11:** Well 4 – Looking north-west towards Cape Smith Road. Photograph taken September 13, 2012. See accompanying text for description of the well and site conditions.

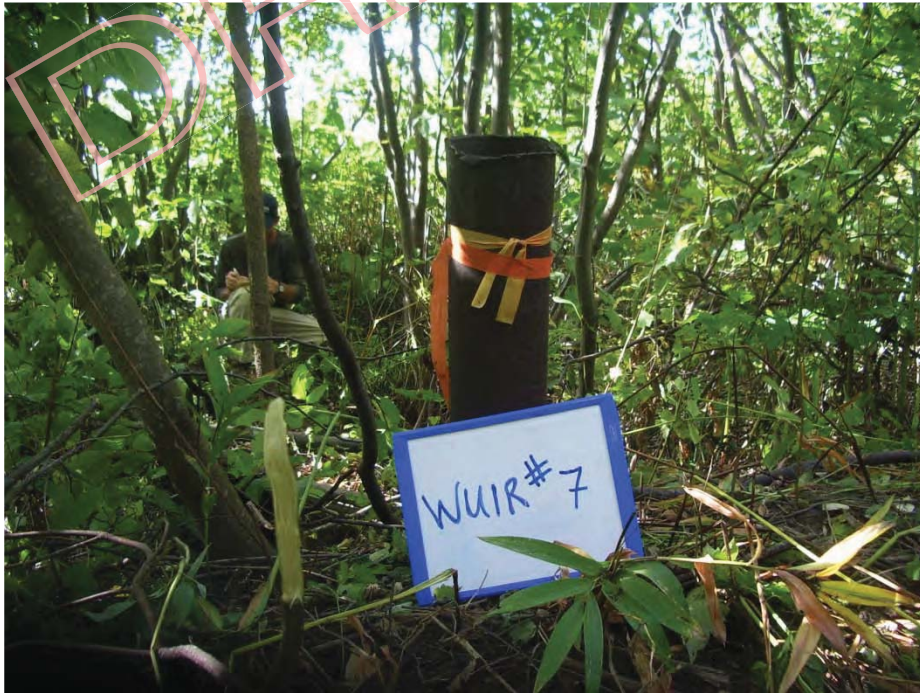
**Photograph 12:** Well 7 – Looking west. Well is approximately 14 m east of Kaboni Road in wooded area. Photograph taken September 13, 2012. See accompanying text for description of the well and site conditions.

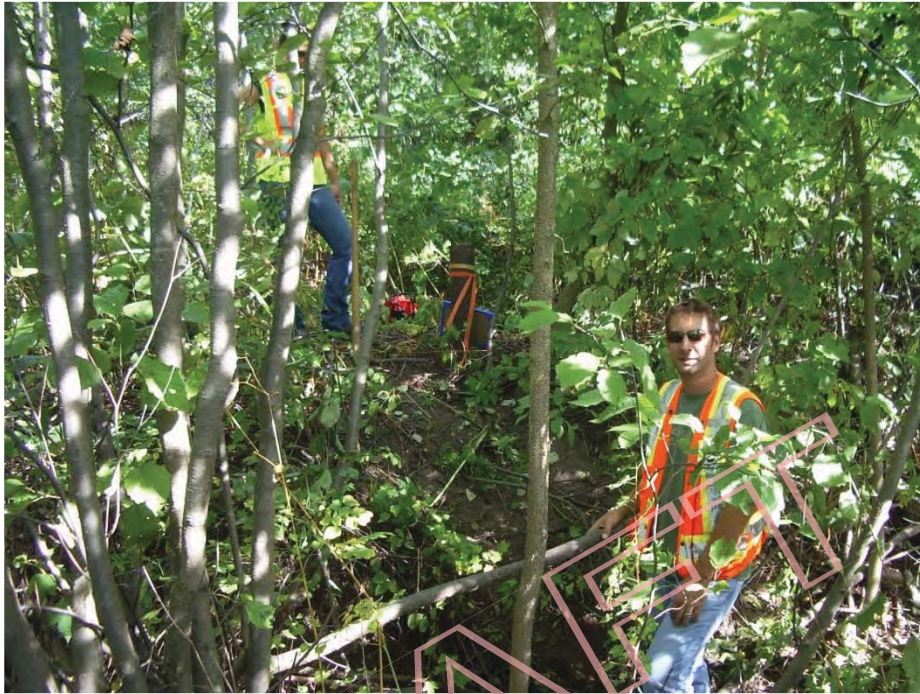
**Photograph 13:** Well 7 – Looking south-east. A drainage swale is located east of the well. Photograph taken September 13, 2012. See accompanying text for description of the well and site conditions.

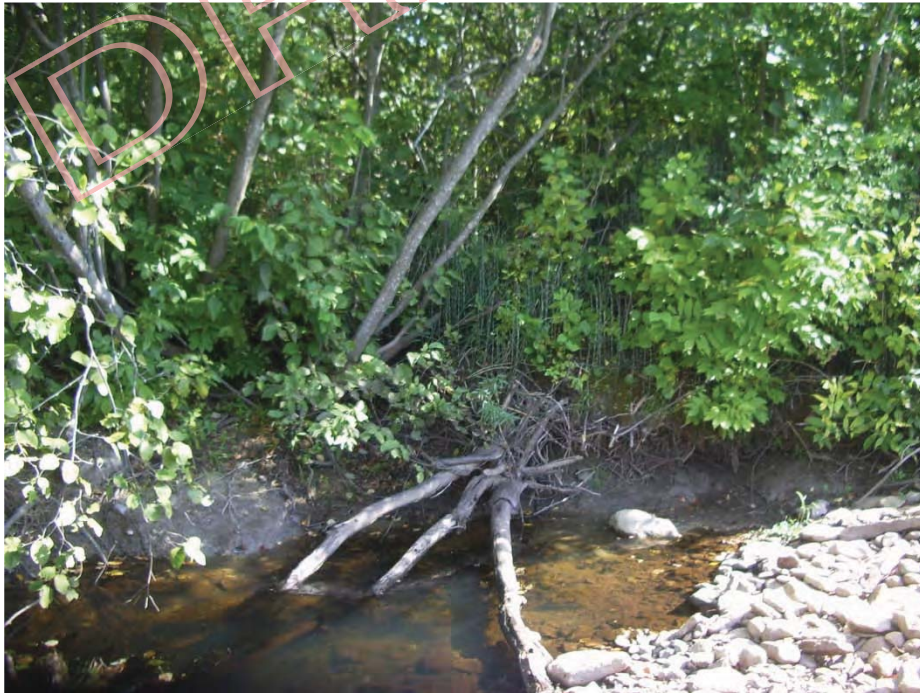
**Photograph 14:** Well 7 – Looking south towards discharge point of swale into nearby creek. Photograph taken September 13, 2012. See accompanying text for description of the well and site conditions.

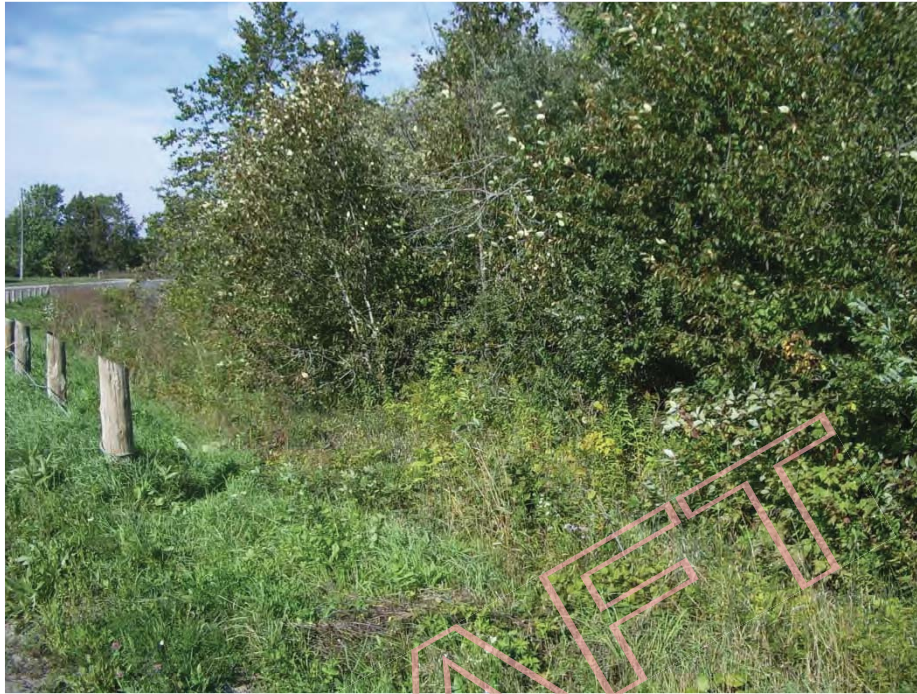
**Photograph 15:** Well 7 – Looking north-east from Kaboni Road. Well is to east of road within wooded area. Photograph taken September 13, 2012. See accompanying text for description of the well and site conditions.

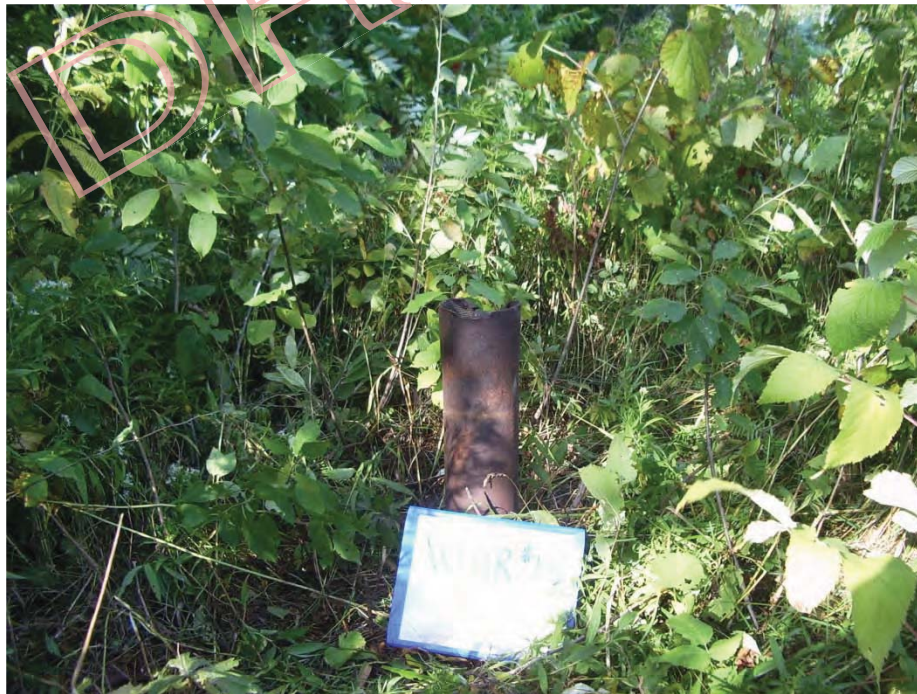
**Photograph 16:** Well 13 – Looking north. Photograph taken September 13, 2012. See accompanying text for description of the well and site conditions.

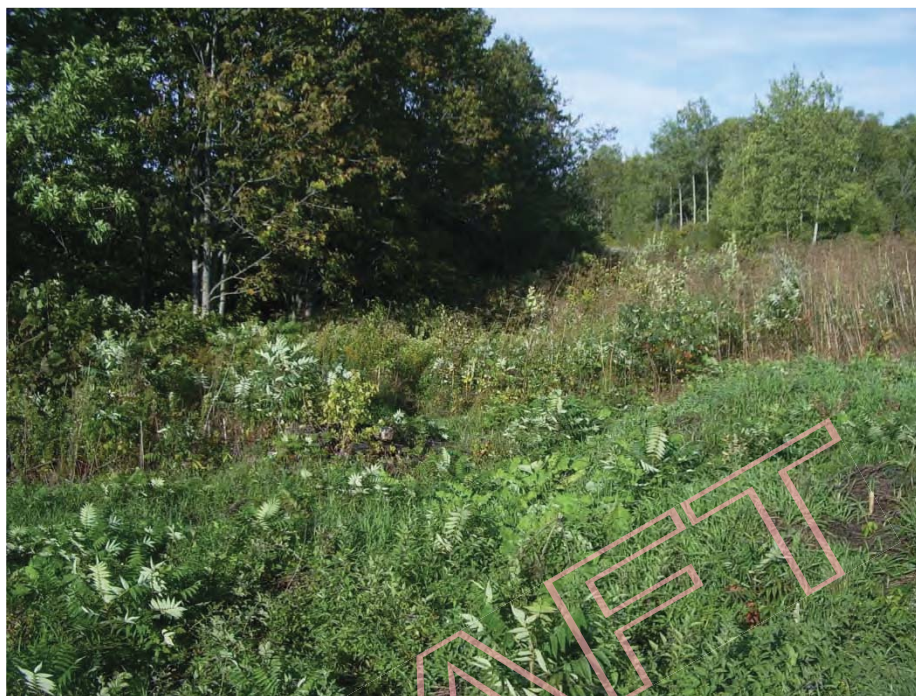
**Photograph 17:** Well 13 – Looking north. Well is located within roadside ditch approximately 16m west of Kaboni Road, immediately east of treeline. Photograph taken September 13, 2012. See accompanying text for description of the well and site conditions.
