REPORT: T021204-A1

Public Works and Government Services Canada
Geotechnical Investigation Report
National War Memorial Structural Upgrade Phase I
Confederation Square
Ottawa, Ontario

September 20, 2013

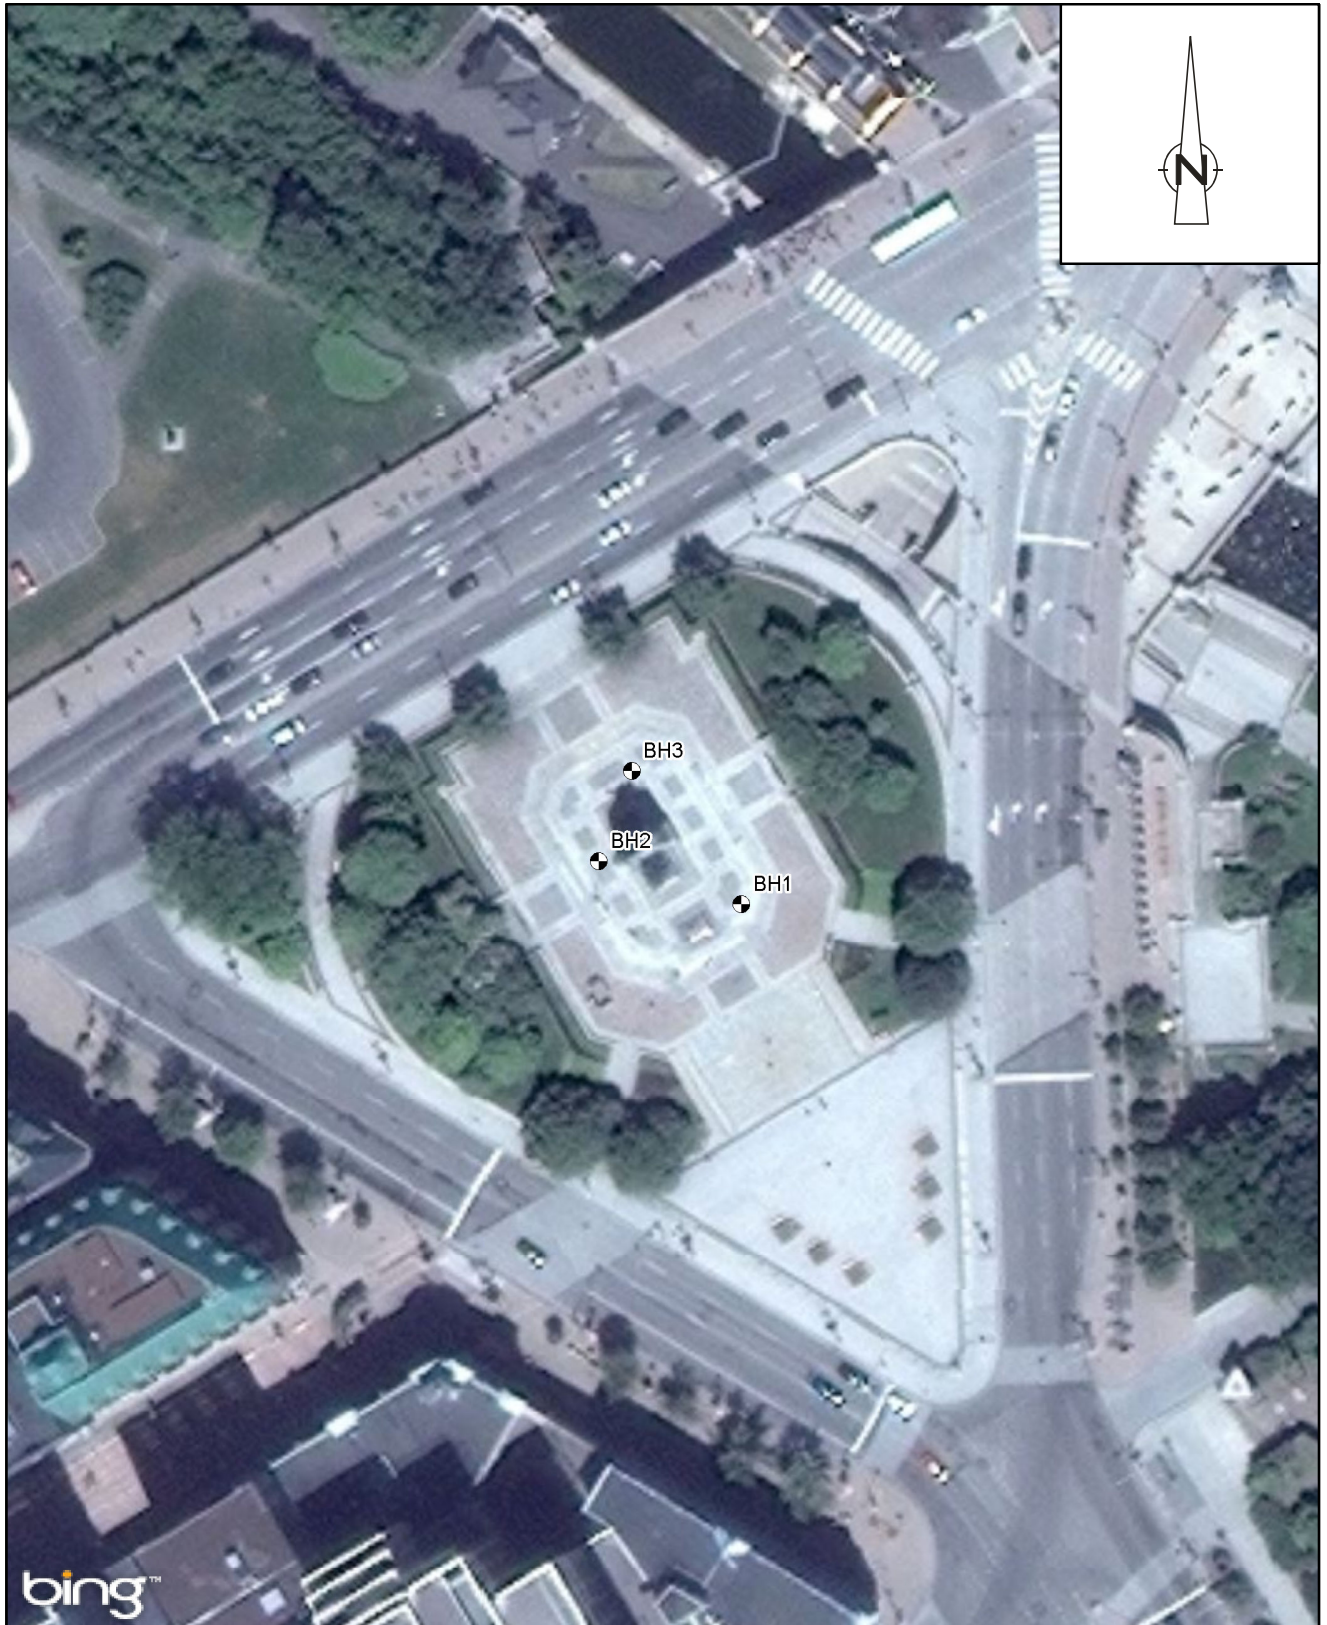
BOREHOLE PLAN

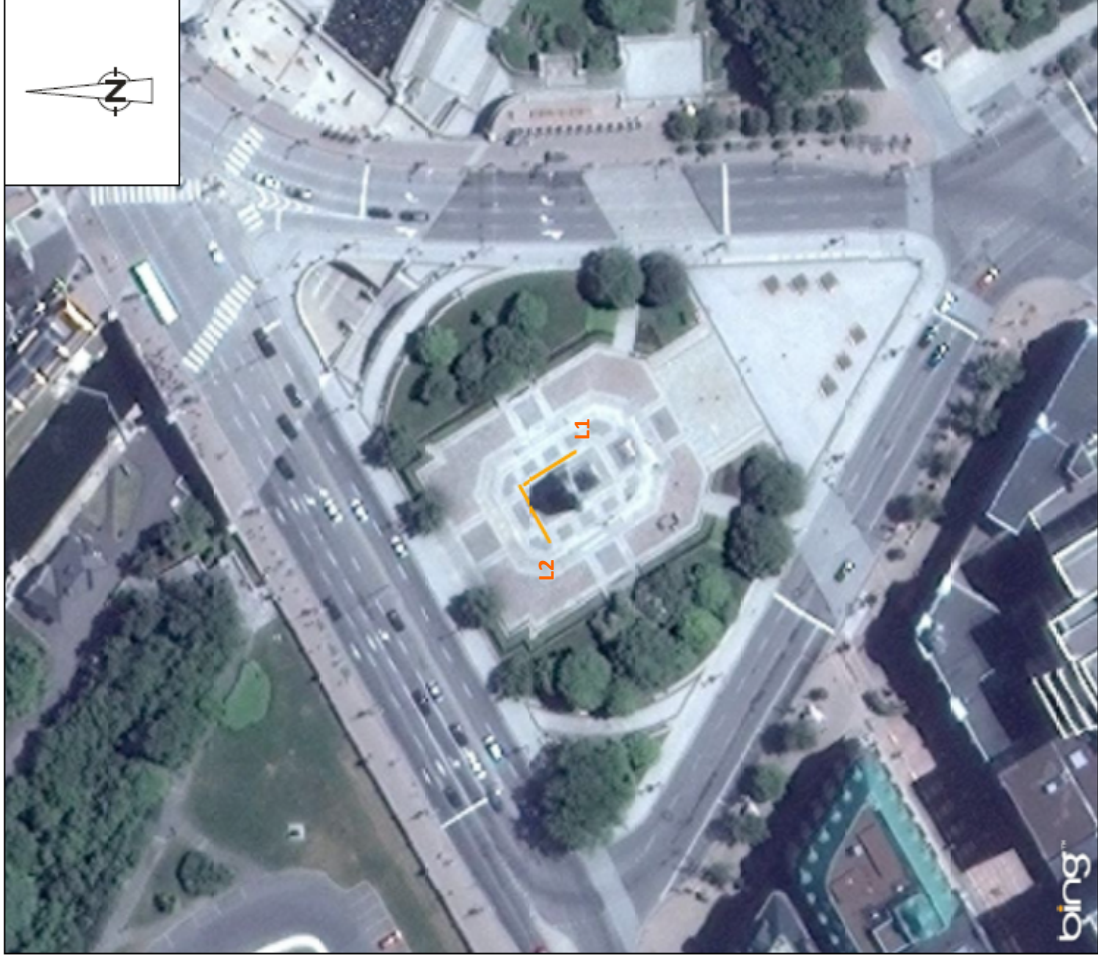
DRAWN BY: A.(Z).G	SCALE: N.T.S	REFERENCE NO: T021204-A1
CHECKED BY: A.N.M	DATE: August 2013	FIGURE NO: 1

— Approximate investigation line locations

MASW TEST INVESTIGATION LINE PLAN
SHEAR WAVE VELOCITY PROFILE, LINES 1 and 2
NATIONAL WAR MEMORIAL
CONFEDERATION SQUARE, OTTAWA, ONTARIO

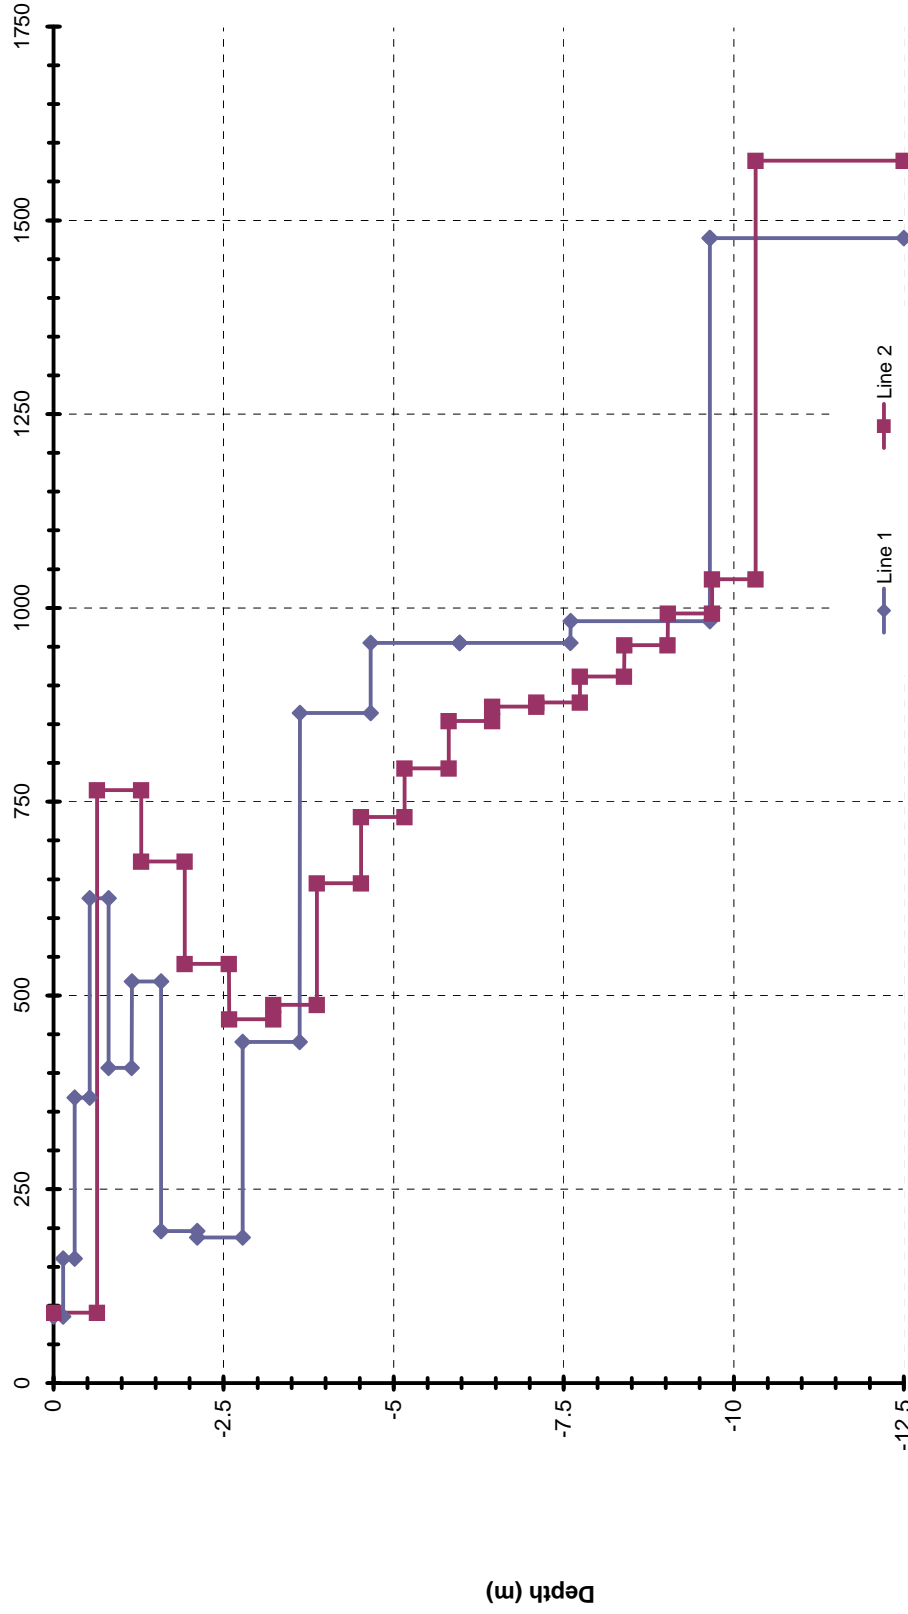
Shear Wave Velocity versus Depth - Line 1 and 2

Shear Wave Velocity (m/s)

MASW TEST RESULTS
SHEAR WAVE VELOCITY PROFILE, LINES 1 and 2
NATIONAL WAR MEMORIAL
CONFEDERATION SQUARE, OTTAWA, ONTARIO

It should be noted that due to the poor data the wave penetration depth was relatively shallow (up to 10 m or so). Considering that the bedrock is shallow, the velocity measured for the last depth to 30 m below was extrapolated to obtain the average shear wave velocity. This is in line with Code recommendation.

Based upon the results of the geophysical testing program, we recommend that the building be designed to **Site Class 'B'**, with respect to Table 4.1.8.4.A of the OBC-2006. The results of the geophysical testing program as well as the Site Class calculation can be found in *Seismic Site Classification* attached as *Appendix: C* at the end of this report.

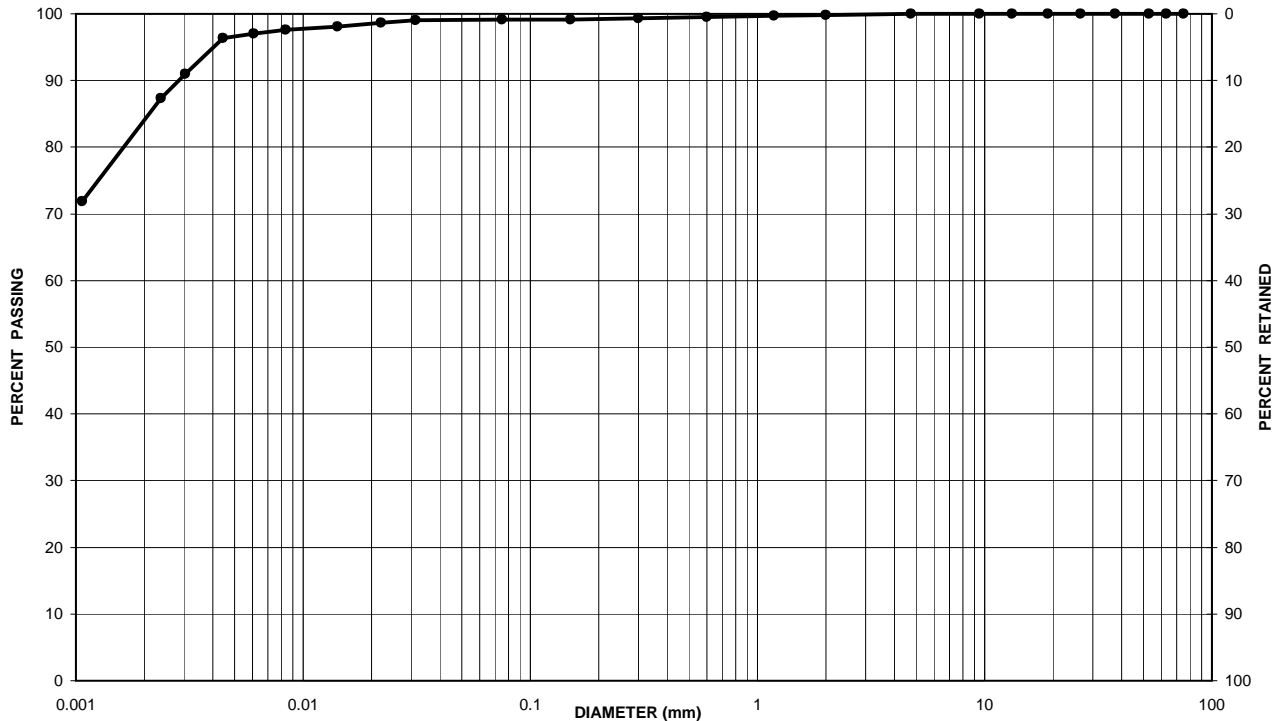
Borehole No.: 1 Sample No.: 2

Soil Description	Gravel	Sand	Clay & Silt
Clay some Silt trace Sand	0	1	99

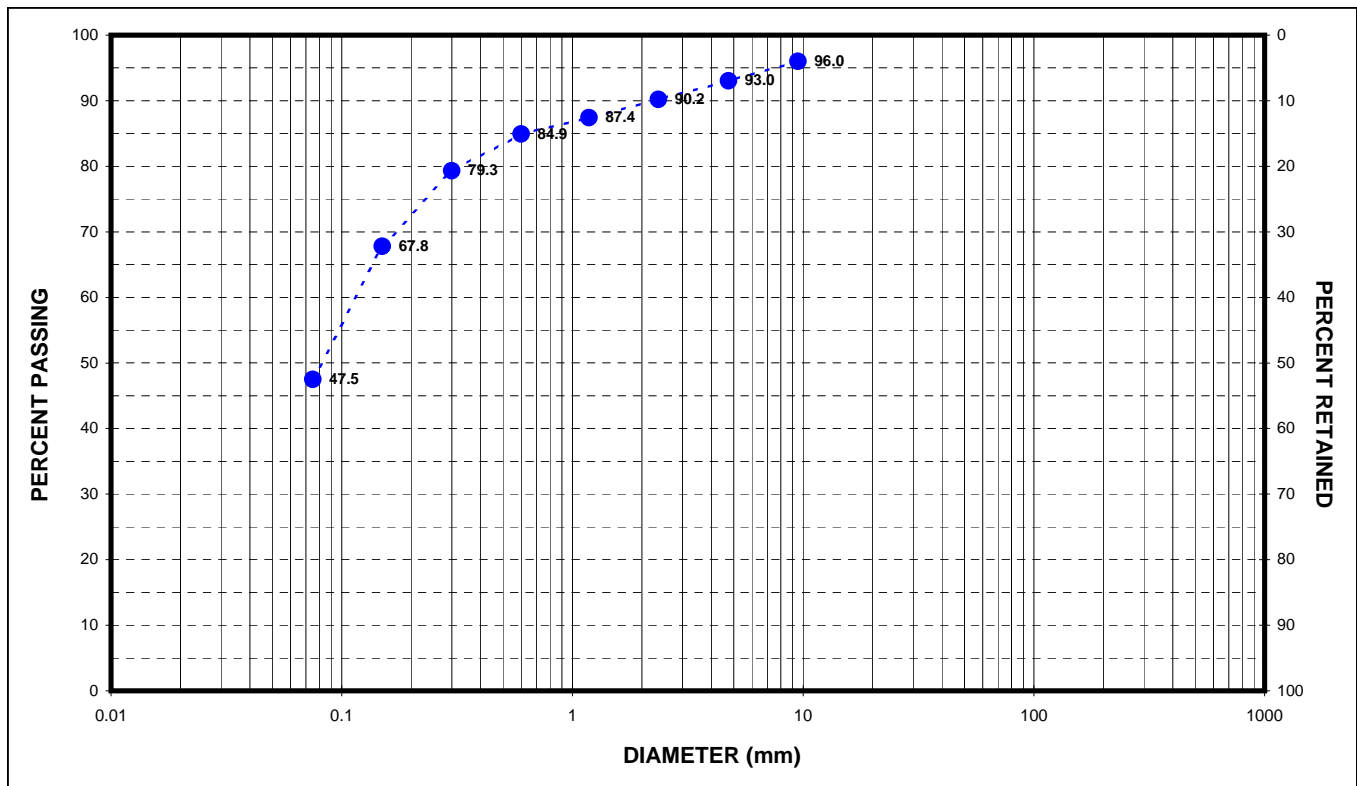
SIEVE SIZE (mm)	SAMPLE % PASSING	
9.50	96.0	
4.75	93.0	
2.36	90.2	
1.18	87.4	
0.600	84.9	
0.300	79.3	
0.150	67.8	
0.075	47.5

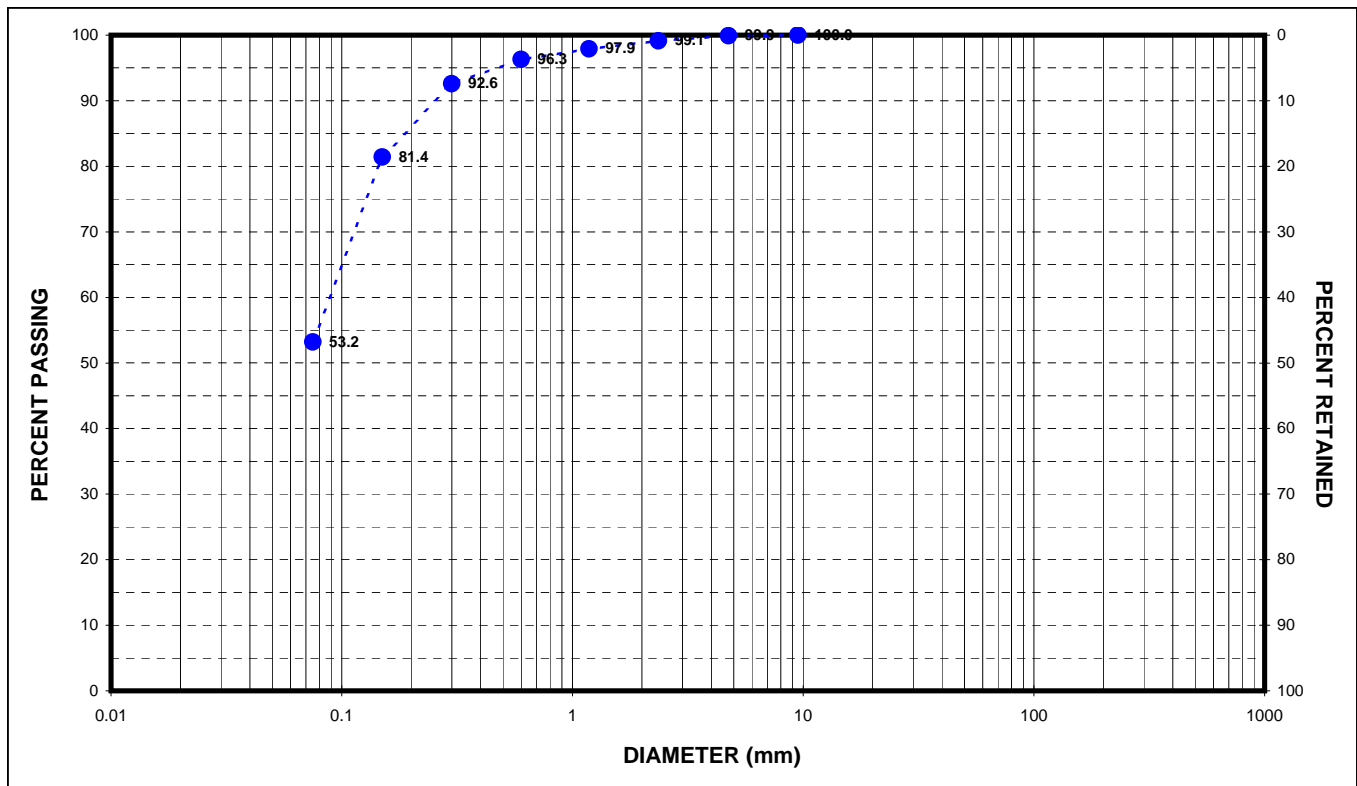
SIEVE SIZE (mm)	SAMPLE % PASSING	
9.50	100	
4.75	99.9	
2.36	99.1	
1.18	97.9	
0.600	96.3	
0.300	92.6	
0.150	81.4	
0.075	53.2

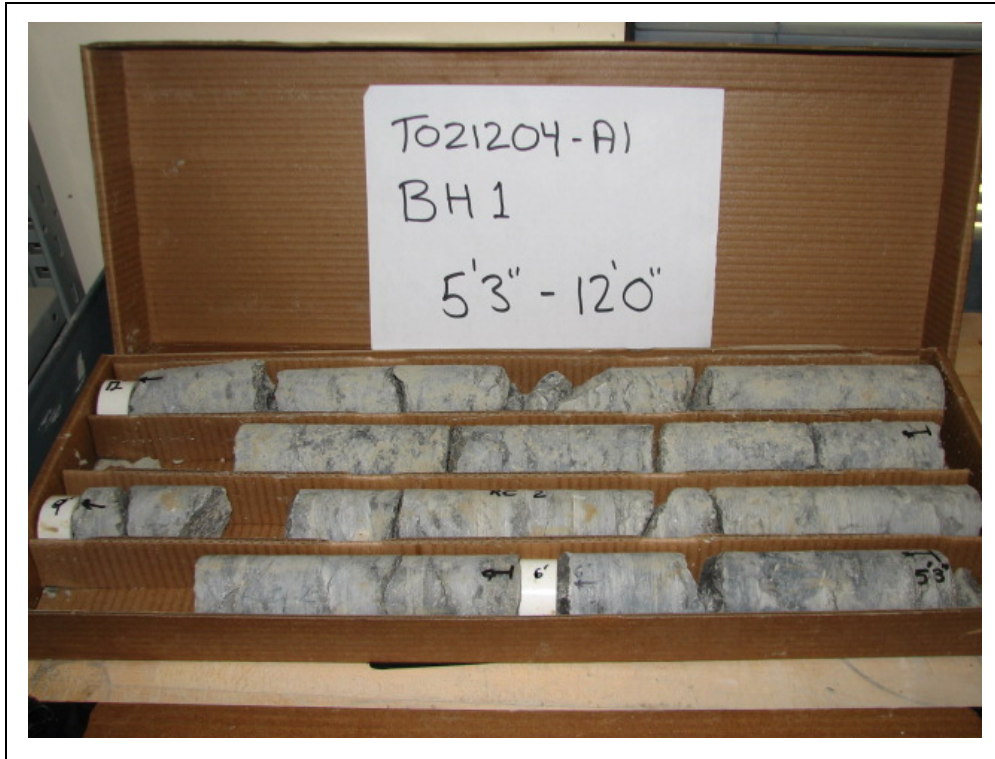
Photo 1: Borehole BH1 Rock Core

Practical refusal was encountered in all boreholes below the overburden soils and was found to range in depth from 1.4 m in BH3 to 1.7 m in BH2. The type of rock and its quality was confirmed by retrieving rock samples from all the boreholes by diamond coring techniques. Bedrock is described as medium grey fossiliferous micritic limestone cut by numerous stylolitic seams. The quality of this rock ranged from very poor to excellent depending on location and depth. The result of the uniaxial unconfined compressive strength test on nine (9) representative core samples revealed that bedrock has an unconfined compressive strength of between 90 Mpa to 160 Mpa. The photos of the rock cores are attached as *Appendix D* at the end of this report.

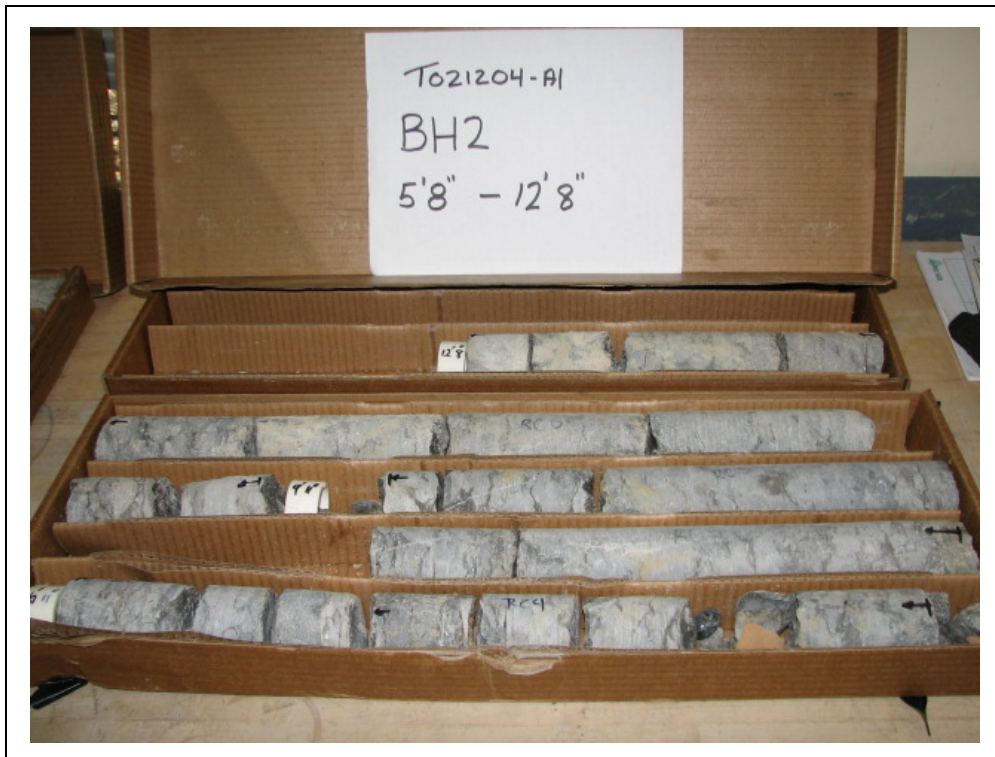
Photo 2: Borehole BH2 Rock Core

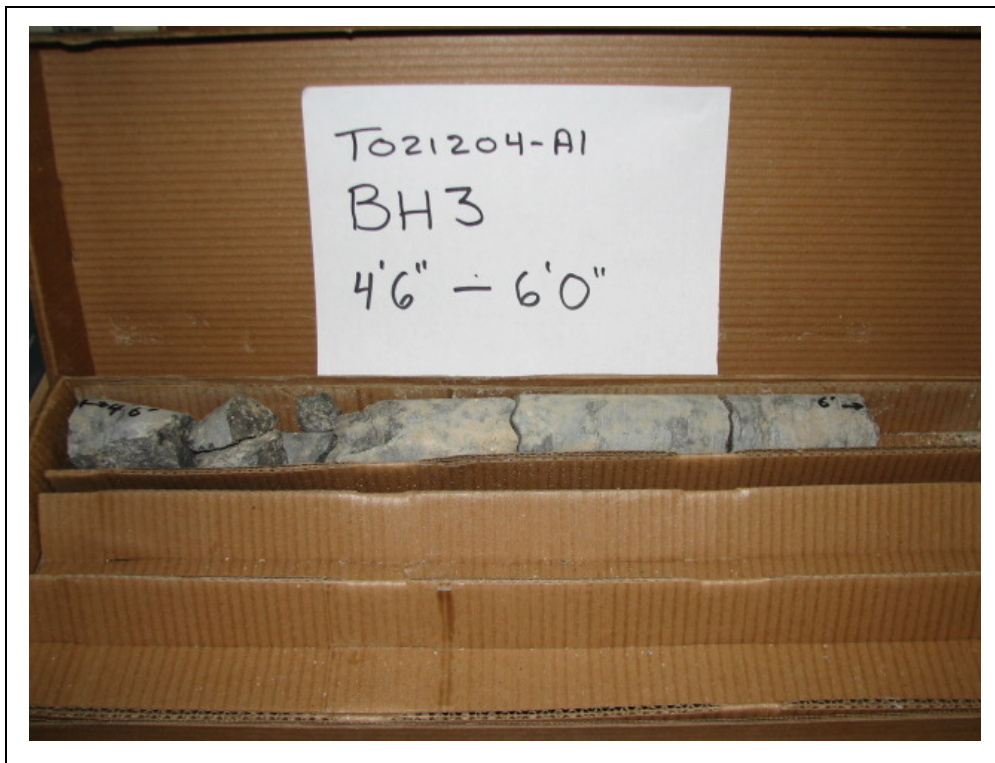
Photo 3 – Borehole BH3 Rock Core
