December 9, 2013

**XCG File No. 1-336-161-03**

**Re: Designated Substances and Hazardous Materials Review and Select Sampling of Potential Asbestos-Containing Materials and Lead-Containing Coatings in Buildings WW03 and WW02 at Warkworth Institution, Warkworth, Ontario**

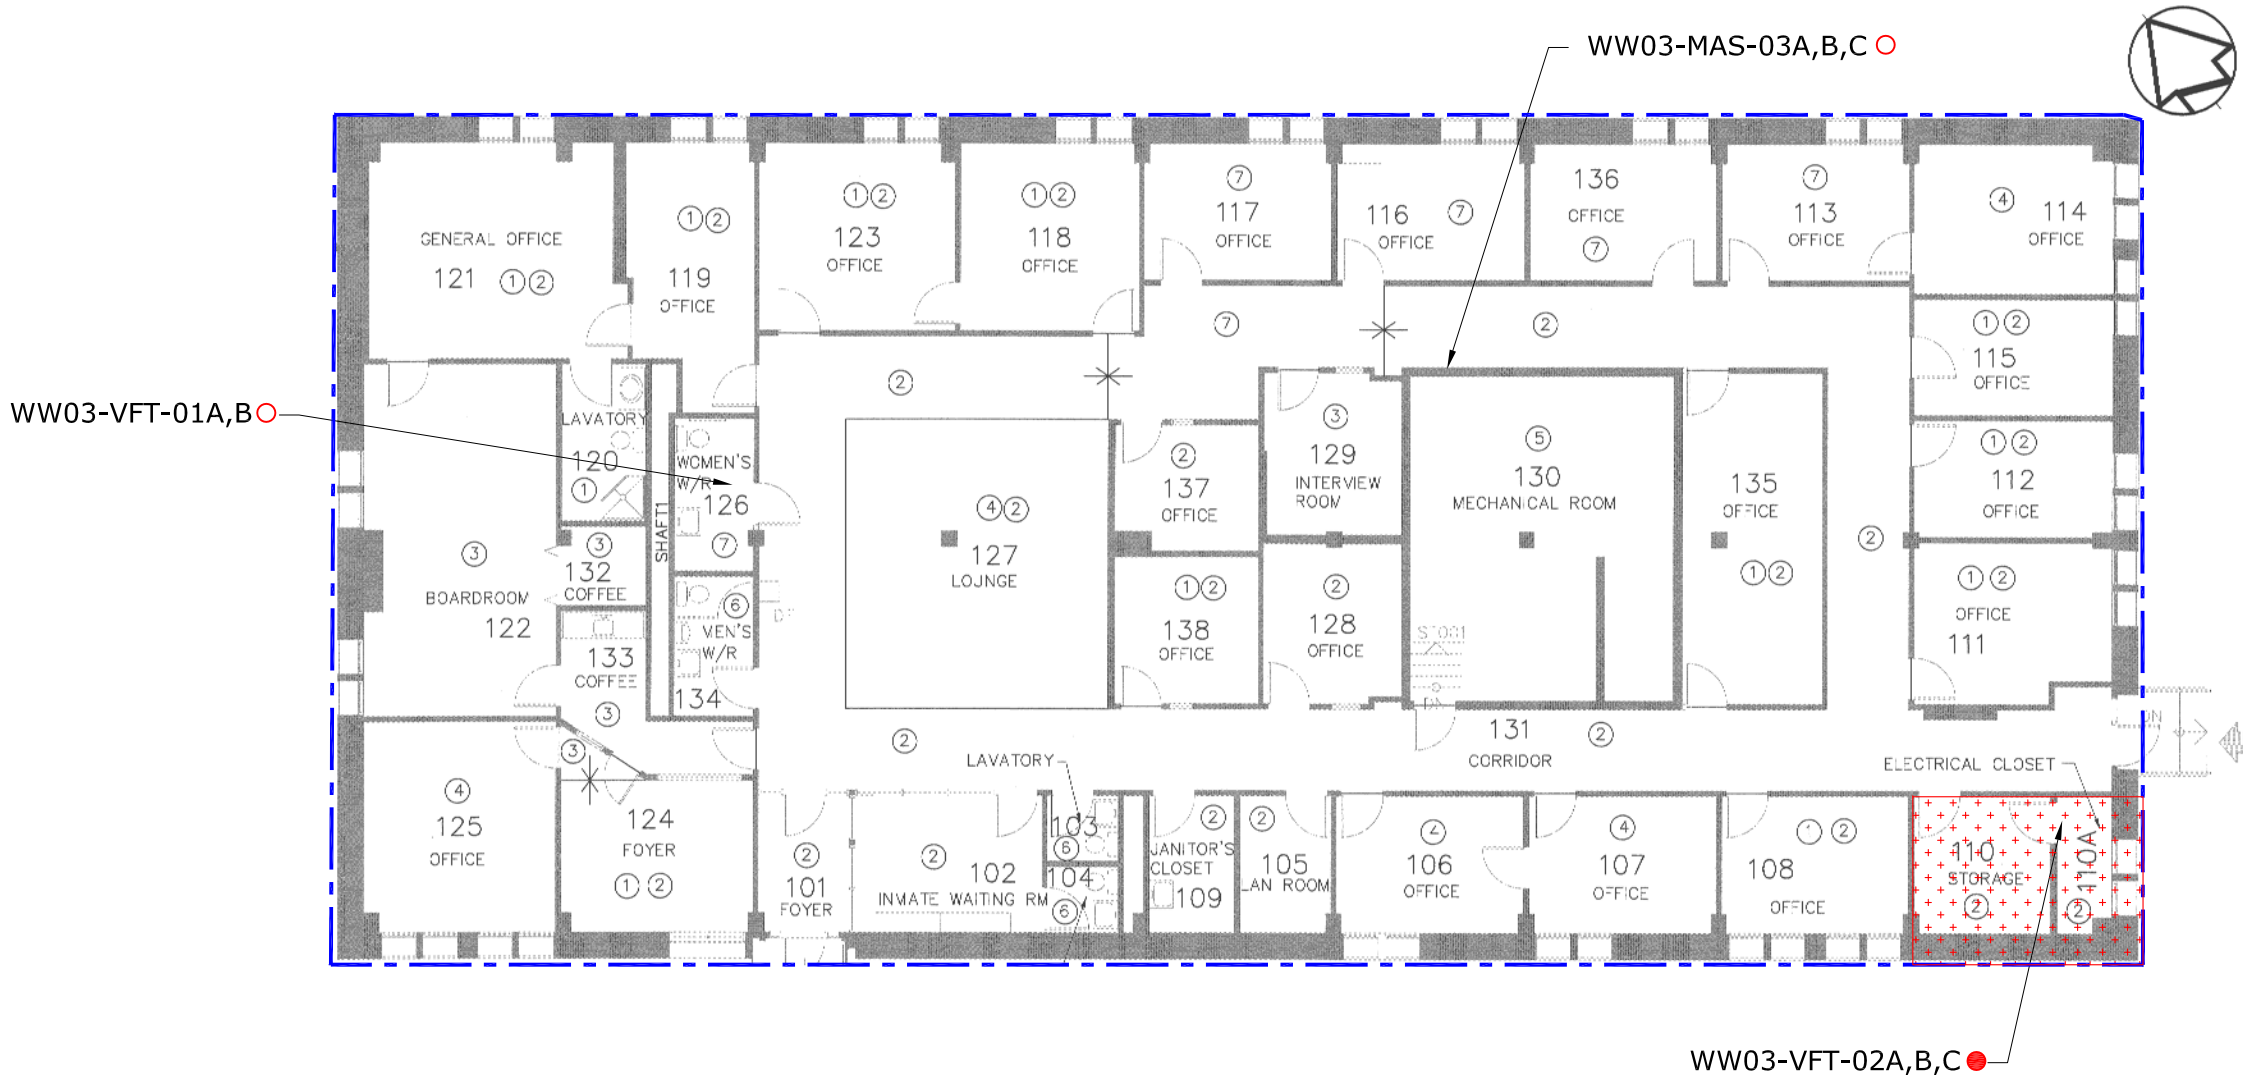
TITLE:  
BUILDING WW03  
DSHMS SURVEY  
SAMPLE LOCATIONS

The summarized analytical results for the samples collected from the proposed work area in Building WW03 are provided in Table 1. No newly suspected ACMs were observed in the work area in Building WW02; therefore, no samples were collected. Approximate ACM sampling locations are shown on Figure 1 located in Attachment A. Laboratory certificates of analysis for the samples collected have been included in Attachment B.

The wall baseboard tan mastic from corridor 131 (WW03-MAS-03A) had detectable levels of chrysotile asbestos at concentrations less than 0.5 percent. As such, this material is not considered to be an ACM. One floor tile sample and mastic (WW03-VFT-02A) were determined to be asbestos-containing with asbestos concentrations of 2.1 percent and 4.9 percent chrysotile asbestos, respectively; thus, these two materials are considered to be asbestos-containing.

Based on the findings of this survey and laboratory analytical results, the following additional materials were identified as asbestos-containing in the proposed work areas of Building WW03:

- Room 110 Floor Tile and Mastic – Pink with grey streaks (9 inches by 9 inches). These materials were found to have an asbestos concentration of 2.1 percent and 4.9 percent chrysotile asbestos, respectively.

If the identified asbestos-containing floor tiles and mastic are to be disturbed as part of the renovation activities, a minimum of Type 1 asbestos abatement procedures should be followed. Type 1 Operations are required if:

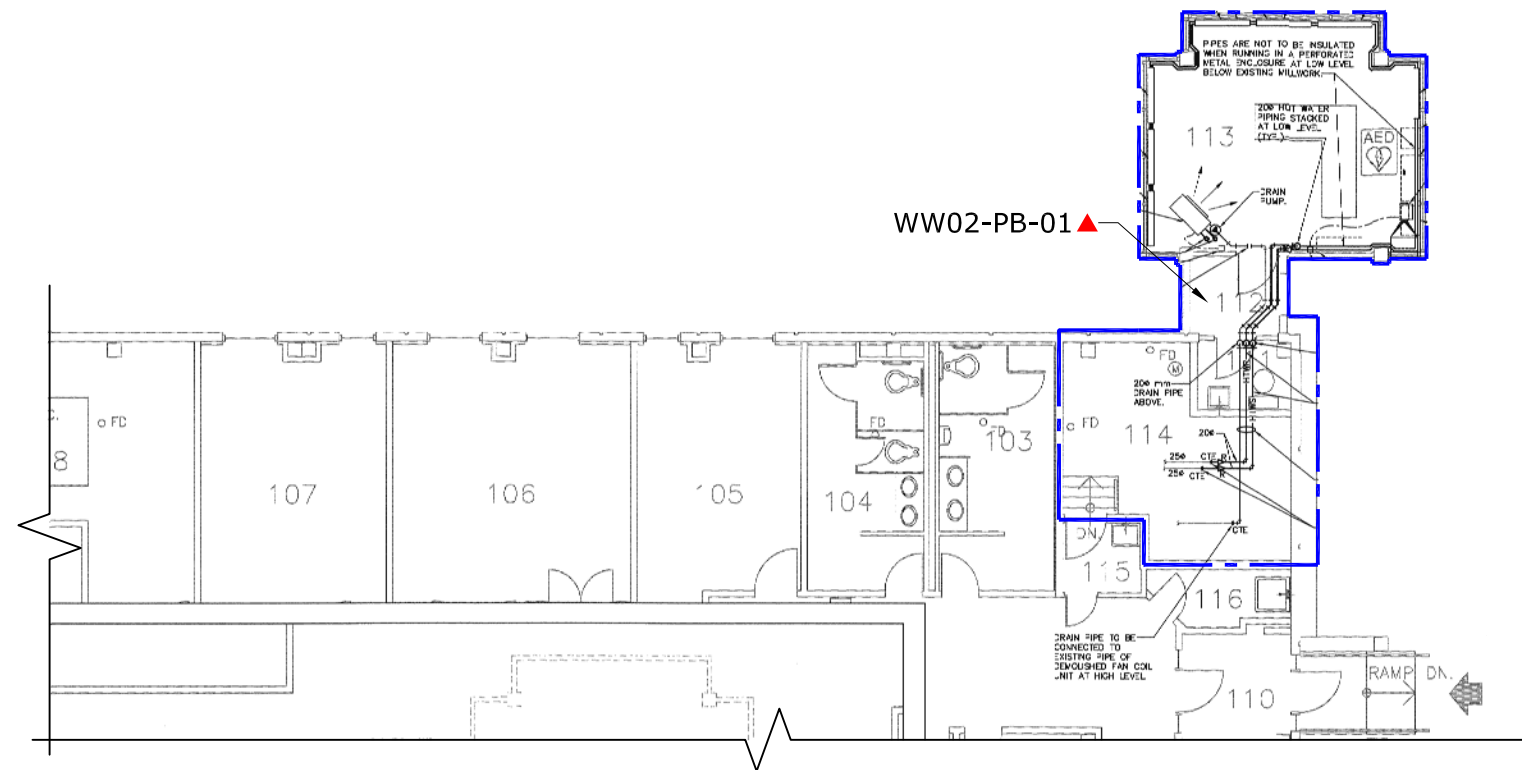
TITLE:  
BUILDING WW02  
DSHMS SURVEY  
SAMPLE LOCATIONS

The approximate sampling location is shown on Figure 2 in Attachment A. A laboratory certificate of analysis for the sample collected is included in Attachment B.

Based on the findings of the survey and laboratory analytical results, the cream paint in Building WW02 Room 113 was found to have lead concentrations above the permissible concentration of 90 ppm (0.009 percent by weight) as specified in the Federal Hazardous Products Act – Surface Coating Material Regulation (2005), as amended, and is considered to be lead-containing.

XCG recommends that the above painted surfaces be treated as lead-containing and that any demolition/renovation activities that would involve the disturbance of this paint be conducted in accordance with O. Reg. 490/09 and the Ontario Ministry of Labour Guideline “Lead on Construction Projects,” dated April 2011. Workers are not at risk of being exposed to lead unless they are undertaking an activity that disturbs surfaces covered with lead-based paint.
