**Re: Marine Test Pit Investigation – McEachern's Point, NB, Harbour Channel
And Gully Entrance (Call Up EC015-110732/001/PWB)**

GEMTEC Limited was retained by Public Works and Government Services Canada to undertake a marine test pit investigation in the McEachern's Point Wharf channel and the Gully entrances. We understand that the test pit data will be used to determine dredging methods. The purpose of this investigation was to assess the soils in the channel. This report contains a summary of the fieldwork carried out.

Descriptive Terms and Detailed Test Pit Logs

Select Site Photos

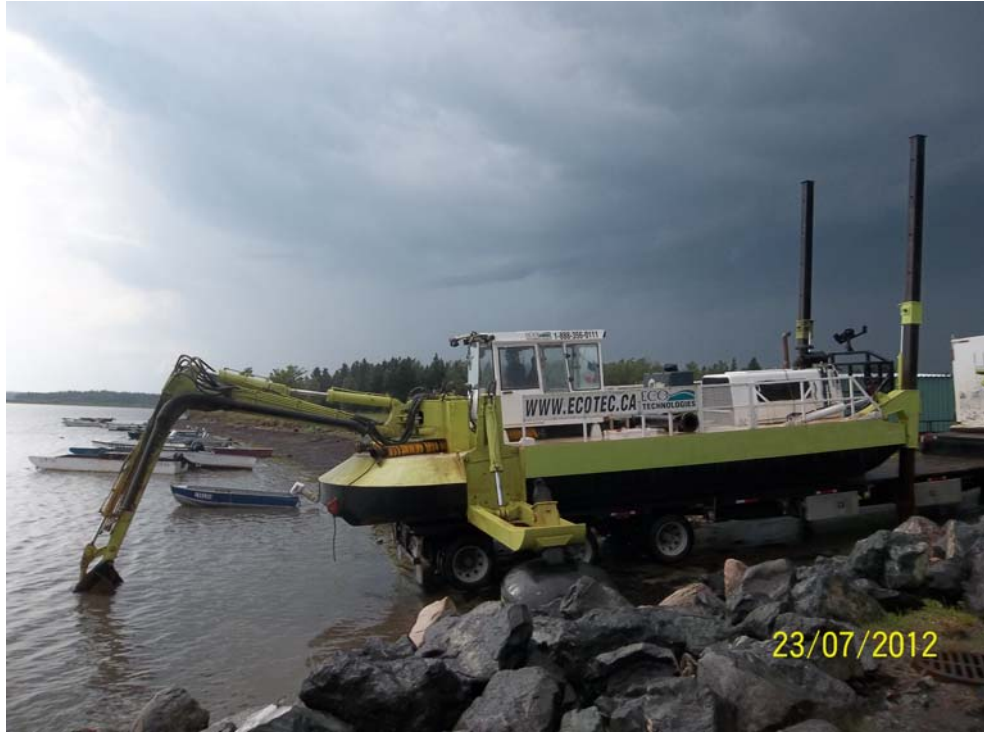
Photo 1 - ECO Technologies Amphibian Excavator at McEachern's Point Wharf.

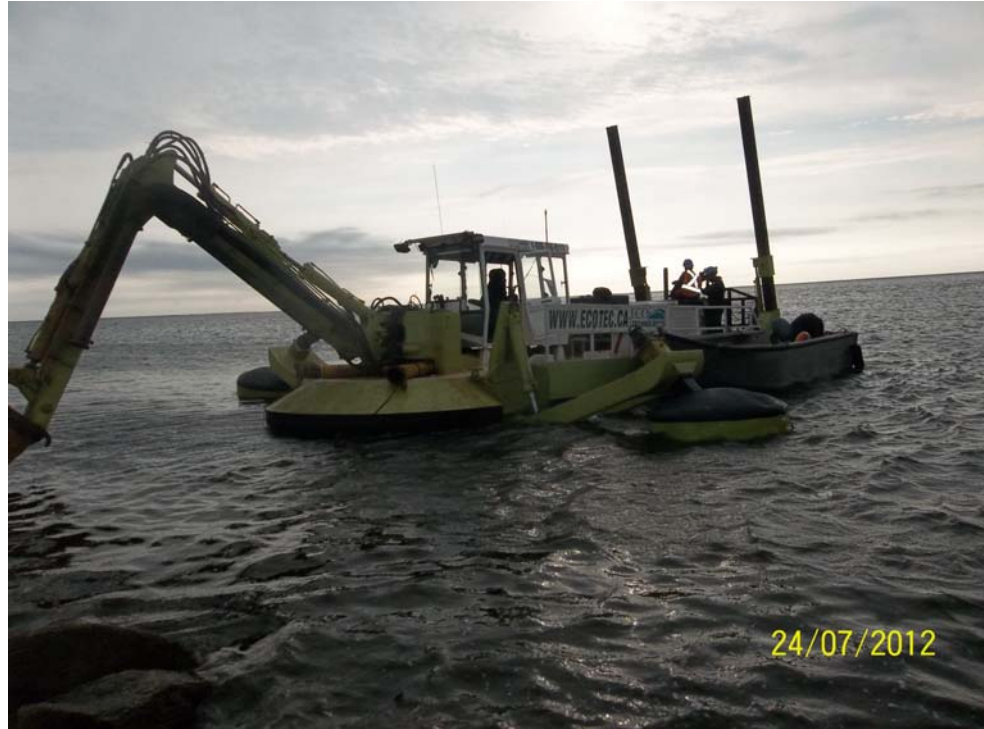
Photo 2 - Amphibian excavator in McEachern's point channel.

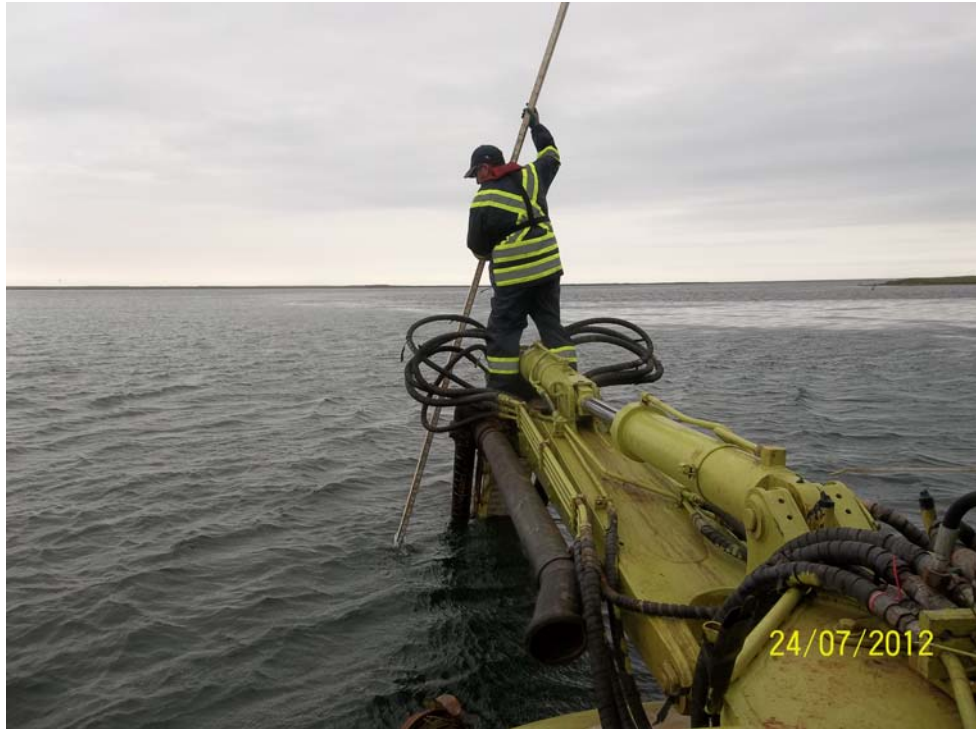
Photo 3 - Manual sounding undertaken at test pit locations.

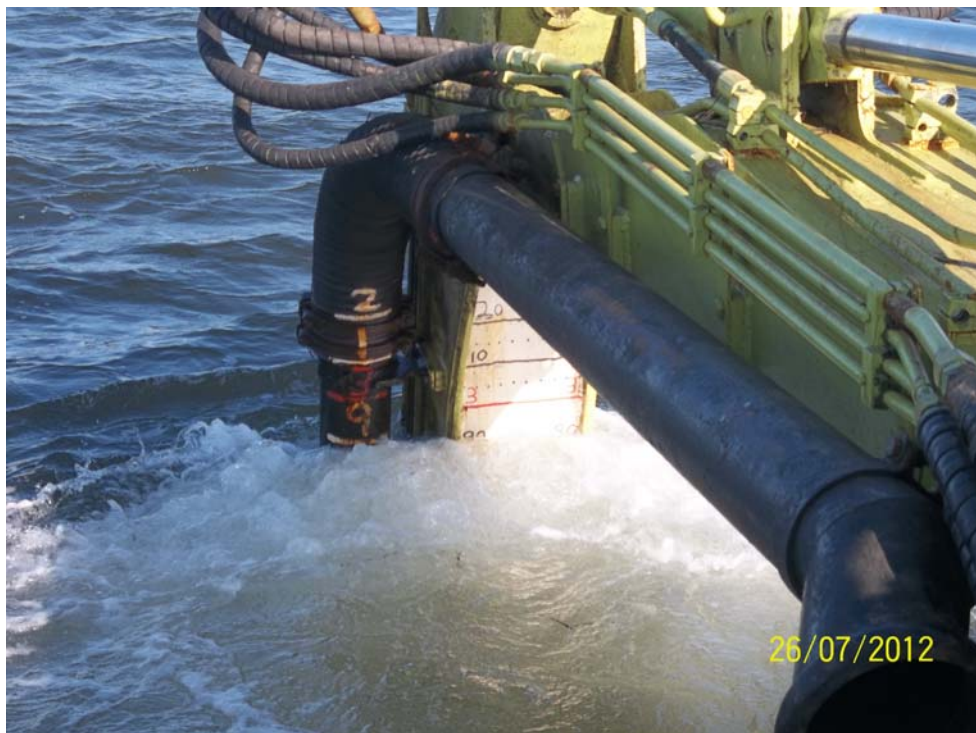
Photo 4 - Depth during excavation tracked by sounding measurements on inside of excavator arm.

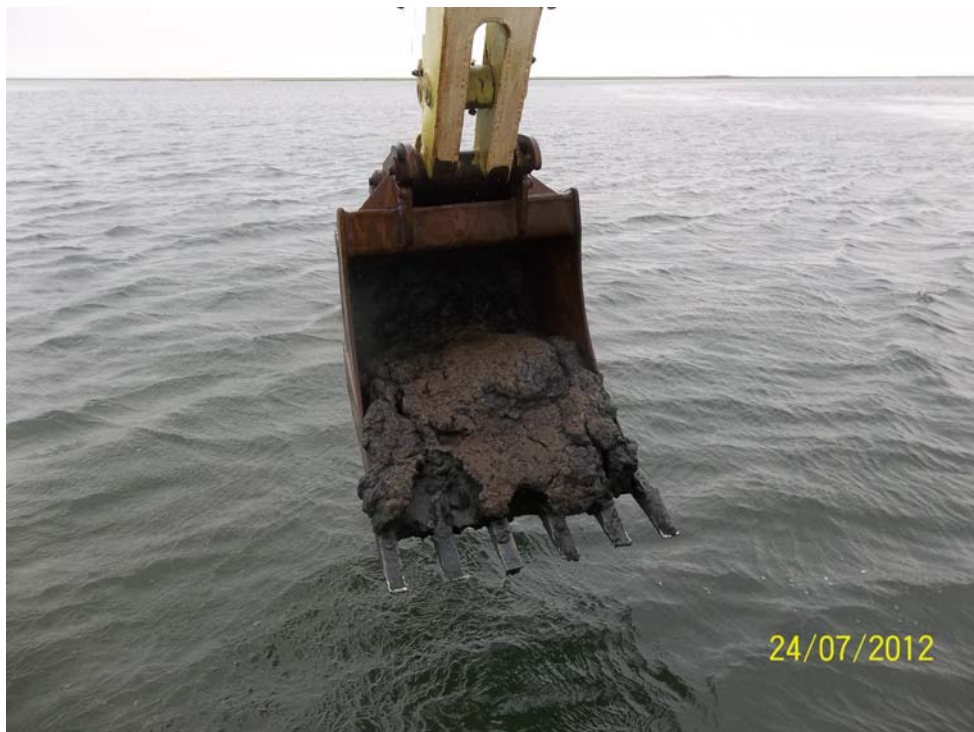
Photo 5 - Dark silt with organics encountered at TP 1 - McEachern's Point (Elev. -1.60 to -2.60 CD).

0										Black SILT some organics.									
1										Brown SILT, some sand and organics.									
2										End of Test Pit at elevation -3.60 metres chart datum as referenced to benchmark 88B9004 with a published elevation of +3.12 chart datum.

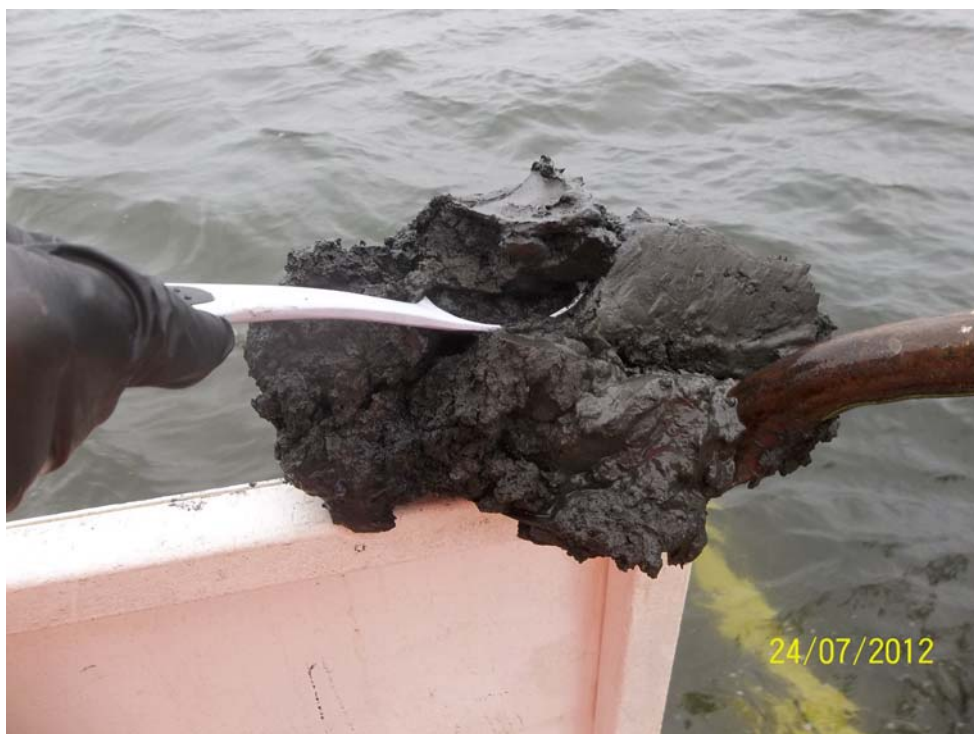
Photo 6 - Dark grey silt encountered at TP 2 - MaEachern's Point (Elevation -1.34 to -2.34 CD).

Client		Public Works and Government Services Canada				Proj No.		6489.07		Test pit	
Project		Marine Test Pit Investigation				Date End		24.July.2012		TP 2 (MP) Page 1 of 1	
Location		McEachern's Point, NB									
Ground Level, m		-1.34		Datum: Chart		Logged By		TDS			
DEPTH m	SAMPLE				LOG	DESCRIPTION					
	No	TYPE	N (RQD)	REC mm							
0						Dark grey SILT some organics.					
1						Dark grey SILT some sand and organic layers (compressed sea weed).					
2						Dark grey SAND and GRAVEL, some cobbles.					
						End of Test Pit at elevation -3.84 metres chart datum as referenced to benchmark 88B9004 with a published elevation of +3.12 chart datum.

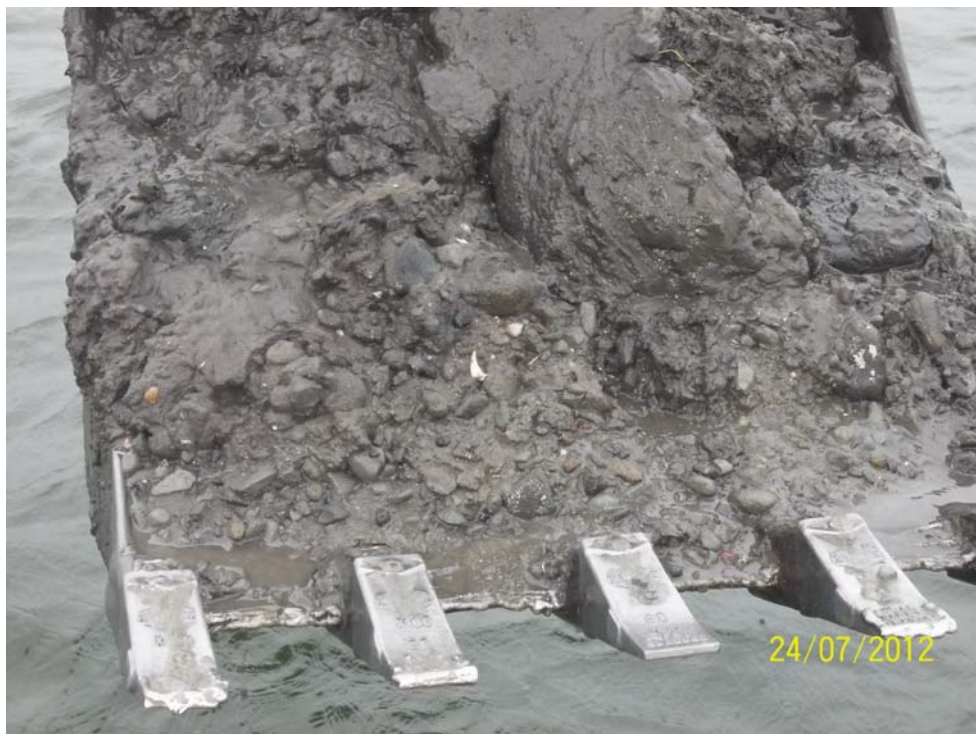
Photo 7 - Dark silt with some organics some gravel encountered at TP 3 - McEachern's Point (Elevation -1.00 to -1.80 CD).

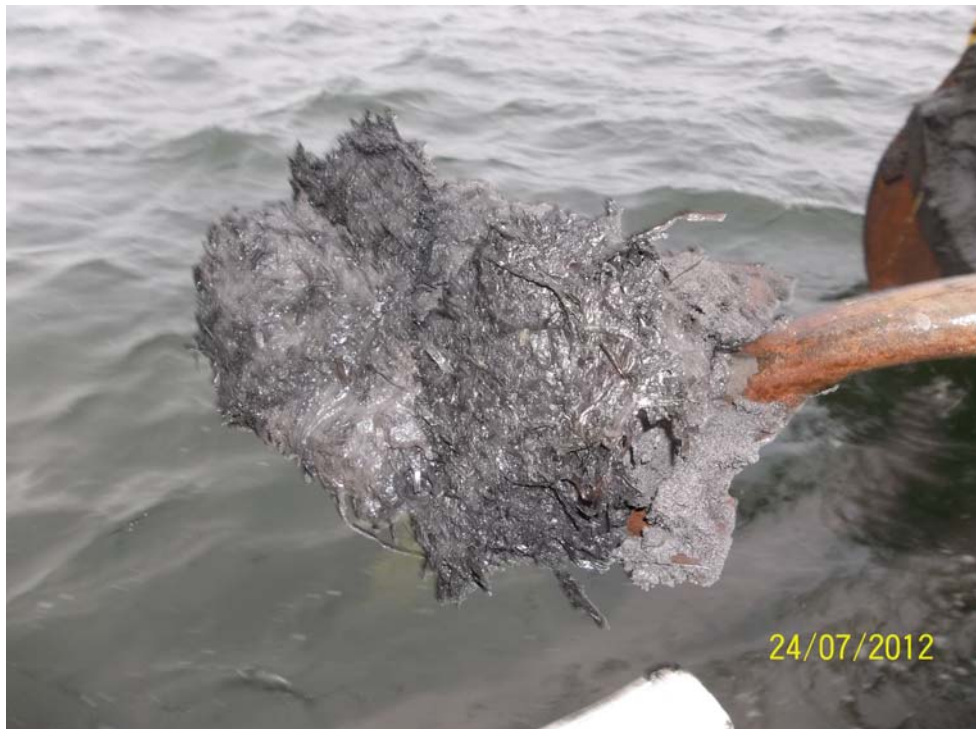
Photo 8 - Organics present in silt layer at TP 4 - McEachern's Point (Elevation -1.21 to -2.21 CD).

Ground Level, m		-1.21		Datum: Chart		Logged By		TDS			
DEPTH m	SAMPLE				LOG	DESCRIPTION					
	No	TYPE	N (RQD)	REC mm							
0						Dark grey SILT, some sand and organics.					
1						Brown SAND with some gravel and cobbles and intermittent organic layers (compressed sea weed).					
						SAND and GRAVEL, some cobbles.					
2						End of Test Pit at elevation -3.31 metres chart datum as referenced to benchmark 88B9004 with a published elevation of +3.12 chart datum.

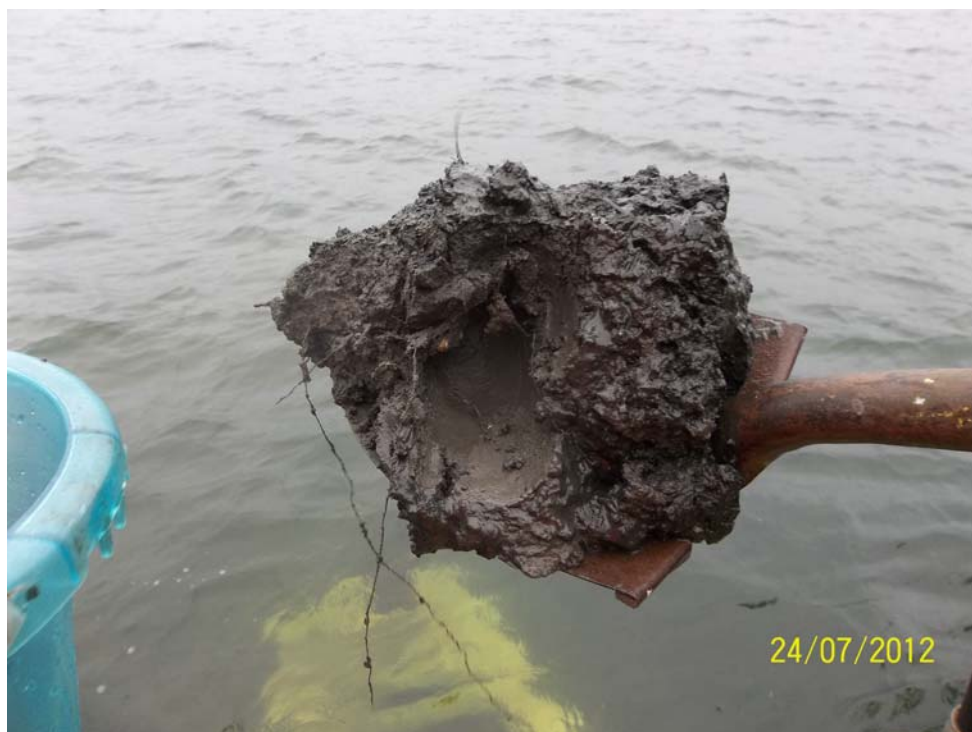
Photo 9 - Dark grey silt with some organics at TP 5 - McEachern's Point (Elevation – 1.29 to –2.49 CD).

Client		Public Works and Government Services Canada				Proj No.		6489.07		Test pit	
Project		Marine Test Pit Investigation				Date End		24.July.2012		TP 5 (MP) Page 1 of 1	
Location		McEachern's Point, NB									
Ground Level, m		-1.29		Datum: Chart		Logged By		TDS			
DEPTH m	SAMPLE				LOG	DESCRIPTION					
	No	TYPE	N (RQD)	REC mm							
0						Dark grey SILT, some organics.					
1						Grey SAND, some gravel and cobbles. - Sand medium to dense compact at 1.6 metres.					
						End of Test Pit at elevation -3.19 metres chart datum as referenced to benchmark 88B9004 with a published elevation of +3.12 chart datum.

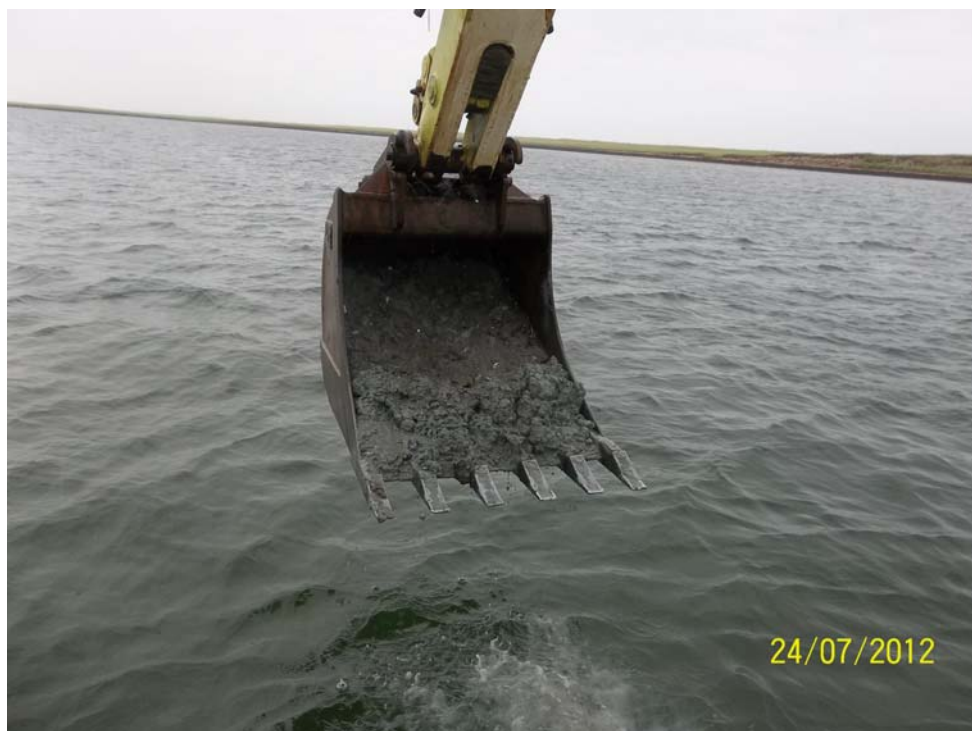
Photo 10 - Grey silty sand with some cobbles encountered at TP 6 - McEachern's Point (Elevation –1.86 to –2.36 CD).

Client		Public Works and Government Services Canada				Proj No.		6489.07		Test pit	
Project		Marine Test Pit Investigation				Date End		24.July.2012		TP 6 (MP) Page 1 of 1	
Location		McEachern's Point, NB									
Ground Level, m		-1.16		Datum: Chart		Logged By		TDS		<input type="checkbox"/> Pocket Penetrometer <225 <input checked="" type="checkbox"/> Field Vane Test <input checked="" type="checkbox"/> Pocket Penetrometer <input checked="" type="checkbox"/> Remoulded	
DEPTH m		SAMPLE			LOG		DESCRIPTION				
		No	TYPE	N (RQD)	REC (mm)						
0											
1											
2						End of Test Pit at elevation -3.26 metres chart datum as referenced to benchmark 88B9004 with a published elevation of +3.12 chart datum.

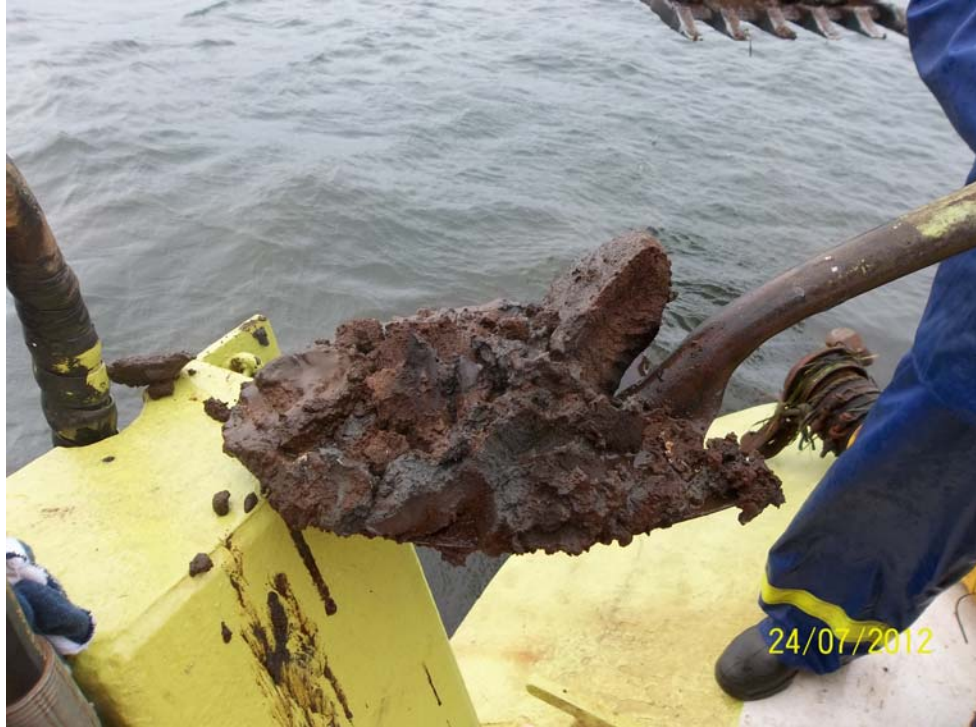
Photo 11 - Brown silty sand with trace gravel and wood debris encountered at TP 7 - McEachern's Point (Elevation -1.00 to -1.85 CD).

Client		Public Works and Government Services Canada				Proj No.		6489.07		Test pit	
Project		Marine Test Pit Investigation				Date End		24.July.2012		TP 7 (MP)	
Location		McEachern's Point, NB								Page 1 of 1	
Ground Level, m		-0.85		Datum:		Chart		Logged By		TDS	
DEPTH m		SAMPLE			LOG		DESCRIPTION				
		No	TYPE	N (RQD)	REC mm						
0						Dark SILT, some organics (Wood and sea shells)					
						Brown sity SAND, trace gravel and wood debris.					
1						Brown SAND, some gravel and cobbles with trace to some boulders (300 - 400 mm)					
2						End of Test Pit at elevation -2.85 metres chart datum as referenced to benchmark 88B9004 with a published elevation of +3.12 chart datum.

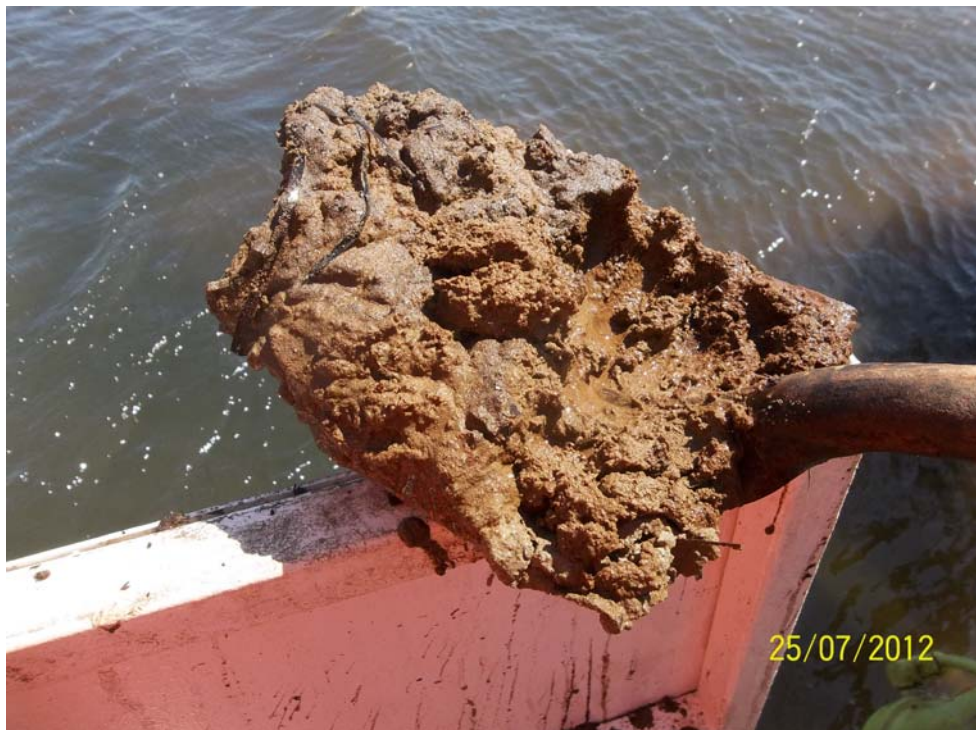
Photo 12 - Orange brown sand with some gravel encountered at TP 8 – McEachern's Point (Elevation – 1.35 to -1.85 CD).

0.40 -1.15					
						Brown SAND with organic layering (compressed sea weed)					
						0.60 -1.35					
						Orange brown SAND with some gravel.					
1						1.10 -1.85					
						Grey SAND and GRAVEL with some cobbles and trace to some boulder (300 to 540 mm)					
2						2.00 -2.75					
						End of Test Pit at elevation -2.75 metres chart datum as referenced to benchmark 88B9004 with a published elevation of +3.12 chart datum.

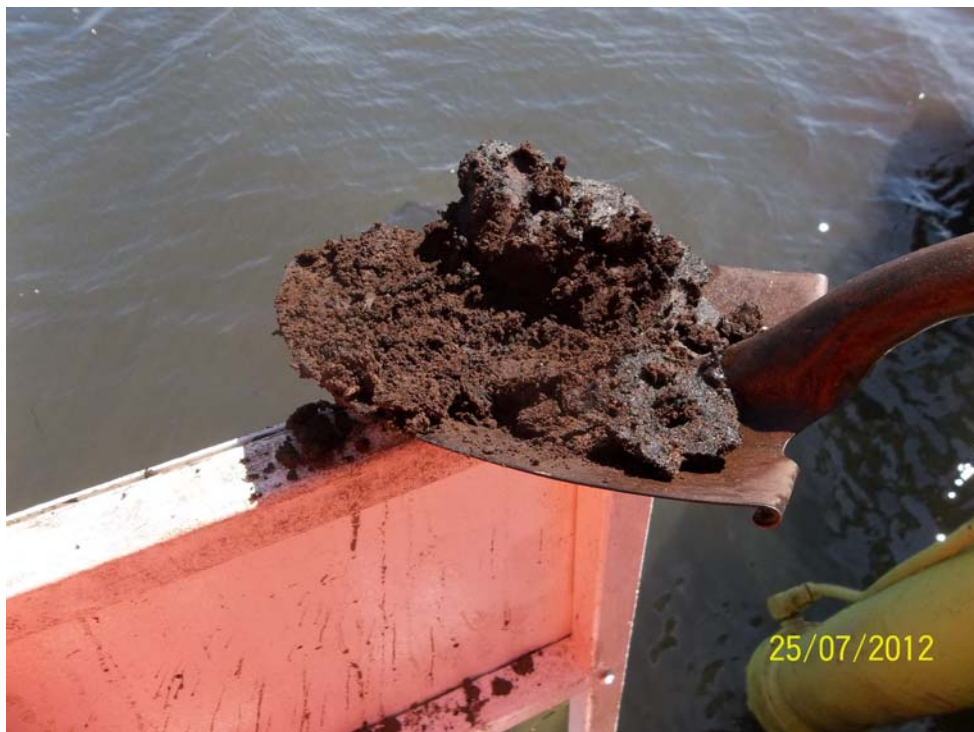
Photo 13 - Peat encountered at TP 9 - McEachern's Point (Elevation –1.58 to –1.73 CD).

Ground Level, m		-1.28		Datum:		Chart		Logged By		TDS	
DEPTH m		SAMPLE			LOG		DESCRIPTION				
		No	TYPE	N (RQD)	REC mm						
0						<div> <div>0.30</div> <div>-1.58</div> </div> <div> <div>Peat</div> </div> <div> <div>0.45</div> <div>-1.73</div> </div> <div> <div>Brown silty SAND, some organics, trace gravel and trace to some cobbles.</div> </div>					
1						<div> <div>1.20</div> <div>-2.48</div> </div> <div> <div>Grey SAND and GRAVEL with trace to some cobbles.</div> </div>					
2						<div> <div>1.90</div> <div>-3.18</div> </div> <div> <div>End of Test Pit at elevation -3.10 metres chart datum as referenced to benchmark 88B9004 with a published elevation of +3.12 chart datum.</div> </div>

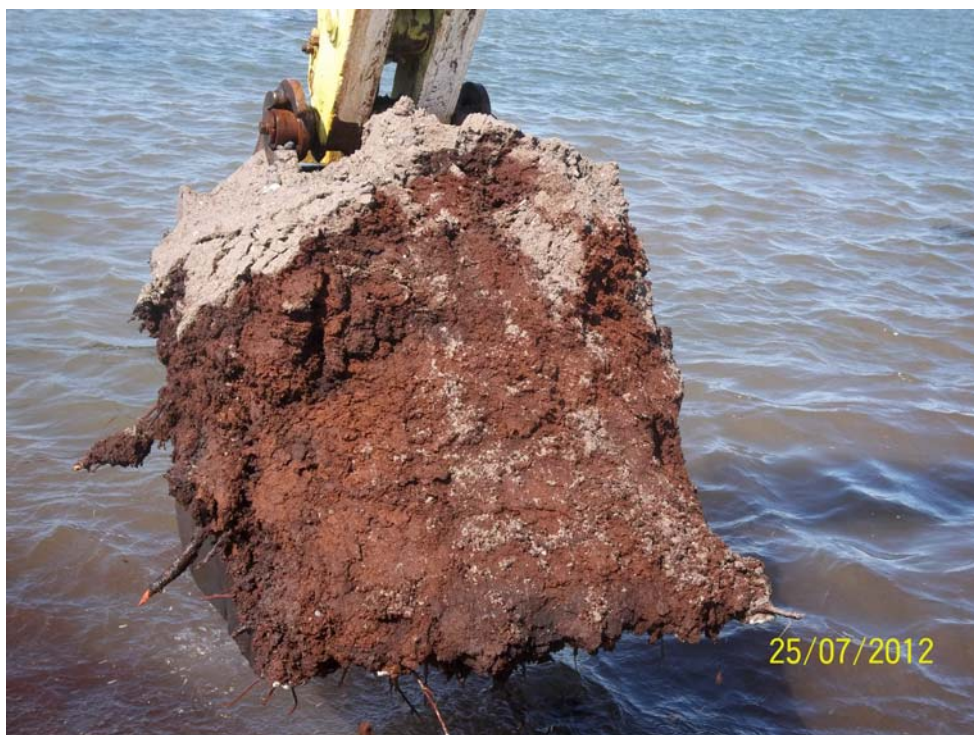
Photo 14 - Thick peat layer encountered at TP 10 - MaEachern's Point (Elevation – 0.47 to –1.12 CD).

0.45 Peat -0.47					
1						1.10 Compact brown SAND -1.12					
						1.60 Brown to grey SAND and GRAVEL, some cobbles -1.62					
2											
3

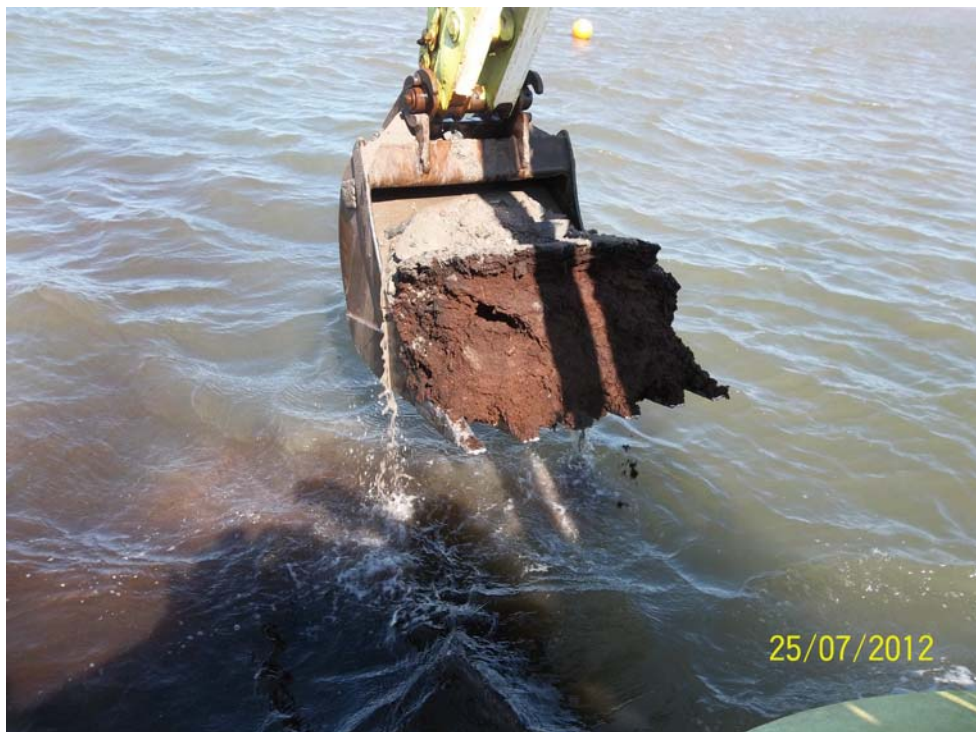
Photo 15 - Thick layer of peat encountered at TP 11 - McEachern's Point (Elevation -0.60 to -1.15 CD).

0						Brown silty SAND, trace to some gravel.													
						0.15 -0.30 Brown SAND and GRAVEL, some cobbles and boulders.													
						0.45 -0.60 Peat													
1						1.00 -1.15 Grey to brown silty sand some gravel and cobbles, trace organics.													
2						2.00 -2.15 - Sand compact at 1.8 metres.													
						End of Test Pit at elevation --2.15 metres chart datum as referenced to benchmark 88B9004 with a published elevation of +3.12 chart datum.

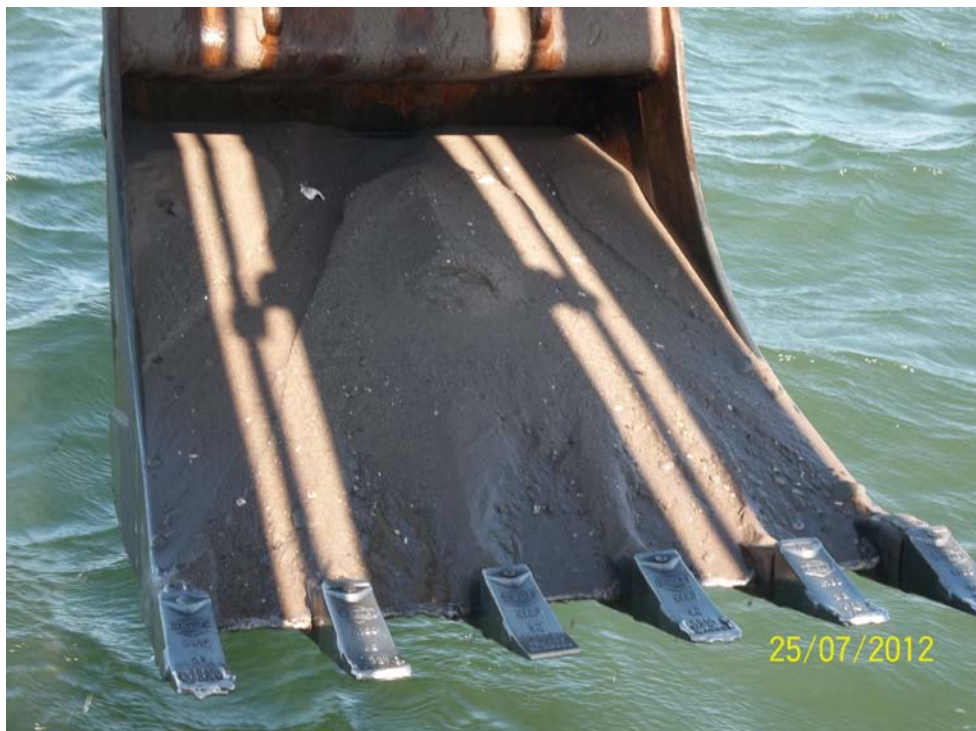
Photo 16 - Brown sand with some cobbles and organics encountered at TP 12 - McEachern's Point (Elevation -1.03 to -1.53 CD).

No	TYPE	(RQD)	REC mm														
0						Brown SAND, some cobbles and organics.												
						0.50 ----- -1.53												
						Peat												
						0.70 ----- -1.73												
						Brown silty SAND, some cobbles and trace organicis with intermitent peat layers.												
1						1.50 ----- -2.53												
						End of Test Pit at elevation -2.53 metres chart datum as referenced to benchmark 88B9004 with a published elevation of +3.12 chart datum.

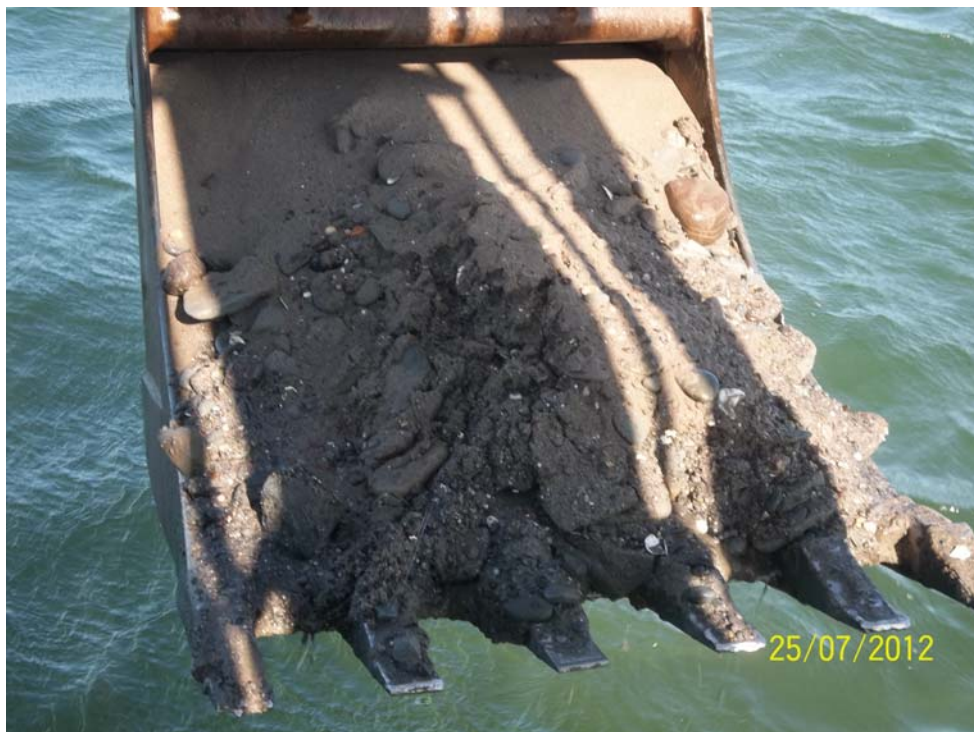
Photo 17 - Brown sand and gravel with cobbles and organics encountered at TP 13 - McEacherns Point (Elevation -1.22 to -1.72 CD).

0.50 Peat -1.72												
						0.80 Grey SAND and GRAVEL, some cobbles and trace organics. -2.02												
1						1.20 Grey SAND, trace to some gravel. Sand compact at 1.2 metres. -2.42

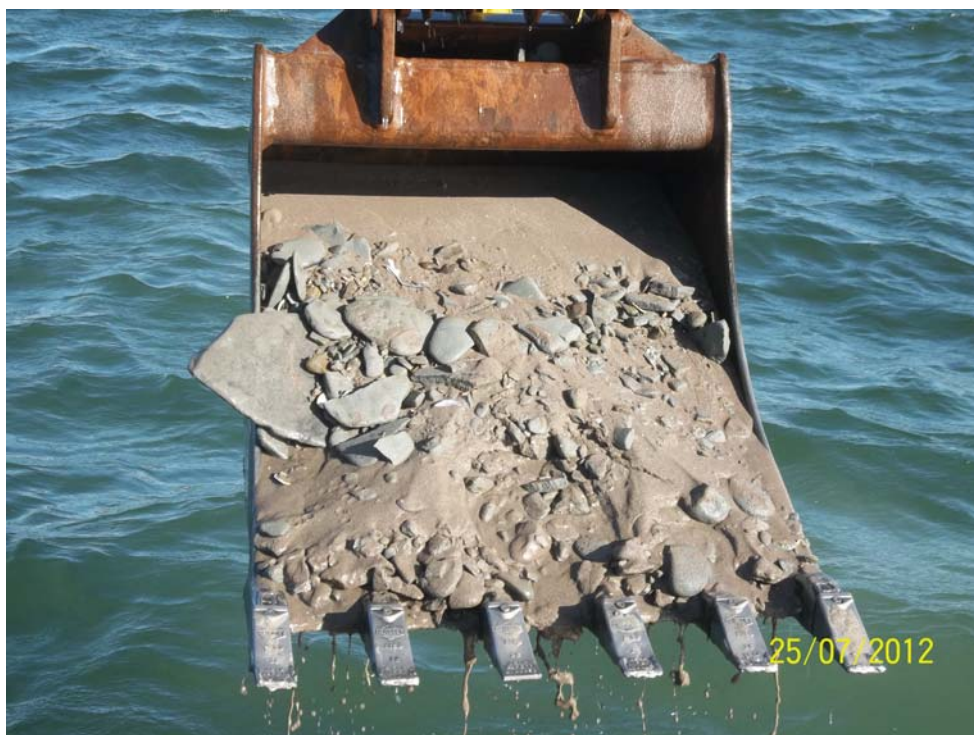
Photo 18 - Brown sand and gravel with some cobbles and flat boulders encountered at TP 14 - McEachern's Point (Elevation -0.90 to -2.60 CD).

0										Brown SAND and GRAVEL with some cobbles and boulders.									
1										- flat boulders in excess of 300 mm observed. - Sand content increases with depth.

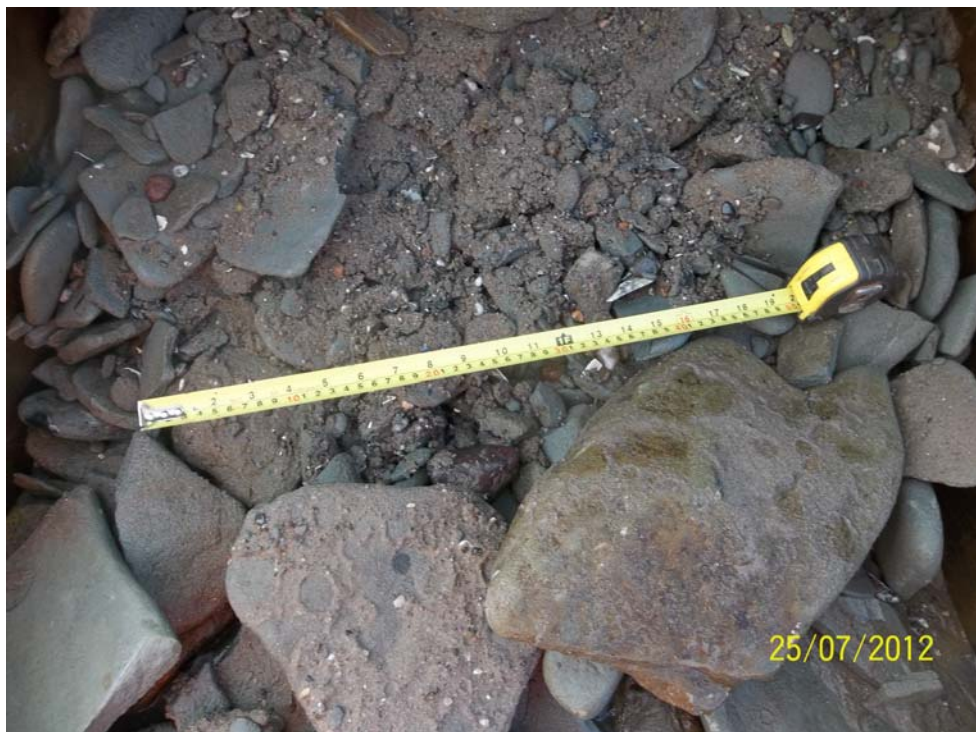
Photo 19 - Brown sand and gravel with cobbles and boulders encountered at TP 15 - McEachern's Point (Elevation -1.40 to -2.90 CD).

Client		Public Works and Gouvernement Services Canada			Proj No.		6489.07		Test pit		
Project		Marine Test Pit Investigation			Date End		24.July.2012		TP 15 (MP) Page 1 of 1		
Location		McEachern's Point, NB			<div>0 25 50 75 100</div> <div>Undrained Shear Strength - kPa</div> <div><input type="checkbox"/> Pocket Penetrometer <225 <input checked="" type="checkbox"/> Pocket Penetrometer</div> <div><input checked="" type="checkbox"/> Field Vane Test <input checked="" type="checkbox"/> Remoulded</div> <div>Water Content & Atterberg Limits</div> <div>Dynamic Penetration Test, blows/0.3m</div> <div>Standard Penetration Test, blows/0.3m</div> <div>0 10 20 30 40 50 60 70 80 90 100</div> <div>w_p w w_L</div>						
Ground Level, m		-1.40		Datum:		Chart		Logged By		TDS	
DEPTH		m		SAMPLE		LOG		DESCRIPTION			
No		TYPE		(RQD)		REC mm					
0								Brown SAND and GRAVEL with COBBLES and BOULDERS (300 to 600 mm)

1											
								1.50 -2.90			
								Grey to orange brown silty SAND, trace organics with trace to some cobbles.			
								1.70 -3.10			
								End of Test Pit at elevation -3.10 metres chart datum as referenced to benchmark 88B9004 with a published elevation of +3.12 chart datum.
