**Historical Records Review of Waldron
(aka Barnston) River Property
Akaitcho Region,
Northwest Territories
SM 487**

Prepared for:
**Indian and Northern Affairs
Contaminates and Remediation Directorate**
Waldron Building
48th Street, Yellowknife, NT
X1A-1N5

Prepared by:
Ryan Silke, historical consultant
60 Mandeville Dr.
Yellowknife, NT
X1A-3N3

March 31, 2011

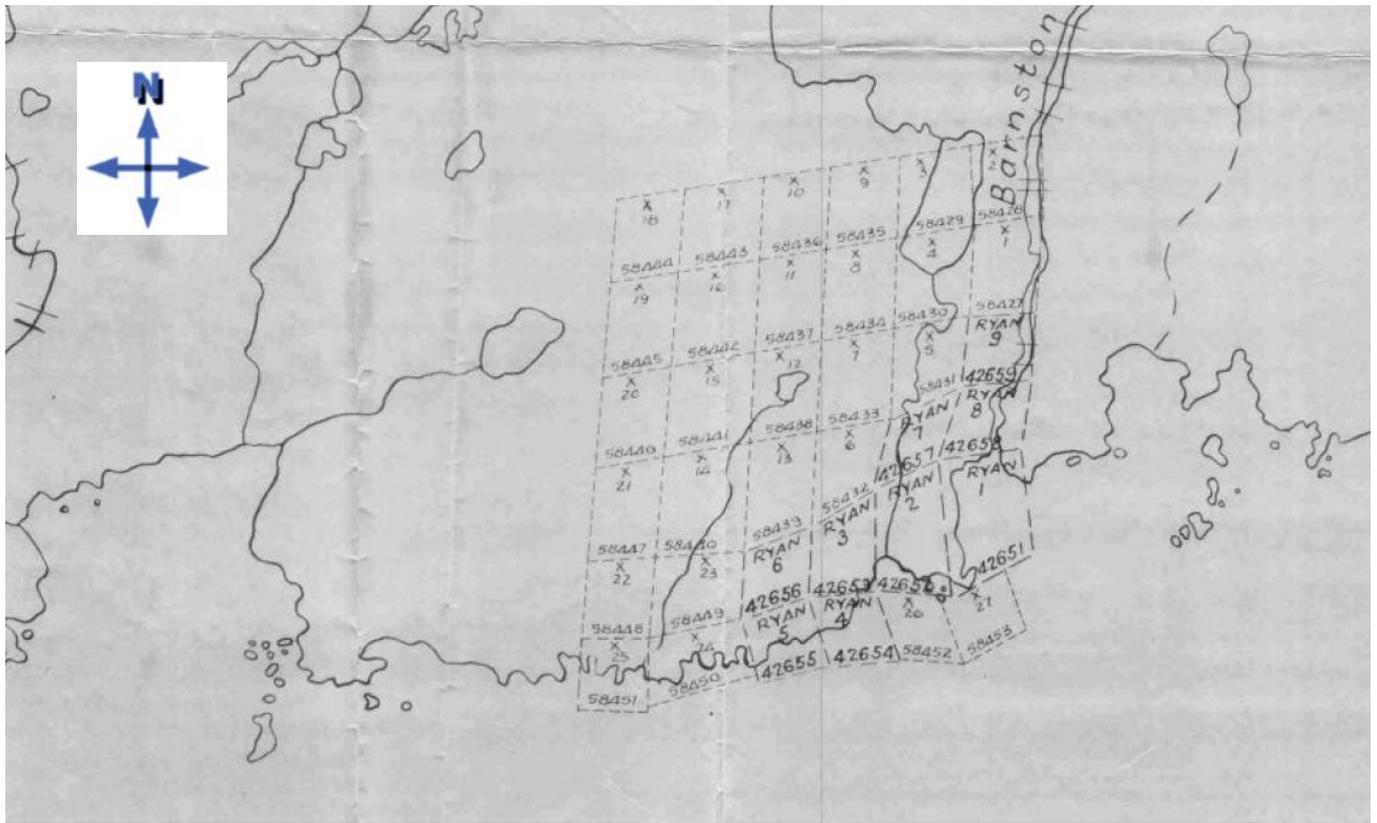
Figure 1. Claim Map, 1946

NTS 75 L-12, 1946

The RYAN claims are staked in August 1939 by J. Russell and T.O. Evans of the Ryan Exploration and Development Company Limited of Edmonton. (Lord, 1951) (see Appendix 1, Figure 1)

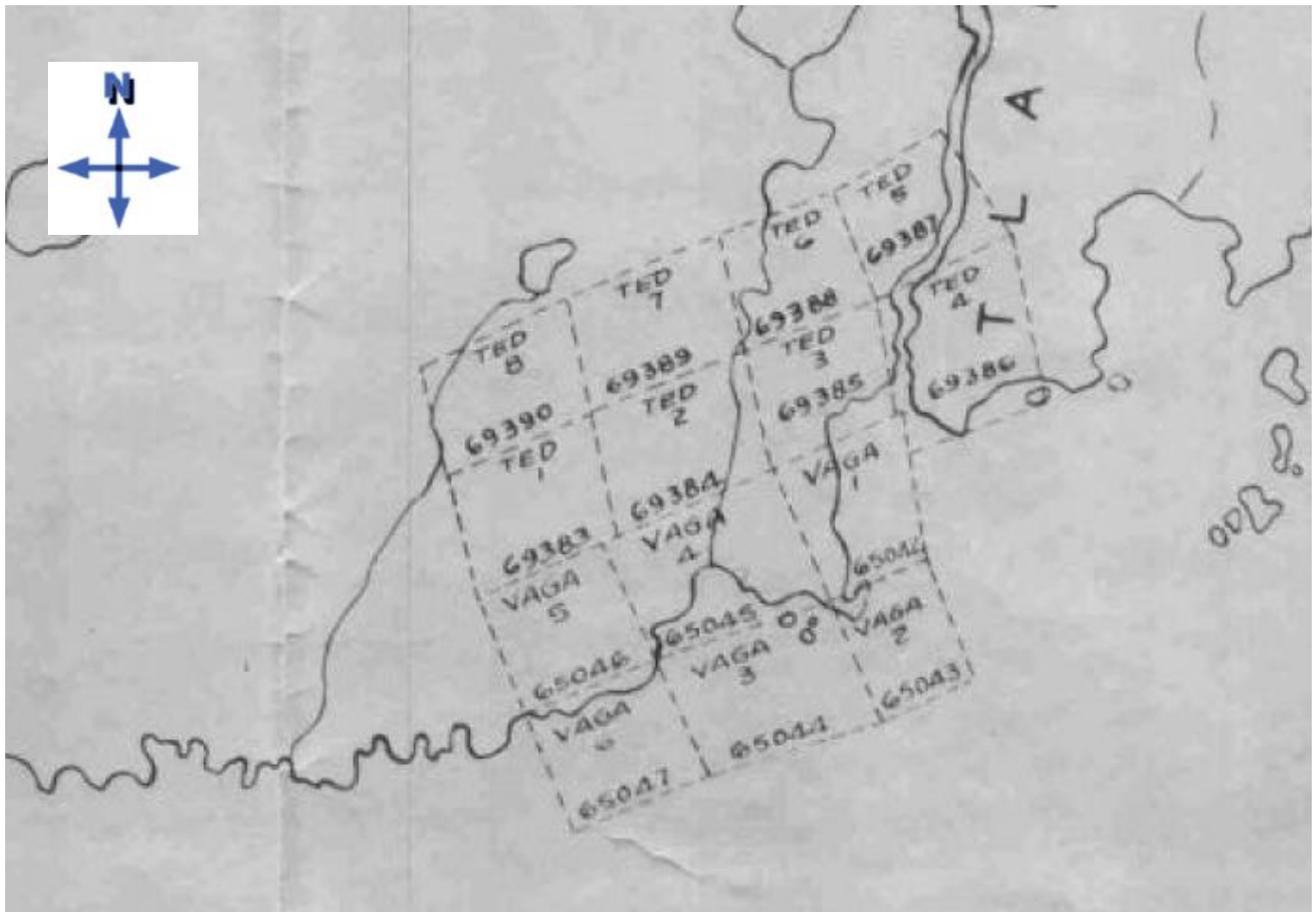
Figure 2. Claim Map, 1949

NTS 75 L-12, 1949

The VAGA claims are staked in 1947. (see **Appendix 1, Figure 2**)

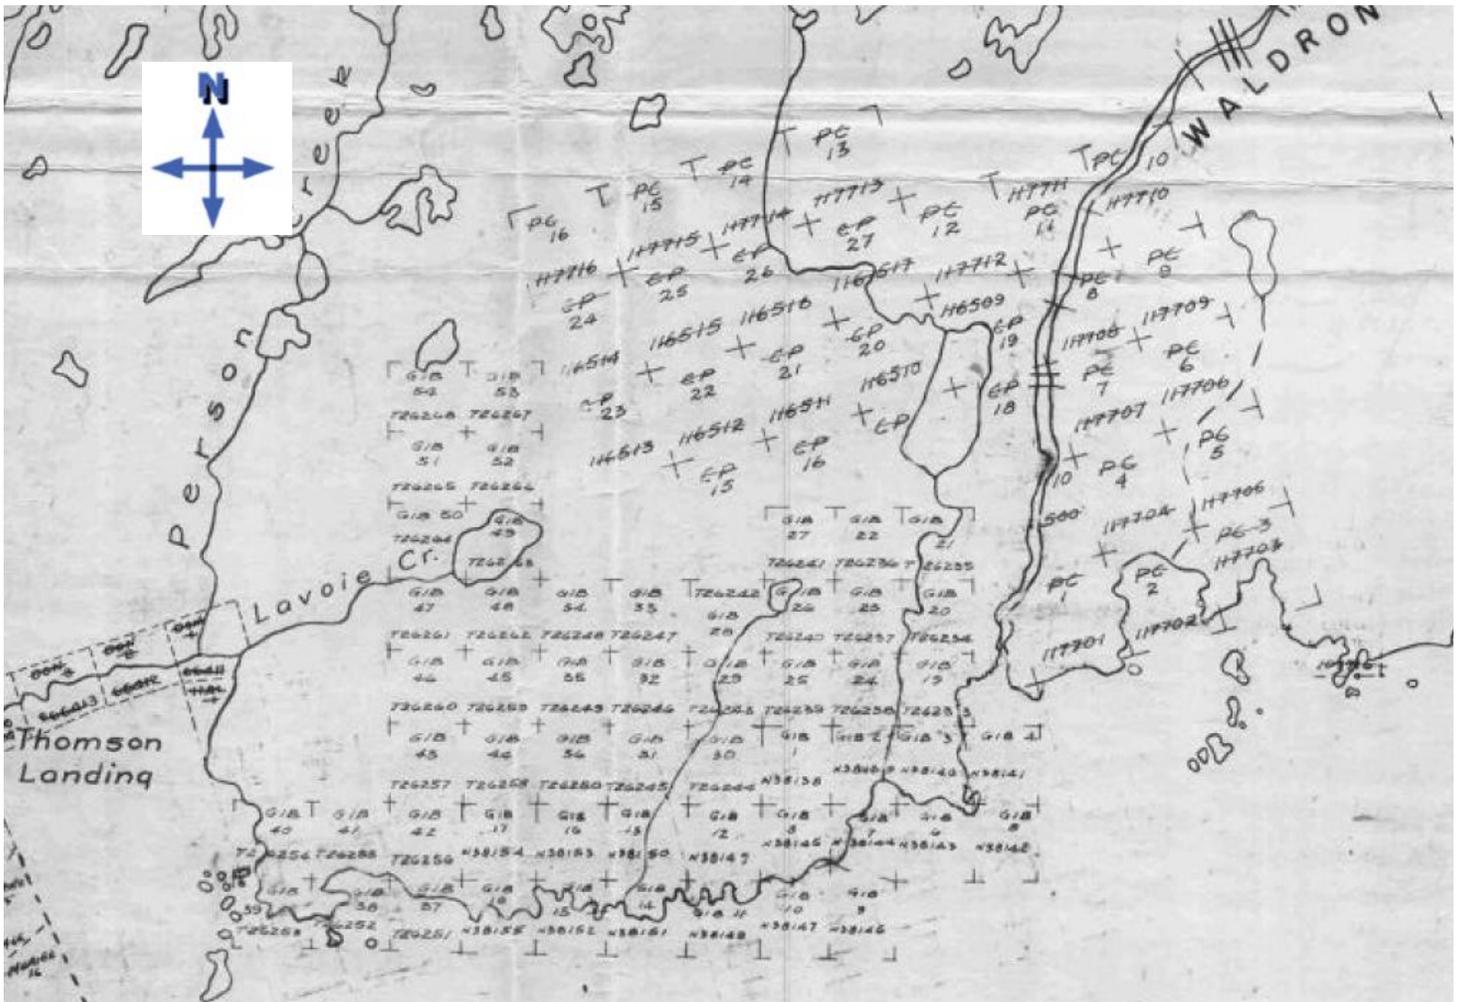
Figure 5. Claim Map, 1969

NTS 75 L-12, 1969

In March 1967, the GIB claims (18 claims) are acquired by Polaris Mines Limited. An air-photo study is made and it was decided that additional claims should be staked. In September 1967, 36 claims are added to the GIB group. Grab samples from the pits on the property assay as high as 26.4% copper. An electro-mag survey is conducted on contract with Precambrian Mining Services Limited. Four conductor zones are identified, including a significant conductor on the EM-04 zone. 145 feet of diamond drilling is conducted on this ore zone but with disappointing results with only trace copper mineralization found. On the EM-01 zone near the old shaft site (GIB #3 mineral claim) where copper ore was mined in the 1940s, a hole is put down and intersected four feet of chalcopyrite running 2.90% copper, 0.01 ounces gold and 0.05 ounces silver. Another hole is put down 50 feet west of the shaft for 107 feet depth and intersected the zone at a vertical depth of 25 feet. On the EM-02 zone (GIB #8 claim), four holes are drilled. Drilling ceased on October 17, 1967. K.J. Christie, consulting geologist, recommends further drilling and sampling on the GIB property for the following season. (**Christie, 1967**) (see **Appendix 1, Figures 6, 7, 8, & 9**)
