**Historical Records Review of
Wilson Island (aka Aurous) Mine
Akaitcho Region,
Northwest Territories
SM 194**

Prepared for:
**Indian and Northern Affairs
Contaminates and Remediation Directorate**
Waldron Building
48th Street, Yellowknife, NT
X1A-1N5

Prepared by:
Ryan Silke, historical consultant
60 Mandeville Dr.
Yellowknife, NT
X1A-3N3

March 31, 2011

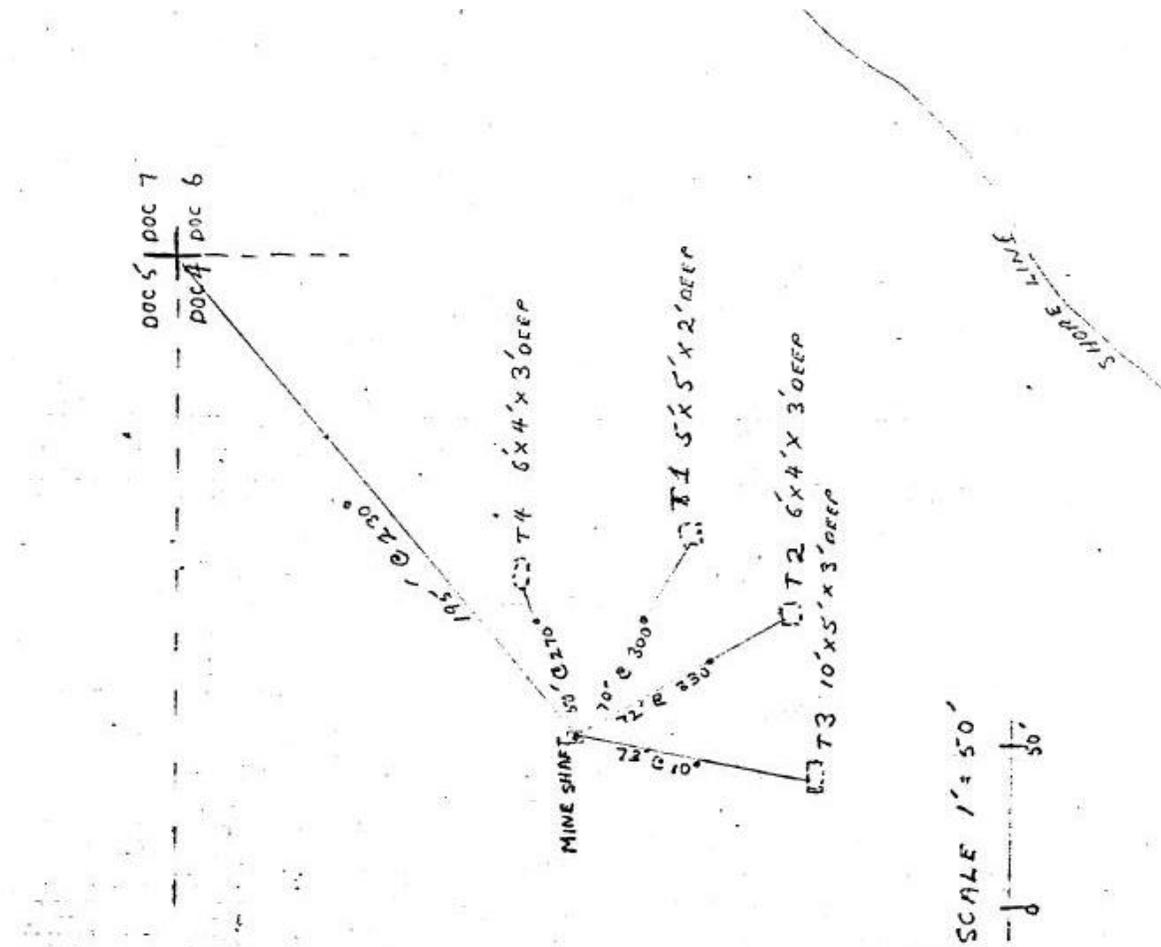
Figure 4. Property Sketch, 1975 (Assessment Report, #015062)

SKETCH SHOWING THE
TRENCHES ON THE DOC CLAIMS
BY R. A. LEES
AUG 3-9/1975

Robert Lee stakes the DOC claims in 1974 and performs basic assessment work through trenching in August 1975. Four trenches totaling 12.7 yards are excavated near the old shaft on DOC #4 claim. (see **Appendix 1, Figure 4**) Several samples are sent for assay and return negligible gold assays, the highest being 0.1 ounces per ton gold. (**NWT Geoscience Assessment Report, #015062**)

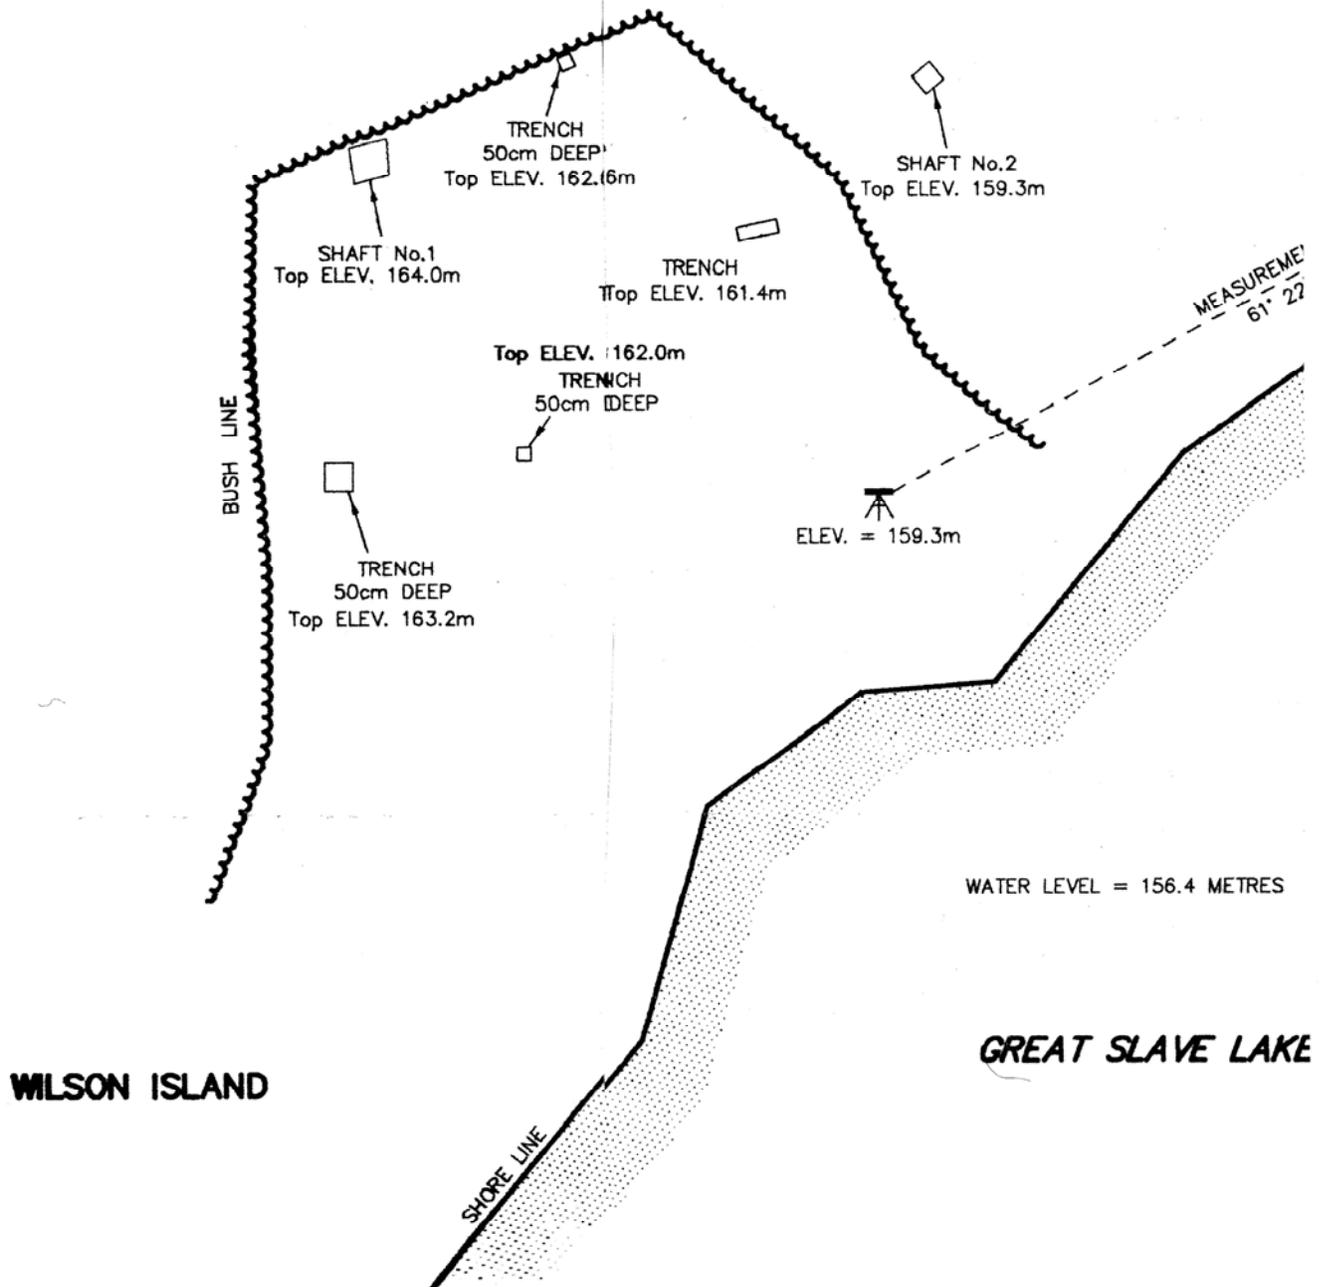
Figure 6. Site Plan, 1992

In 1992, when the site was inspected by All-Can Engineering & Surveys Limited, there were very little ruins left at the Wilson Island Mine. The shafts were both opened and filled with water. The main shaft (#1) was filled with water to within 2 meters of the surface. The #2 shaft was filled with water to about 1 meter below the surface and appeared obstructed with debris below 0.7 meters. There was a collapsed timber headframe above the #1 shaft. There were no other structural ruins identified at that time. Miscellaneous scrap metal in the form of wheels and a camp stove were identified. The report identified the location of these ruins as the possible campsite; however, no location is cited on the maps or text, so these artifacts may not have been from the camp identified in literature as being on ‘Safety Cove’. (**All-Can Engineering & Surveys, 1993a + b**) (for map, see **Appendix 1, Figure 6**)

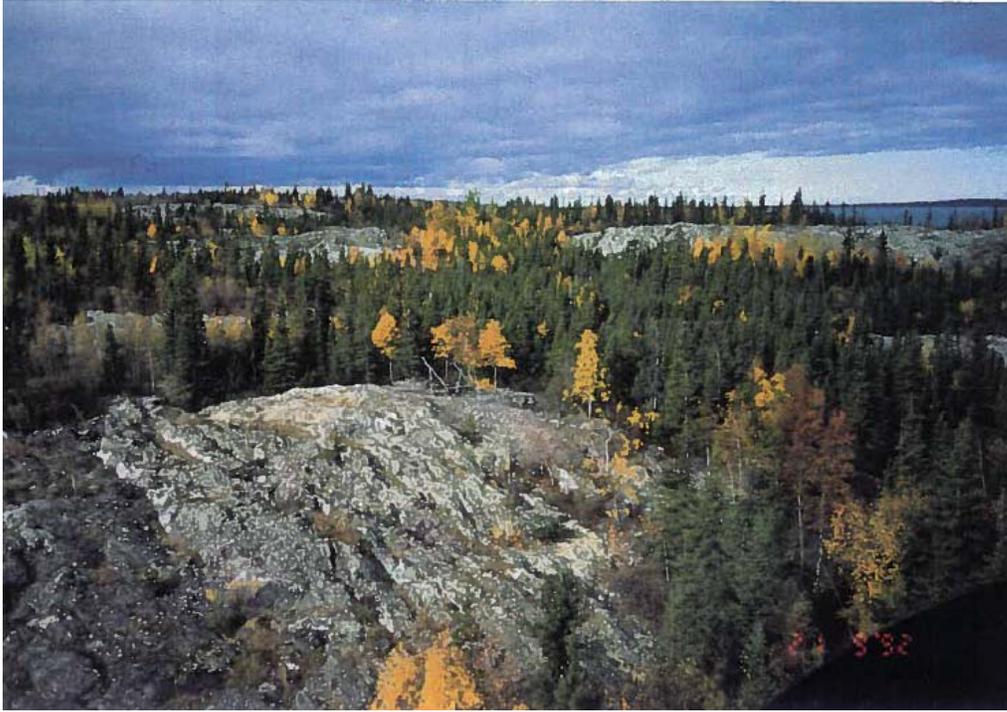
View of shaft site from the air

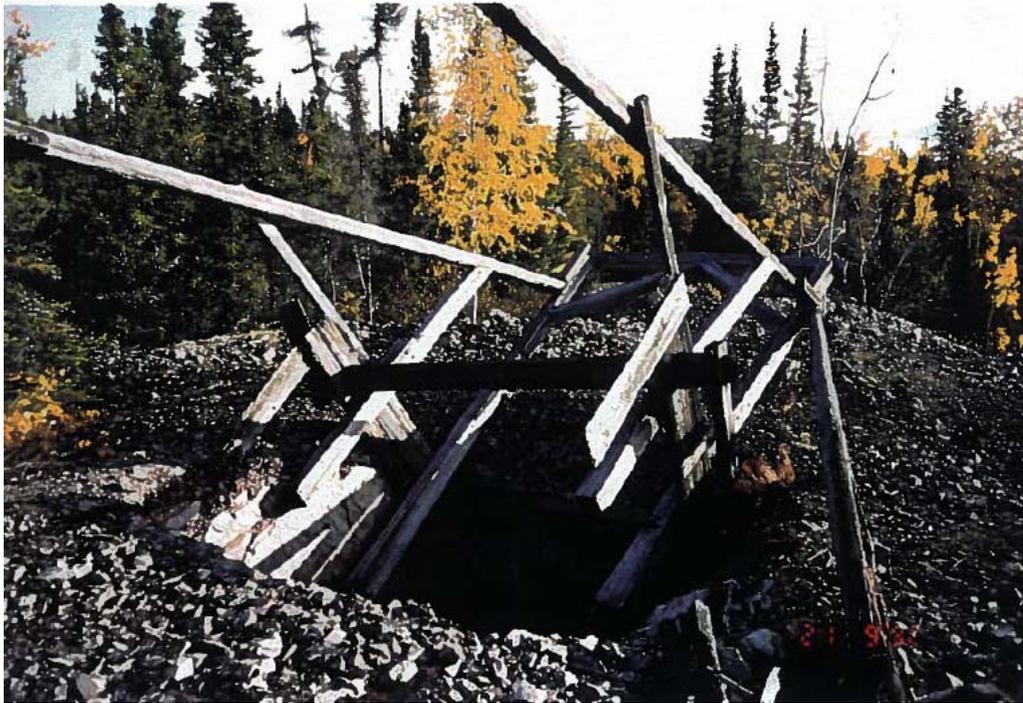
Collapsed headframe at shaft

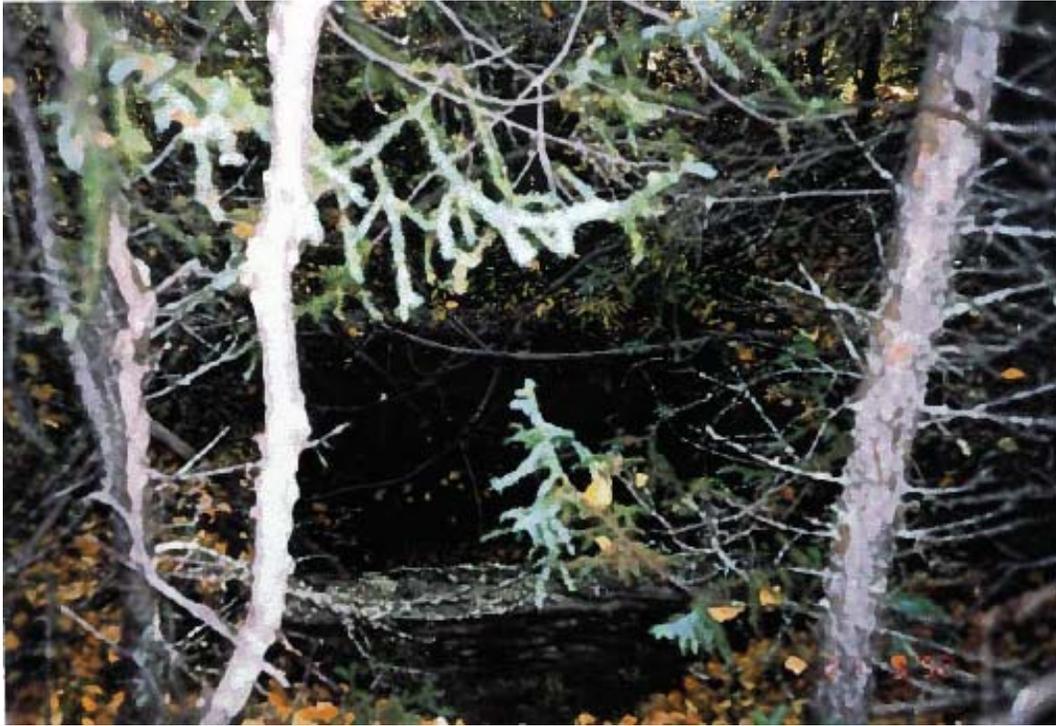
Shaft hidden in trees

Due to the limited nature of mineral development and the absence of significant structural ruins, All-Can Engineering classified the Wilson Island mine site as ‘low-risk’ based on national contaminated site standards (NCSCS). It did not represent a high-priority for remediation implementations at that time. The main concerns were associated with the hazard created by open shafts. (**All-Can Engineering & Surveys, 1993a + b**)
