TEST OPENING # 8: MAIN ENTRANCE CANOPY

0	ISSUED FOR TENDER	05/12/2014
revisions		date
project	WALL CLADDING & ROOF INVESTIGATION GOVERNMENT OF CANADA BUILDING 633 QUEEN STREET, FREDERICTON, NB	
drawing	design	
INVESTIGATIVE OPENING No. 8		
designed	conqu	
date		
drawn	GK	
date	MAY 12, 2014	
approved	RG	
date	12 June 2014	
Tender	Submission	
PWSC Project Manager	Administrateur de projets TPSCC	
project number	no. du projet	
	R.063299.001	
drawing no.	no. du dessin	
	A4

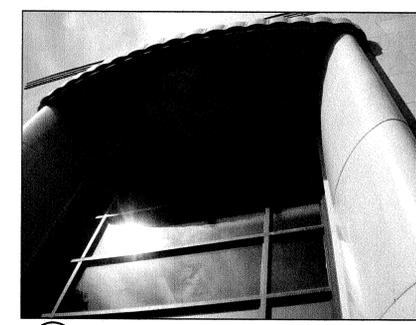
1 VIEW OF UNDERSIDE OF CANOPY - FRONT ENTRANCE

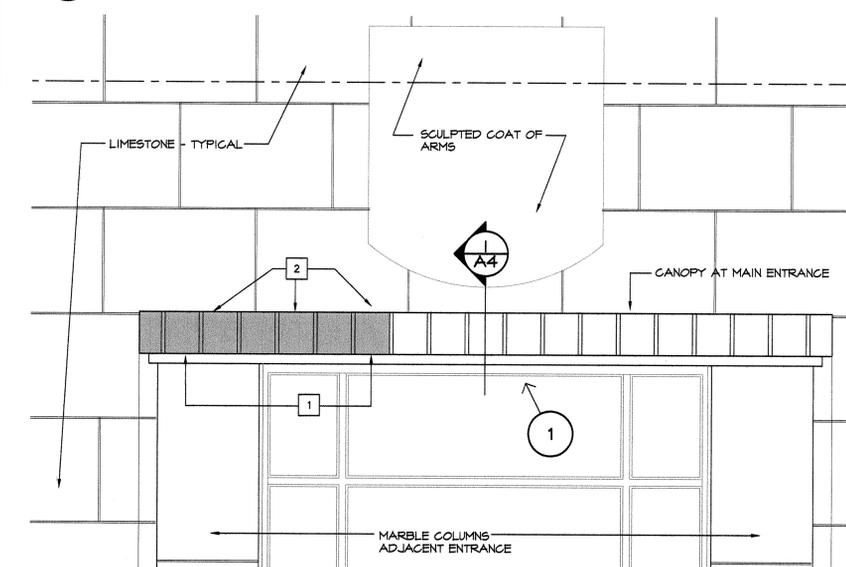
ELEVATION
SCALE : 1:20

INTENT: TO CONFIRM AS-FOUND CANOPY ASSEMBLY AT MAIN ENTRANCE, AND AS-FOUND CONDITIONS OF CANOPY, ADJACENT STONE WALLS / COLUMNS, METAL FLASHINGS, TRANSITION MEMBRANE FLASHINGS, AND SEALANTS. TO CONFIRM AS-FOUND CONDITION OF CANOPY SOFFIT. TO INVESTIGATE POSSIBLE SOURCES OF MINERAL DEPOSITS AND STAINING ON ADJACENT STONE. PROVIDE TEMPORARY SHORING AS REQUIRED.

- 1 CAREFULLY REMOVE 1 OR 2 SCALLOPED STONES AT CANOPY FASCIA (SHOWN SHADED) TO REVEAL AS-FOUND CONDITION OF CANOPY / SOFFIT ASSEMBLY. AVOID DAMAGE TO ADJACENT MATERIALS. PROVIDE TEMPORARY SHORING.
 - SAWCUT HORIZONTAL MORTAR JOINTS USING ONE CUTLINE INITIALLY TO ALLOW FOR RAKING OUT BY HAND TOOLS. DO NOT SAWCUT VERTICAL JOINTS.
 - RECORD STONES ON A KEY DRAWING AND MARK STONES FOR RE-INSTATEMENT TO MATCH THEIR EXISTING LOCATION AND ORIENTATION.
 - STORE IN A MANNER THAT PREVENTS DAMAGE TO STONE UNITS.
- 2 CAREFULLY REMOVE METAL FLASHING AS REQUIRED TO ALLOW REMOVAL OF SCALLOPED FASCIA STONES. RE-INSTALL METAL FLASHING AT END OF TEST AND MAKE GOOD.

AFTER COMPLETION OF TEST OPENING REVIEW, REASSEMBLE AND REINSTATE ALL MATERIALS. CLOSE OFF OPENING AND MAKE GOOD AND WATER TIGHT.
