## GIANT MINE REMEDIATION PROJECT

# Overview Information for Advanced Remediation Stabilization Activities

**Reference Number: 1314260010-078-R-Rev1-5000**

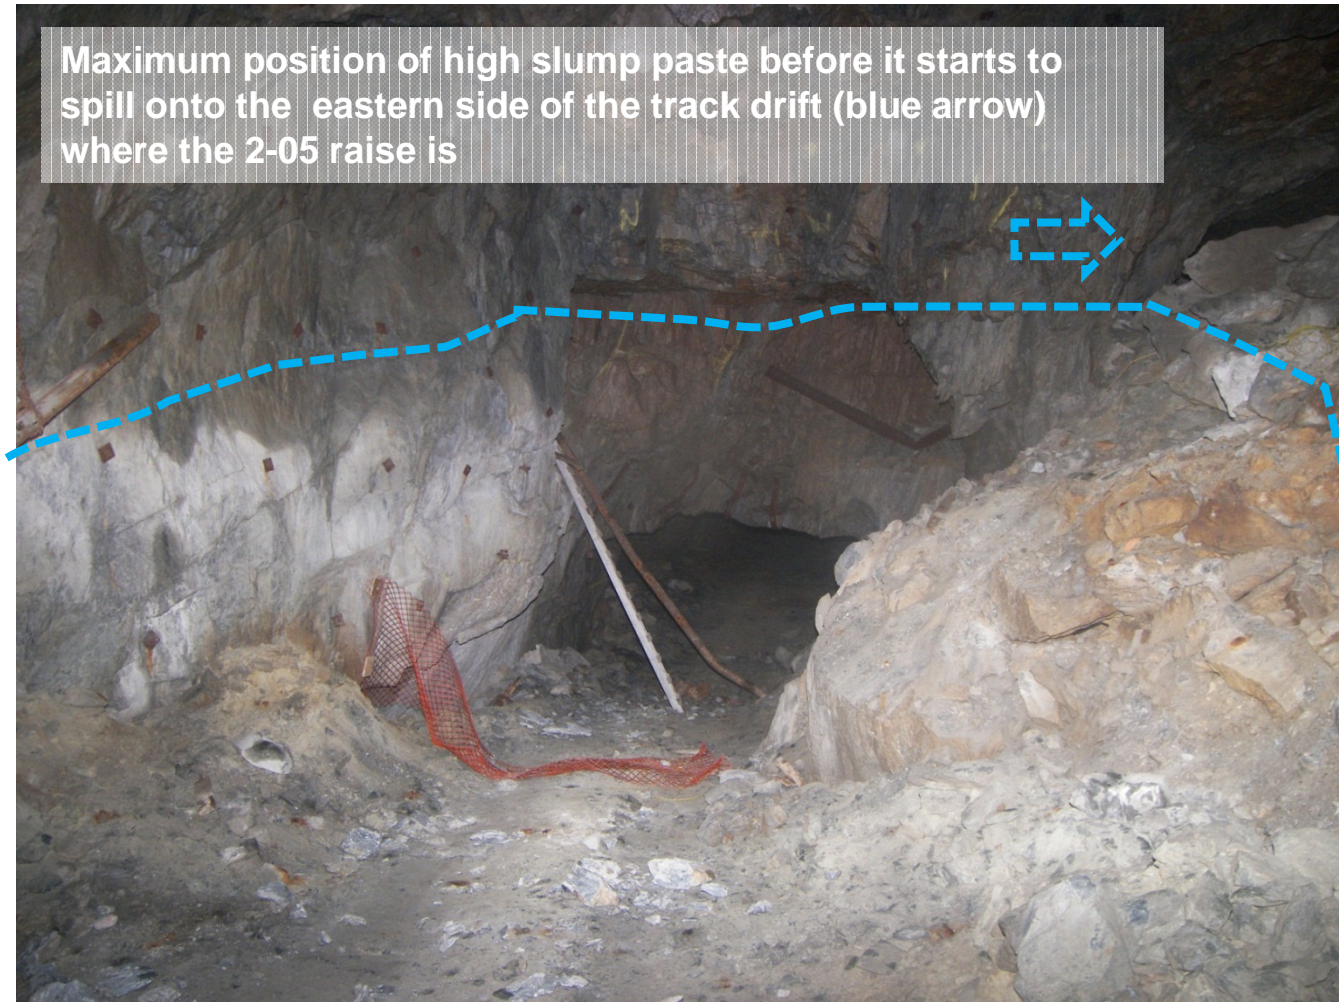
Maximum position of high slump paste before it starts to spill onto the eastern side of the track drift (blue arrow) where the 2-05 raise is

- Start backfilling 1-18 EA from surface boreholes
- Because we cant safely access the 2-05 raise area, we will use high slump paste to fill the lowest area up until the point where we think it is spilling out down the raise.
- We can get the fill into the northern portion of 1-18 EA where it goes under the track drift as seen in the photos
- Once the fill gets to the point of the blue line, it can spill down the track drift and we will need to stop pumping and let the paste setup.
- We will also have to have cameras on the 2<sup>nd</sup> level where the ore pass is intersected to check for paste entering the raise.

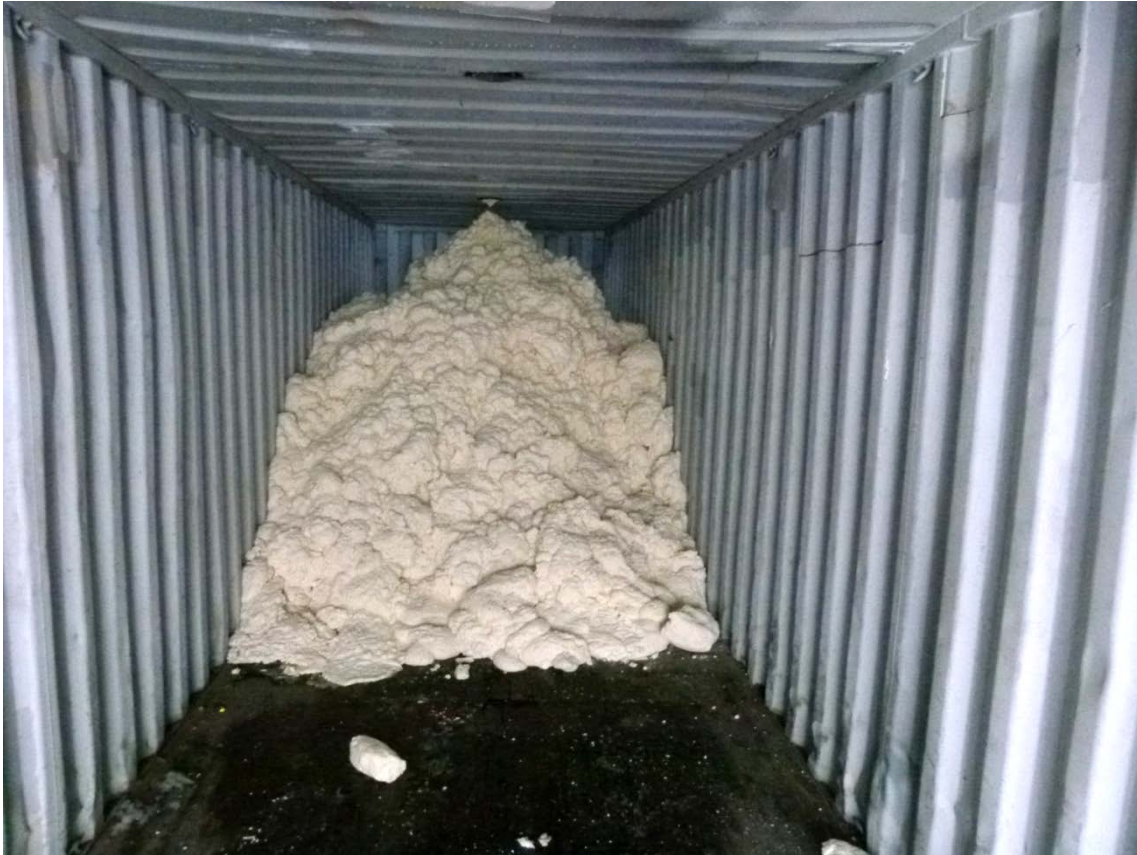
*Figure 1: Foamed Resin Plug*

Refer to **Appendix 5**. Expanding foam was tested to evaluate its usefulness as a product for building remote barricades. This appendix contains the results and recommendations that were a product of the foam test that occurred in November of 2013.

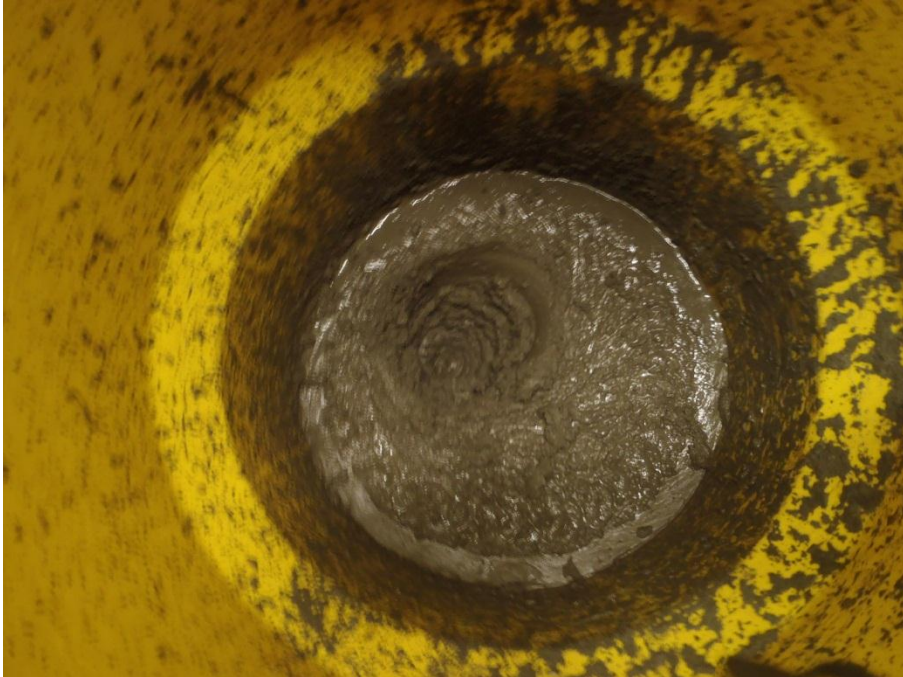
<p>Photograph 24</p> <p>13-1426-0010 SPTP 1-2-3 as received</p> <p>Observations:</p> <ul style="list-style-type: none"> <li>- mostly till with some small to large clay chunks</li> <li>- larger clay chunks easy to break up as long as material is above a 7" – 8" slump</li> <li>- after thoroughly homogenizing material small clay balls are present throughout the entire sample</li> <li>- clay balls can be easily broken up between fingers and after sitting undisturbed for 48 hrs all clay balls were broken up and not visible after re-homogenizing the sample</li> </ul>

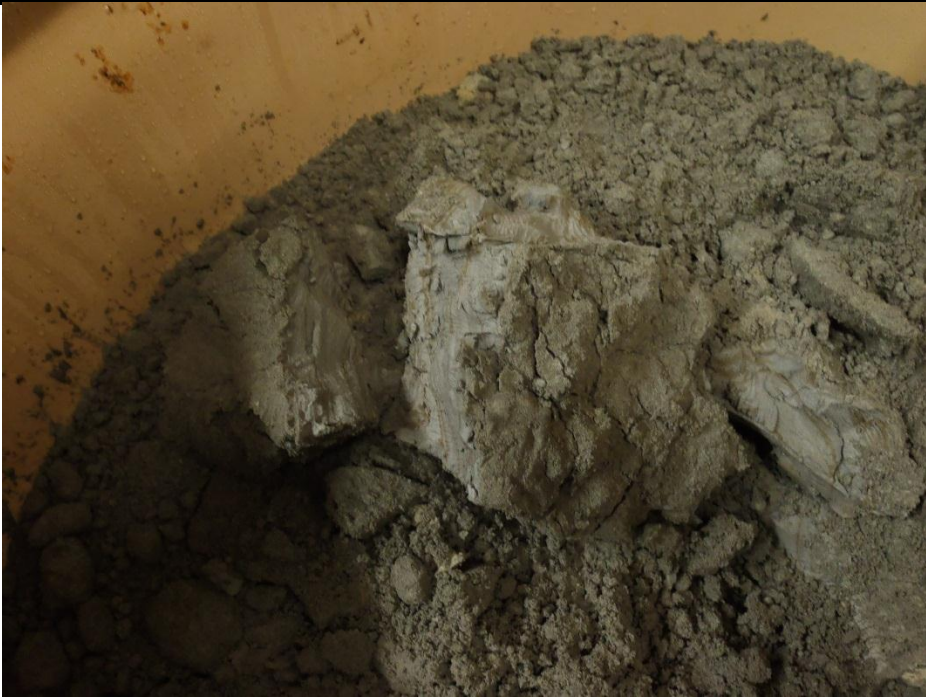
<p>Photograph 26</p> <p>13-1426-0010 SPTP</p> <p>-4 - 178mm slump</p>

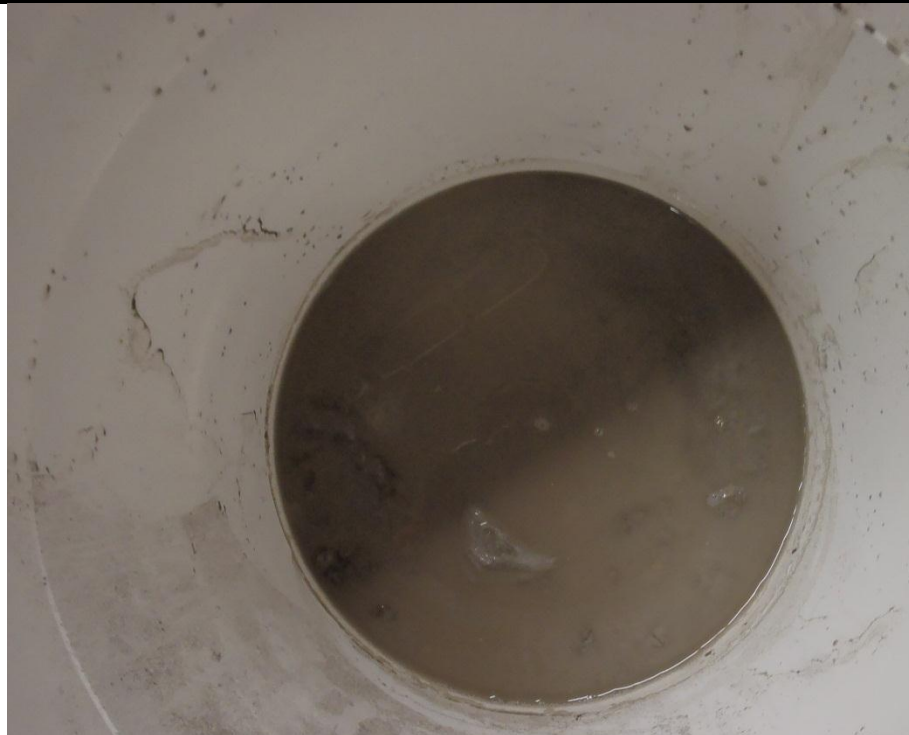
Observations: <ul style="list-style-type: none"><li>- received weight = 7.41 Kg</li><li>- sample came in wet</li><li>- pail had hole in bottom, lost some sample and water</li><li>- till + lots of clay present</li><li>- mixed well, no clay balls after mixing</li><li>- small amount of water bleed</li><li>-sticky material</li><li>- as received moisture= 74.96 wt% solids</li><li>- water added = 320 mL</li><li>- Final moisture = 71.74 wt% solids</li></ul>

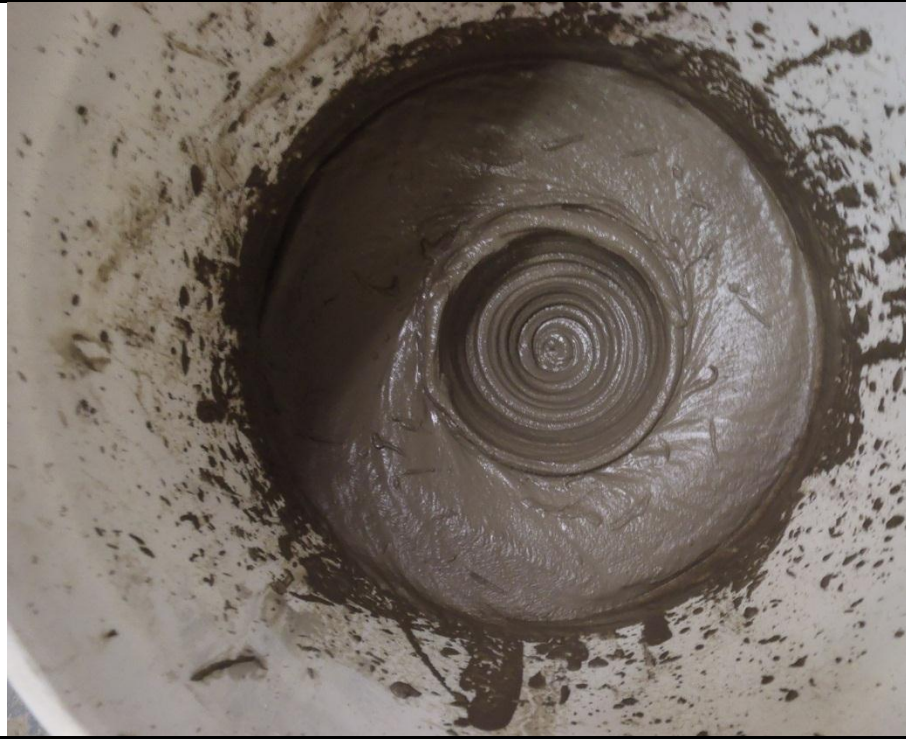
Photograph 10 13-1426-0010 CTP - GA13-TP14-1 as received  Observations: <ul style="list-style-type: none"><li>- received weight = 12 Kg</li><li>- sand, silt and small amount of clay present</li><li>- mixed well, no clay balls present after mixing</li><li>- bleeds water as soon as mixing stops</li><li>- as received moisture = 88.4 wt% solids</li><li>- water added = 1600 mL</li><li>- final moisture = 76.73 wt% solids</li></ul>

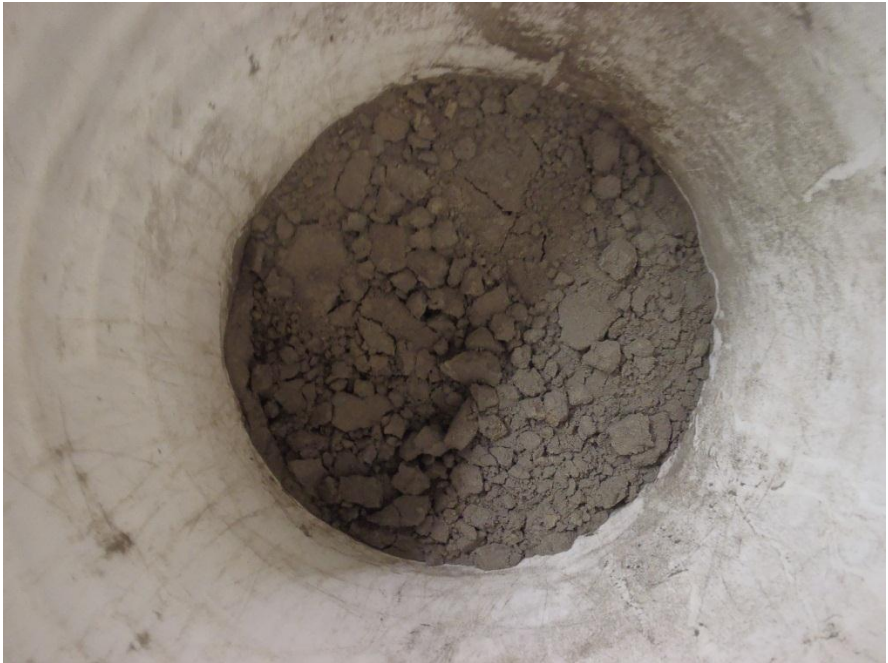
Observations: <ul style="list-style-type: none"><li>- received weight = 13.82 Kg</li><li>- silt and sand with very little clay visible</li><li>- bleeds water</li><li>- Mixed well, no clay balls present after mixing</li><li>- as received moisture = 92.83 wt% solids</li><li>- water added = 2770 mL</li><li>- final moisture = 77.14 wt% solids</li></ul>

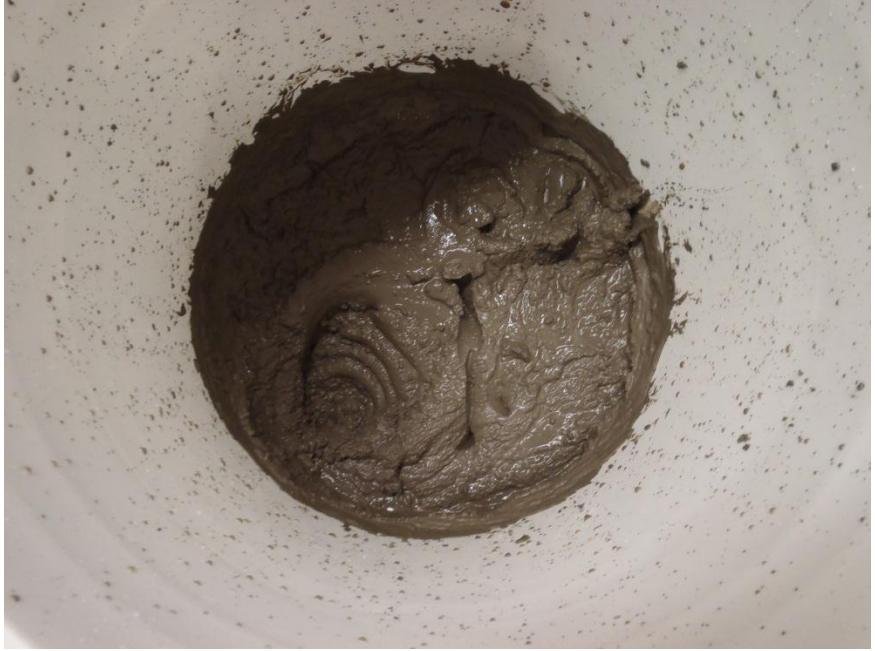
Photograph 22 13-1426-0010 CTP - GA13-TP18 as received Observations: <ul style="list-style-type: none"><li>- received weight – 13.49 Kg</li><li>- sand, silt, and very little clay present</li><li>- bleeds water</li><li>- mixes well, no clay balls present after mixing</li><li>- as received moisture = 89.12 wt% solids</li><li>- water added = 1700 mL</li><li>- final moisture = 76.17 wt% solids</li></ul>

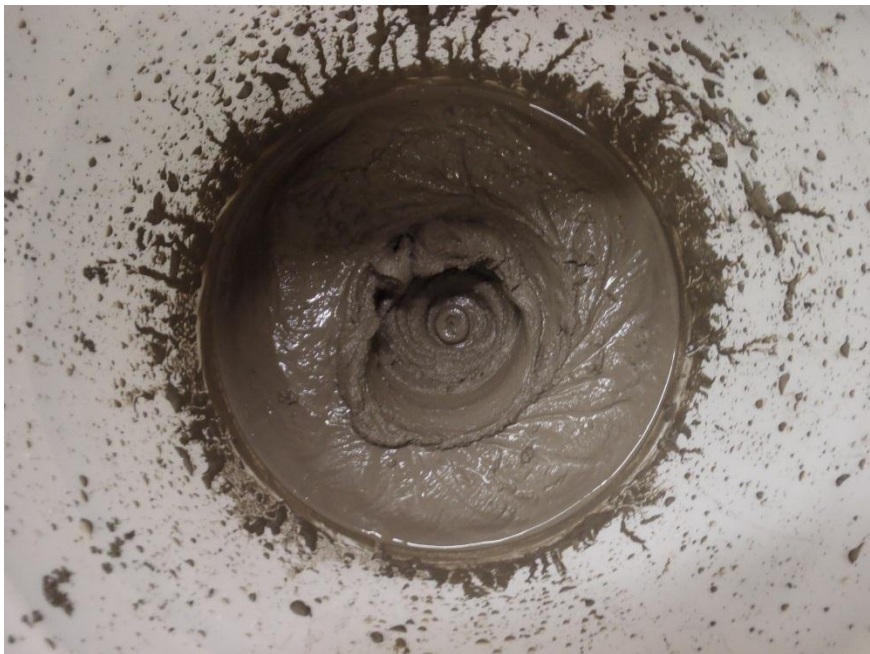
<b>Client : PWGSC Giant Mine</b>	<b>Project Number : 13-1426-0010</b>
<b>Site Name : Sudbury Laboratory</b>	
<p>Photograph 25 13-1426-0010 CTP - GA13-TP19 as received</p> <p>Observations:</p> <ul style="list-style-type: none"><li>- received weight = 12.04 Kg</li><li>- sand, silt, and small amount of clay present</li><li>- bleeds water</li><li>- mixes well, no clay balls present after mixing</li><li>- as received moisture = 90.06 wt% solids</li><li>- water added = 2000 mL</li><li>- final moisture = 76.11 wt% solids</li></ul>

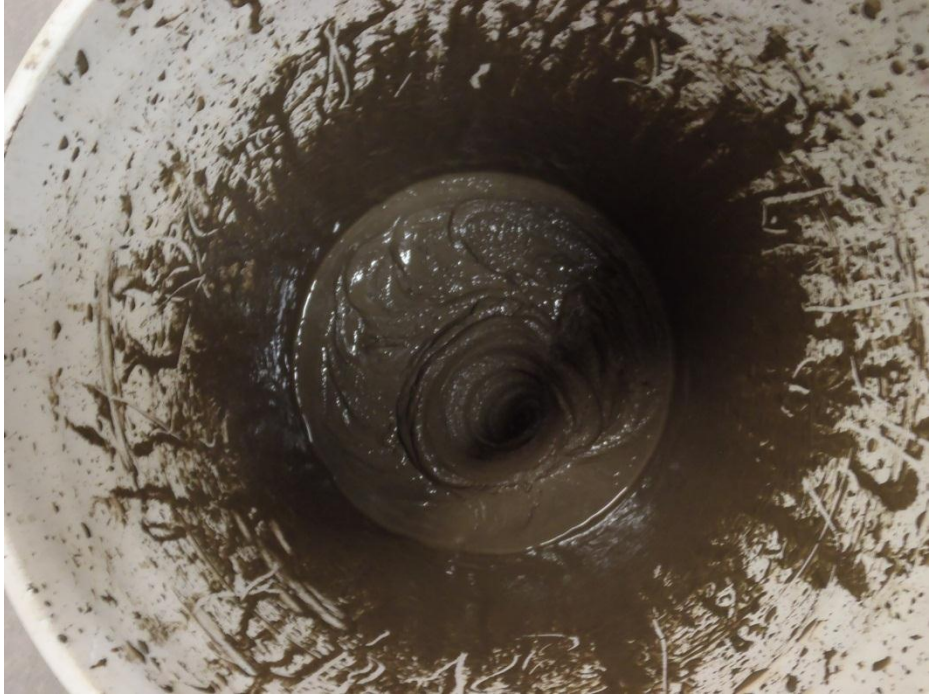
Photograph 28 13-1426-0010 CTP - GA13-TP20 as received Observations: <ul style="list-style-type: none"><li>- received weight = 8.96 Kg</li><li>- sand, silt, and some clay present</li><li>- mixes well, no clay balls present after mixing</li><li>- bleeds water</li><li>- as received moisture = 82.17 wt% solids</li><li>- water added = 1300 mL</li><li>- final moisture = 72.64 wt% solids</li></ul>

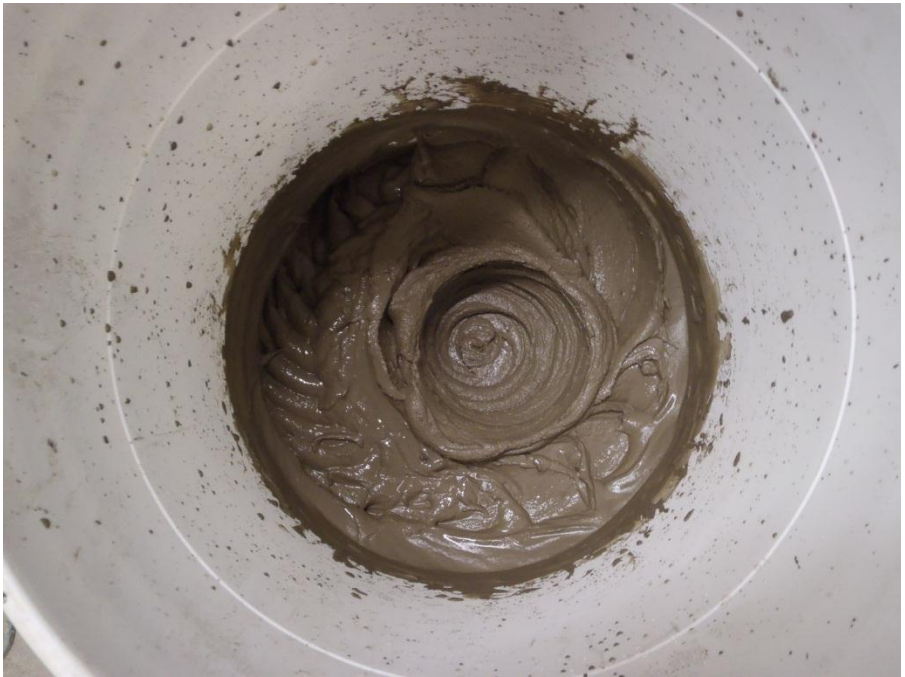
<b>Client : PWGSC Giant Mine</b>		<b>Project Number : 13-1426-0010</b>
<b>Site Name : Sudbury Laboratory</b>		
<b>Photograph 31</b> 13-1426-0010 CTP - GA13-TP26 as received Observations: <ul style="list-style-type: none"><li>- received weight – 13.61 Kg</li><li>- silt and clay mix</li><li>- mixed well, no clay balls present after mixing</li><li>- no water bleed</li><li>- as received moisture = 81.12 wt% solids</li><li>- water added = 1500 mL</li><li>- final moisture = 72.60 wt% solids</li></ul>

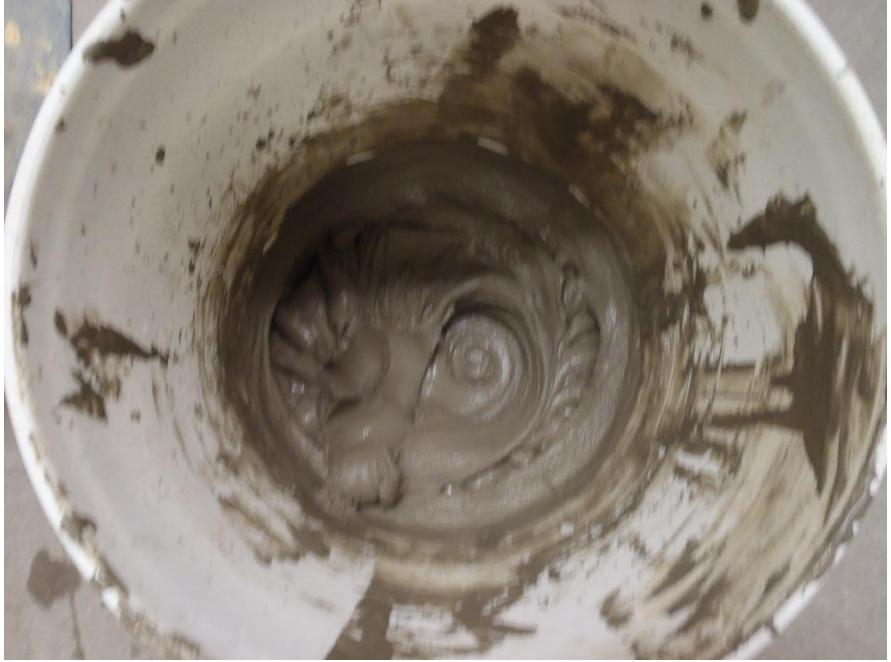
Photograph 34 13-1426-0010 STP - GA13-TP27 as received  Observations: <ul style="list-style-type: none"><li>- received weight = 18.44 Kg</li><li>- silt, sand, and clay</li><li>- various colours present in sample (orange, gold, brown)</li><li>- mixes well, no clay balls present after mixing</li><li>- bleeds water slightly</li><li>- slightly sticky</li><li>- as received moisture = 81.99 wt% solids</li><li>- water added = 1400 mL</li><li>- final moisture = 74.73 wt% solids</li></ul>

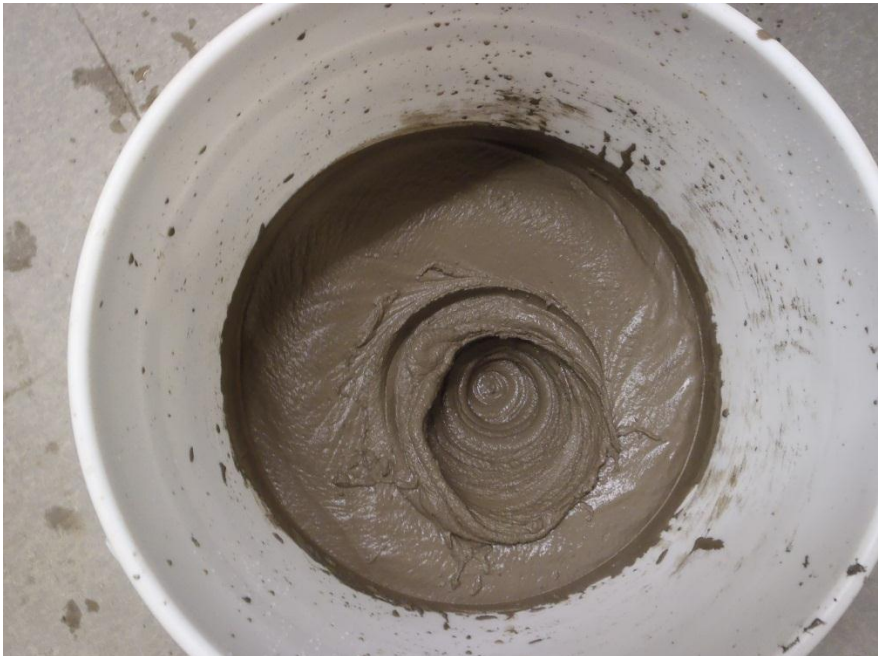
<b>Client : PWGSC Giant Mine</b>	<b>Project Number : 13-1426-0010</b>
<b>Site Name : Sudbury Laboratory</b>	
<b>Photograph 37</b> 13-1426-0010 STP - GA13-TP35 as received  Observations: <ul style="list-style-type: none"><li>- received weight = 10.5 Kg</li><li>- till and clay present</li><li>- mizes well, no clay balls present after mixing</li><li>- bleeds water slightly</li><li>- as received moisture = 86.28 wt% solids</li><li>- water added = 1000 mL</li><li>- final moisture = 76.70 wt% solids</li></ul>

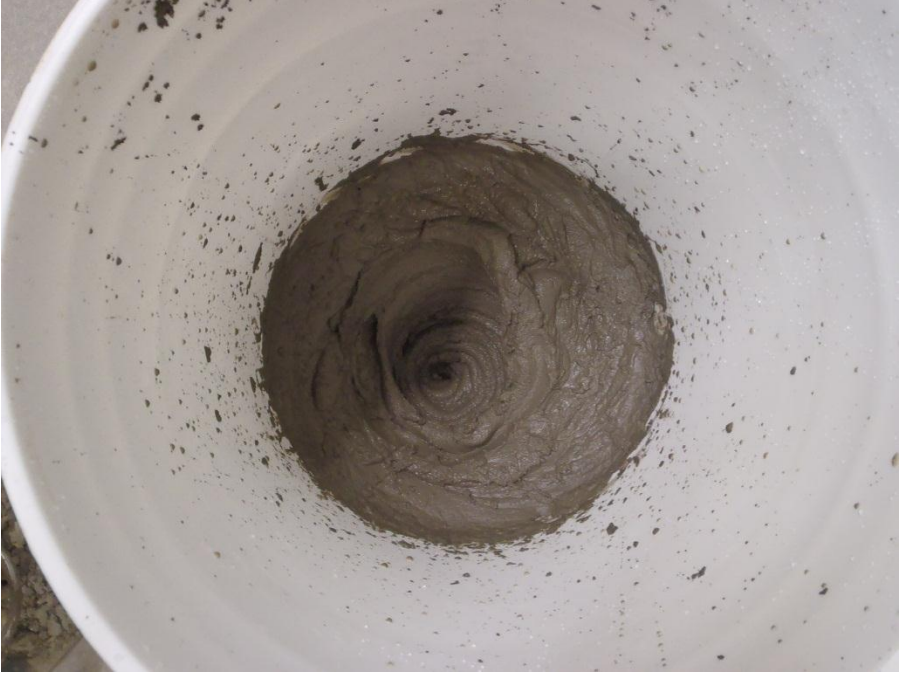
Photograph 40 13-1426-0010 STP - GA13-TP36 as received  Observations: - received weight = 12.61 Kg - mostly clay with some silt present - no water bleed - mixed well, no clay balls present after mixing - very sticky material - as received moisture = 71.61 wt% solids - water added = 770m mL - final moisture = 68.3 wt% solids

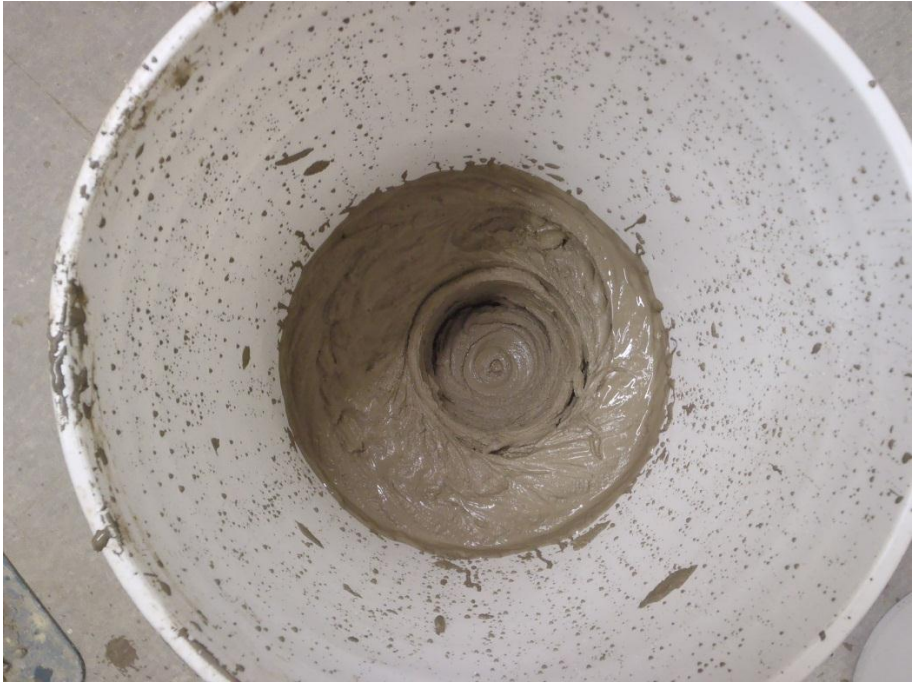
Client : PWGSC Giant Mine	Project Number : 13-1426-0010
Site Name : Sudbury Laboratory	
Photograph 43 13-1426-0010 STP - GA13-TP38 as received  Observations: <ul style="list-style-type: none"><li>- received weight = 16.93 Kg</li><li>- Till and clay (very moist)</li><li>- mixes well, no clay balls present after mixing</li><li>- bleeds water slightly</li><li>- sticy material</li><li>- as received moisture = 70.54 wt% solids</li><li>- water added = 1160 mL</li><li>- final moisture = 66.9 wt% solids</li></ul>

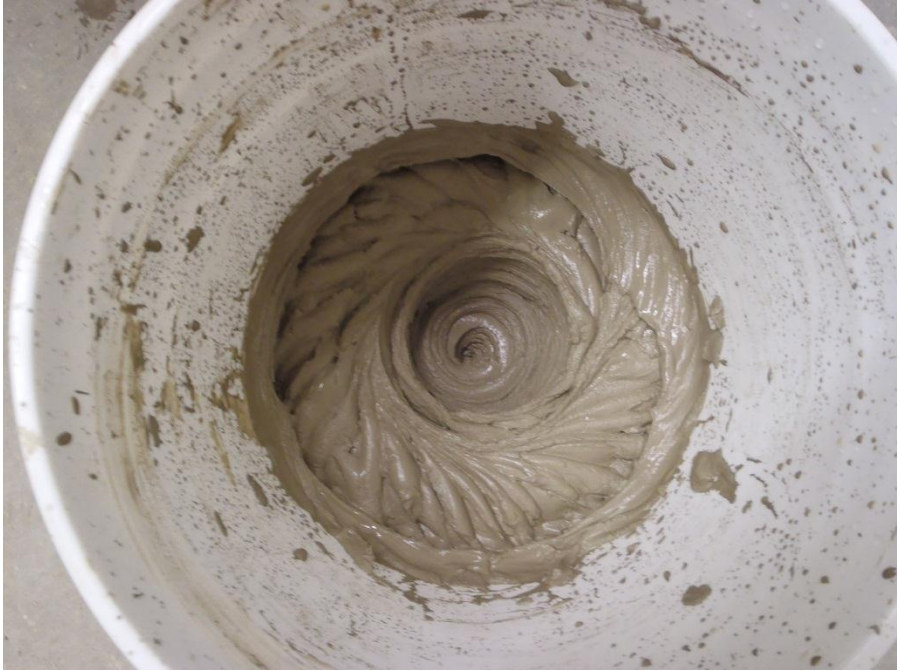
Photograph 46 13-1426-0010 STP - GA13-TP41 as received  Observations: <ul style="list-style-type: none"><li>- received weight = 7.77 Kg</li><li>- till and clay</li><li>- received sample wet</li><li>- no water bleed</li><li>- mixes well, no clay balls present and mixing</li><li>- sticky material</li><li>- as received moisture = 68.12 wt% solids</li><li>- no water added to sample to homogenize</li></ul>

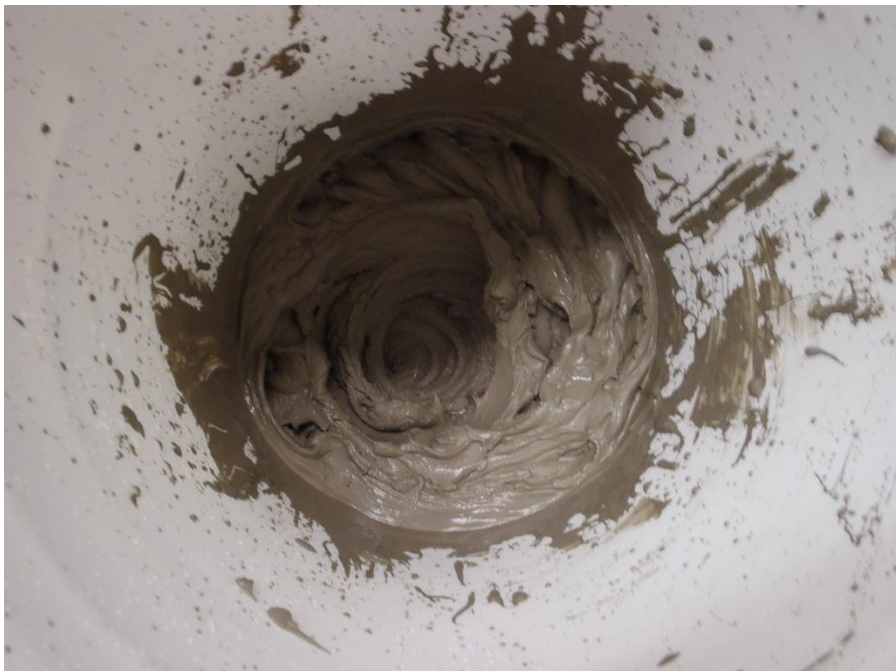
<b>Client : PWGSC Giant Mine</b>	<b>Project Number : 13-1426-0010</b>
<b>Site Name : Sudbury Laboratory</b>	
<b>Photograph 49</b> 13-1426-0010 STP - GA13-TP52 as received  Observations: <ul style="list-style-type: none"><li>- received weight = 15.78 Kg</li><li>- till and clay</li><li>- no water bleed</li><li>- slightly sticky material</li><li>- mixes well, no clay balls present after mixing</li><li>- as received moisture = 76.75 wt% solids</li><li>- water added = 500 mL</li><li>- final moisture = 72.92 wt% solids</li></ul>

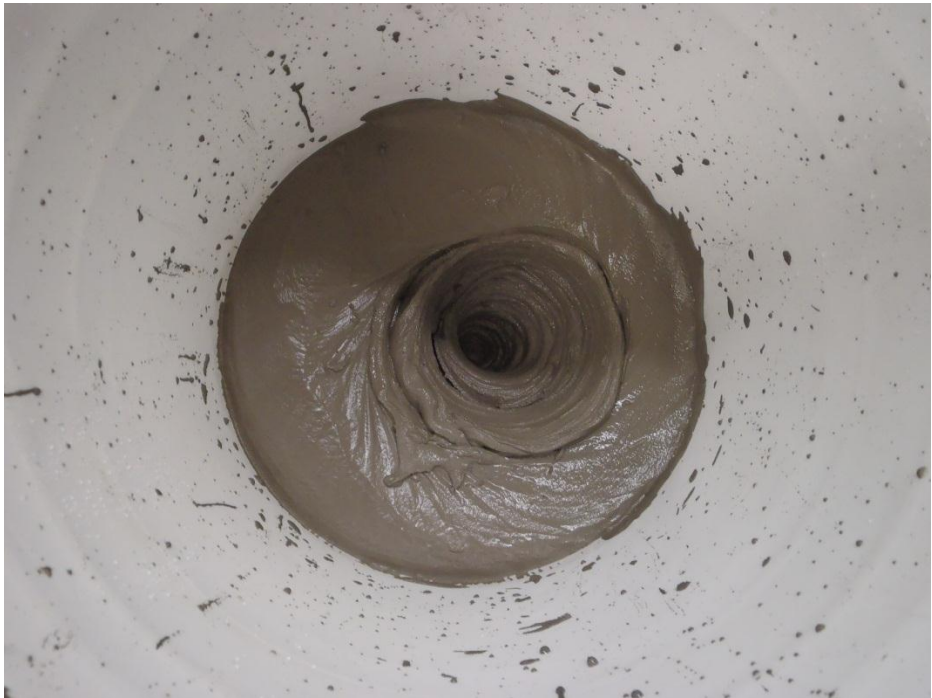
Photograph 52 13-1426-0010 SCTP - BS - Silty Sand as received  Observations: <ul style="list-style-type: none"><li>- received weight – 244.8 Kg</li><li>- sand/silt with some clay balls present</li><li>- bleeds water as soon as mixing stops</li><li>- no clay balls present after mixing</li><li>- as received moisture = 90.4 wt% solids</li><li>- water added = 38.6L</li><li>- final moisture = 75.71 wt% solids</li></ul>

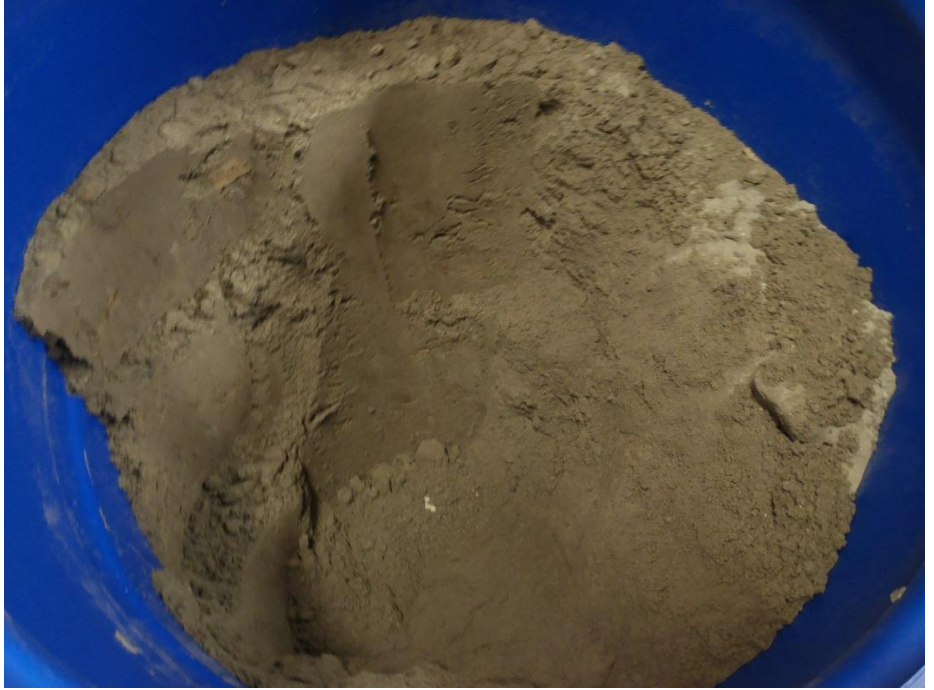
Photograph 54 13-1426-0010 SCTP - BS - Mixed (Silt- Sand -Clay) as received  Observations: - received weight = 271.56 Kg - sand, silt, and clay chunks - bleeds water as soon as mixing stops - took a while to break clay balls with mixer - as received moisture = 86.94 wt% solids - water added = 35.15L - final moisture = 72.92 wt% solids

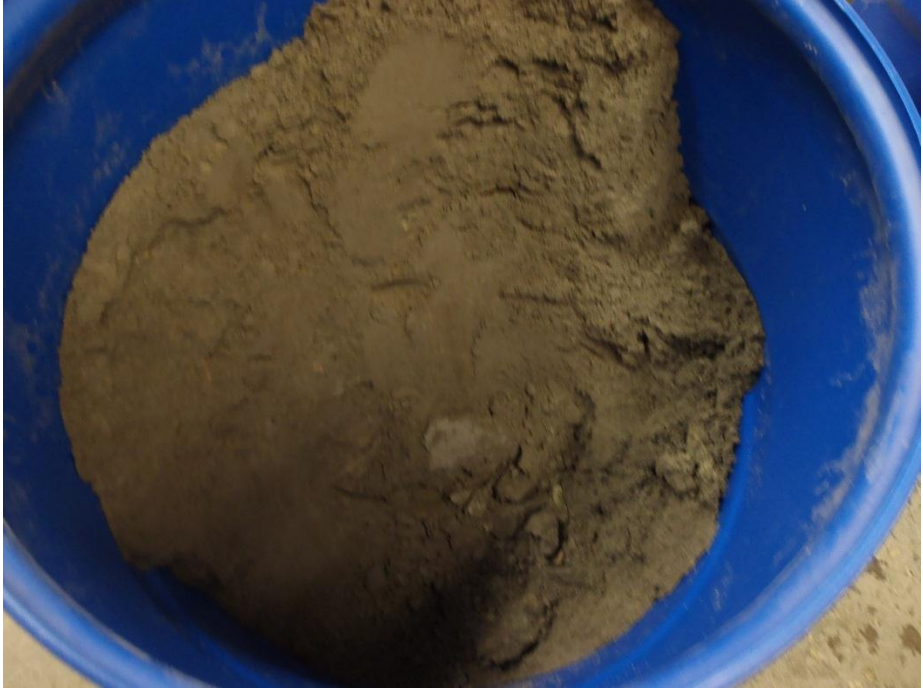
Photograph 56 13-1426-0010 SCTP - BS - Clay – Silt as received  Observations: <ul style="list-style-type: none"><li>- received weight = 127.27 Kg</li><li>- chunks of clay with silt</li><li>- sample came in wet</li><li>- very sticky material</li><li>- no water bleed</li><li>- mixed well with no clay balls present after mixing</li><li>- as received moisture = 74.07 wt% solids</li><li>- water added = 7.26L</li><li>- final moisture = 69.84 wt% solids</li></ul>

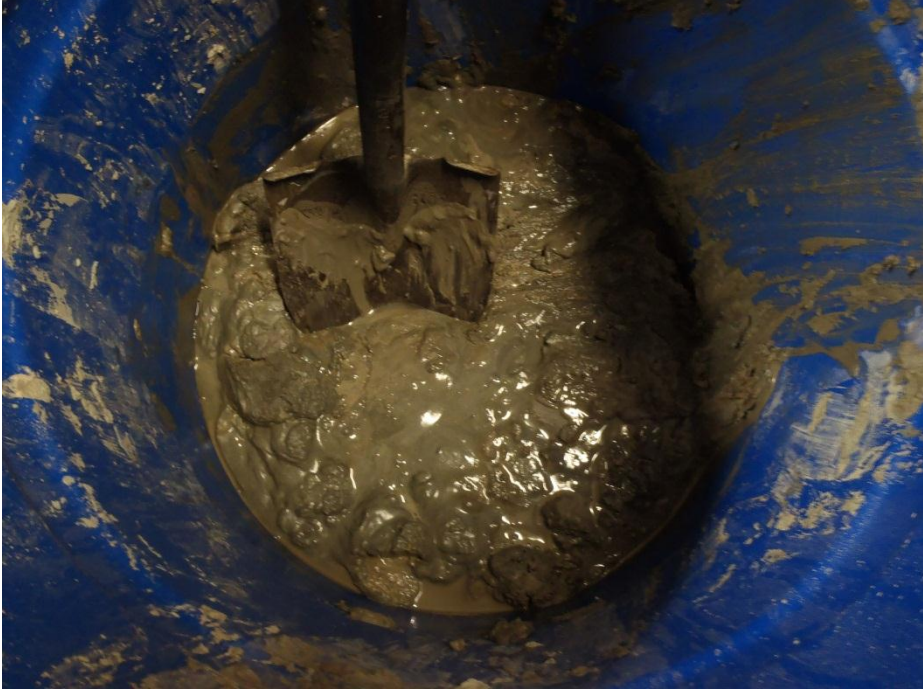
Photograph 58 13-1426-0010 SCTP - BS - Clay - Silt (S2) as received  Observations: <ul style="list-style-type: none"><li>- received weight – 191.96 Kg</li><li>- mostly sand with some balls/chunks of clay</li><li>- bleeds water as soon as mixing stops</li><li>- bottom of drum had more clay than the top portion</li><li>- mixes well with no clay chunks after mixing</li><li>- as received moisture = 92.49 wt% solids</li><li>- water added = 11.83 Kg</li><li>- final moisture = 76.98 wt% solids</li></ul>

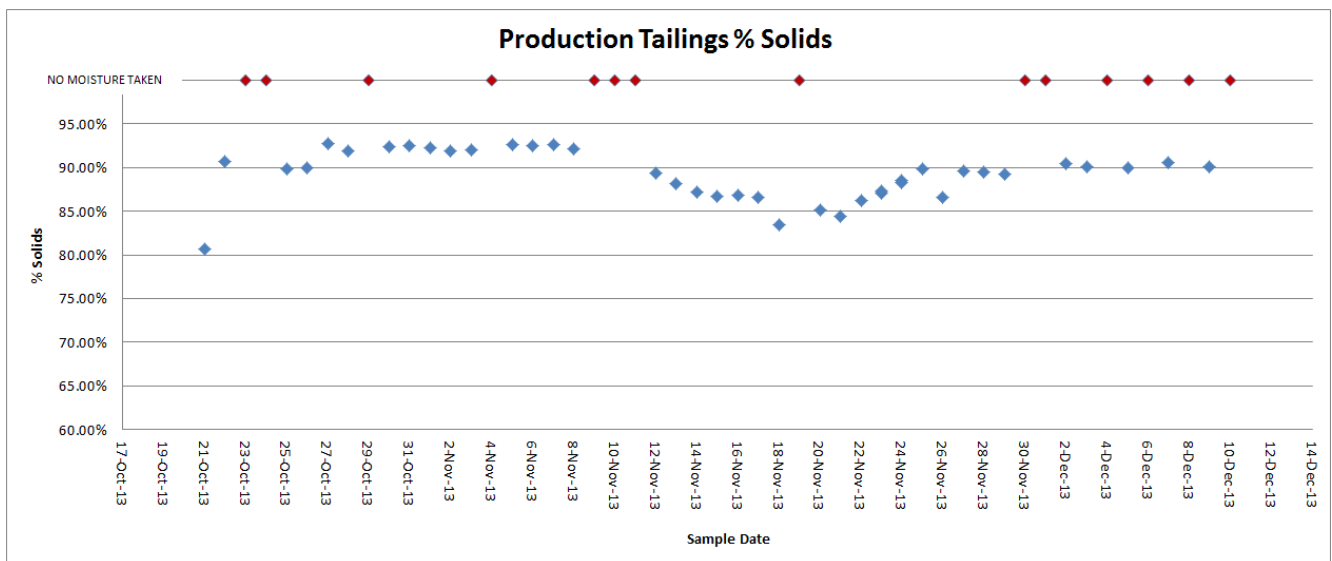
Figure 1: Tailings Feed Material % Solids Content
