Final Report

Detailed Environmental Impact Assessment for the Thompson Bay Dam, Peterborough, Ontario

PWGSC File: R.065830.110

Prepared for
Public Works and Government Services Canada

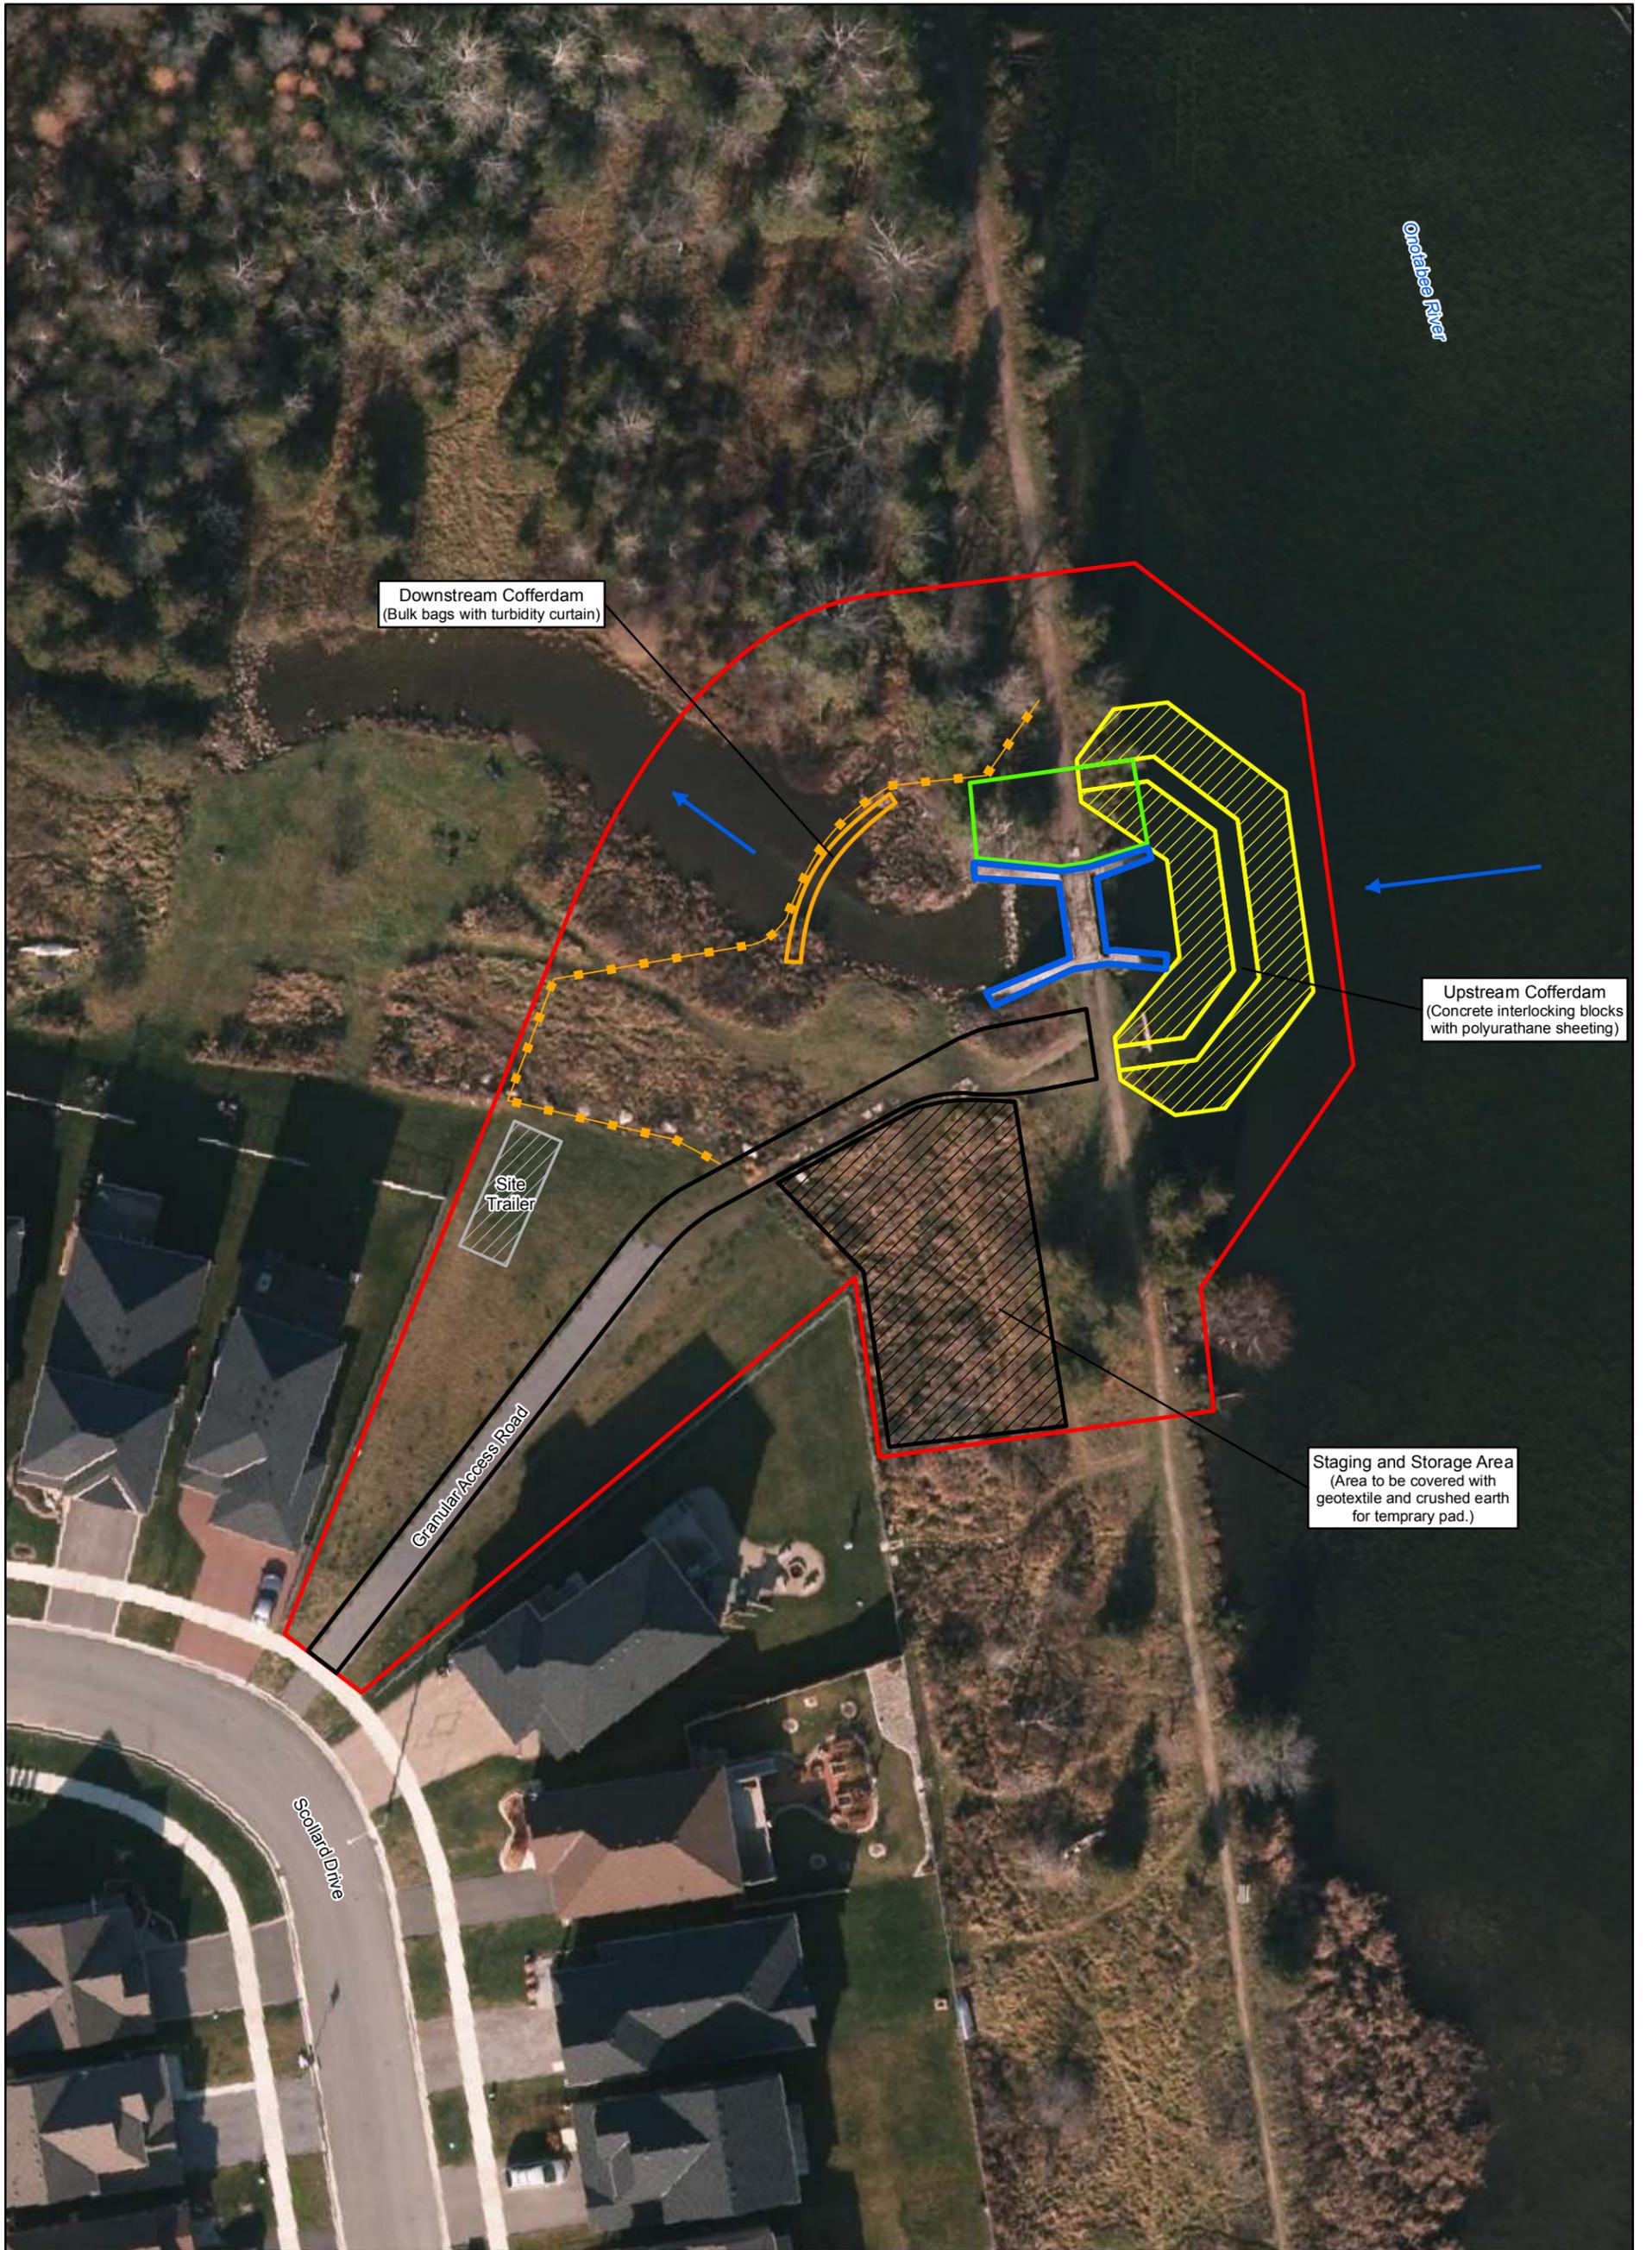
Downstream Cofferdam
(Bulk bags with turbidity curtain)

Upstream Cofferdam
(Concrete interlocking blocks
with polyurathane sheeting)

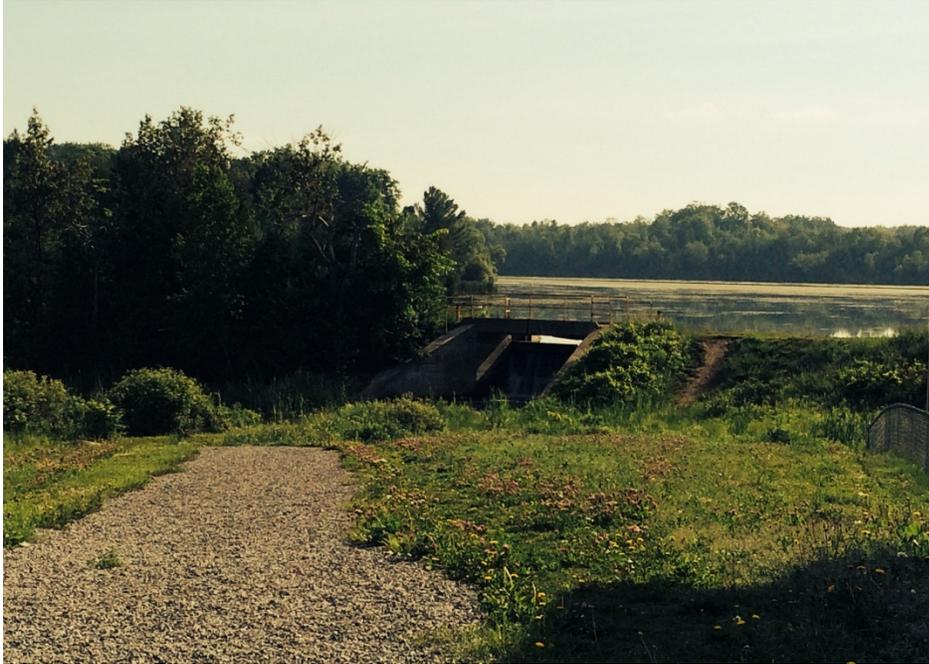
Photo 1: View of Thompson Bay Dam looking east.

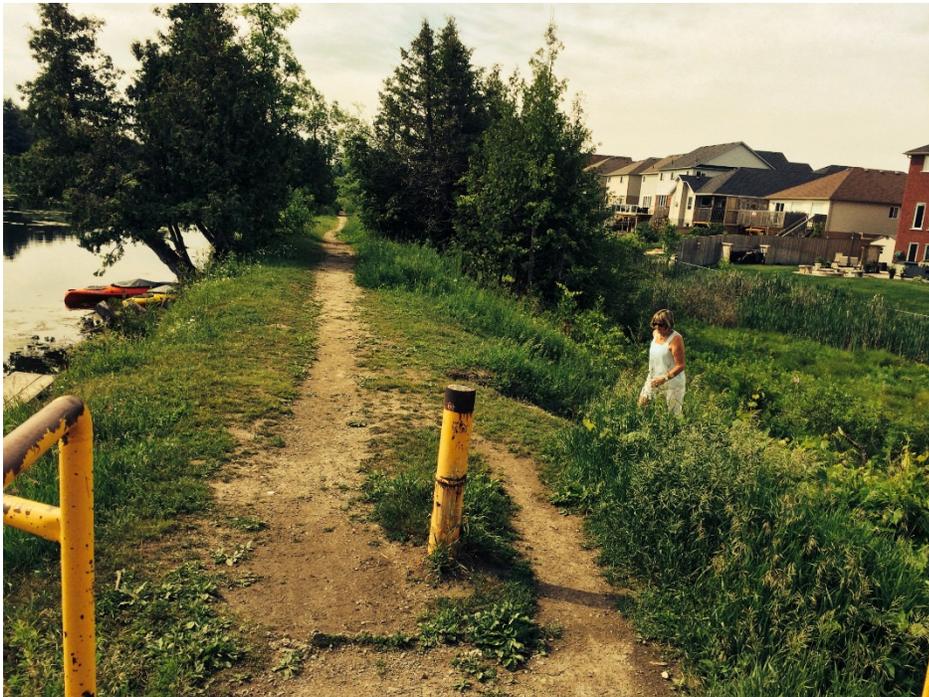
Photo 2: View of earth embankment (walking trail) along south side of Thompson Bay Dam; residential housing development present on the right and Thompson Bay present on the left side of photograph.

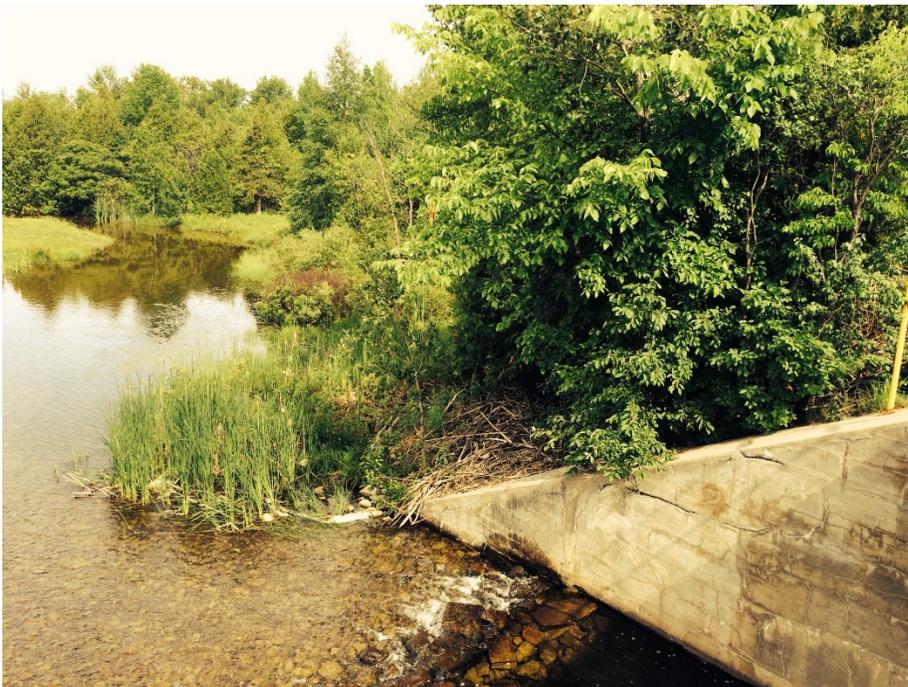
Photo 4: View of Thompson Creek and abutment wall on downstream (northwest) side of Thompson Bay Dam

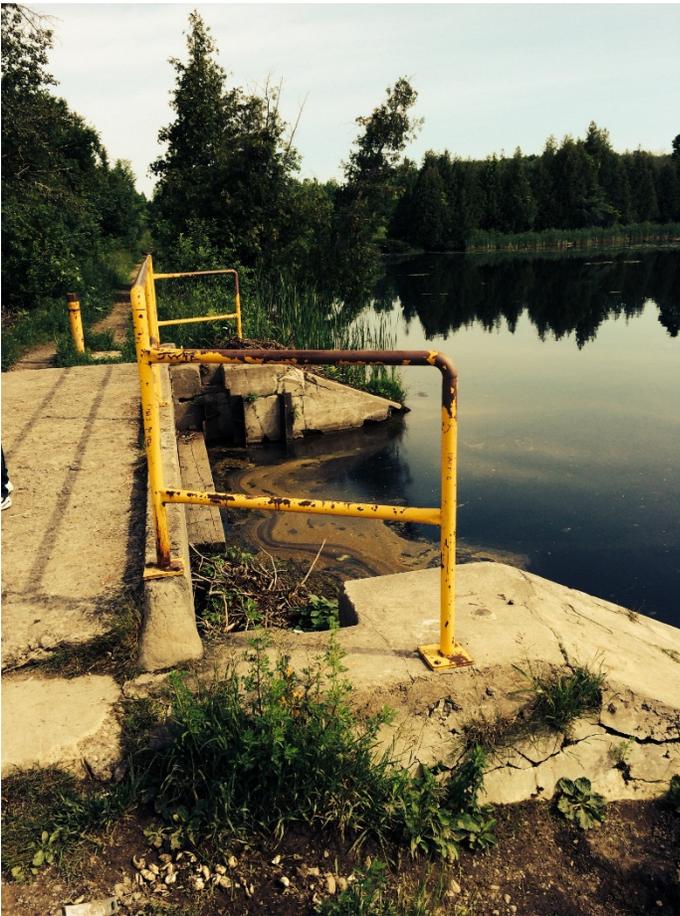
Photo 5: View of upstream (east) side of Thompson Bay Dam and Thompson Bay

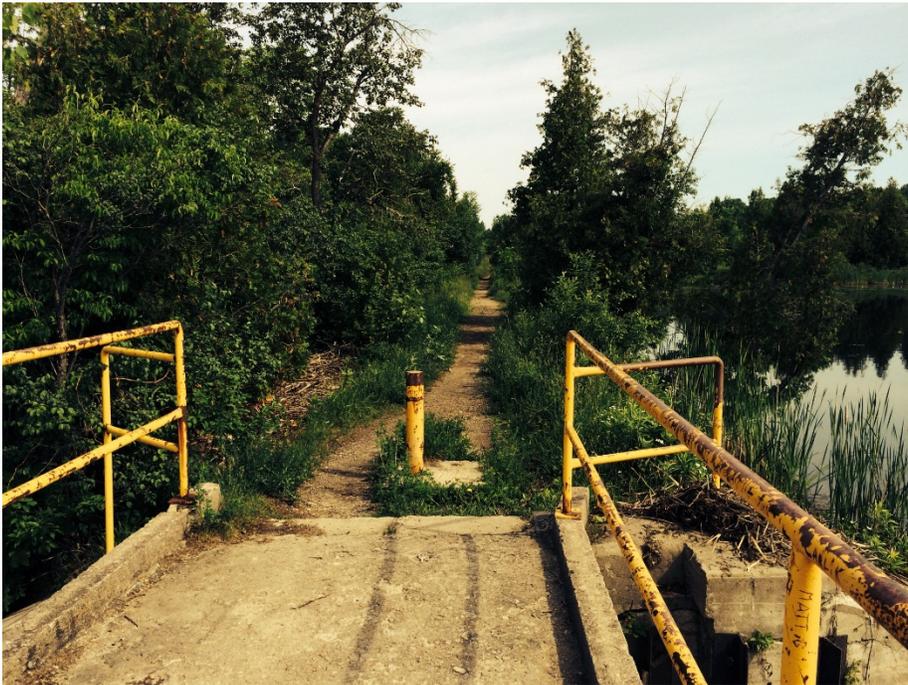
Photo 8: View of earth embankment (walking trail) north of Thompson Bay Dam.
