# CCGS Earl Grey

## Condition Assessment Report

January 2014

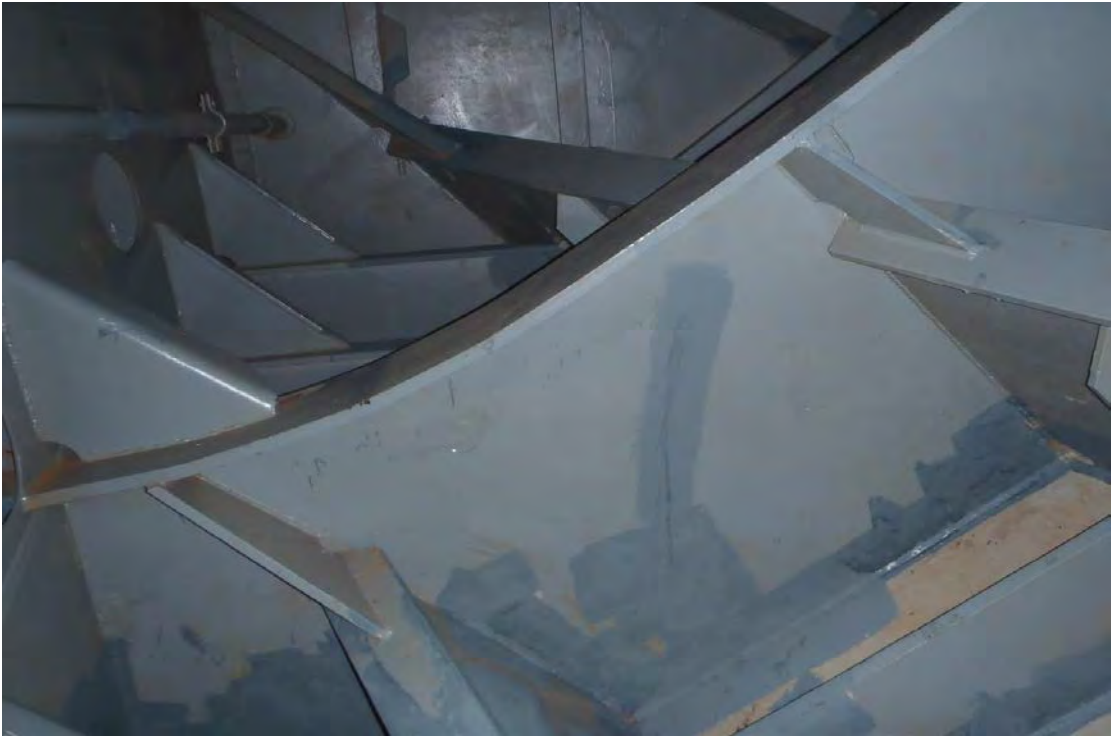
Figure 4-1: No 1 FWD Water Ballast Tank – Detail 1

The tank coating was found in generally good condition. Approx. 35 % of coating repaired this time.

There were no structural damages noted.

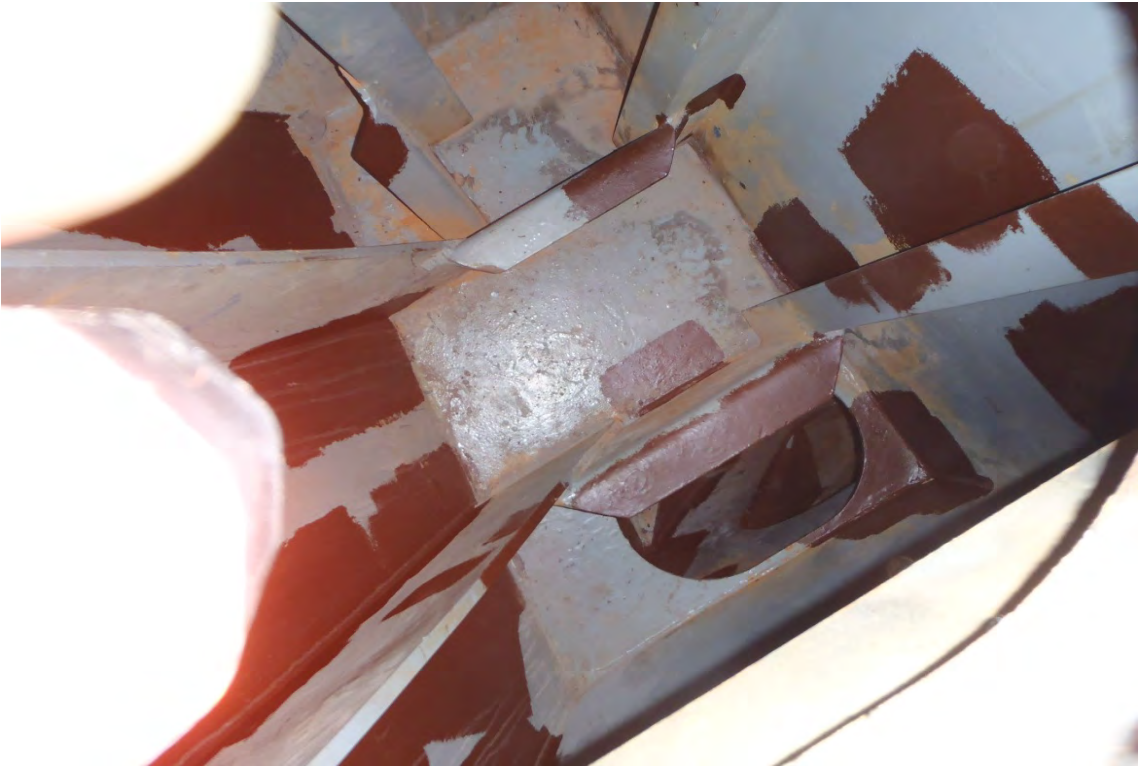
Figure 4-7: No 2 PS Water Ballast Tank – Detail 1

The tank coating was found generally in fair condition. Upon completion of refit tank was soft coated.

There were no structural damages noted.

Soft coating will have to be removed prior to next close-up survey.

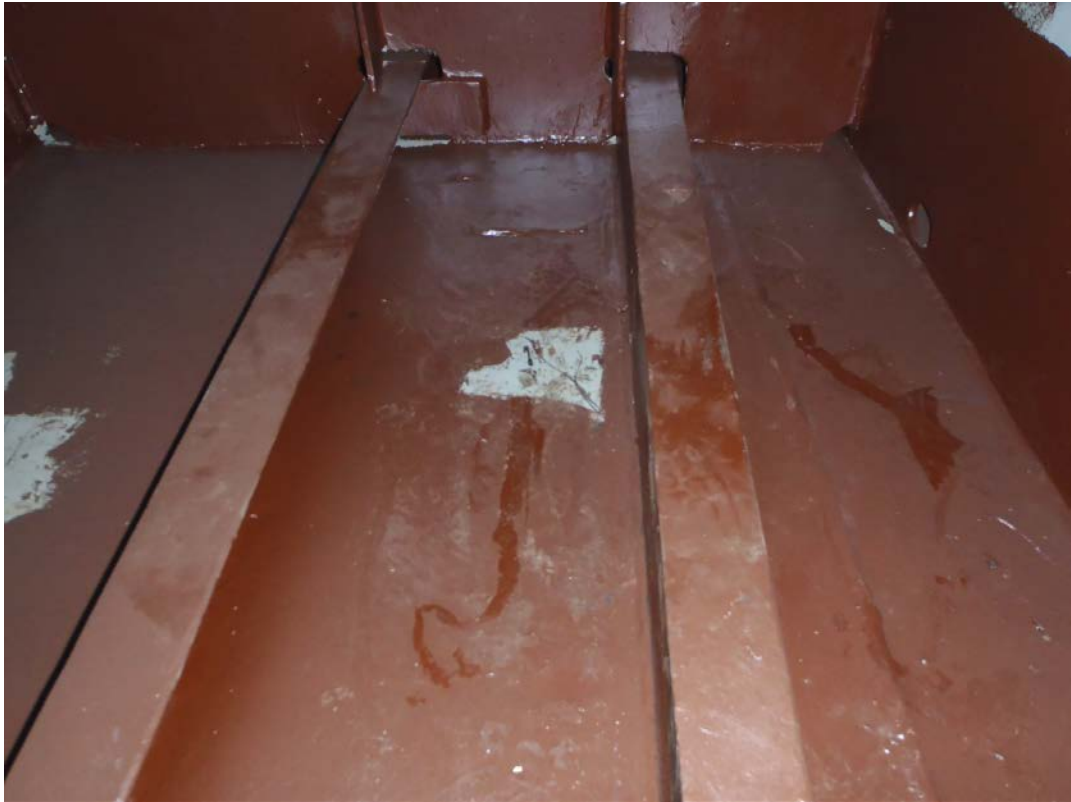
Figure 4-14: No 2 STBD Water Ballast Tank – Detail 1

The tank coating was found in good condition and approx. 45% of coating was renewed this time.

There were no structural damages noted.

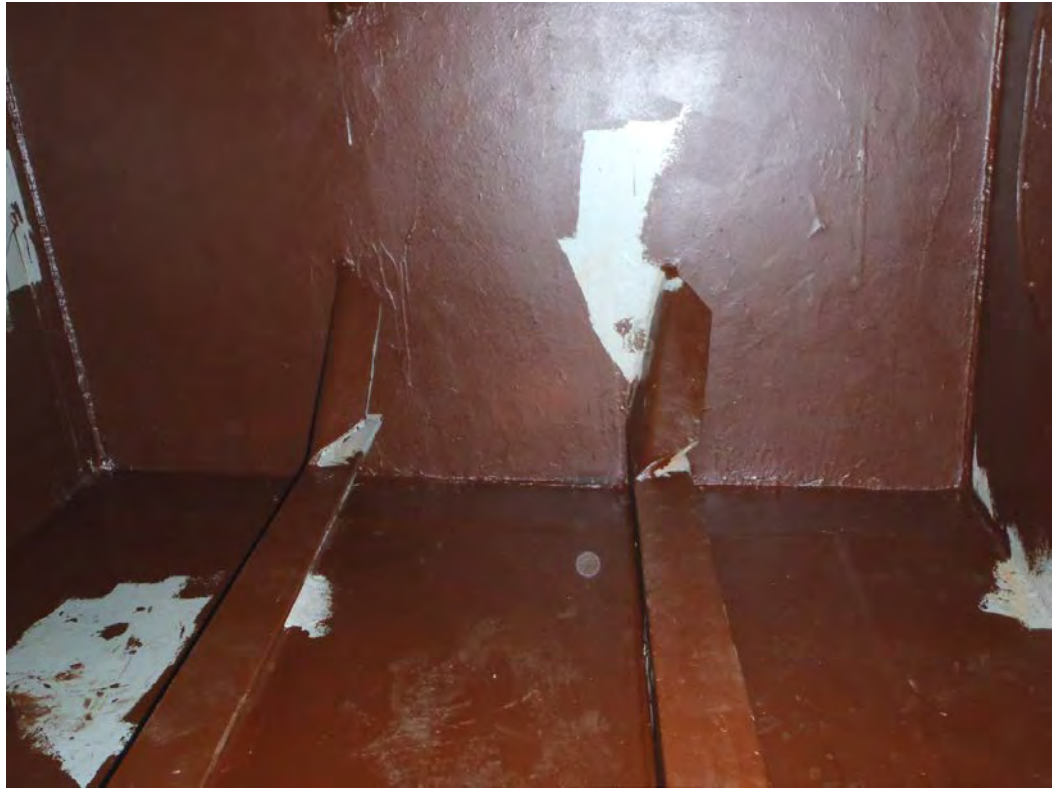
Figure 4-20: No 3 PS Water Ballast Tank – Detail 1

The tank coating was found in good condition and approx. 60% of coating was renewed this time.

There were no structural damages noted.

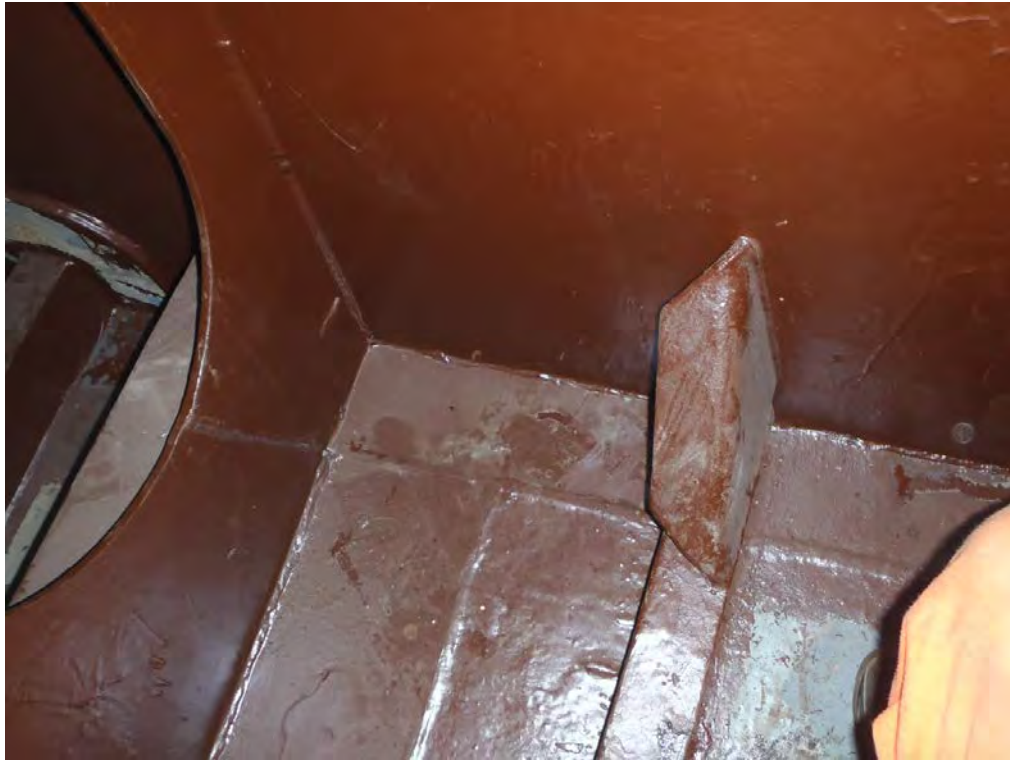
Figure 4-23: No 3 STBD Water Ballast Tank – Detail 1

The tank coating was found in good condition and approx. 65% of coating was renewed this time.

There were no structural damages noted.

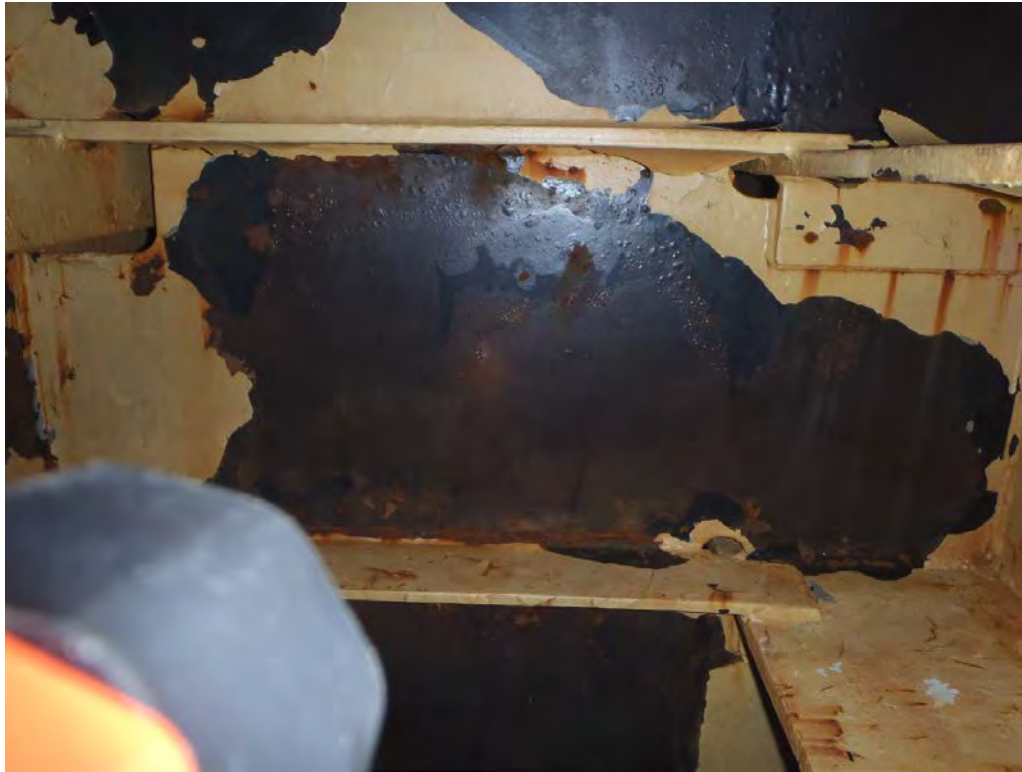
Figure 4-26: No 4 PS Water Ballast Tank – Detail 1

General condition of tank structure	GOOD
General condition of coatings	POOR

The tank coating was found in poor condition. It is recommended that the entire surface be prepared and new coating applied.

The coating in the No.4 Water Ballast Tank was found in poor condition. It should be renewed at first opportunity.

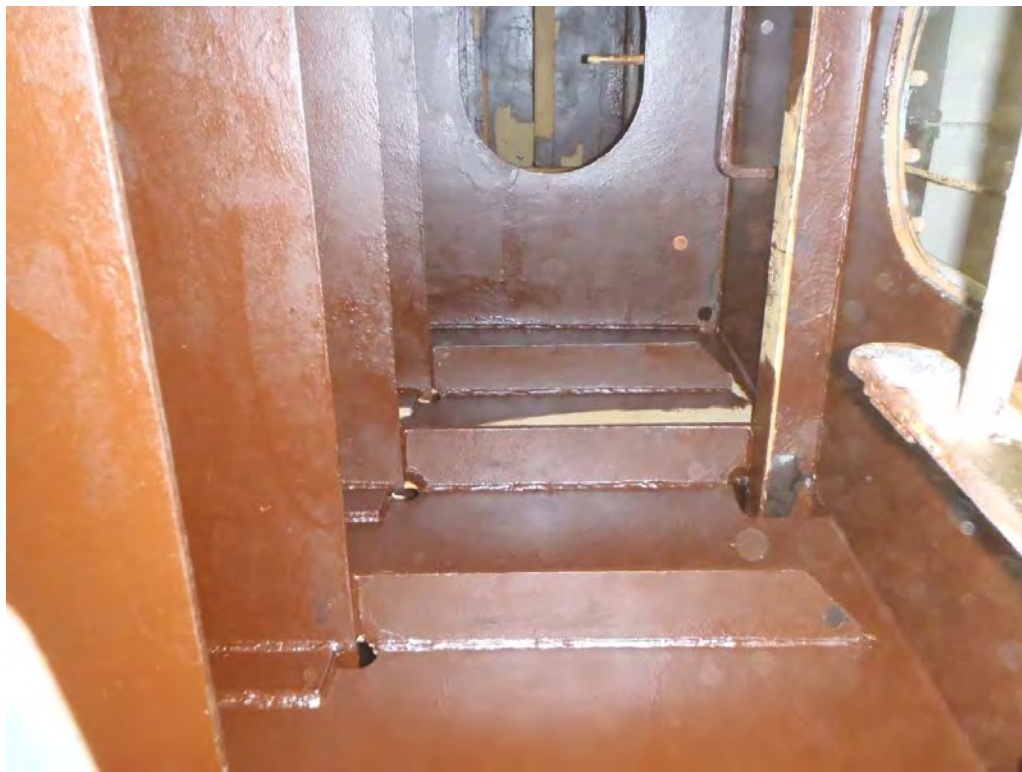
Figure 4-32: No 4 STBD Water Ballast Tank – Detail 1

The tank coating was found in generally good condition and approx. 45 % of the coating was repaired this time.

There were no structural damages noted.

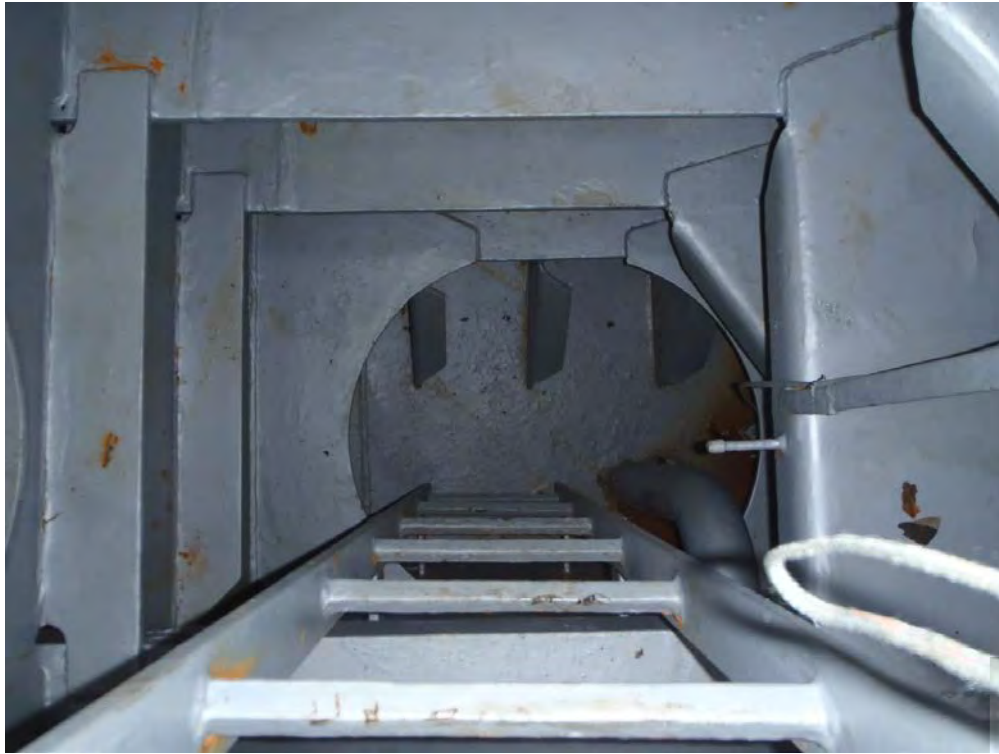
Figure 4-35: No 5 PS Water Ballast Tank – Detail 1

The tank coating was found in generally good condition.

There were no structural damages noted.

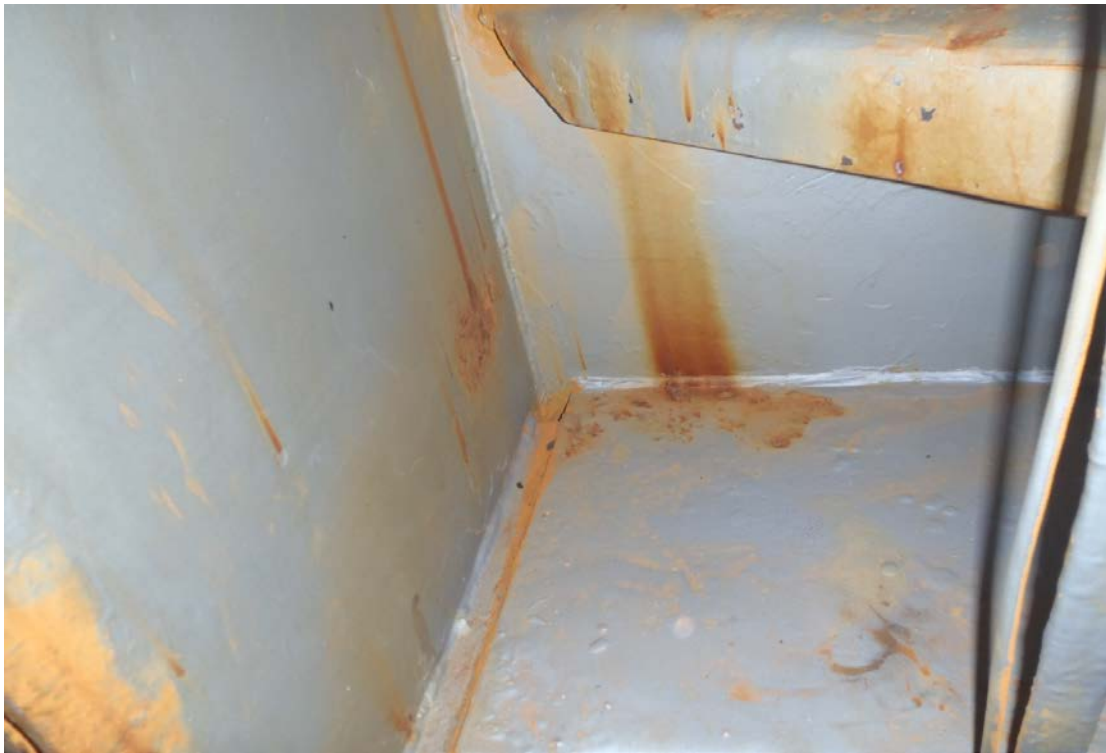
Figure 4-40: No 5 STBD Water Ballast Tank – Detail 1

The tank coating was found in generally good condition.

There were no structural damages noted.

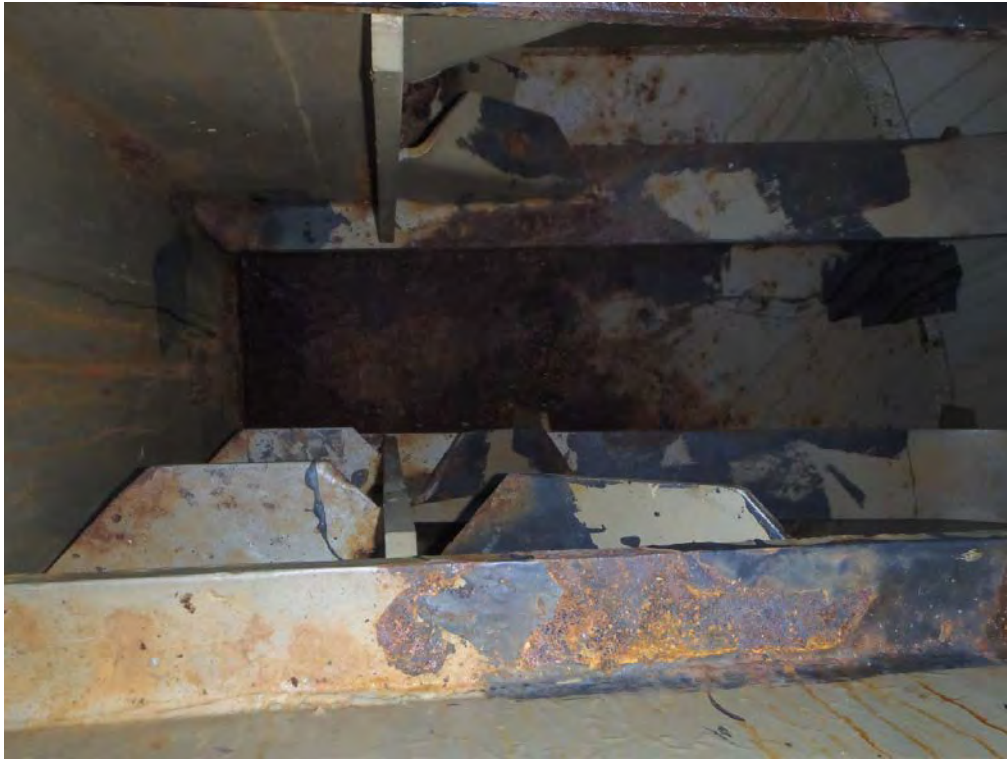
Figure 4-46: Aft Void Space – Detail 1

The tank coating was found generally in fair condition. Upon completion of refit tank was soft coated.

There were no structural damages noted.

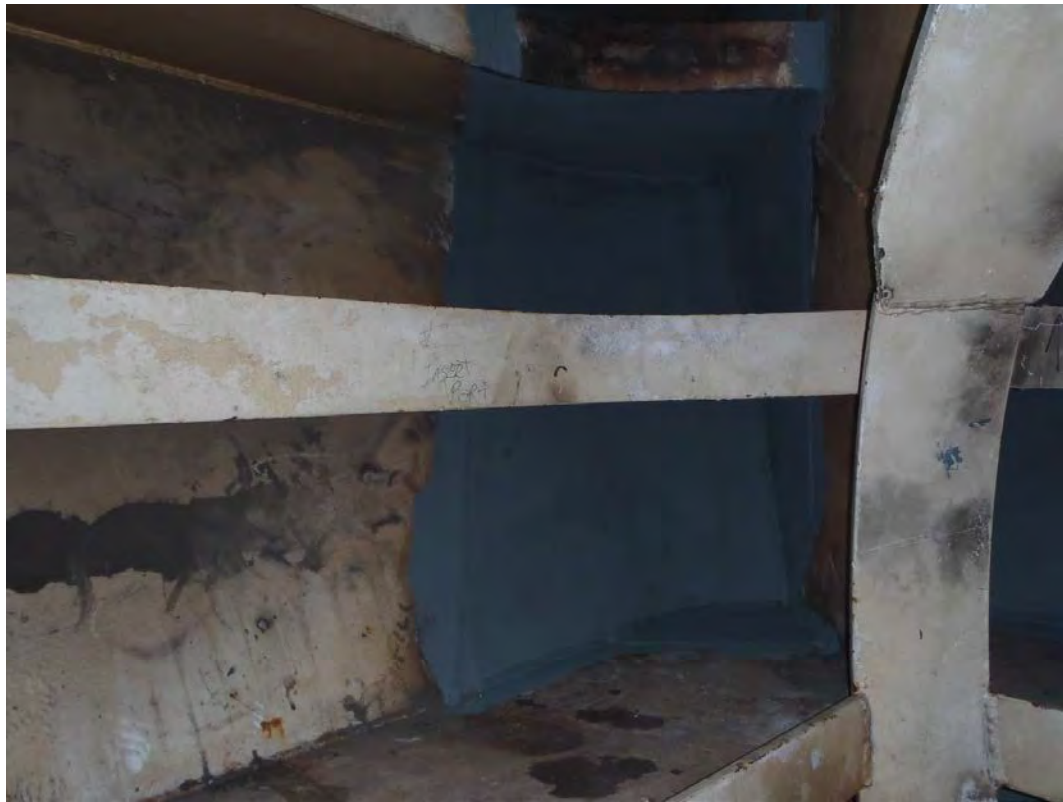
Figure 4-50: FWD Void Space – Detail 1

The tank coating was found generally in good condition.

Damaged area now permanently repaired using approved materials and procedures by certified welders, iwo Frames 1PS & 1STBD at 2 m approximately above the waterline.

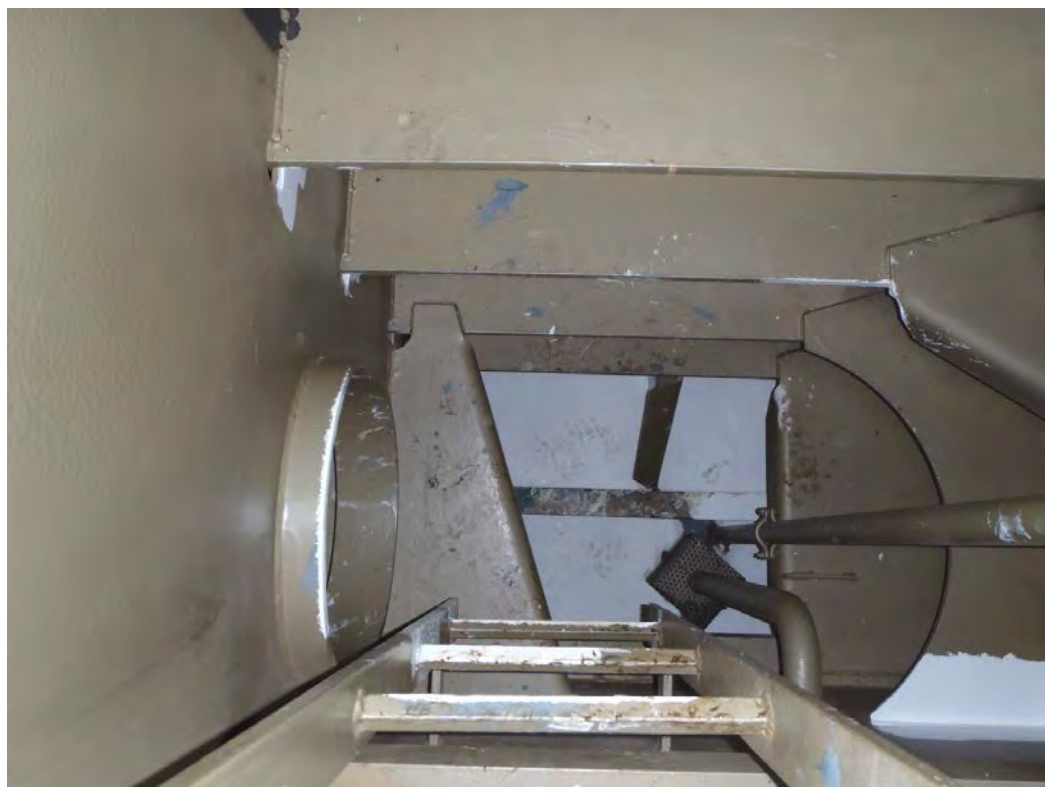
Figure 4-57: PS Cofferdam – Detail 1

The tank coating was found in generally good condition and approx. 10% of coating was renewed this time.

There were no structural damages noted.

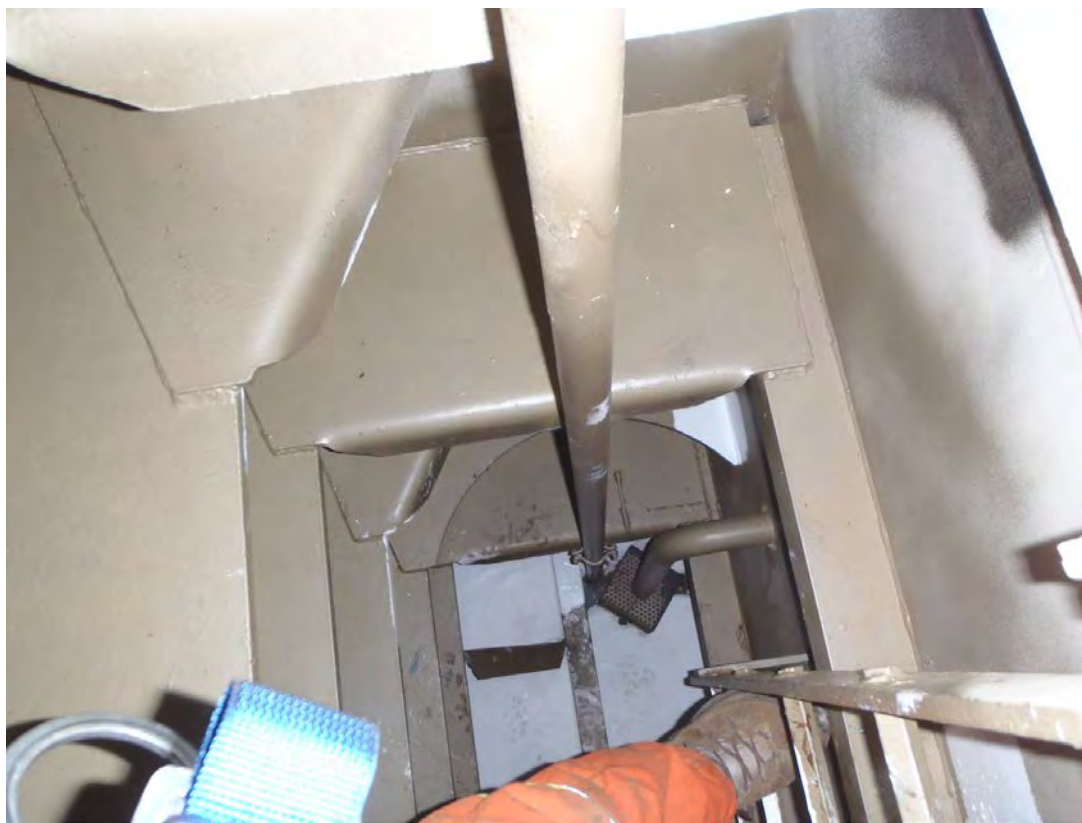
Figure 4-62: STBD Cofferdam – Detail 1

The tank coating was found in good condition and approx. 10% of coating was renewed this time.

There were no structural damages noted.

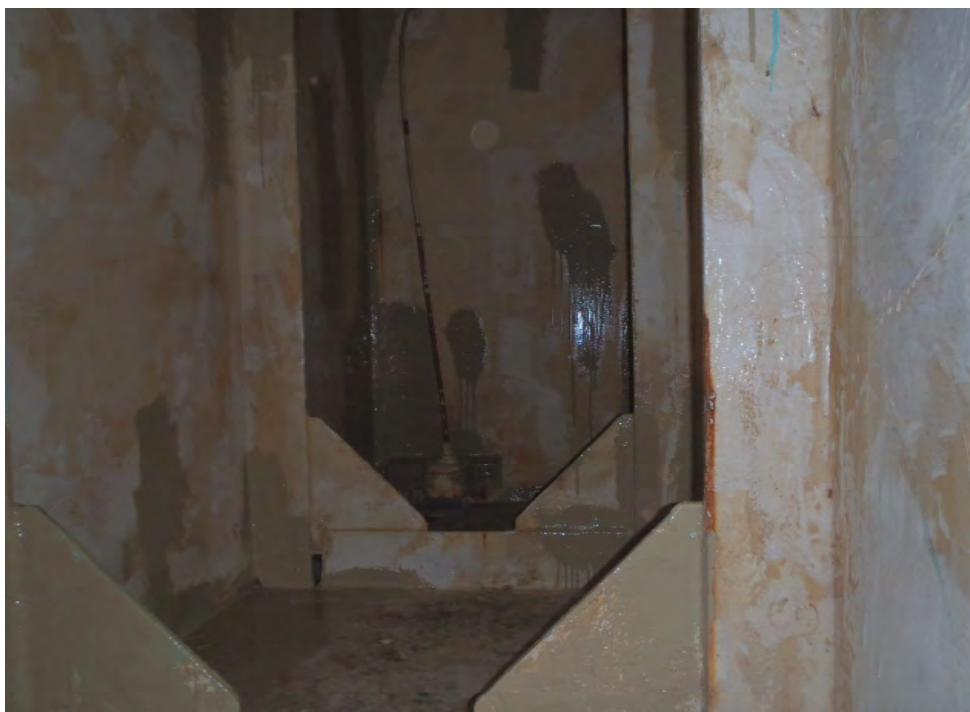
Figure 4-65: Daily Service Fresh Water Tank – Detail 1

The tank coating was found in good condition and approx. 30% of coating was renewed this time.

There were no structural damages noted.

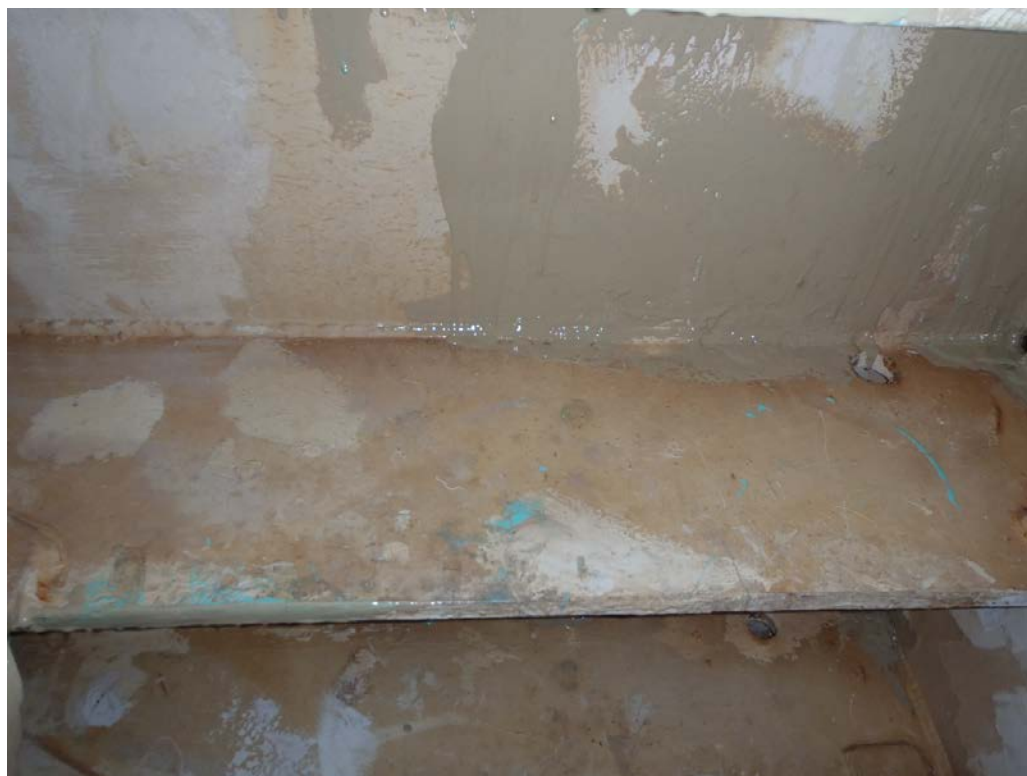
Figure 4-67: STBD Fresh Water Tank – Detail 1

The tank coating was found in good condition and approx. 40% of coating was renewed this time.

There were no structural damages noted.

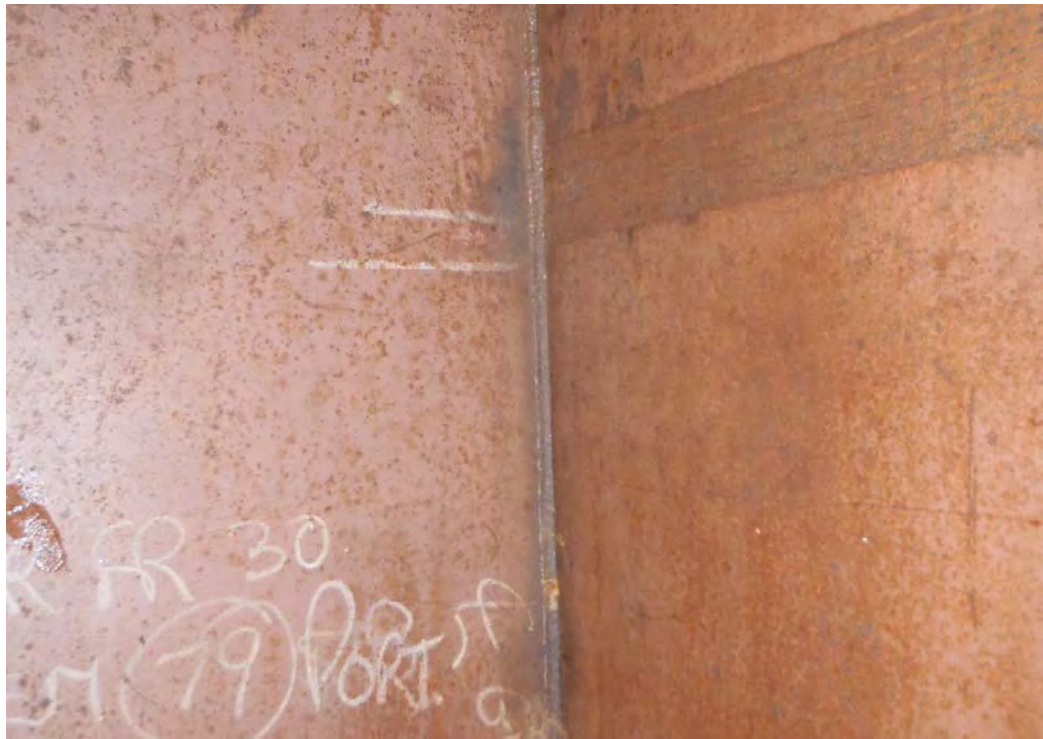
Figure 4-69: Engine Room Jacket Water Drain – Detail 1

The tank was found not coated.

There were no structural damages noted, structure deemed efficient meantime.

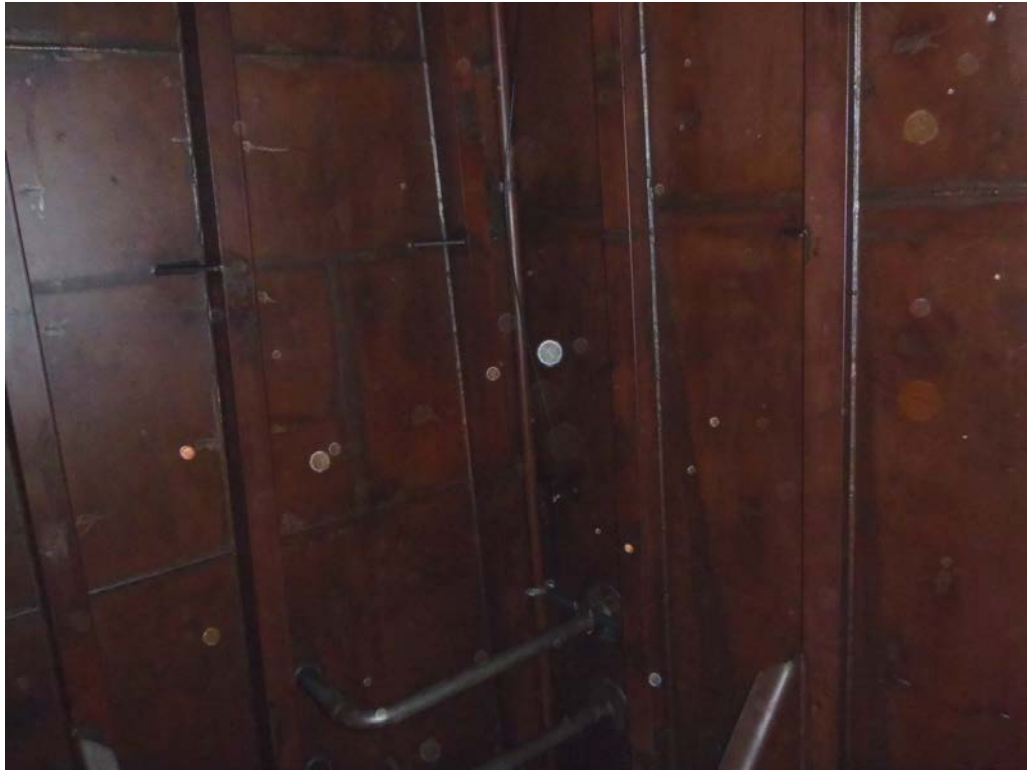
Figure 4-71: Fuel Oil Settling Tank – Detail 1

The tank was found not coated.

There were no structural damages noted, structure deemed efficient meantime.

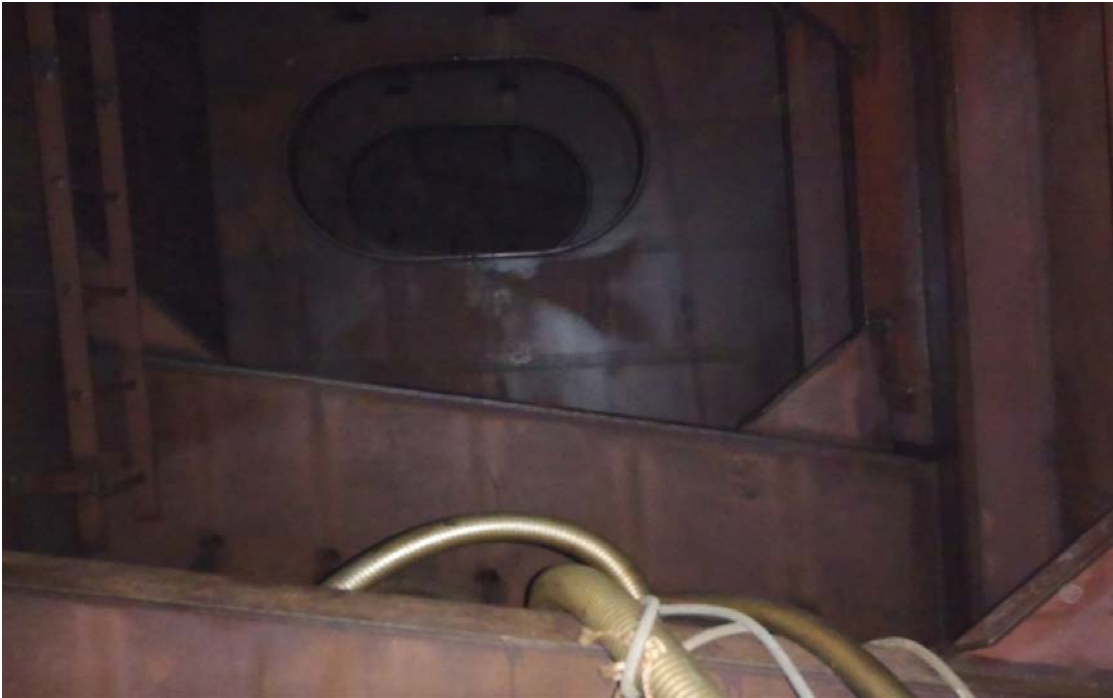
Figure 4-73: No 3 Fuel Oil Tank STBD – Detail 1

The tank was found not coated.

There were no structural damages noted.

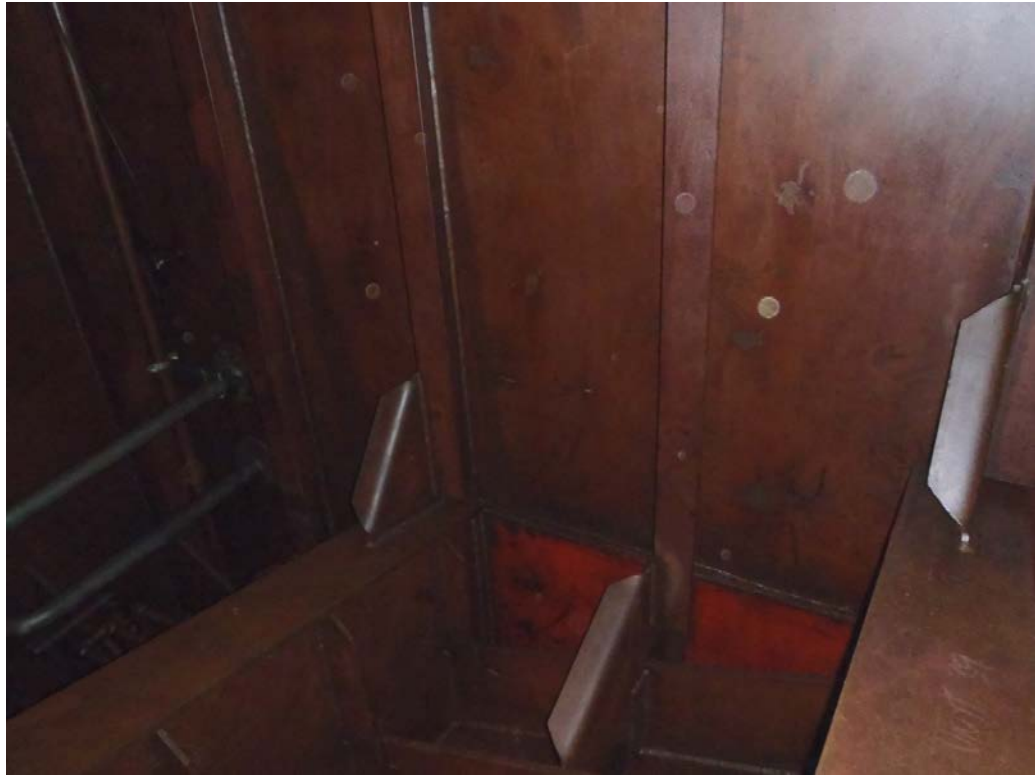
Figure 4-79: No 4 Fuel Oil Tank PS – Detail 1

The tank was found not coated.

There were no structural damages noted, structure deemed efficient meantime.

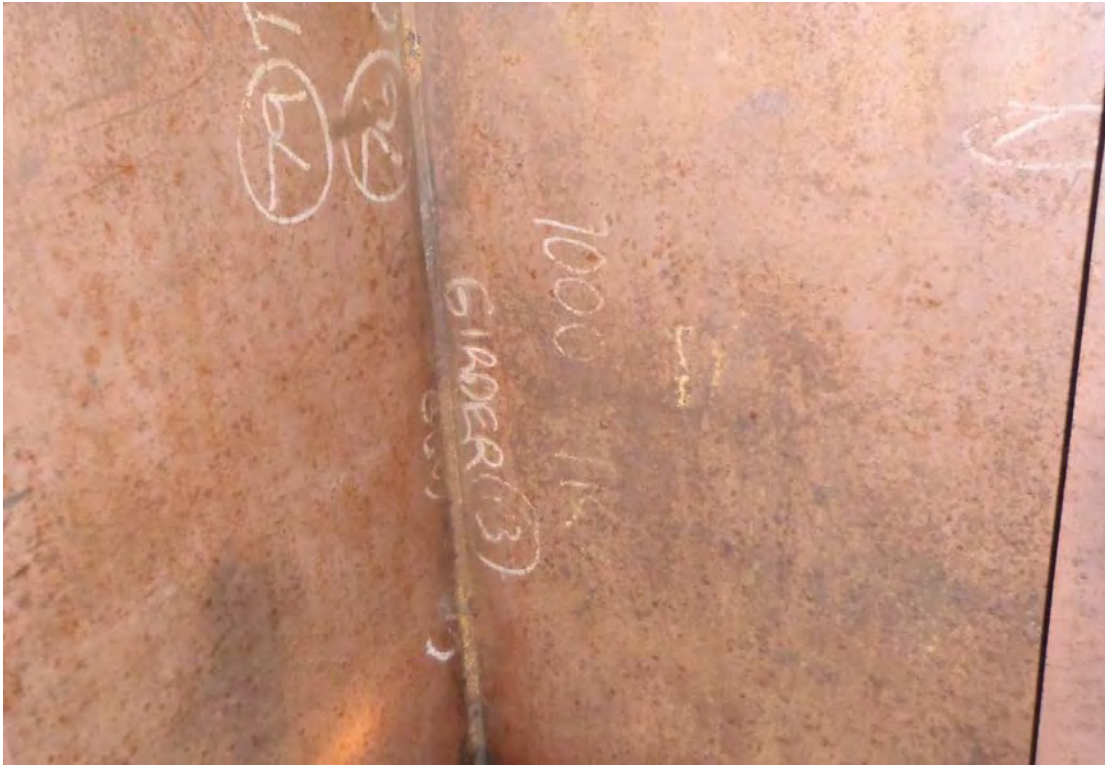
Figure 4-81: Oily Waste Tank – Detail 1

Pitting ( approx. 6mm deep) found under sounding pipe. Pitting repaired, striker plate installed.

There were no other structural damages noted, structure deemed efficient meantime.

Item No.	Plate / Structural Member	Findings and Recommendations
1	Oily Waste tank – Fr.30 starboard	Localised but heavy pitting noticed, 6-7 pits in total. Only 3.2 mm remaining under the sounding pipe. Pits repaired, striker plate installed under sounding pipe.

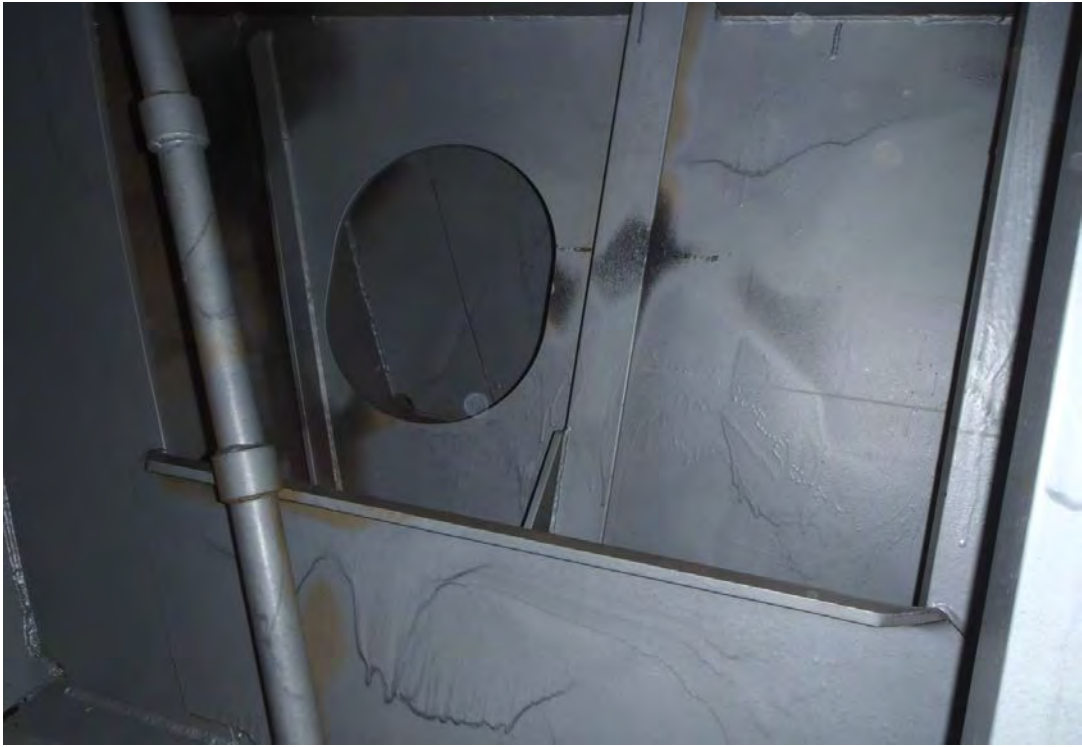
Figure 4-83: PS FWD Sewage Tank – Detail 1

The tank coating was found in good condition and approx. 50% of coating was renewed this time.

There were no structural damages noted.

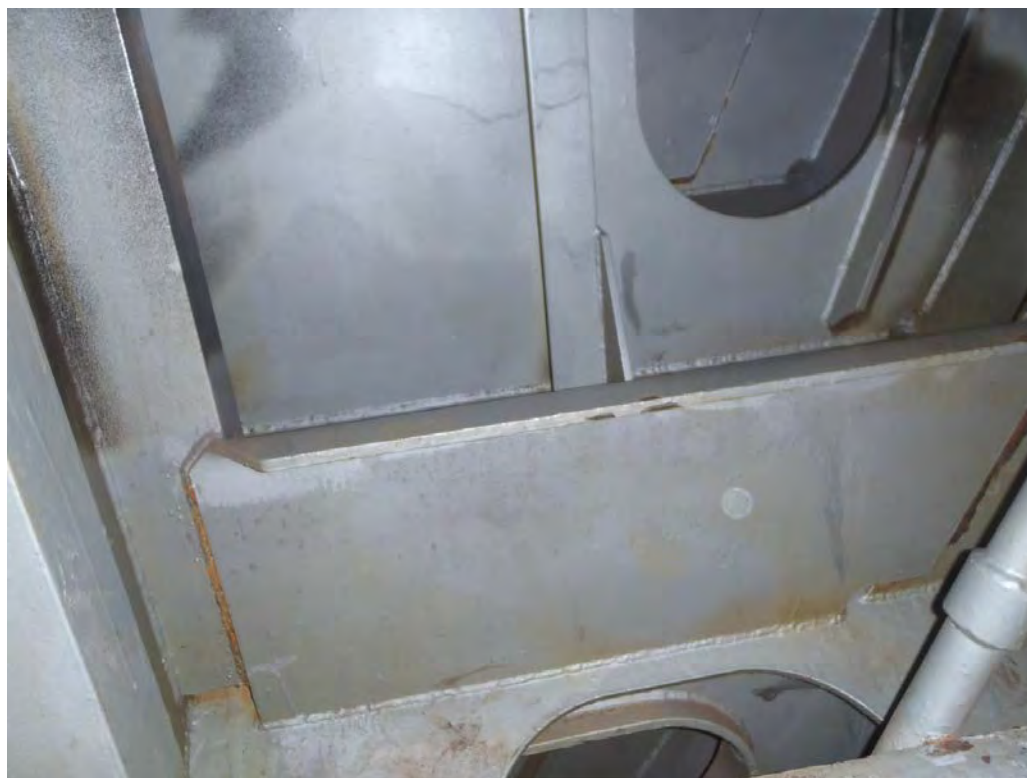
Figure 4-87: STBD FWD Sewage Tank – Detail 1

The tank coating was found in good condition and approx. 50% of coating was renewed this time.

There were no structural damages noted.
