Re: Marine Test Pit Investigation –Pigeon Hill, NB Gully Entrance and Pigeon Hill to Miscou Channel (Call Up EC015-110732/001/PWB)

GEMTEC Limited was retained by Public Works and Government Services Canada to undertake a marine test pit investigation in a section of the Pigeon Hill to Miscou channel, and the Gully entrances at the Pigeon Hill wharf. We understand that the test pit data will be used to determine dredging methods. The purpose of this investigation was to assess the soils in the wharf channels. This report contains a summary of the fieldwork carried out.

Descriptive Terms and Detailed Test Pit Logs

Select Site Photos

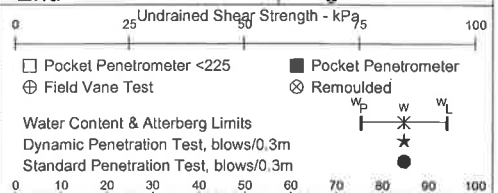
TP 3 (PH)

DEPTH m	SAMPLE				LOG	DESCRIPTION
	No	TYPE	N (RQD)	REC mm		
0						Brown SAND with trace to some silt, trace gravel and organics (Sea Shells)
1						
					1.40	
						Grey silty sand with trace to some gravel and organics (Sea Shells)
2						
					2.70	
						End of Test Pit at elevation -2.62 metres chart datum as referenced to benchmark 90B9020 with a published elevation of +4.158 chart datum.
					-2.62

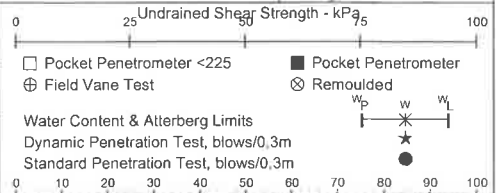
TP 9 (PH)

DEPTH m	SAMPLE				LOG	DESCRIPTION
	No	TYPE	N (RQD)	REC mm		
0						Gravel with some sand, trace to some cobbles and boulders (300 to 450 mm).
1						
						Brown SAND and GRAVEL with trace to some cobbles and boulders.
						End of Test Pit at elevation -2.69 metres chart datum as referenced to benchmark 90B9020 with a published elevation of +4.158 chart datum.

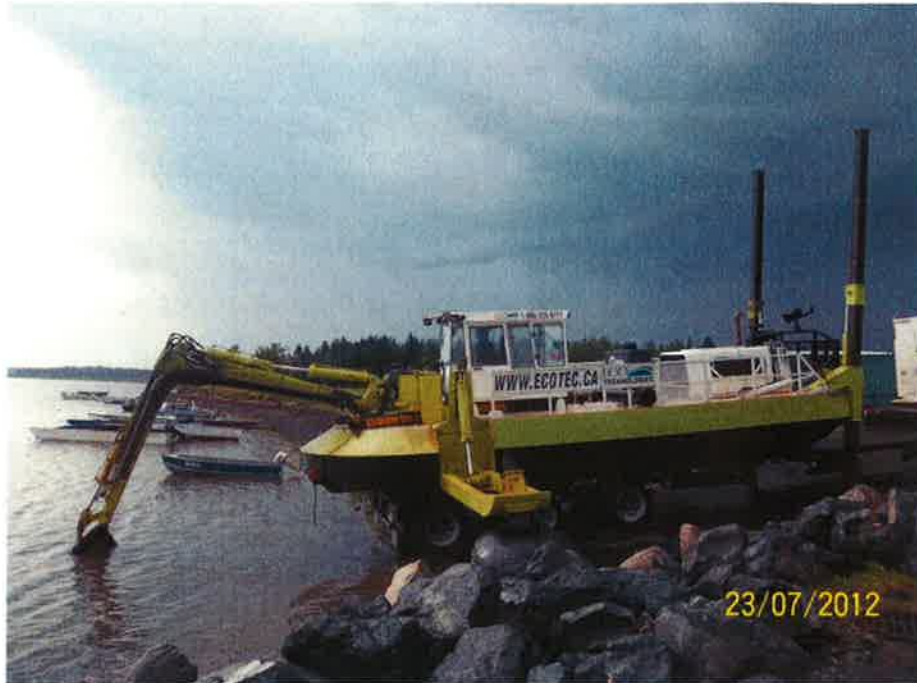
Photo 1 - ECO Technologies Aphibian Excavator at McEachern's Point Wharf.

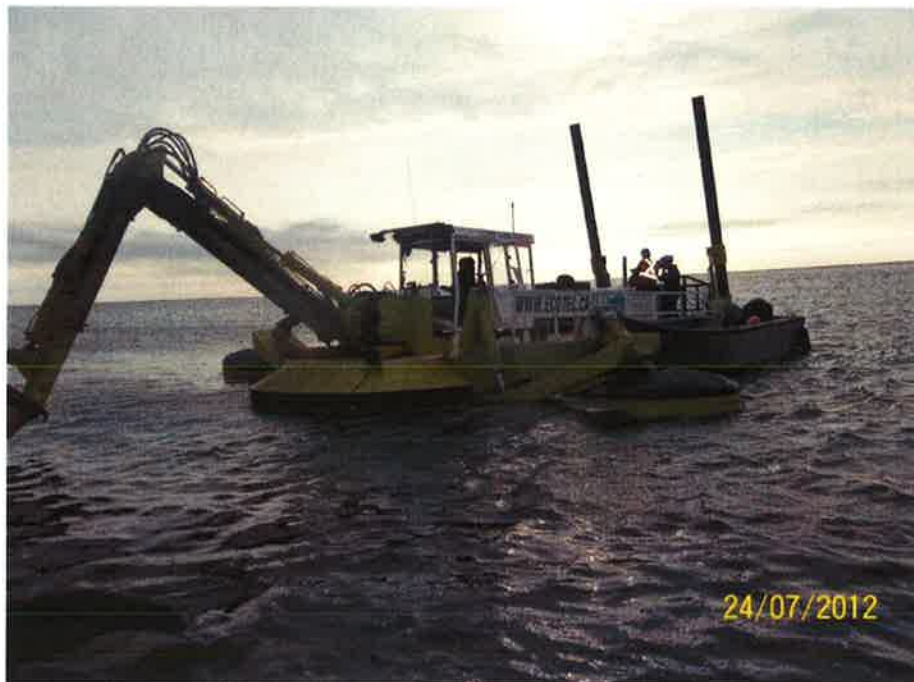
Photo 2 - Amphibian excavator in McEachern's point channel.

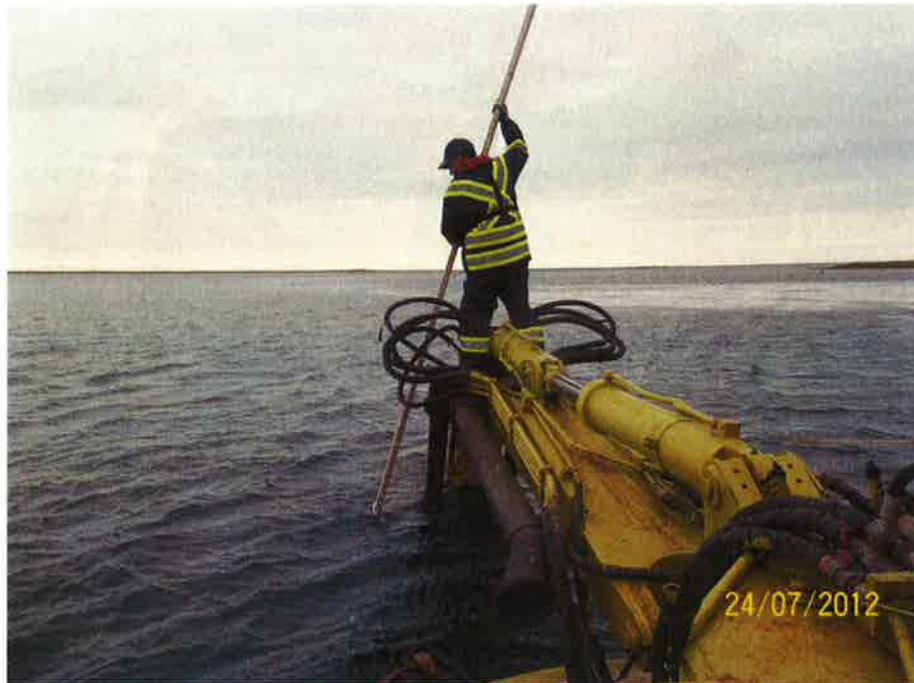
Photo 3 - Manual sounding undertaken at test pit locations.

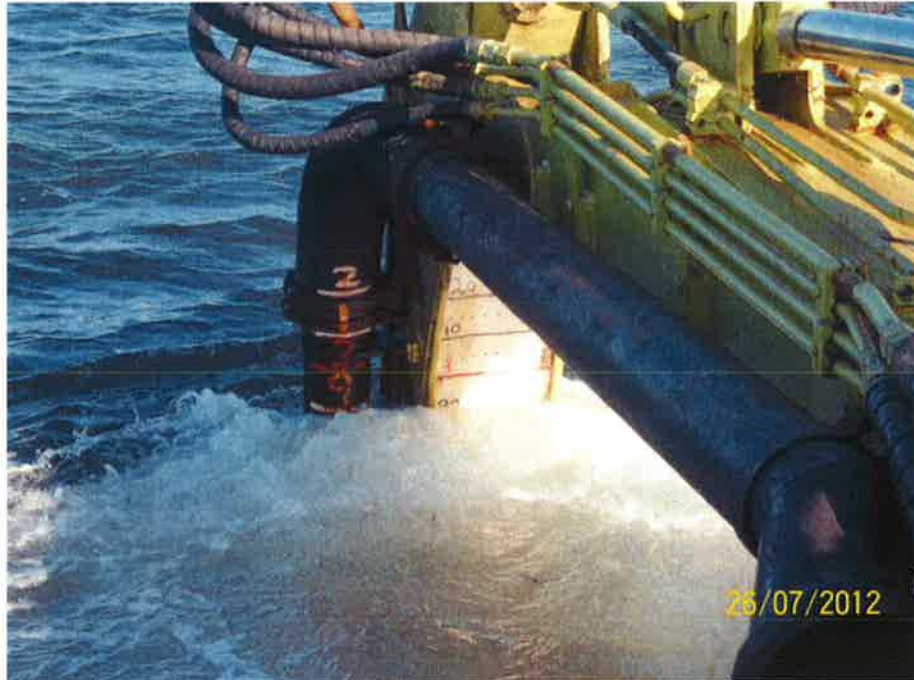
Photo 4 - Depth during excavation tracked by sounding measurements on inside of excavator arm.

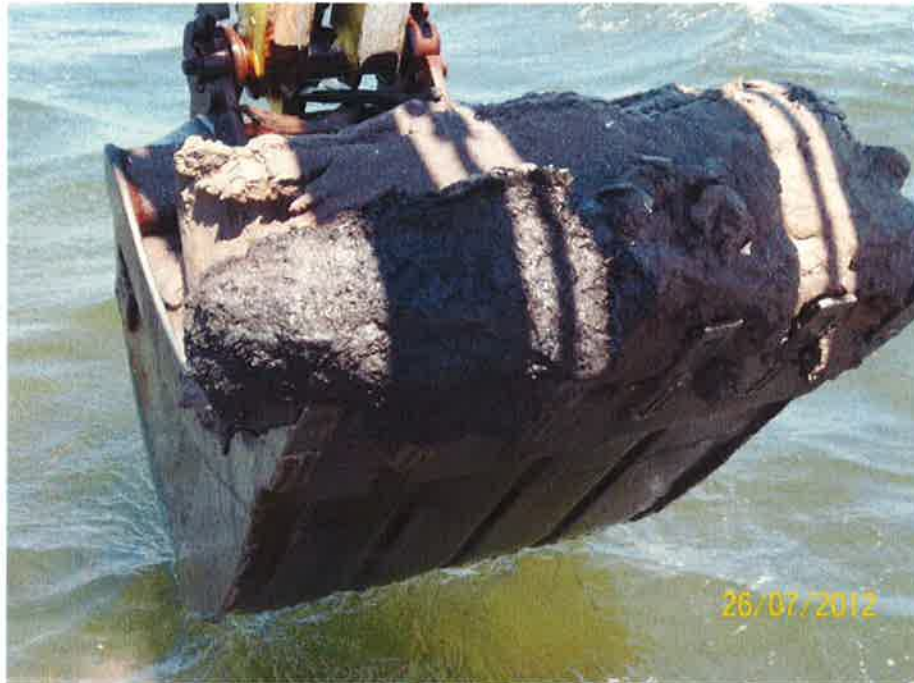
DEPTH m	SAMPLE				LOG	DESCRIPTION
	No	TYPE	N (RQD)	REC mm		
0						Dark grey silty SAND with trace to some organics (Sea weed and sea shells).
					0.30	Organics (compressed sea weed).
					0.60	Grey brown silty SAND with trace gravel.
1					1.60	End of Test Pit at elevation -2.91 metres chart datum as referenced to benchmark 90B9020 with a published elevation of +4.158 chart datum.

Photo 5 - Dark grey silty sand with organics at TP 1 - Pigeon Hill (Elevation -1.31 to -1.61 CD).

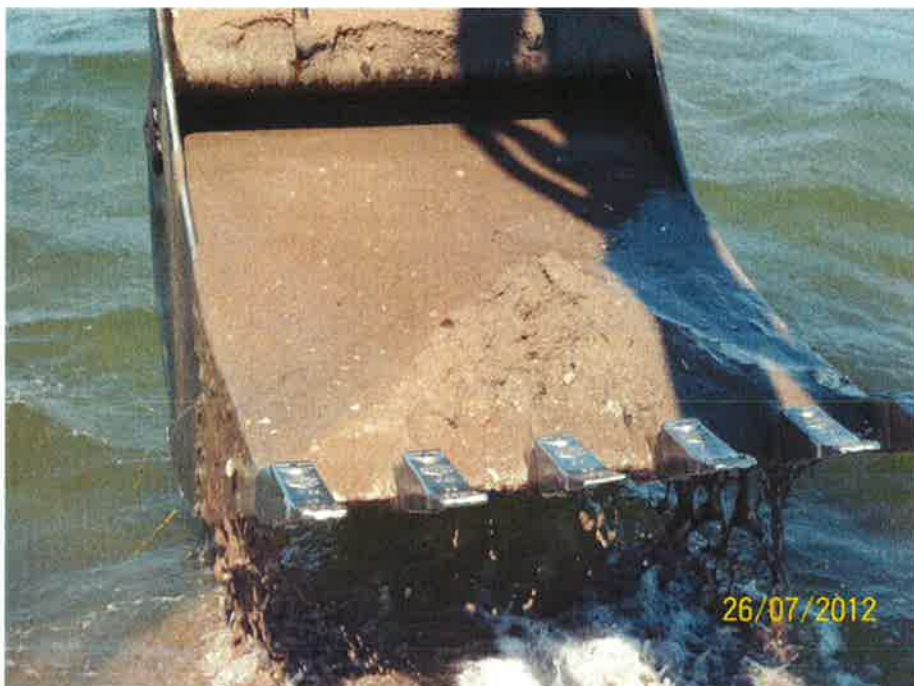
Brown SAND with trace to some silt, trace and
gravel and organics (Sea Shells).

Photo 6 - Brown sand with trace silt, gravel and organics at TP 2 - Pigeon Hill (Elevation -0.64 to -2.94 CD).

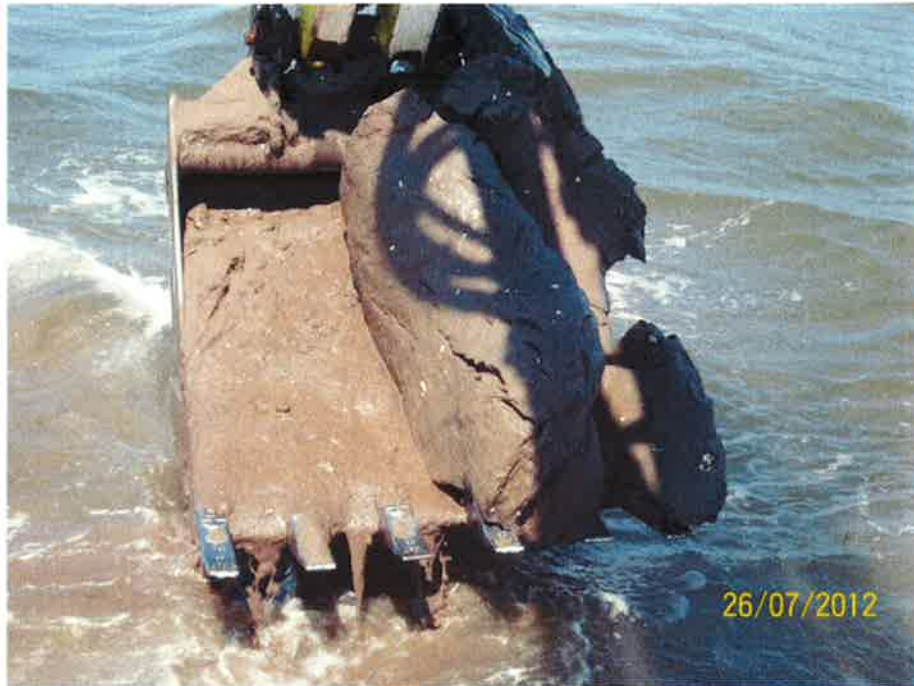
Photo 7 - Brown sand with trace silt, gravel, and organics at TP3 - Pigeon Hill (Elevation 0.08 to -1.32 metres CD).

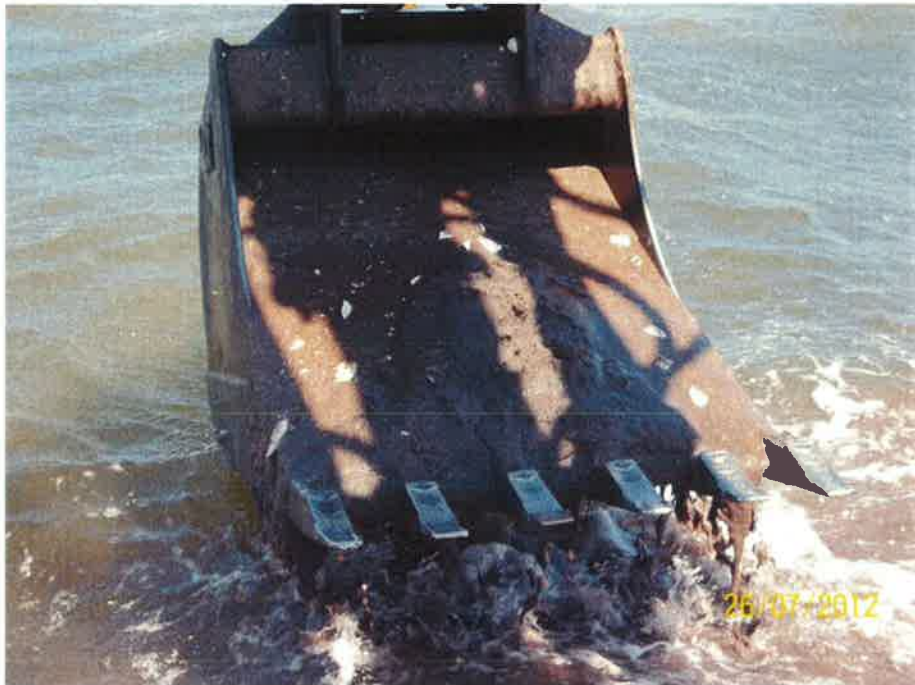
Grey SAND, some gravel with trace silt and organics (sea shells).

Photo 8 - Sand with some gravel and trace silt and organics at TP 4 - Pigeon Hill (Elevation -1.15 to -2.75 CD).

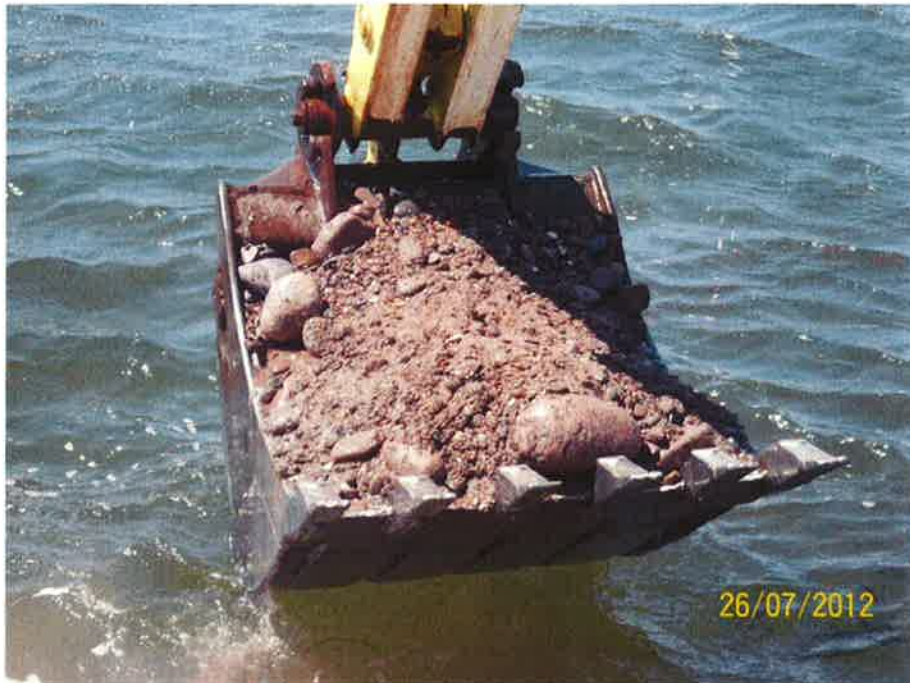
Brown GRAVEL with some sand and cobbles
and trace to some boulders (300 to 400mm).Brown SAND and GRAVEL with some cobbles
and trace to some boulders (250 to 600mm).End of Test Pit at elevation -2.63 metres chart
datum as referenced to benchmark 90B9020
with a published elevation of +4.158 chart
datum.

Photo 9 - Brown gravel with some snad, cobbles and boulders at TP 5 - Pigeon Hill (Elevation -1.13 to -2.63 CD).

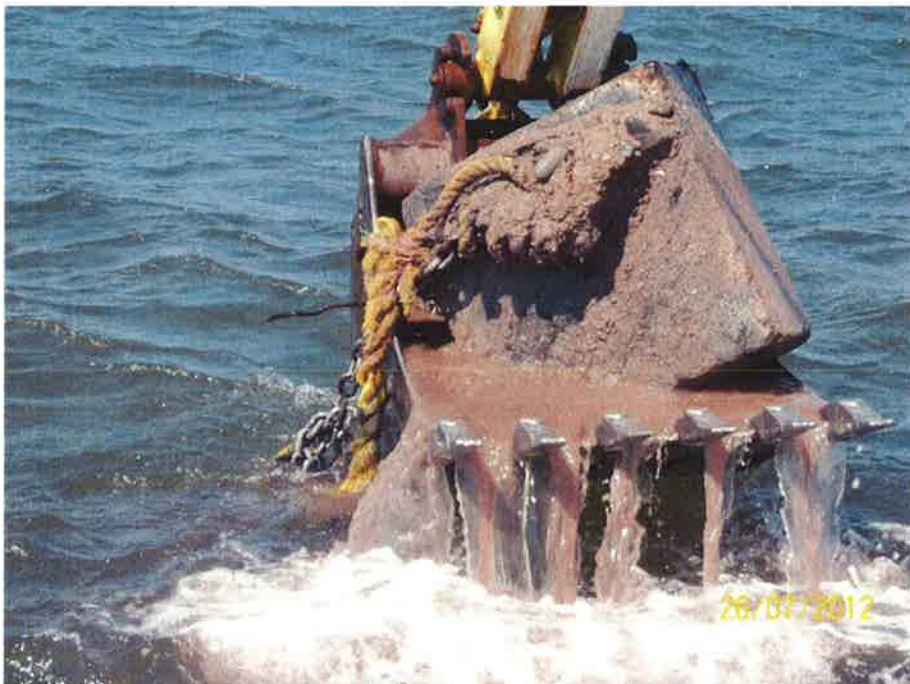
Brown GRAVEL with some sand and trace to
some cobbles and boulder and debris
(Concrete Block and Chain)

Photo 10- Concrete block with chain encountered at TP 6 - Pigeon Hill (Approximate elevation -0.61 CD). The location was marked with a buoy.

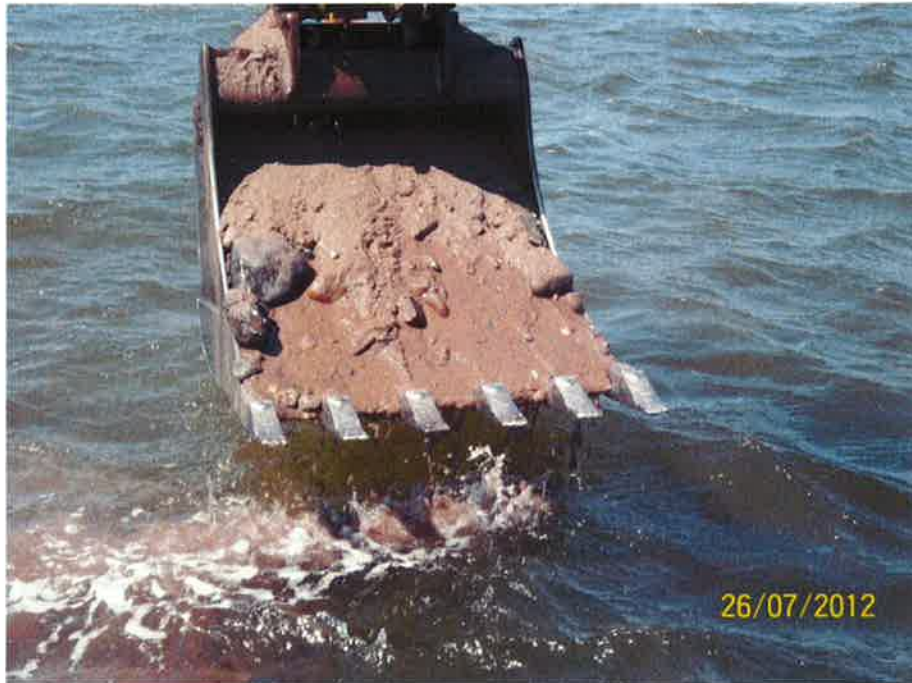
1						<div> <div>0.40</div> <div>-0.94</div> </div>		Brown SAND and GRAVEL with trace to some cobbles and boulders.			
2						<div> <div>2.20</div> <div>-2.74</div> </div>		End of Test Pit at elevation -2.74 metres chart datum as referenced to benchmark 90B9020 with a published elevation of +4.158 chart datum.

Photo 11 – Brown sand and gravel with cobbles and boulders at TP7 - Pigeon Hill (Elevation -0.94 to -2.74 CD).

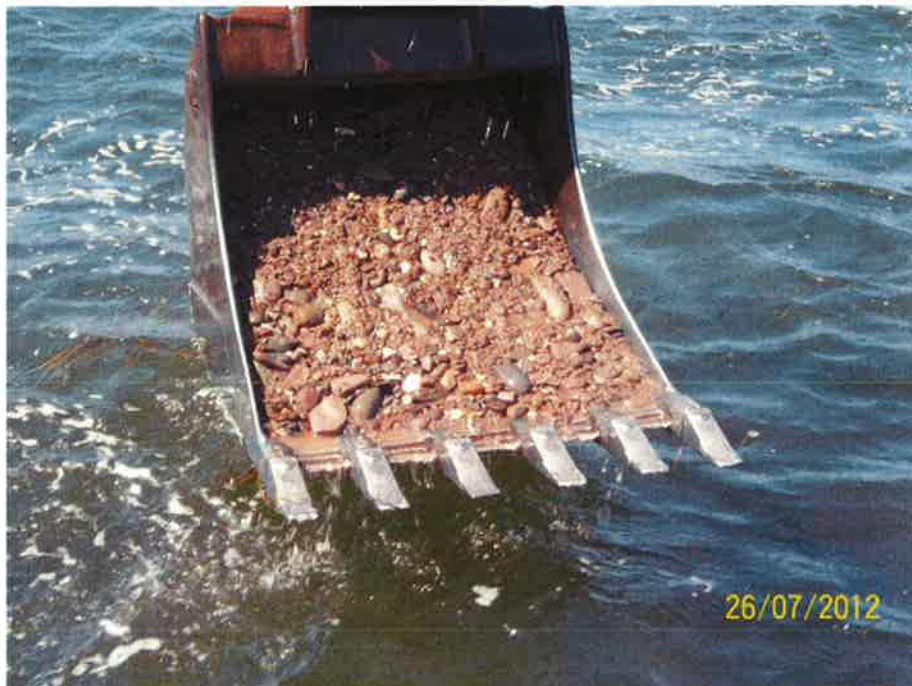
Gravel with some sand, trace to some cobbles
and boulders (300 to 450 mm).

Photo 12 - Gravel with cobbles and some sand and occasional boulder at TP 8 - Pigeon Hill (Elevation -0.83 to -1.53 CD).

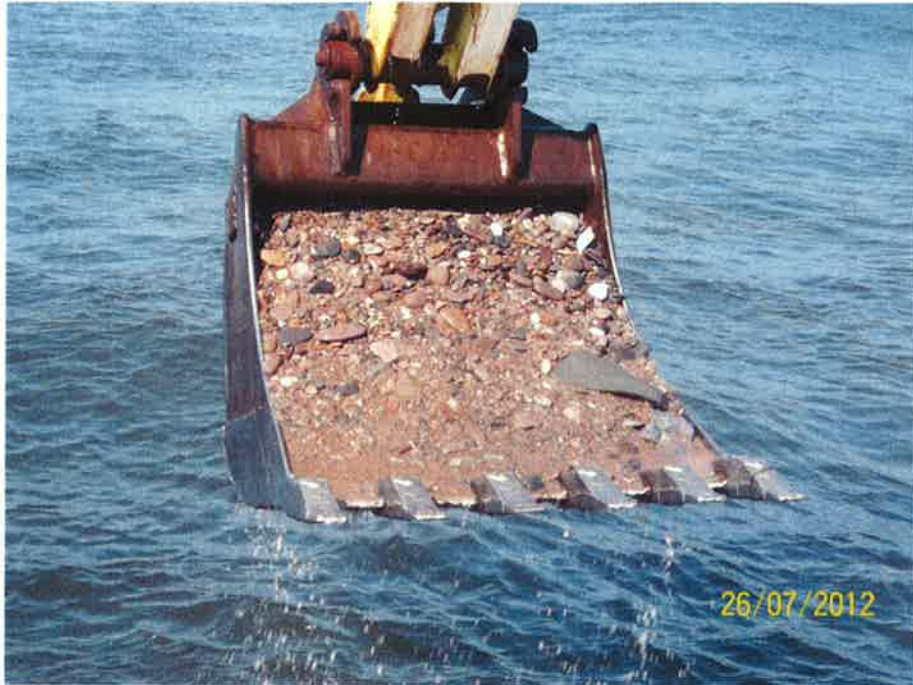
Photo 13 - Gravel with some sand and some cobbles and boulders at TP 9 - Pigeon Hill (Elevation - 0.79 to -2.69 CD).

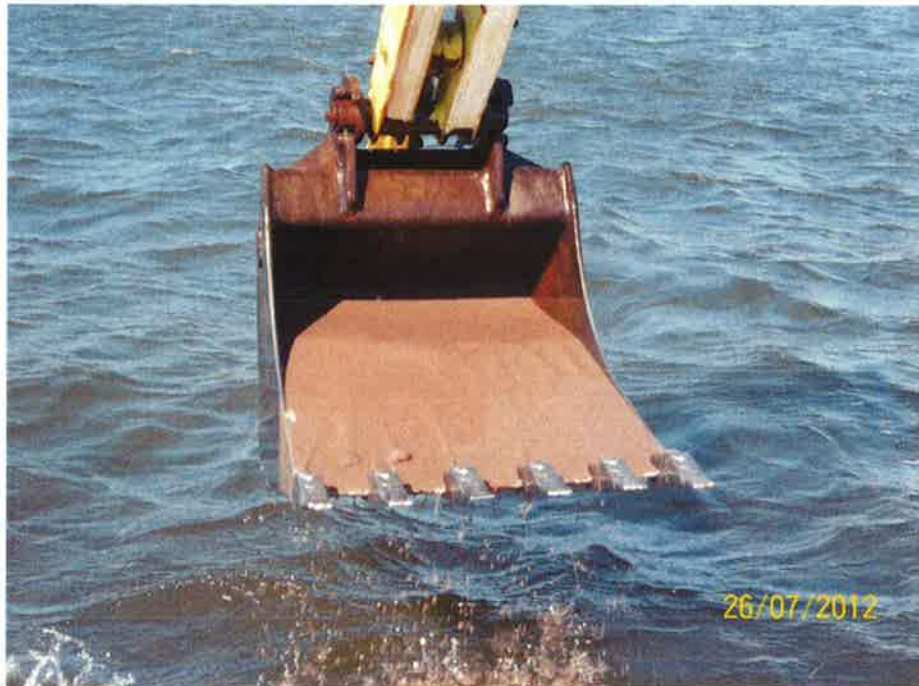
Brown SAND with trace to some gravel and
trace to some cobbles.

Photo 14 - Brown sand with some gravel and occasional cobbles at TP 10 - Pigeon Hill (Elevation - 0.93 to -3.13 CD).

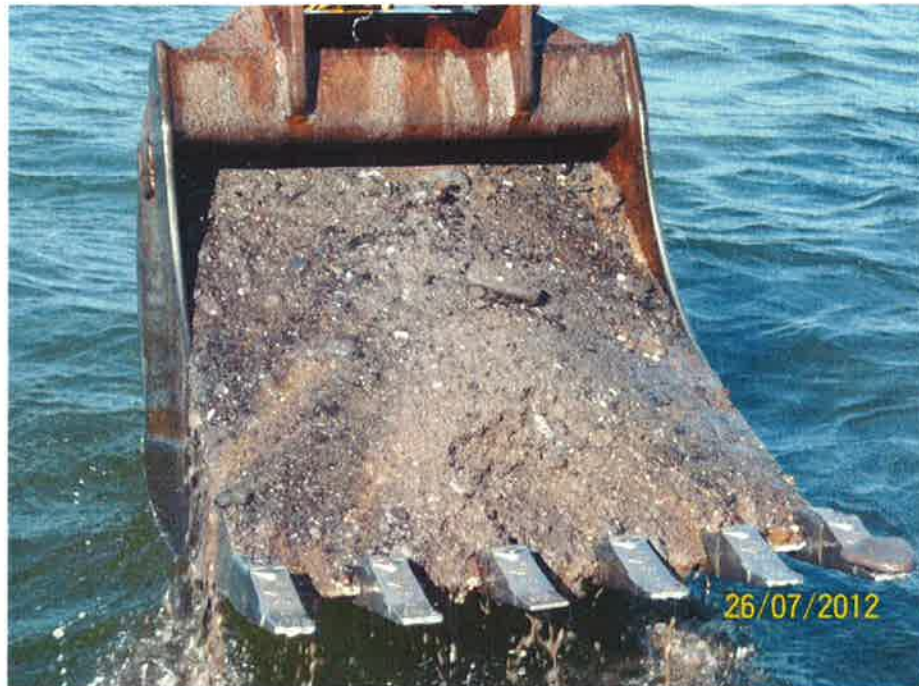
Grey SAND and GRAVEL with some cobbles and trace to some flat and rounded boulders (300 to 450 mm)

Photo 15 - Grey sand and gravel with some cobbles and occasional boulder at TP 11 - Pigeon Hill (Elevation -0.70 to -2.80 CD).

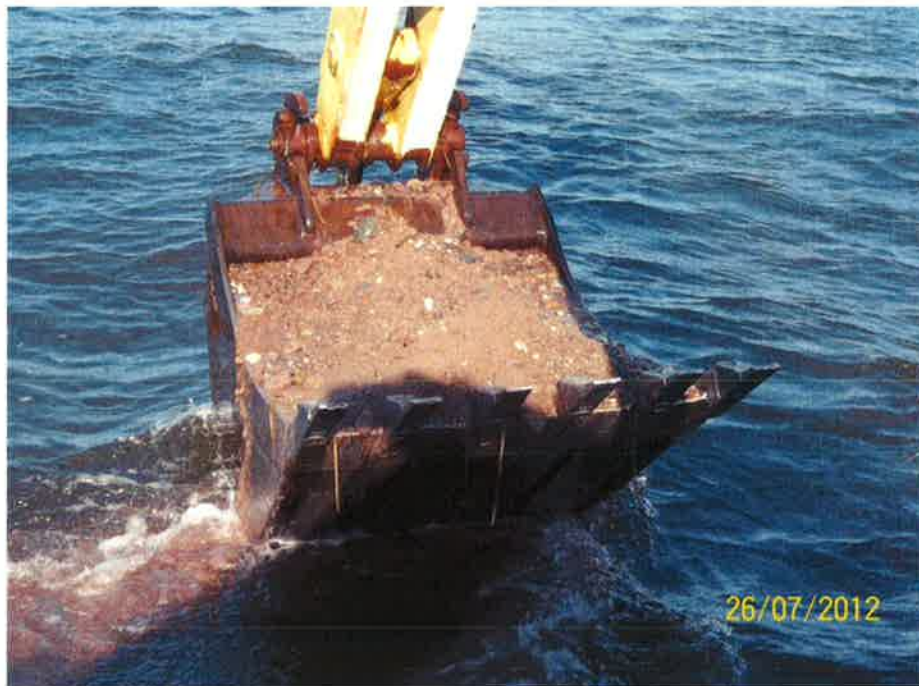
Photo 16 - Sand and gravel with some cobbles and occasional boulders at TP 12 - Pigeon Hill (Elevation -0.57 to -2.77 CD).
