SHOAL COVE BROOK BRIDGE REPLACEMENT - GROS MORNE, NL

Geotechnical Investigation

Public Works and Government Services Canada

Internal ref. 616809-GEOT-4GER-0001_00

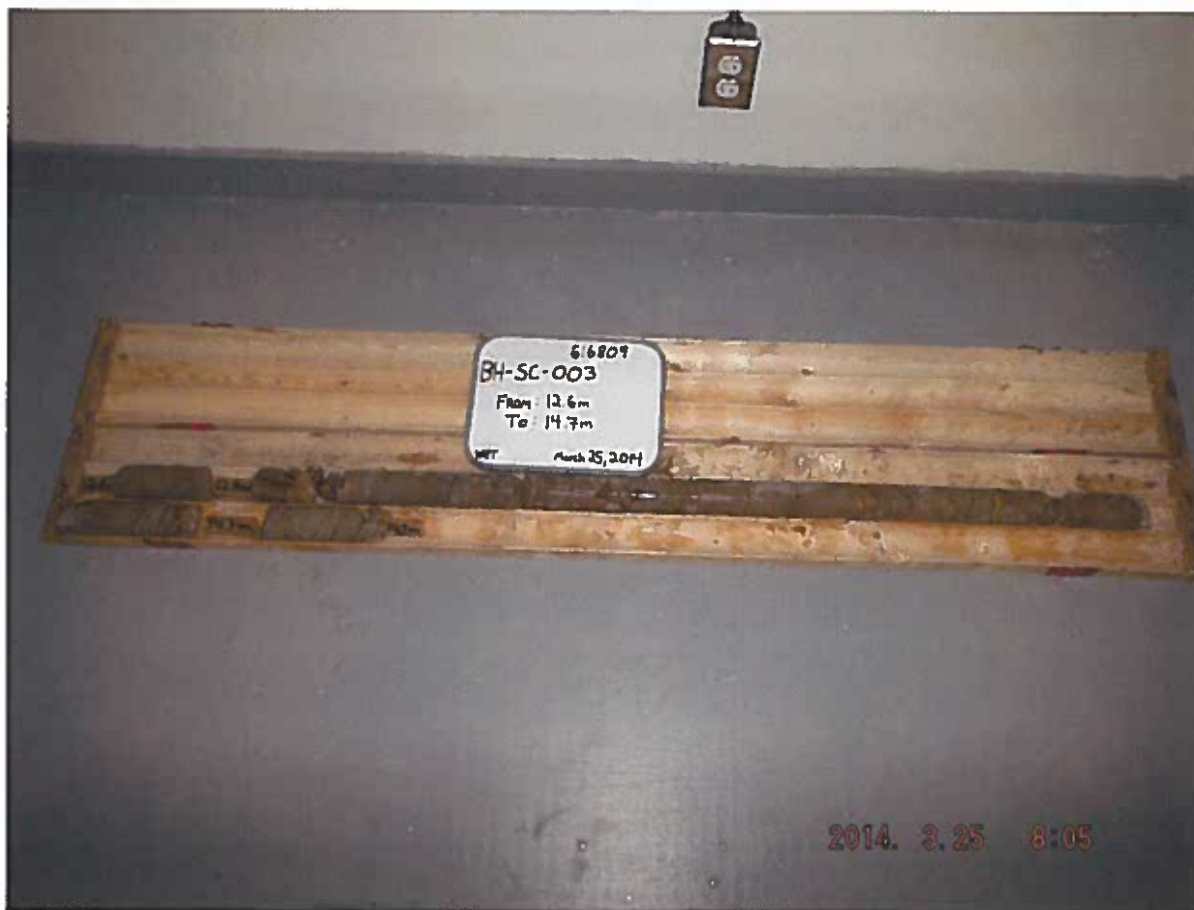
Core Photograph (wet): BH-SC-003-2014, 12.6 mbgs – 14.7 mbgs.

Bedrock was encountered in only one (1) of the boreholes, BH-SC-004-2014, beginning at a depth of 12.6 mbgs. The borehole was drilled down to a maximum depth of 14.7 m, and based on the total amount of recovered core (2.1 m) and consistent lithology; it is SLI's opinion that bedrock was proven rather than a large boulder. The bedrock is a very fine-grained quartz arenite (orthoquartzite), which agrees with the fieldwork and mapping published by Knight in 2013. The Rock Quality Designation (RQD) was calculated for the only full core run that was drilled and the RQD was 56%, which can be classified as Fair quality rock; the percent recovery for the core run was 93%. Photographs of the recovered core are presented on the following pages.

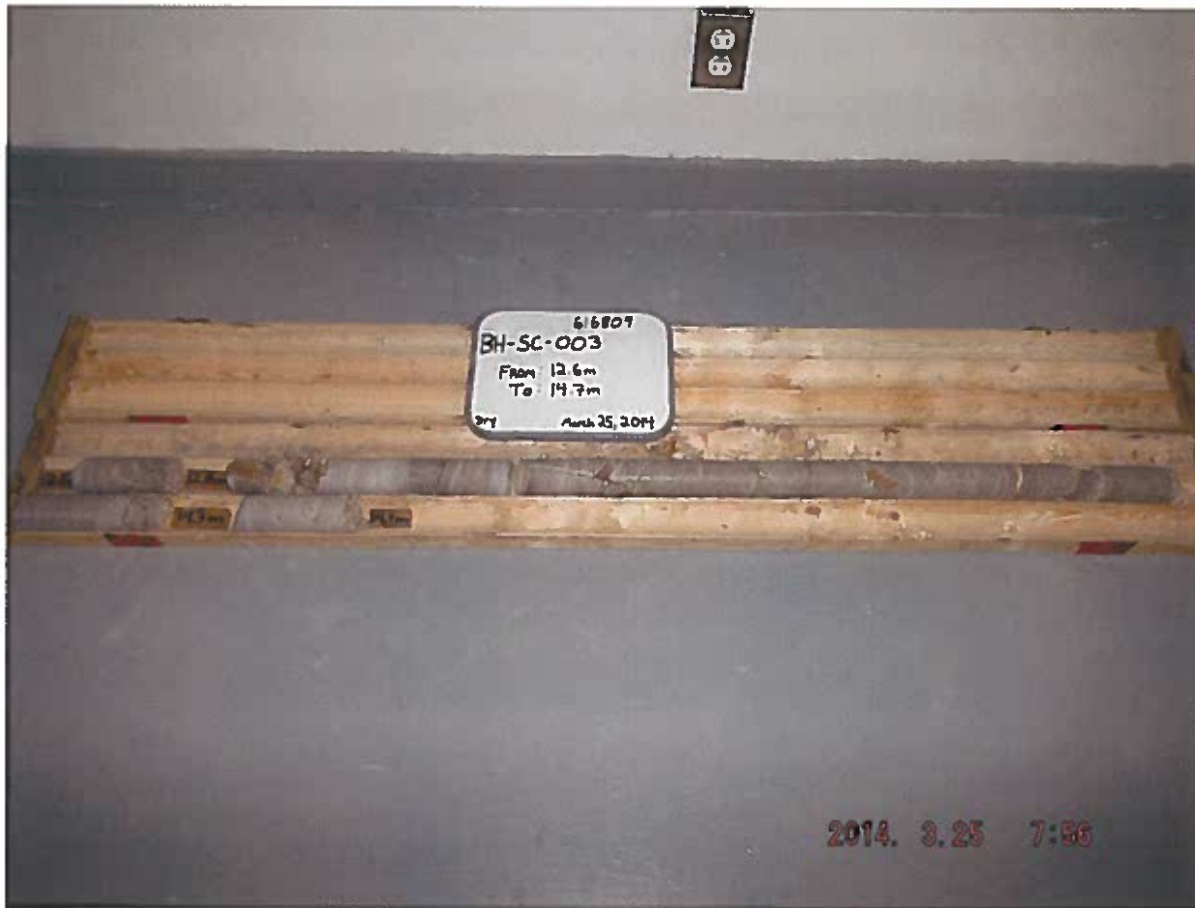
Core Photograph (dry): BH-SC-003-2014, 12.6 mbgs – 14.7 mbgs.

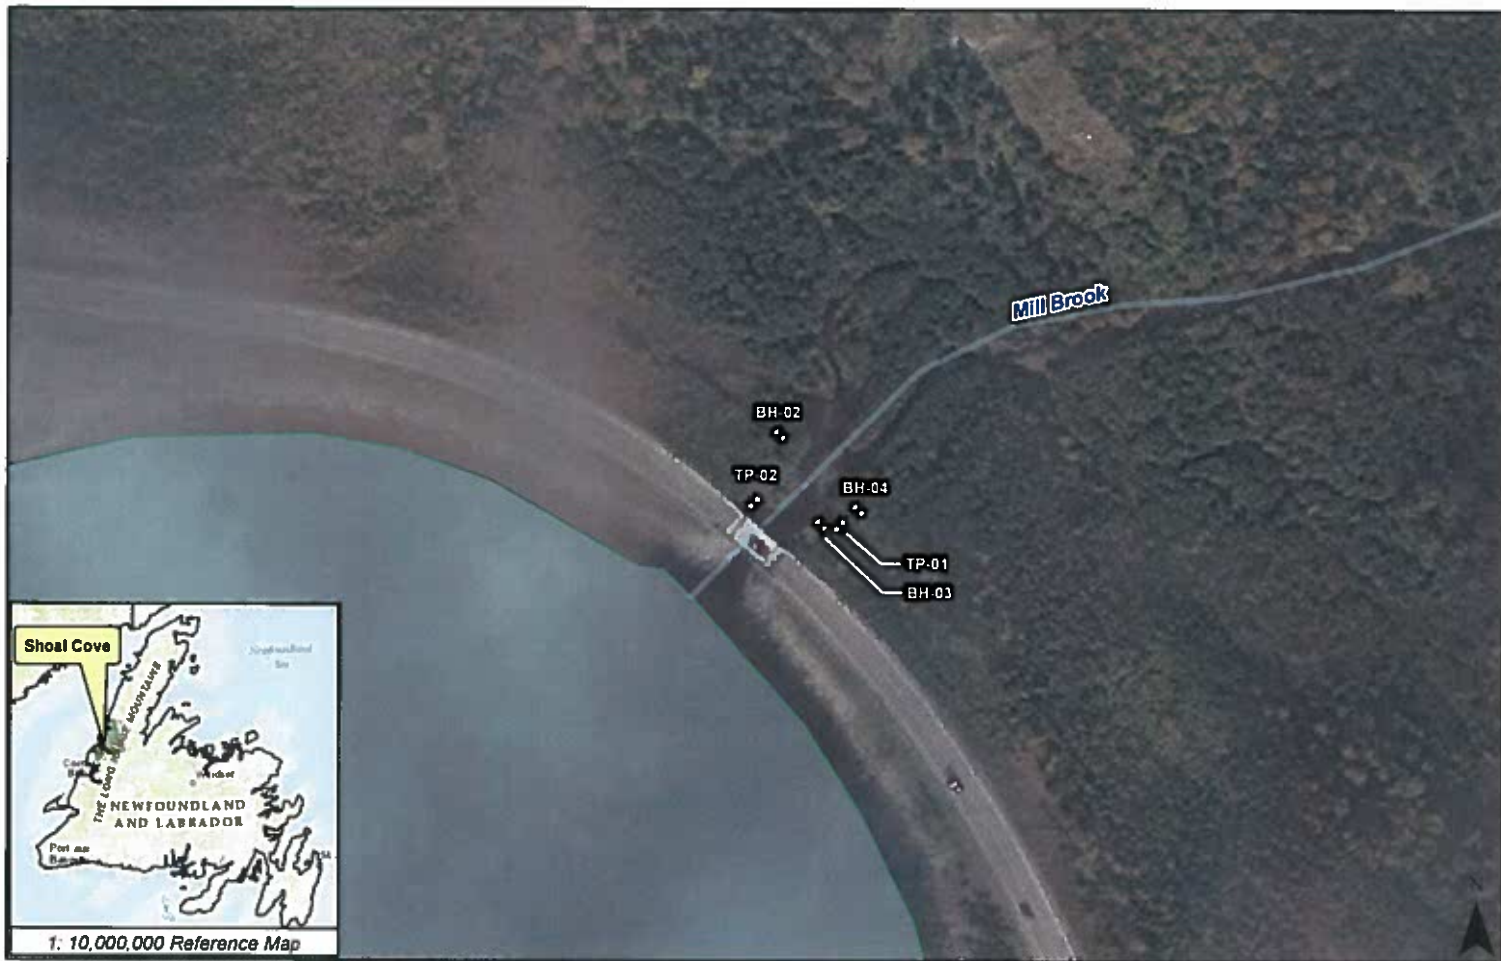
Borehole and Test Pit Reference Map

Site and the locations of the boreholes and test pits are presented on the drawing and figure in [Appendix A](#). Borehole logs are presented in [Appendix B](#) and detailed test pit logs are presented in [Appendix C](#).

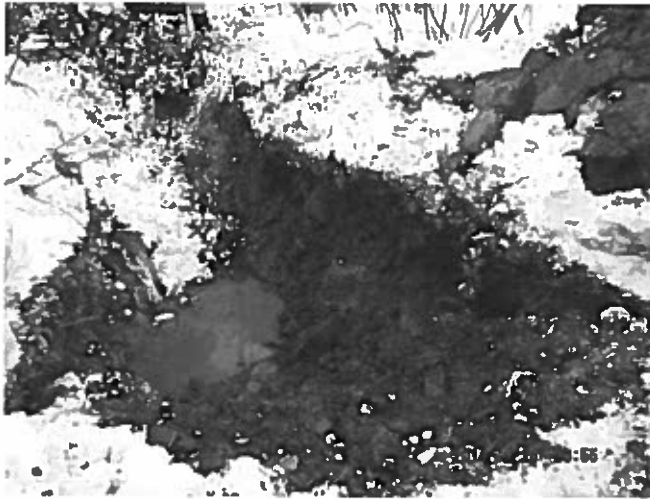
Test pit excavation.

Test Pit Identification Number	Depth* (mbgs) From - To	Soil Description
TP-SC-001-2014 UTM NAD 83 Zone 21 5484626N 441363E	0.0 – 0.1	Topsoil – Dark brown, frozen root mat with organic matter.
	0.1 – 1.1	Fill – Dark brown, wet, compact, cobbly, bouldery gravel, some sand, trace silt. Approximately 25% boulder; maximum boulder diameter approximately 600 mm. Boulders are angular to sub-angular. Composition on boulders indiscernible.
	1.1	Test pit terminated due to refusal on large boulders.

- Sample taken between 0.4 – 0.6 mbgs
- Seepage noted at 0.6 mbgs.
- Groundwater pool at base of pit approximately 0.2 m deep.
- CAT 315CL hydraulic excavator used to dig test pits (provided by CABO Drilling Corp.).

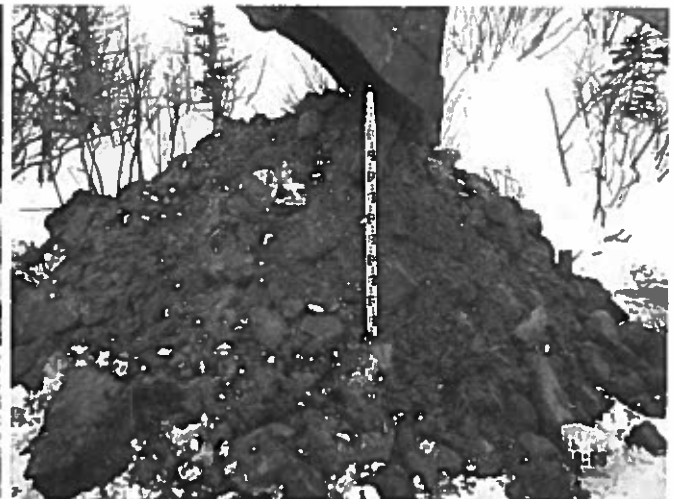
Test pit spoilage. Levelling rod for scale.

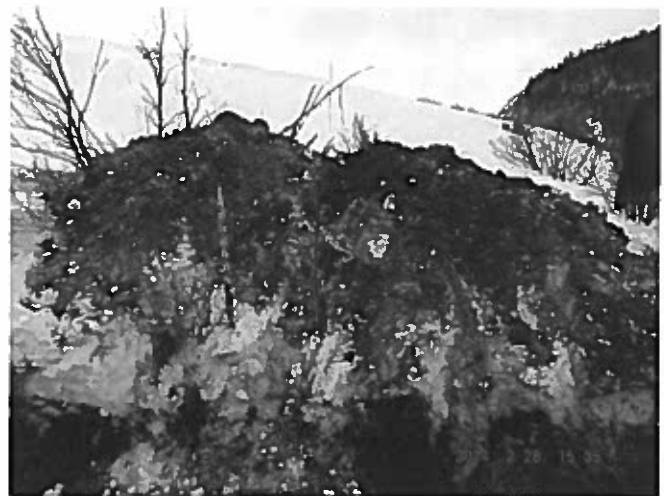
Test pit spoilage with levelling rod for scale.
