# **APPENDIX A – GEOTECHNICAL ENGINEERING REPORTS**

1. "GEOTECHNICAL EVALUATION - CBSA PORT OF ENTRY - PLEASANT CAMP, BC." PREPARED BY TETRA-TECH EBA, DATED DECEMBER 9, 2014, FILE: W14103501-01.
2. "ROCK PIT DESIGN AND SITE BACKFILL RECOMMENDATIONS - CBSA PORT OF ENTRY - PLEASANT CAMP, BC." PREPARED BY TETRA\_TECH EBA, DATED FEBRUARY 2, 2015, FILE W14103501-01.

**Subject:** Geotechnical Evaluation  
CBSA Port of Entry - Pleasant Camp, BC

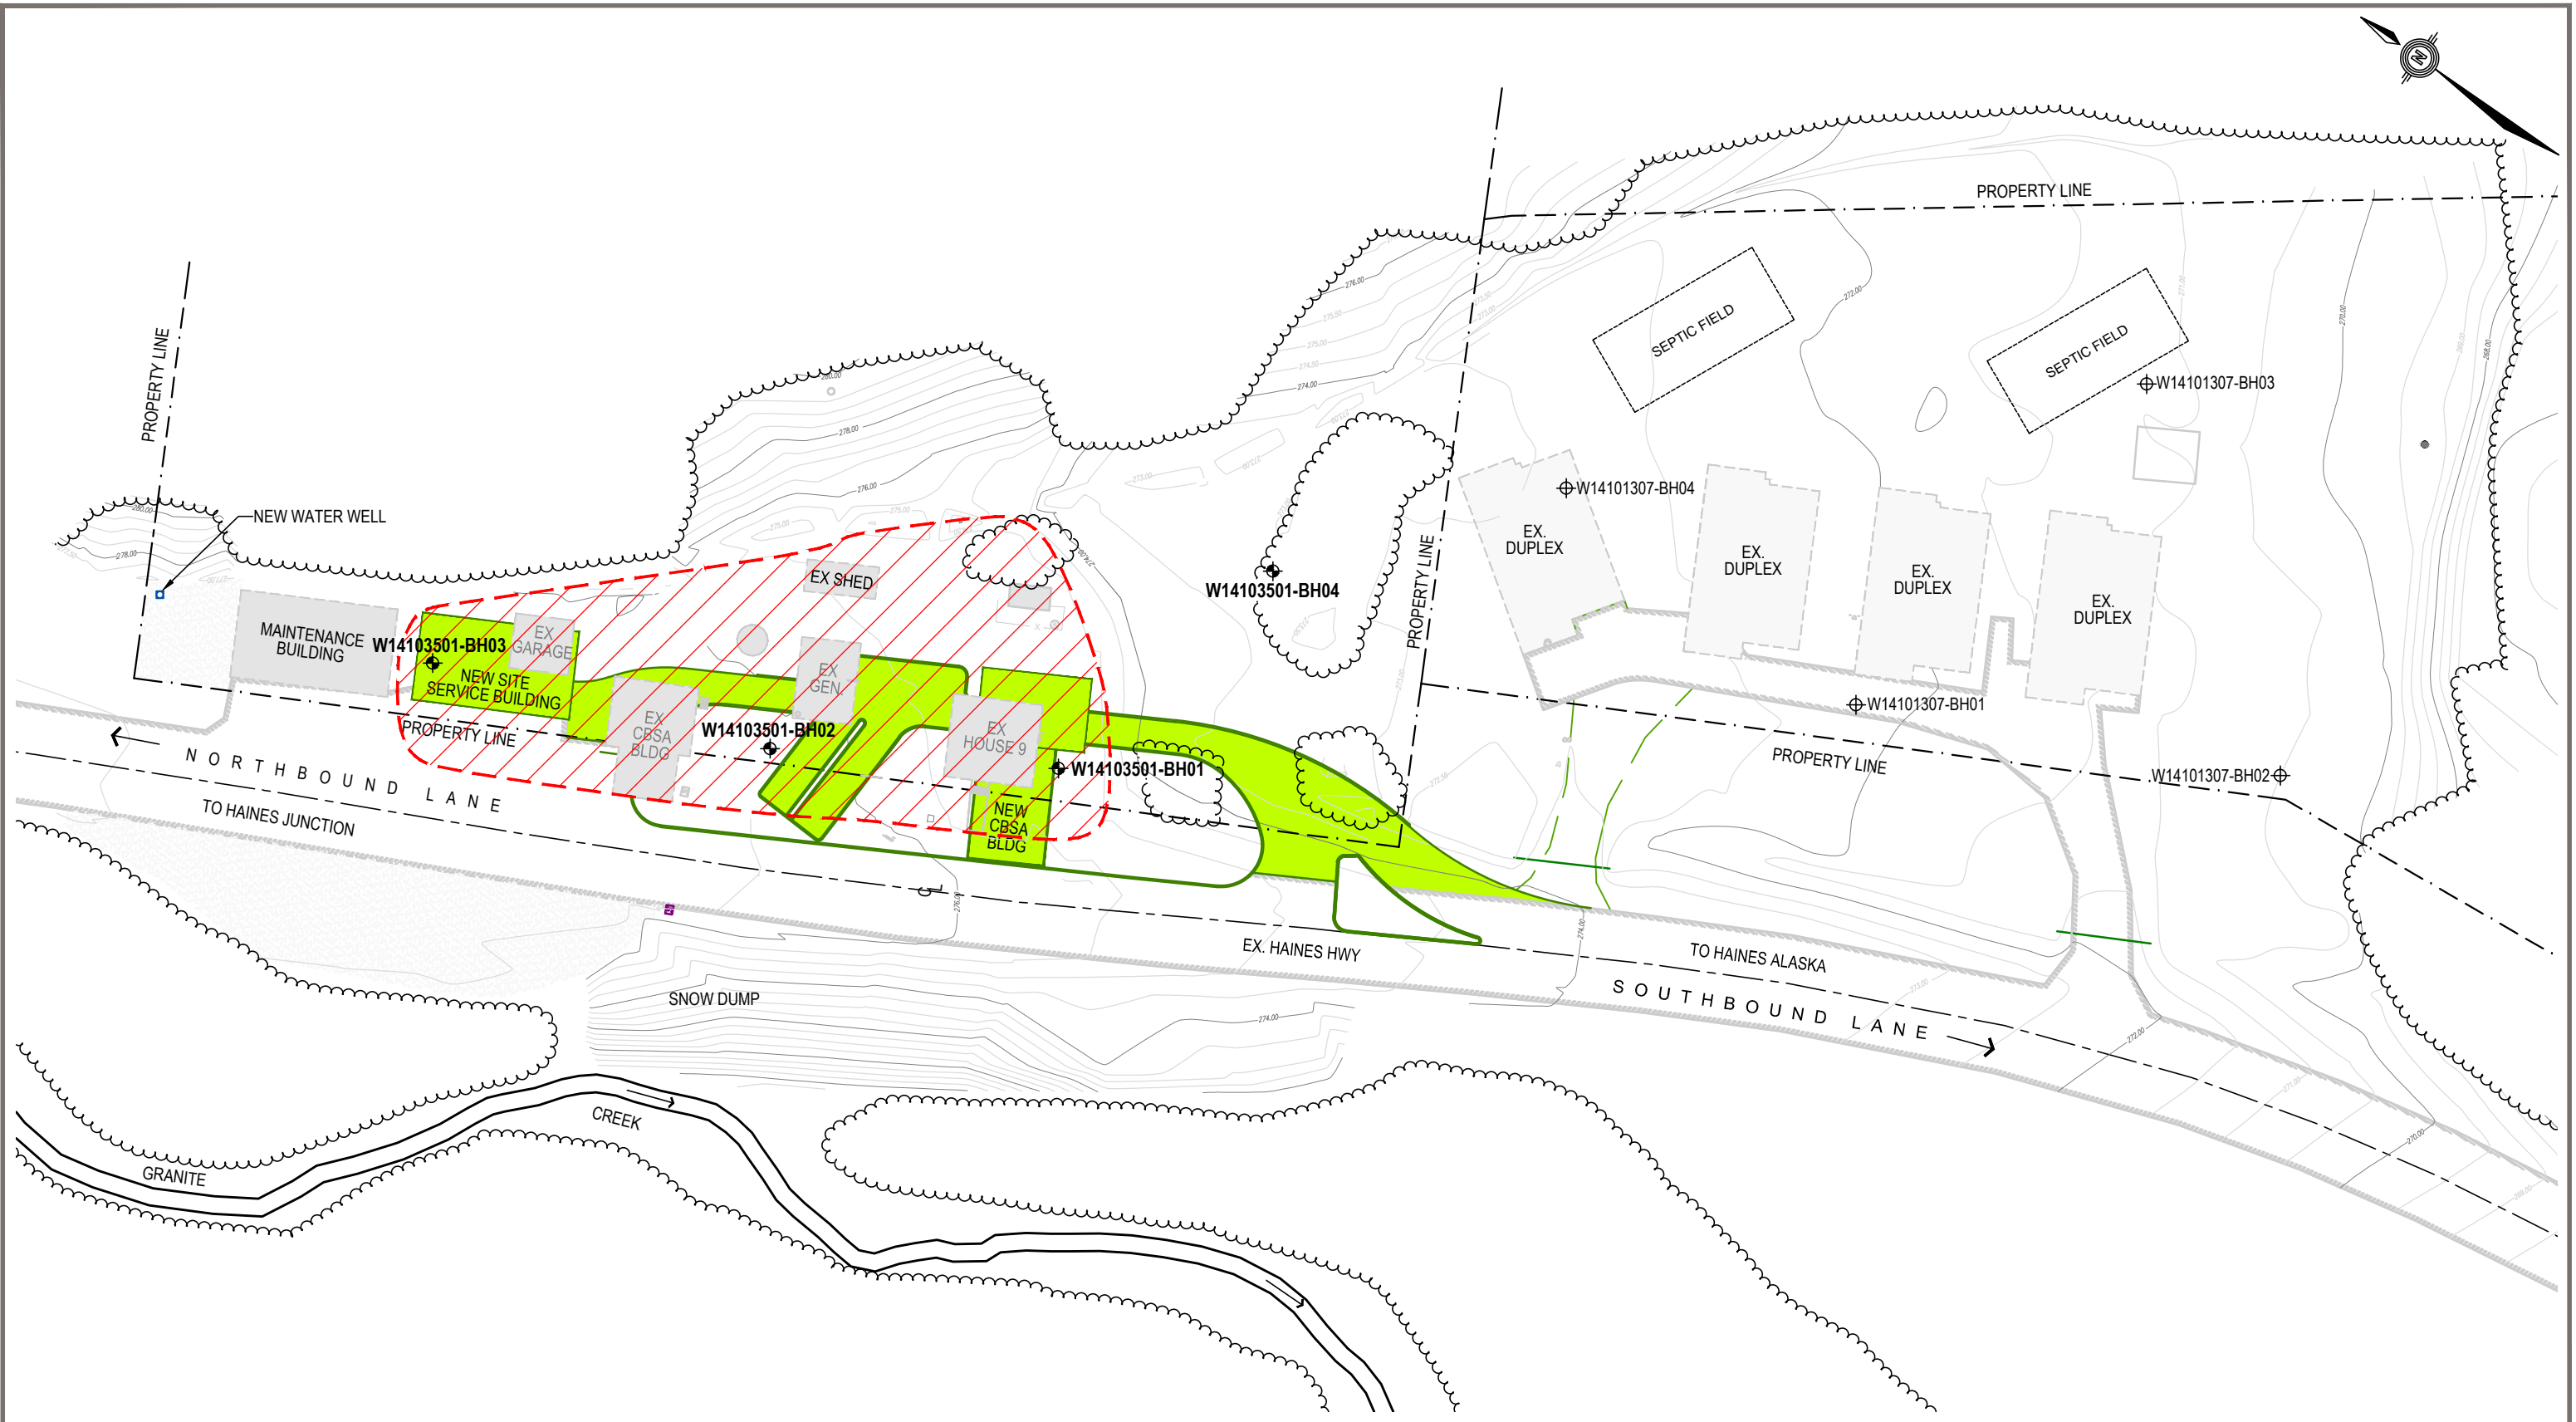
Q:\Whitehorse\Data\Drawings\Pleasant Camp\W14103501-01\_CBSA Port of Entry\W14103501-01\_Fig.1\_R0.dwg [FIGURE 1] November 28, 2014 - 3:54:28 pm (BY: BUCHAN, CAMERON)

- LEGEND**
- ⊕ - 2009 BOREHOLE LOCATION
  - ⊕ - 2014 BOREHOLE LOCATION
  - ▨ - ZONE OF POTENTIALLY LIQUEFIABLE SOIL
  - - PROPOSED NEW SITE LAYOUT

A new water well is also included in the overall scope of upgrades at the site. Drilling of the well had been completed and flow testing was underway at the time of our site visit to complete the field drilling program. The site layout, including locations of existing and proposed new infrastructure, is shown in Figure 1, attached.

In general, and as noted above, potentially liquefiable zones were primarily identified in the northern portion of the site where the depth to bedrock, and consequently the groundwater table above the bedrock, is relatively shallow. In the southern portion of the site, the bedrock surface and groundwater table is deeper, and the saturated soil at depth appears to be sufficiently dense to resist liquefaction.

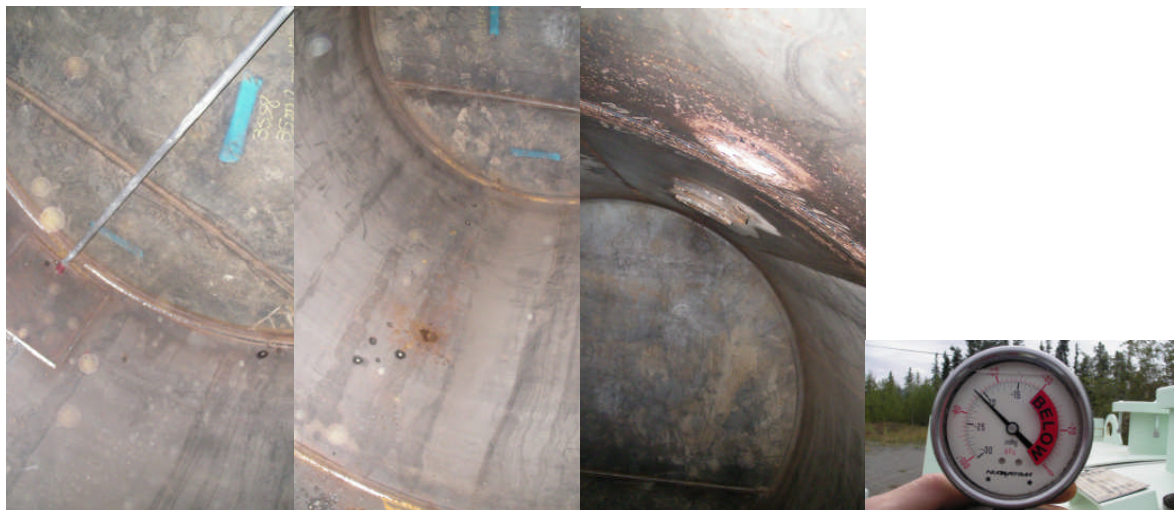
Subject Tank

Tank interior is in very good condition. Interior is clean, no water, no sediment, minimal corrosion observed on tank ceiling from atmospheric moisture. Note: non-coated (non aviation use only) Vacuum monitor of double wall containment working and reading tight.

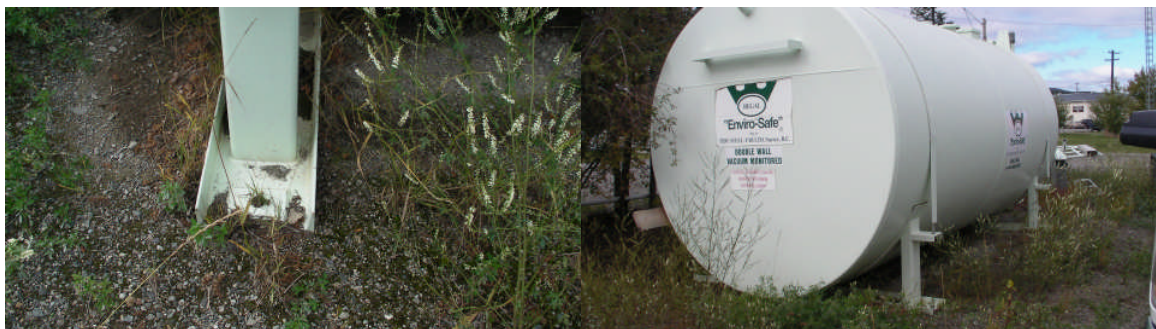
Tank cradel foundation ready for seismic restraint. Tank exterior coating in very good condition.
