**APPENDIX G – FY 2009/2010
MONITORING AND REMEDIATION
CLOSURE REPORT, CBSA PORT OF
PLEASANT CAMP, PLEASANT CAMP, BC**

**FY 2009/2010
MONITORING AND REMEDIATION
CLOSURE REPORT**

**Port of Pleasant Camp
Canada Border Services Agency
Pleasant Camp, BC**

**131416
March 31, 2010**

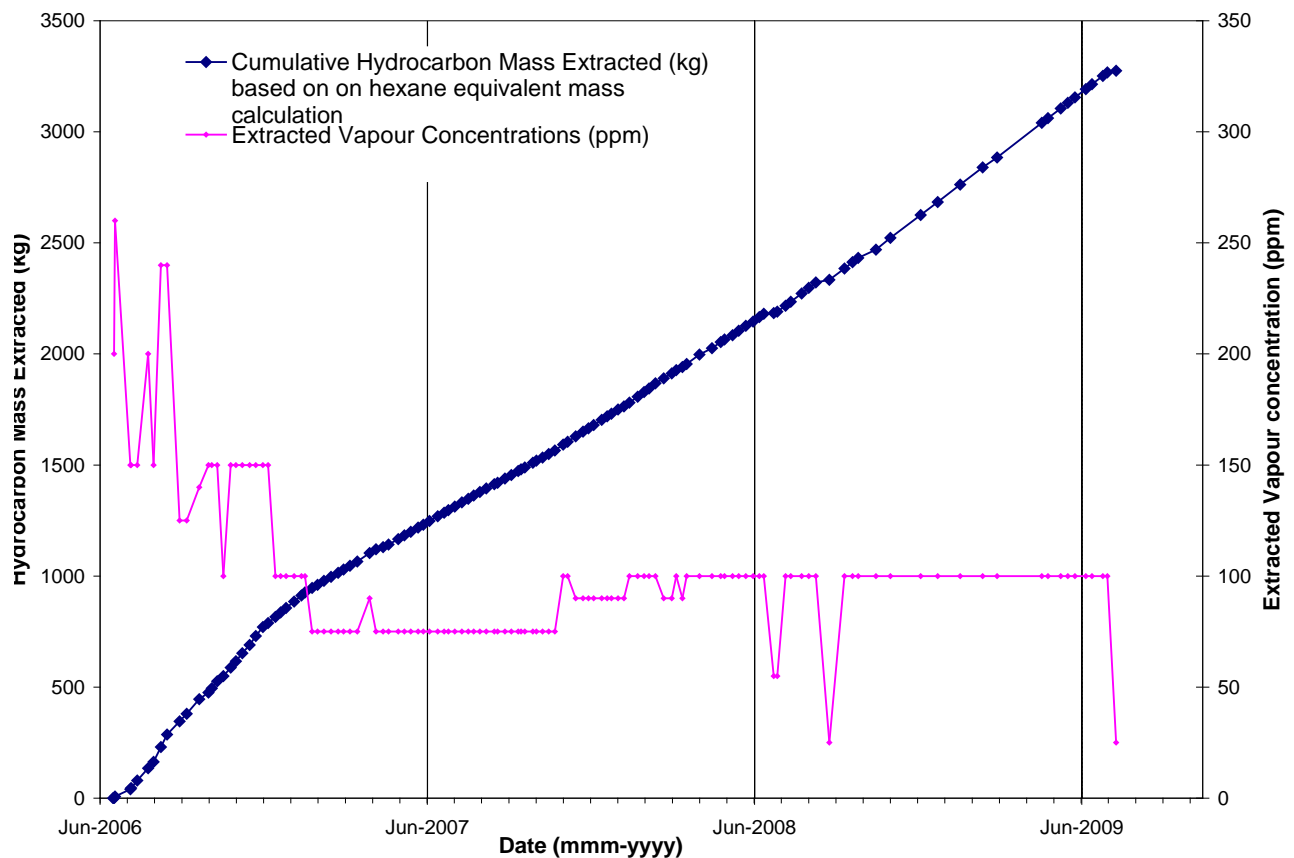
FIGURE A: Cumulative Hydrocarbon Mass Extracted

The total mass estimate is based on hydrocarbon vapour concentrations for the pretreated stream using a Gastech Tracetehtor hydrocarbon analyzer (Gastech), flow rate for the extracted stream, and runtime for the system. Vapours were extracted at flow rates ranging between 340 m³/hr (200 cfm) and 408 m³/hr (240 cfm); the average flow rate was approximately 374 m³/hr (220 cfm). Measurements of extracted hydrocarbon vapour concentrations during the period of operation ranged between 25 ppm and 260 ppm (average 100 ppm). Monitoring of the discharge from the carbon vessels indicated hydrocarbon vapour concentrations ranging from 0 ppm to 150 ppm (average 33 ppm). It should be noted while there is confidence in the numbers for the flow rate and runtime of the system, measured Gastech concentrations may provide an overestimate (versus carbon tube sampling). The extracted concentrations are fairly low (on the order of 100 ppm), and given the error/variability in Gastech measurements the actual vapour concentration could be lower. As noted previously, this mass estimate does not include in situ bioremediation, which may exceed the volatile extracted portion particularly when the contaminant is a heavier hydrocarbon (e.g., diesel fuel) such as at this site.
