Parks Canada

Waterton Lakes National Park Canyon Church Camp Bridge Replacement Environmental Assessment

April 2015

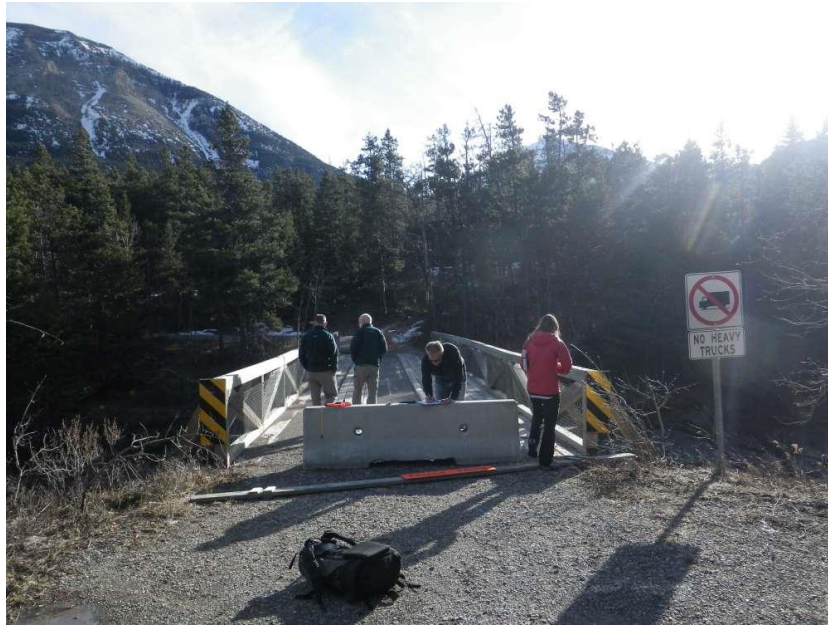
Photo 1: View south of the Canyon Church Camp Bridge over Blakiston Creek (January 27, 2015)

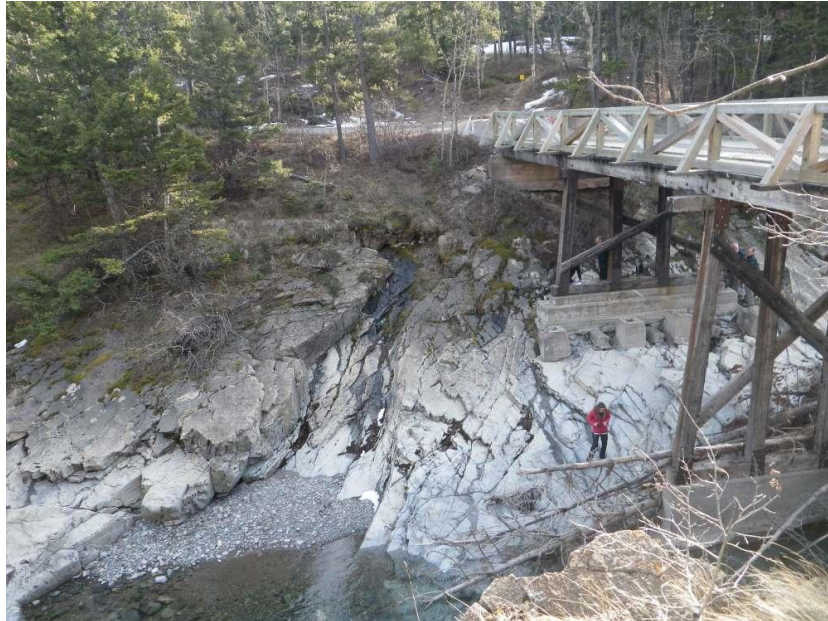
Photo 2: View of the existing bridge crossing and the downstream right bank of Blakiston Creek (January 27, 2015).

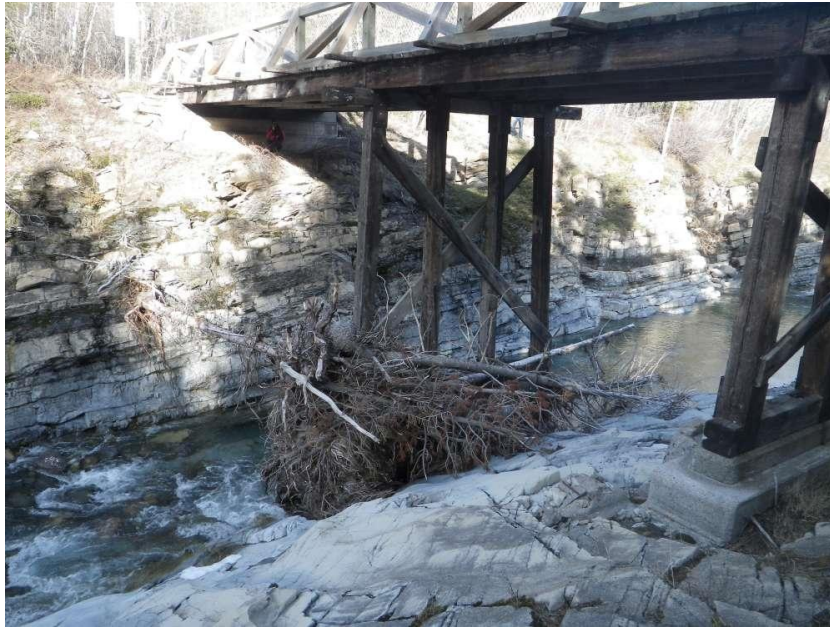
Photo 3: View downstream of the Canyon Church Camp Bridge crossing and flood debris jam on the instream pier (January 27, 2015)

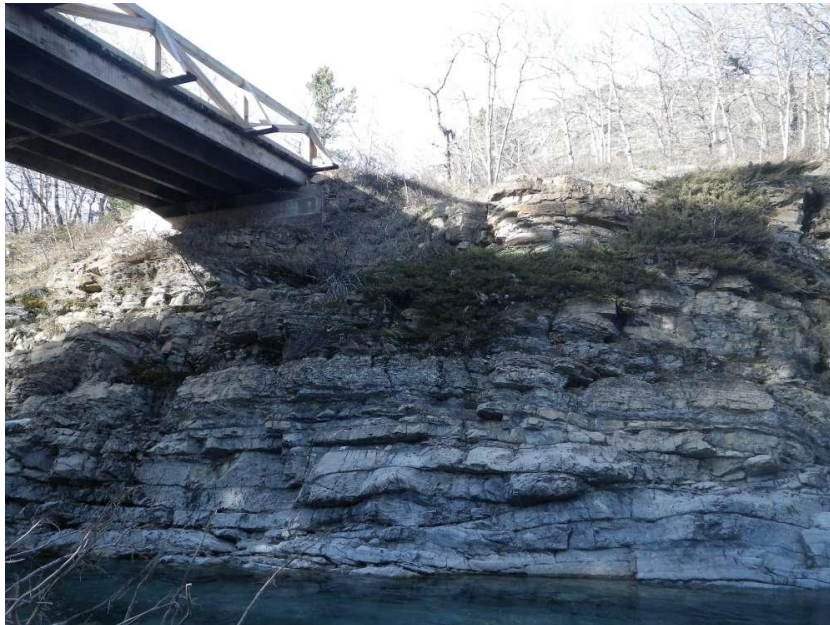
Photo 4: View of the steep left bank of Blakiston Creek at the watercourse crossing (January 27, 2015).

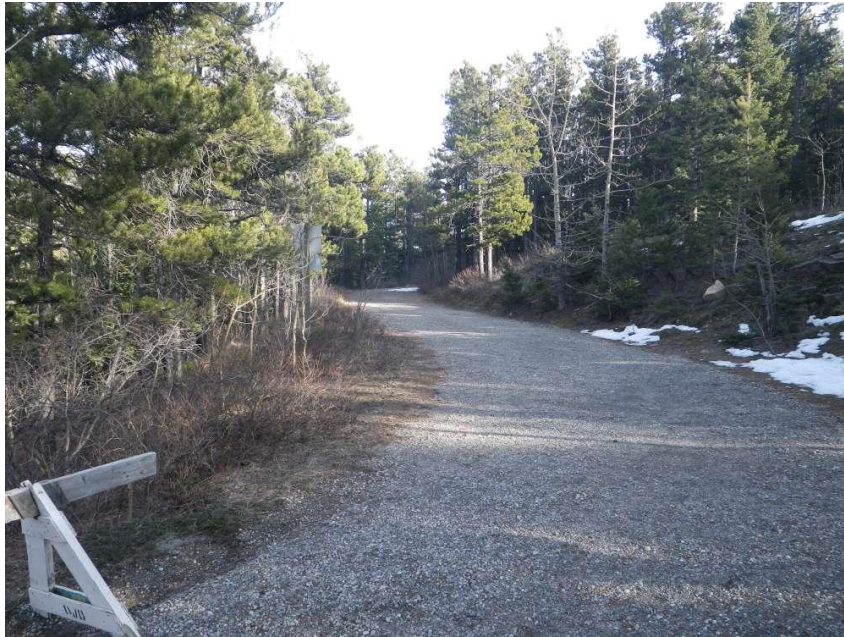
Photo 5: View southeast of the south bridge approach and access road (January 27, 2015)

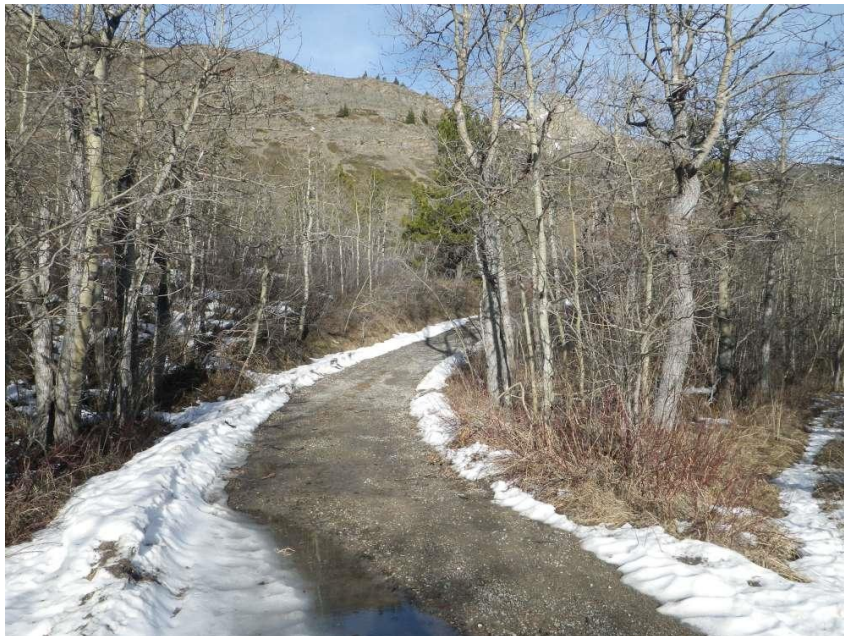
Photo 6: View of the north bridge approach. The Crandell Lake Trail system is shown on the right side of the image (January 27, 2015).

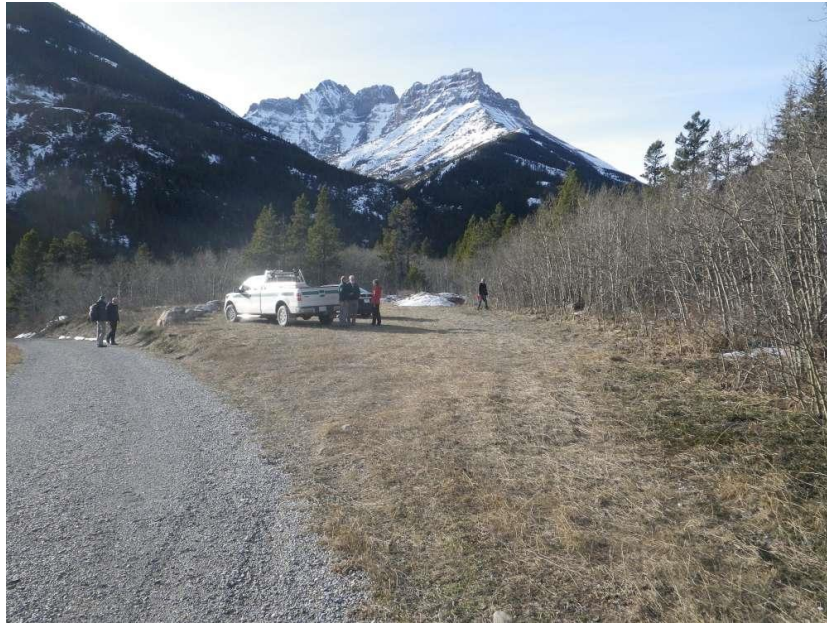
Photo 7: View west of the proposed laydown and material storage location on the north side of the bridge crossing (January 27, 2015). Accessed off of the Canyon Church Camp access road.

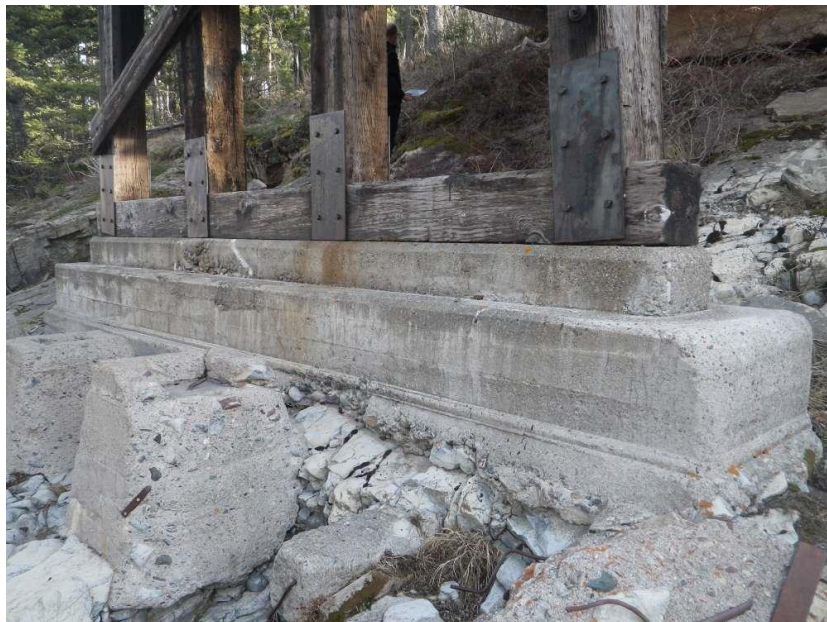
Photo 8: View of the concrete pier footing on the right (south) bank of the watercourse. This pier footing can be used to assist the debris collection measures proposed (January 27, 2015)

- Netting or other containment measures must be used beneath the existing bridge during removal of piers and bridge railings, deck material and girders. Containment measures implemented must be durable enough to catch large, heavy material in addition to loose nails and debris that may come loose during removal, yet still allow rain to pass through. Containment system to be approved by the Departmental Representative.

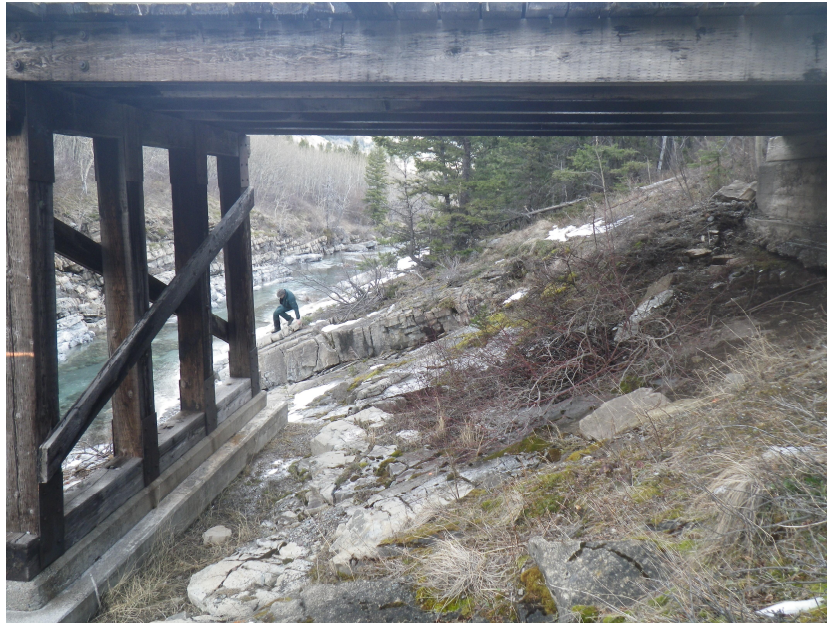
Photo 9: View downstream of the right bank of the watercourse and the existing bridge piers (March 12, 2015).

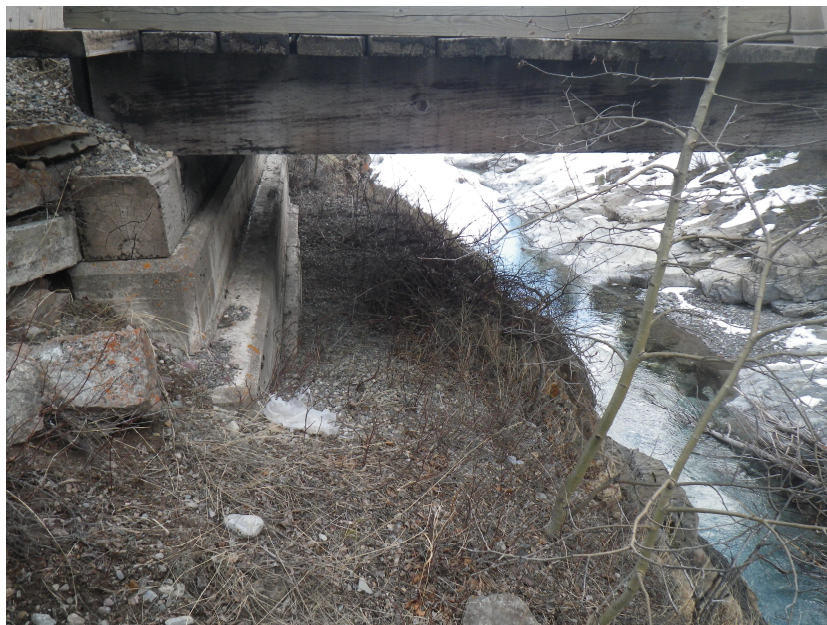
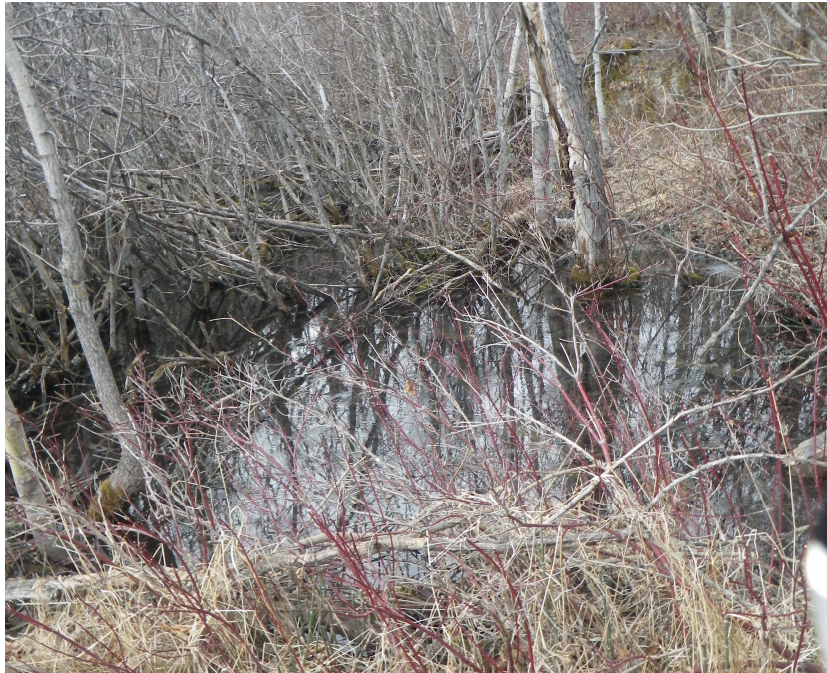
was identified in this area which indicates it is a permanent feature and may provide habitat for amphibians. This location should be considered a wetland.

Photo 10: View of the low wet area adjacent to the Canyon Church Camp access road on the north side of the bridge (March 12, 2015).

Photo 11: View of the low wet area adjacent to the Canyon Church Camp access road on the north side of the bridge (March 12, 2015).

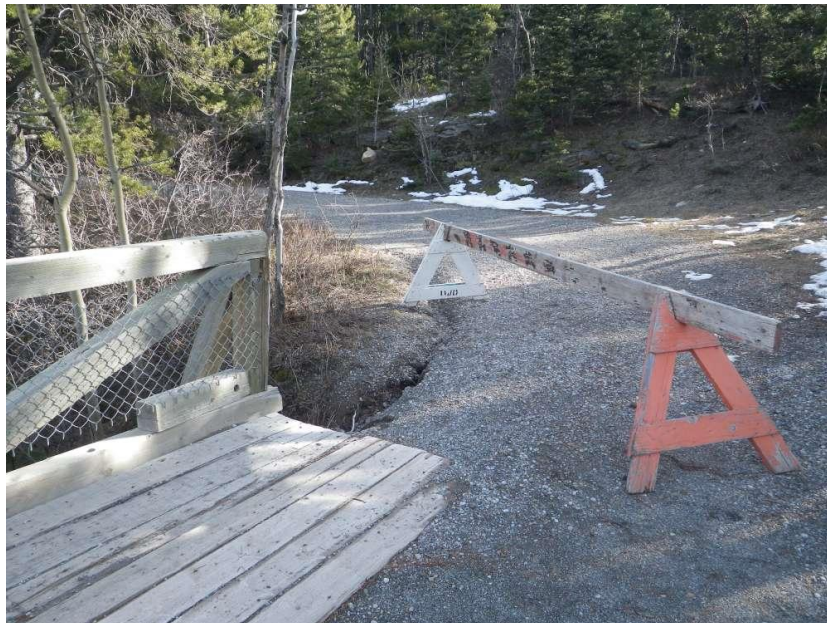
The banks of Blakiston Creek at the crossing location are primarily bedrock and the watercourse is largely confined within a narrow canyon. Earthen and organic material is present along the top of the watercourse banks. During the site assessment, erosion gullies were observed at the existing bridge abutments and approaches on the south side of the bridge. Erosion has resulted in removal of soils down to bedrock around the existing bridge abutment.

Photo 12: View of an erosion gully at south downstream approach to the existing bridge (January 27, 2015).

- For ditchlines and other channelized erosion zones, rock check dams can be used to slow flow and prevent erosion (BMP #7). Alternatively, biodegradable Rolled Erosion Control Products (BMP #13) can be used in channelized areas to protect exposed soils and seeds applied to reclaimed areas.
