**Soil Sampling, Contaminated  
Soil Stockpile, Wabush Airport,  
Wabush, NL**

**File No: 121412845**

**Final Report**

January 31, 2014

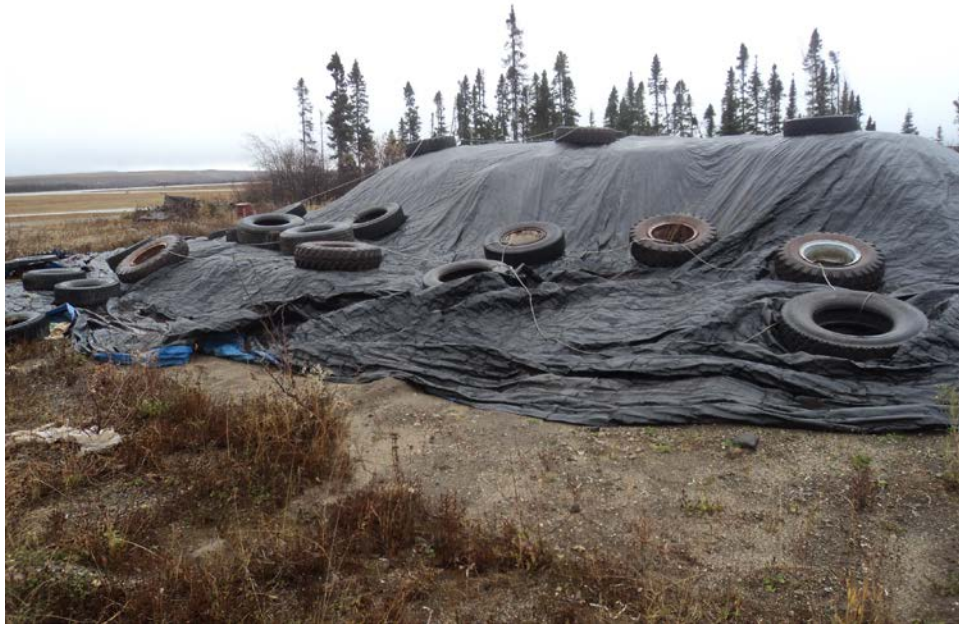
Based on a visual inspection of the soil stockpile, the berm surrounding the stockpile has weathered and decreased in size over time. The likely cause is suspected to be the result of

wind and snow cover in addition to previous soil turning events (see photographs 1, 2, 5, and 6 in Appendix B).

Photo 1. Contaminated Soil Stockpile prior to sampling and turning, looking southwest.

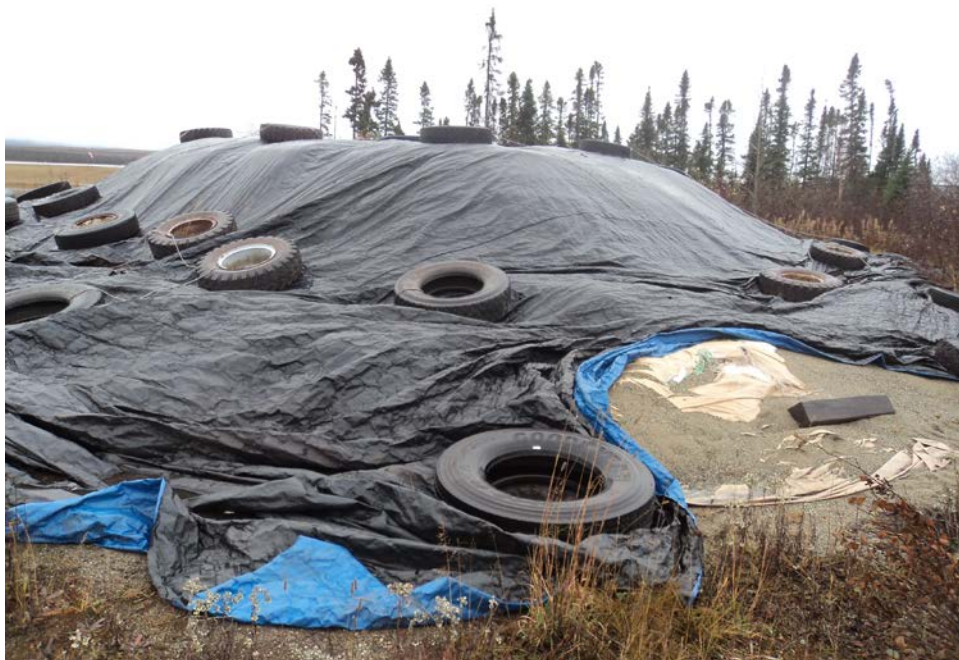
Photo 2. Contaminated Soil Stockpile prior to sampling and turning, looking west.

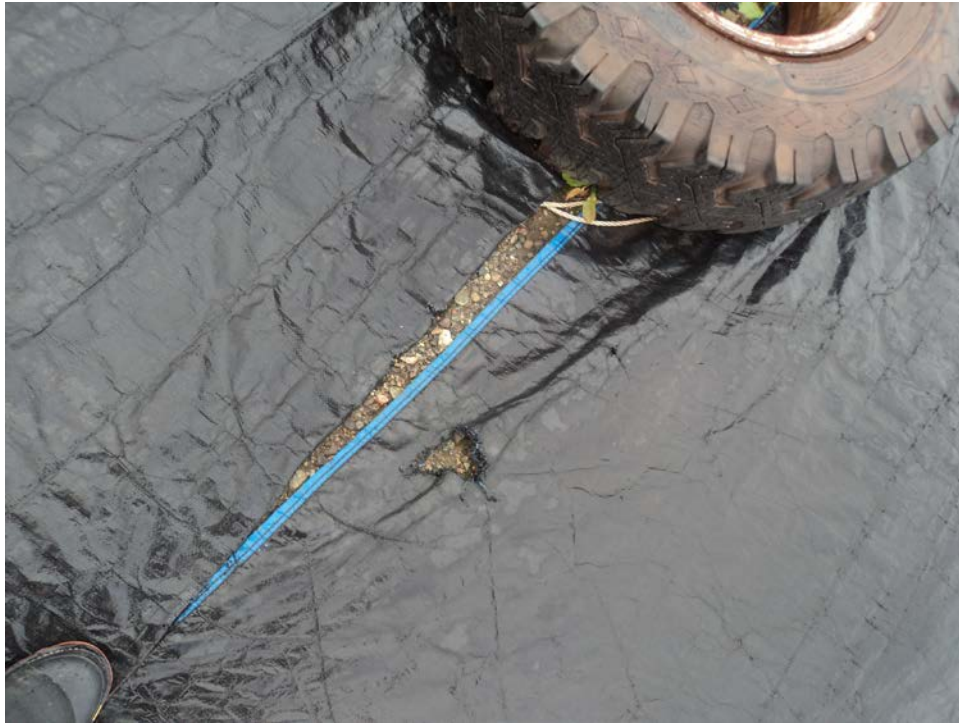
On October 21, 2013 Stantec personnel were on site to remove the tarp that covers the contaminated soil stockpile. Several rips and tears were present on the tarp when Stantec personnel arrived on-site. With the aid of a labourer from Big Land Solutions of Wabush, NL and an excavator operator from Dexter Mining Inc. of Wabush, NL, the tires used to secure the tarp were removed and the tarp was pulled off the soil stockpile and laid to the west of the pile during sampling activities. Care was taken to avoid further ripping/tearing the tarp during removal.

Photo 3. Tear along seam of covering tarp.

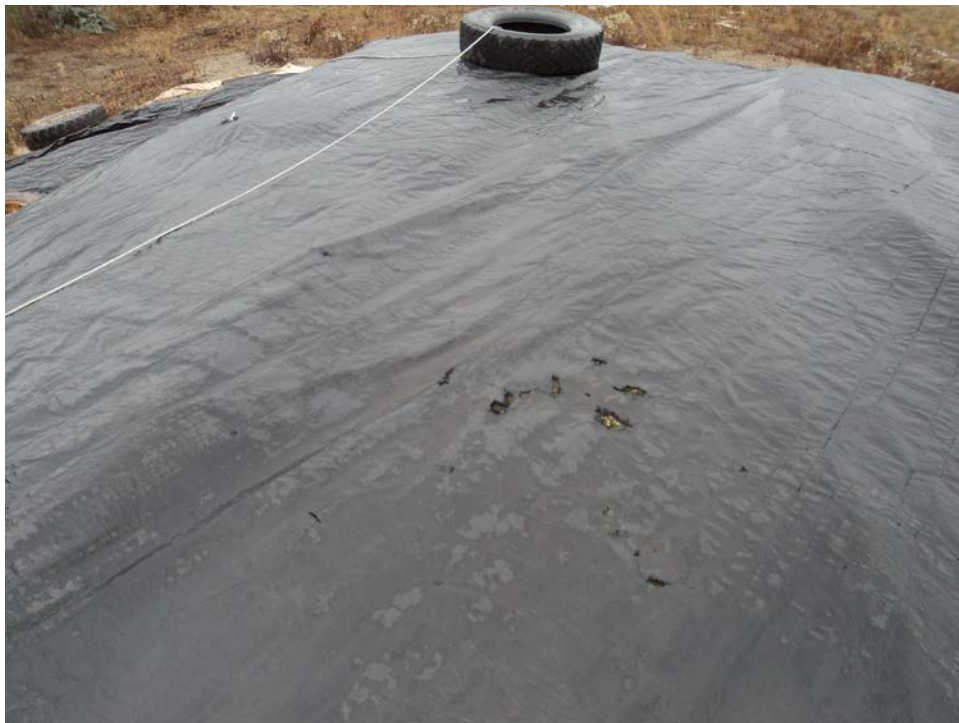
Photo 4. Small tears in covering tarp.

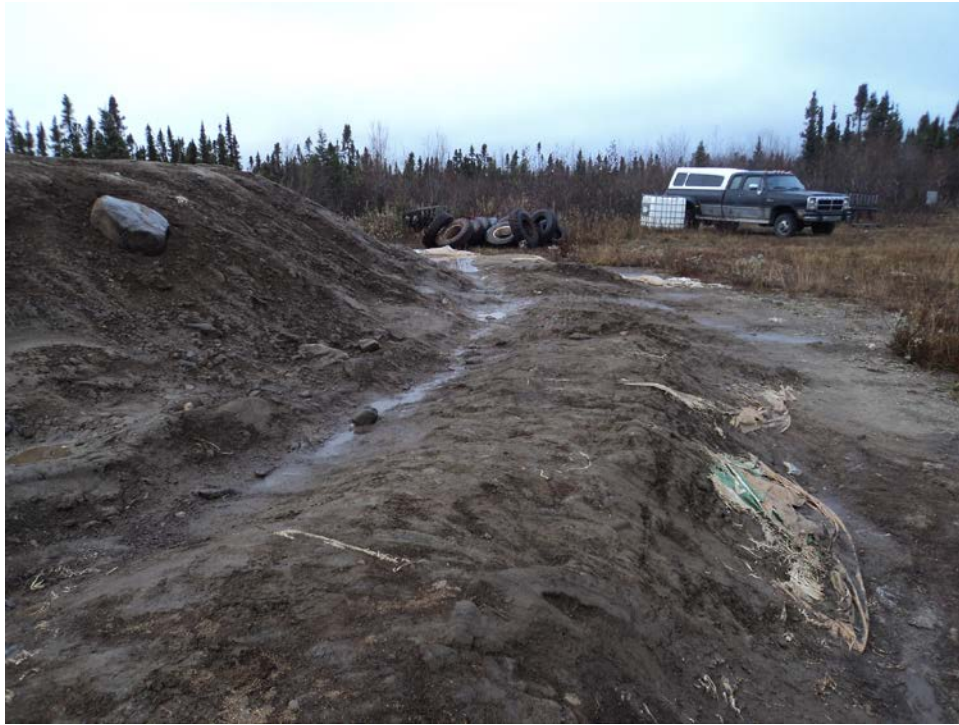
Photo 5. Berm, looking west – slightly weathered with reduced height.

Based on a review of analytical data and the management options presented in Table 7.1, Stantec recommends enhancing the *ex-situ* natural attenuation of TPH in the contaminated soil stockpile. In 2014 it is suggested to complete option # 2 – On-site Treatment at the contaminated soil stockpile. As such, TC would have to initiate the biotreatment program with a) a select consultant who would manage the program; or, b) a licensed soil treatment company who would be responsible for treating and disposing the soil. Additionally, based on a visual inspection of the contaminated soil stockpile, the berm surrounding the stockpile has weathered and decreased in size over time and various tears are present on the tarp cover; therefore, berm maintenance and tarp replacement is recommended for both management options #1 and #2.

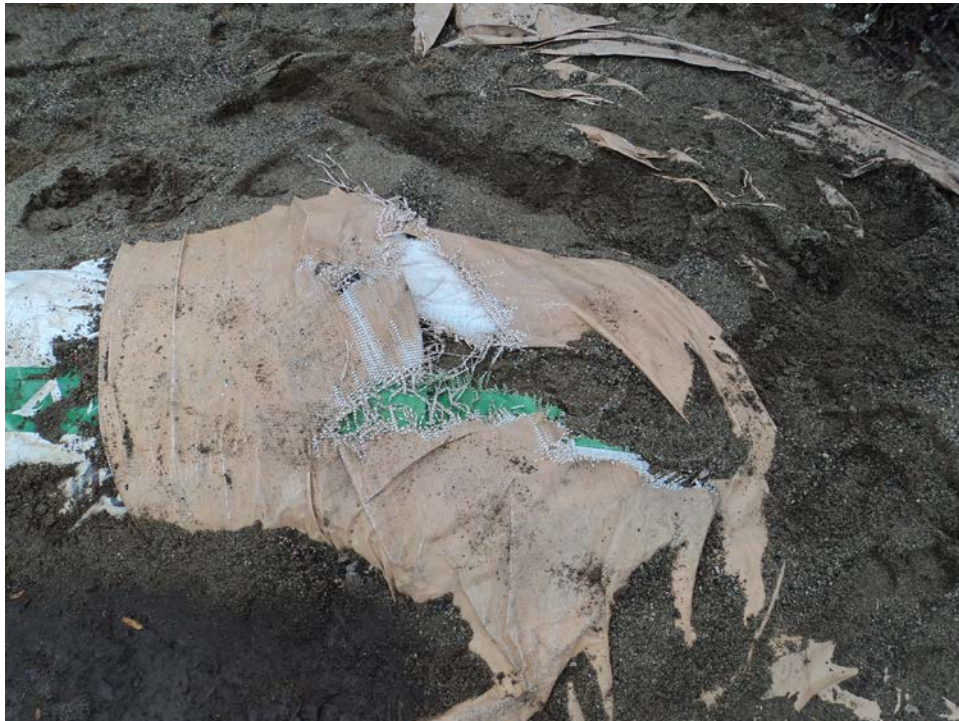
Photo 6. Weathered ripped area of berm.

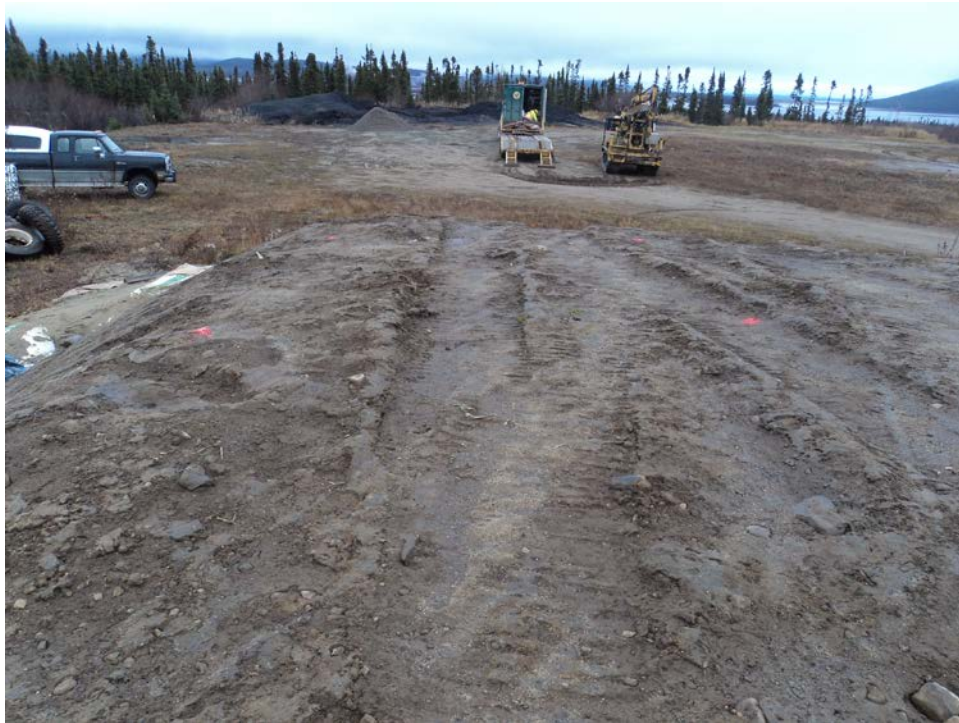
Soil sampling of the contaminated stockpile was carried out on October 21, 2013. Soil samples were collected from eleven (11) locations (*i.e.*, SS1 to SS8, and SS10 to SS12). In addition, one (1) field duplicate sample of SS8 (labeled SS9) was collected. The sample locations were selected by TC in 2006 and are shown on Drawing No. 121412845-EE-03 provided in Appendix A.

Photo 7. Various marked sample locations prior to sampling Contaminated Soil Stockpile.

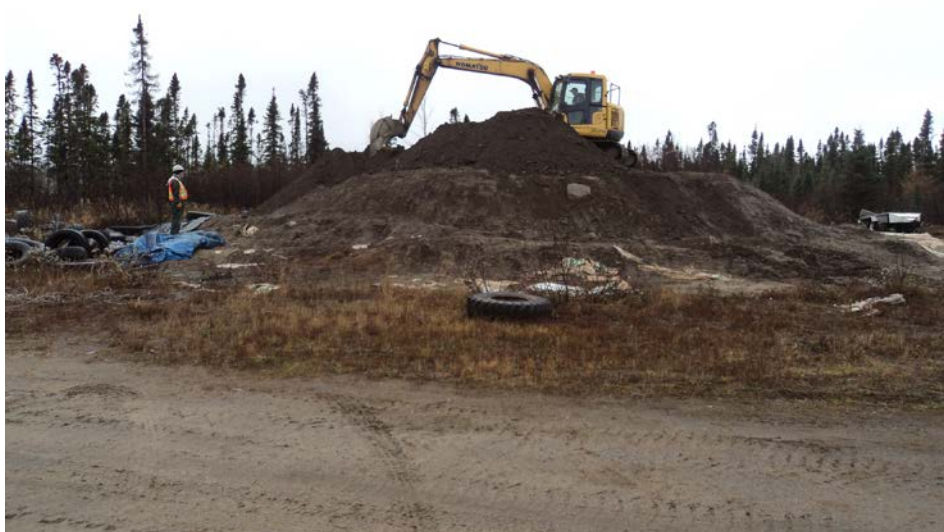
Following the collection of soil samples, on October 22, 2013 the entire soil stockpile was turned using an excavator and operator provided by Dexter Mining Inc. Care was taken to compact the soil stockpile to its initial compaction and shape and to ensure that the side slopes were properly maintained.

Photo 8. Turning Contaminated Soil Stockpile, looking west.

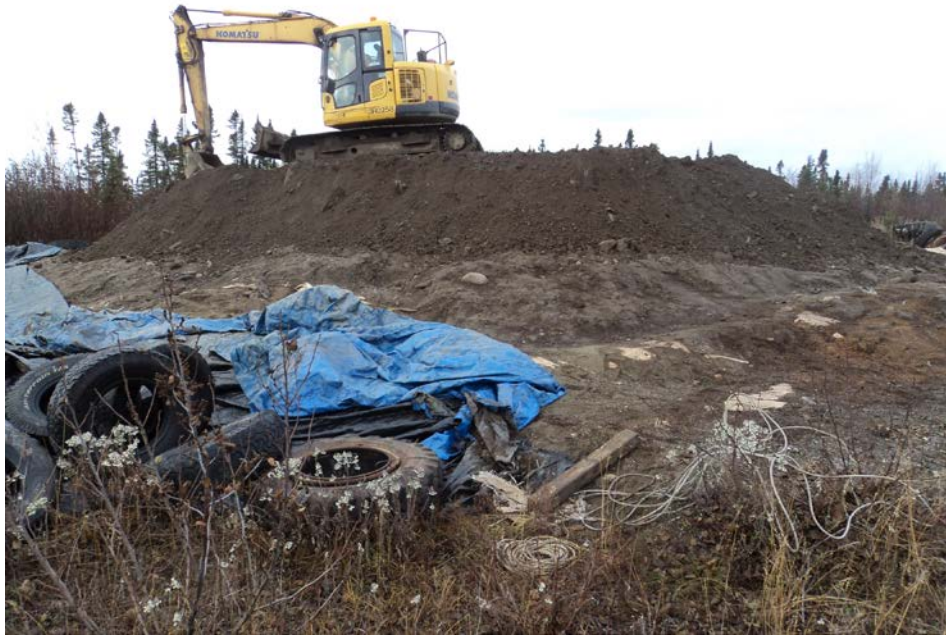
During stockpile turning activities, a moderate to strong hydrocarbon odour was noted, particularly near the bottom of the soil stockpile. Following completion of the stockpile turning, the tarp was replaced and the tires were secured on top of the stockpile (see photograph 9 in Appendix B).

Photo 9. Turning Contaminated Soil Stockpile, looking north.

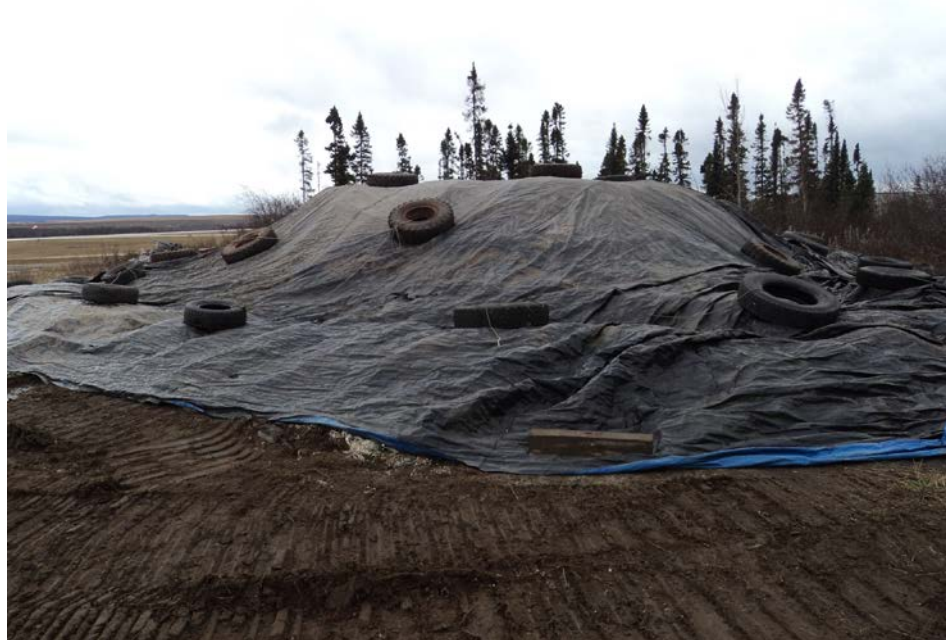
Photo 10. Contaminated Soil Stockpile following sampling and turning, looking southwest.
