Title - Sujet Palace Grand Theatre Foundation Rep	
Solicitation No. - N° de l'invitation EZ899-152418/A	Amendment No. - N° modif. 002
Client Reference No. - N° de référence du client	Date 2015-06-17
GETS Reference No. - N° de référence de SEAG PW-\$PWY-022-7522	
File No. - N° de dossier PWY-5-38030 (022)	CCC No./N° CCC - FMS No./N° VME
Solicitation Closes - L'invitation prend fin at - à 02:00 PM on - le 2015-06-30	Time Zone Fuseau horaire Pacific Daylight Saving Time PDT
F.O.B. - F.A.B. Plant-Usine: <input type="checkbox"/> Destination: <input checked="" type="checkbox"/> Other-Autre: <input type="checkbox"/>	
Address Enquiries to: - Adresser toutes questions à: Arthur (PWY), Carolyn	Buyer Id - Id de l'acheteur pwy022
Telephone No. - N° de téléphone (604) 775-6667 ()	FAX No. - N° de FAX (604) 775-6633
Destination - of Goods, Services, and Construction: Destination - des biens, services et construction: Parks Canada - Palace Grand Theatre - Dawson City, YT

BID DOCUMENTS FOR
PALACE GRAND THEATRE FOUNDATION REPLACEMENT

**PALACE GRAND THEATRE
FOUNDATION REPLACEMENT**
DAWSON CITY, YUKON

PROJECT NO. R.068835.001
PALACE GRAND THEATRE FOUNDATION REPLACEMENT
DAWSON CITY, YUKON TERRITORY

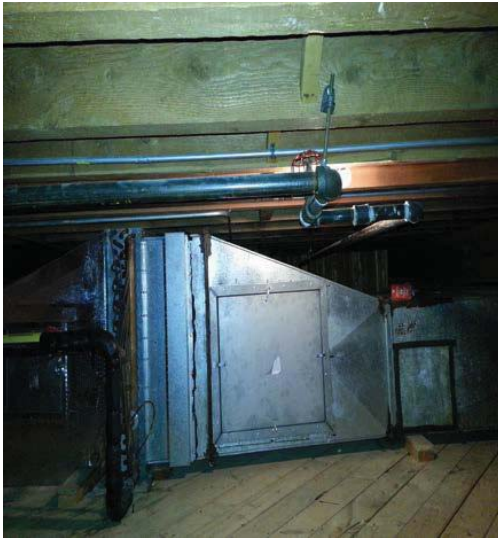
Existing AHU in stage crawl space

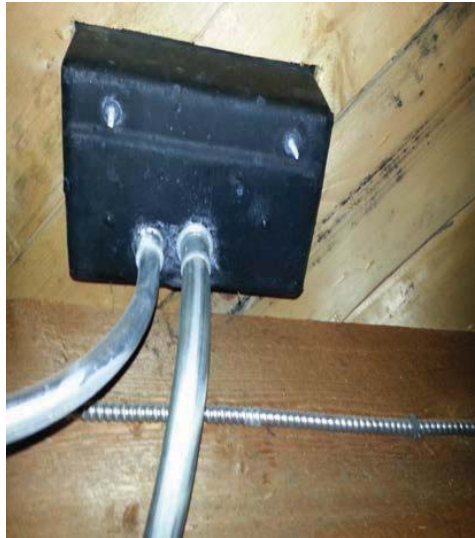
Typical Floor Box's

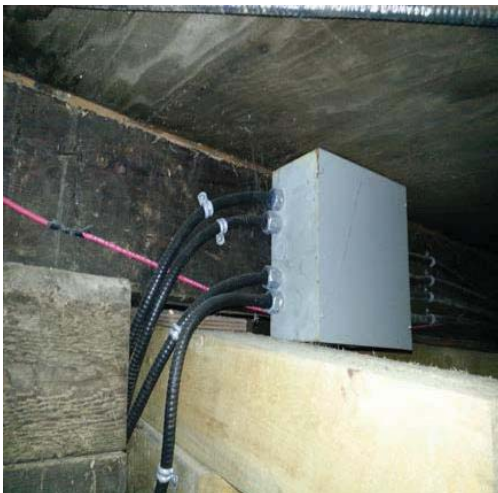
Car plugs J.B feed all car plugs

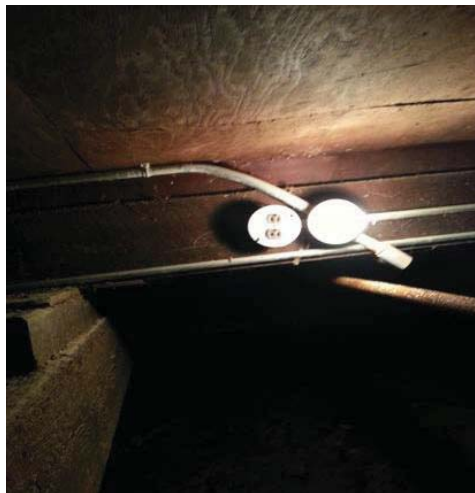
**Keyless Light Fixtures and
Receptacles in the crawl space**

E7.	Contractor to replace crawl space receptacles with new (new plugs and weather proof in-use covers), use same circuits and wiring. Allow for 20 plugs re-placements in the bid price.
E8.	Contractor to replace existing keyless lighting fixtures in the crawl space with new vapor tight fixtures, standard of acceptance: VXBRL13DG RCL complete with wire guard for complete operational lights. Allow for 20 light fixtures in the bid price.
E9.	General Note: most of the electrical devices in the building fed through the crawl space. In most of the areas the conduits and wiring required to be removed to allow for the civil work on the floor s and crawl space, contractor is encouraged to visit the site to familiarize himself with the scope. Allow for all work in the bid price for complete operational systems. All work must be coordinated with other trades.
