**SEISMIC RESEARCH STUDY  
FOR  
CENTRE BLOCK, PARLIAMENT HILL**

**Work Package 1**

*Prepared for:*  
Public Works and Government Services Canada  
Parliamentary Precinct Branch

14Y160-113A

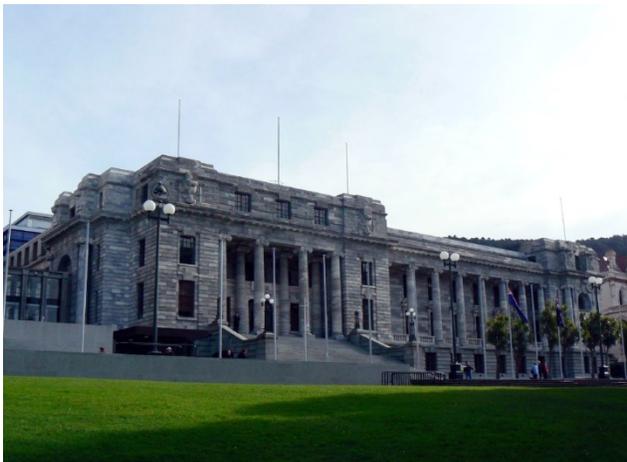
## 5.2 **New Zealand Parliament House<sup>2</sup>**

The Parliament House is the primary building of the New Zealand Parliament Buildings, which house the national government in Wellington, New Zealand. The building was reconstructed in 1922, after the original Parliament House was destroyed by fire, and consists of 4 levels above grade and one basement level. The original lateral load resisting system of the building consisted of brick and stone masonry bearing walls. The floor system consisted of simply reinforced concrete slabs bearing on steel beams. In 1989, the New Zealand government decided to strengthen the existing building as part of an overall refurbishment of the existing facilities and construction was completed in 1995.

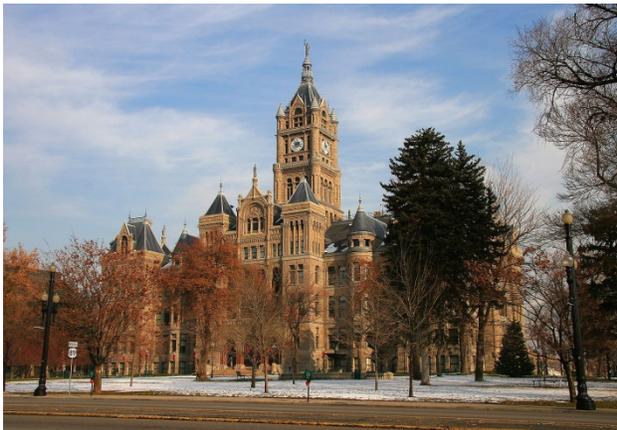
### 5.3 Salt Lake City and County Building<sup>3,4</sup>

The Salt Lake City and County Building (City-County Building) houses the municipal government of Salt Lake City, Utah. Constructed in 1894, the main building has an approximate height of 30 m, while the main tower is approximately 76 m tall. The gravity and lateral load resisting system is primarily comprised of unreinforced sandstone and brick masonry walls, typically varying in thickness from 0.6 m to 0.9 m, but increasing up to 2.5 m thick at the base of the piers of the tower. The floor structures consist of either wood joists or iron beams with brick arches. In 1984, the city decided to proceed with the seismic strengthening.

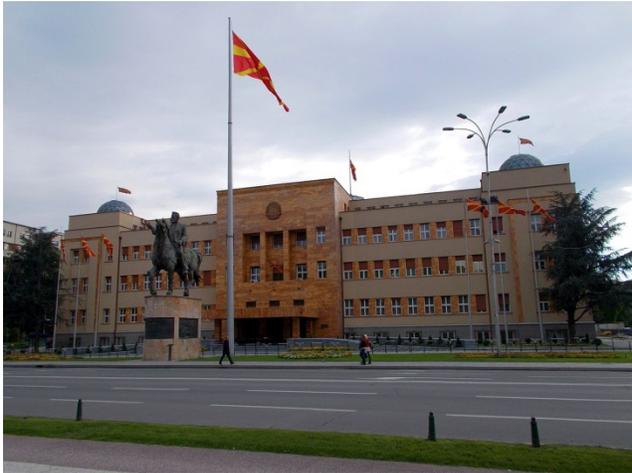
#### 5.4 The Parliament Building of Macedonia<sup>5</sup>

The Parliament Building of the Republic of Macedonia in Skopje, was originally constructed between 1936 and 1939, although there were many enlargements and additions added over the subsequent years. The building forms an unequal pentagon with one basement level and 3 storeys above grade. The floor structures are comprised of reinforced concrete slabs bearing directly on brick masonry walls and concrete columns. The building suffered extensive damage during an earthquake in 1963, primarily at the ground floor, and was repaired the following 2 years but not strengthened. Due to the need to add a fourth storey to the structure, it was decided to complete a seismic upgrade program, and construction began in 2010.

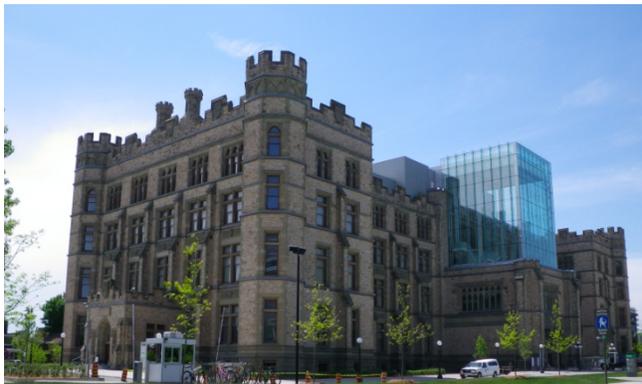
## 5.5 Victoria Memorial Museum Building<sup>6</sup>

The Victoria Memorial Museum Building (VMMB) is a Classified heritage structure and Canadian National Historic Site, located in Ottawa, Ontario. Constructed between 1905 and 1910, the building has served as home to several museums, and temporarily to the Canadian parliament, after the original Centre Block burned down in 1916. The four storey exterior walls are comprised of unreinforced stone and brick masonry with a rubble core, while the interior walls are primarily brick masonry. The floors were originally composed of terra cotta flat arches with a cementitious topping. As part of a major renovation program that began in 2000, the decision was made to seismically strengthen the building and construction was completed in 2010.

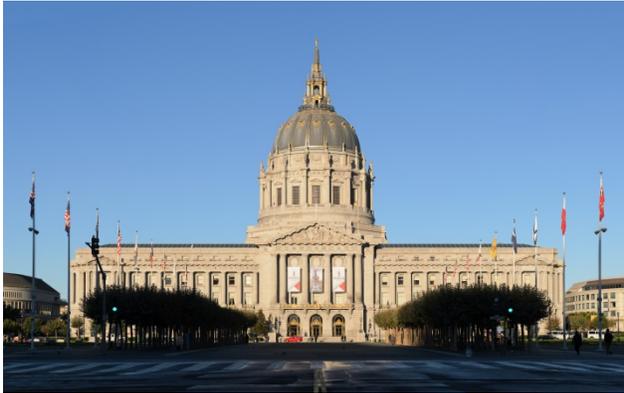
## 5.6 San Francisco City Hall<sup>7</sup>

The San Francisco City Hall was designed in 1913 to replace the original city hall that was destroyed by the 1906 San Francisco earthquake. Listed in the National Register of Historic Places, the City Hall is recognised throughout the United States as one of the best examples of classical American architecture. The main building consists of 5 stories above grade, while the dome has a height of approximately 90 m above the ground. The gravity load system consists of reinforced concrete slabs supported by steel beams and columns. Lateral loads are primarily resisted by exterior integral stone and unreinforced brick masonry walls and interior hollow clay tile walls. The City Hall was significantly damaged in the 1989 Loma Prieta earthquake but did not collapse. As a part of the repair work, the building was seismically strengthened and reopened in 1999.

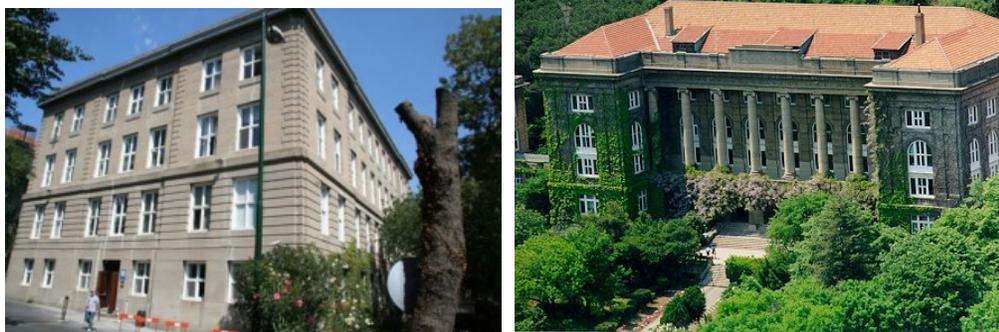
### 5.7 Sage and Gould Halls, Robert College<sup>8</sup>

Sage and Gould Halls are two historic, academic buildings located on the campus of Robert College in Istanbul, Turkey and were both constructed between 1910 and 1914. The four and five-storey buildings are both supported by similar types of construction, primarily unreinforced exterior concrete walls, unreinforced block masonry interior walls and steel columns. The exterior walls typically vary between 500 and 700 mm thick and are the primary lateral load resisting system. The floor structure consists of steel beams encased in plain concrete and reinforced concrete floors. The foundations consist of reinforced concrete strip footings bearing on rock. In 2007, a seismic assessment determined that both structures did not meet the current seismic code requirements and a retrofit plan was determined.

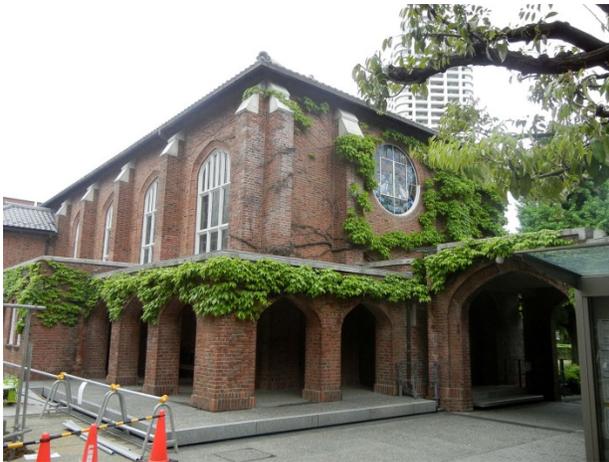
## 5.8 Rikkyo University Chapel<sup>9, 10</sup>

The Rikkyo University Chapel is one of the most architecturally significant buildings of the Rikkyo University campus in Tokyo, Japan, and was constructed in 1920. The 3 storey building is primarily comprised of unreinforced masonry walls and piers with a timber. After the buildings walls were damaged in the 1923 Kanto Great Earthquake, a thin, reinforced concrete layer was added to the inside of the masonry walls to strengthen them. However, the building was again damaged in the 1995 Hyogoken Nanbu Earthquake and a more modern seismic retrofit was completed in 1999.

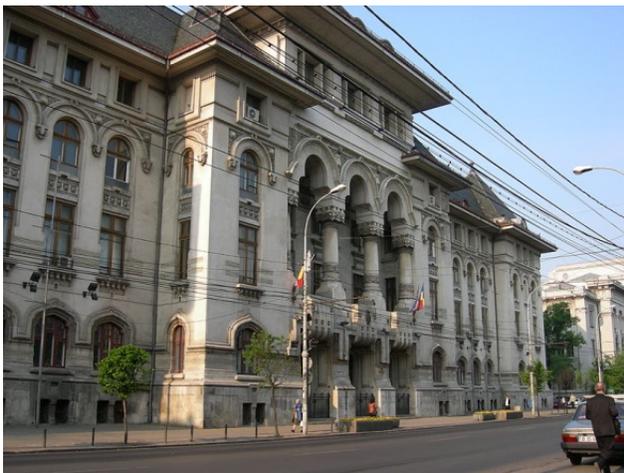
## 5.9 Bucharest City Hall<sup>11</sup>

Bucharest City Hall in Romania serves as the main municipal office of the capital city of Bucharest and was constructed between 1906 and 1911. The main building has 4 stories with a total height of approximately 21 m above grade. The floors are made of reinforced concrete slabs, which are primarily supported on unreinforced brick masonry walls that act as the lateral load resisting system. Due to the age of the structure and four past earthquakes that affected the building, it was determined that the building should be seismically upgraded and two schemes were developed. Work was anticipated to begin in 2012 but no additional literature was found to confirm that date.

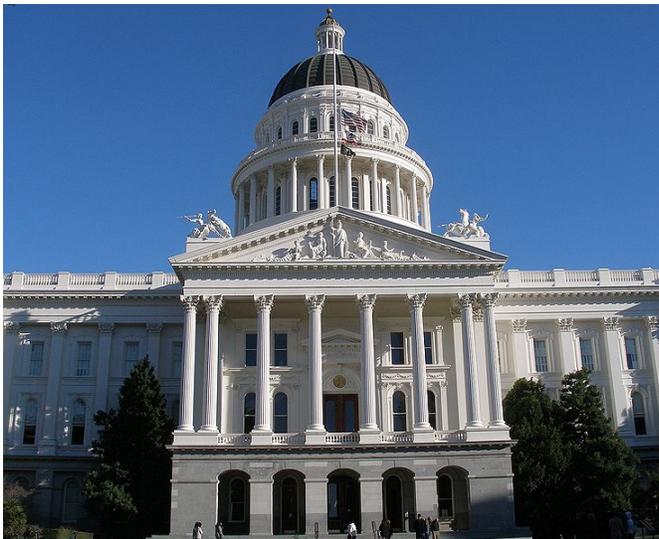
### 5.10 California State Capitol West Wing<sup>12</sup>

The California State Capitol West Wing is the primary government building of the California State government in Sacramento, which was constructed in between 1861 and 1874. The building consists of 4 stories above grade and one below grade, with a central dome that extends above a rotunda to a height of approximately 65 m. The existing lateral load system consists of unreinforced brick masonry walls, which support a floor system of shallow brick arches that span to wrought-iron beams. The brick walls are supported on unreinforced concrete spread footings. In 1972, the structure was declared a seismic hazard and was largely vacated until a seismic retrofit was completed in 1982 and the building was reopened to the public.

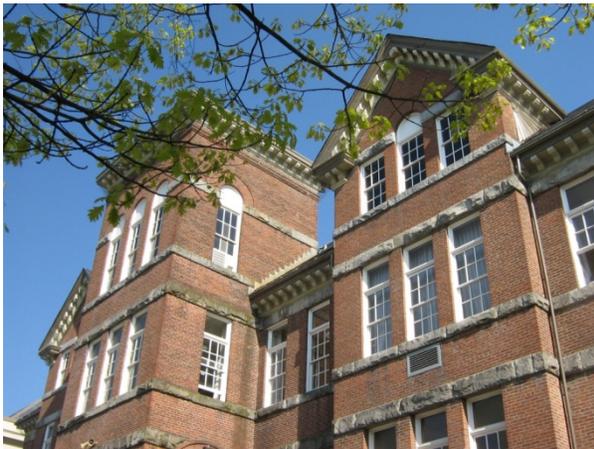
### 5.11 Lord Strathcona Elementary School, Vancouver

The Vancouver School Board's Lord Strathcona Elementary School, located in downtown Vancouver, consists of three buildings with City heritage status. The 'Junior Building', a classroom building, was constructed in 1897 and had the attic restored after a fire in 1974. The three storey building plus basement has approximately 2200 m<sup>2</sup> of floor area including the 'full height' attic. The basement perimeter walls are made of stone, while the upper floor perimeter and interior load bearing walls are made of multi-wythe brick. The floors and roof are constructed of timber construction. The school is planned for seismic upgrade, beginning in 2015. To date, the schematic design phase has been

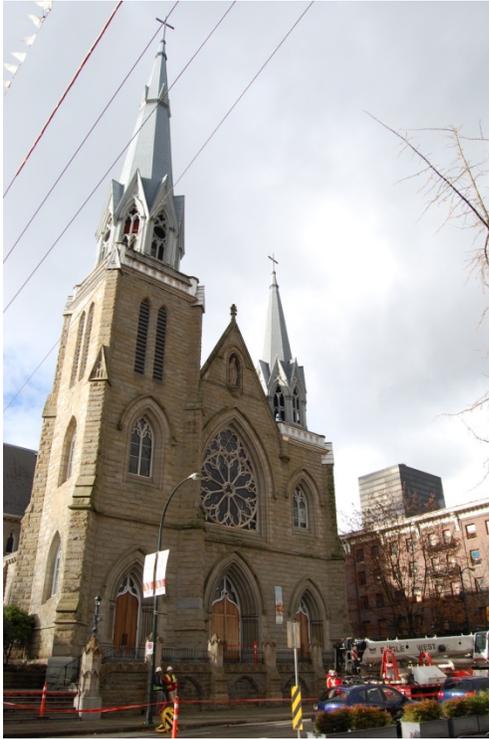
## 5.12 Holy Rosary Cathedral, Vancouver

The Roman Catholic Archdiocese of Vancouver's Holy Rosary Cathedral, located in downtown Vancouver, was constructed in 1899 and is a recognised heritage building. The cathedral is approximately 30 m by 50 m in plan, and has two towers the highest of which is approximately 37 m in height. The 3-wythe stone walls, ranging in thickness from 0.6 m to 1 m thick, consist of ashlar sandstone, rubble infill, and mortared random sandstone. The floors and roof are of timber construction. There is a partial basement, with a low crawl space beneath the majority of the ground floor slab. A voluntary seismic retrofit is proposed to commence in 2015. The work may be completed in combination with an extensive excavation beneath the cathedral to create a new full height basement.

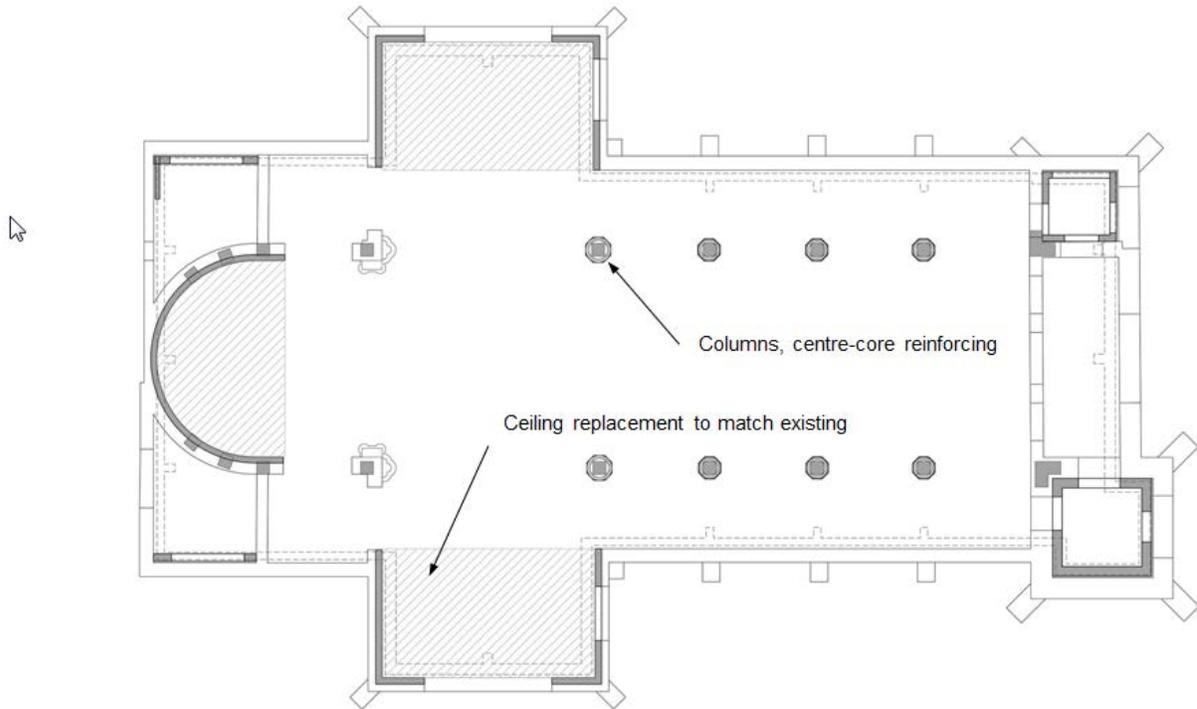
# New Shear Walls
