**Archaeological Investigation of
Preliminary Geotechnical
Boreholes for the Centre Block
Rehabilitation Project.**

Parliament Hill, Ottawa, Ontario

April 7, 2015

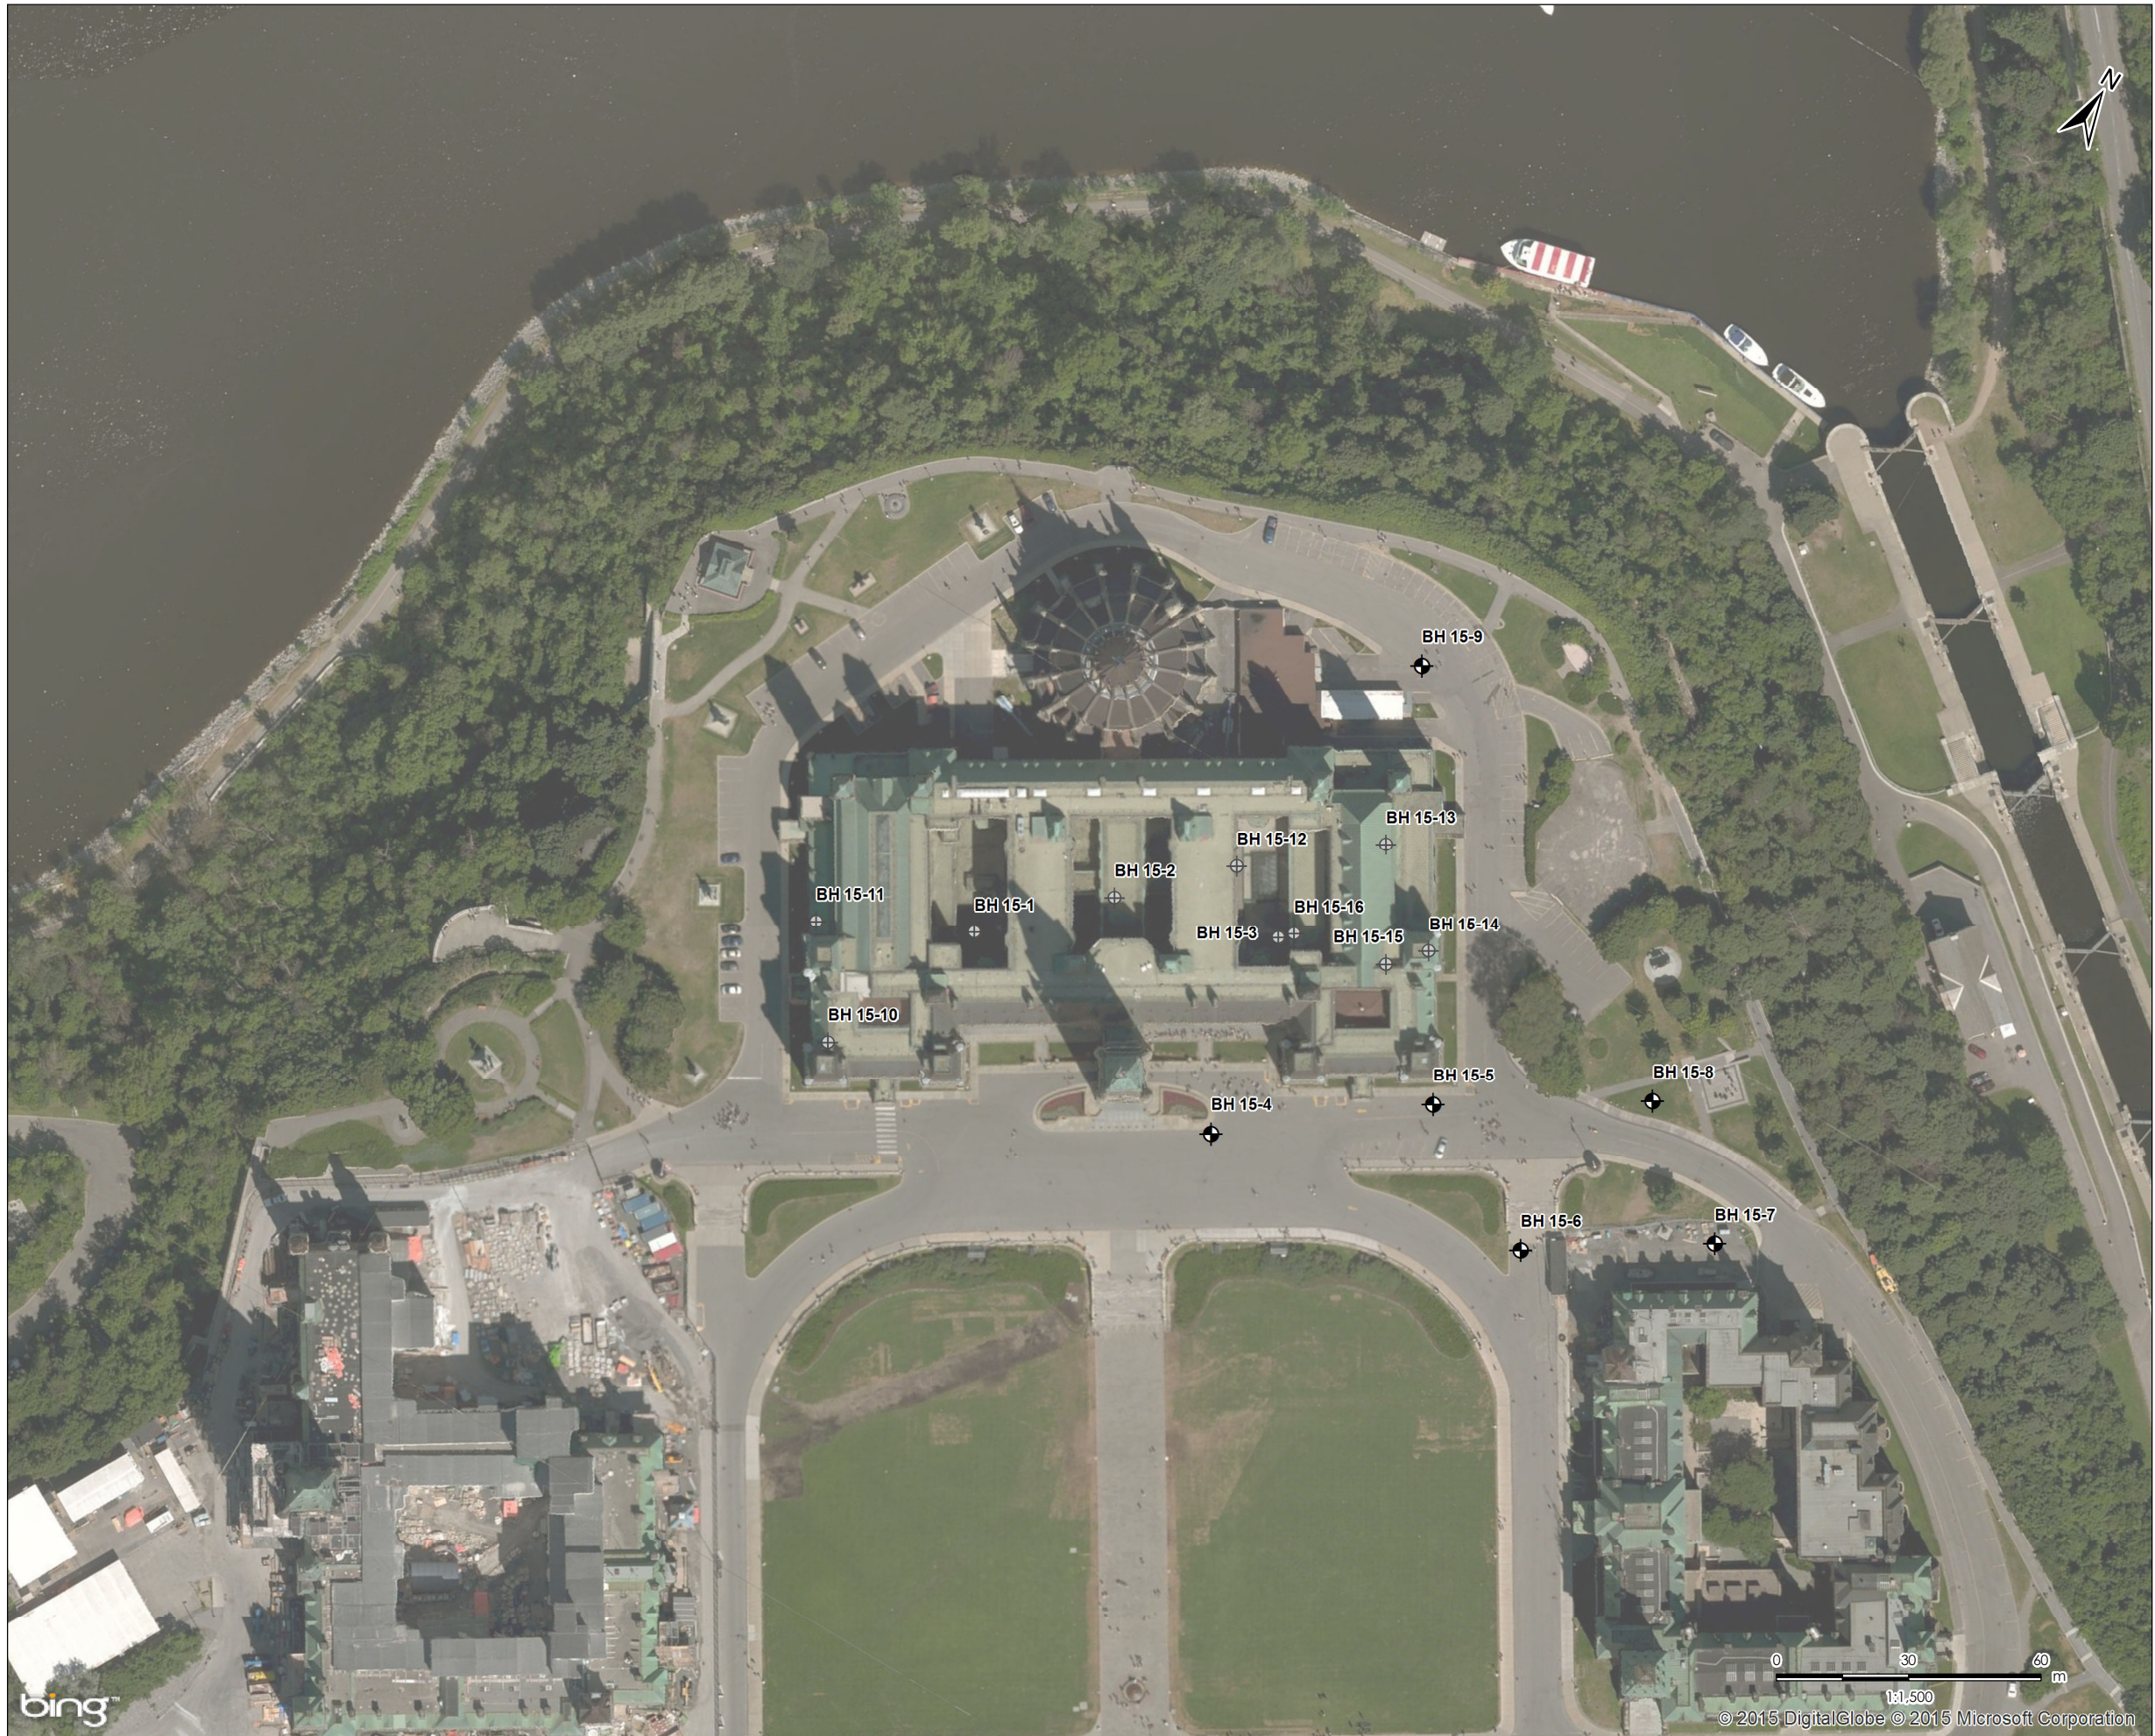
Title
**Borehole Location Map
Current Conditions**

A total of ten boreholes were drilled in the basement of Centre Block (Figures 2, 6 and 7). The location, composition and depths of the boreholes are detailed in Table 3.

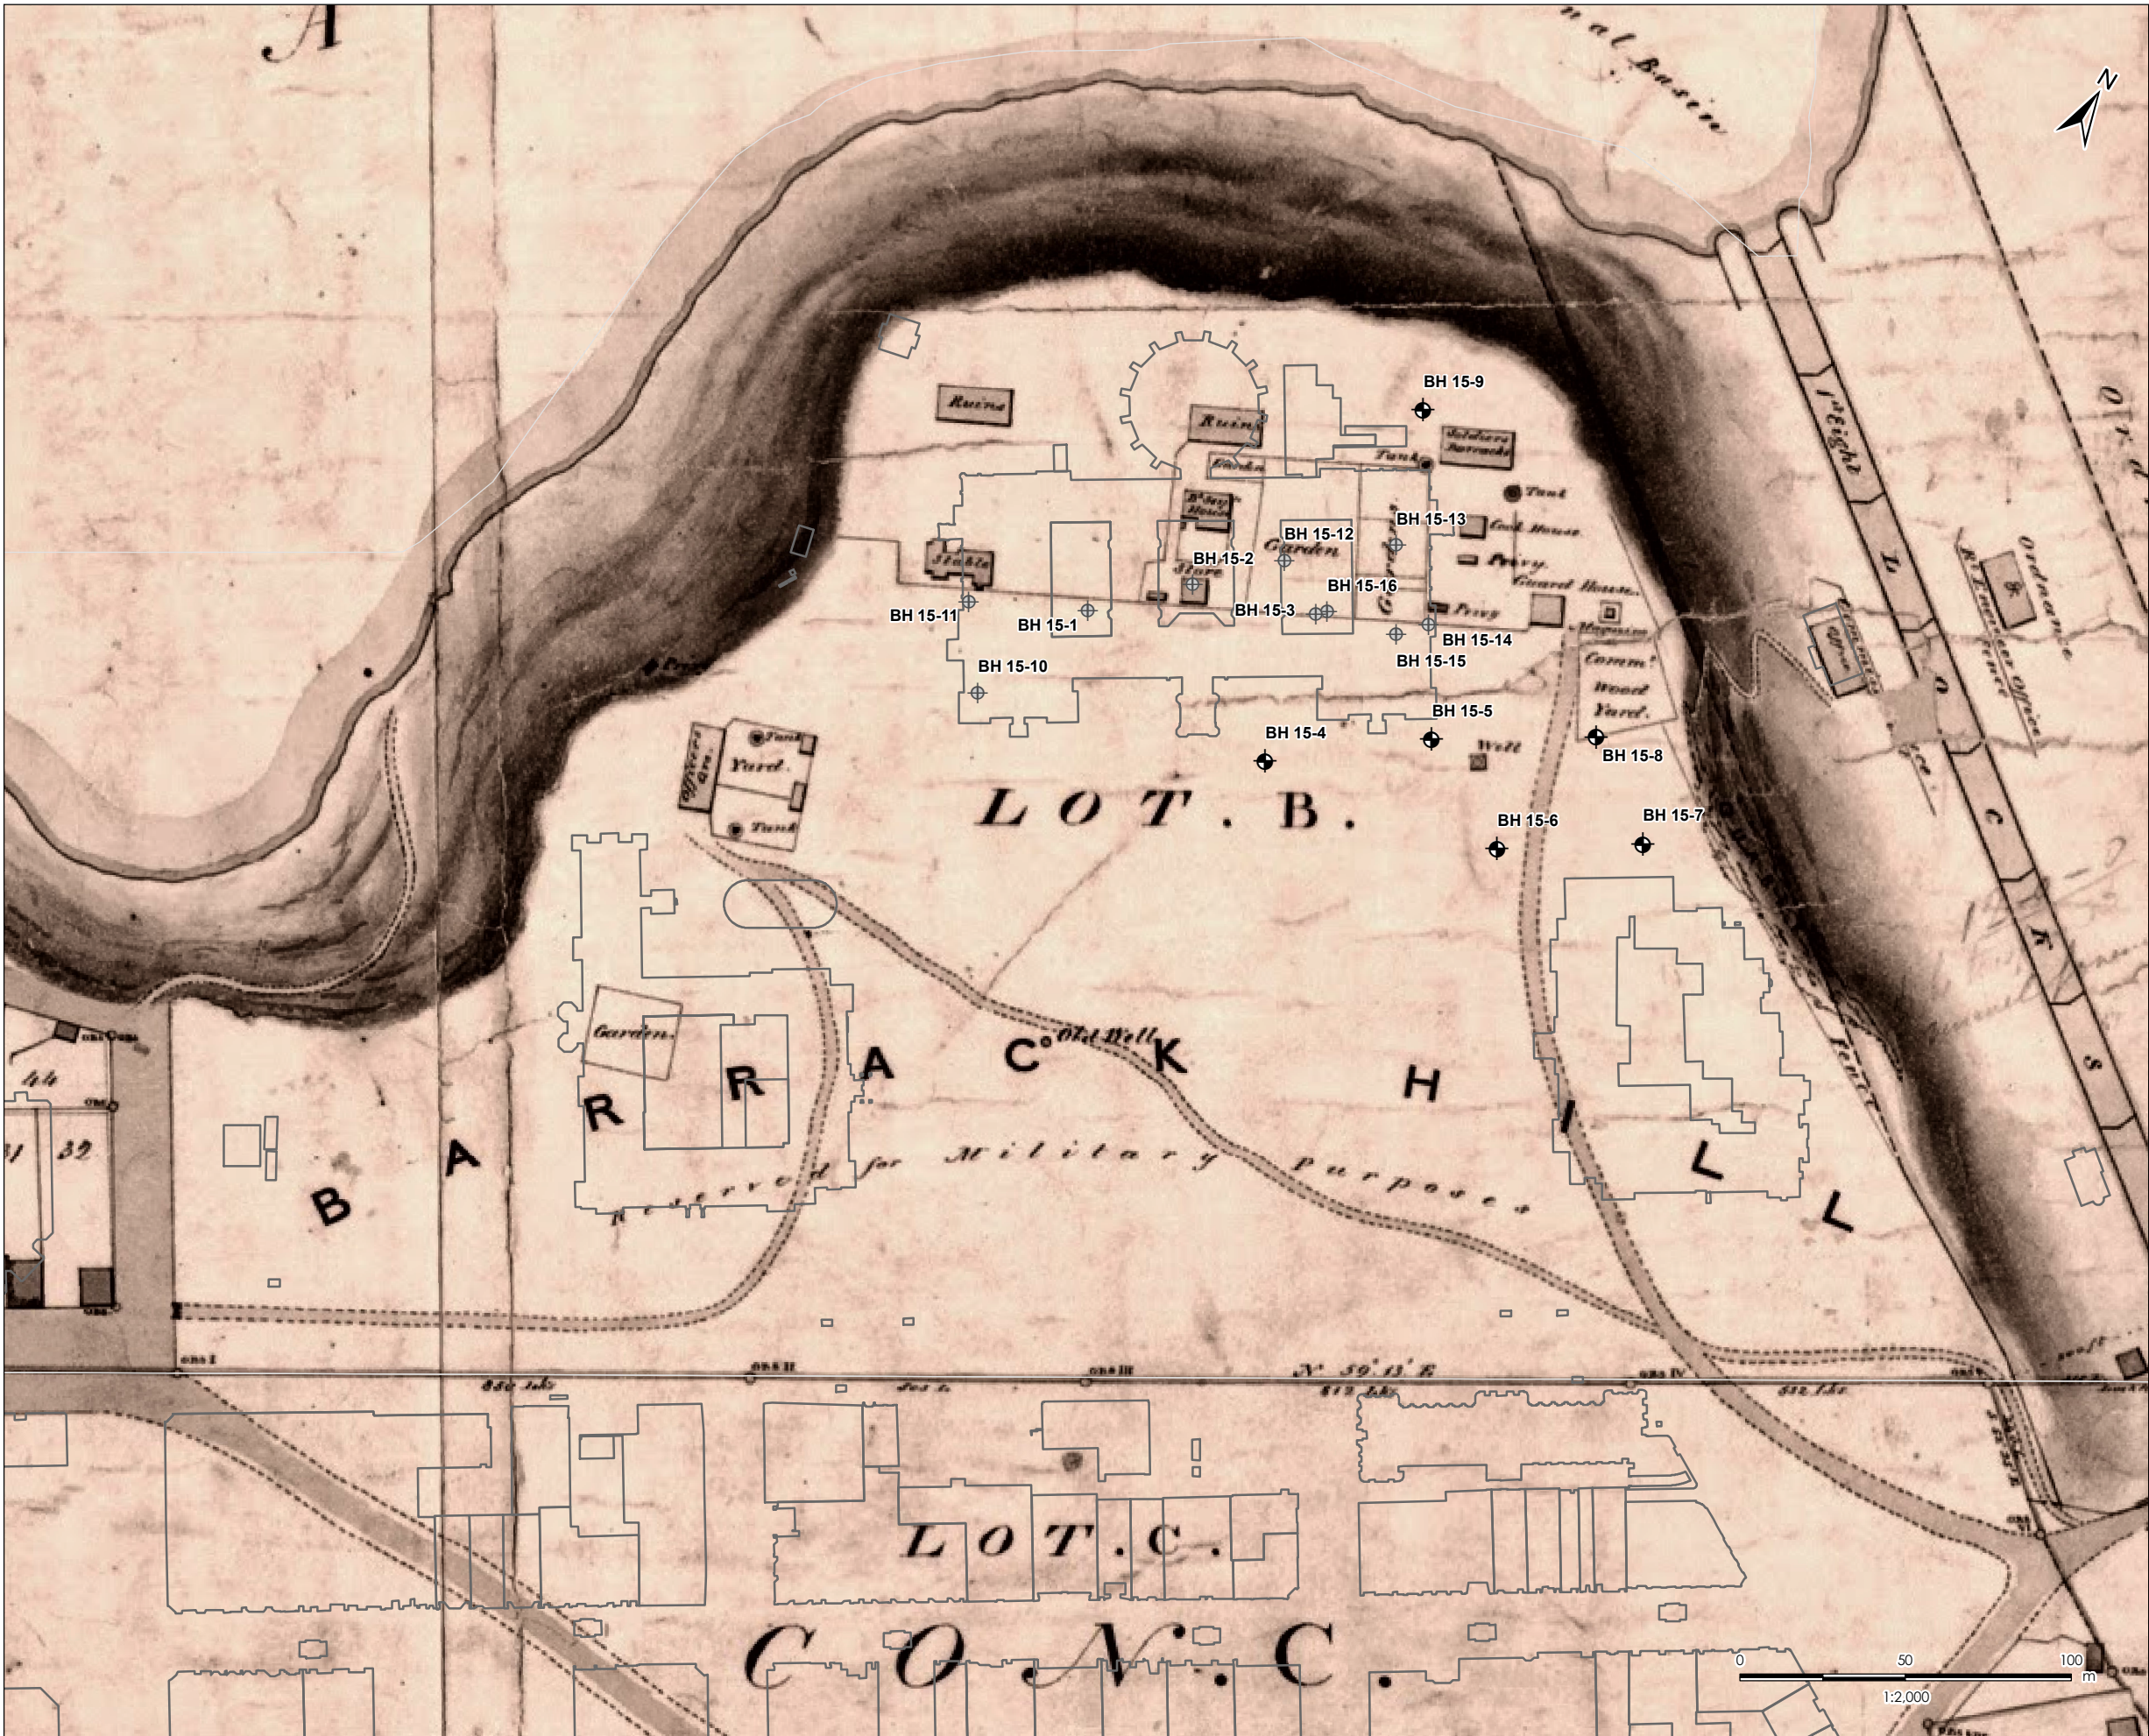
Title
**Borehole Locations over
1845 Plan of Barracks Hill**

Both historic plans of Barracks Hill show several structures within close proximity of the borehole locations. Anticipated resources from the Barracks Hill occupation of the Hill could include:

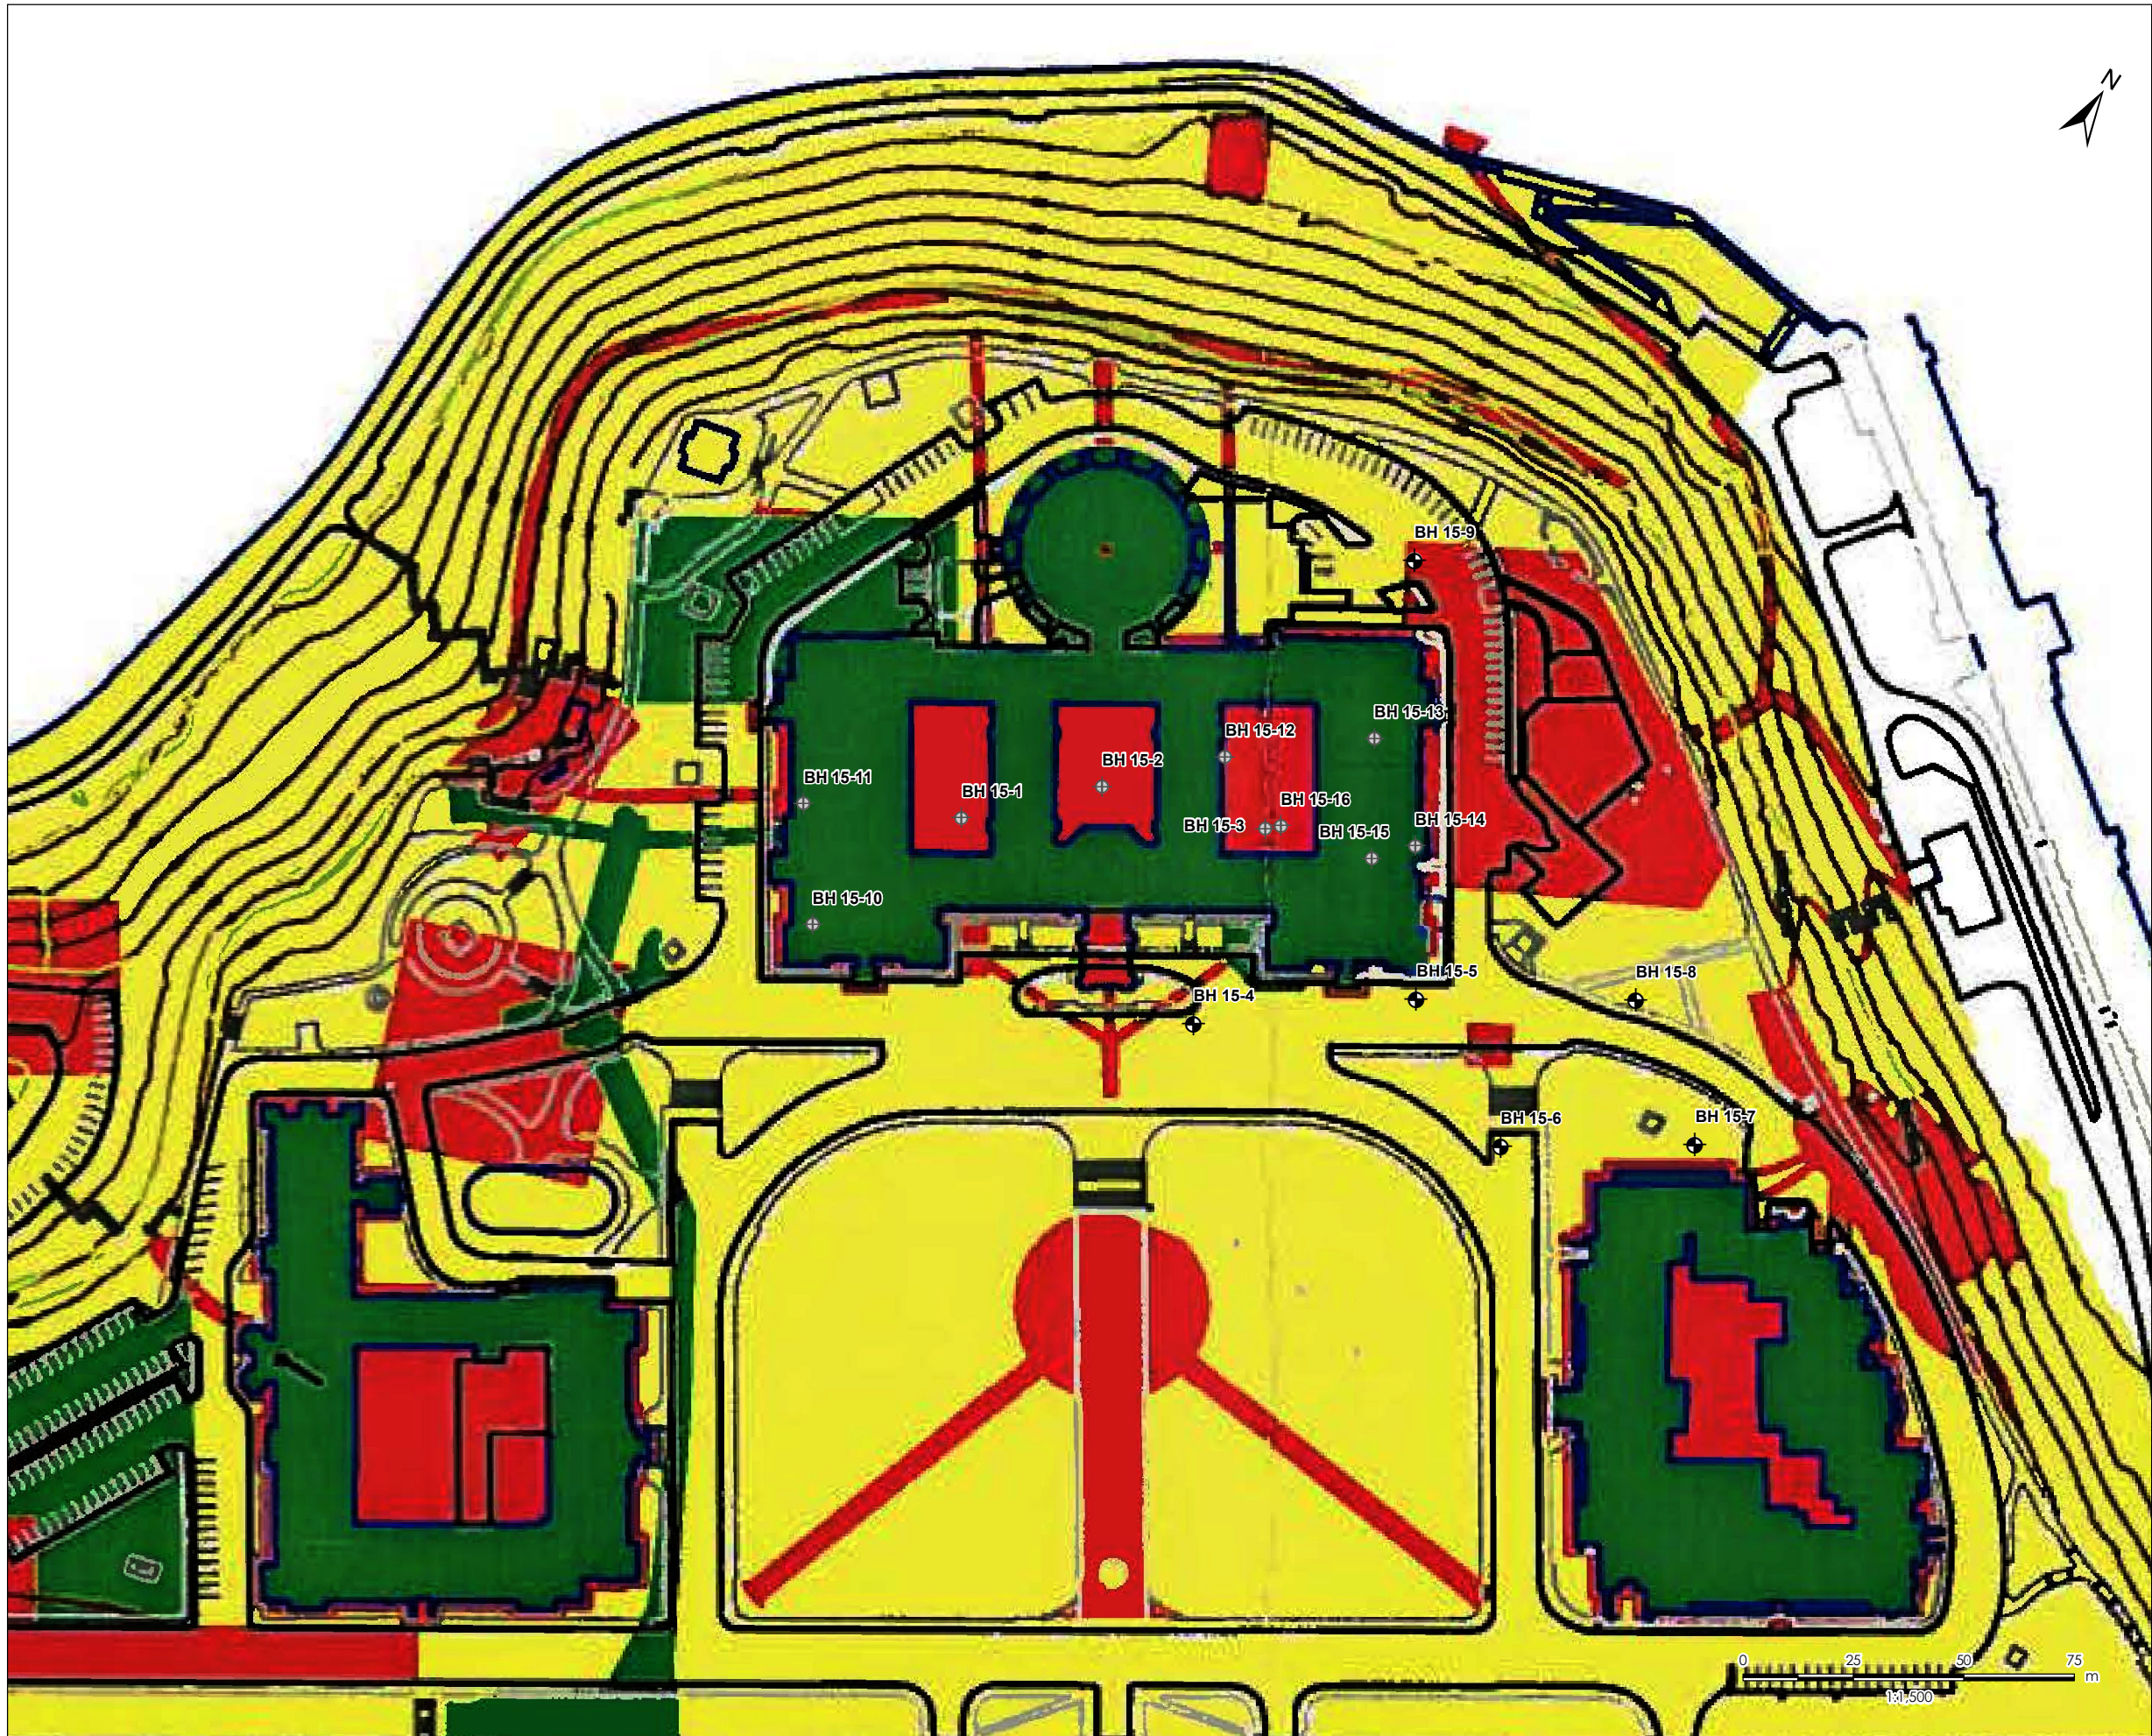
In December 2005 an Archaeological Potential map was completed that showed areas of archaeological potential as well areas where archaeological investigations have been undertaken (Figure 6) The 2005 map shows the interior of Centre Block as either not requiring archaeological assessment (green) or where archaeological investigations are recommended (red). This 2005 map reflects a misunderstanding of the Centre Block Building. The courtyards within the building are shown as red, and recommended for archaeological assessment, but these courtyards sit on the first floor and the basement of the building extends beneath (Nixon 2015). All but one exterior borehole (BH 15-9) are shown in areas that require archaeological monitoring. Figures 4 – 8 show the locations of the boreholes over historic plans, aerial photos and potential mapping. Because the interior boreholes are in areas of extensive disturbance the focus is on the exterior boreholes.

- Legend**
- Exterior Borehole
 - Interior Borehole
- Archaeological Potential (City of Ottawa 2005)**
- No Archaeological Work Required
 - Archaeological Monitoring
 - Archaeological Investigations

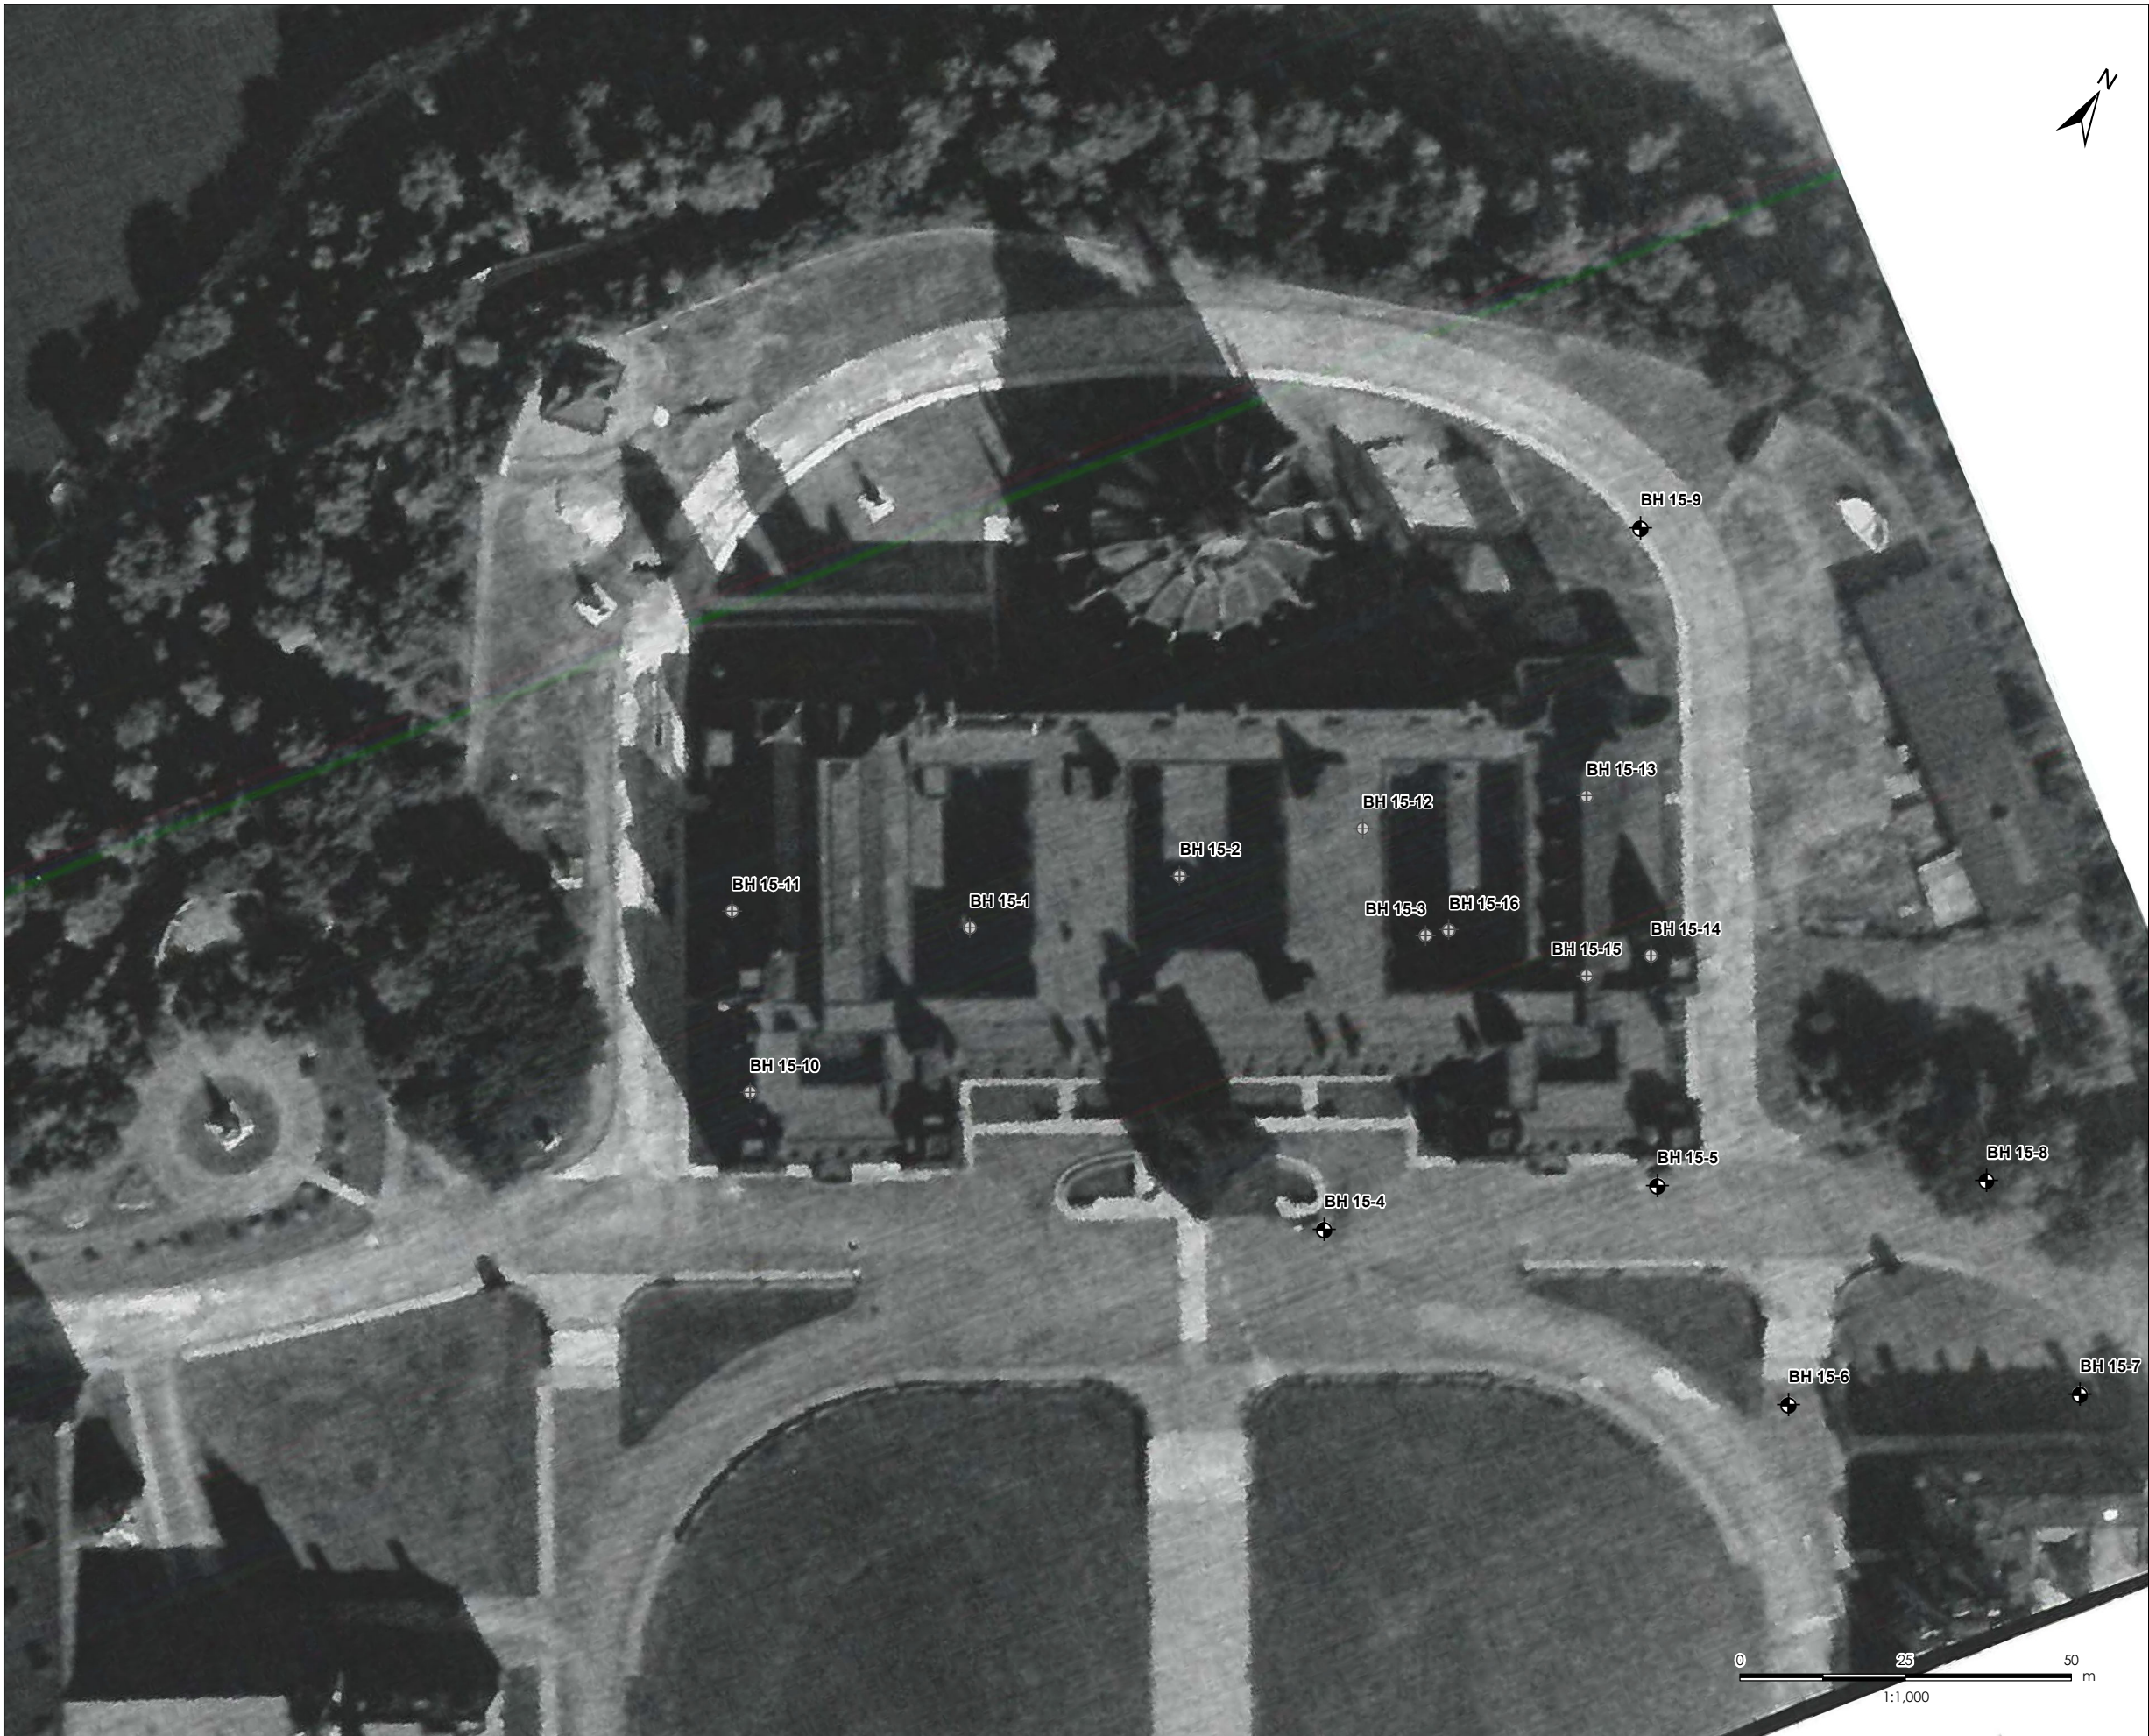
A 1923 aerial photograph (Figure 7) shows the study area in similar conditions to present-day conditions. A building presumably associated with the construction of the Centre Block building is shown in the study area east of Centre Block. Anticipated resources from the construction of the Parliament buildings could include temporary construction buildings as well as associated infrastructure and building materials.

The 1923 aerial photography (Figure 7) shows the study area in similar conditions to current conditions. Two buildings associated with the construction of the Centre Block building are shown in the study area east of Centre Block. The larger building to the south is likely the model, carpenter and blacksmith shop, while the smaller northern building is likely the office of the general contractor of the project, Lyall & Sons (Nixon 2015). Anticipated resources from the construction of the Parliament buildings could include these and other temporary construction buildings as well as associated infrastructure and building materials.

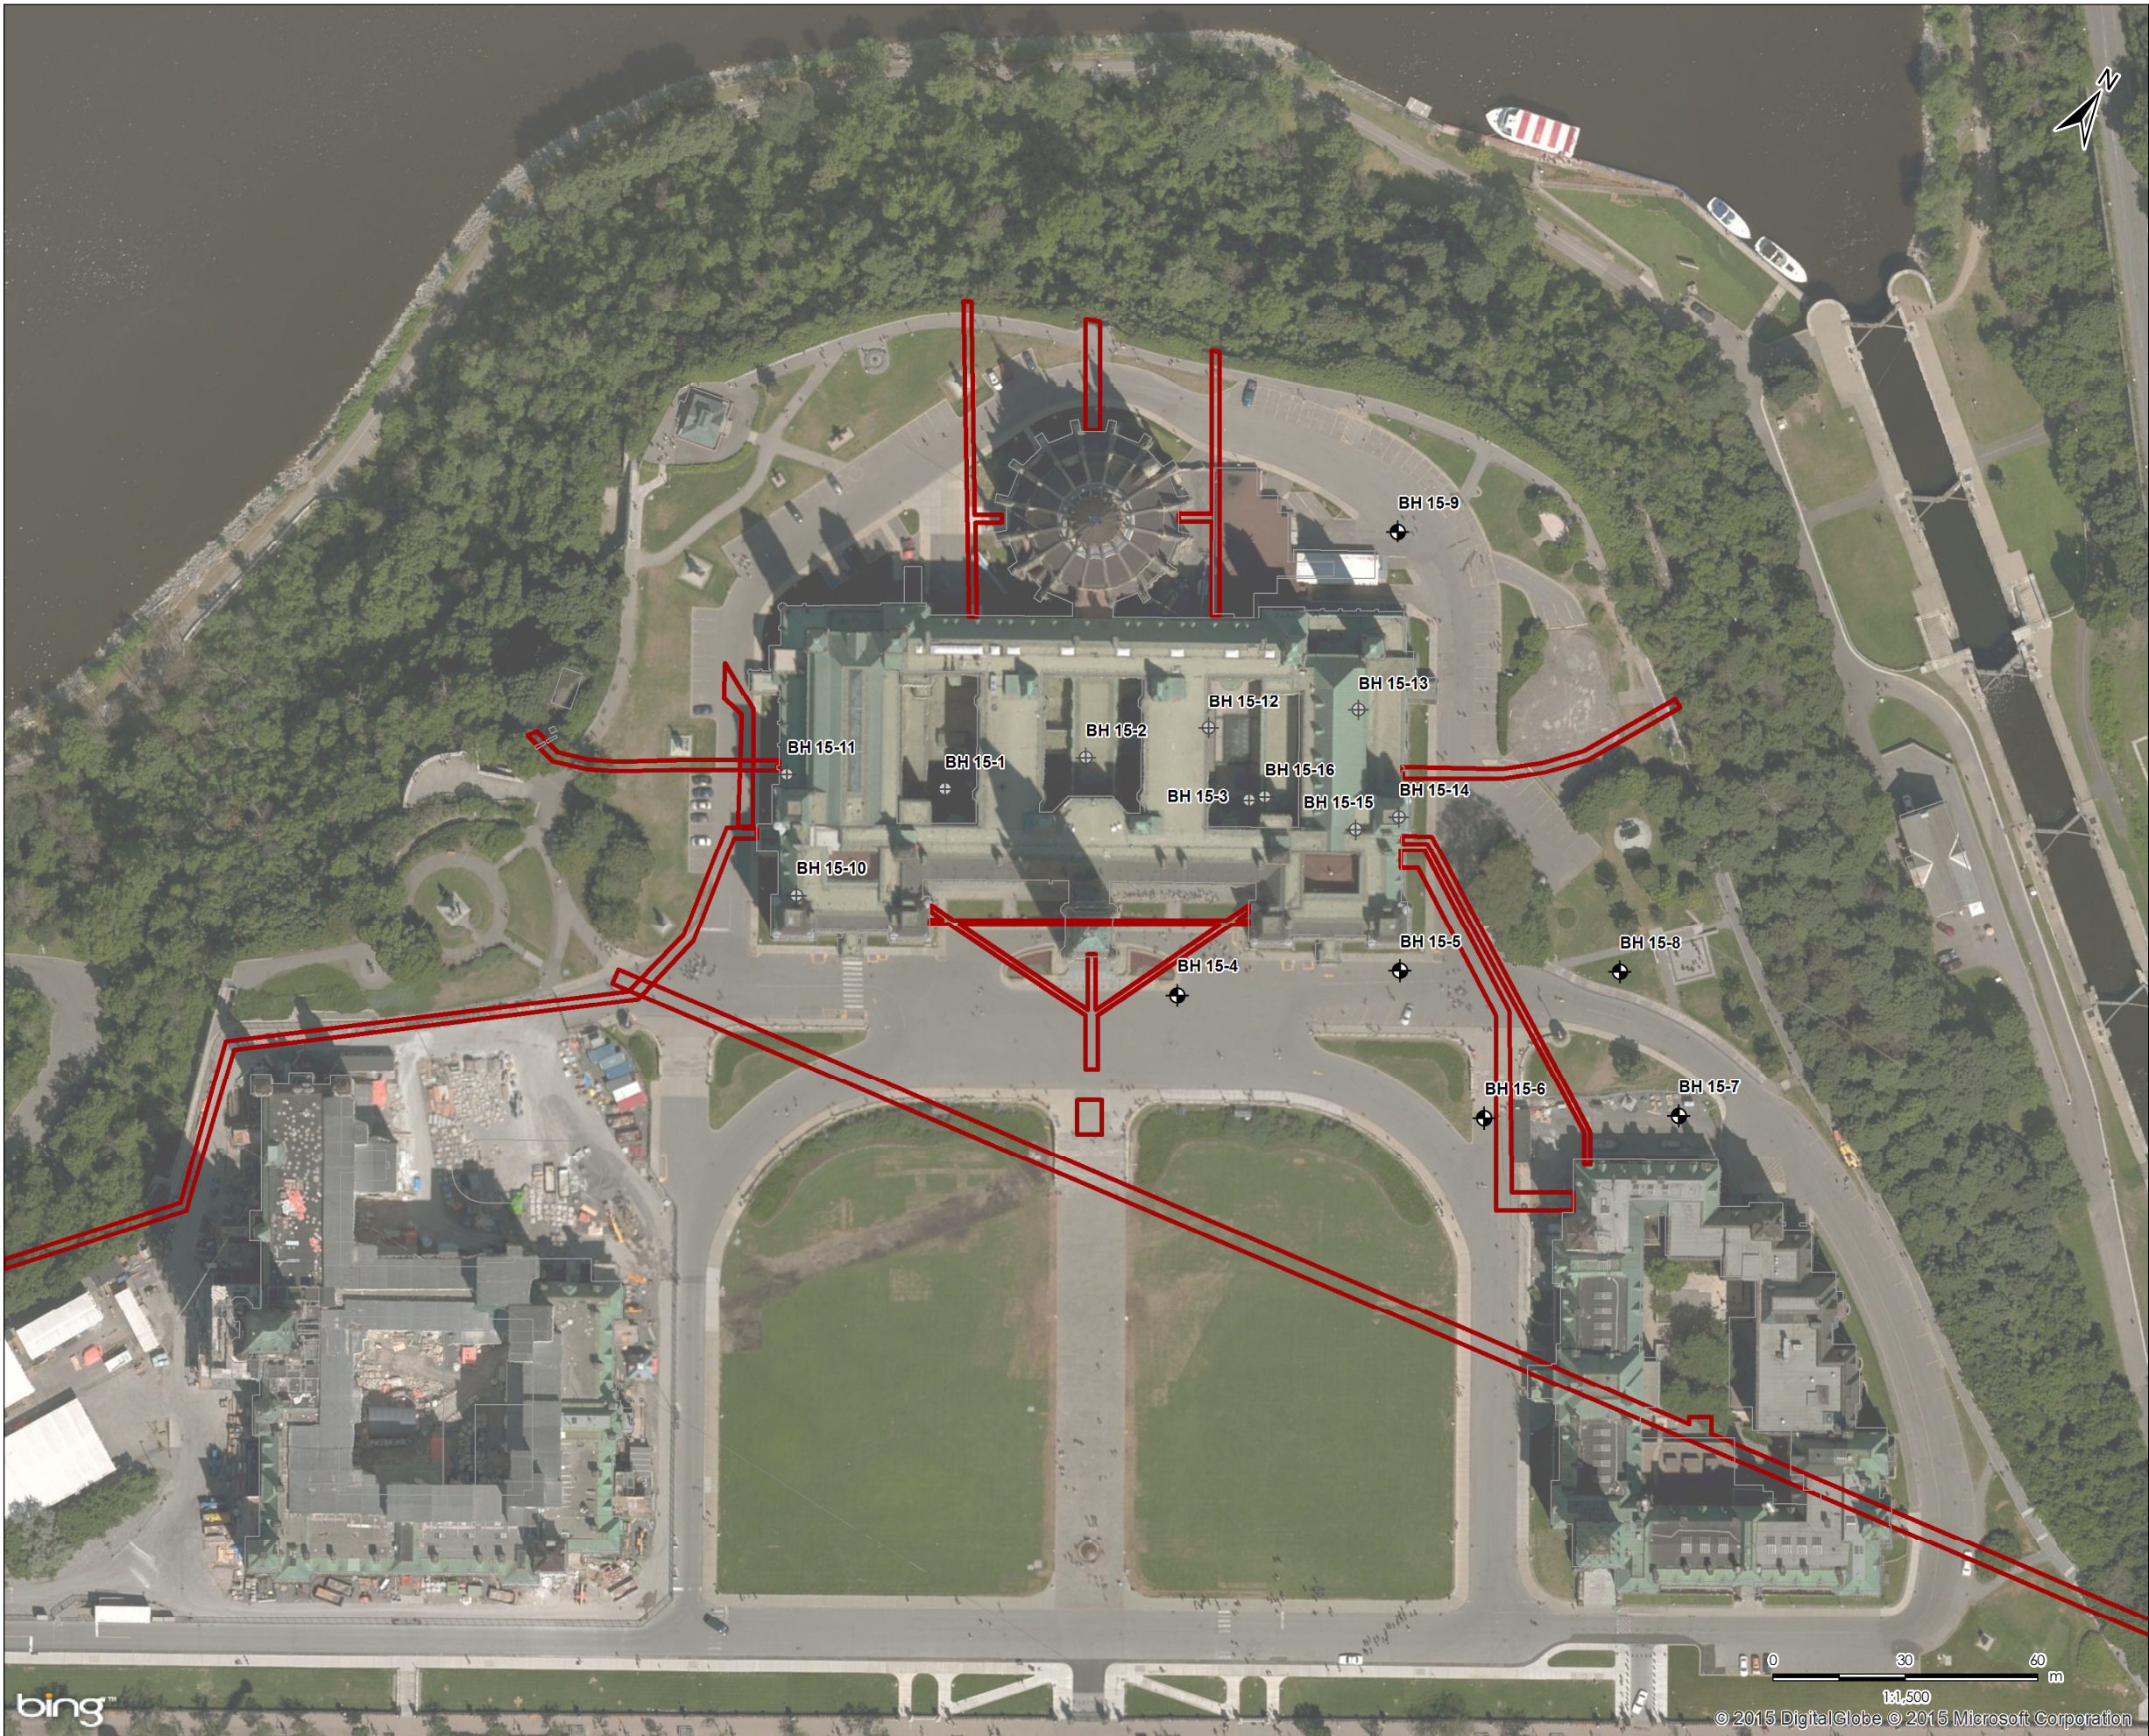
The infrastructure of the Parliament Buildings includes ventilation tunnels that connect all three Parliament buildings and most have been filled in to protect against collapse and for security. Figure 8 shows the approximate locations of the tunnels. Tunnels connecting Centre and East Blocks, spanning from in front of the Peace Tower to the east side of Centre Block, from the east side of Centre Block to the east edge of the hill and from the Parliamentary Library are located within the study area and could be encountered during construction of the project.
