**SUPPLEMENTAL SEISMIC REPORT  
FOR  
CENTRE BLOCK, PARLIAMENT HILL**

**Work Package 3**

14Y160-113A

May 2015

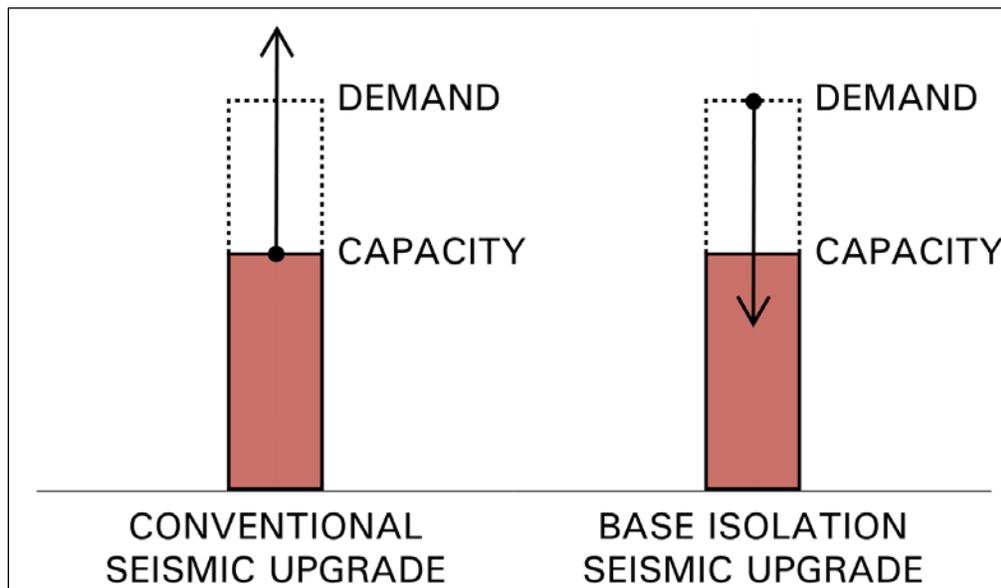
Figure 5-1: Conceptual Seismic Upgrade Strategies

The potential seismic upgrade options for the Centre Block structure can be grouped into two general categories of either a conventional strengthening upgrade or base isolation. The conceptual difference between the two strategies is demonstrated in Figure 5-1. Conventional strengthening strategies aim to increase the capacity of a structure to resist seismic demands by either inserting new seismic force resisting elements into the structure and/or augmenting the existing seismic force resisting elements. A base isolation strategy aims to reduce the seismic demands on a structure rather than increase its capacity by preventing seismic loads from being transmitted to the structure from the underlying founding material. The insertion of damping braces into an existing structure is also a strategy for reducing seismic demand; however, it is not a viable option for the Centre Block due to the high stiffness of the existing structure. A brief, qualitative discussion of a Conventional strengthening upgrade or a base isolation upgrade examining the relative feasibility, advantages, disadvantages, risks and heritage impacts is provided below.

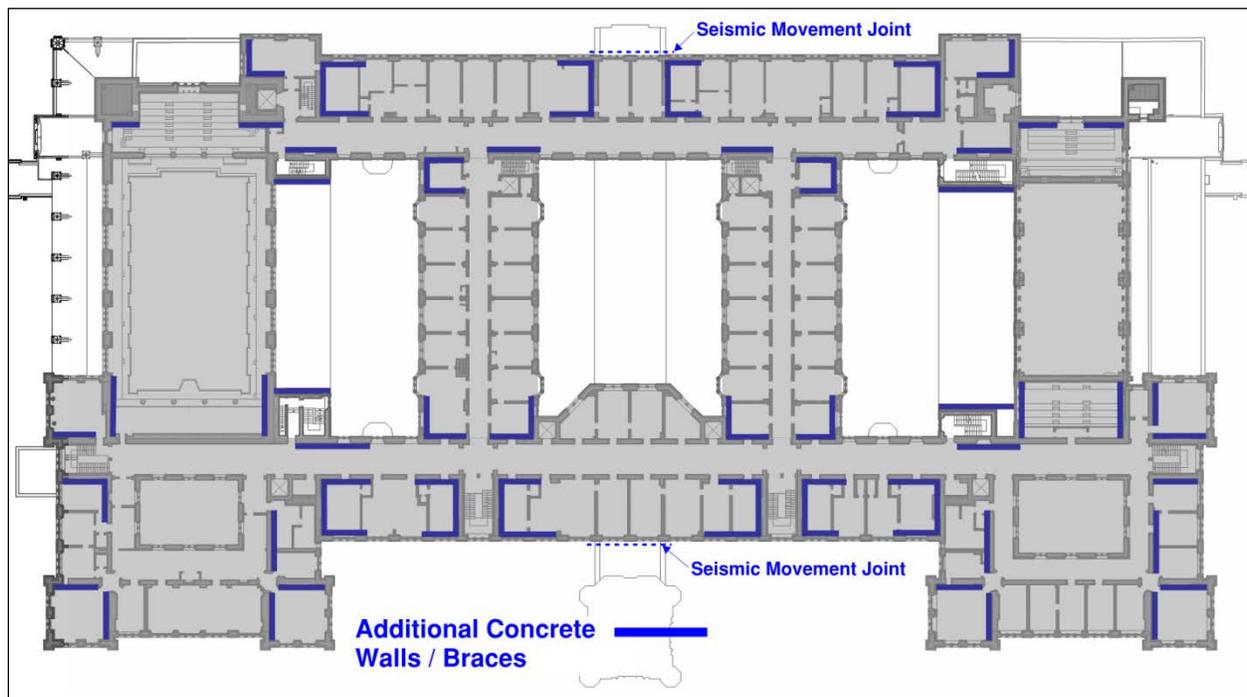
**Figure 5-2:** Conventional Seismic Upgrade – Insertion of Walls/Braces (Conceptual Only)

- 1) Construct footings at basement level for new wall/brace frame elements;
- 2) Shore floor/roof structures at locations of new walls/braces;
- 3) Locally cut/disconnect the floor/roof structure at the face of an existing masonry wall to allow for the construction of a continuous wall/steel brace frame;
- 4) Form concrete walls /insert steel columns and braces; and
- 5) Re-support floor/roof structure at face of new walls/brace frames.

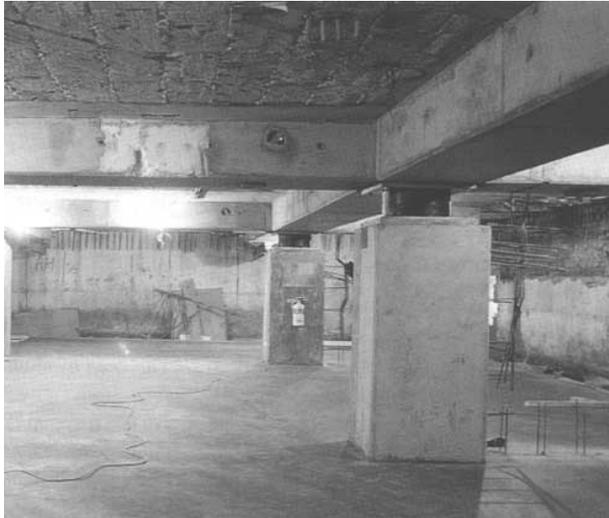
Figure 5-3: Example of seismic isolators at underside of a ground floor slab

The isolation plane can be located at the base of a structure, between the footings and the founding material. Alternatively, for structures with a basement level, the isolation plane can be located somewhere above the base of the structure e.g. at the underside of the ground floor level. An example of this application is shown in Figure 5-3.

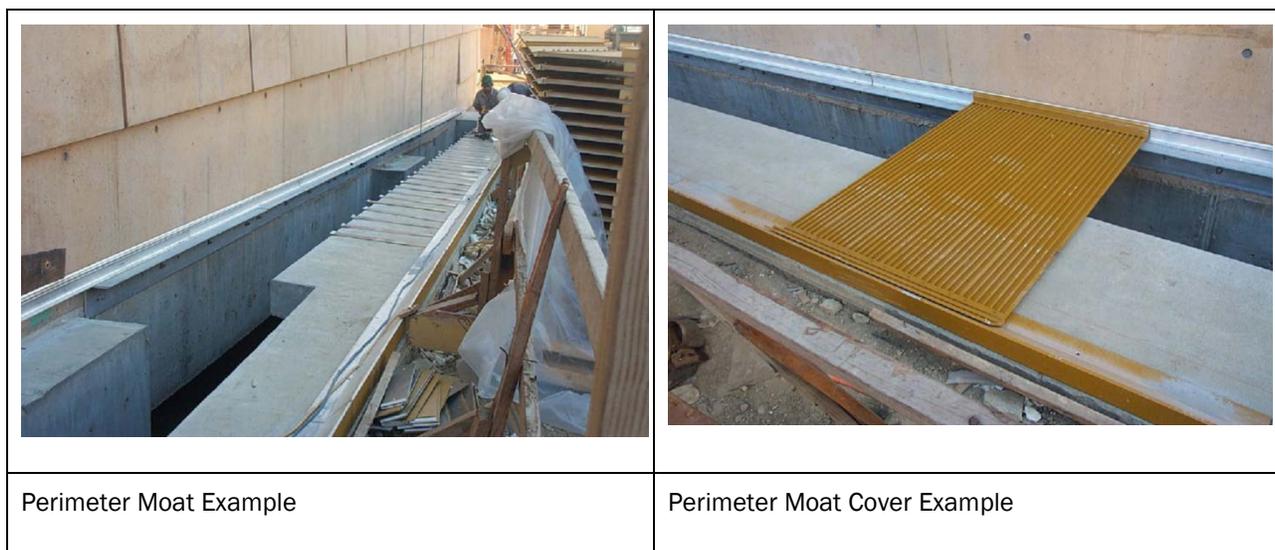
Figure 5-4: Example of Base Isolation Perimeter Moat Construction

For structures with the isolation plane located below grade, this typically requires a “moat” to be constructed around the building to allow for the lateral displacement of the isolators. Figure 5-4 provides an example of a base isolation moat in the process of being constructed around a base isolated building. The finished condition, with the moat covered and concealed is shown in Figure 5-5.

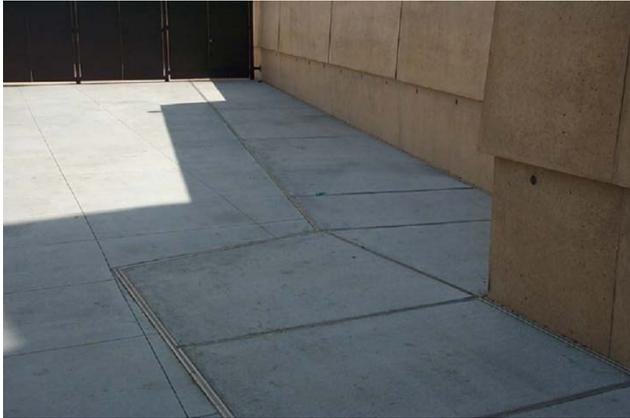
Figure 5-5: Example of finished base Isolation perimeter moat condition

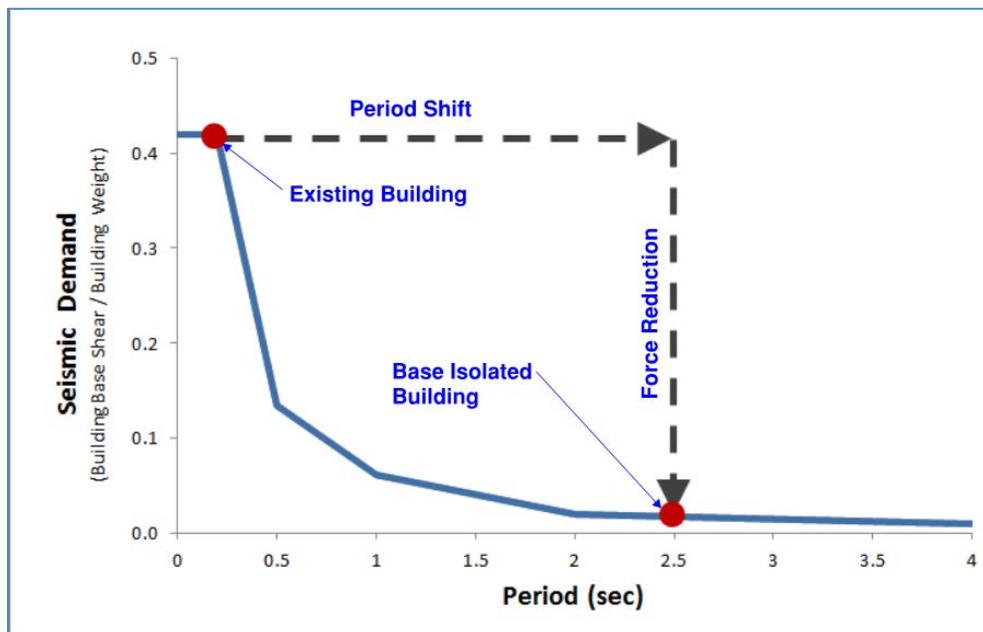
Figure 5-6: Potential Base Isolation Seismic Demand Reduction
