Geotechnical Report

Centre Block Project:
Seismic Upgrade
Visitor Welcome Centre Phases 2 & 3
East Block Underground Services
(EBUS)
Parliament Hill, Ottawa, ON

Prepared by:
Stantec Consulting Ltd.
400-1331 Clyde Avenue
Ottawa, ON K2C 3G4

April 2015

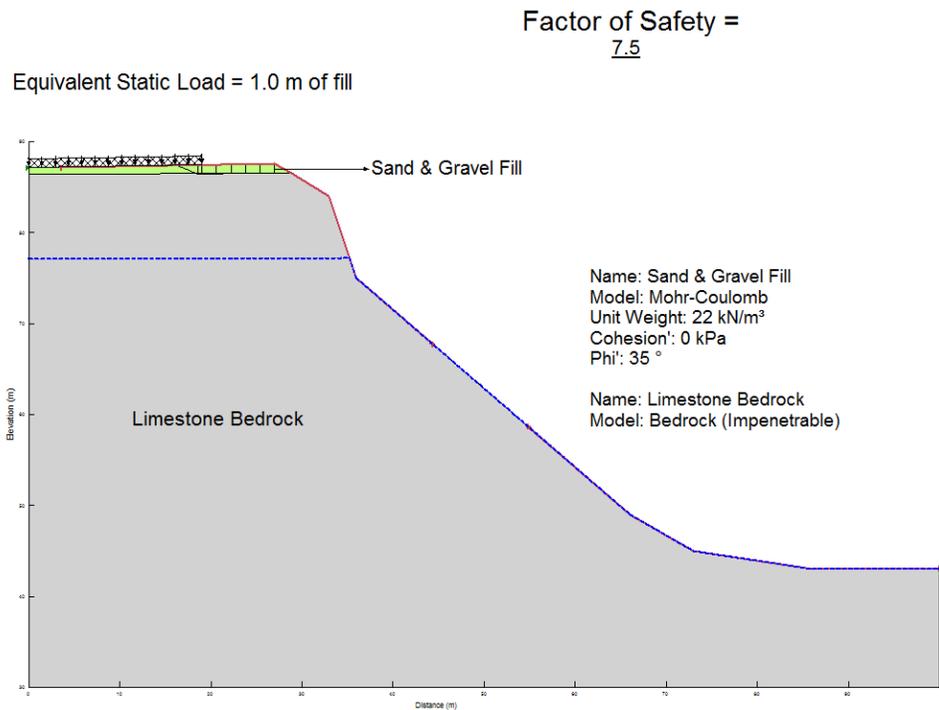
Figure 8.3: Slope/W Global Stability Analysis Output for Drained Conditions

Slope stability analysis was carried out using the GeoStudio 2012 SLOPE/W computer modeling software. The Morgenstern-Price method as presented in the SLOPE/W software was used for the stability modeling.

It is recommended that a slope stability analysis be performed on this slope once details are known regarding construction equipment loads and placement. Since the actual staging location and loading is unknown, an accurate slope stability analysis could not be performed at this time. However, based on the contours shown on drawings provided by PWGSC, a preliminary global slope stability check was carried out on one cross-section located northeast of the Centre Block building at Section A-A (See Drawing No.3). Section A-A is considered to be within the most critical area due to the grade of the slope itself. Figures 8.3 and 8.4 show the Slope/W outputs for drained and seismic conditions, respectively.

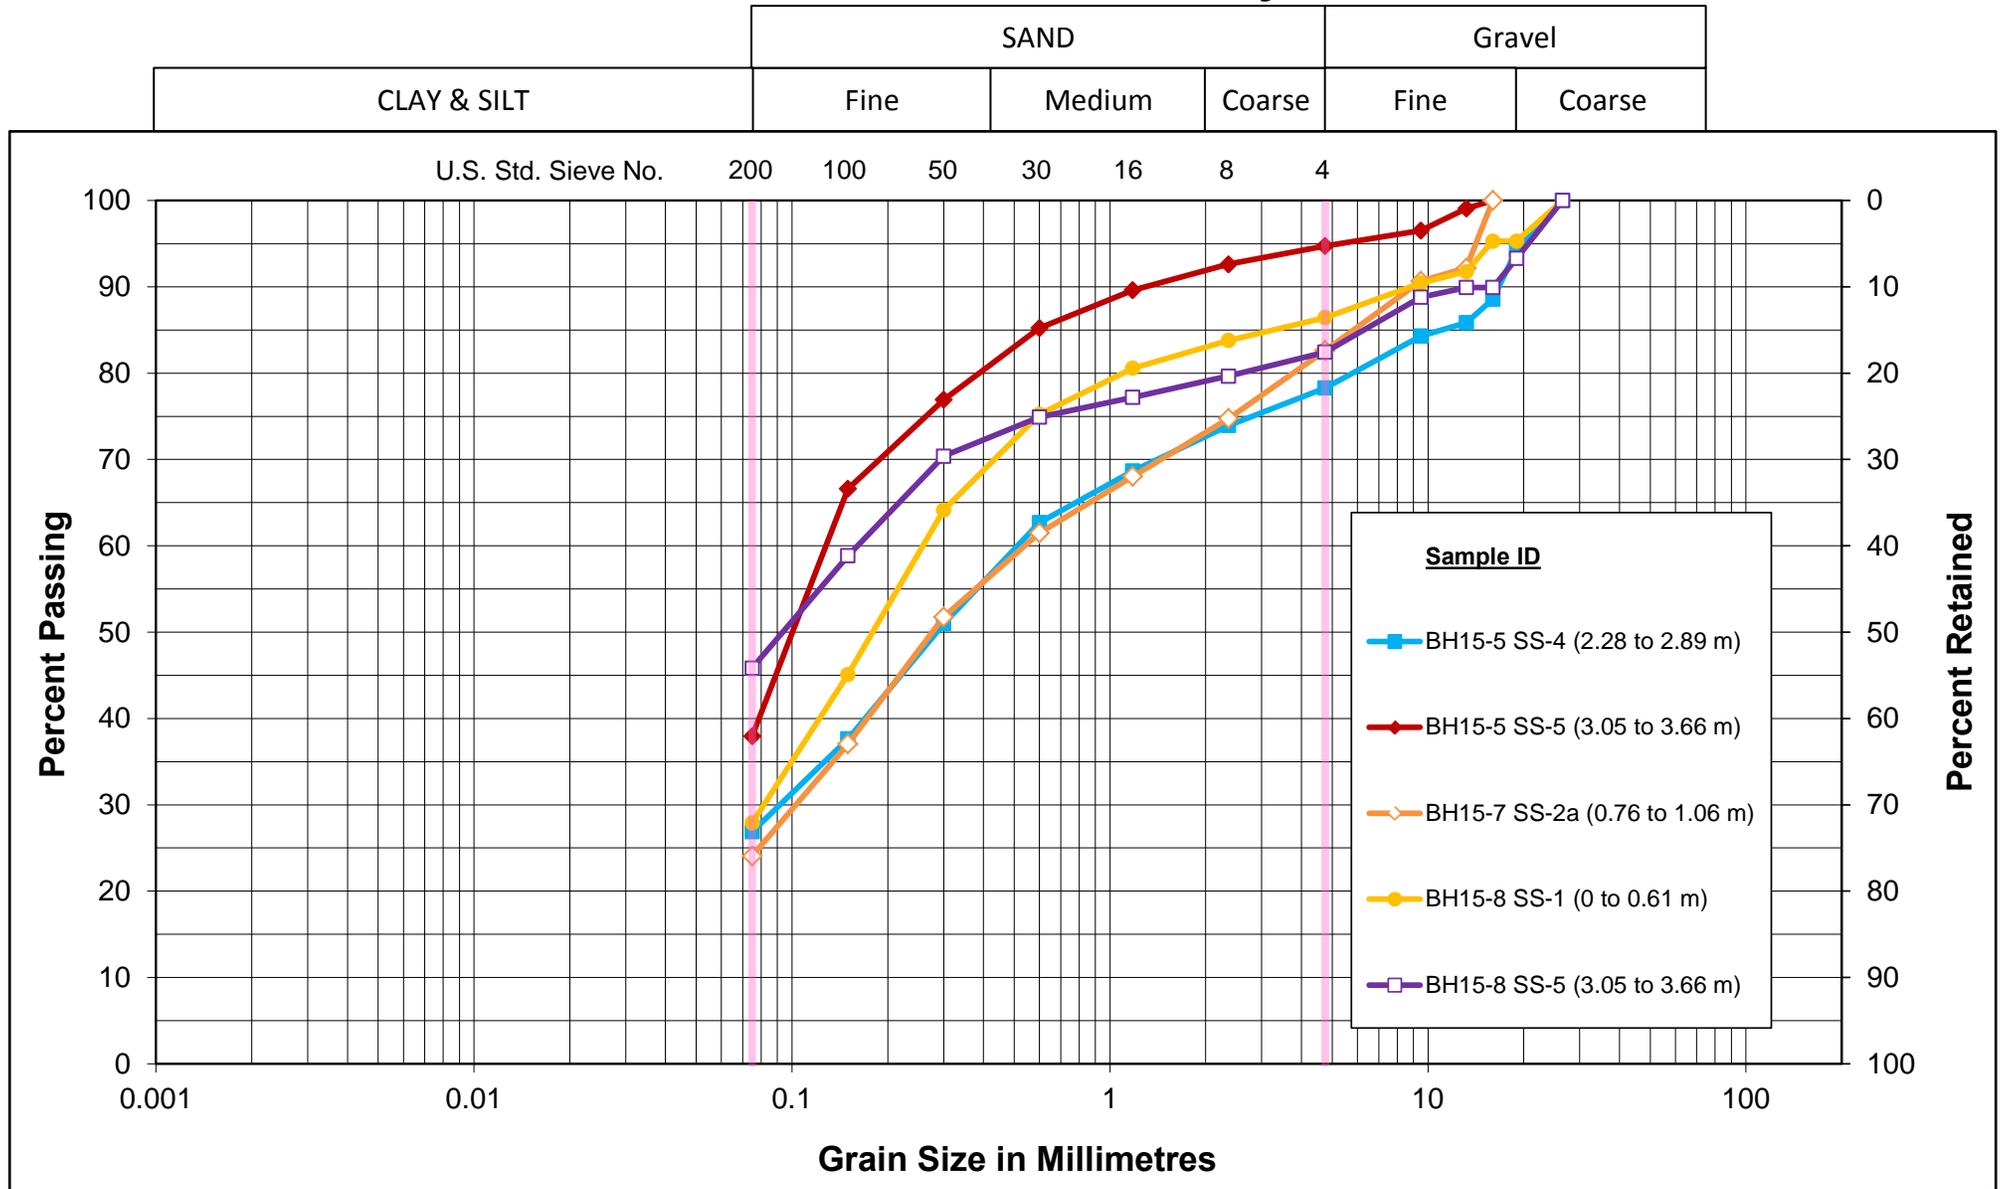
Figure No. 1

GRAIN SIZE DISTRIBUTION
FILL: Silty Sand (SM) with gravel

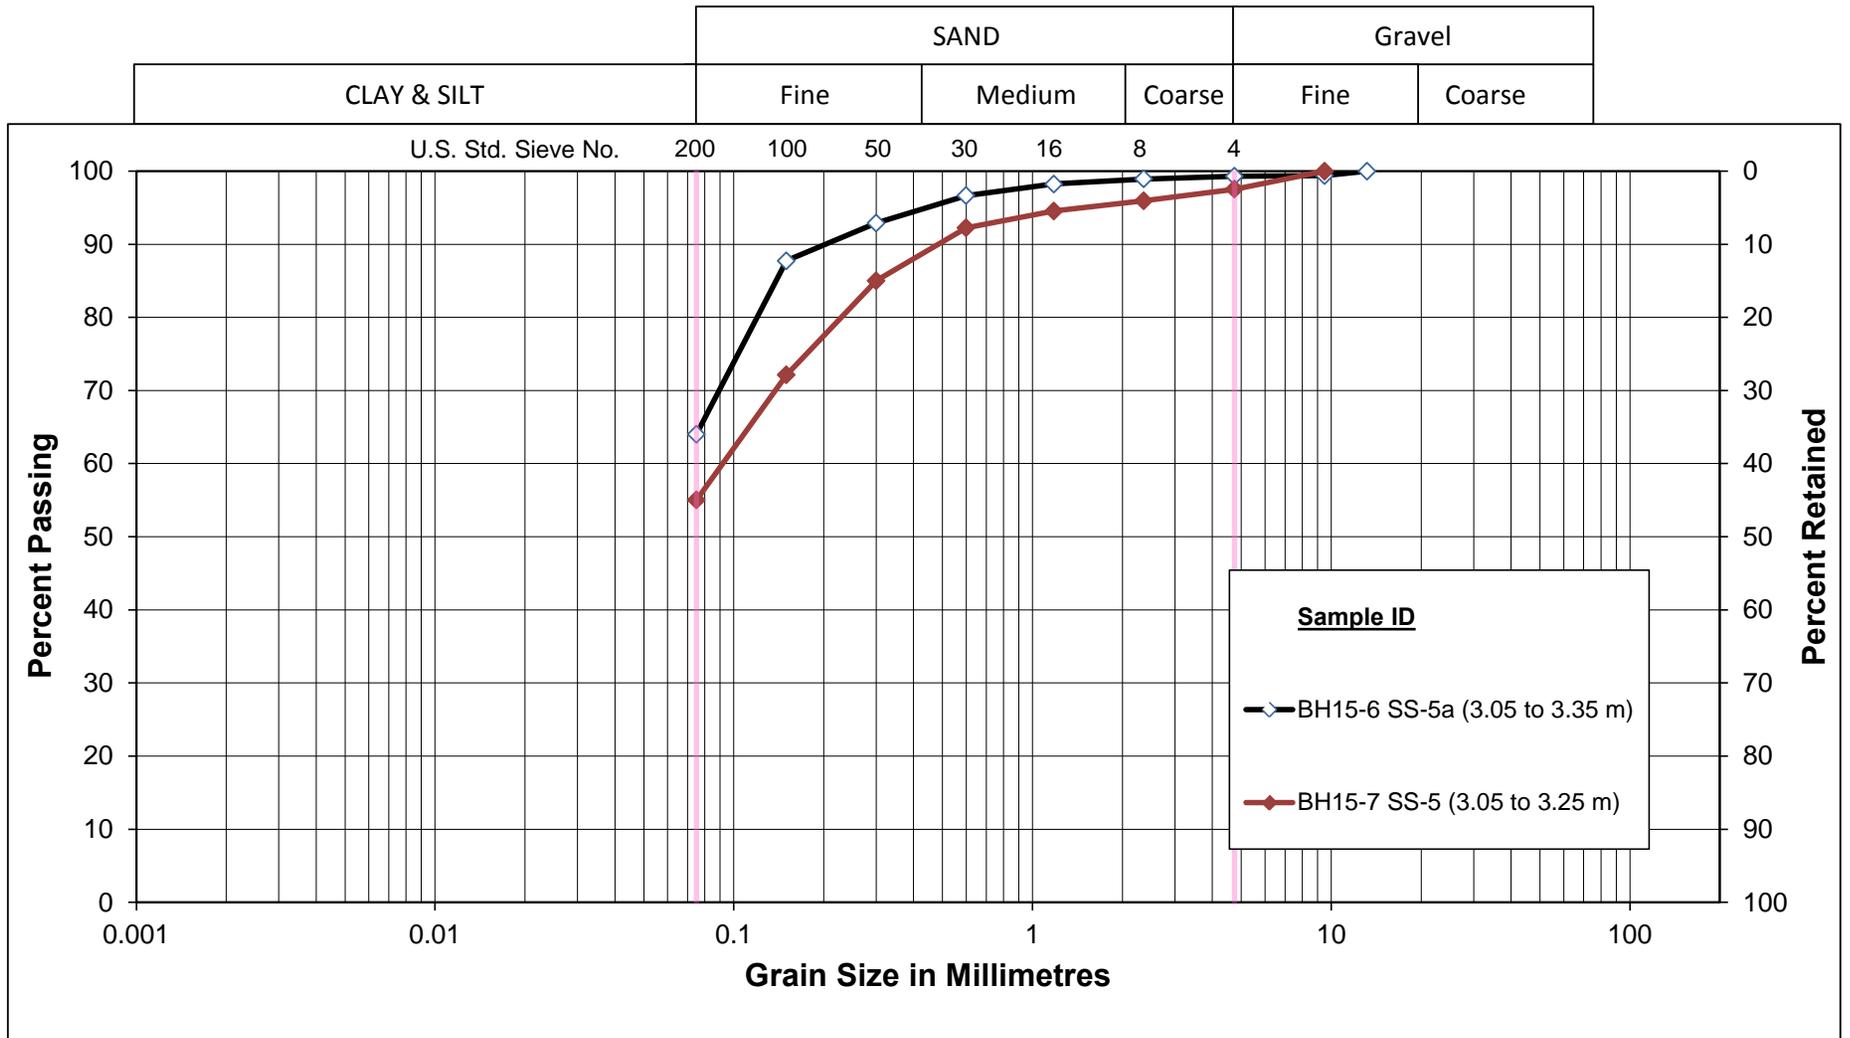
GRAIN SIZE DISTRIBUTION

Sandy Silt (ML), TILL

The moisture content of a sample of the till was 12% which is shown on the Borehole Records in Appendix C. Grain size analysis of two samples of the till indicated 1 and 2% gravel, 35 and 43% sand, and 55 and 64% silt and clay-sized particles. The till can be classified as primarily a sandy silt (ML). Grain size analysis results are included in Figure 2, Appendix D

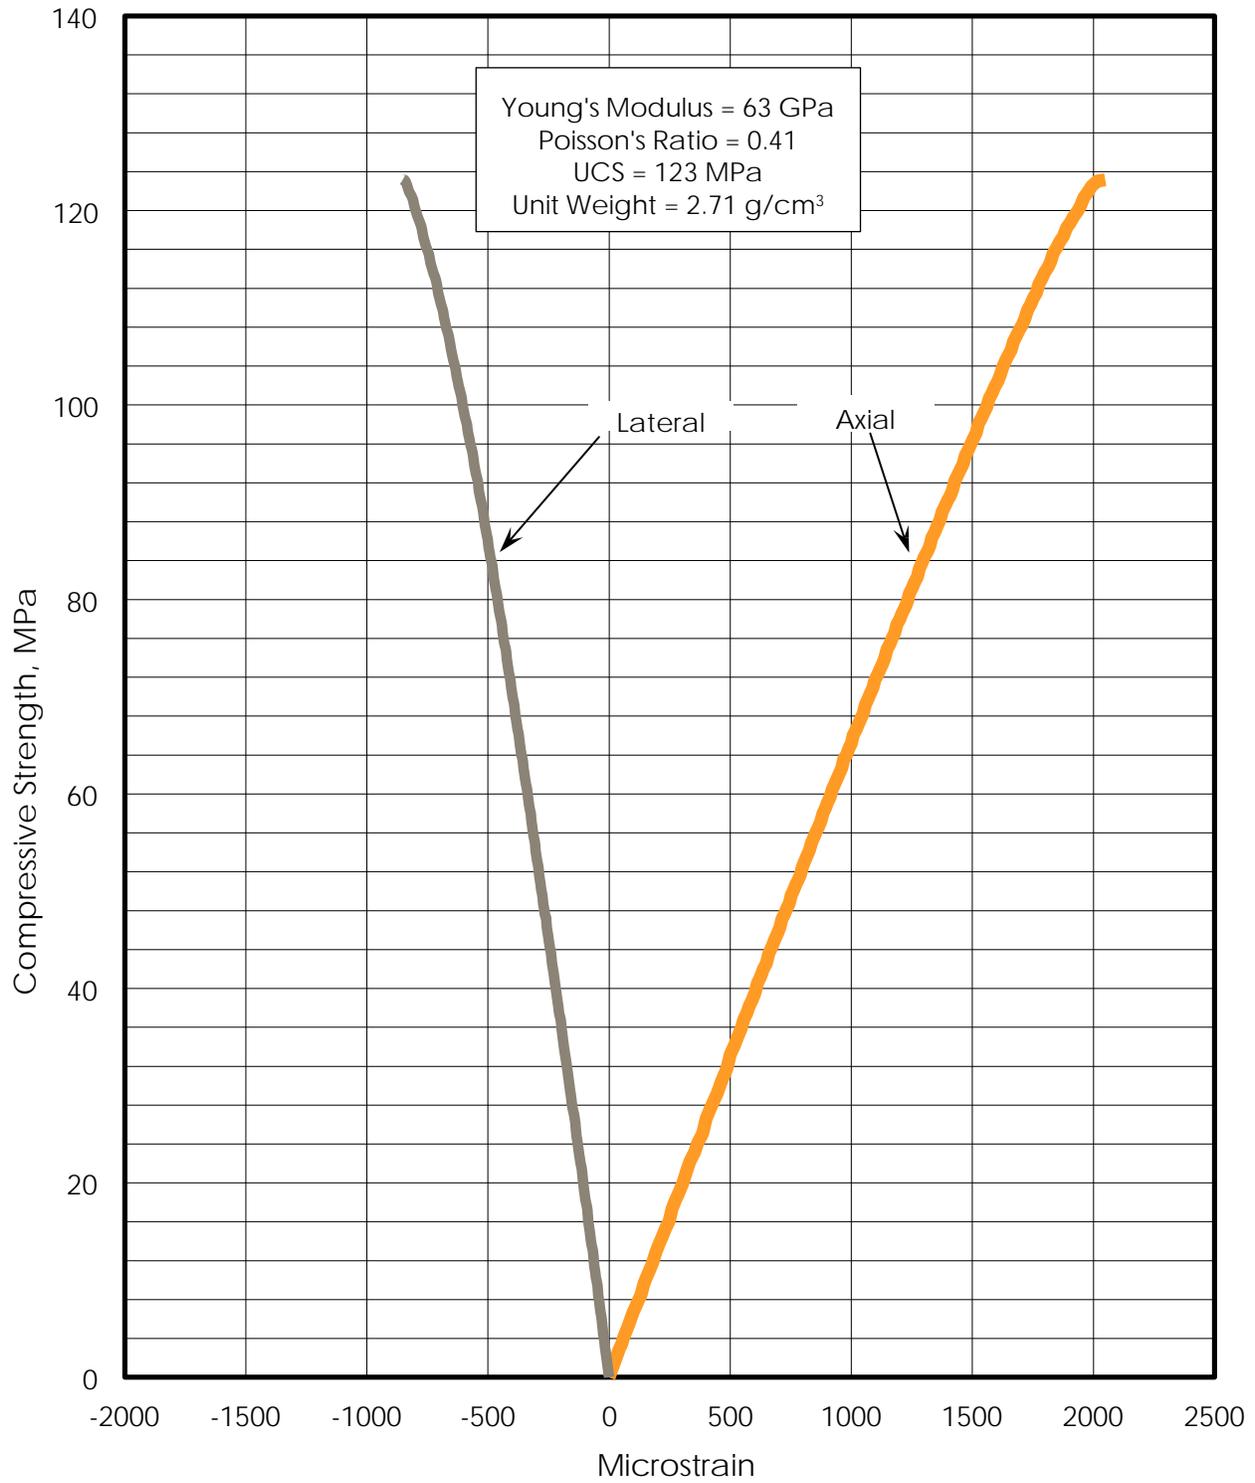
Figure No. 3: Elastic Moduli of Intact Rock
Core Specimens Uniaxial Compressive
Strength
BH 15-4, Sample HQ-9

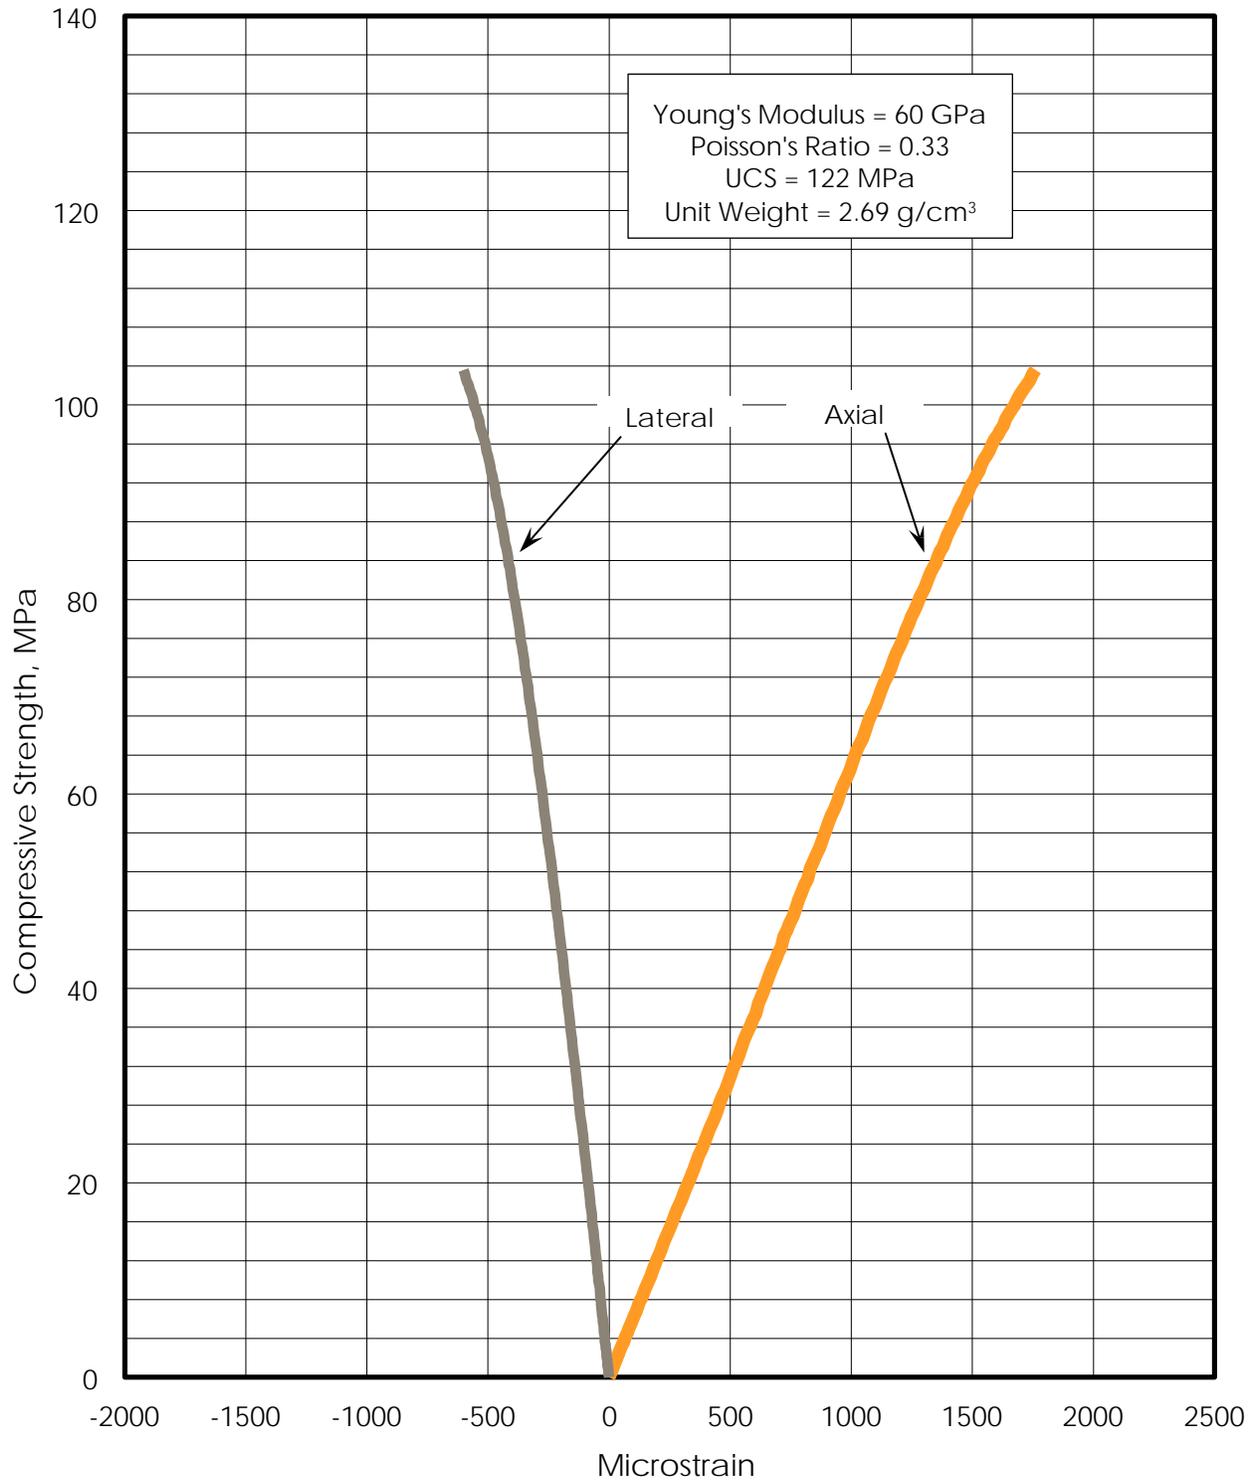
Figure No. 4: Elastic Moduli of Intact Rock
Core Specimens Uniaxial Compressive
Strength
BH 15-4, Sample HQ-21

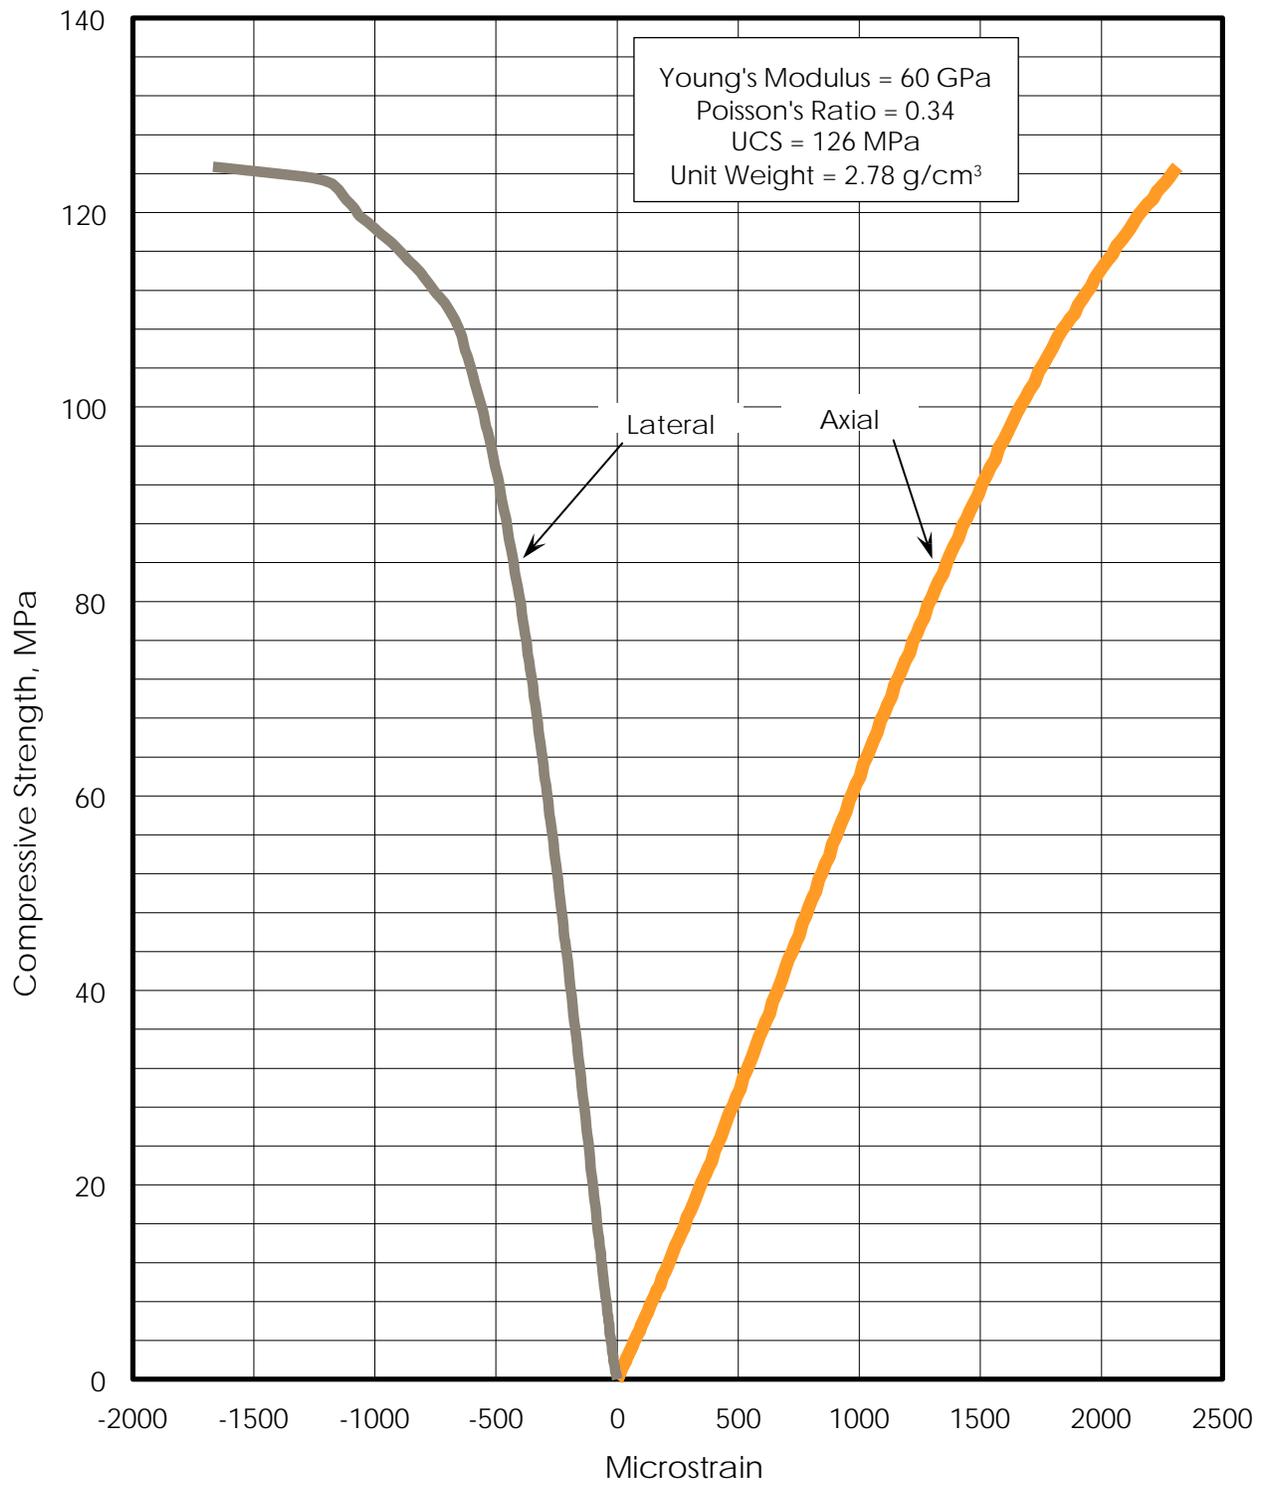
Figure No. 5: Elastic Moduli of Intact Rock
Core Specimens Uniaxial Compressive
Strength
BH 15-4, Sample HQ-24

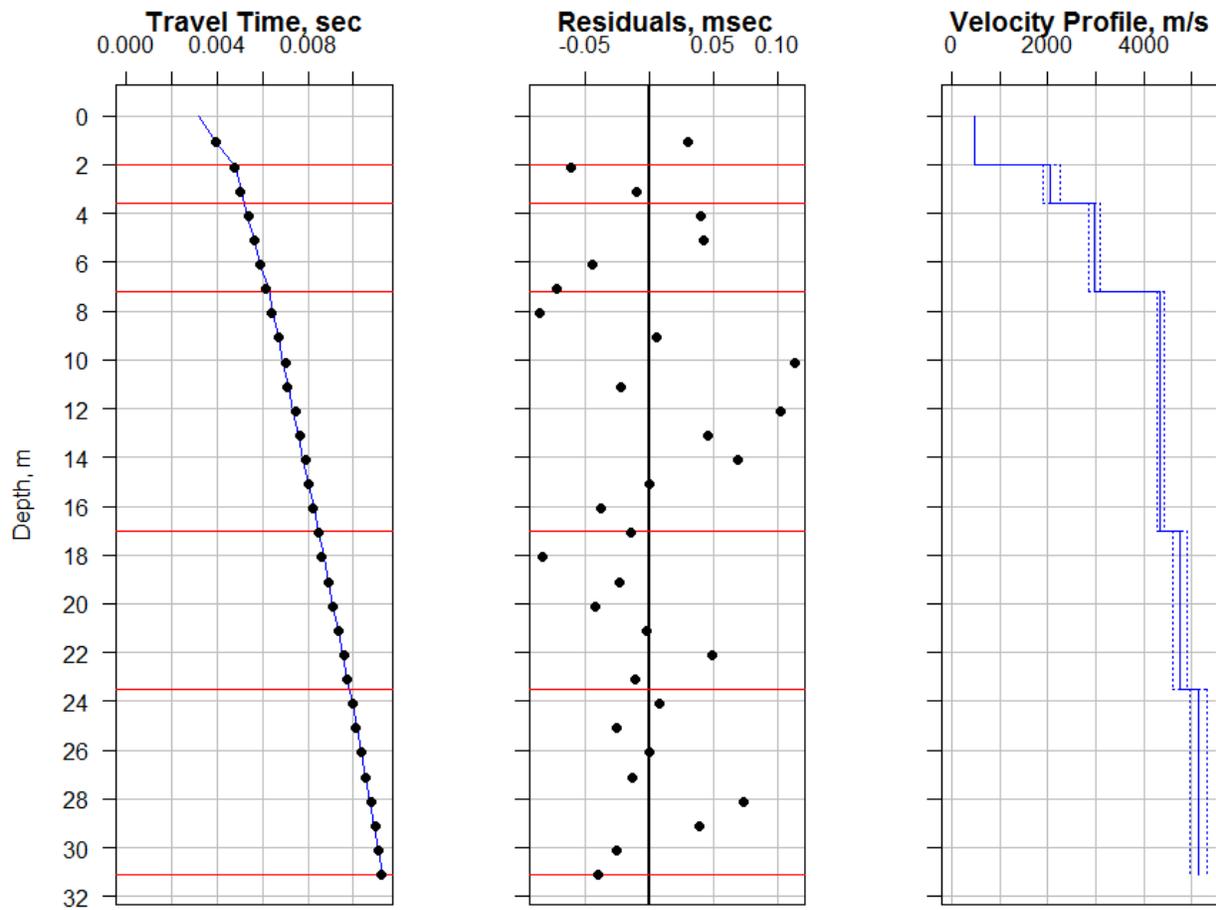
Figure 3: P-wave arrival time data and velocity model

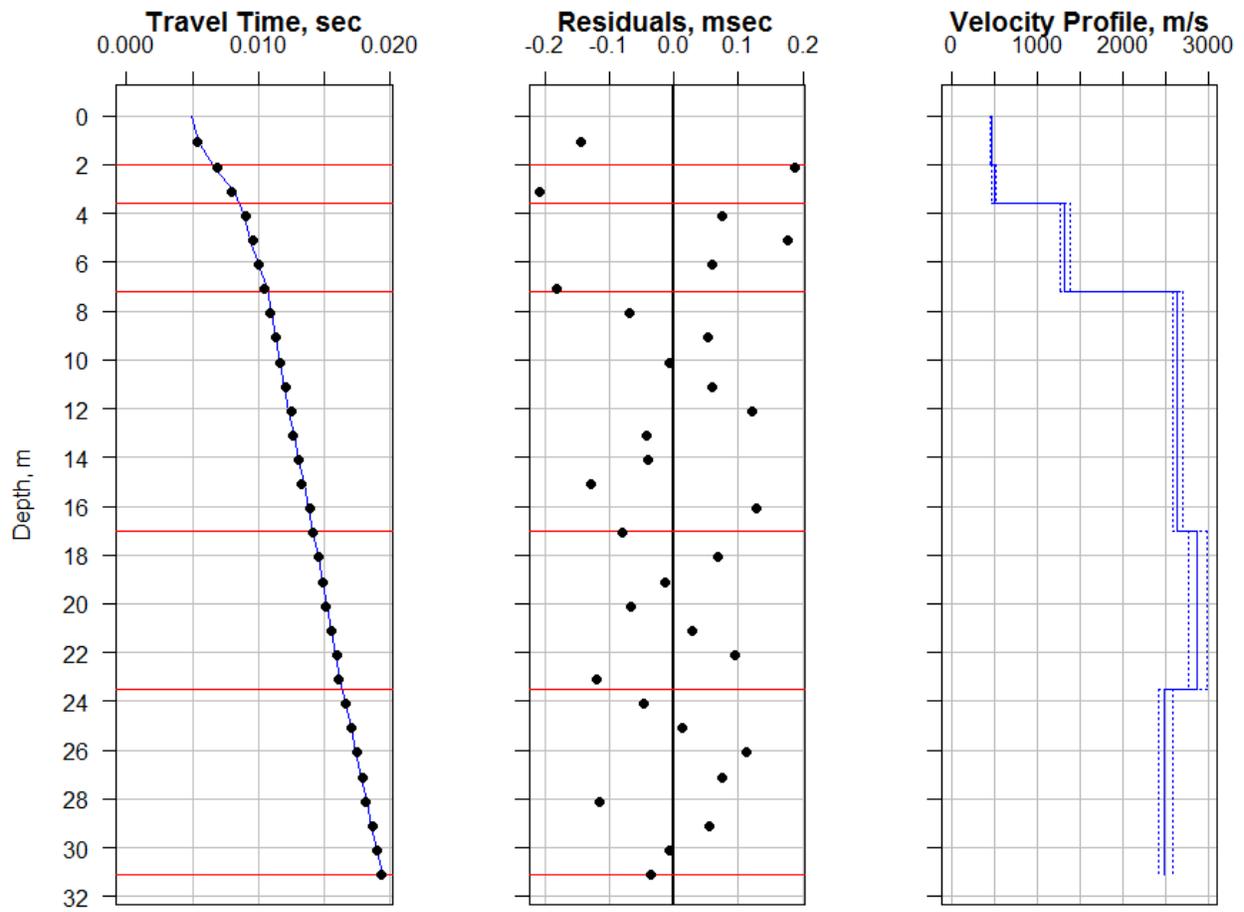
Figure 4: S(vertical)-wave arrival time data and velocity model

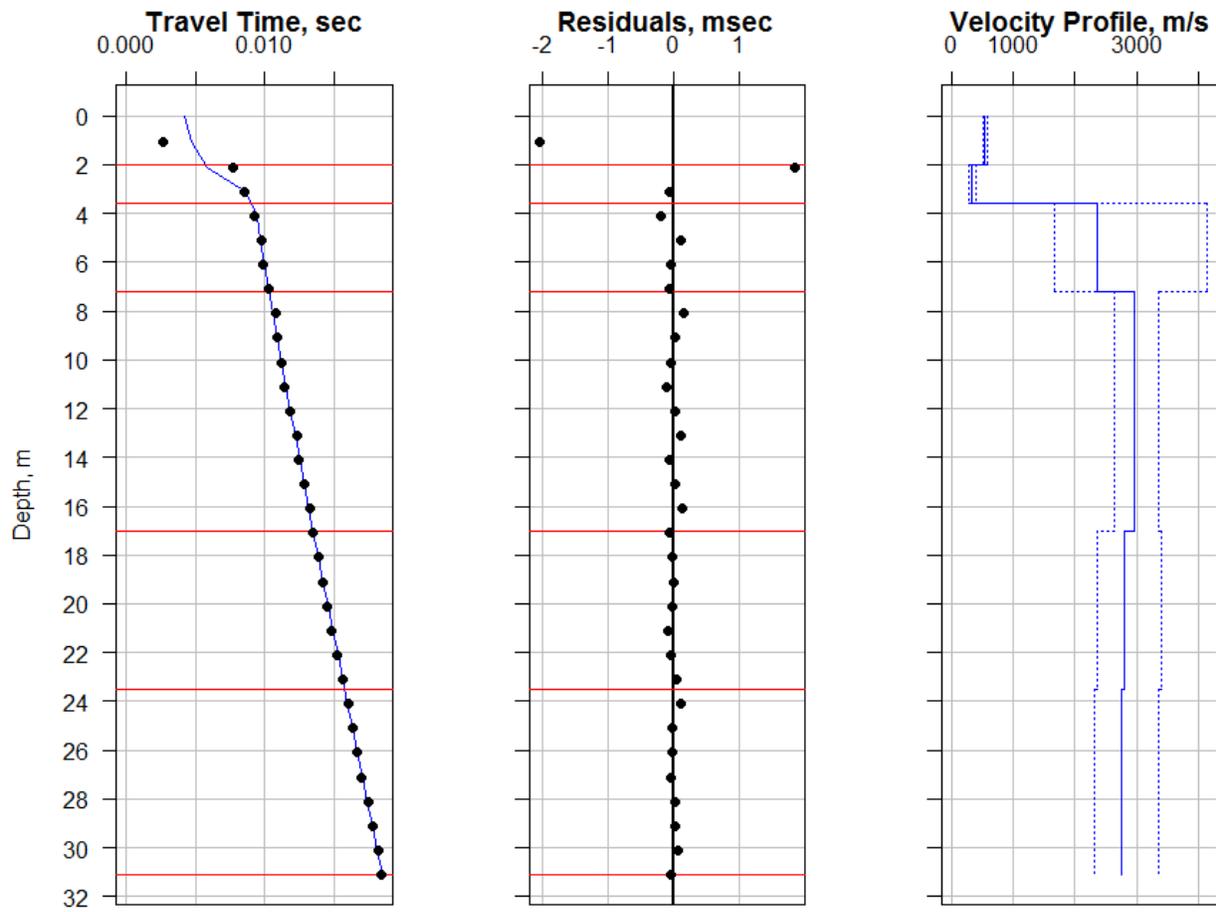
Figure 5: S(horiz)-wave arrival time data and velocity model

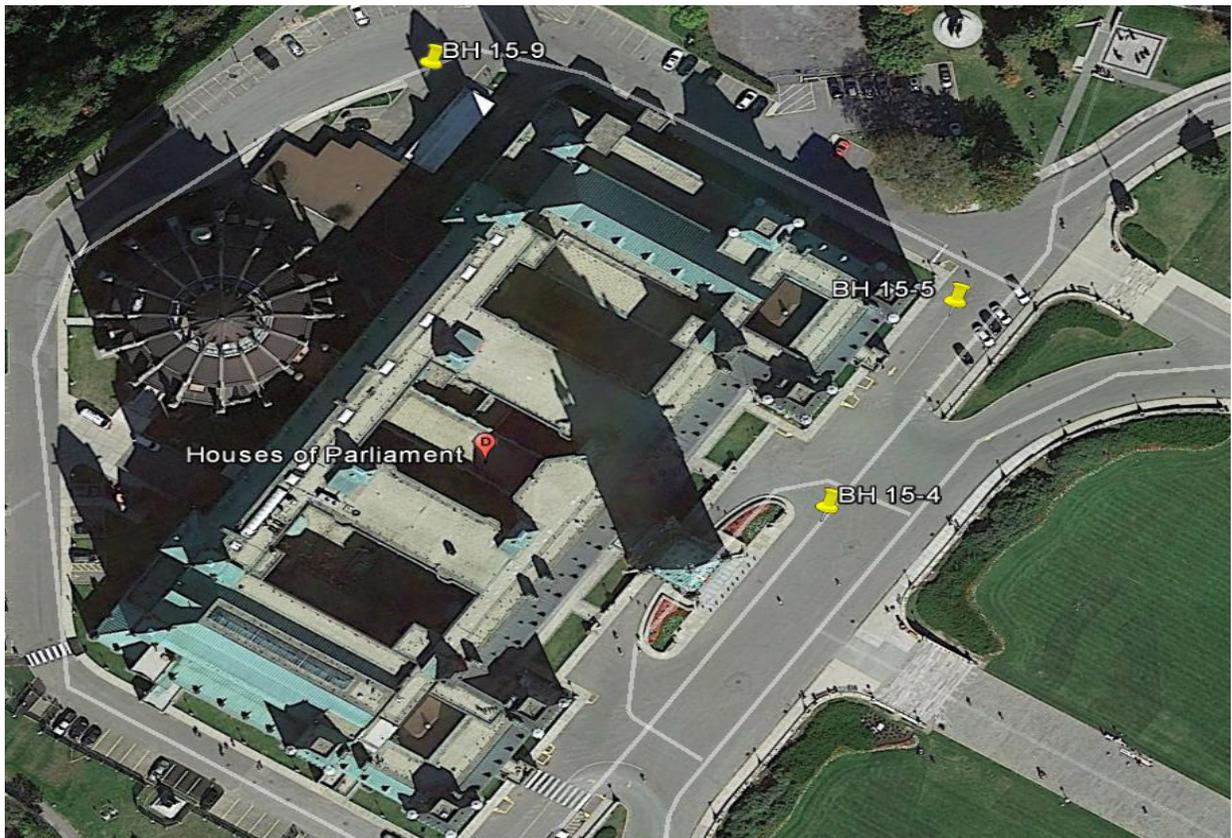
Figure 2: Location of Optical Televiewer Sites, Parliament Hill, Ottawa

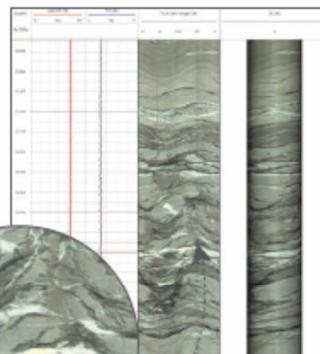
- Detailed and oriented structural information
- Reference for core orientation
- Fracture detection and evaluation
- Breakout analysis
- Detection of thin beds
- Determination of bedding dip
- Lithology characterisation
- Casing inspection

OBI40, OBI40 GR QL40, OBI optical borehole imager

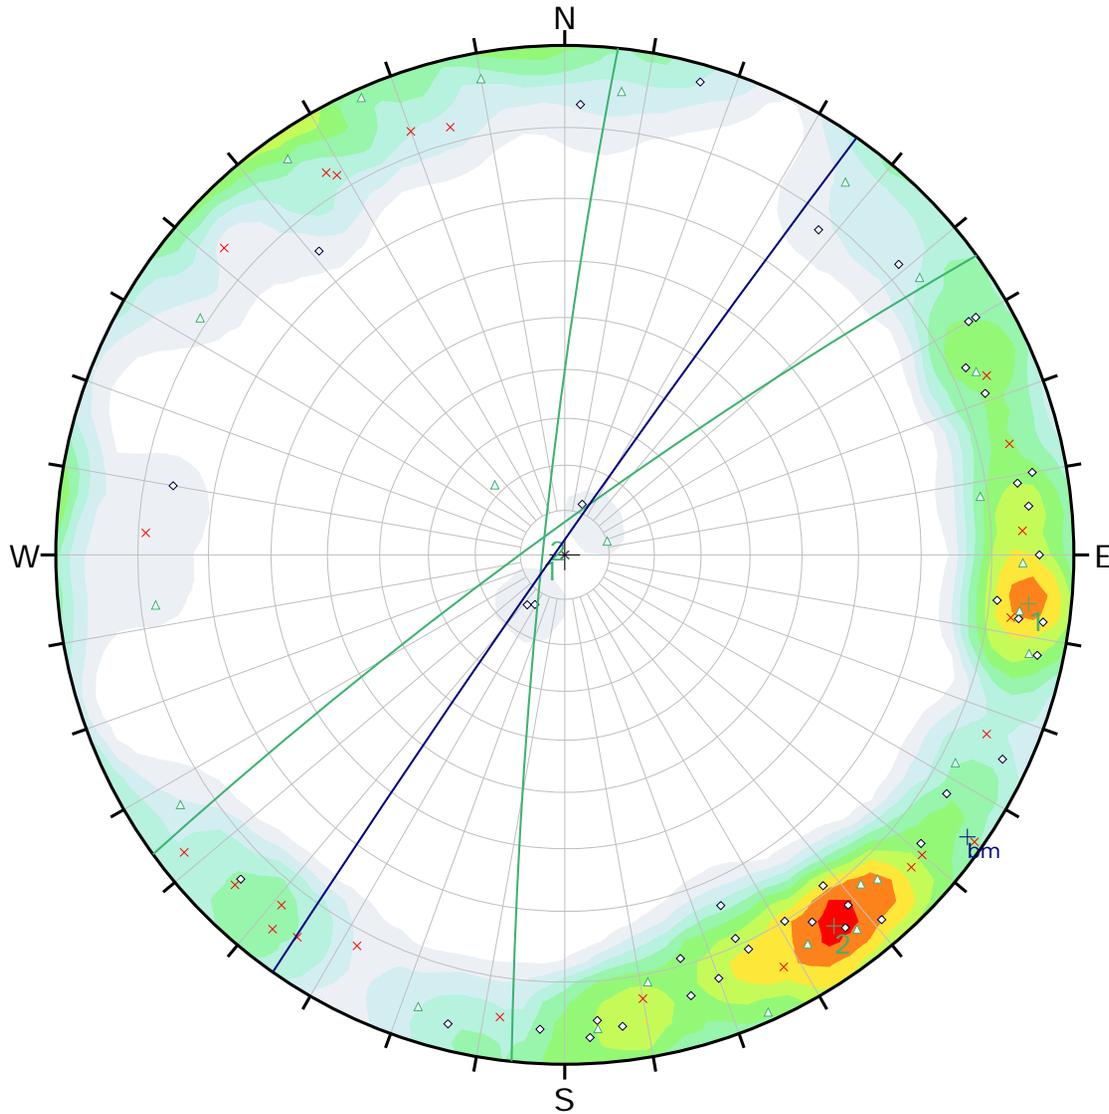
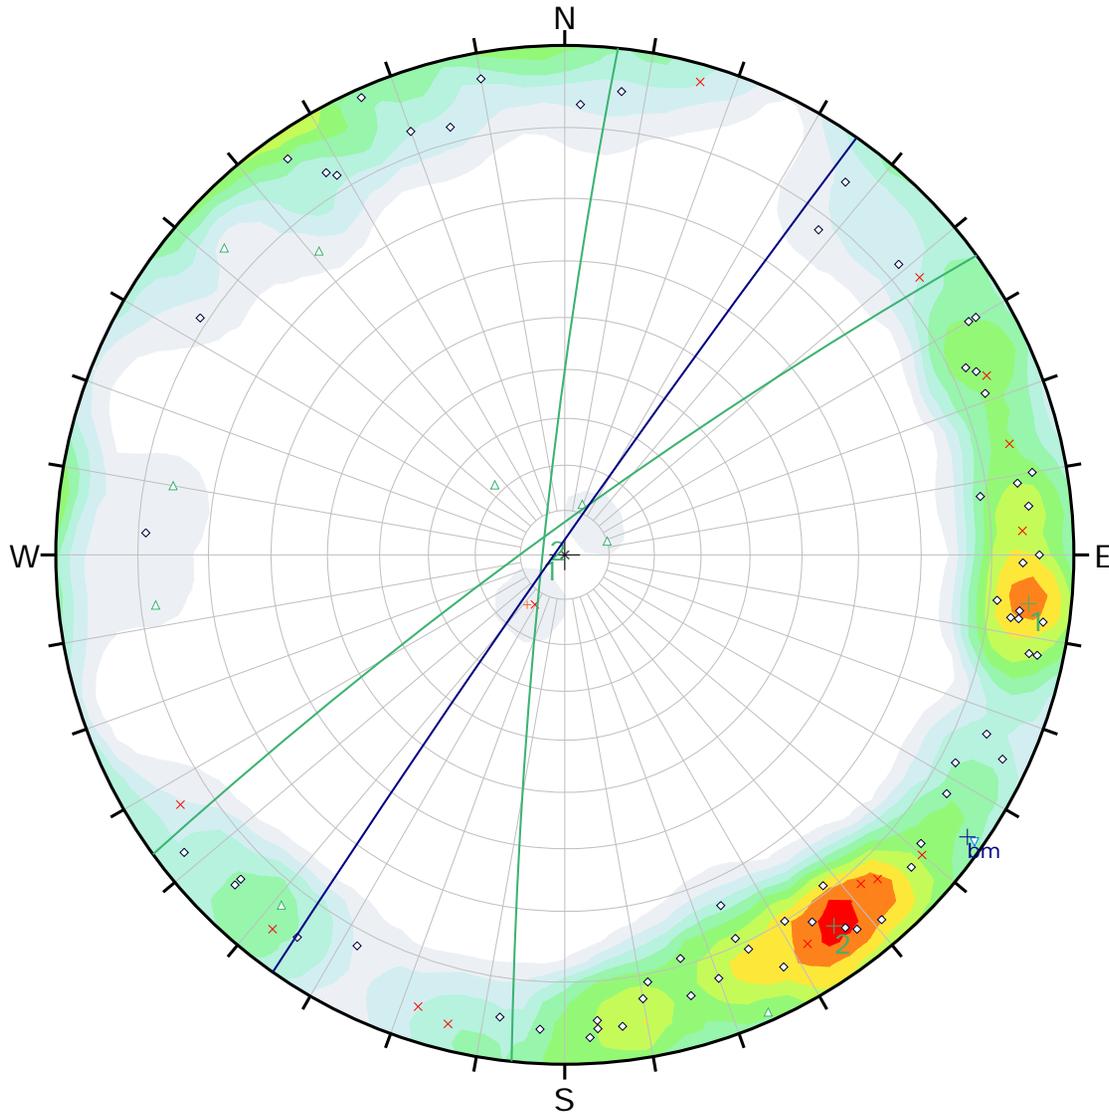
BH15-4,5,&9 (Recovered).dips6

Three optical televiewer surveys were conducted in BH 15-4, BH 15-5 and BH 15-9 to determine the orientation of the structures. Stereographic plots have been created using the Dips program and are included in Appendix E. Based on the optical televiewer data, sub-horizontal fractures dipping mainly 0 to 15° toward southeast are present throughout the length of the boreholes and represent the main joint set in the boreholes. There were a few vertical fractures observed dipping mainly 75 to 79°.

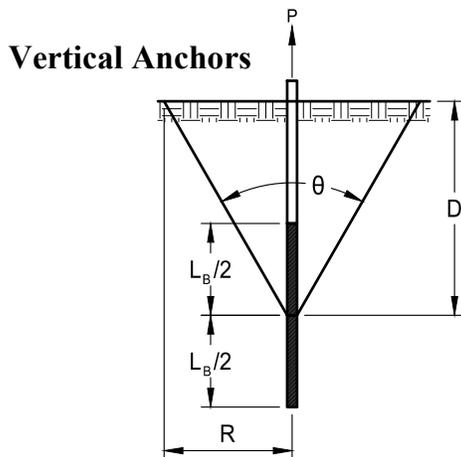
Grouted Rock Anchors

1. Use 60° or 90° apex angle as per recommendations in the geotechnical report
