Project title / Titre du projet
**RIDEAU CANAL
BLACK RAPIDS LOCK 13
UPGRADES 2015**

Drawing title / Titre du dessin
MASONRY REPAIRS III

Drawing Number/
Numéro du Dessin
106
PWGSC Project Number / Numéro du projet TPSGC
R.078218.001
Sheet
Feuille
7 of 21
du

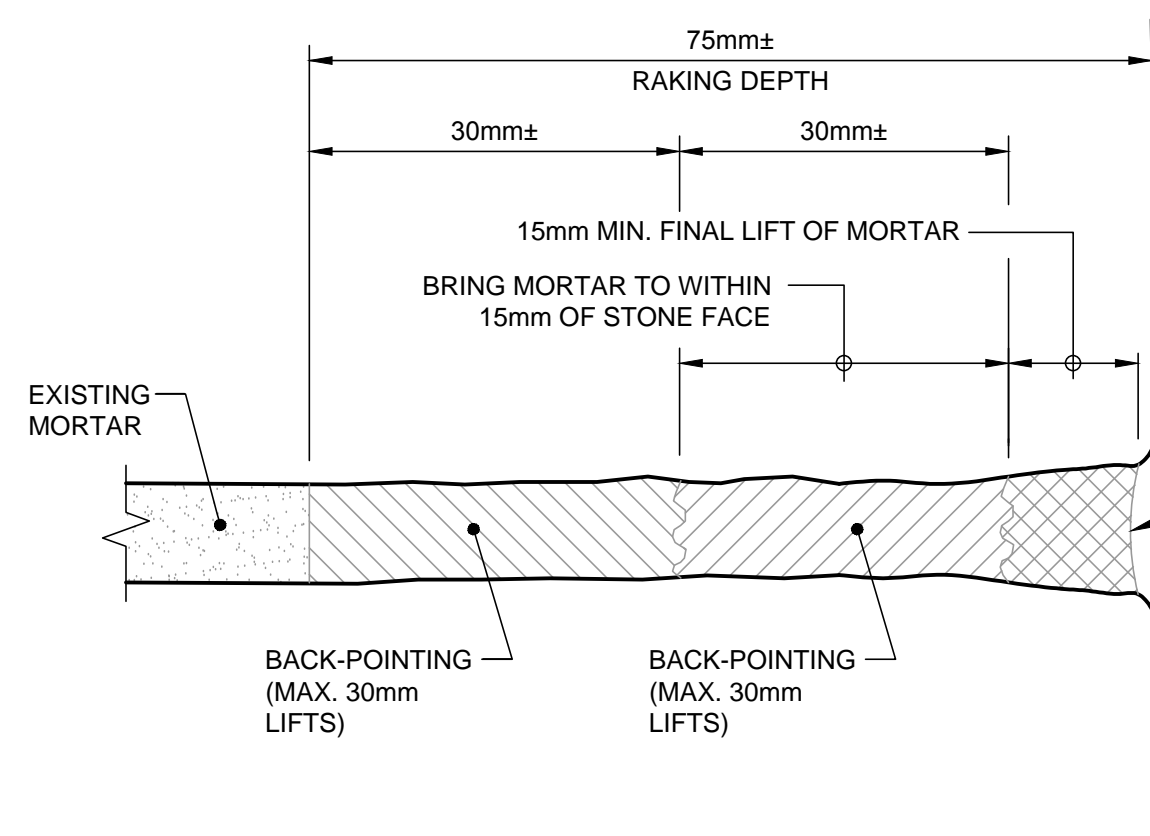
MORTAR JOINT DETAIL
N.T.S.

NOTE :
IF MORTAR IS MISSING FROM JOINT BEYOND 75mm, CONTRACTOR TO FILL GAP WITH GROUT AFTER ALLOWING BACK POINTING TO CURE FOR 72 HOURS. ALLOW ANOTHER 72 HOURS, AFTER PLACING GROUT, BEFORE APPLYING FINISH COAT OF MORTAR.

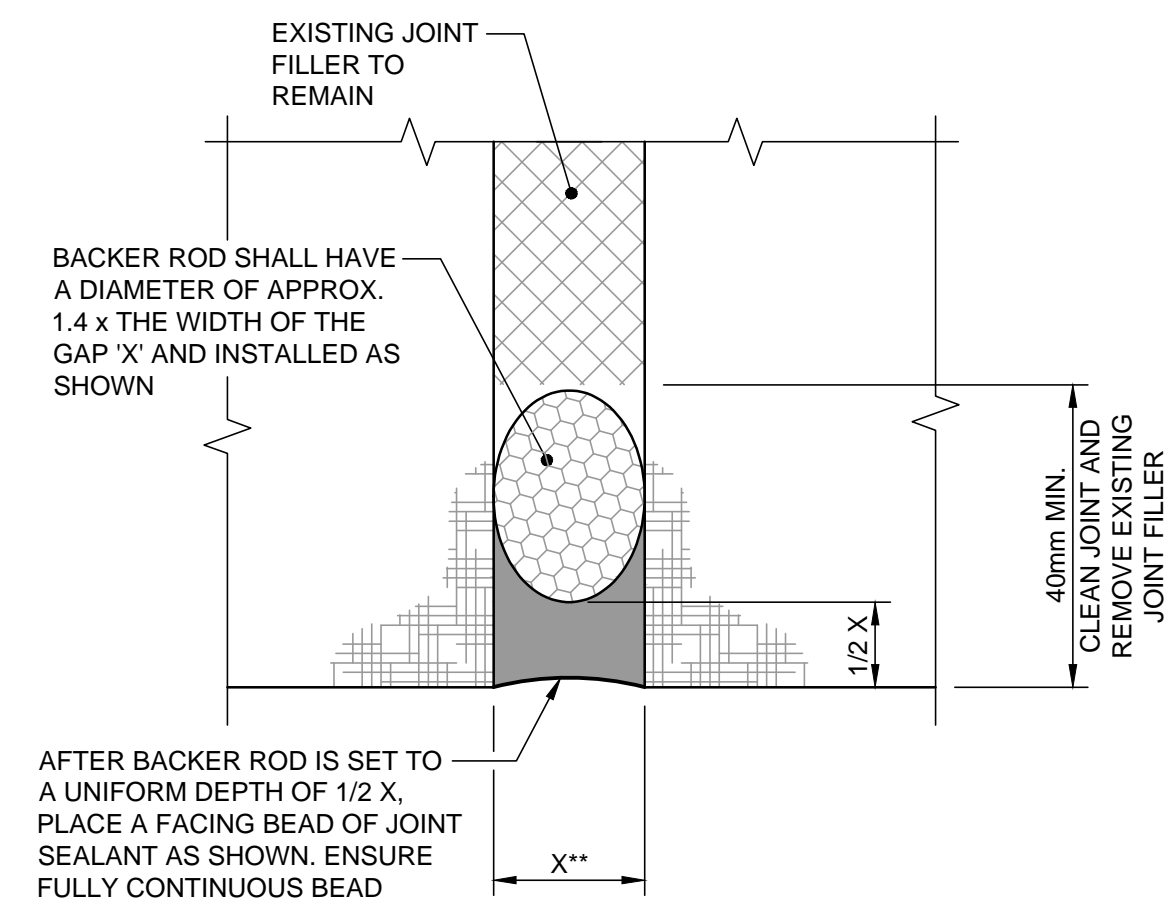
EXPANSION JOINT DETAIL
N.T.S.

** 20mm THEORETICAL EXPANSION JOINT THICKNESS WAS USED FOR DESIGN PURPOSES.

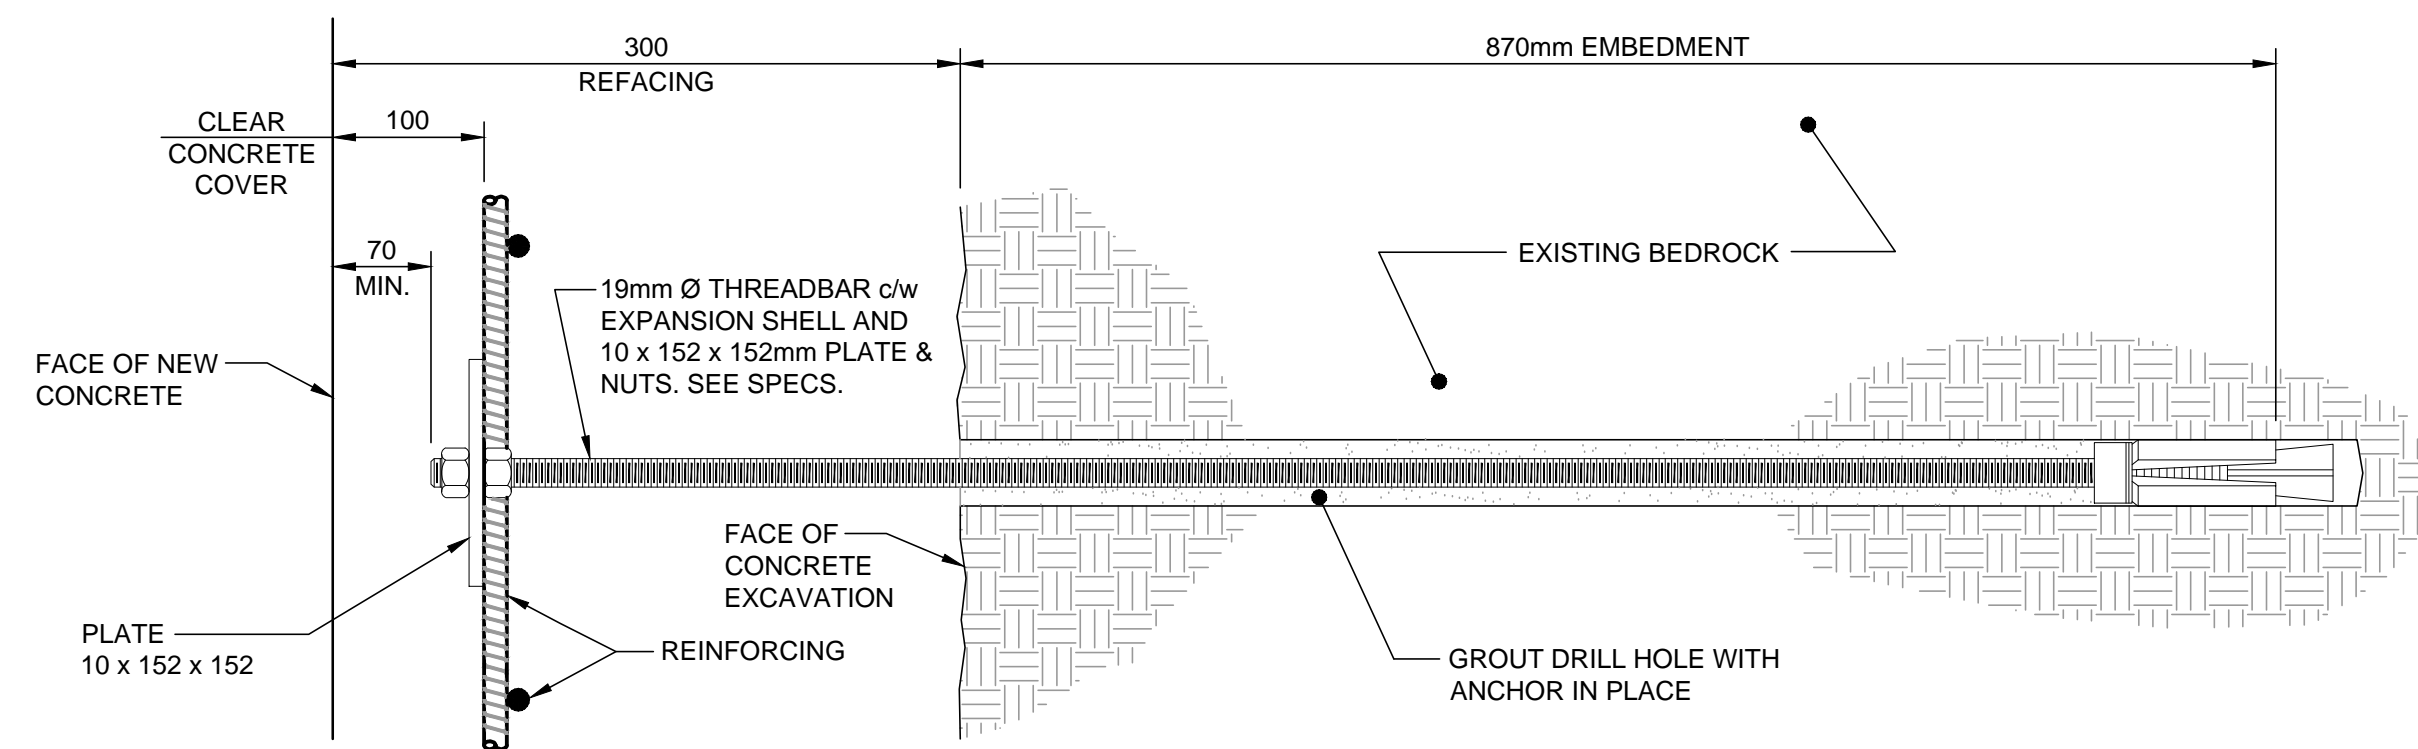
TYPE B ANCHOR 1
N.T.S.

BREASTWALL REFACING
