Title - Sujet BNP Wastewater System Upgrade	
Solicitation No. - N° de l'invitation E0209-161419/A	Amendment No. - N° modif. 004
Client Reference No. - N° de référence du client Parks-E0209-161419	Date 2015-11-26
GETS Reference No. - N° de référence de SEAG PW-\$PWU-201-10619	
File No. - N° de dossier PWU-5-38238 (201)	CCC No./N° CCC - FMS No./N° VME
Solicitation Closes - L'invitation prend fin at - à 02:00 PM on - le 2015-12-17	
Time Zone Fuseau horaire Mountain Standard Time MST	
F.O.B. - F.A.B. Plant-Usine: <input type="checkbox"/> Destination: <input type="checkbox"/> Other-Autre: <input type="checkbox"/>	
Address Enquiries to: - Adresser toutes questions à: Ho (RPC), Hector	Buyer Id - Id de l'acheteur pwu201
Telephone No. - N° de téléphone (780) 901-0989 ()	FAX No. - N° de FAX (780) 497-3510
Destination - of Goods, Services, and Construction: Destination - des biens, services et construction:

Project Title	Addendum No.:
Septic System Upgrades	3
Project Location:	Project Number:
Banff National Park, Alberta	R.077777.001
Consultant's Name:	Date:
AECOM Canada Ltd.	November 26, 2015
The following changes on the bid documents are effective immediately. This addendum will form part

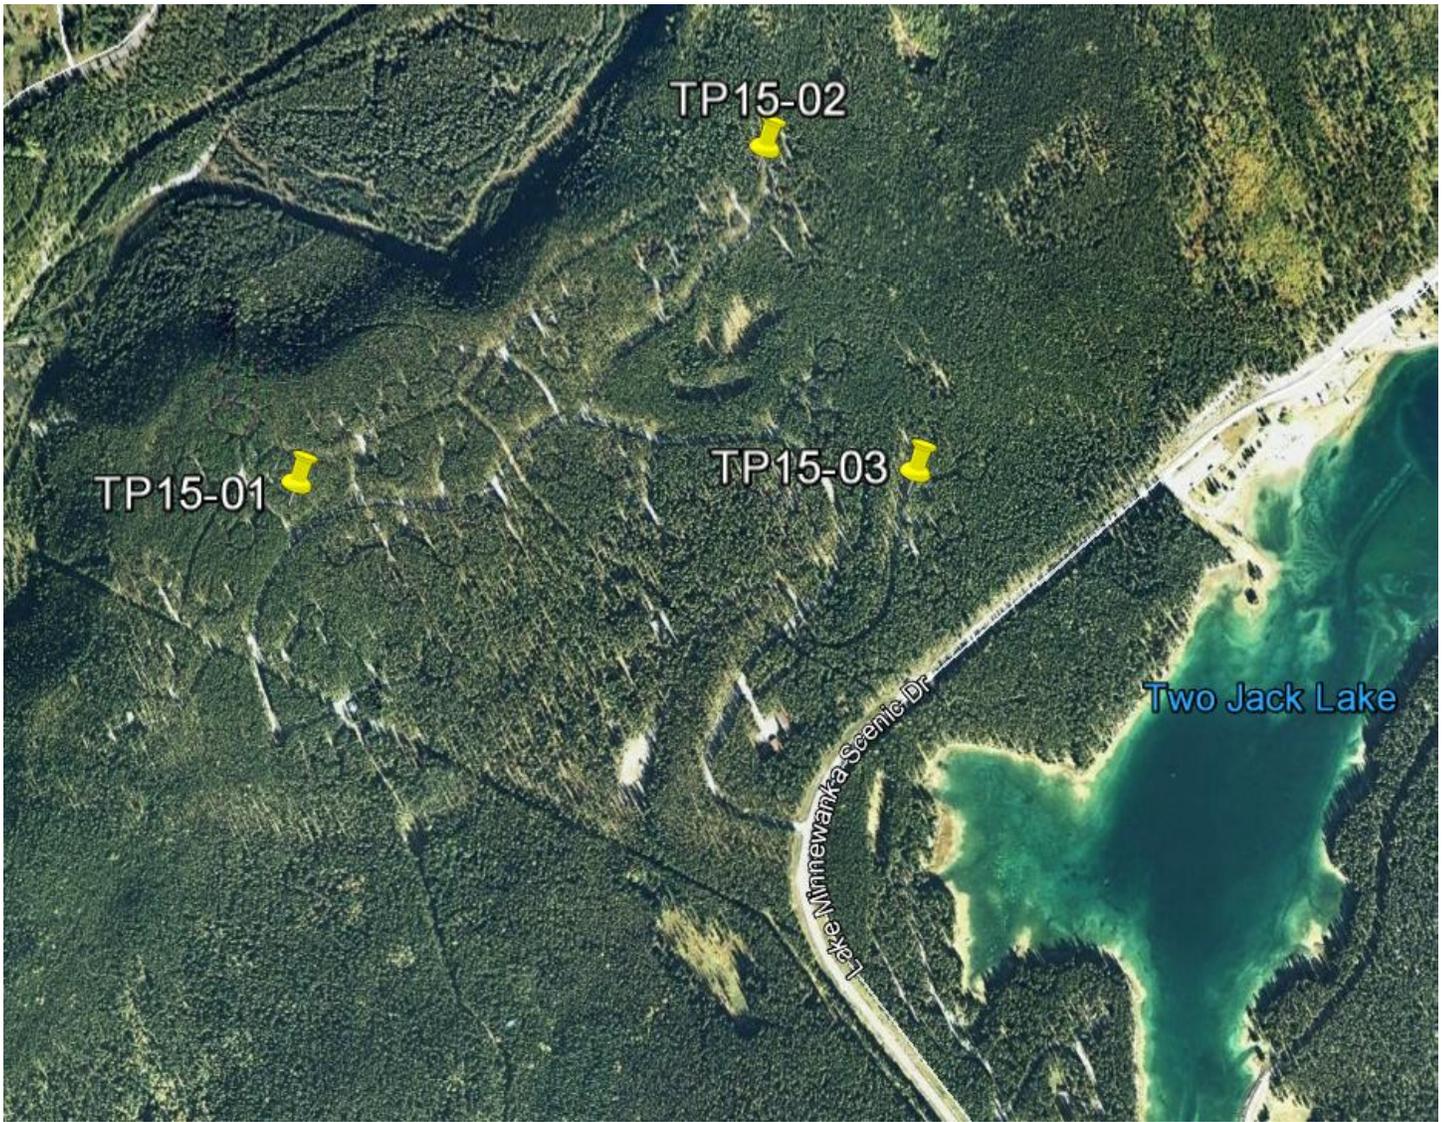
Bore Hole Locations

Project: Two Jack Main
Location: Banff, Alberta

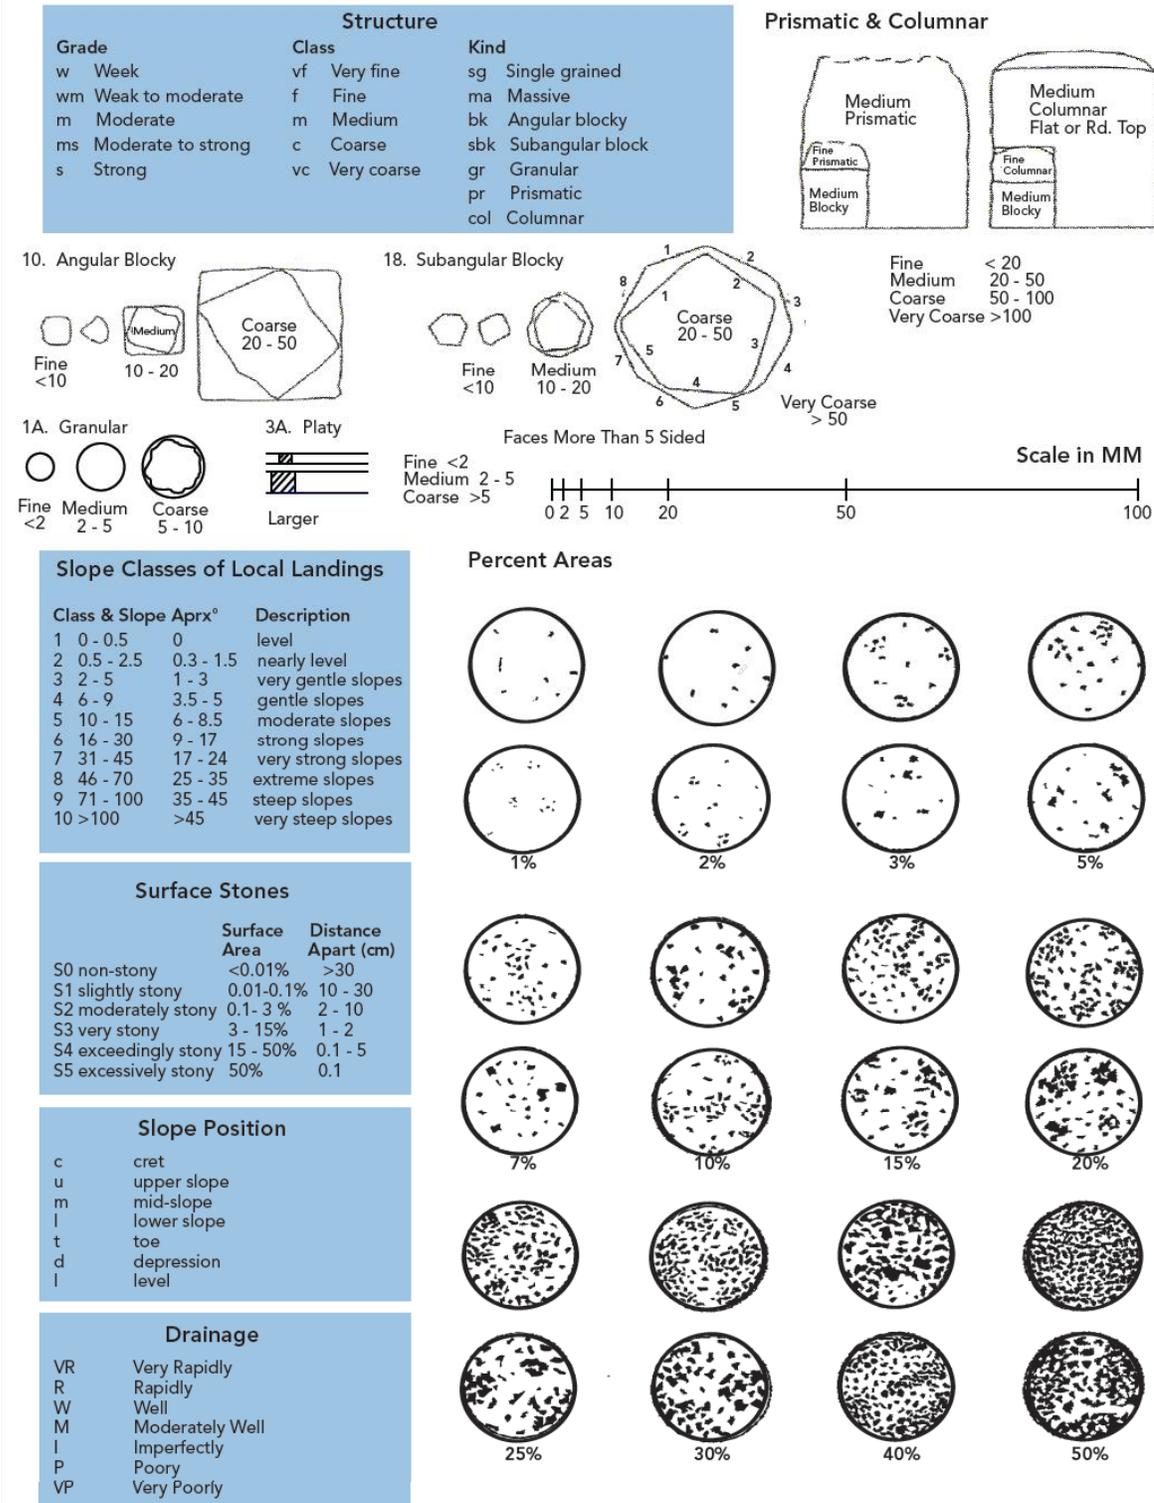
Figure : Soil Structure Shapes and Estimating Coarse Fragment Percentage

The graphic on the following page shows the various soil structure shapes found in soil and assists in correct identification of soil structure. The graphics on this page showing a circle with dots within the circles and titles “Percent Areas” assists with estimating the amount of coarse fragment (gravel) in the soil.
