SPECIFICATIONS
For
Pacific Forestry Centre
506 West Burnside
LIGHTING & POWER DISTRIBUTION UPGRADE
Victoria, BC

Project No. R. 076284.001 October 31, 2015

- .1 Work of this Contract comprises installation of a new primary voltage service entrance and associated equipment, and further identified as:
**Pacific Forestry Centre 506 West Burnside
Lighting and Power Distribution Upgrade
Job No. R. 076284.001**

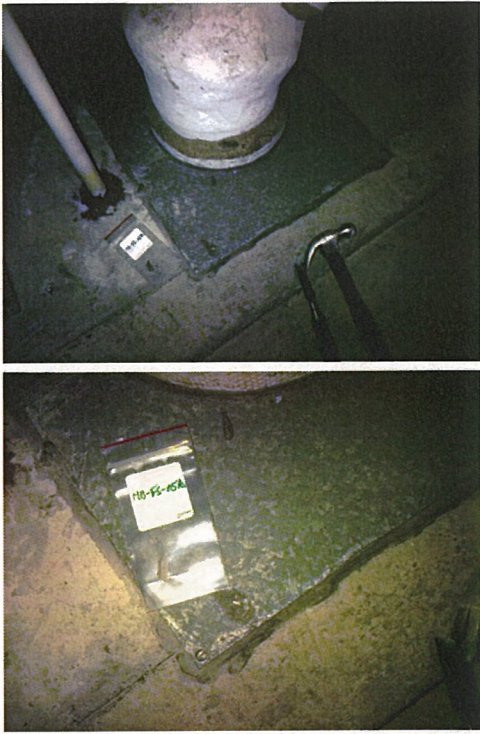
Table 5.1-1: Summary of Identified ACMs – <u>A WING</u>		Photo
Identified ACM Description		
Grey colour fire stop caulking applied to floor penetrations for mechanical ductwork throughout the penthouse.

Condition	GOOD	
% Type	5% Chrysotile	
Friability	Non-friable	
Silver colour fire stop caulking (rigid consistency) applied to floor penetrations for mechanical ductwork throughout the penthouse.

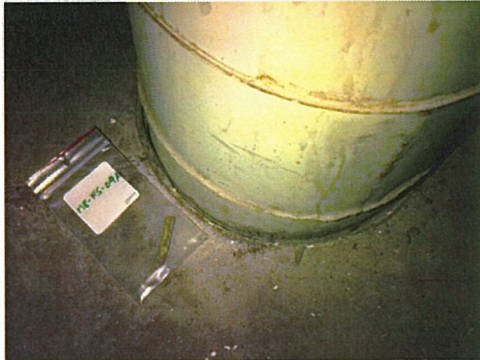
Condition	GOOD	
% Type	5% Chrysotile	
Friability	Non-friable

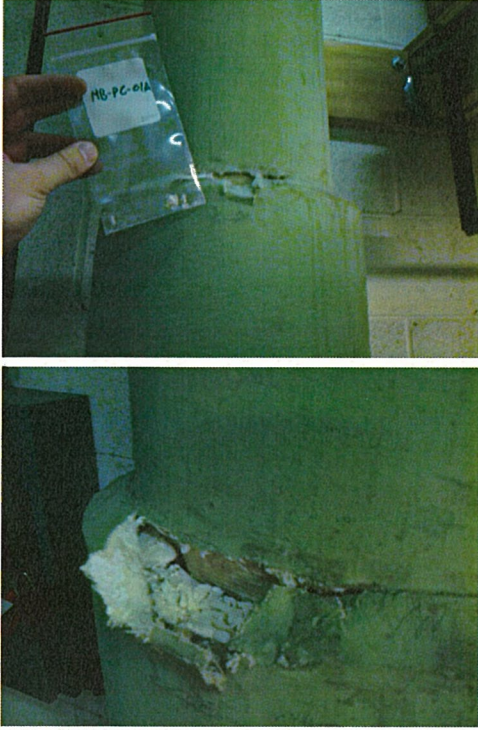
Identified ACM Description		Photo
<p>Light grey colour chalk-like parging cement applied to pipe fittings observed in rooms 069, 073 and 045 on the ground floor and a fitting observed in the first floor east hallway.</p> <p>Presumed present in other locations throughout A Wing including inaccessible wall and ceiling cavities.</p>

Condition	GOOD in general, the fitting (flange) shown here in room 069 was observed in POOR condition.	
% Type	8 – 10% Amosite, 2 - 8% Chrysotile Sampled in room 069 on the ground floor and in the first floor east hallway, visually similar materials present in rooms 073 and 045.	
Friability	Friable

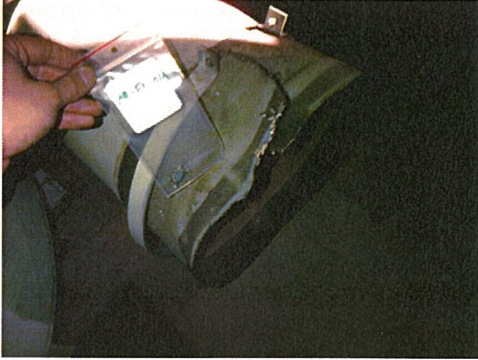
Identified ACM Description		Photo
Flex duct fabric between mechanical ductwork in the penthouse.

Condition	GOOD	
% Type	75 - 80% Chrysotile	
Friability	Friable	
White colour fibrous insulation between mechanical ductwork and floor penetrations in the penthouse. This material may be present, concealed in other areas of the building.

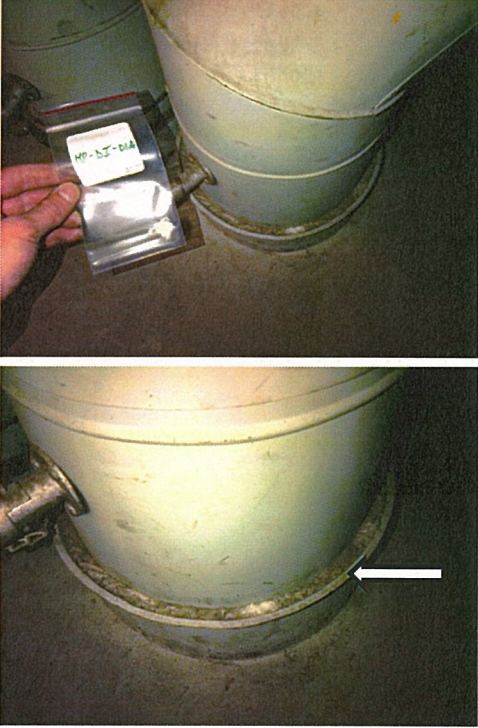
Condition	GOOD	
% Type	50% Chrysotile	
Friability	Friable

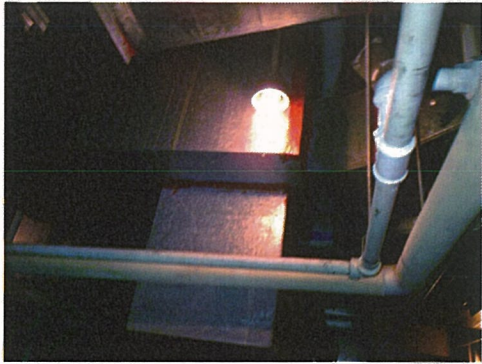
Table 5.1-1: Summary of Identified ACMs – A WING		Photo
Identified ACM Description Red colour duct mastic on mechanical ductwork joints throughout the building.

Condition	GOOD	
% Type	4% Chrysotile	
Friability	Non-friable	
Identified ACM Description Cement products (including): <ul style="list-style-type: none"> • Cement board lining within fume hoods throughout. • Cement exhaust pipe leading from fume hoods to exhaust fans on the roof throughout. • Exhaust fans on the roof with cement vent caps (eight cement vent caps observed on the roof).

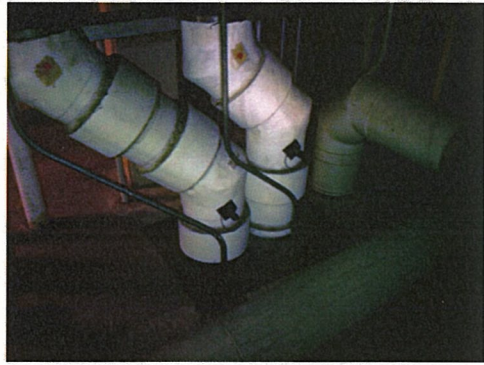
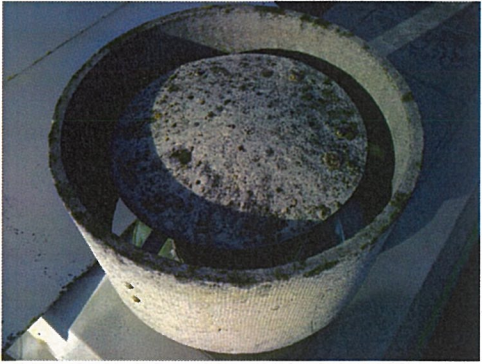
Condition	GOOD	
% Type	Presumed asbestos-containing material – Not sampled to preserve its mechanical integrity.	
Friability	Non-friable

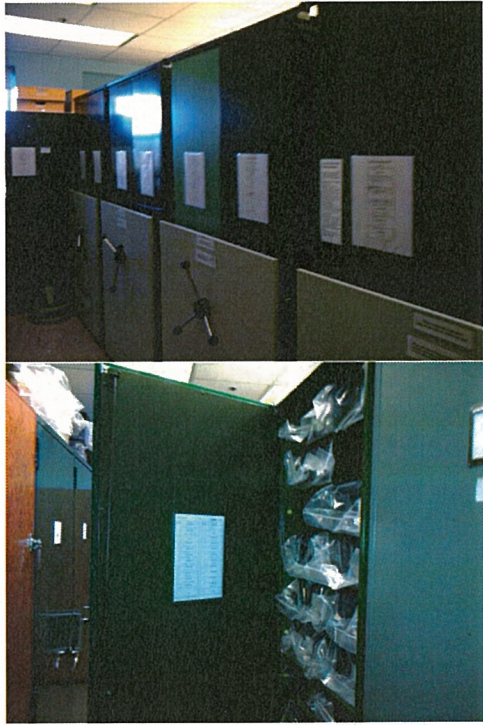
Identified ACM Description		Photo
Previously Identified ACMs (North West Assessment and Workplace Investigation)		
Inner lining material within herbarium storage cabinetry (ACM is not visible, it is reportedly present within the metal cabinet panels).

Condition	GOOD	
% Type	90% Chrysotile (as indicated in the Workplace Investigation)	
Friability	Non-friable in-situ (contained within metal panels). Friable if panels are dismantled.	
Floor tile (9"x9" size) – Brown and blue colour tiles (brown colour tile shown here) present in various room areas on all floors.

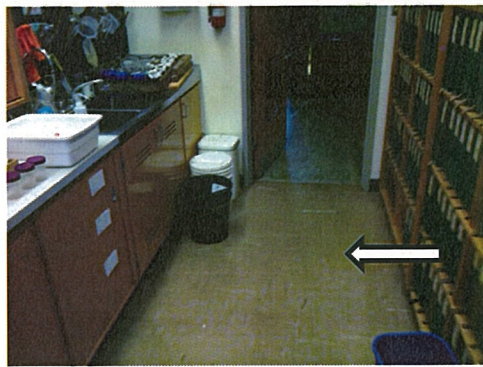
Condition	GOOD	
% Type	2 – 10% Chrysotile (as indicated in the North West Assessment)	
Friability	Non-friable

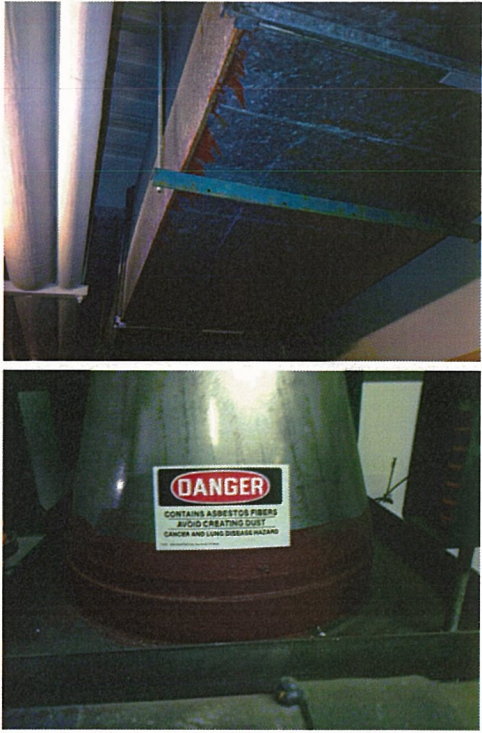
Identified ACM Description		Photo
Red colour duct mastic on mechanical ductwork joints throughout (exhaust ducting and return ducting).

Condition	GOOD	
% Type	4% Chrysotile	
Friability	Non-friable

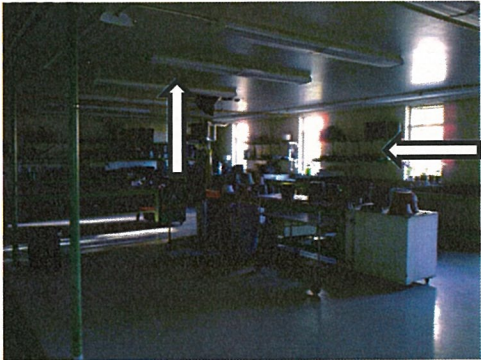
Identified ACM Description		Photo
Drywall joint compound applied to drywall walls and ceilings throughout the building.

Condition	Generally in GOOD condition with some minor damage (POOR condition) to various wall areas.	
% Type	3% Chrysotile	
Friability	Non-friable in situ (friable once disturbed)	
Floor tile (9"x9" size) green colour present within workshop H05 and rooms H06, H07, H08 and H09.

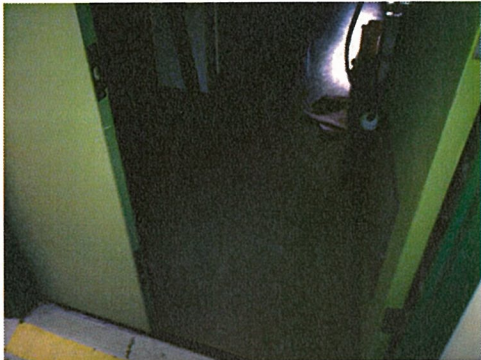
Condition	GOOD	
% Type	4% Chrysotile Sampled in workshop H05 and room H09, visually similar materials present in rooms H06, H07 and H08.	
Friability	Non-friable

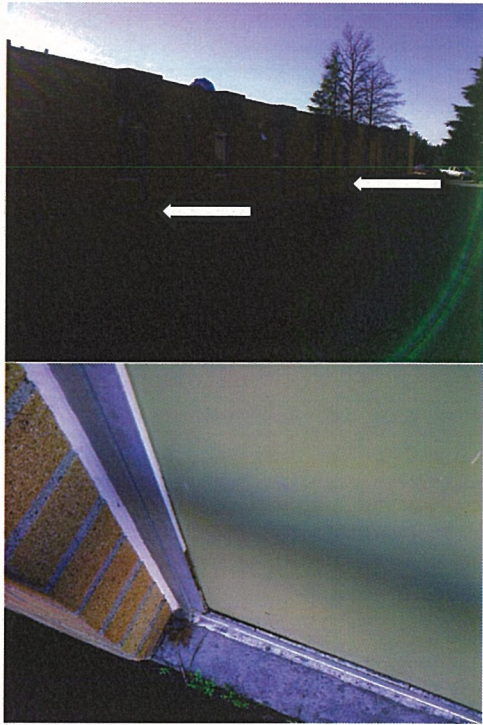
Identified ACM Description		Photo
Cement panels present beneath windows on the exterior of the building.

Condition	GOOD	
% Type	15% Chrysotile	
Friability	Non-friable	
Cement board liner within a fume hood in room H08.		No photo
Condition	GOOD	
% Type	Presumed ACM – Not sampled	
Friability	Non-friable

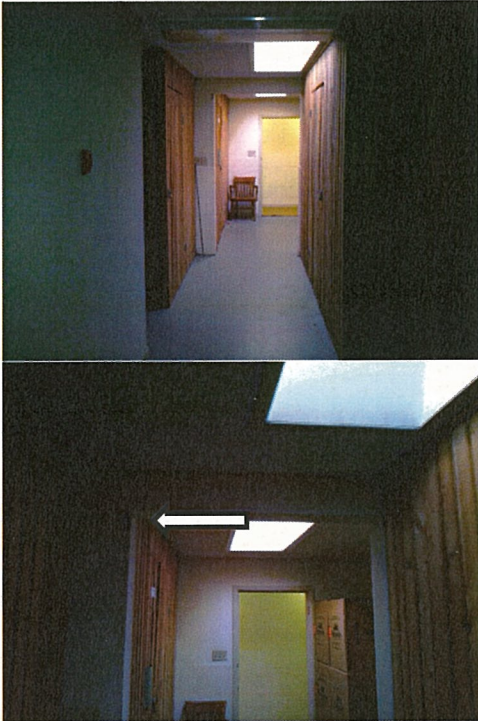
Identified ACM Description		Photo
Drywall joint compound applied to drywall walls and ceilings throughout.

Condition	Generally GOOD with some damaged (POOR condition) areas observed.	
% Type	< 1-3% Chrysotile	
Friability	Non-friable in situ (friable once disturbed)	
Floor tile (12"x12" size) beige with brown streaks present within the men's and women's washrooms.

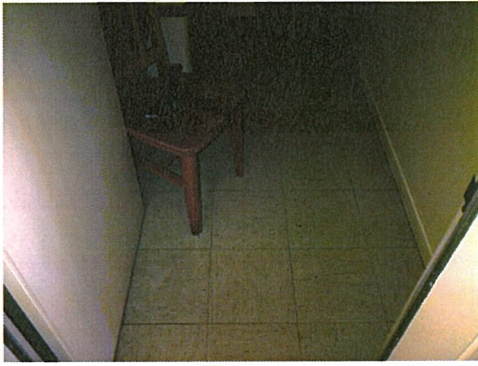
Condition	GOOD	
% Type	3% Chrysotile	
Friability	Non-friable

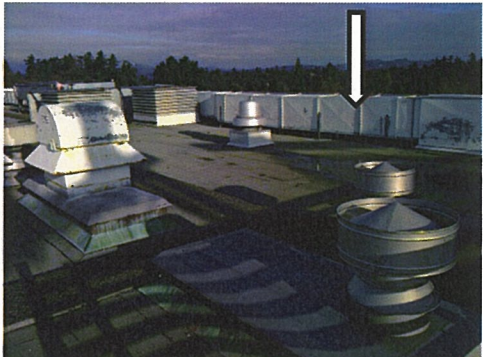
Lead-Containing Material Description	Photo
<p>Grey colour paint – Present on metal rooftop mechanical ductwork (1, 700 ppm).</p> <p>This material was generally observed to be in GOOD condition with the exception of some peeling due to outdoor deterioration.</p>

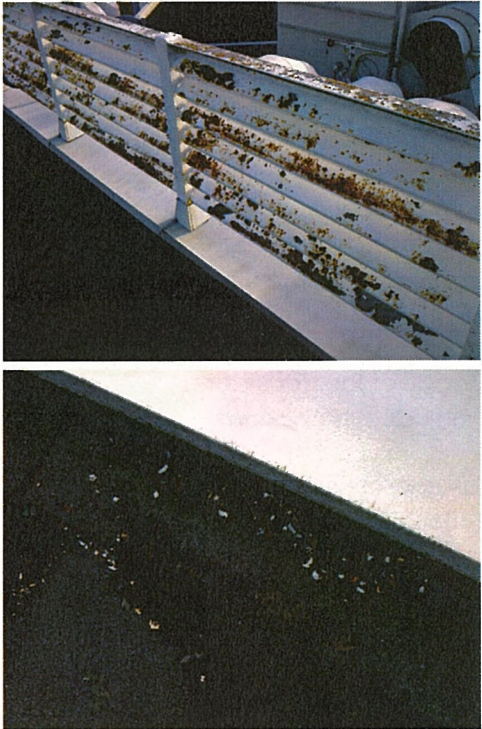
Lead-Containing Material Description	Photo
<p>White colour paint – Present on metal rooftop railing (18,000 ppm).</p> <p>This material was observed in POOR condition (rusting and flaking paint throughout railing structure) and paint chip debris was observed on the roof.</p>

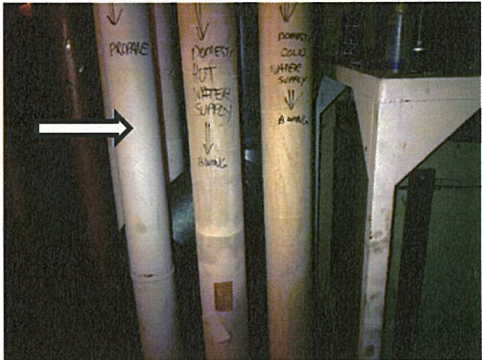
<p>Cream colour paint – Present on steel mechanical pipe within the penthouse (990 ppm).</p> <p>This material was generally observed to be in GOOD condition.</p>

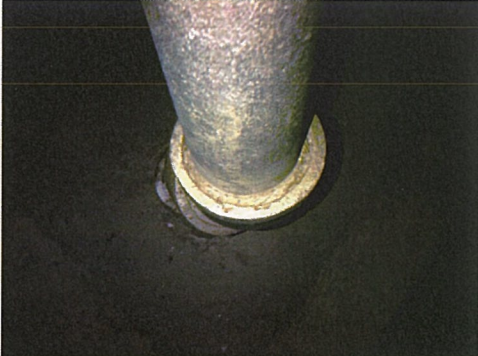
Lead-Containing Material Description	Photo
<p>Silver colour paint – Present on cast iron drain pipe within the penthouse (960 ppm).</p> <p>This material was generally observed to be in GOOD condition.</p>

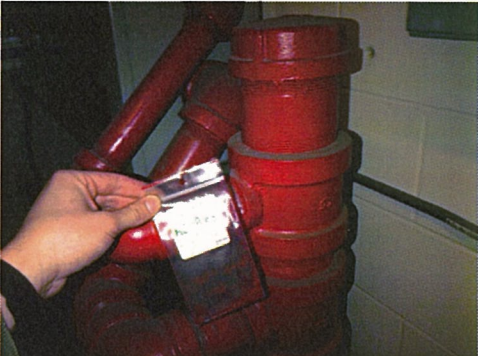
<p>Red colour paint – Present on steel sprinkler pipe throughout the building (7,600 ppm).</p> <p>This material was generally observed to be in GOOD condition.</p>

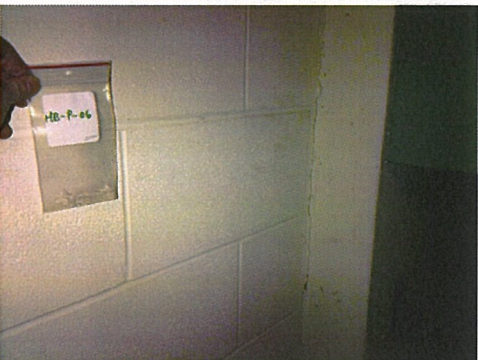
<p>Cream colour paint – Present on the walls and ceiling within the penthouse (940 ppm).</p> <p>This material was generally observed to be in GOOD condition.</p>

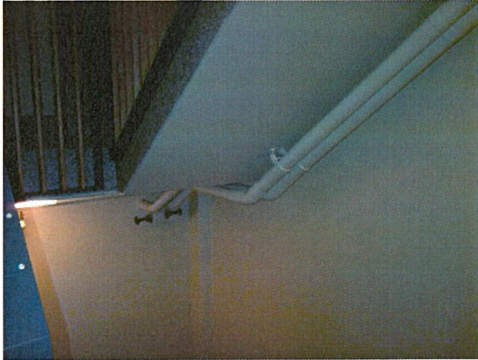
Lead-Containing Material Description	Photo
<p>Grey/blue colour paint – Present on the concrete floor in the east hallway on the 1st floor (630 ppm). This material was generally observed to be in GOOD condition.</p>	<p>No photo</p>
<p>White colour paint – Present on plaster walls and ceilings in stairwells (1,600 ppm). This material was generally observed to be in GOOD condition.</p>

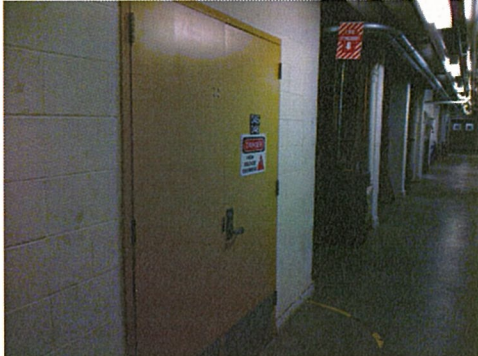
<p>Red colour paint (with yellow colour paint layer beneath) – Present on metal doors and door frames throughout the ground floor north and south hallways (2,800 ppm). No photo for the red colour door frame sampled, however this photo shows the yellow colour paint present beneath (which is present on the majority of doors/door frames throughout the ground floor north and south hallways). This material was generally observed to be in GOOD condition.</p>

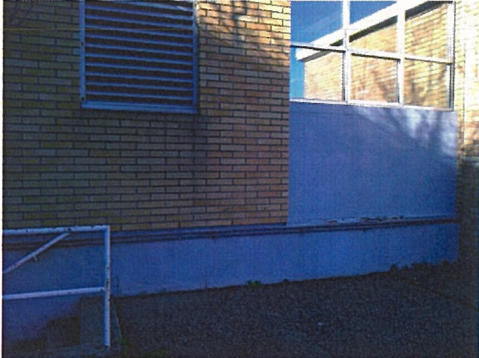
Lead-Containing Material Description	Photo
<p>Grey colour paint – Present on metal exterior trim and stucco siding on the building (2,800 ppm).</p> <p>This material was generally observed to be in GOOD condition with the exception of some peeling due to outdoor deterioration.</p>

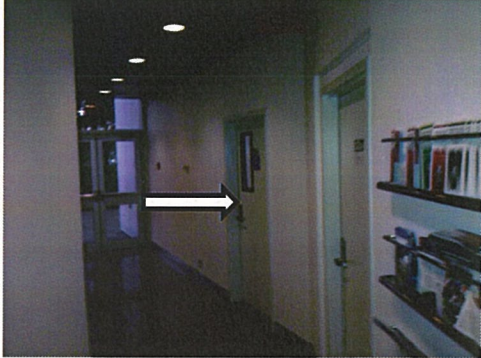
Lead-Containing Material Description	Photo
<p>Off-white colour paint – Present on metal doors and door trim throughout the ground floor (2,000 ppm).</p> <p>This material was generally observed to be in GOOD condition.</p>

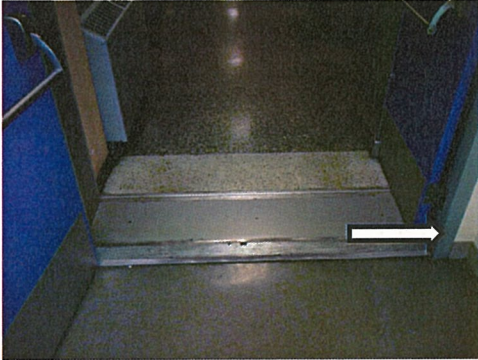
Lead-Containing Material Description	Photo
<p>Yellow colour paint – Present on metal door trim throughout the ground floor (1,100 ppm). This material was generally observed to be in GOOD condition.</p>	<p>No photo</p>
<p>Grey colour paint – Present on metal door trim on the entrance door to A Wing on the 3rd floor (2,400 ppm). This material was generally observed to be in GOOD condition.</p>

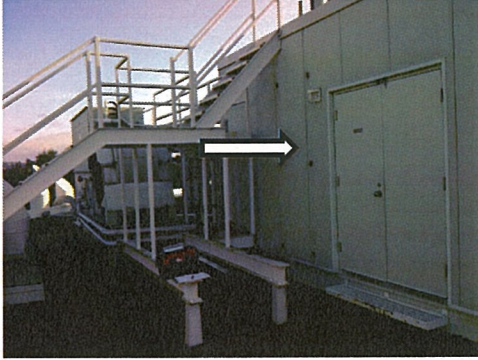
A photograph showing the interior of a door frame. The door is open, revealing a grey-painted metal threshold and trim. A white arrow points to the grey-painted metal trim on the right side of the door frame.
<p>Grey colour paint – Present on metal siding on the exterior of the building (1,200 ppm). This material was generally observed to be in GOOD condition.</p>

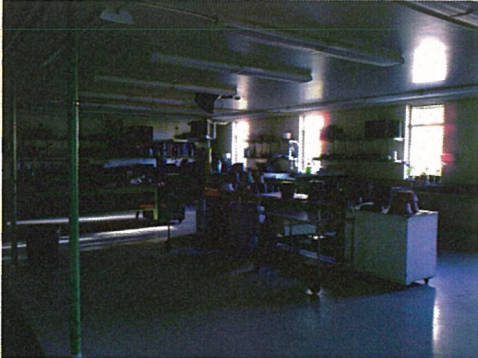
Lead-Containing Material Description	Photo
<p>Beige colour paint – Present on drywall interior walls and ceilings throughout (1,800 ppm). This material was generally observed to be in GOOD condition.</p>

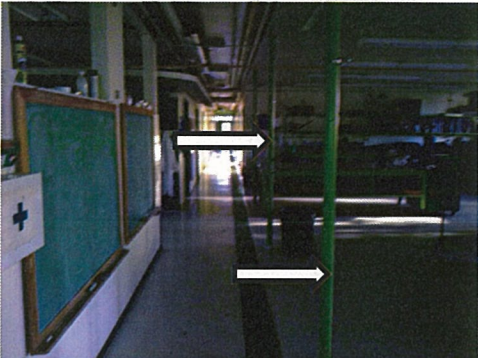
<p>Light green colour paint – Present on metal interior posts and doors throughout (3,800 ppm). This material was generally observed to be in GOOD condition.</p>

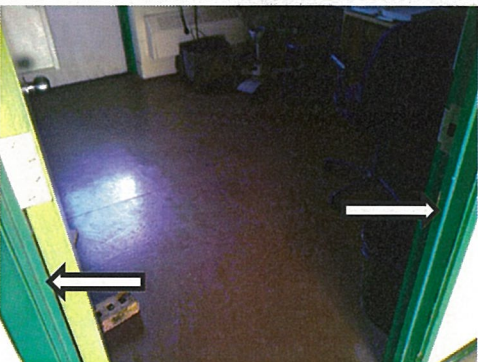
<p>Dark green colour paint – Present on metal interior doors throughout (27,000 ppm). This material was generally observed to be in GOOD condition.</p>

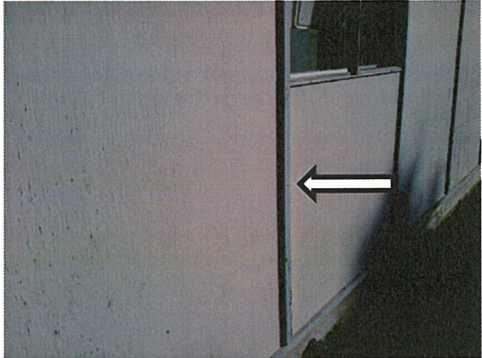
Lead-Containing Material Description	Photo
<p>Grey colour paint – Present on wood exterior trim on the building (1,200 ppm).</p> <p>This material was generally observed to be in GOOD condition with the exception of some peeling due to outdoor deterioration.</p>

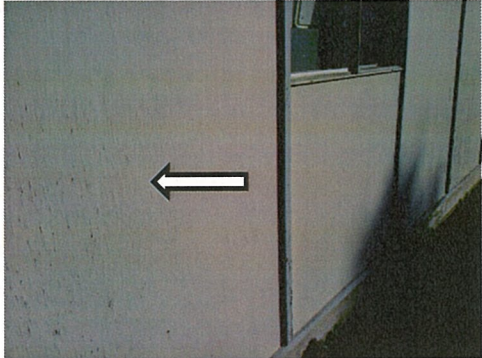
A photograph showing a close-up of a grey-painted wood exterior trim. A white arrow with a black outline points to the right, indicating the location of the lead-containing material.
<p>White colour paint – Present on wood exterior siding on the building (2,300 ppm).</p> <p>This material was generally observed to be in GOOD condition with the exception of some peeling due to outdoor deterioration.</p>

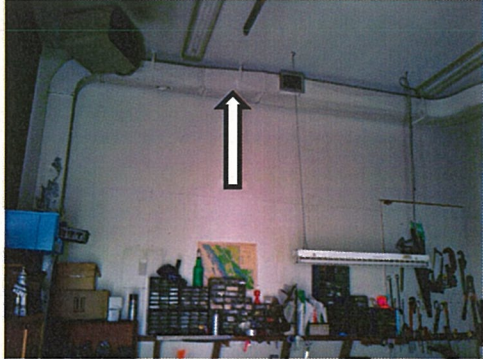
Lead-Containing Material Description	Photo
<p>Beige colour paint – Present on metal mechanical ductwork throughout (2,400 ppm). This material was generally observed to be in GOOD condition with the exception of some peeling.</p>

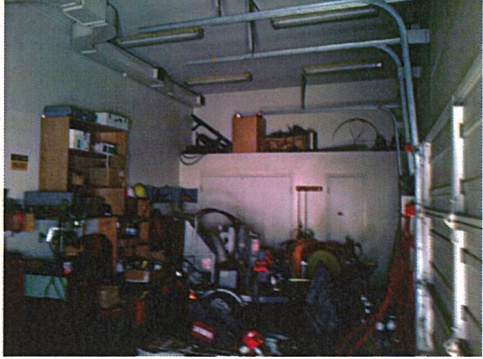
<p>White colour paint – Present on drywall interior walls and ceilings throughout (680 ppm). This material was generally observed to be in GOOD condition.</p>

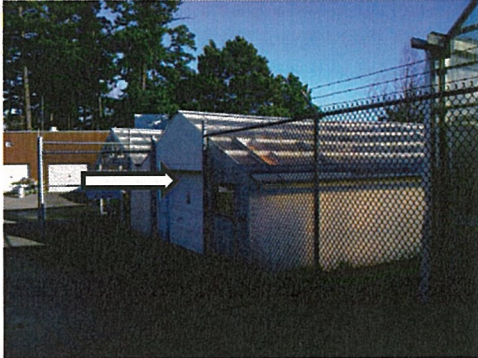
Lead-Containing Material Description	Photo
<p>White colour paint – Present on wood shed structure (6,700 ppm).</p> <p>This material was generally observed to be in GOOD condition with the exception of some peeling due to outdoor deterioration.</p>

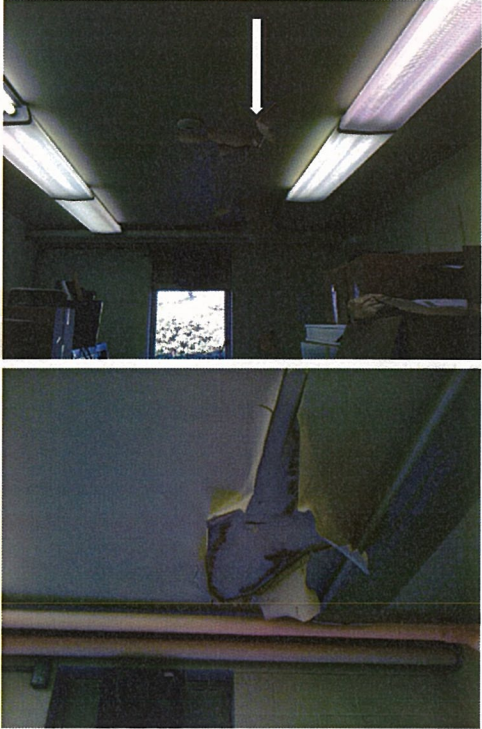
Identified/Suspect Mould and/or Moisture Impacted Building Material Observed	Photo
<p>Suspect mould and moisture-impacted drywall was on the ceiling in room H9.</p> <ul style="list-style-type: none"> • NOTE: The above noted suspect mould/moisture-impacted material is an identified ACM.

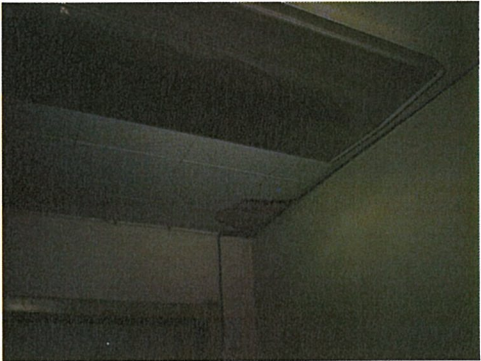
Identified/Suspect Mould and/or Moisture Impacted Building Material Observed	Photo
Moisture-impacted ceiling tiles were observed on the ceiling and within a light fixture near the alternate entrance to the building.

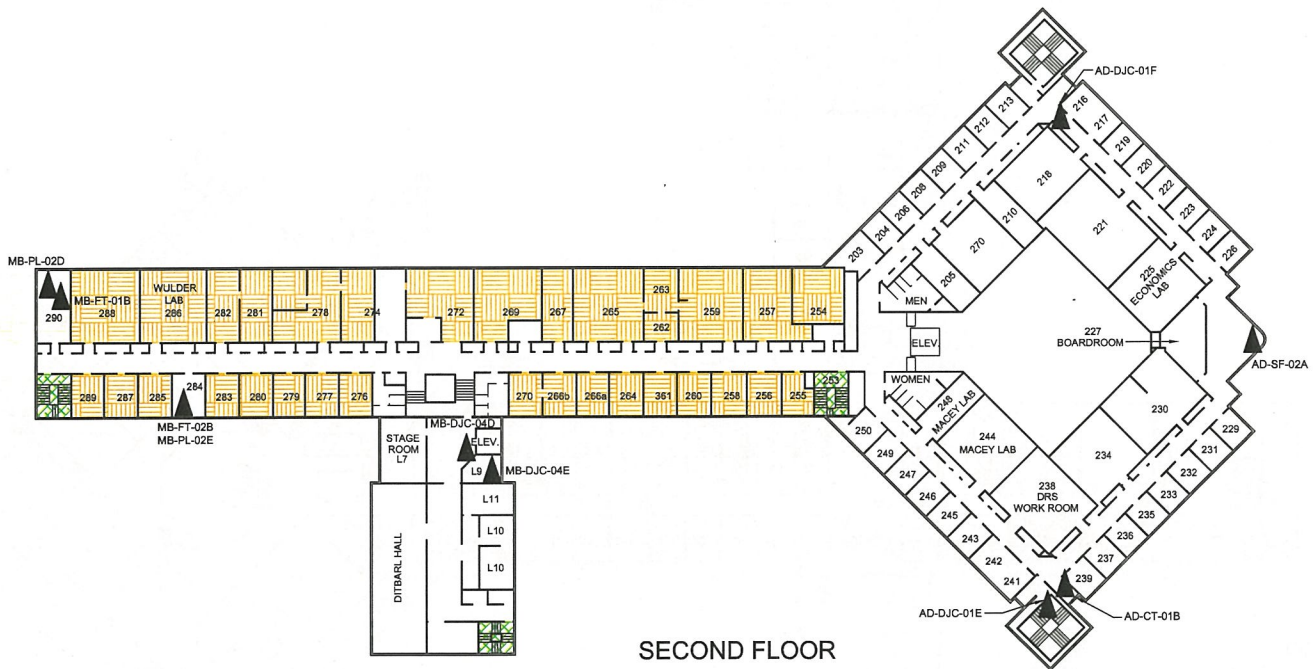
Dwg. No.:	3

FLOOR PLAN SHOWING HAZARDOUS BUILDING MATERIALS AND BULK SAMPLE LOCATIONS

SECOND FLOOR

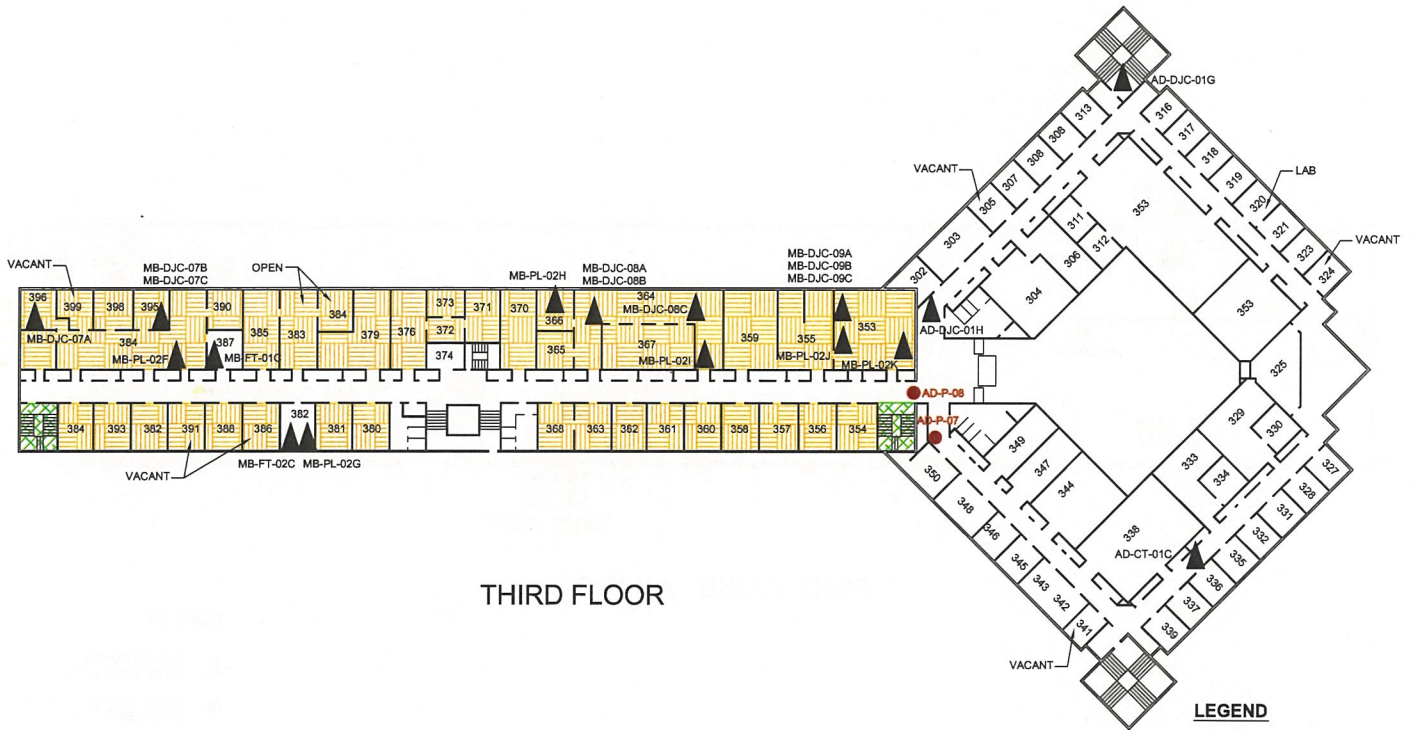
4

FLOOR PLAN SHOWING HAZARDOUS BUILDING MATERIALS AND BULK SAMPLE LOCATIONS

THIRD FLOOR

- NOTES:** 1. ASBESTOS-CONTAINING CEMENT BOARD LINES PRESENT WITHIN FUME HOODS THROUGHOUT.
 2. ASBESTOS-CONTAINING CEMENT PIPE (FUME HOOD EXHAUST PIPING) PRESENT WITHIN PIPE CHASES THROUGHOUT.
 3. THIS DRAWING ILLUSTRATES SUPPORTING INFORMATION SPECIFIC TO A STANTEC CONSULTING LTD. REPORT AND MUST NOT BE USED FOR OTHER PURPOSES.
