## ADDENDUM NO. A03

Project: **CFIA Fallowfield Lab Retrofit  
3851 Fallowfield Road,  
Ottawa, ON  
K2H 8P9**

**PROJECT SPECIFIC DESIGNATED SUBSTANCE SURVEY  
A-WING and C-WING RENOVATION PROJECT  
BUILDING 201 – 3851 FALLOWFIELD ROAD, OTTAWA, ONTARIO**

**JANUARY, 2016**

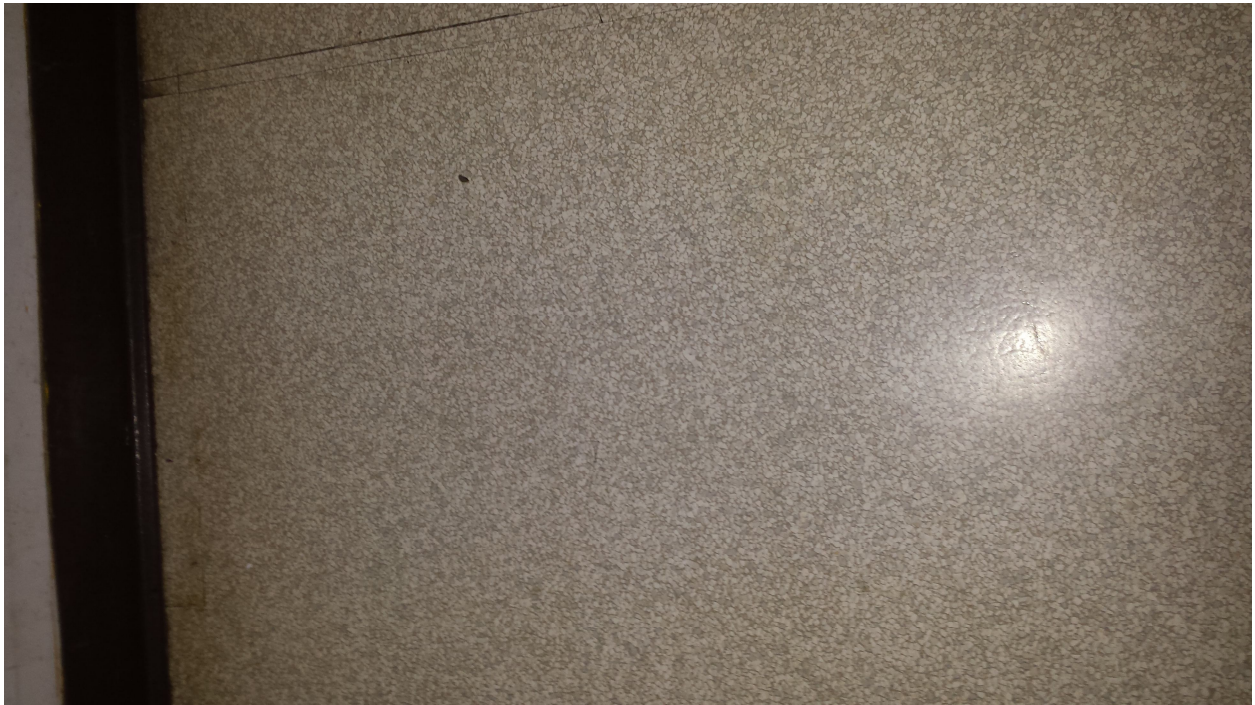
- Three (3) samples (SA-01A/B/C) of a sheet vinyl flooring of a beige sheet vinyl flooring (stone pattern with paper backing) were collected from the 4<sup>th</sup> Floor A-Wing Corridor for analysis. Based on the laboratory analysis, the vinyl flooring was found to contain **10% Chrysotile asbestos**.
  - This particular style of sheet vinyl flooring was identified as the primary flooring material within A-Wing.
  - Any manipulation of this particular style of sheet vinyl flooring must be completed in accordance with the procedures outlined in O.Reg 278/05.

**Photo 1 – ACM Sheet Vinyl Flooring with Stone Pattern and Paper Backing.**

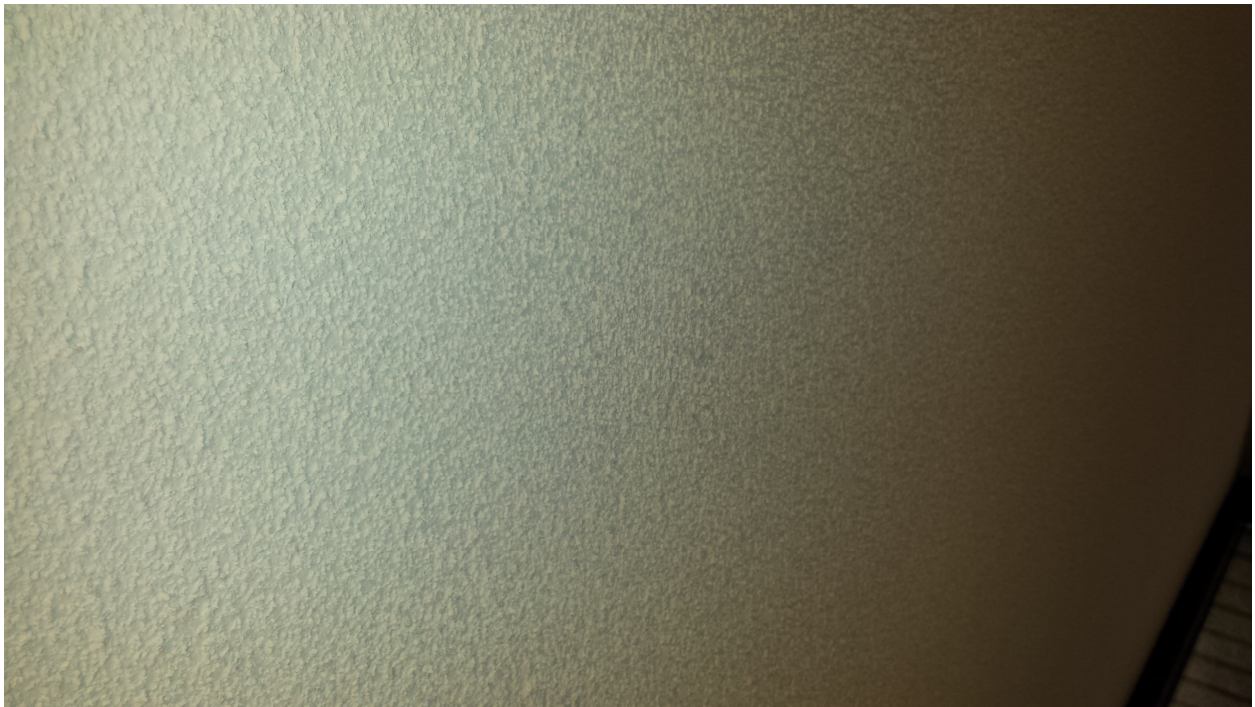
- Three (3) samples (SA-07A/B/C) of a textured ceiling/wall finish were collected from within the C-Wing Lobby area for analysis. Based on the laboratory analysis, SA-07A was found to contain **3% Chrysotile asbestos**.

**Photo 2 – ACM Textured Ceiling Finish**

- All textured ceiling finish within the project area must be treated as an ACM.
  - Any manipulation of textured wall finish must be completed in accordance with the procedures outlined in O.Reg 278/05.
- Three (3) samples (SA-06A/B/C) of an acoustic ceiling tile (60cm x 120cm with patterned pinholes and pink back) were collected from the 4<sup>th</sup> floor A-Wing corridor and submitted for laboratory analysis. Based on the laboratory analysis, SA-06A was found to contain **2.32% Chrysotile asbestos** and **0.77 Amosite asbestos**.
    - All visually similar acoustic ceiling tiles within the project area must be treated as an ACM.
    - Any manipulation of the acoustic ceiling tiles must be completed in accordance with the procedures outlined in O.Reg 278/05.

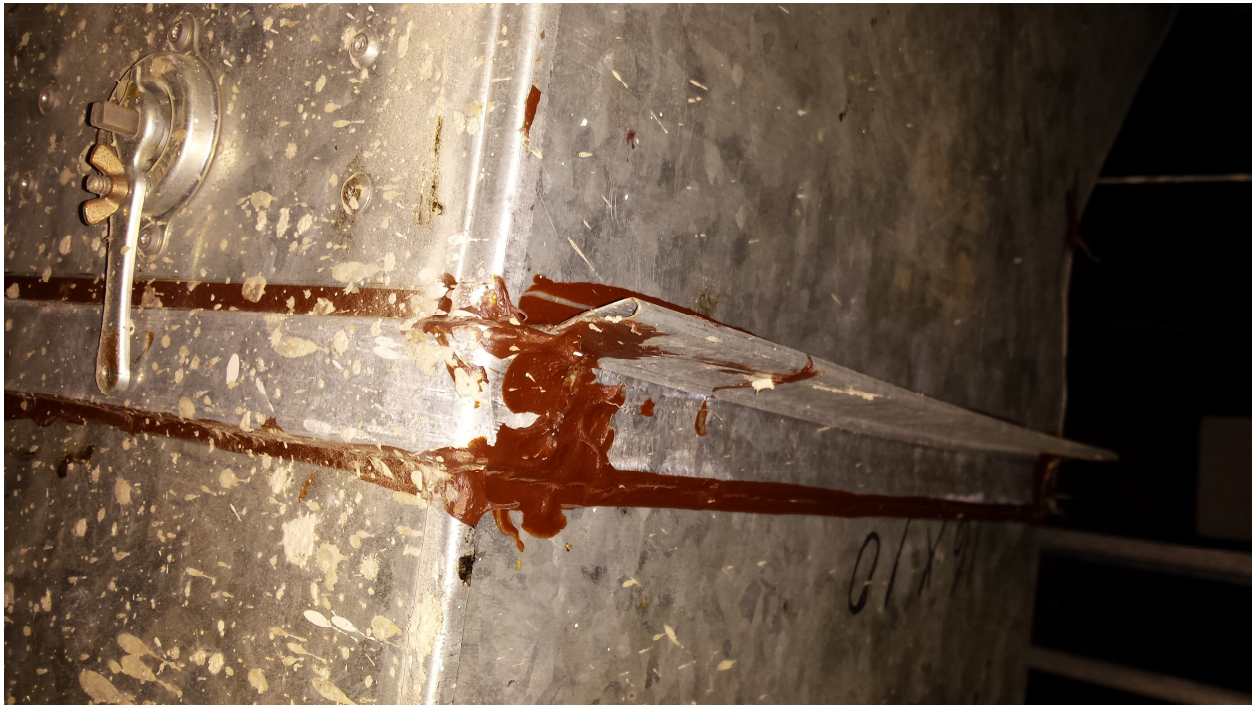
- Three (3) samples (SA-03A/B/C) of a brown duct sealant were collected from the A-Wing ceiling space and submitted for laboratory analysis. Based on the laboratory analysis, SA-03A was found to contain **1.56% Chrysotile asbestos**.
  - All brown duct sealant finish within the project area must be treated as an ACM.

**Photo 3 – Asbestos Containing Brown Duct Sealant**

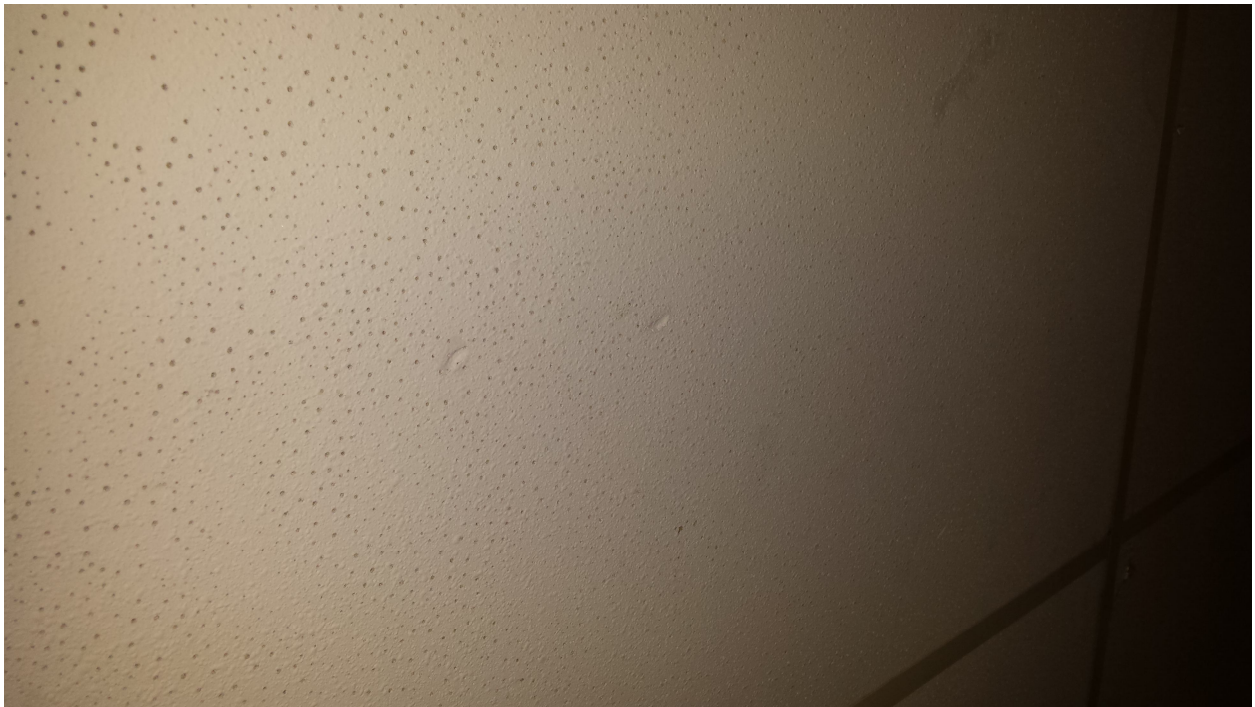
**Photo 4 – Asbestos Containing Pink Back Acoustic Ceiling Tile**
