Design Drawings / Repair Details

BANFF VISITOR'S CENTRE EXTERIOR REPAIRS

BANFF, ALBERTA
FEBRUARY 2016 - ISSUE FOR TENDER

A0.0 COVER SHEET
A1.0 PHOTOGRAPHIC REFERENCE - WEST
A1.1 PHOTOGRAPHIC REFERENCE - WEST
A2.0 PHOTOGRAPHIC REFERENCE - SOUTH
A2.1 PHOTOGRAPHIC REFERENCE - SOUTH
A2.2 PHOTOGRAPHIC REFERENCE - SOUTH
A2.3 PHOTOGRAPHIC REFERENCE - SOUTH
A3.0 PHOTOGRAPHIC REFERENCE - EAST
A4.0 PHOTOGRAPHIC REFERENCE - NORTH
A4.1 PHOTOGRAPHIC REFERENCE - NORTH

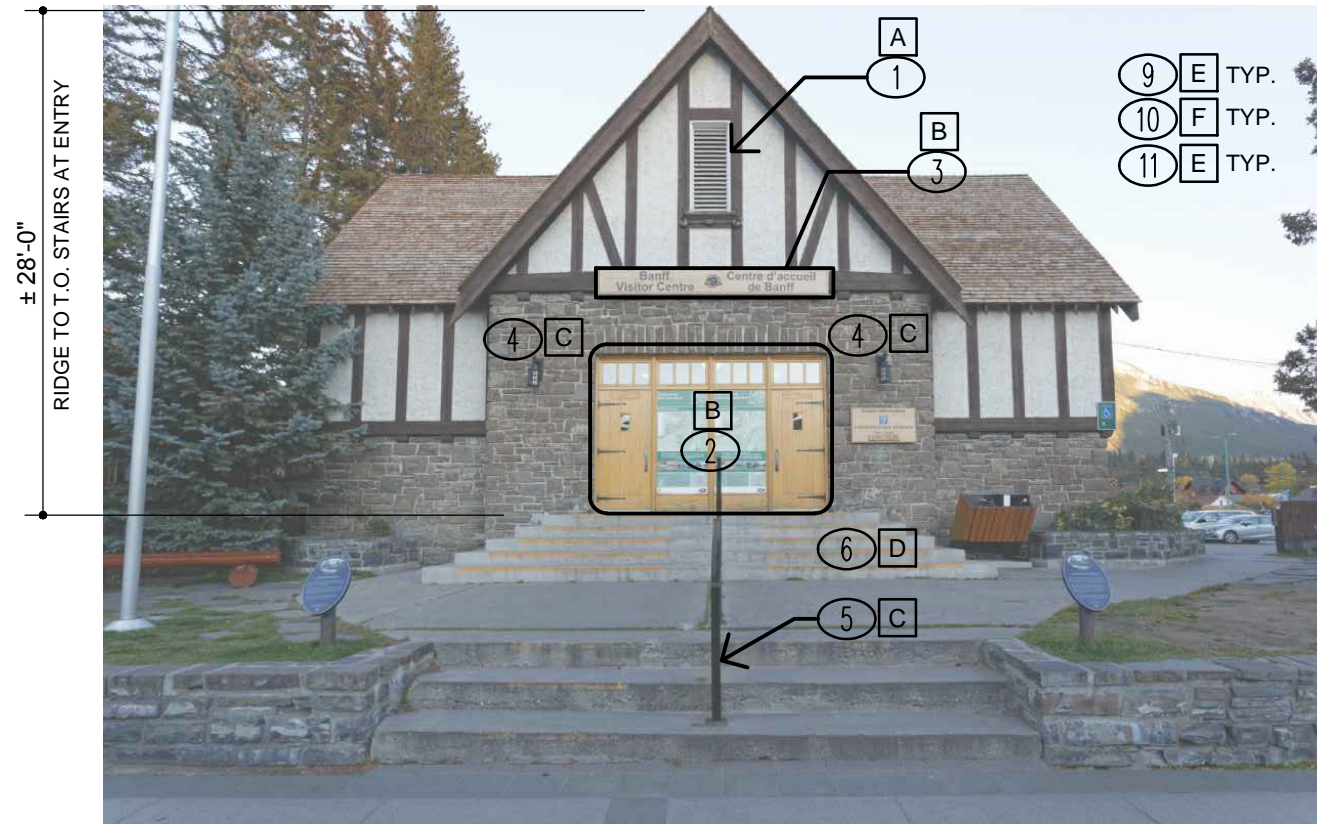
1 | WEST FACADE – FRONT FACING BANFF AVE.

CONDITION KEYNOTES - (WEST FACADE):

- ① FADED, PEELING & GENERALLY WEATHERED PAINED FINISH - WOOD.
- ② FADED & WEATHERED CLEAR VARNISH/ CLEAR COAT FINISH - WOOD ENTRY DOORS, FRAMES (MINOR) & SIGNAGE.
- ③ WORN FINISH AT HARDWARE. MINOR CORROSION AT HINGES.
- ④ WORN PAINTED FINISH AND MINOR CORROSION AT LIGHT FIXTURES.
- ⑤ CORROSION & PAINT DETERIORATION AT METAL HANDRAIL.
- ⑥ FADED YELLOW STRIPING (PAINTED FINISH) AT STAIRS.
- ⑦ NOT USED
- ⑧ DETERIORATED MORTAR AT STONE MASONRY.
- ⑨ DIRTY STUCCO FINISH, TYPICAL AT ALL PANELS
- ⑩ FADED DARK STAINED FINISH AT ALL HALF TIMBER FRAMING, FASCIA BOARDS & SOFFIT.
- ⑪ DIRTY & STAINED STONE, TYPICAL.

SCOPE OF WORK - (WEST FACADE):

- A SCRAPE AWAY LOOSE PAINT, LIGHTLY SAND & PAINT.
- B STRIP AWAY CLEAR COAT. CLEAN STAINING AT DOOR. APPLY NEW CLEAR COAT.
- C STRIP EXISTING FINISH TO FULLY EXPOSE CORROSION. REMOVE CORROSION - LIGHT SAND BLAST. PRIME & PAINT. (ALTERNATE: PROVIDE ORGANIC CORROSION REMOVER)
- D PROVIDE NEW PAINTED STRIPING AT EXISTING LOCATIONS.
- E 'DOFF' STEAM CLEAN OR 'JOS TORC' POWER WASH. LIGHTLY SCRUB DIFFICULT STAINS WITH SOFT BRISTLE BRUSH & SURFACTANT.
- F PROVIDE NEW STAINED FINISH TO MATCH EXISTING.
- G REMOVE LOOSE SOFT & DETERIORATED MORTAR. REPOINT. TOOLING JOINT TO MATCH EXISTING ADJACENT.

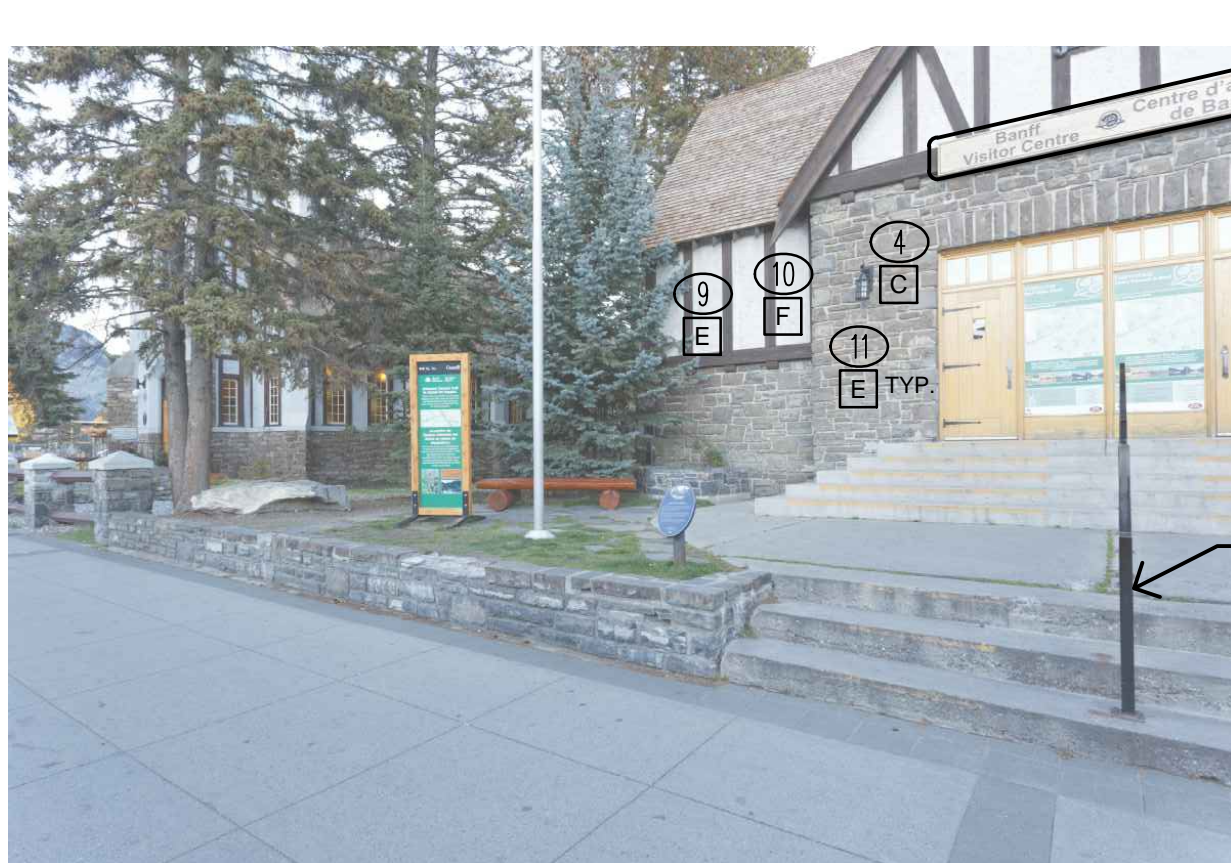
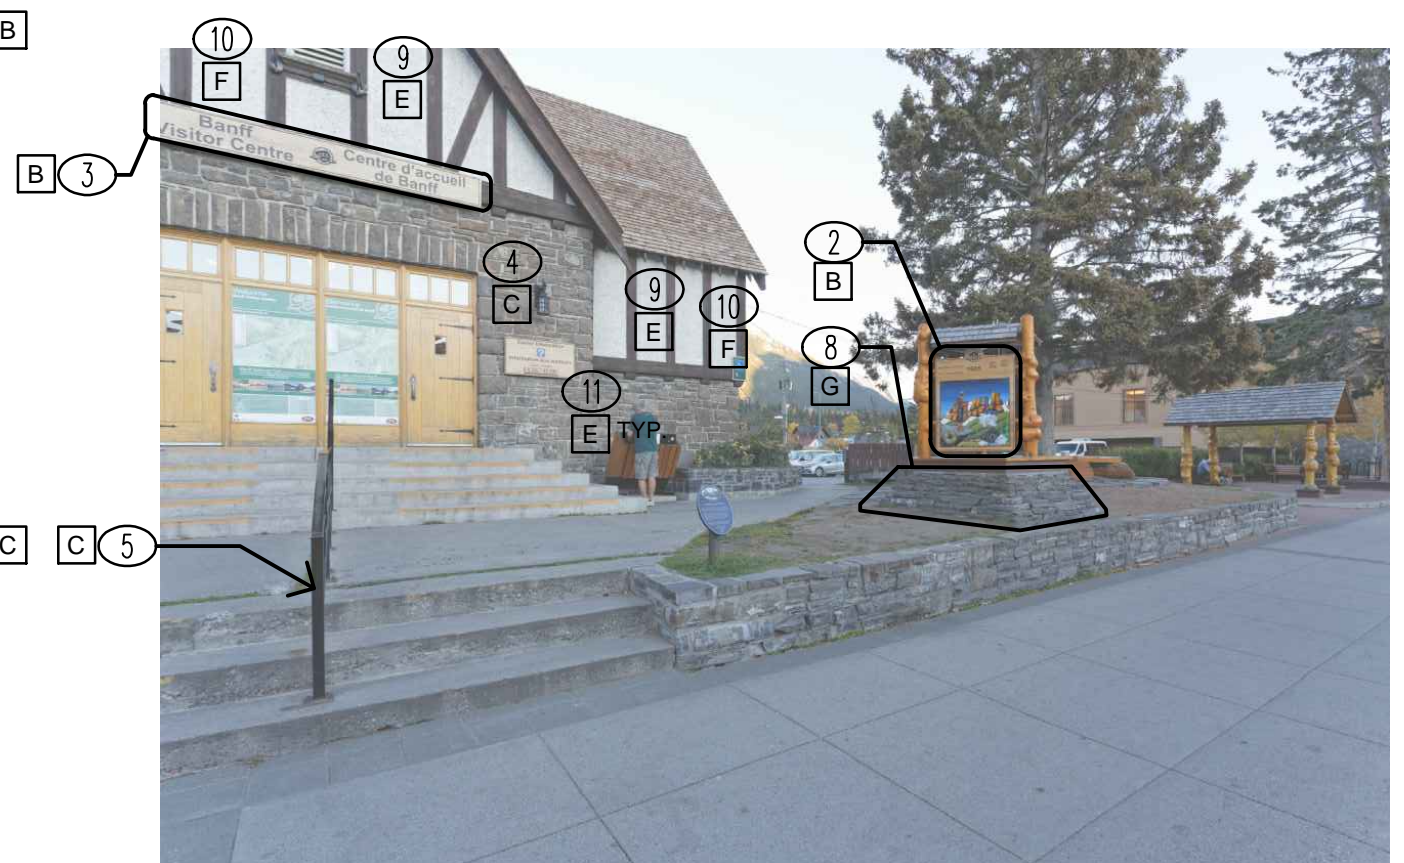
1 | WEST FACADE – FRONT FACING BANFF AVE.

- 1 FADED, PEELING & GENERALLY WEATHERED PAINTED FINISH - WOOD. OCCURS AT ALL WINDOW SILLS & FRAMES, AND AT WOOD SASHES WHERE THEY OCCUR. TYPICAL AT THIS FACADE.

- 2 SPLIT HALF TIMBER BOARD. INCLUDES DETERIORATED & SPLIT BOARD ENDS AT BOARDS INSTALLED VERTICALLY.
- 3 FADED DARK STAINED FINISH AT ALL HALF TIMBER FRAMING, FASCIA BOARDS, SOFFIT & RAFTER TAILS, TYPICAL AT THIS FACADE

- 4 DIRTY & STAINED STUCCO FINISH. TYPICAL AT ALL AREAS, THIS FACADE.
- 5 DIRTY & STAINED STONE - TYPICAL.
- 6 GAP BETWEEN HALF TIMBER FRAMING & STUCCO.
- 7 DETERIORATED MORTAR AT STONE MASONRY.

- 8 CHIPPED & WEATHERED PAINT AT HANDRAIL, GUARDRAIL & AT METAL STAIR & LANDING ASSEMBLY. LIGHT CORROSION VISIBLE.
- 9 DAMAGED PAINTED FINISH AT METAL DOOR & METAL GRILL.

- 10 PAINT SPLASHES AT STONE FACADE.
- 11 NOT USED
- 12 NOT USED
- 13 LOOSE, CUPPED, WARPED & OTHERWISE DETERIORATED HALF TIMBER BOARDS, THIS AREA. GAPS BETWEEN BOARDS AT JOINTS.

- 14 CRACKED & SPALLED STUCCO. DETERIORATED STUCCO EDGE ADJACENT TO HALF TIMBER FRAMING TYPICAL.
- 15 DAMAGED, LOOSE METAL FLASHING AT UPPER WINDOWS - CURVED 'EYEBROW'.

- A** SCRAPE AWAY LOOSE PAINT, LIGHTLY SAND & PAINT. PROVIDE EPOXY REPAIR AT SILLS & FRAMES WITH DRY ROT, AS REQUIRED. REMOVE & REPLACE WINDOW PUTTY WHERE LOOSE & CRACKED

- B** EPOXY REPAIR SPLITS & CRACKS AT HALF TIMBER BOARDS.
- C** PROVIDE NEW STAINED FINISH TO MATCH EXISTING.
- D** 'DOFF' STEAM CLEAN OR 'JOS TORC' POWER WASH. LIGHTLY SCRUB DIFFICULT STAINS WITH SOFT BRISTLE BRUSH & SURFACTANT.

- E** PROVIDE PAINTABLE CAULKED JOINT AT GAPS.
- F** REMOVE LOOSE SOFT & DETERIORATED MORTAR. REPOINT. TOOLING JOINT TO MATCH EXISTING ADJACENT.
- G** STRIP EXISTING FINISH TO EXPOSE CORRODED AREAS. REMOVE CORROSION WITH LIGHT SANDBLAST. PRIME & PAINT. ALTERNATE: ORGANIC CORROSION REMOVER.

- H** SAND SMOOTH. PRIME & PAINT.
- I** NOT USED
- J** NOT USED
- K** REMOVE & REPLACE CUPPED & WARPED BOARDS TO MATCH EXISTING SPECIES & DIMENSIONS. CLEAN & REPAIR STUCCO FINISH AROUND & BEHIND BOARDS AS REQUIRED TO MAINTAIN WATERTIGHT FINISH.

- L** CHIP & REMOVE LOOSE & DAMAGED STUCCO ADJACENT TO CRACK OR SPALLED AREA. ROUGHEN & PREPARE SURFACE TO RECEIVE BONDING AGENT. APPLY SCRATCH, BROWN & FINISH COATS. TEXTURE TO MATCH EXISTING.

- M** FASTEN & CAULK AT FLASHING TO MAKE WEATHERTIGHT. REPLACE AS REQUIRED.

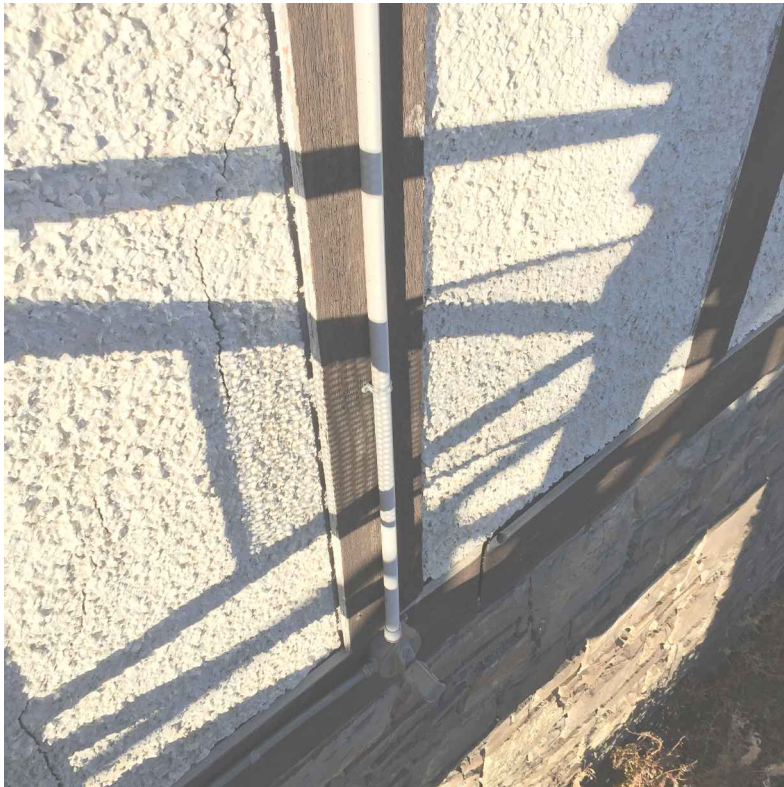
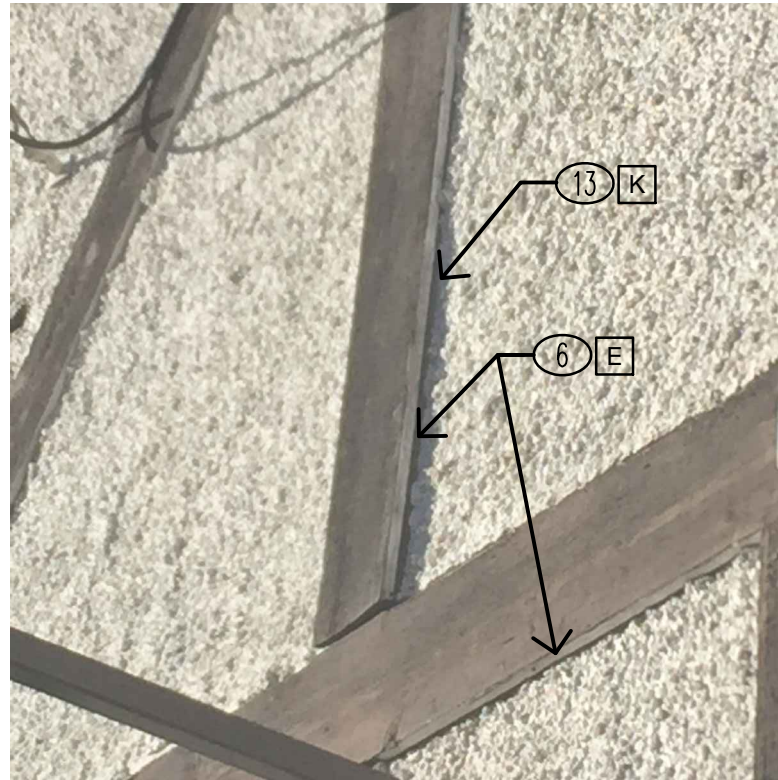
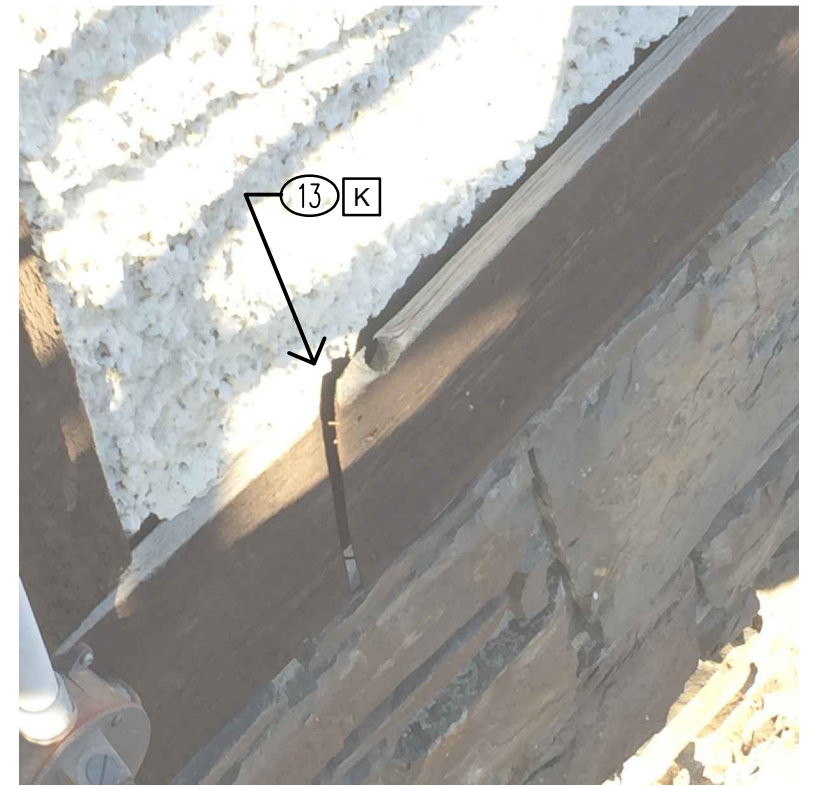
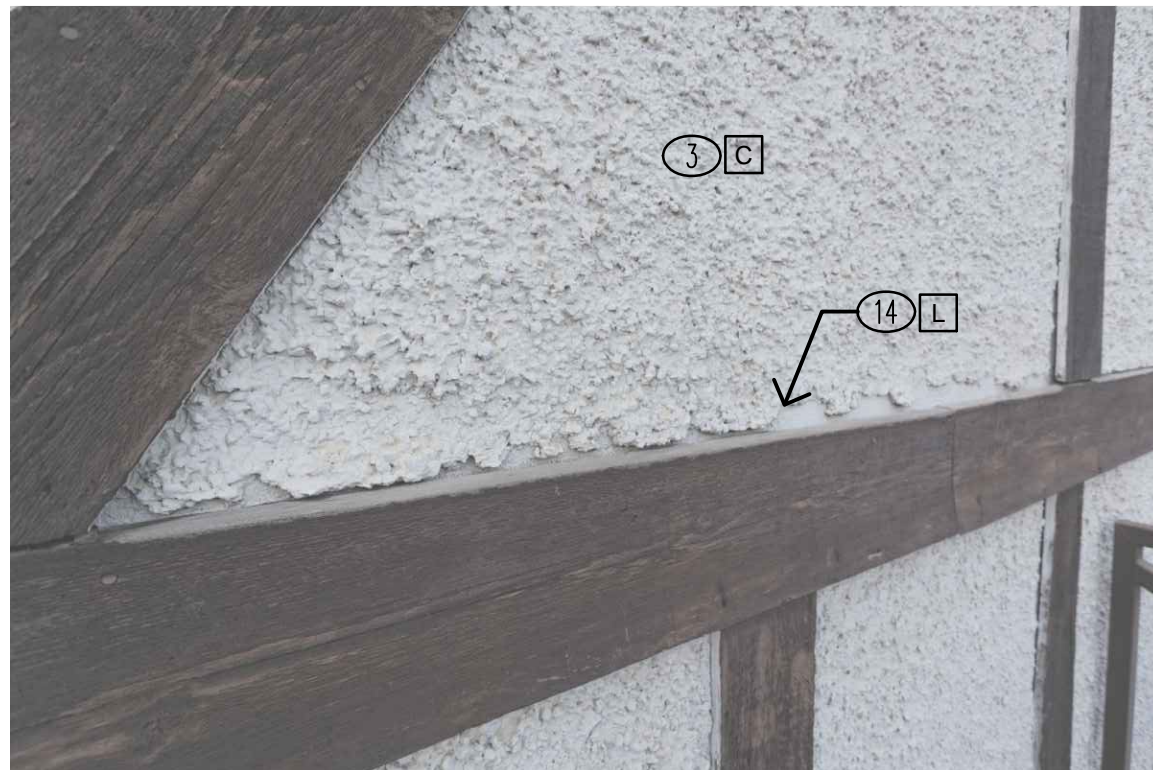
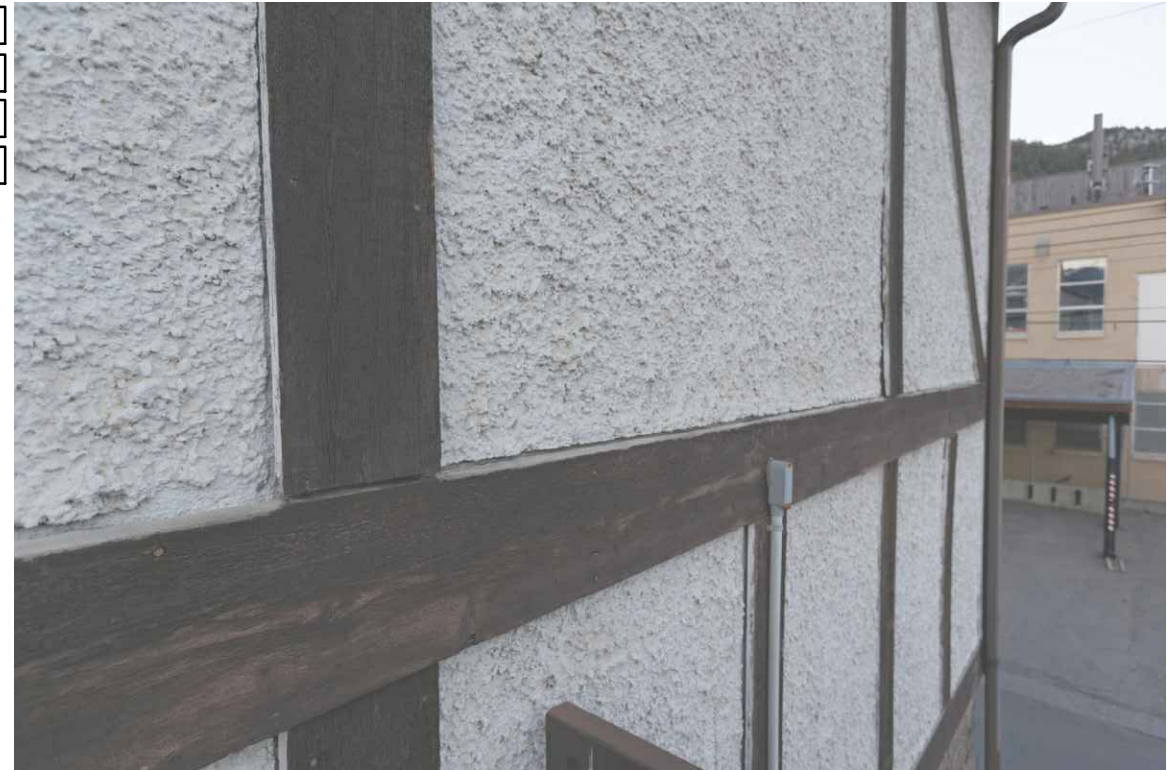
1 | SOUTH DETAIL – TYPICAL

3 C
6 E
13 K
14 L

- 2 SPLIT HALF TIMBER BOARD. INCLUDES DETERIORATED & SPLIT BOARD ENDS AT BOARDS INSTALLED VERTICALLY.
- 3 FADED DARK STAINED FINISH AT ALL HALF TIMBER FRAMING, FASCIA BOARDS, SOFFIT & RAFTER TAILS, TYPICAL AT THIS FACADE

- 10 PAINT SPLASHES AT STONE FACADE.
- 11 NOT USED
- 12 NOT USED
- 13 LOOSE, CUPPED, WARPED & OTHERWISE DETERIORATED HALF TIMBER BOARDS, THIS AREA. GAPS BETWEEN BOARDS AT JOINTS.

- 14 CRACKED & SPALLED STUCCO. DETERIORATED STUCCO EDGE ADJACENT TO HALF TIMBER FRAMING TYPICAL.
- 15 DAMAGED, LOOSE METAL FLASHING AT UPPER WINDOWS - CURVED 'EYEBROW'.

- C PROVIDE NEW STAINED FINISH TO MATCH EXISTING.
- D 'DOFF' STEAM CLEAN OR 'JOS TORC' POWER WASH. LIGHTLY SCRUB DIFFICULT STAINS WITH SOFT BRISTLE BRUSH & SURFACTANT.

- E PROVIDE PAINTABLE CAULKED JOINT AT GAPS.
- F REMOVE LOOSE SOFT & DETERIORATED MORTAR. REPOINT. TOOLING JOINT TO MATCH EXISTING ADJACENT.
- G STRIP EXISTING FINISH TO EXPOSE CORRODED AREAS. REMOVE CORROSION WITH LIGHT SANDBLAST. PRIME & PAINT. ALTERNATE: ORGANIC CORROSION REMOVER.

- H SAND SMOOTH. PRIME & PAINT.
- I NOT USED
- J NOT USED
- K REMOVE & REPLACE CUPPED & WARPED BOARDS TO MATCH EXISTING SPECIES & DIMENSIONS. CLEAN & REPAIR STUCCO FINISH AROUND & BEHIND BOARDS AS REQUIRED TO MAINTAIN WATERTIGHT FINISH.

- L CHIP & REMOVE LOOSE & DAMAGED STUCCO ADJACENT TO CRACK OR SPALLED AREA. ROUGHEN & PREPARE SURFACE TO RECEIVE BONDING AGENT. APPLY SCRATCH, BROWN & FINISH COATS. TEXTURE TO MATCH EXISTING.

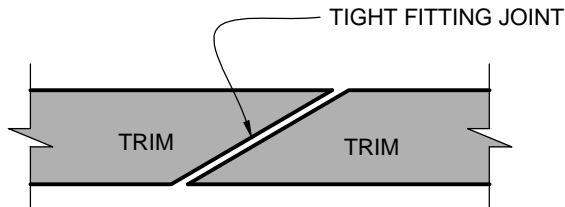
4 | TIMBER TRIM - TYPICAL JOINT

NOTE: MAINTAIN ANGLED 'BUTT JOINTS' AT REPLACEMENT BOARDS.

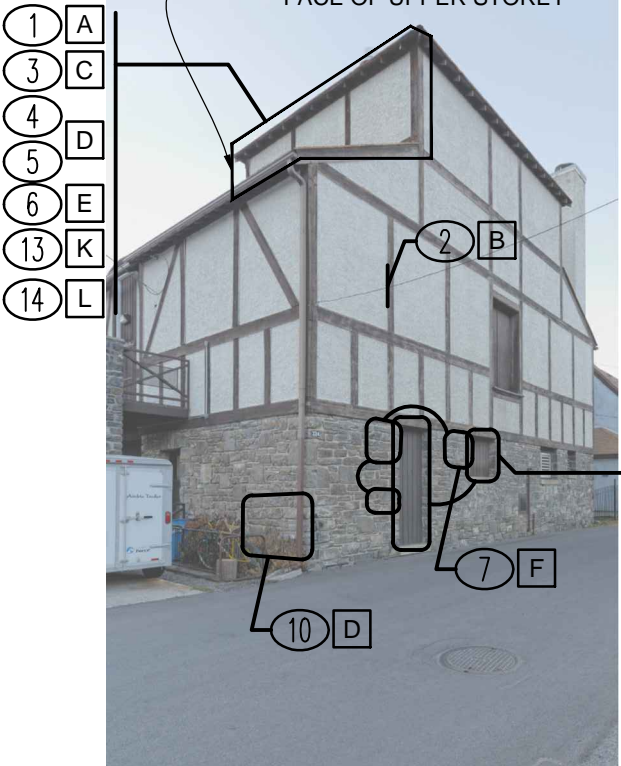
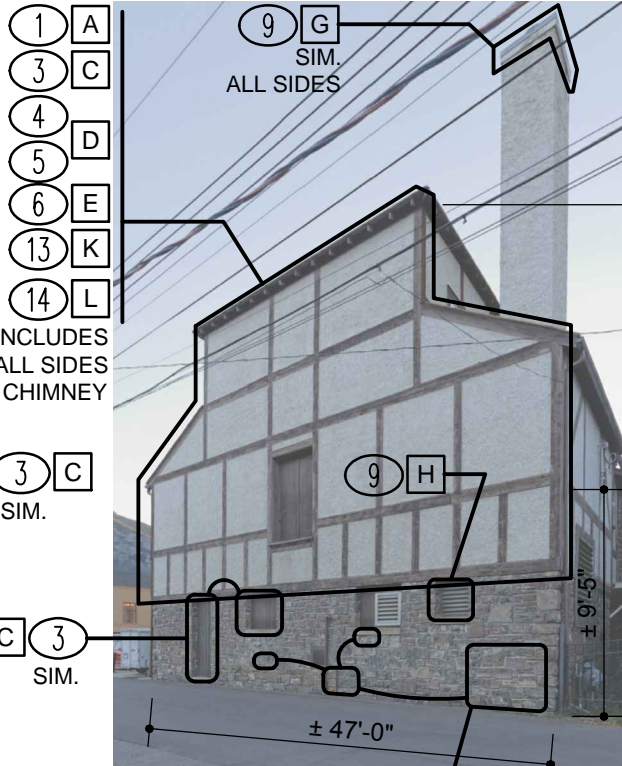
1 | EAST FACADE

9 (G) SIM. ALL SIDES

- 8 CHIPPED & WEATHERED PAINT AT HANDRAIL, GUARDRAIL & AT METAL STAIR & LANDING ASSEMBLY. LIGHT CORROSION VISIBLE.
- 9 DAMAGED PAINTED FINISH AT METAL DOOR & METAL GRILL.

- E PROVIDE PAINTABLE CAULKED JOINT AT GAPS.
- F REMOVE LOOSE SOFT & DETERIORATED MORTAR. REPOINT. TOOLING JOINT TO MATCH EXISTING ADJACENT.
- G STRIP EXISTING FINISH TO EXPOSE CORRODED AREAS. REMOVE CORROSION WITH LIGHT SANDBLAST. PRIME & PAINT. ALTERNATE: ORGANIC CORROSION REMOVER.

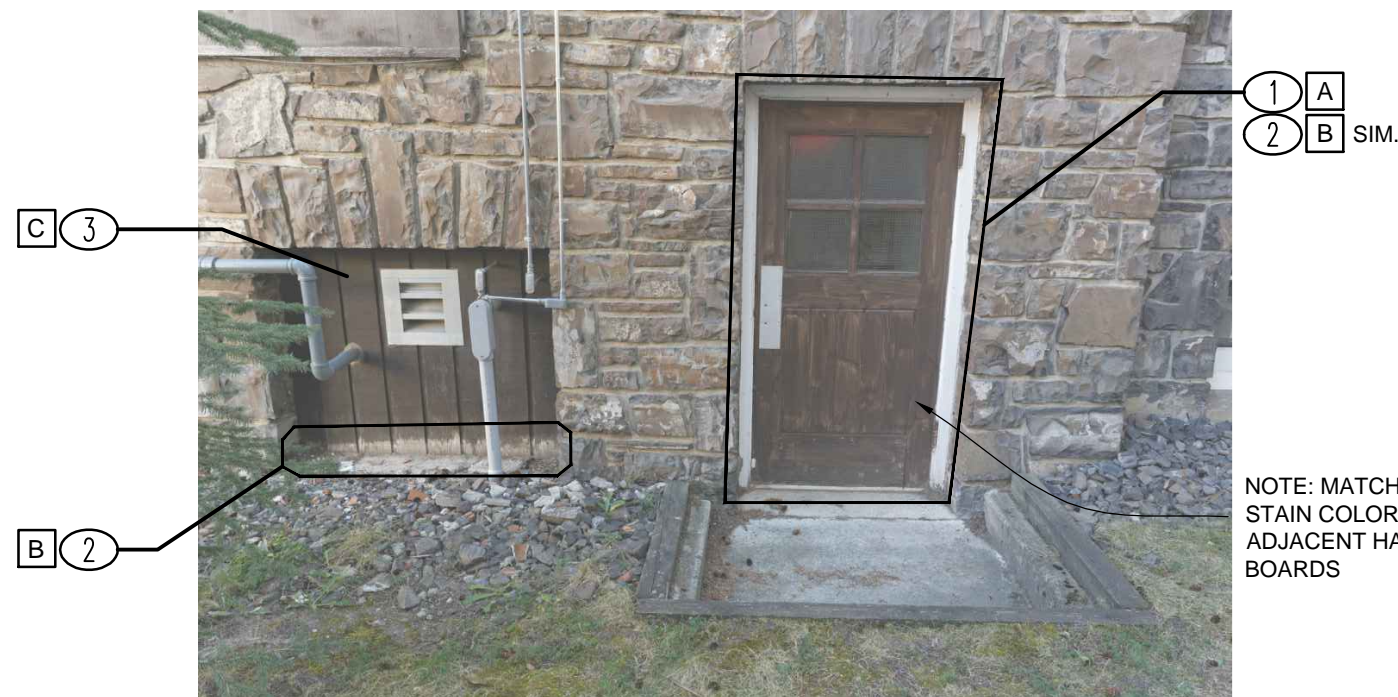
4 | NORTH FINISH DETAIL

NOTE: MATCH 'DARK'
STAIN COLOR OF
ADJACENT HALF TIMBER
BOARDS
