Appendix A Figures

PROJECT
TRANS-CANADA HIGHWAY SLOPE REPROFILING – YOHO NATIONAL PARK - 2016 WORKS

TITLE	PROJECT NO.	CONTROL	REV.	FIGURE
OVERVIEW OF PROJECT AREA	1540777	2000	0	1A

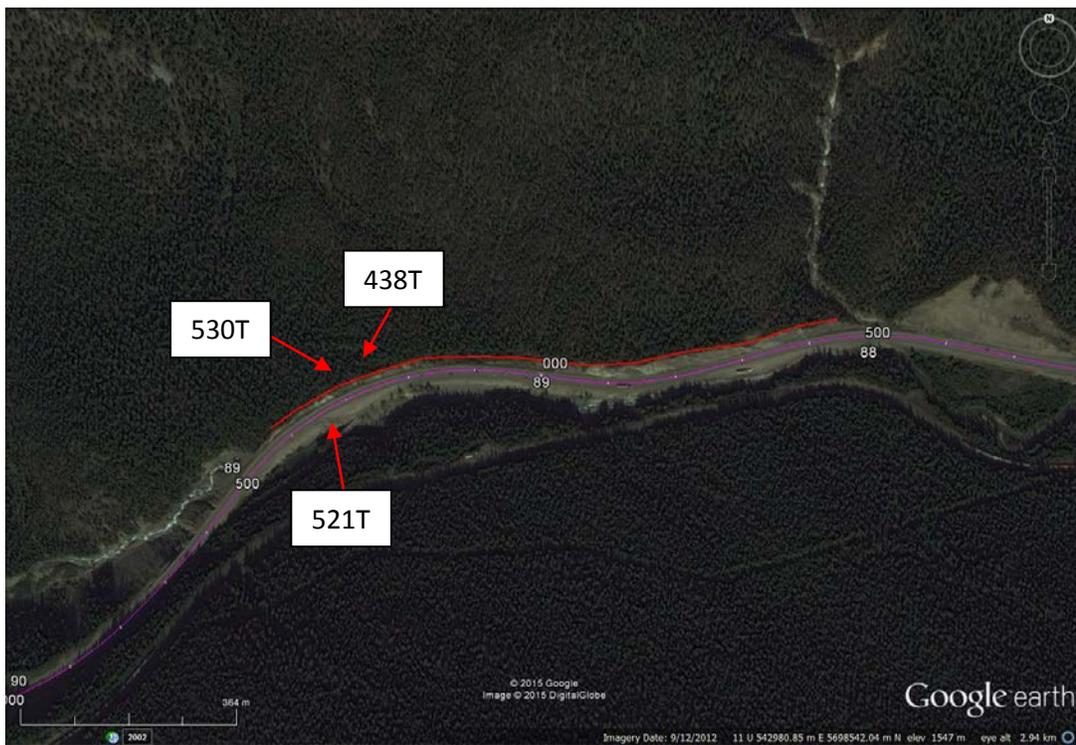
Figure 2. Upper (to the right) and lower Sherbrook (to the left) areas. Red line indicates area of proposed rock scaling and vegetation removal. Sites 521T, 530T and 438T are located at arrows.

- a. Upslope of the proposed rock scaling area is historic site 530T (figures 2 and 8), an historic railway- related train wreckage site and associated rail spur (Site 438T). All three of these historic resources are associated with the Kicking Horse Pass National Historic Site and therefore are of national significance. The train wreckage from site 430T is located 20m north of the edge of rock while the lower section of the rail grade is potentially vulnerable to impact from its use as a vehicle/equipment access way. **Site avoidance is recommended.** The rock scaling and vegetation removal should not impact the known location of the site but vegetation removal may result in the accidental uncovering of additional historic items. If this occurs, **please refer to the “accidental discovery clause”** contained in Appendix 1 of this document. **In addition, if the**

- b. The historic highway bridge, site 521T, will not be impacted from proposed construction (see figure 8). There is a possibility however, that construction staging/parking may take place in the gravel pull-out in front of the historic structure. **It is recommended that any such activity keep away from the actual bridge structure.**

- c. The historic rail grade, site 438T, is part of the Big Hill Safety Switch system put in place to deal with run-away trains before the construction of the Spiral Tunnels (a portion of this safety switch grade can be seen in figure 8). The lower portion of this rail grade where it has been impacted by the TCH may be vulnerable to proposed machinery access to the project area. **It is recommended that care should be taken to not impact the grade with heavy machinery or tracked vehicles without mitigating adverse effects on the rail grade.**

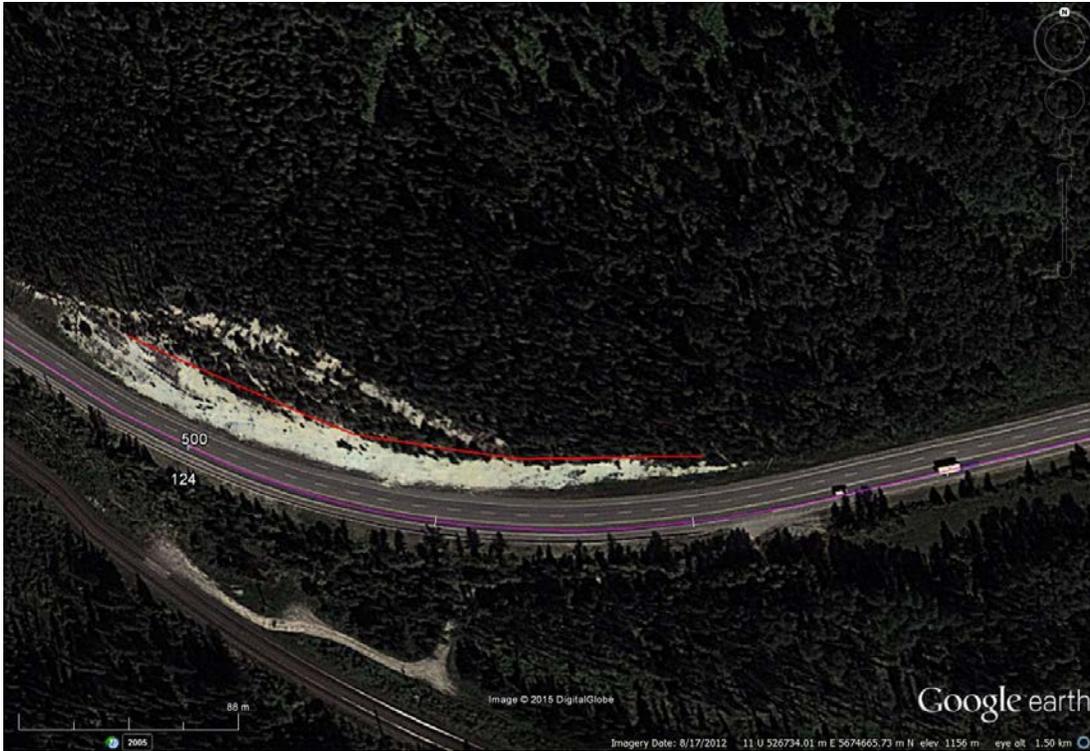
Figure 3. Phyllite Rock Slope project area.

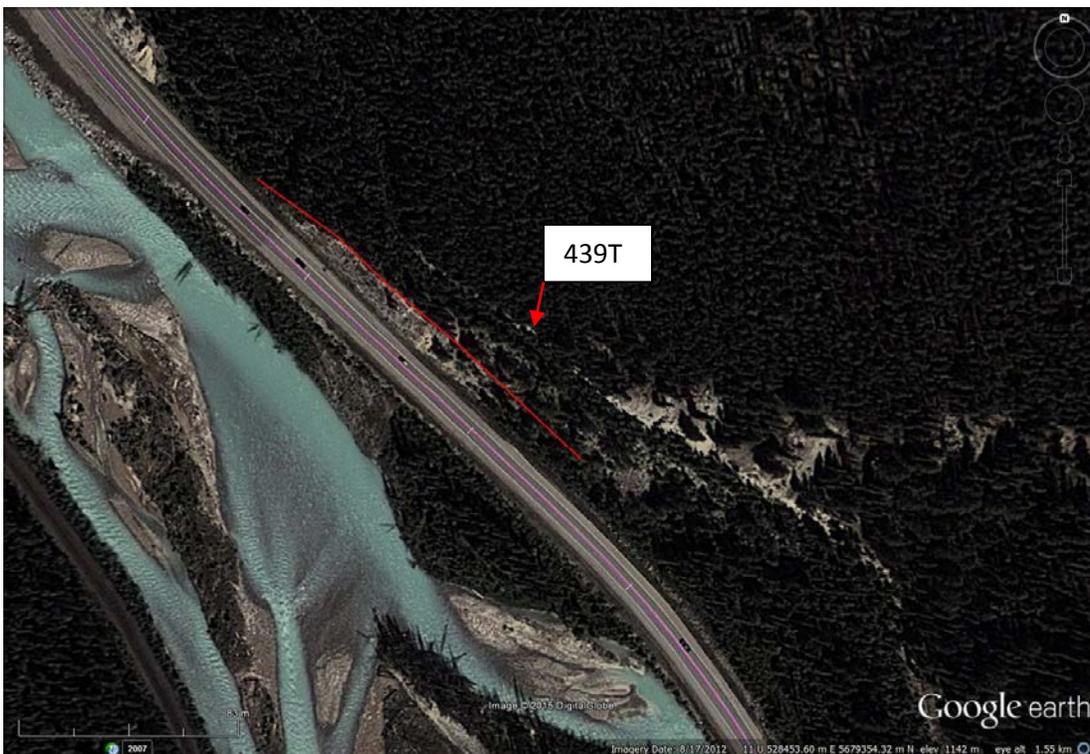
Figure 4. Little Toppie Slope. Site 439T, the old highway grade can be seen behind the rock face.

4. Little Topple Slope (figure 4). Site 439T, the historic highway grade, traverses the backside of the project area at this location as can be seen on the air photograph in figure 4. If access to the construction site is required through the use of this historic highway grade, it is recommended **that care should be taken to not impact the grade with heavy machinery or tracked vehicles without mitigating the effects on the road grade.** Otherwise, there are no known archaeological sites at this location and the project area affords low archaeological potential.

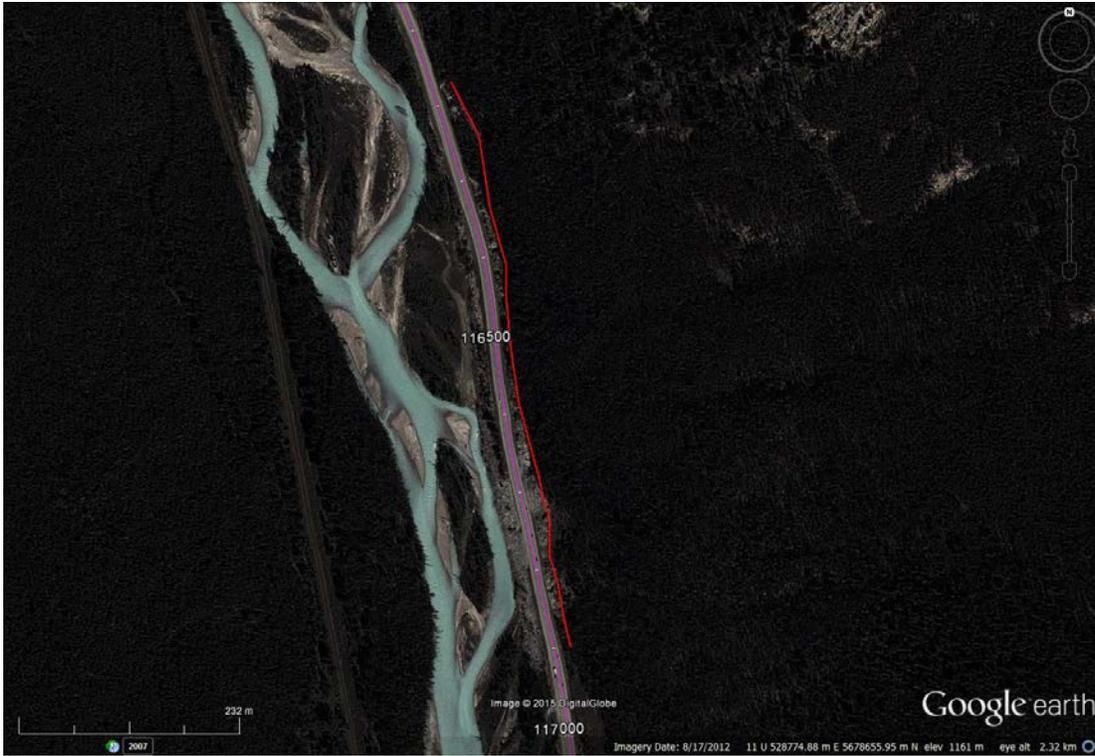
Figure 5. Mt. Vaux Rock slope.

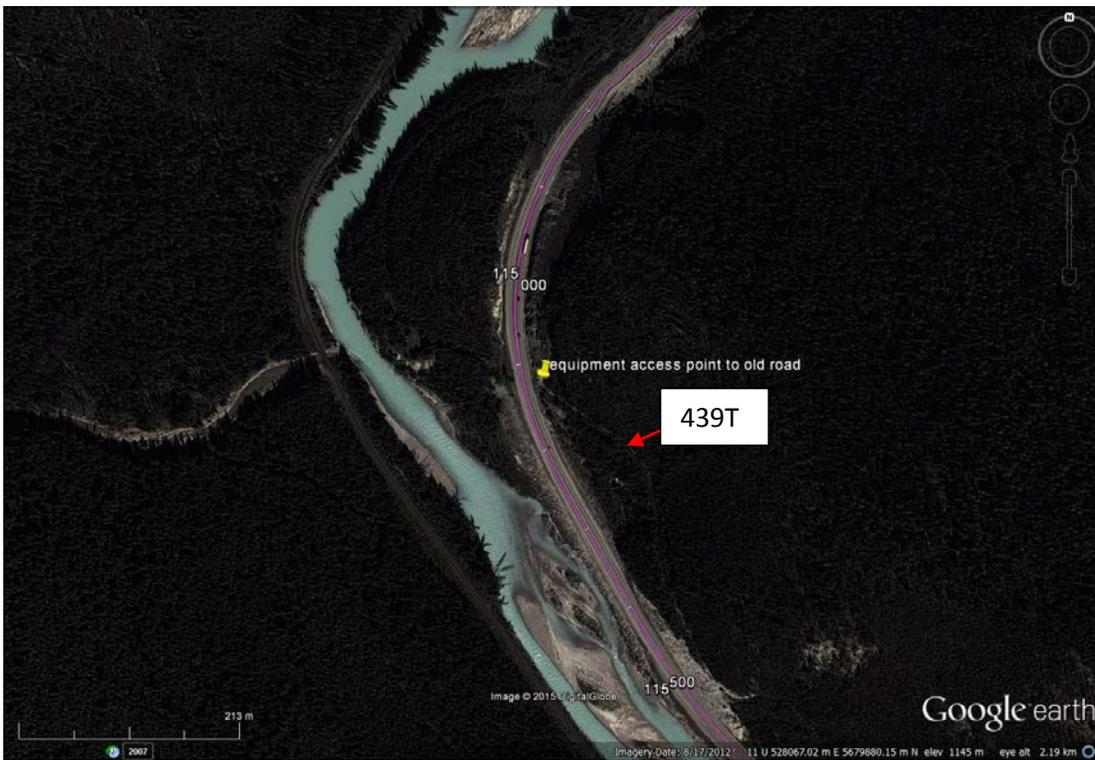
Figure 6. Access point for Little Topple. Site 439T can be seen traversing the slopes east of the TransCanada Highway on this air photograph.

6. Access point for Equipment on old Roadbed near Porcupine Creek (figure 6). This is required to get equipment onto the upper slopes above the highway to access the “Little Topple” project area, located just to the south. The road bed is again, part of site 439T, the old highway grade which can be seen traversing the upper slopes in the air photograph in figure 6. If this historic highway grade is required to facilitate construction access, it is recommended **that care should be taken to not impact the grade with heavy machinery or tracked vehicles without mitigating the effects on the road grade.**

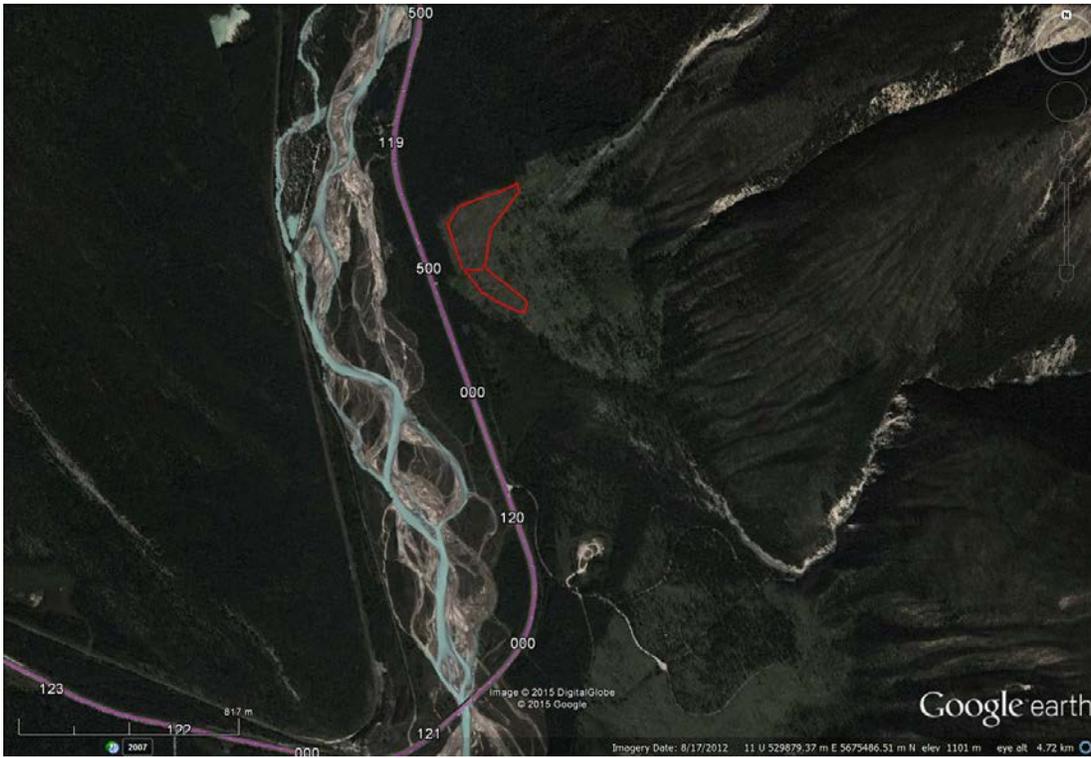
Figure 7. Stockpile area at base of Mt. Vaux (outlined in red).

8. A second stockpile area was identified on the lower colluvial slopes of Mt. Vaux (figure 7). This area has been subject to past burning and logging activities. Proposals call for stripping of the soils and surface preparations. This project area has no nearby known archaeological sites and the landform has low archaeological potential. No concerns are warranted. **No further work is required.**

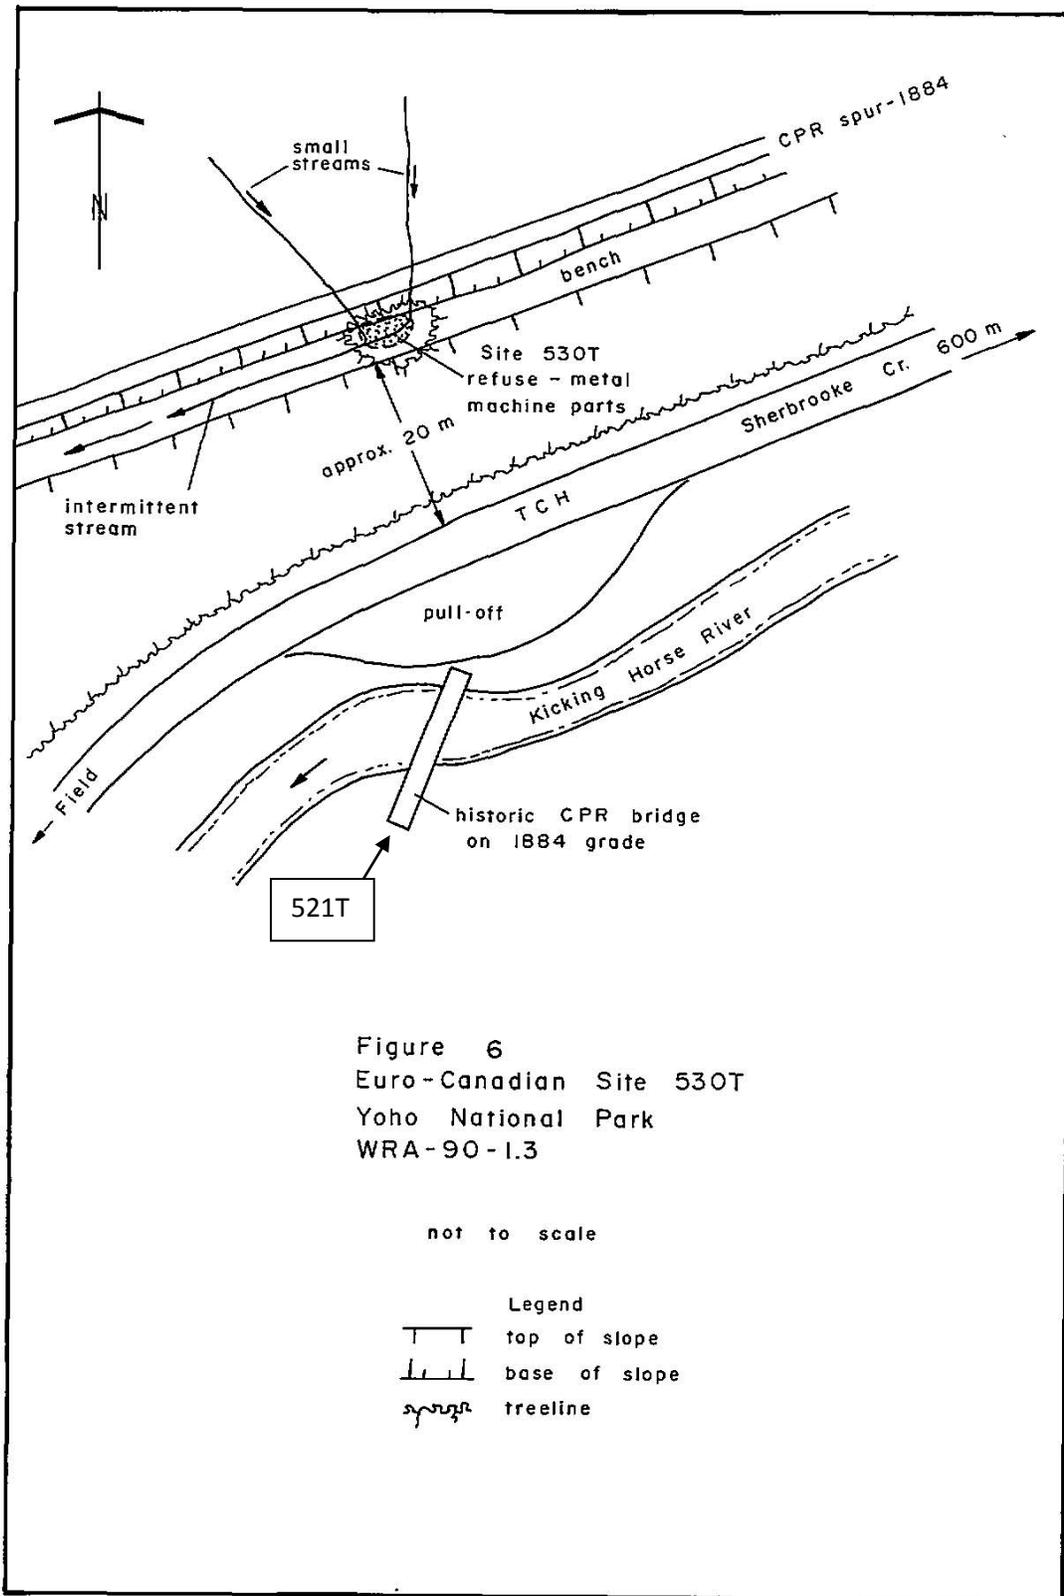
Figure 8. Sketch map of sites 530T and 521T.

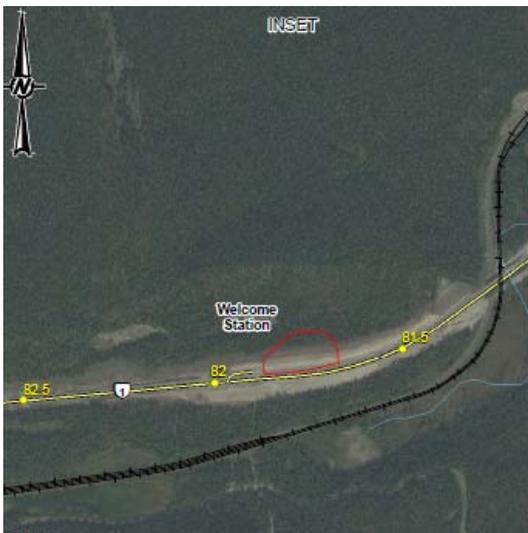
Figure 2. Location of Welcome station disposal area.

This project area is located at the pull-off and interpretive area adjacent to the Alberta/BC boundary (figure 1 and 2). This is a proposed disposal site. There are no known archaeological resources for this location which has minimal archaeological potential. If the proposed construction activities should impact historic items, adherence to the **“accidental discovery clause”** contained in Appendix 1 of this document is recommended.

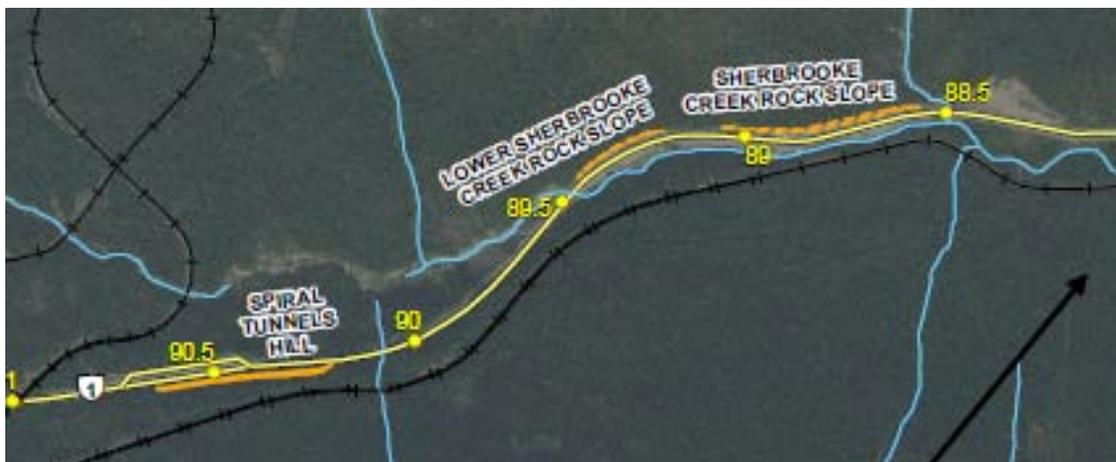
Figure 3. Sherbrook and Spiral Tunnels Hill project areas.

Located east of Sherbrook Creek, two closely spaced areas are slated for approved construction/reprofiling (figure 3). Both areas were previously assessed as part of the 2015 Rock profiling archaeological overview assessment (Perry 2015). The lower Sherbrook Creek Rock slope is coincident with the location of archaeological resources. The following observations and recommendations were offered in 2015:

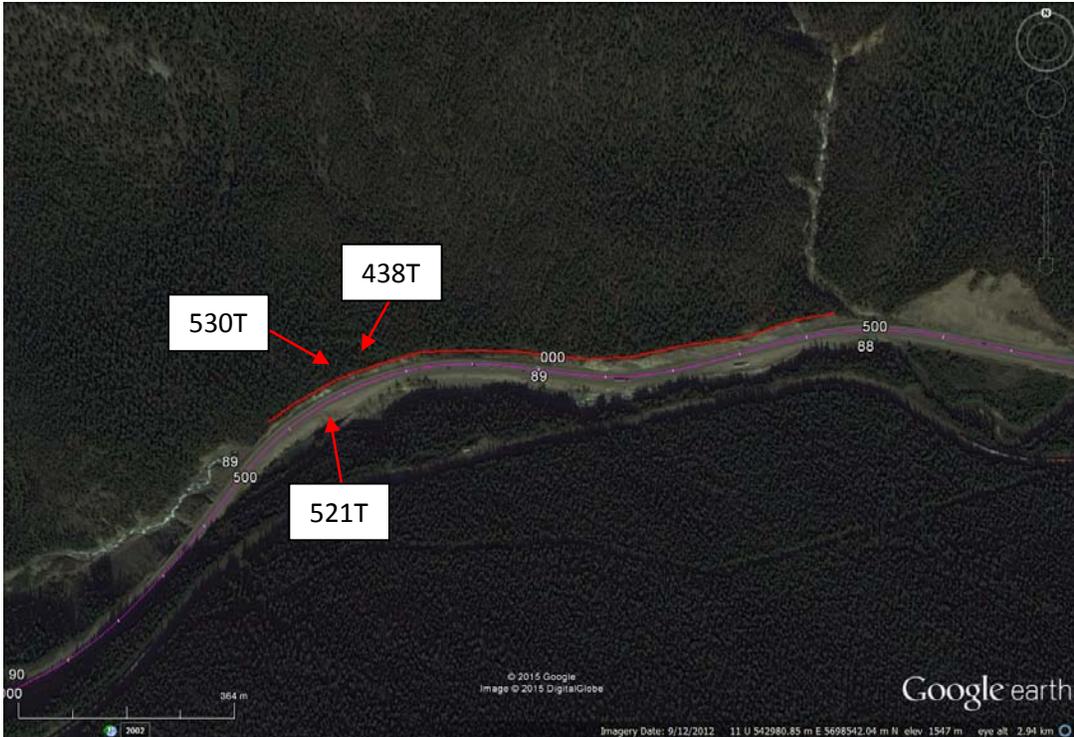
Figure 4 Upper (to the right) and lower Sherbrook (to the left) areas. Red line indicates area of proposed rock scaling and vegetation removal. Sites 521T, 530T and 438T are located at arrows.

The historic highway bridge, site 521T, will not be impacted from proposed construction (see figure 4). There is a possibility however, that construction staging/parking may take place in the gravel pull-out in front of the historic structure. **It is recommended that any such activity keep away from the actual bridge structure.**

The historic rail grade, site 438T, is part of the Big Hill Safety Switch system put in place to deal with run-away trains before the construction of the Spiral Tunnels (a portion of this safety switch grade can be seen in figure 8). The lower portion of this rail grade where it has been impacted by the TCH may be vulnerable to proposed machinery access to the project area. **It is recommended that care should be taken to not impact the grade with heavy machinery or tracked vehicles without mitigating adverse effects on the rail grade.**

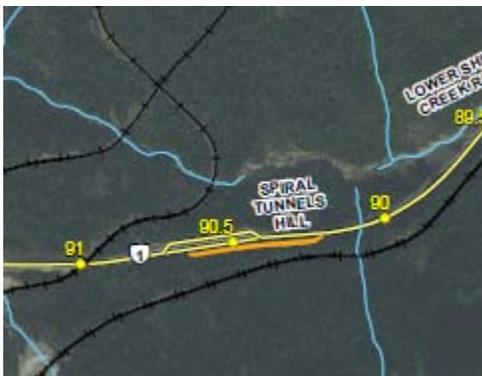
Figure 5. Spiral Tunnels Hill project area.

This is located across the highway from the Spiral Tunnels viewpoint (figure 5). The area is slated for proposed construction and reprofiling. The scaling is to take place on the south side of the highway. Attention to the nearby historic site of the original 1884 or “Big Hill” railgrade (438T-see attached site form) is noted. The grade is located some 40-50m upslope of the project area and will not be directly affected. Scattered artifacts related to the construction and use of the grade however, is possible along this stretch so that the construction/reprofiling activities may uncover artifacts. **If this occurs, please refer to the “accidental discovery clause”** contained in Appendix 1 of this document.

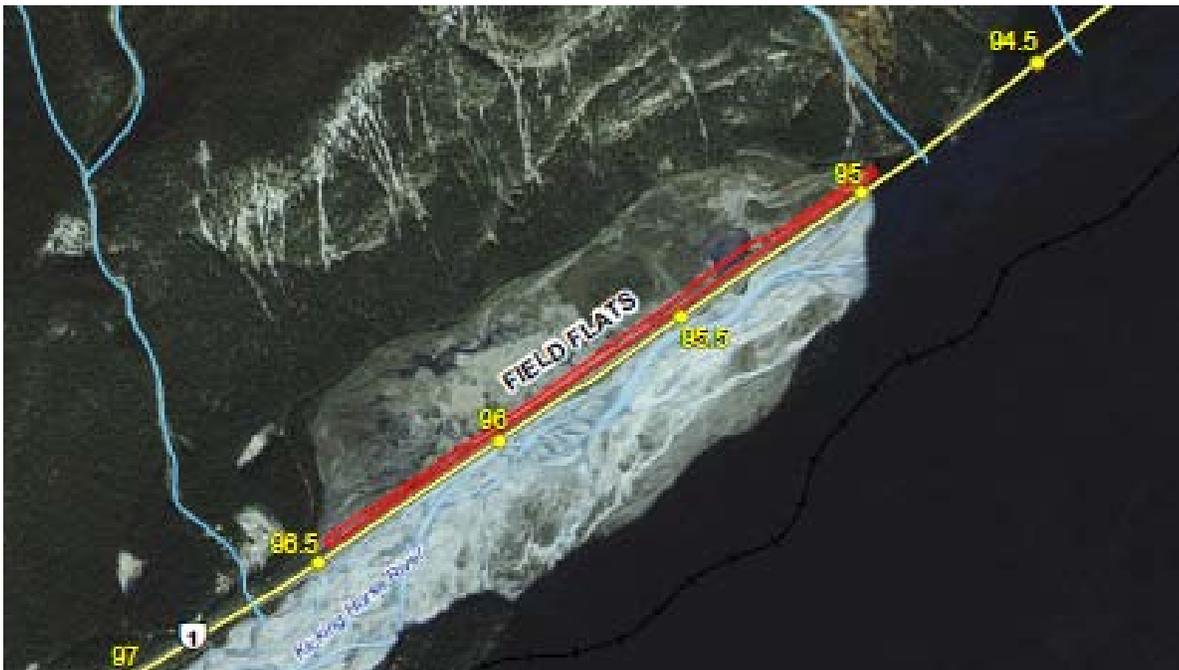
Figure 6. Field Flats project area.

The Field Flats is located along the TCH, east of Field and west of the junction of the TCH and the Yoho Valley Road (figure 6). This location is a proposed disposal site. The project footprint is not in any direct conflict with archaeological resources but two nearby historic sites 396T (figure 7), a refuse dump located north of the highway and west of the project area adjacent to the old explosives bunkers and gravel storage area. The site comprises old CPR china and bottle remains from the turn of the 19th/20thC. **This site is of moderate potential and should be avoided.** In addition, site 439T (figure 7), the historic Kicking Horse Trail road grade follows the toe of the mountain slopes north of the project area but comes out to the TCH in the vicinity of the refuse dump site 396T (figure xx). **Both archaeological resources should be avoided.** Scattered artifacts related to the sites however, are possible along this stretch so that the disposal of rock debris may uncover artifacts. **If this occurs, please refer to the “accidental discovery clause”** contained in Appendix 1 of this document.

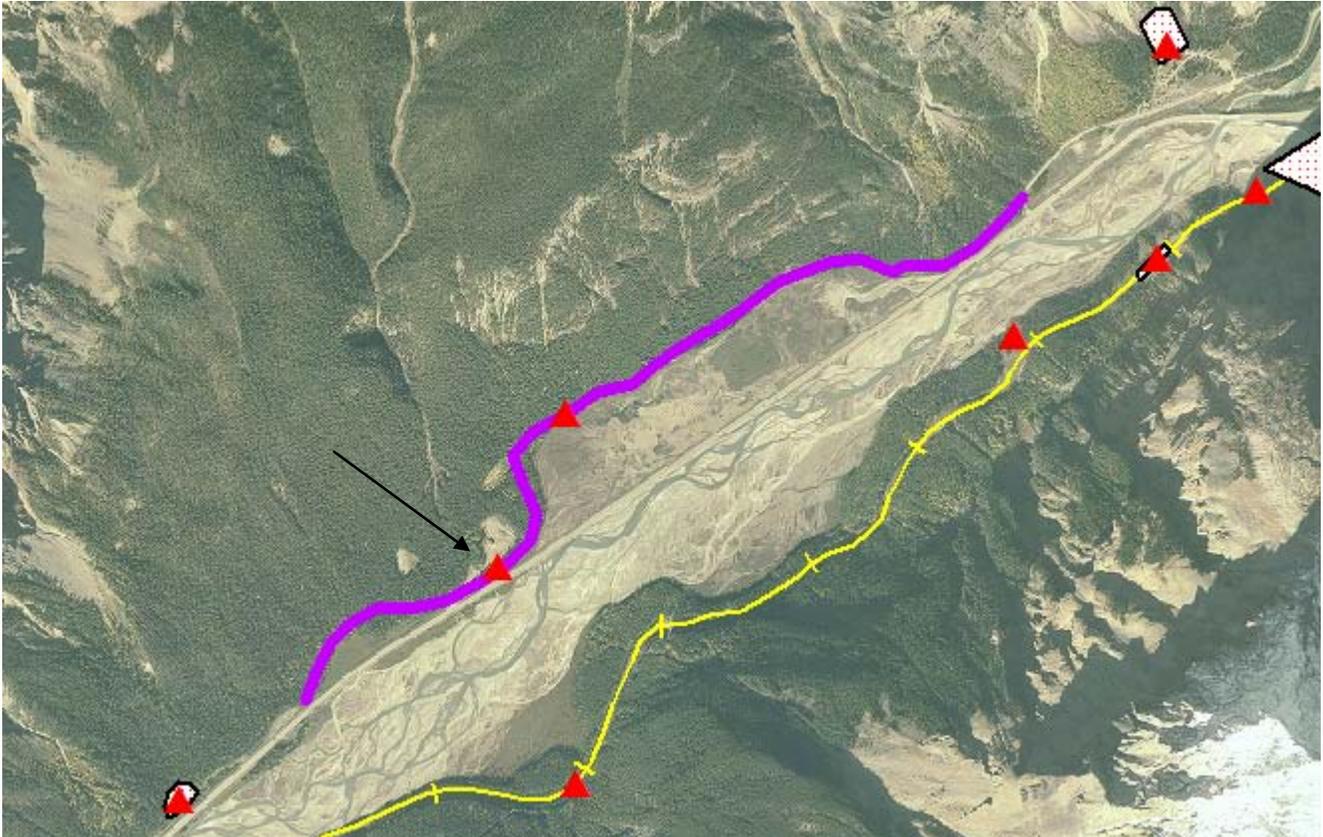
Figure 7. Archaeological resource adjacent to the Field Flats project area. The Kicking Horse Trail highway grade is in purple and the refuse dump 396T is located at the arrow.

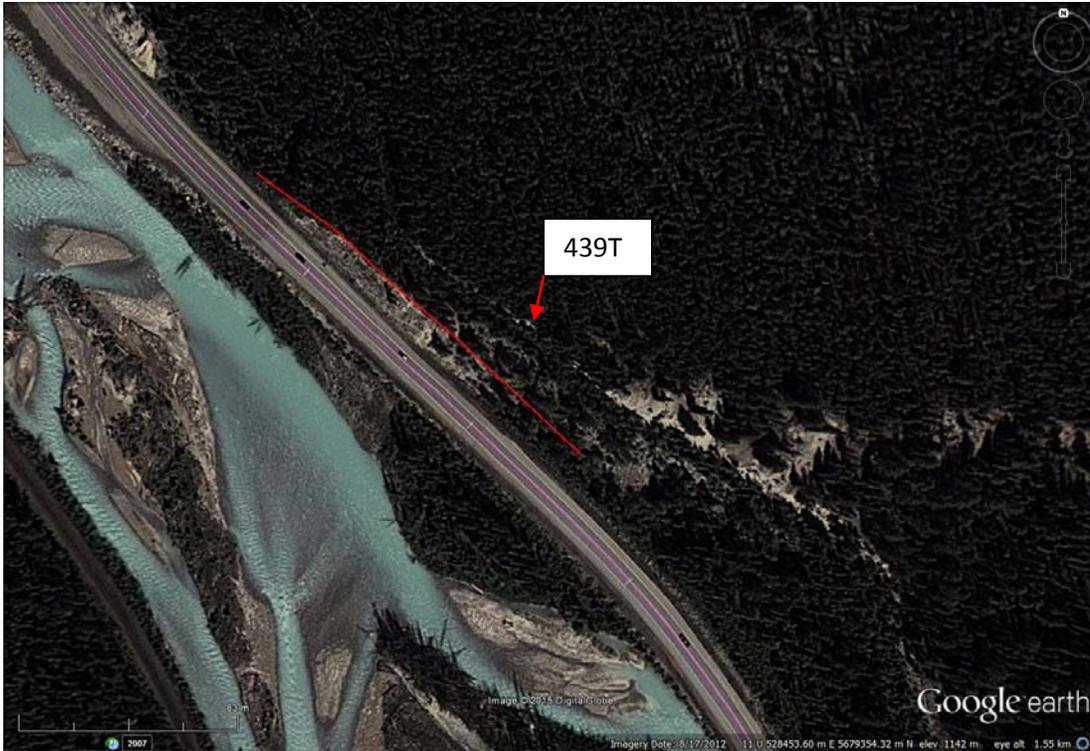
Figure 9. Little Toppie Slope. Site 439T, the old highway grade can be seen behind the rock face.

These areas are located toward the southern end of Yoho National Park on the stretch of highway north of the Hoodoo Creek Campground (figure 8). Both Big Topple and Little Topple are the sites for proposed disposal sites as well as proposed and approved construction/reprofiling. Site 439T, the historic highway grade, traverses the backside of the Little Topple project area (figure 9 and 10 – taken from Perry 2015). If access to the construction site is required through the use of this historic highway grade, it is recommended **that care should be taken to not impact the grade with heavy machinery or tracked vehicles without mitigating the effects on the road grade.** Otherwise, there are no known archaeological sites at this location and the project area affords low archaeological potential.

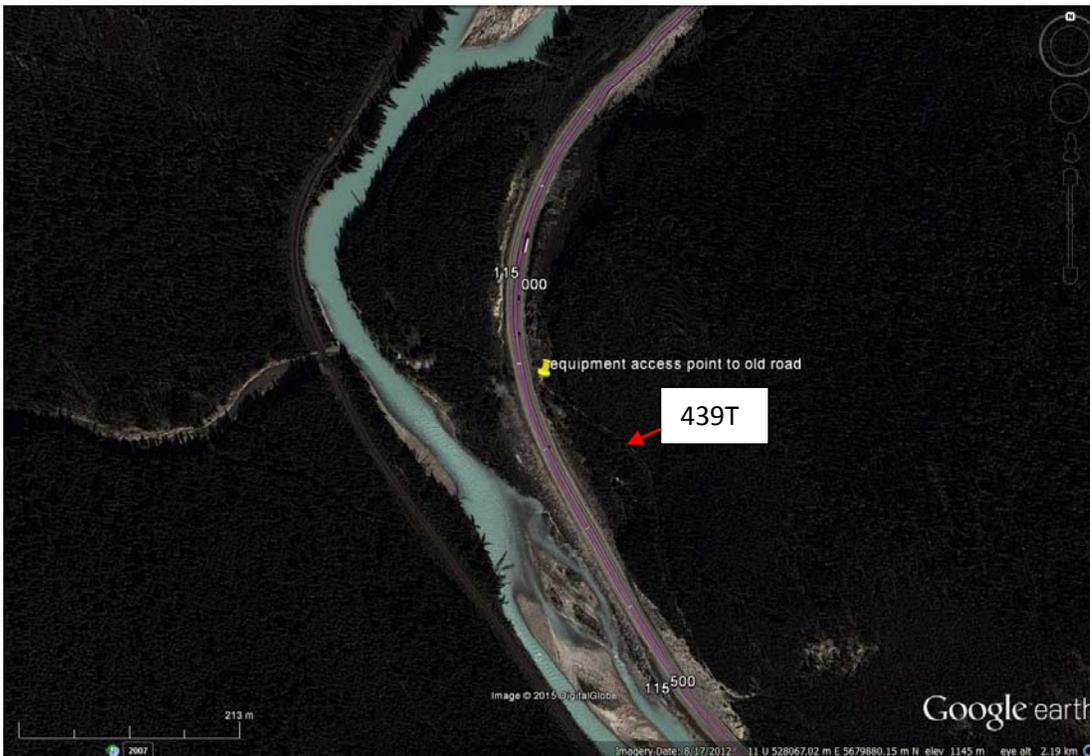
Figure 10. Access point for Little Toppie. Site 439T can be seen traversing the slopes east of the TransCanada Highway on this air photograph.

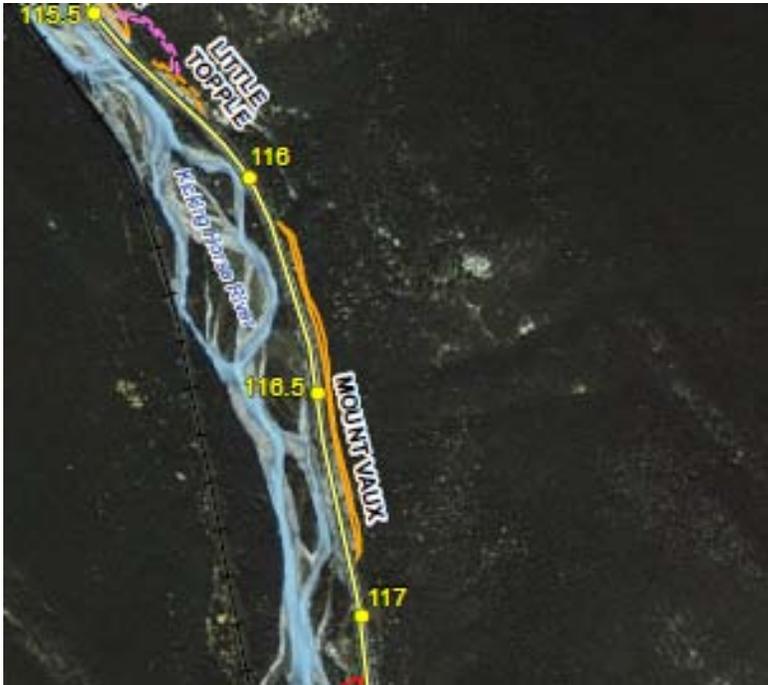
Figure 11. Location of Mount Vaux project area.

The Mount Vaux Rock Slope project area is located along the TCH between the Porcupine Creek/Kicking Horse River confluence and the Hoodoo Creek campground (figure 11). There are no known archaeological sites at this location and the landform is assessed as having low archaeological potential. Scattered artifacts are possible along this stretch and may be encountered during construction. **If this occurs, please refer to the “accidental discovery clause”** contained in Appendix 1 of this document.

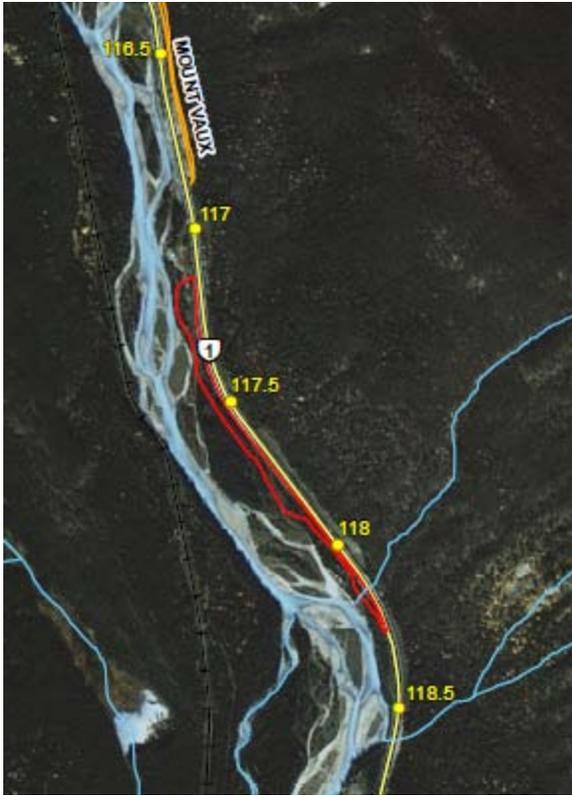
Figure 12. Location of Km 117.5 disposal area.

Another roadside area identified for debris disposal is located between the Mount Vaux reprofiling area and the Mount Vaux Storage site on the east side of the highway (figure 12). There are no known archaeological sites at this location and the landform is assessed as having low archaeological potential. Scattered artifacts are possible along this stretch and may be encountered during construction. **If this occurs, please refer to the “accidental discovery clause”** contained in Appendix 1 of this document.

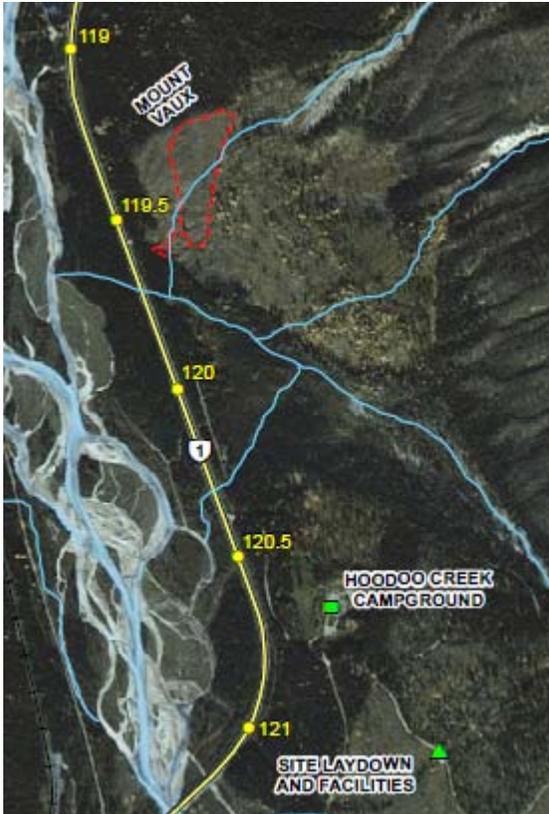
Figure 13. Location of the Mount Vaux storage site (hatched red line) and the site laydown and facilities area.

The Mount Vaux disposal site is located on the lower colluvial slopes of Mt. Vaux, north of the Hoodoo Creek Campground (figure 13). This area has been subject to past burning and logging activities. Proposals call for stripping of the soils and surface preparations. This project area has no nearby known archaeological sites and the landform has low archaeological potential. No concerns are warranted. **No further work is required.**

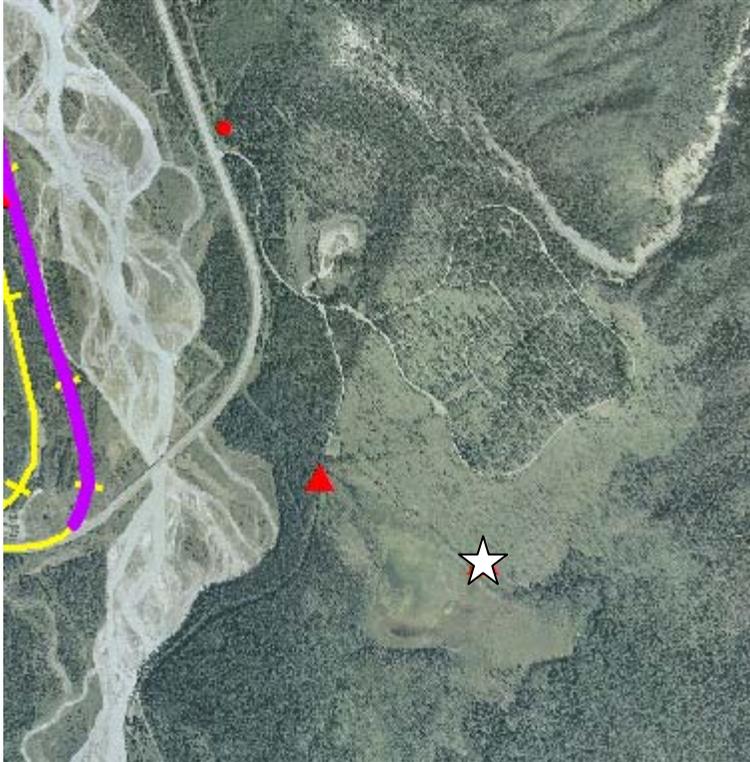
Figure 14. Location of sites 390T (at red triangle) and 397T (at star).

The area south of Hoodoo Creek Campground adjacent to Km 121+000 is planned to house the project's laydown area and facilities (figure 13). A collapsed log bridge (390T) is located along an historic roadgrade servicing the east side of Kicking Horse River (figure 14). The bridge is in poor shape and is of low significance. It is interpreted to be part of the road system servicing the east side of the river. The bridge is located 300m east of the highway and 100m west of the hiking trail. Scattered artifacts are possible near this site and may be encountered during construction. **If this occurs, please refer to the "accidental discovery clause"** contained in Appendix 1 of this document.

An additional site located adjacent to the project area is the historic Deer Lodge Warden Cabin (site 397T-figure 14). The cabin is located south of the campground and 1.6km along the trail to the hoodoos. **This is an structure of high historic significance and must be avoided.** Scattered artifacts are possible near this site and may be encountered during construction. **If this occurs, please refer to the "accidental discovery clause"** contained in Appendix 1 of this document.
