PHASE II
ENVIRONMENTAL SITE ASSESSMENT

FIRST AIR MAINTENANCE HANGAR
(NOSE DOCK HANGAR - BUILDING T-325)
IQALUIT, NUNAVUT

File: CB8809

November 2011

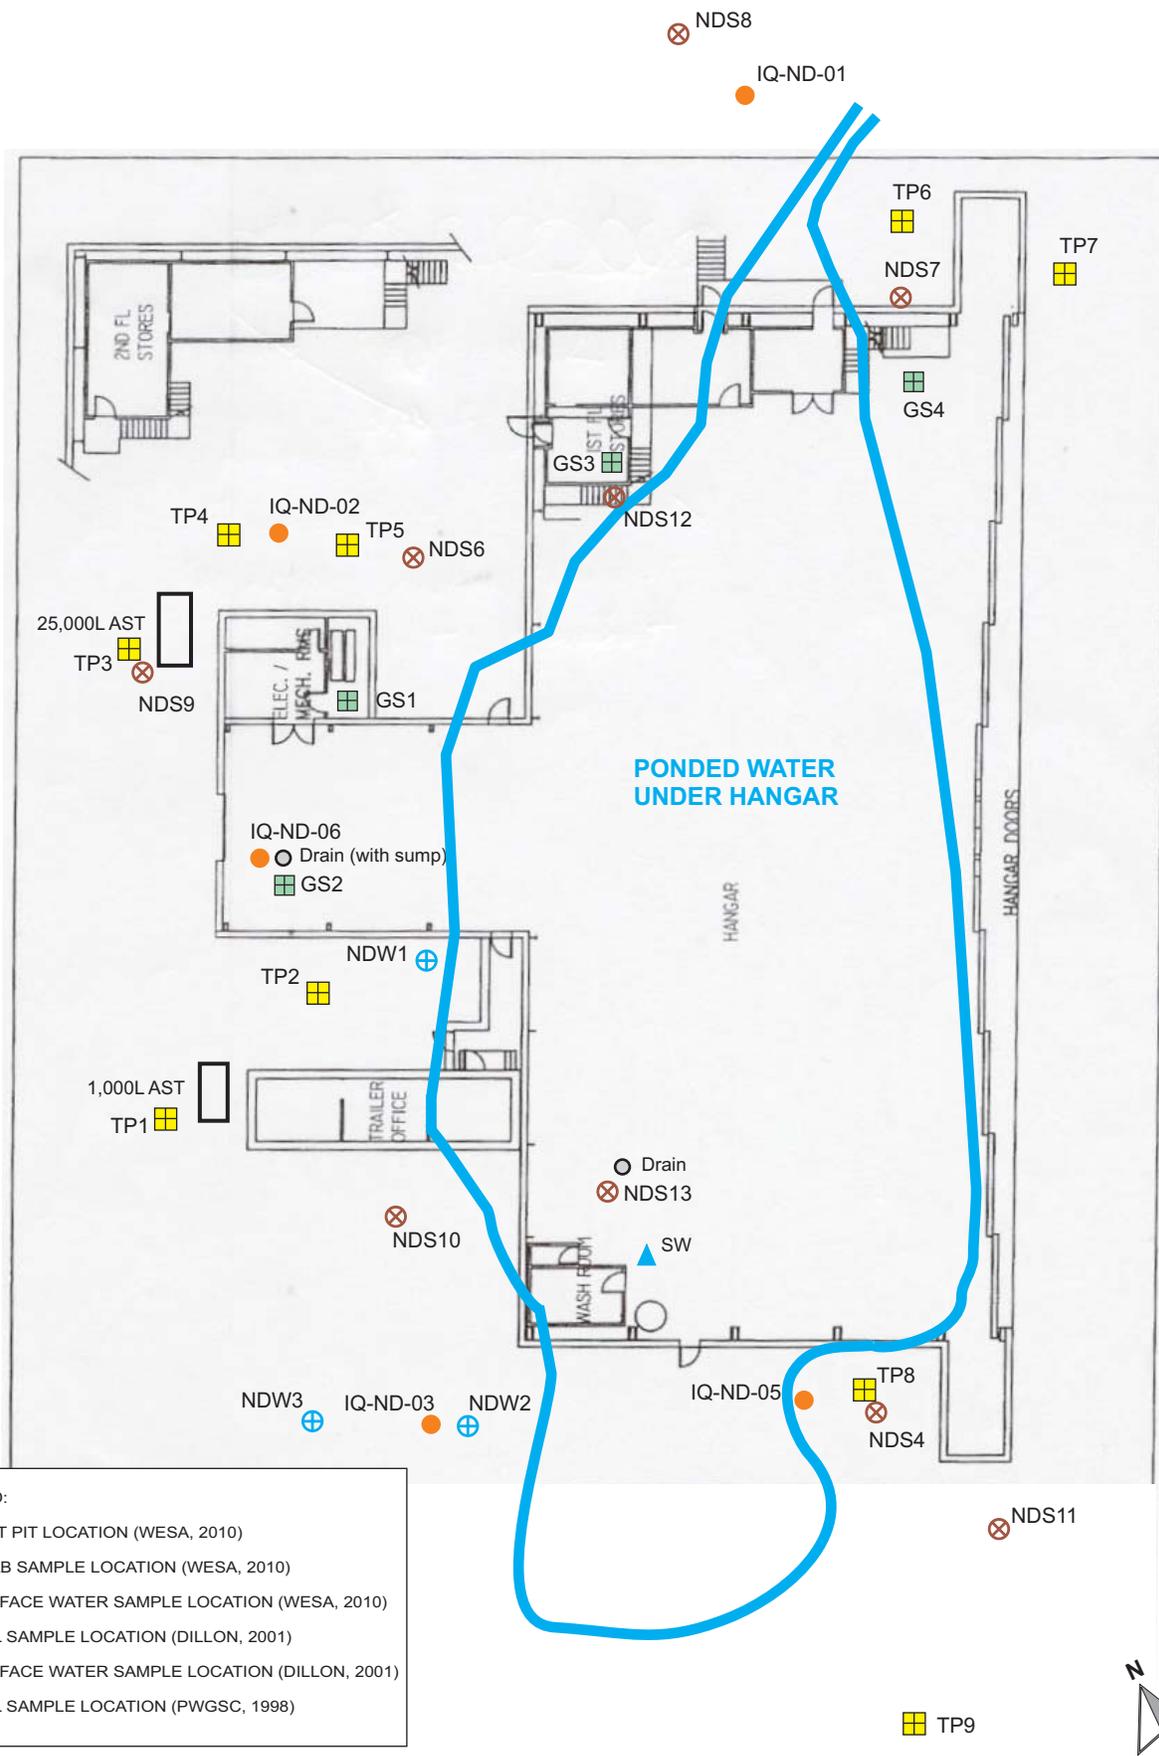
FIGURE 3: SAMPLING LOCATIONS
 First Air Nose Dock Hangar - Iqaluit Airport, Nunavut

The test pit locations were selected to assess the soil and water quality in areas of current and historical fuel storage, as well as areas with previously noted exceedances of applicable soil criteria. Test pits TP1 through TP5 were advanced along the exterior of the northwest side of the subject building. Test pits TP6 and TP7 were advanced near the northeastern corner of the subject building and test pits TP8 and TP9 were advanced near the southwestern corner of the subject building. Test pits could not be advanced east of the subject building due to site access restrictions. Photographs of the test pit locations are included in Appendix A. The selection of each test pit location was based on the following rationale:

Grab soil samples were also collected from areas of concern beneath the hangar using clean stainless steel trowels. Sample GS1 was collected near a waste liquid storage area on the northwest side of the building, GS2 was collected from below the sealed floor drain outside of the electrical/mechanical room, GS3 was collected from below the sealed floor drain in the stores room and GS4 was collected from below the northeast corner of the building. The location of the grab samples can be found on Figure 2.

Shallow groundwater seeping into test pits was collected from test pits TP2 and TP5. For test pit TP2, water entered the test pit at a depth of 0.8 mbgs and permafrost was encountered at 1.10 mbgs. For test pit TP5, a significant portion of groundwater entered from the northern portion of the test pit, from an area with standing water on the ground surface. Eventually the test pit filled with water to a depth of 0.35 mbgs. A grab sample of the standing surface water (SW) below the hangar was collected from the southwest corner of the building.

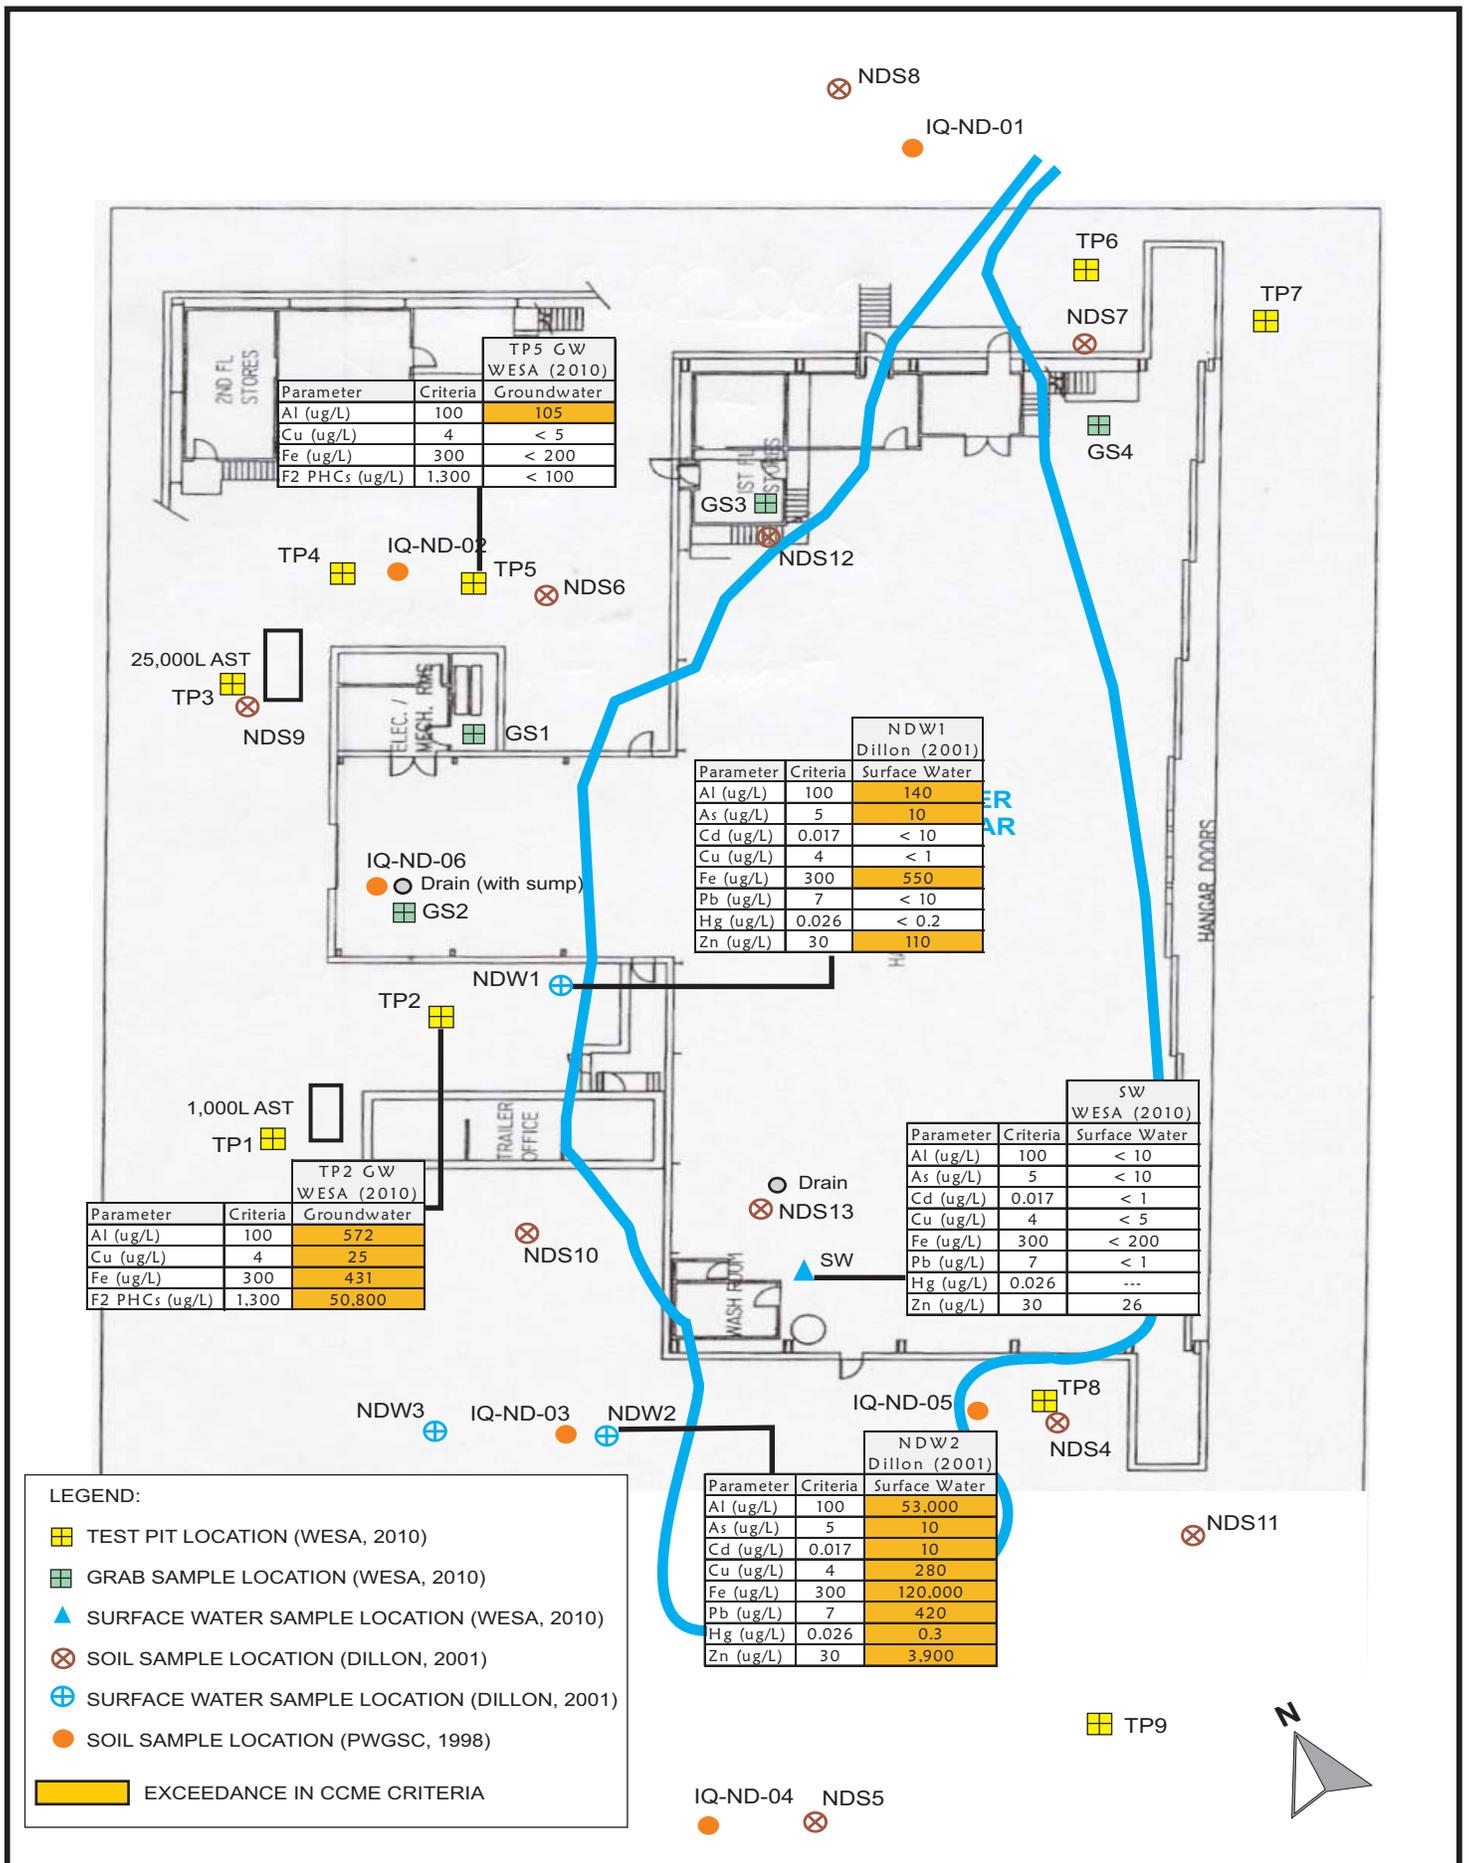
FIGURE 5: **WATER SAMPLE EXCEEDANCES**
 First Air Nose Dock Hangar - Iqaluit Airport, Nunavut

Surface water sample SW was collected from standing water underneath the west corner of the subject building in 2010; the closest comparable historical surface sample is nearby location NDW2, collected in 2001. In 2001, sample NDW2 exhibited elevated concentrations in excess of CCME guidelines for the following parameters: aluminum, arsenic, cadmium, copper, iron, lead, mercury and zinc. In 2010, sample SW did not exhibit detectable concentrations of any of these parameters, with the exception of low levels of zinc which were below the CCME guidelines (it should be noted that sample SW was not analyzed for mercury in 2010).

A comparison of the groundwater and surface water exceedances noted during the 2010 Phase II ESA to those noted during previous studies is provided on Figure 5.

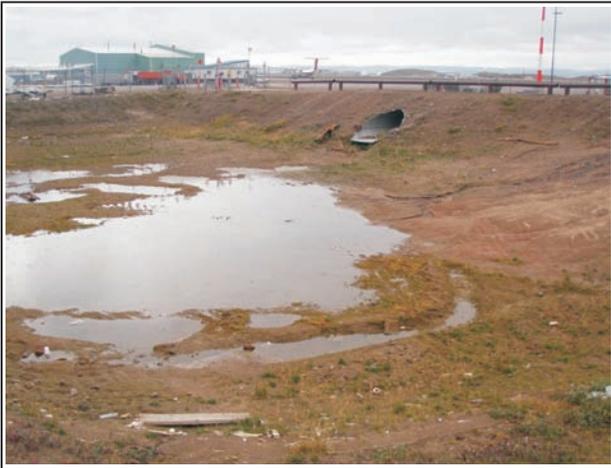
LOCATION OF SEWAGE SPILL SPRING 2010,
SOUTH END OF HANGAR

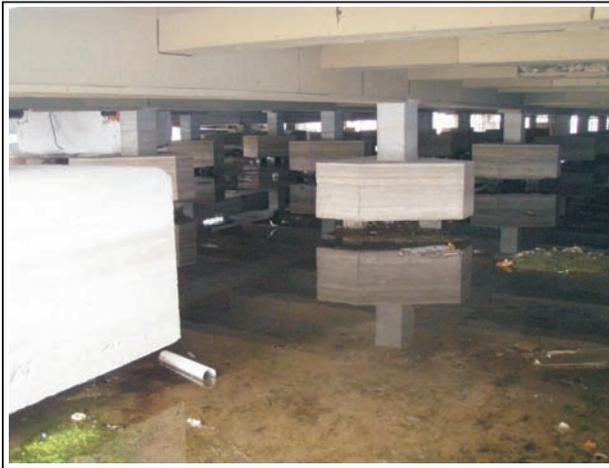
At the time of the site visit by WESA personnel (last week of August/first week of September, 2010), the majority of the hangar had standing water beneath it. Surface drainage is normally directed to a ditch located on the northeast side of the property. It was reported to WESA by First Air personnel that a large sewage spill occurred near the building so it is likely that a portion of the water beneath the building contained sewage. Based on the abundance of water beneath the building, a restriction to the drainage away from the subject building is inferred.

PONDED WATER UNDER HANGAR,
VIEWING NORTH

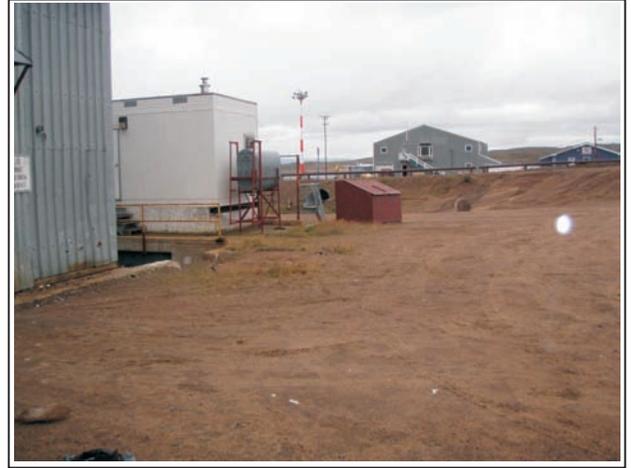
VIEWING SOUTH, WEST SIDE OF HANGAR

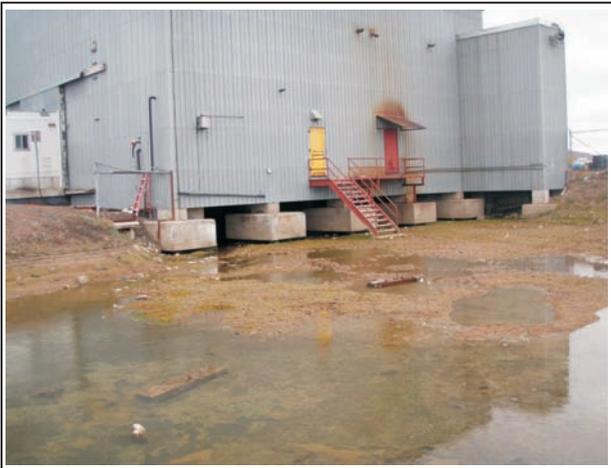
SOUTH END OF MAINTENANCE HANGAR

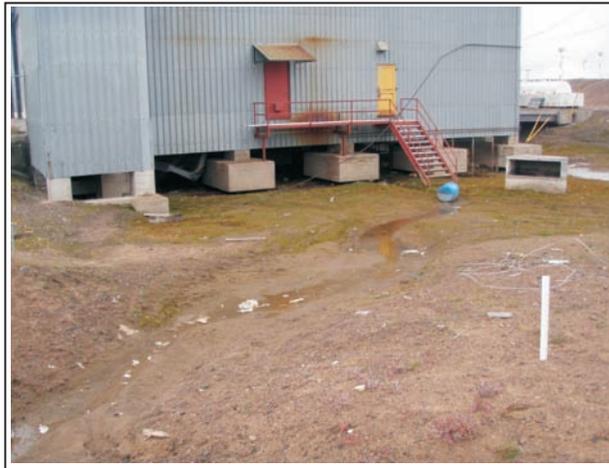
SHALLOW DITCH FLOWING UNDER
HANGAR, VIEWING SOUTH

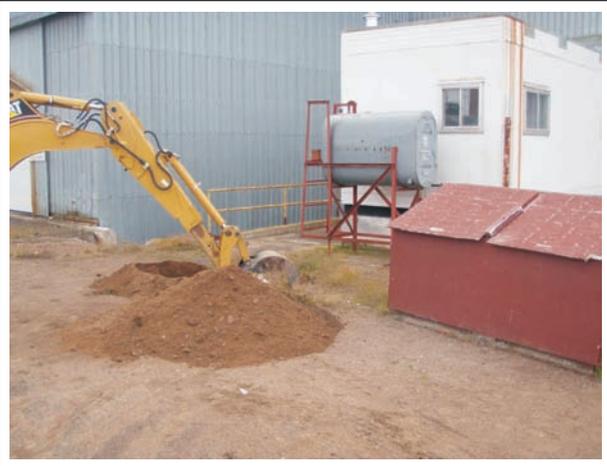
Test Pit Number	Depth in metres		DESCRIPTION	Sample # (depth m)	Headspace Reading ppm/%LEL
	Top	Bottom			
TP1	0.00	1.10	Light brown, moist to wet, granitic, sand and gravel fill.	*S1 (0.6-0.7)	<25 ppm

1.10	1.80	Light brown, moist, stratified, medium to coarse grained	S2 (1.55)	<25 ppm
	1.04	1.88	sand with some gravel. Frost encountered 1.8m.		
TP2	0.00	0.30	Light brown, moist to wet, granitic, sand and gravel fill.	*S1 (0.25)	150 ppm

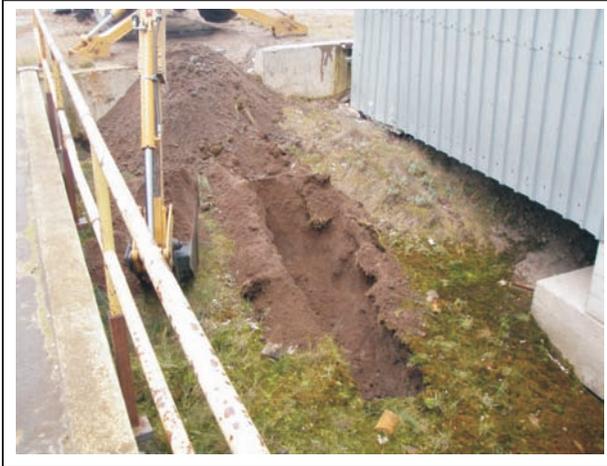
TP2

0.30	1.10	Light brown, moist, fine to medium grained sand with some gravel. Strong odours encountered. Frost 1.10m. Water entering test pit 0.8m.	*S2 (1.0)	5% LEL
TP3	0.00	0.60	Light brown, moist to wet, granitic, gravelly sand fill. Oily film on pebble surface.	*S1 (0.4-0.5)	<25 ppm

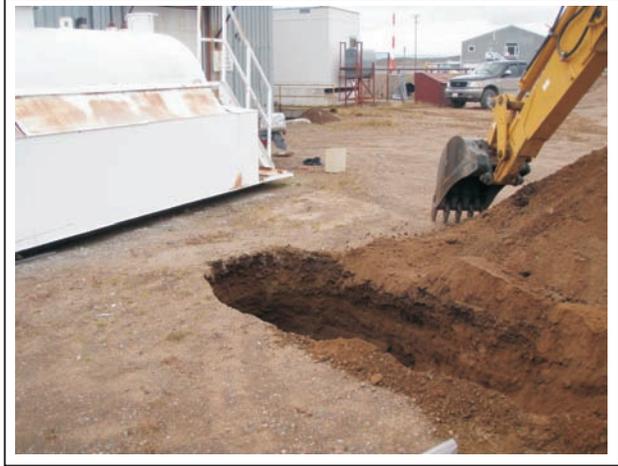
TP3

0.60	0.90	Light brown, moist, medium to coarse grained sand with some gravel.	S2 (0.8)	<25 ppm
	0.90	1.80	Light brown, moist, fine to medium coarse grained sand. Frost encountered 1.8m. Odour present.	*S3 (1.6-1.7)	4% LEL
TP4	0.00	0.50	Light brown, granitic, moist to wet, medium to coarse grained sand with some gravel.	*S1 (1.10)	<25 ppm

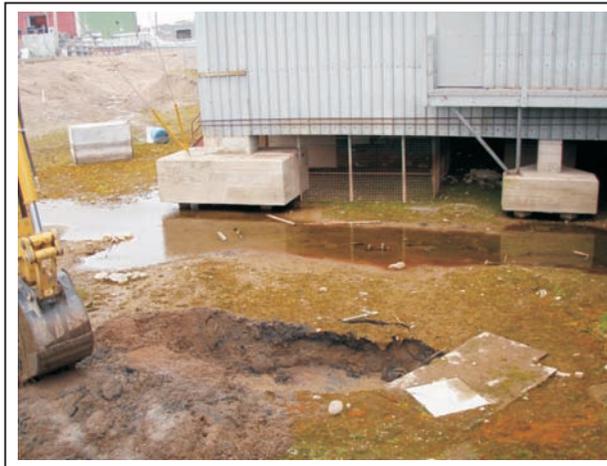
0.50	1.60	Light brown, moist, fine to medium grained sand. Frost encountered 1.6m.	S2 (1.55)	<25 ppm
TP5	0.00	>1.0	Black stained overlying granitic, saturated sand and gravel. Shallow groundwater entering test pit from the north causing soil to collapse.	*S1 (0.3)	<25 ppm
TP6	0.00	1.10	Light brown, granitic, saturated, sand and gravel. Shallow groundwater entering test pit from the north causing soil to collapse.	*S1 (0.30) S2 (1.0)	<25 ppm <25 ppm
TP7	0.00	1.70	Light brown, moist to wet, granitic, gravelly sand fill.	S1 (0.50) *S2 (1.6)	<25 ppm <25 ppm
TP8	0.00	>1.0	Light brown, granitic, saturated sand and gravel to gravelly sand. Test pit location in low area beside standing water. Test pit walls collapse due to saturation.	*S1 (0.2)	<25 ppm
TP9	0.00	1.50	Light brown, granitic, wet to saturated, gravelly sand fill. Water entering 0.7m. Frost encountered 1.5m.	*S1 (0.5-0.6) S2 (1.4-1.5)	<25 ppm <25 ppm

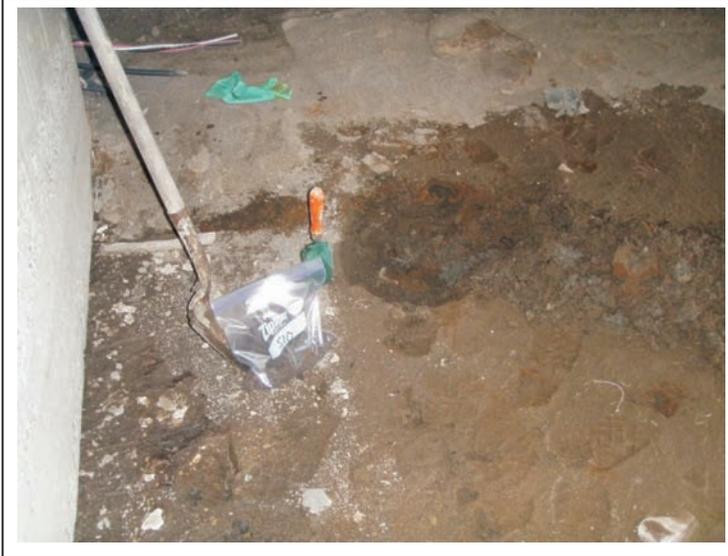
Grab soil sample G51 (0.15-0.2 mbgs) was collected from below the waste liquid storage area outside the electrical/mechanical room, immediately north of the nose hangar portion of the building. The detected PHC F2 concentration of 2,330 µg/g exceeds the CCME criteria of 260 µg/g. No other previous investigations reviewed as part of this Phase II ESA had samples collected in this location, therefore, making a comparison to previous results is not possible. The location of this soil sample is in the down gradient direction of test pit TP3 and, therefore, observed impacts at G51 may be attributed to the same source(s) discussed previously for TP3.

Grab Samples GS1	0.00	0.20	Light brown, granitic, moist, sand with some gravel.	*(0.15-0.2)	45 ppm
GS2	0.00	0.20	Light brown, granitic, moist, sand with some gravel. Some gravel and traces of paper and metal fragments.	*(0.15-0.2)	60 ppm
GS3	0.00	0.15	Light brown, granitic, saturated sand and gravel to gravelly sand.	*(0.15)	<25 ppm
GS4	0.00	0.20	Light brown, granitic, moist, sand with some gravel.	*(0.15-0.2)	<25 ppm
