File No. 15-2288-001

RE: The Forks National Historic Site  
Infrastructure Upgrades Geotechnical Investigation and  
Foundation Assessment for Riverbank Lighting

This report outlines details of the geotechnical site investigations performed by KGS Group and provides geotechnical recommendations relative to the design of the foundation systems for the proposed lighting development along the riverbank between the North Point and Amphitheatre located at the Forks National Historic Site in Winnipeg, Manitoba.

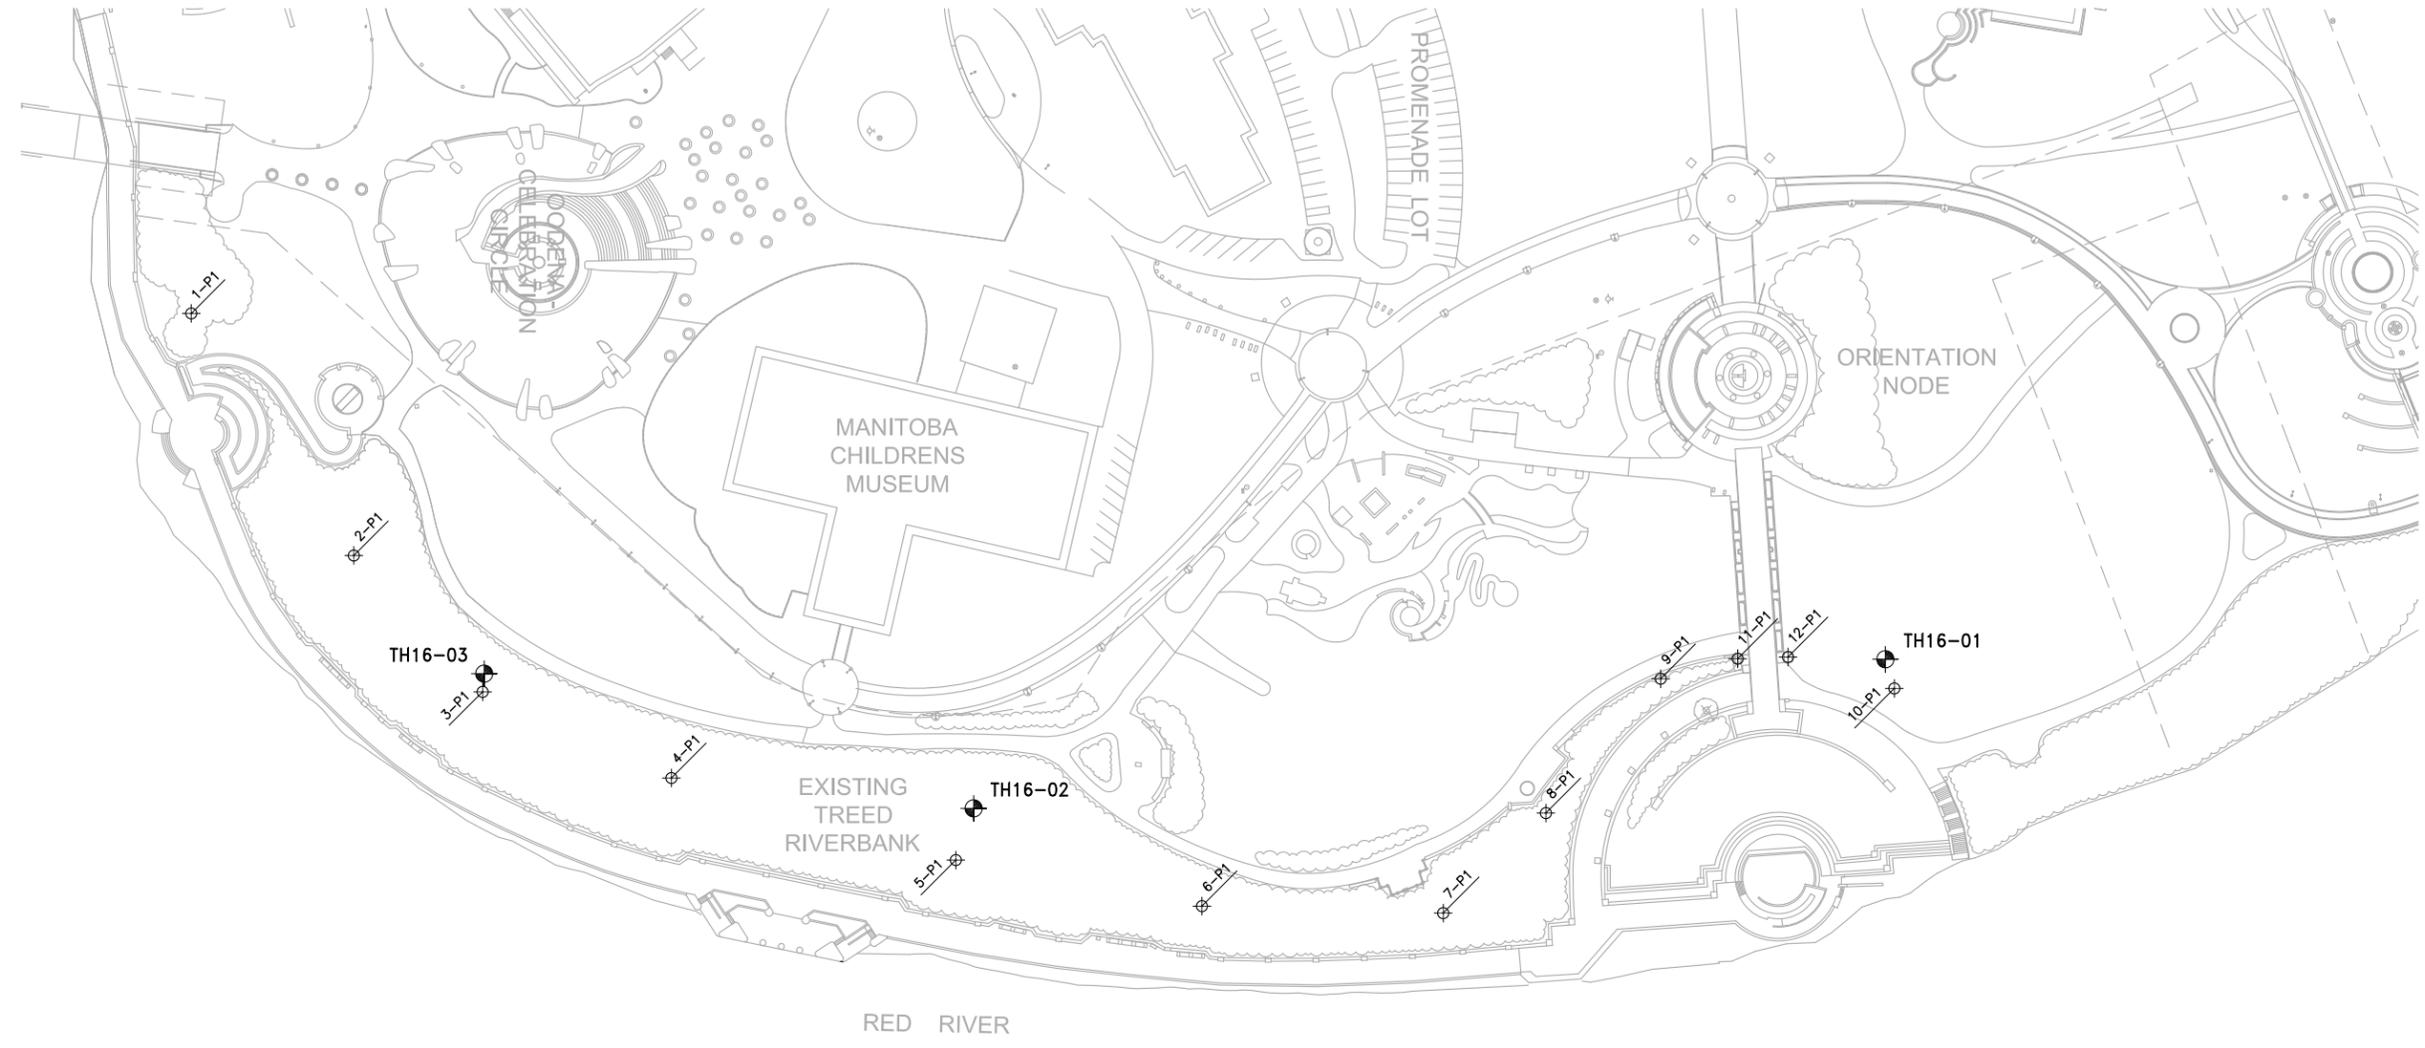
**FIGURE**

- TEST HOLE (KGS GROUP, 2016)
- PROPOSED NEW PILE

It is our understanding the proposed works (i.e. 12 new lighting standards complete with cast-in-place pile foundations) are to be located on the mid bank bench to upper bank area as shown on Figure 1 and will be located at small discrete locations on the bank. The light standard structures will represent a negligible loading to the riverbank due to the excavation of the soil for the foundations and the replacement with concrete. On this basis, KGS Group concludes that the proposed works will have negligible impact to river hydraulics and the critical bank stability. We recommend that a Waterways Construction Permit be granted provided the following is performed:

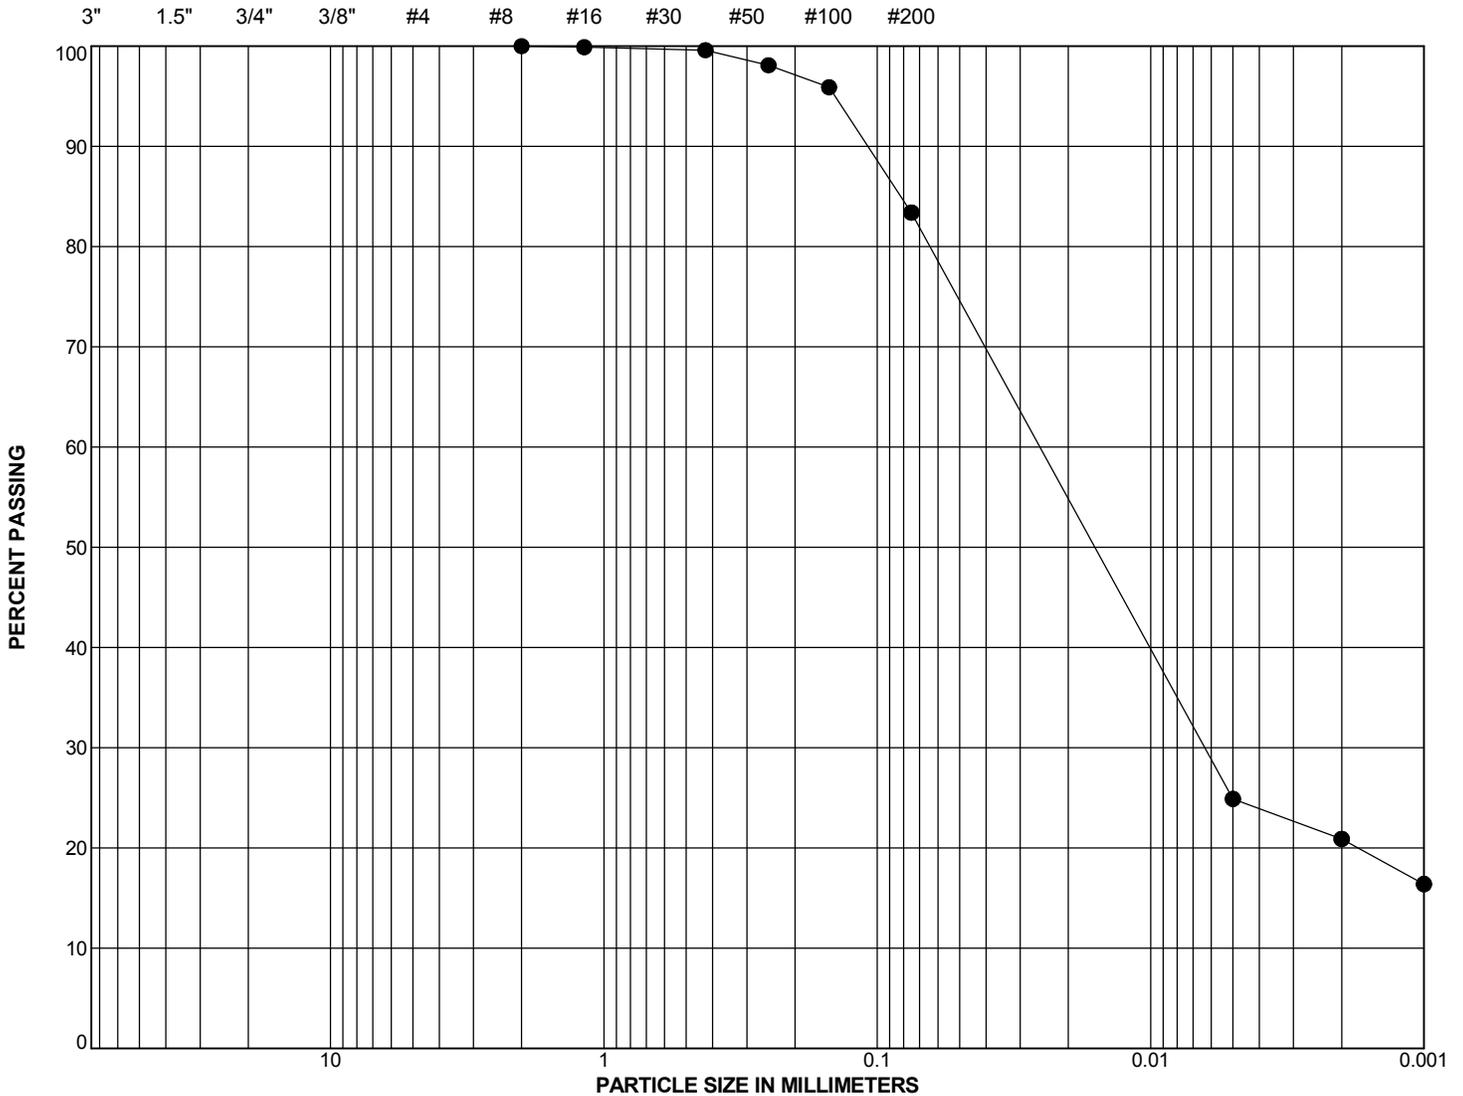
<b>KGS GROUP</b>	<b>1x1 ARCHITECTURE INC.</b>	
	Forks National Historic Site - Infrastructure Upgrades	
<b>GRAIN SIZE ANALYSES</b>		
10/08/2004	Figure A	Page 1 of 1

SYMBOL	HOLE	DEPTH (m)	SAMPLE #	% GRAVEL	% SAND	% SILT	% CLAY	% SILT & CLAY	Cu	Cc	CLASSIFICATION
●	TH16-02	4.0	S03	0.0	16.6	62.5	20.9	83.4			ML

The undrained shear strength of the clayey silt, as estimated by the field Torvane on disturbed samples varied from 10 kPa to 35 kPa. The moisture content of the clayey silt varied from 26% to 36% across all test holes. Atterberg limit testing performed on one (1) sample from TH16-02 at 4.0 m measured a Liquid Limit of 35%, Plastic Limit of 21%, and Plasticity Index of 14%, resulting in a classification of ML.

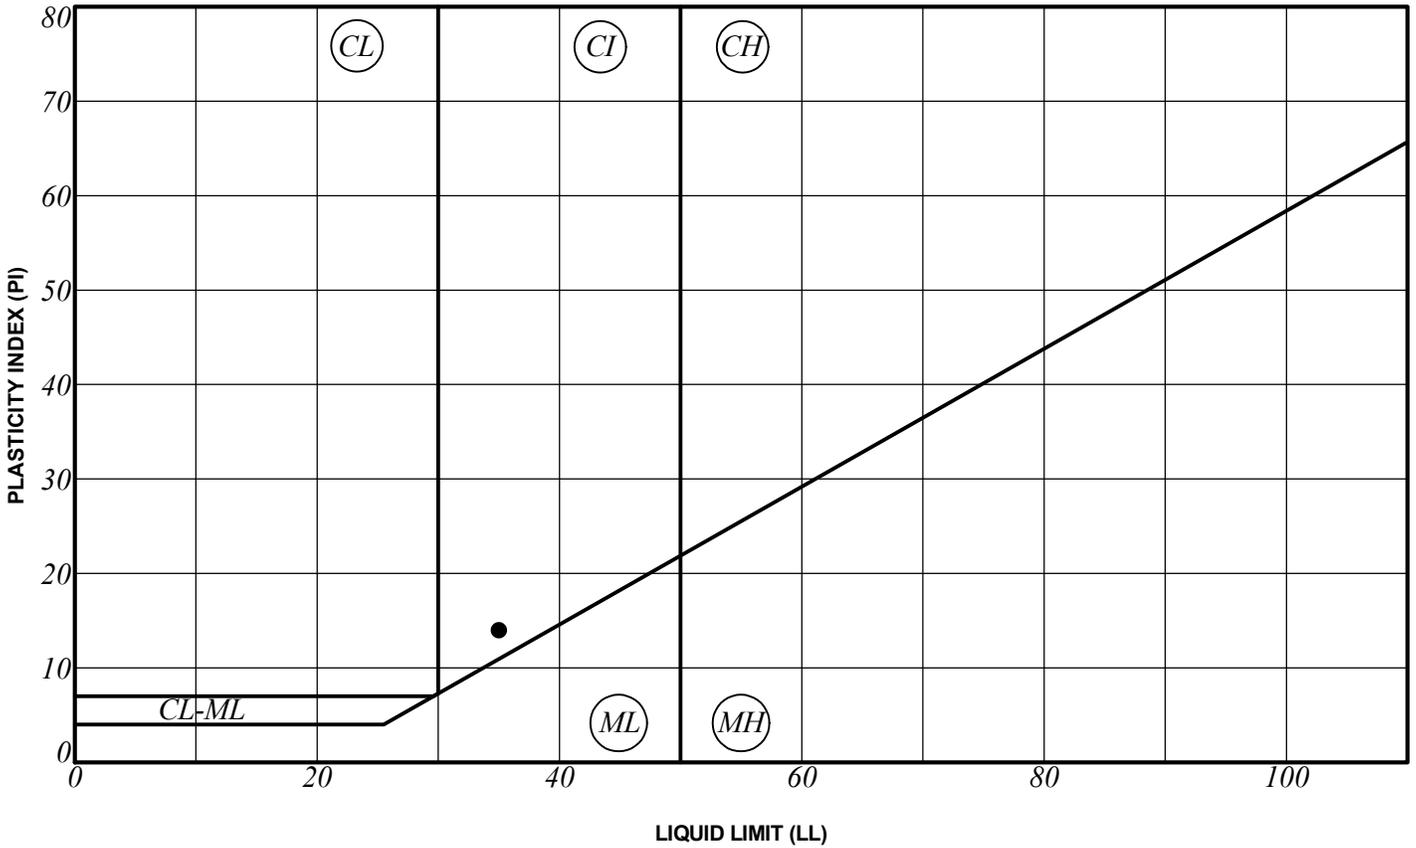
1x1 ARCHITECTURE INC.	
	Forks National Historic Site - Infrastructure Upgrades	
<h2>A-LINE PLOT</h2>		
April 2016	Figure B	Page 1 of 1

SYMBOL	HOLE	DEPTH (m)	SAMPLE #	LL	PL	PI	% SAND	% SILT	% CLAY	% MC	CLASSIFICATION
●	TH16-02	4.0	S03	35	21	14	16.6	62.5	20.9	36.4	ML

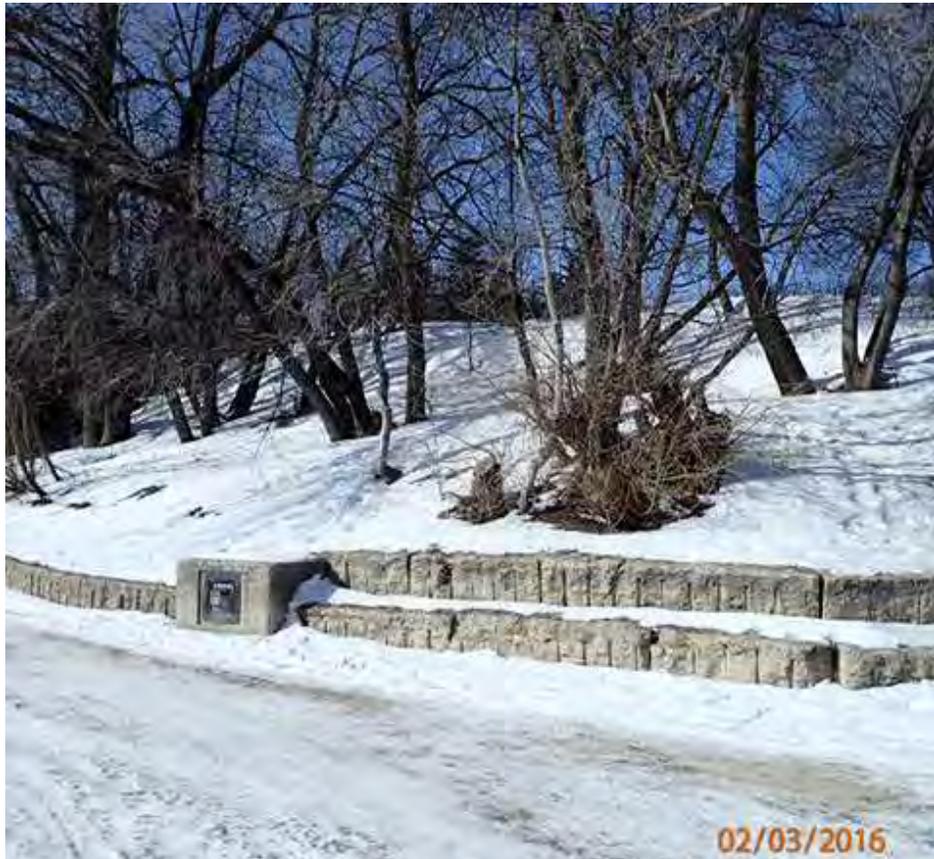
**Photo 1 – Looking upslope at uniform slope from River Walk located upstream of North Point near the southern project extent.**

At the southern project extents just upstream of North Point, the relatively flat upper bank area slopes down uniformly at approximately 3H:1V to the River Walk at the toe of the slope as shown in Photos 1 and 2. A narrow mid bank bench was observed to form downstream of the North Point and near TH16-03 as shown in Photos 3 and 4. The mid bank bench gradually widens further downstream and gently slopes down through the lower bank area towards the River Walk adjacent to the Boat Dock structure and TH16-02, as shown in Photos 5 and 6. The upper bank along this section slopes down to the mid bank bench at approximately 2H:1V. Upstream of the Amphitheatre, the mid bank bench gradually narrows to form a uniform slope at approximately 2.5H:1V, and is shown in Photos 7 and 8. The riverbank along the Amphitheatre is lined by limestone blocks along the crest and toe of the slope as shown on Photo 9. The upper bank is relatively flat and landscaped immediately downstream of the Amphitheatre near TH16-01 and the northern project extents. The riverbank is densely vegetated with large, mature trees and other riparian vegetation throughout the project extents.

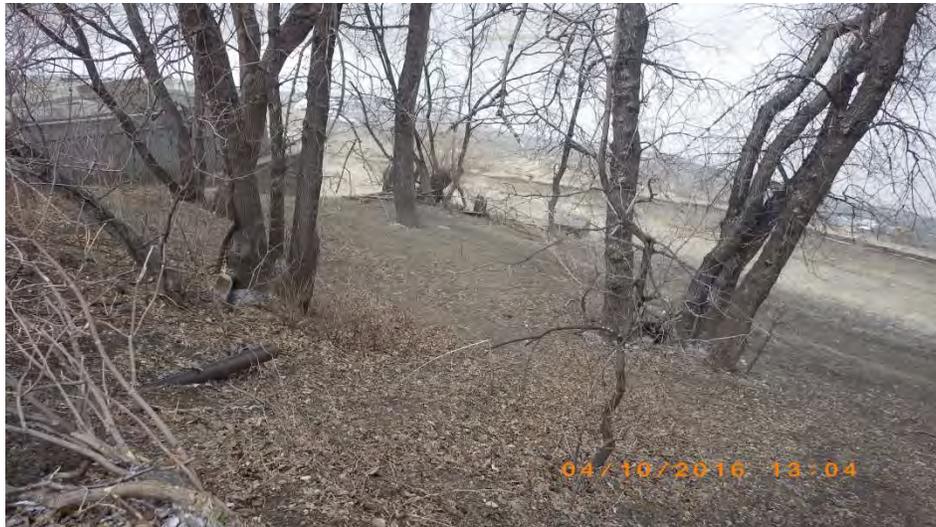
**Photo 2 – Looking downslope at uniform slope from upper bank area located upstream of North Point.**

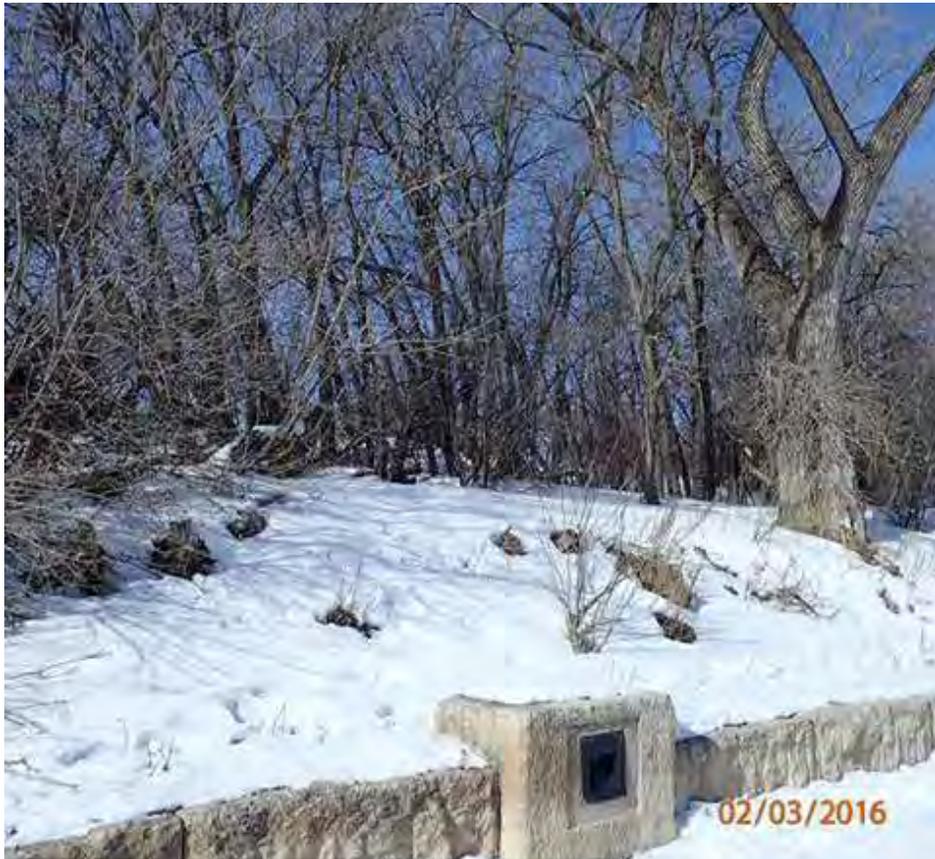
**Photo 3 – Looking upslope from River Walk at upstream extent of mid bank bench located downstream of North Point.**

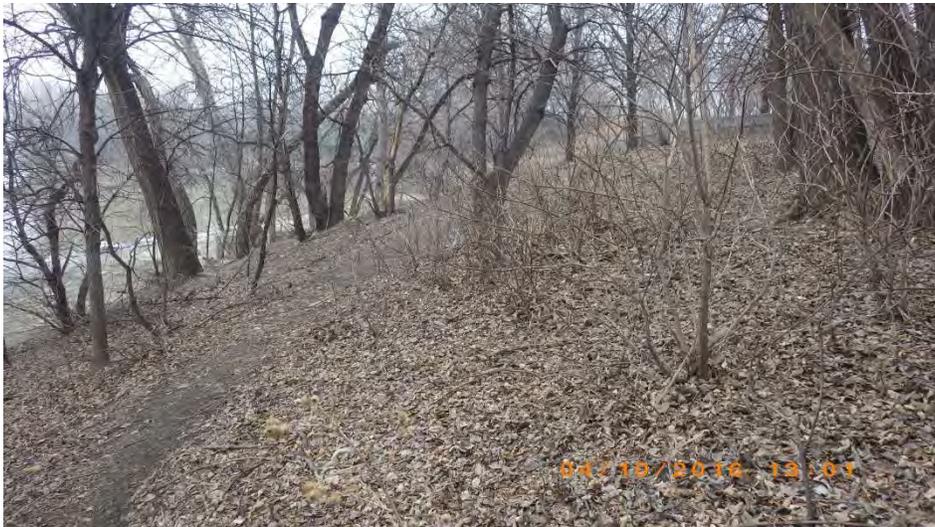
**Photo 4 – Looking upstream at the narrowing mid bank bench area located downstream of North Point.**

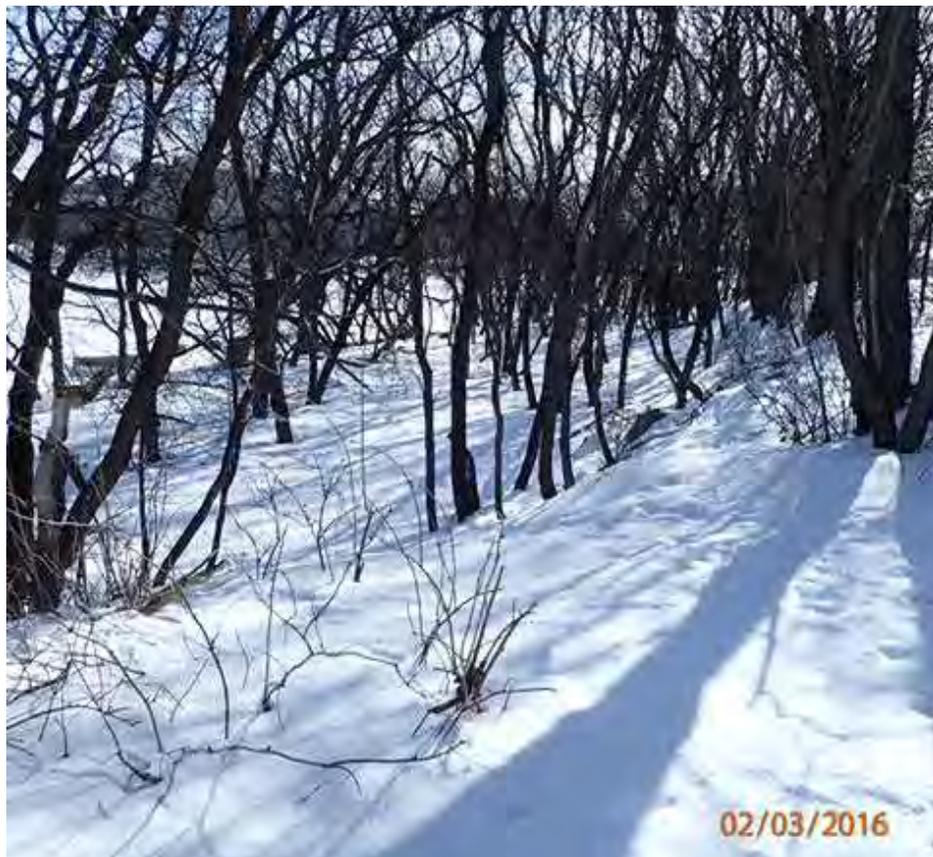
**Photo 5 – Looking upstream and downslope from upper bank area located just downstream of the Boat Dock. Note the slope from the upper bank to mid bank bench areas and numerous trees.**

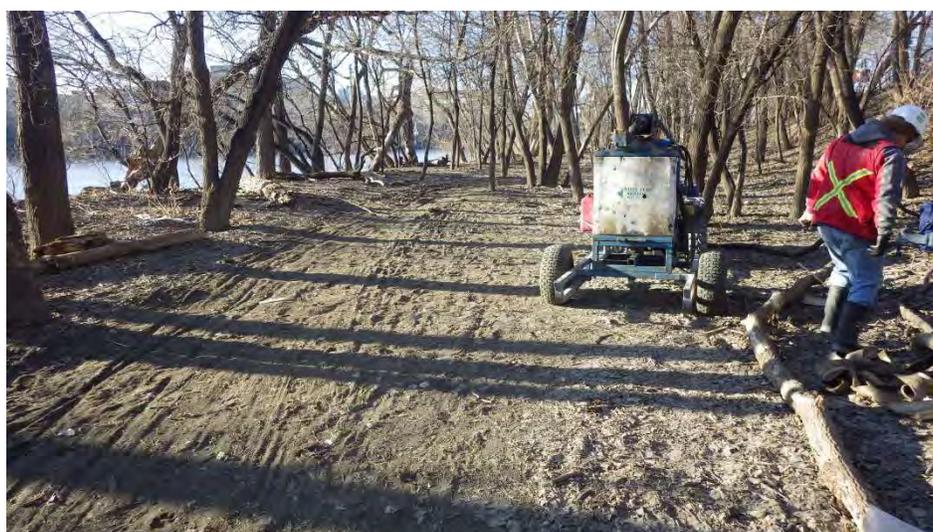
**Photo 6 – Looking upstream at flat mid bank bench area located downstream of the Boat Dock and near TH16-02.**

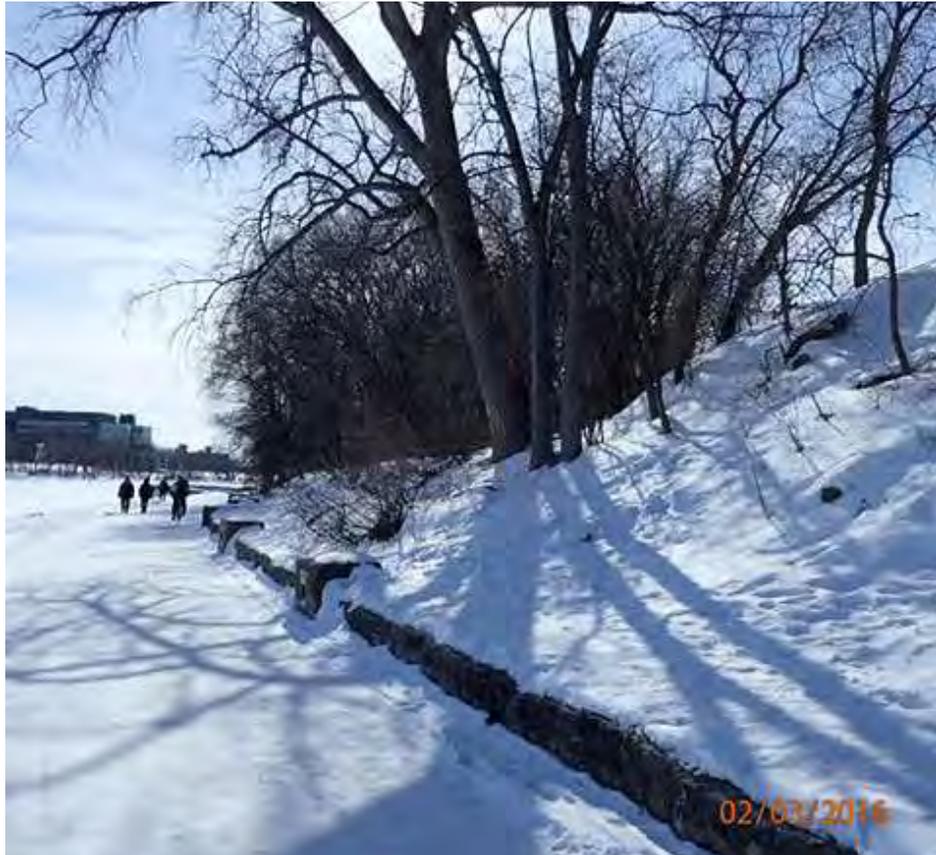
**Photo 7 – Looking upstream from River Walk at downstream extent of mid bank bench area located upstream of the Amphitheatre.**

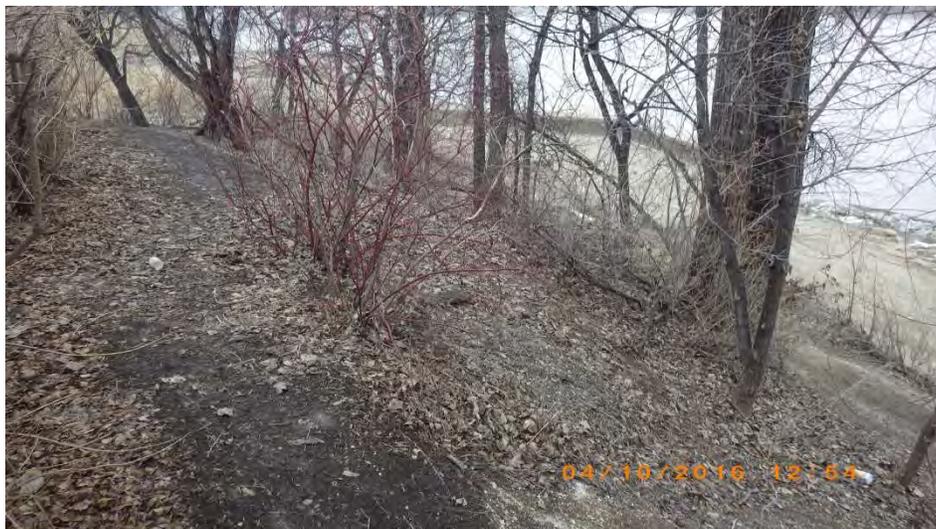
**Photo 8 – Looking downstream at the narrowing mid bank bench area located upstream of the Amphitheatre.**

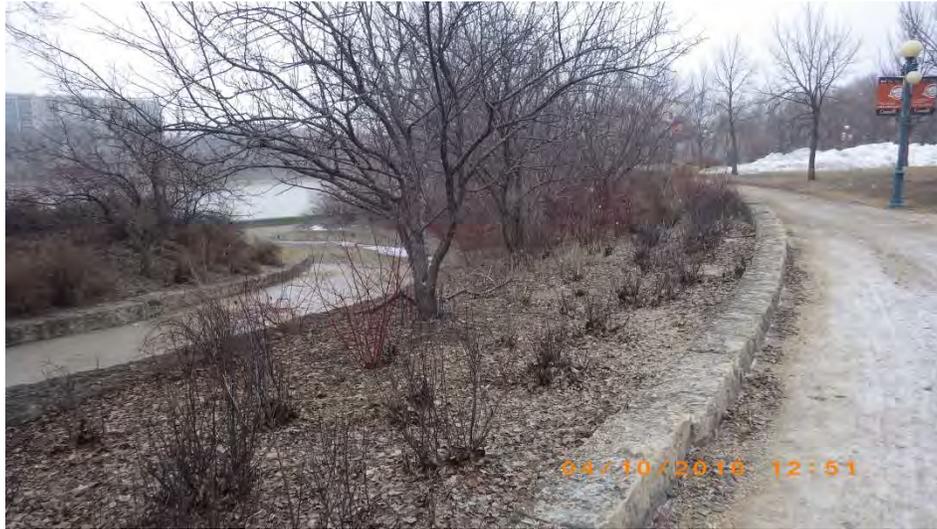
**Photo 9 – Looking upstream from upper bank area located at the Amphitheatre. Note the proposed lighting location is within the vegetated area encompassed by the limestone blocks.**

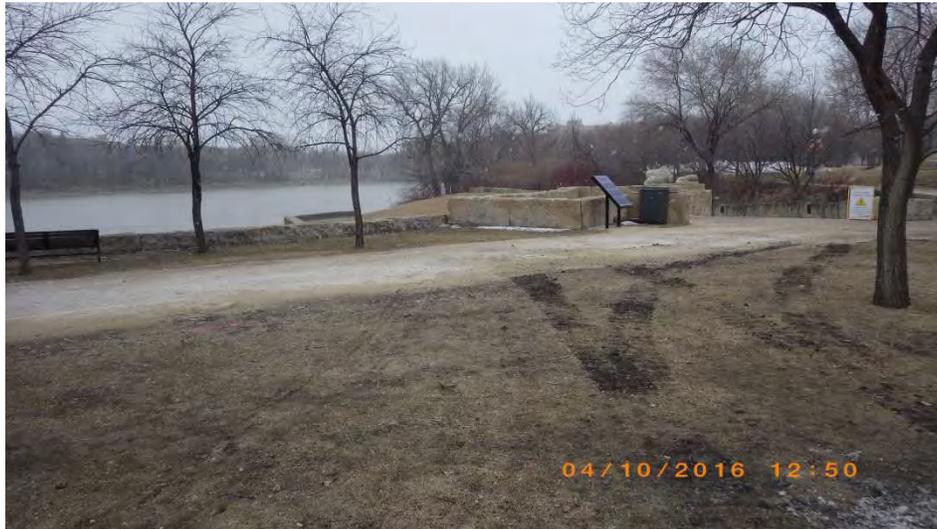
**Photo 10 – Looking upstream from upper bank area located just downstream of the Amphitheatre and near the northern project extent.**

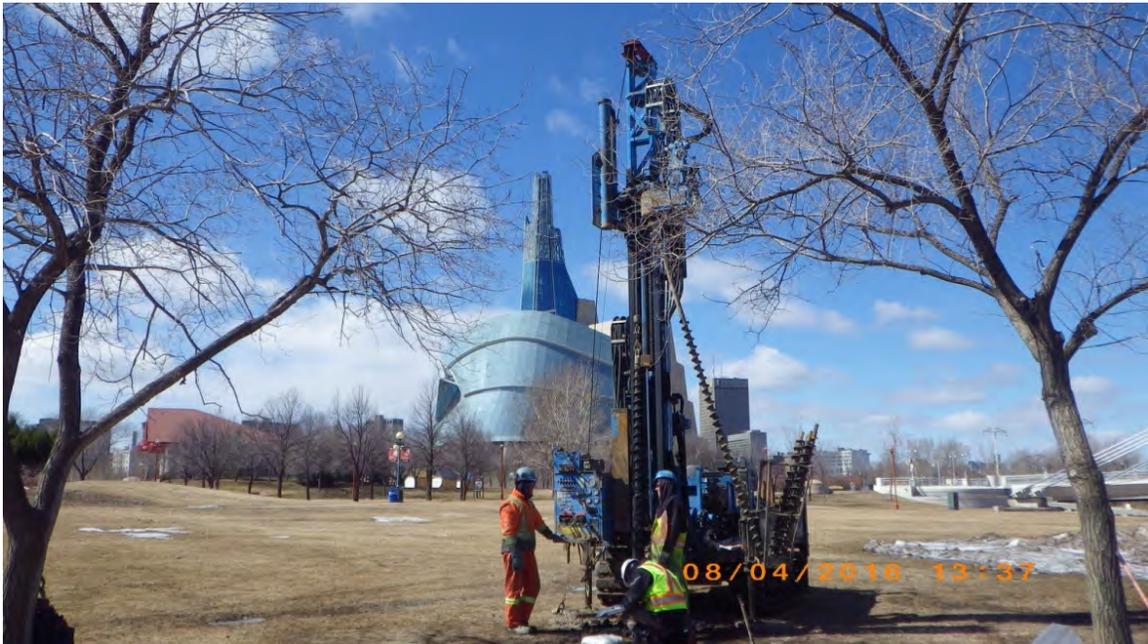
Figure 2. Geotechnical drilling at KGS Test 01 with Canadian Museum for Human Rights (left) and Provencher Bridge (right) in background.

KGS Test 01 is the northern-most drill site situated approximately 350m south of the Provencher Bridge and 400m southeast of the Canadian Museum for Human Rights (Figures 2 and 4). The test location was on the upper terrace from the river on a flat short grass field (Figure 2) west of the gravel-walking path.

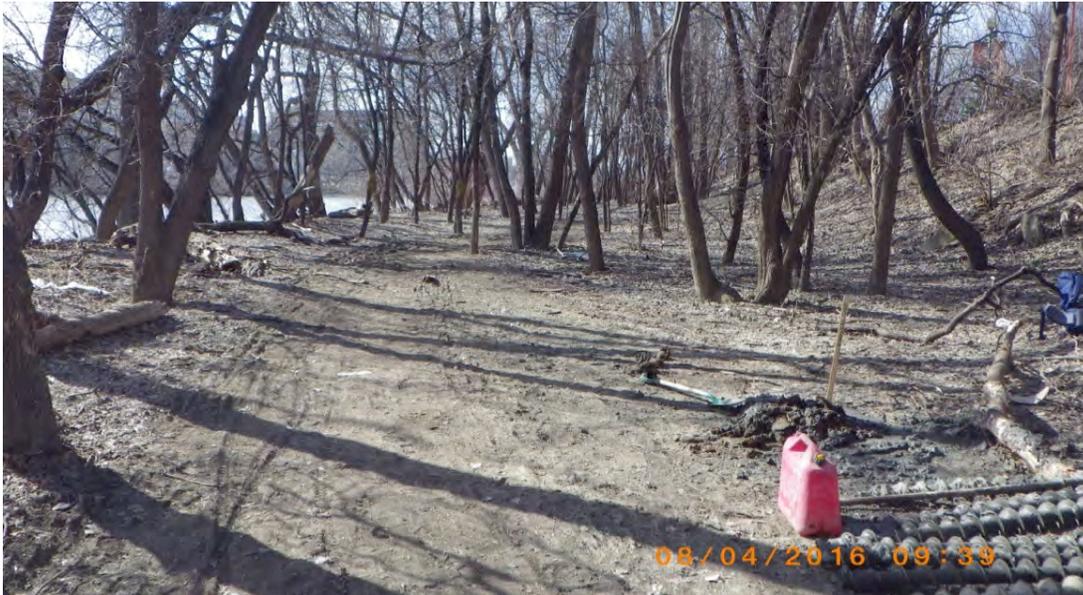
Figure 3. KGS Test 02 location on second terrace in forest.

KGS Test 02 was located on the middle (of three) terrace within a dense copse of trees (Figures 3 and 4), and east of The Children’s Museum. The drill site Test 02 was nearest of the tests to the river and adjacent as well as east of a clay walking/cycling path that followed along the terrace bisecting the narrow forest (Figure 3).

KGS Test 2 located on the lower terrace within an old stand of trees contained a more natural soil matrix (no fill) below the series of flood plain clays deposited for centuries (Figures 3 and 5).

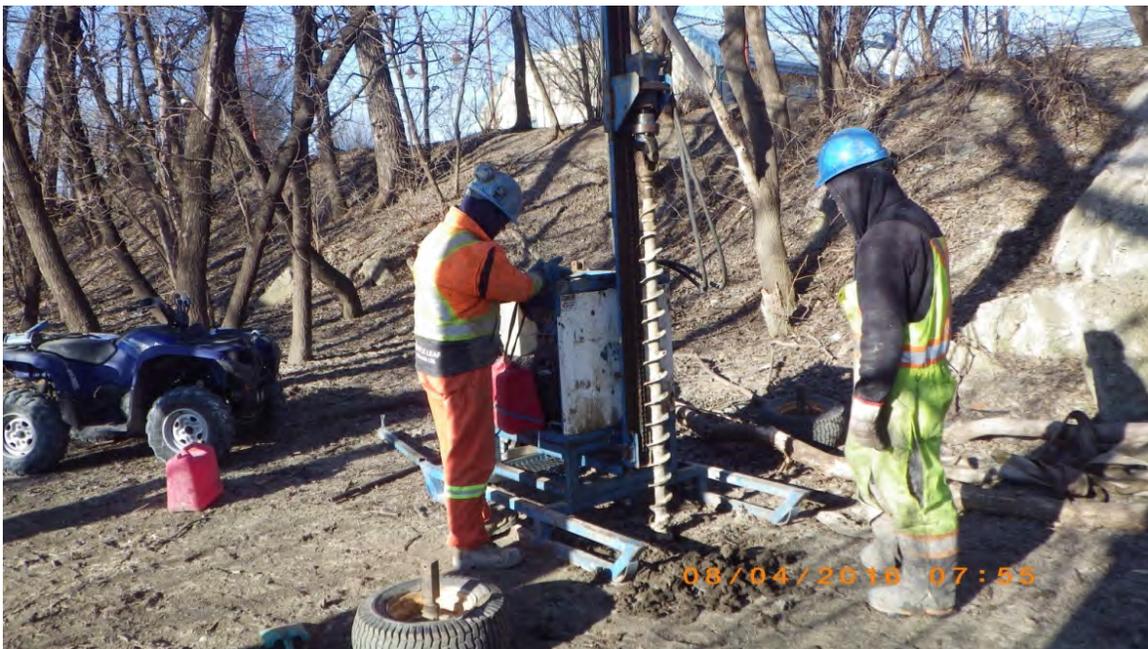
Figure 5. Monitoring soil disruption during geotechnical drilling operations.

The objectives for Bison were to closely monitor the geotechnical drilling (Figure 5) at three locations to: (1) determine the presence or absence of heritage resources at the drill sites; and (2) reduce impact to heritage resources that may be exposed during drilling. If heritage resources are identified, the objects will be examined to determine significance; then further mitigation strategies (ranging from halting drilling and selection of new location to further intensive testing and recovery of artifacts, to full excavation of test location) would be implemented.

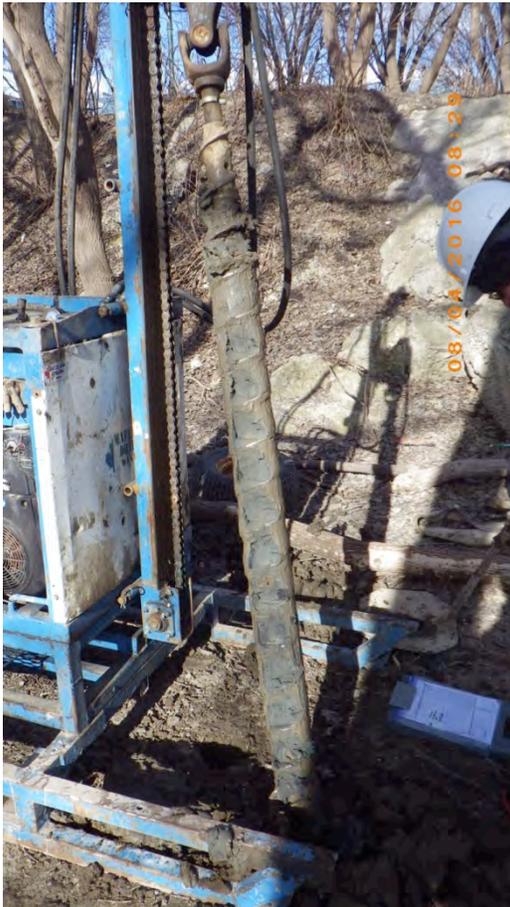
Figure 6. Examining soils from drill at 30cm increments for top 2m+.

The archaeological methods for monitoring the geotechnical drilling consisted of (1) brief pedestrian survey around drill site to identify any heritage resources located on the ground surface; and (2) monitoring of drilling process with halts and drill removal every 30cm for top 2m to examine back dirt and drill bit for evidence of heritage resources (Figure 6).

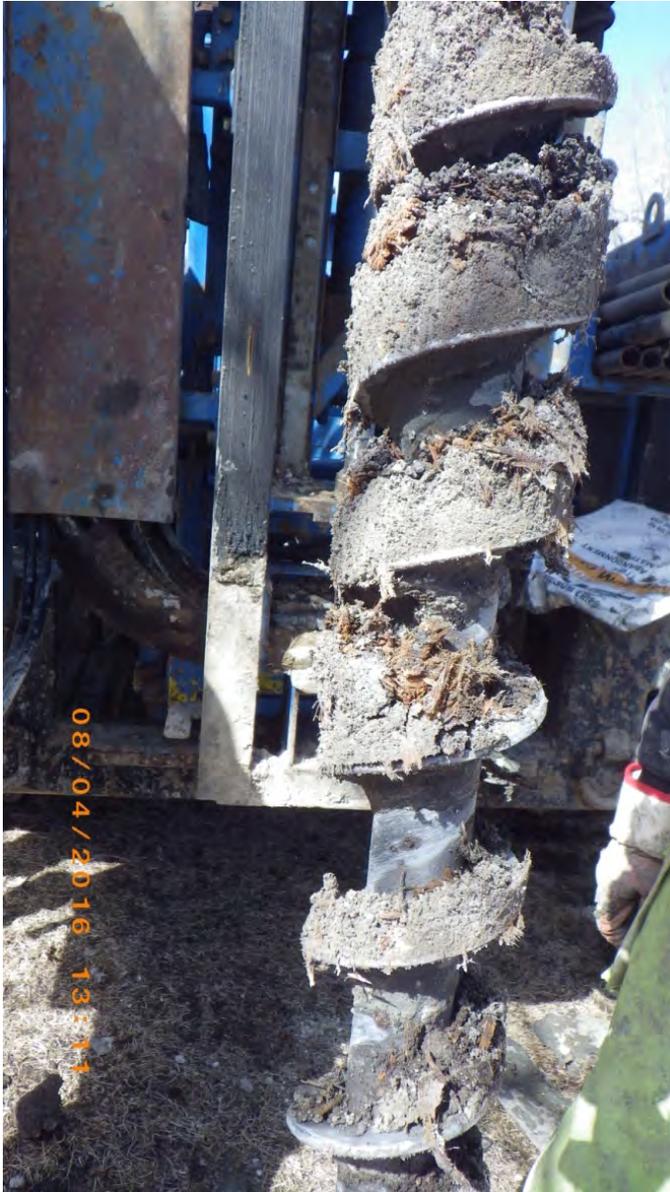
Figure 7. Wood fibres and sand identified in drill KGS Test 01 at approximately 2.5m – 3m depth.

During the drilling process, it was noted that the clean fill was deeper than anticipated and terminated at approximately 2m depth, followed by wet dark silt to 2.5m. Wood fibres and sand (Figure 7) was identified between 2.5 to 3m; likely due to railroad activities a century ago (Kroker et al. 1991; The Forks Public Archaeological Association Inc. 1993; The Forks Renewal Corporation 1993).

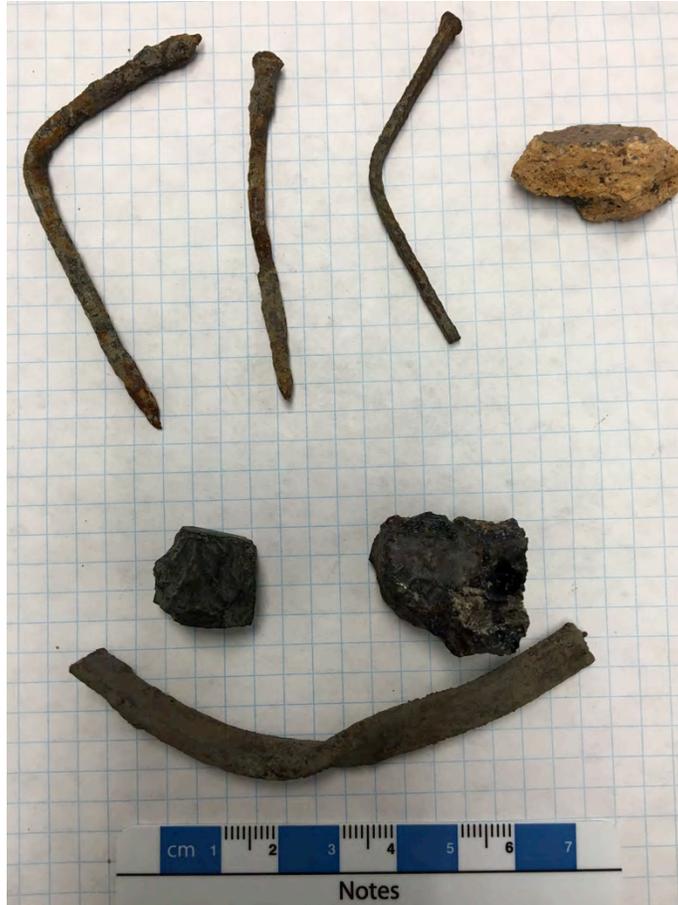
Figure 8. Artifacts recovered from KGS Test 1. Top row (L – R) machine cut nail, two wire nails and brick fragment. Second row – coal fragment and slag. Bottom – cut leather fragment.

A thin lens of black organic (original top soil) was noted below 3m with a small mix of Late Historic architectural debris including two wire nails (ca.1900- present), one machine cut nail (ca.1860-1900) and brick fragments. Also recovered were a thin strip of cut leather, a fragment of slag (from metal working) and a fragment of coal (Figure 8).

The artifacts reflect Late Historic architectural and possible blacksmithing activities. The heritage resources may have been recovered from a disturbed lens due to rail construction activities or modification of the area for newer development. The artifacts did not represent a significant site and geotechnical drilling at activities at KGS Test 1 continued without any further finds.

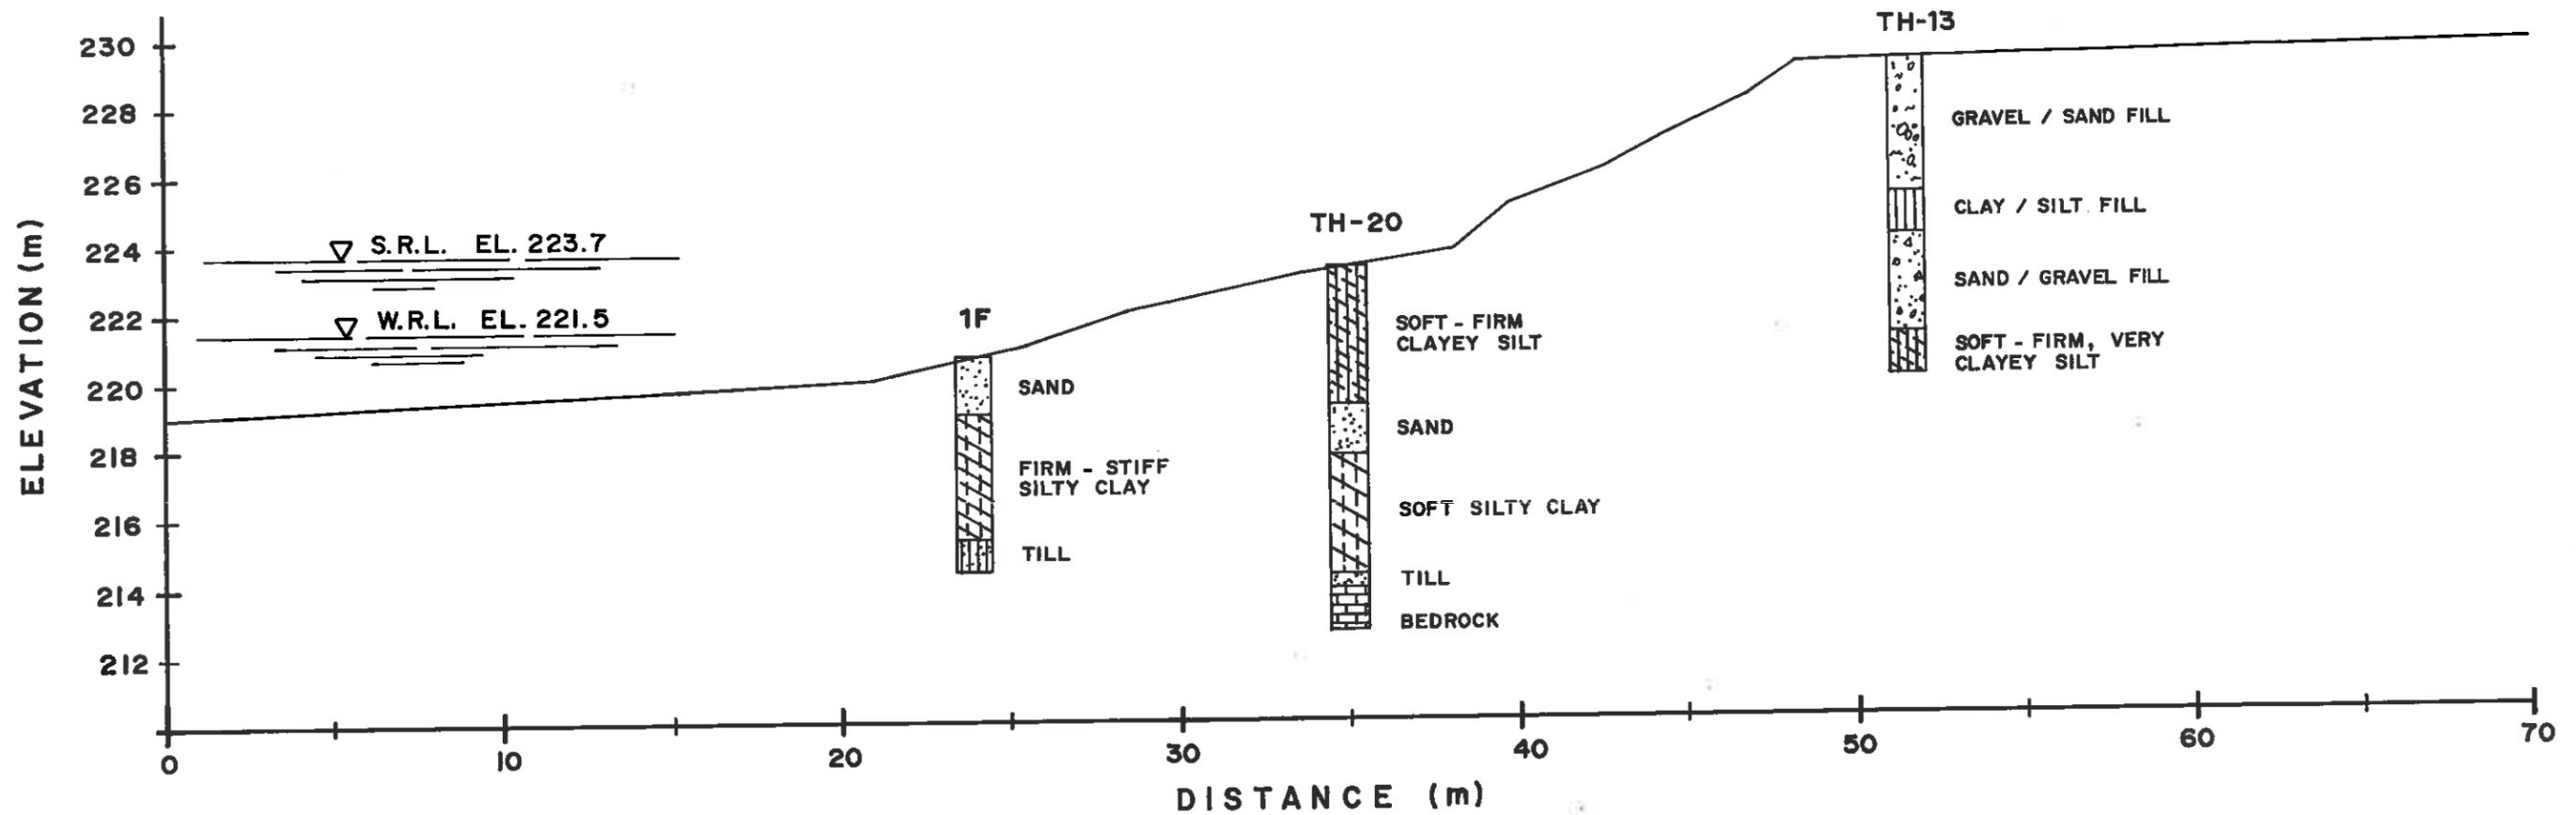
<b>KGS GROUP</b>	<b>PARKS CANADA</b>		
	FORKS PROMENADE EXTENSION		
<b>SOIL STRATIGRAPHY</b>			
DSN. M.J.	DATE	DWG. NO.	
DR. M.N.T		Figure 2

1. CROSS SECTION AND DRILL HOLE LOCATIONS SHOWN ON FIGURE 1.
2. DRILL HOLES TH-13 AND TH-20 FROM ITL, 1987. DRILL HOLE 1F FROM ITL, 1988.
3. DRILL HOLES PROJECTED TO PROFILE AT SECTION A-A
