File No. 15-2288-001

RE: The Forks National Historic Site  
Infrastructure Upgrades Geotechnical Investigation and  
Foundation Assessment for Riverbank Lighting

This report outlines details of the geotechnical site investigations performed by KGS Group and provides geotechnical recommendations relative to the design of the foundation systems for the proposed lighting development along the riverbank between the North Point and Amphitheatre located at the Forks National Historic Site in Winnipeg, Manitoba.

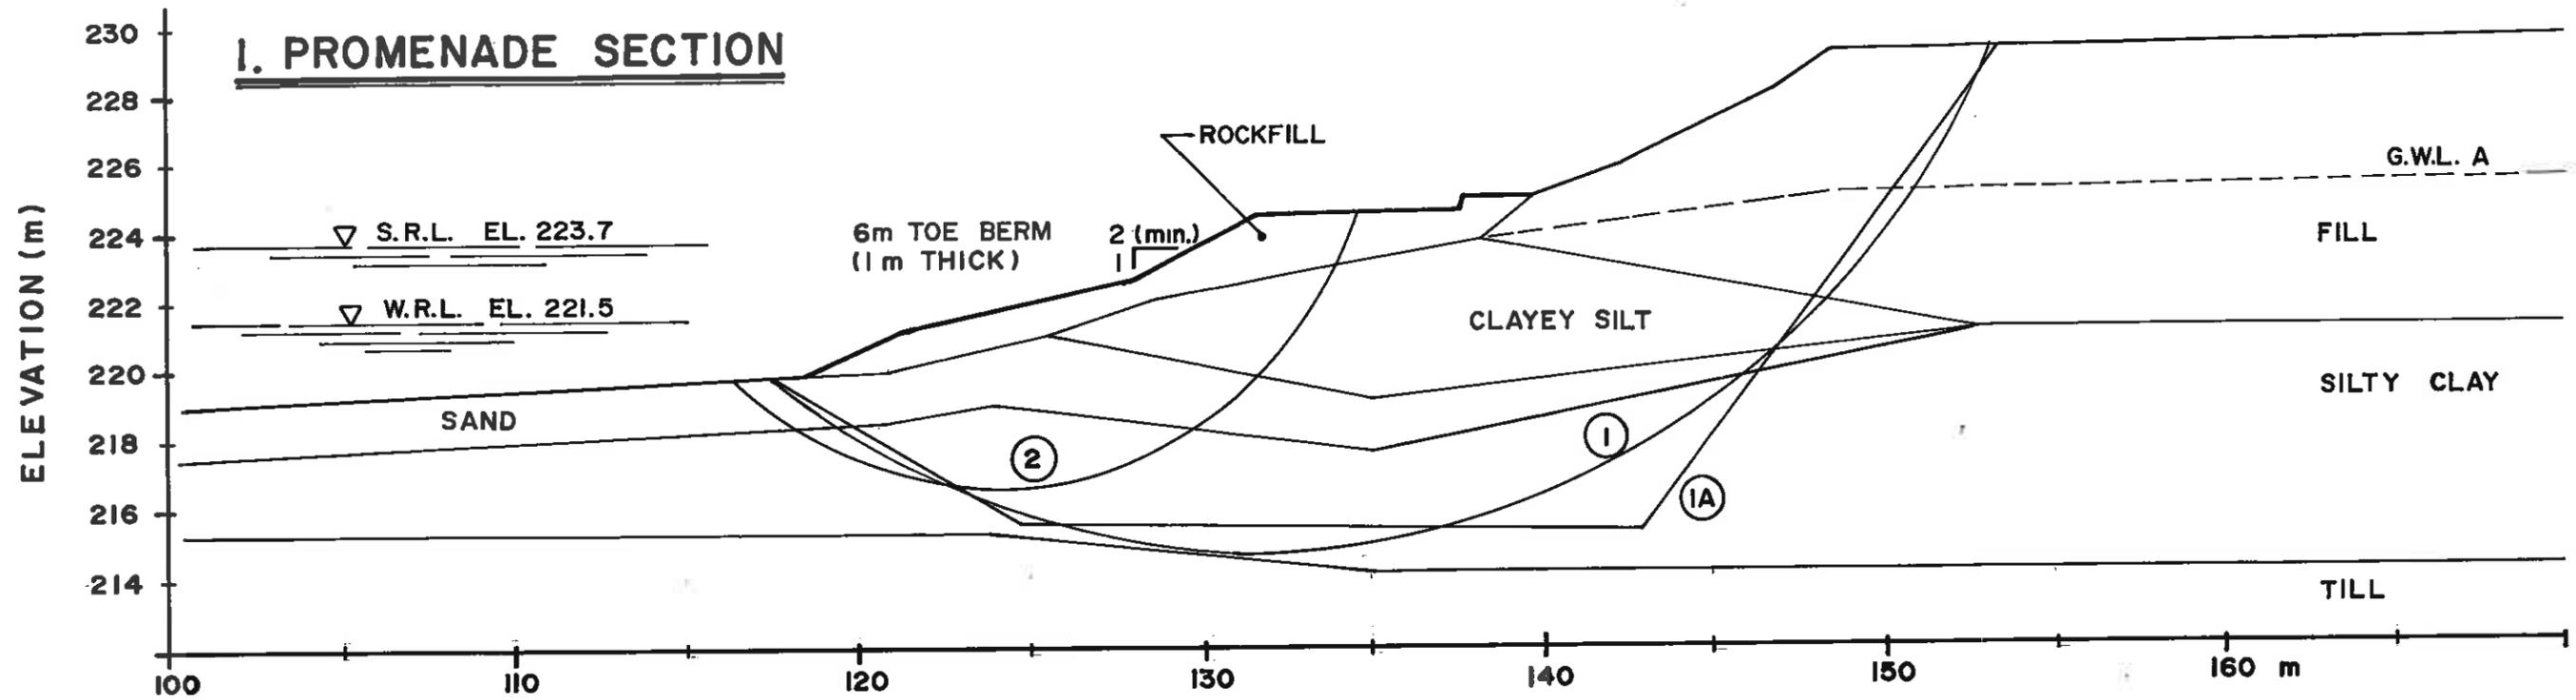
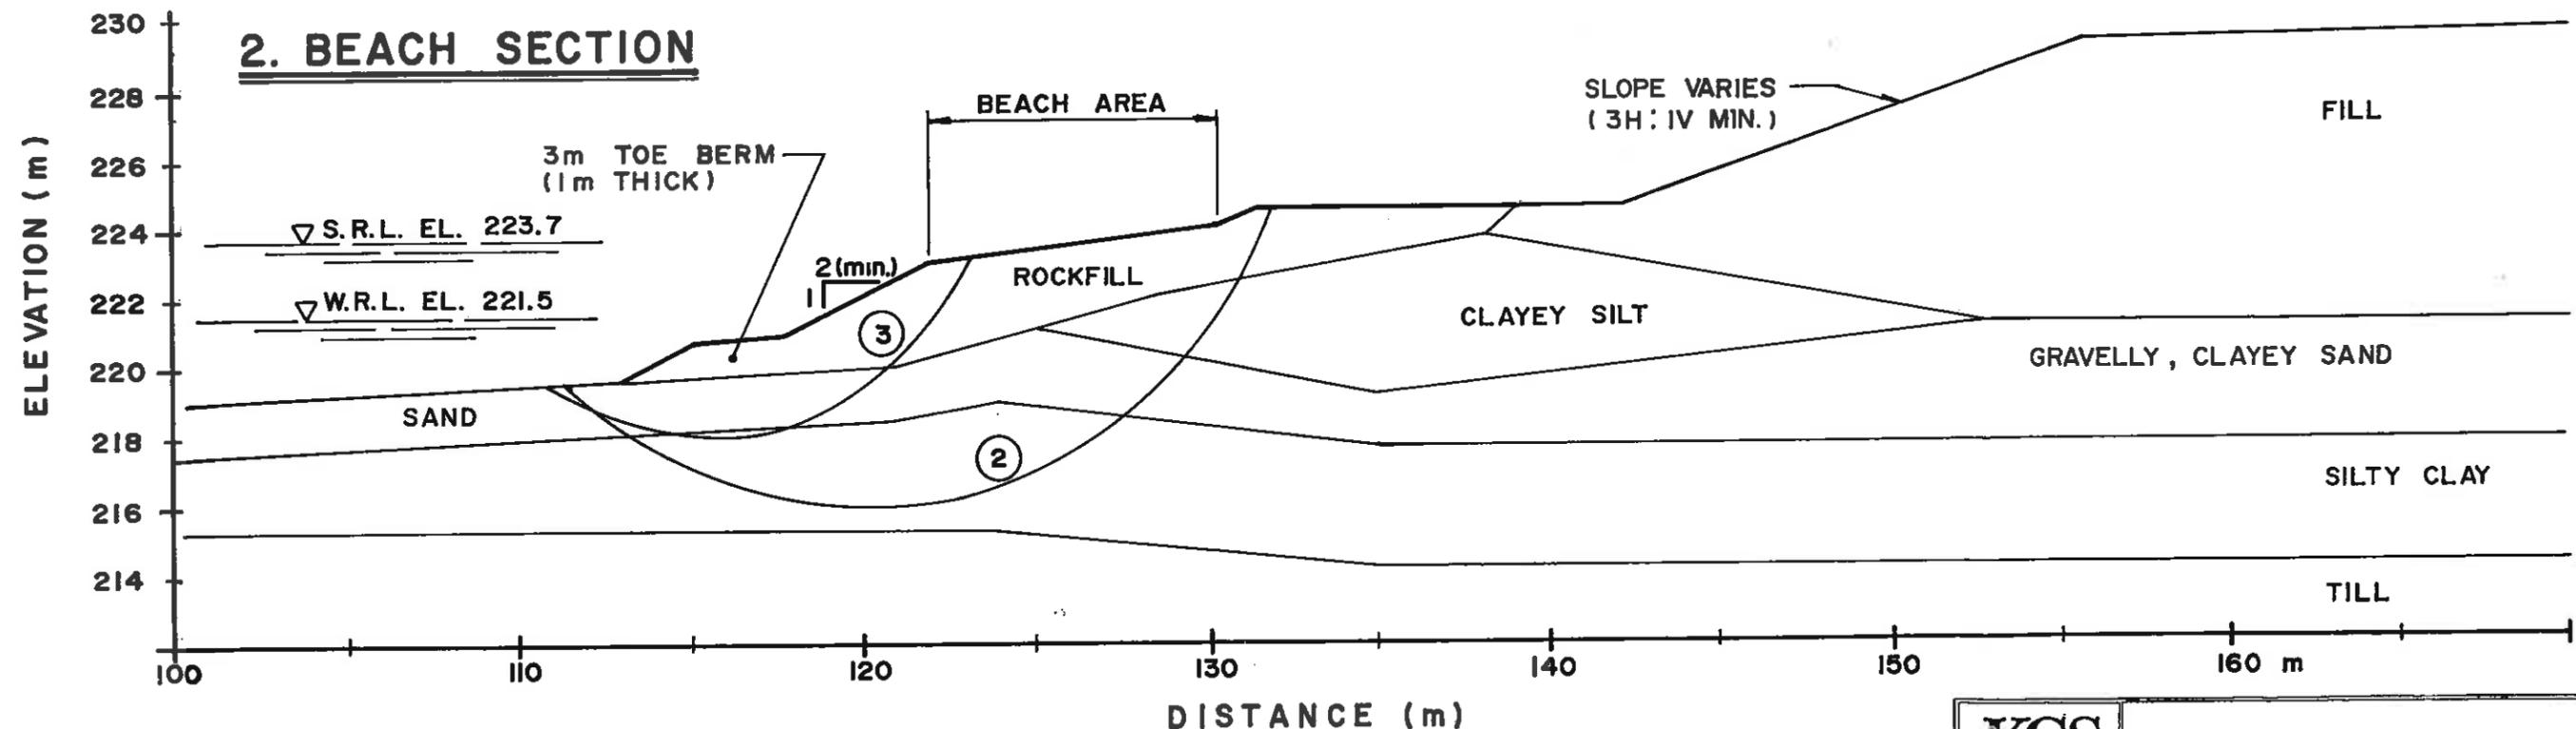
- NOTES:**
1. SEE TABLE 1 FOR FACTORS OF SAFETY
  2. GRAVELLY / CLAYEY SAND LAYER BASED ON ITL DRILLING AT AMPHITHEATER LOCATION (DRILL HOLES TH 1, 2, 9 & 10 - 1987)

STRENGTH PARAMETERS		
	$\phi'$	$c'$ (kPa)
FILL	28°	0
CLAYEY SILT	27°	5
SAND	32°	0
SILTY CLAY	17.5°	5
ROCKFILL	35°	0

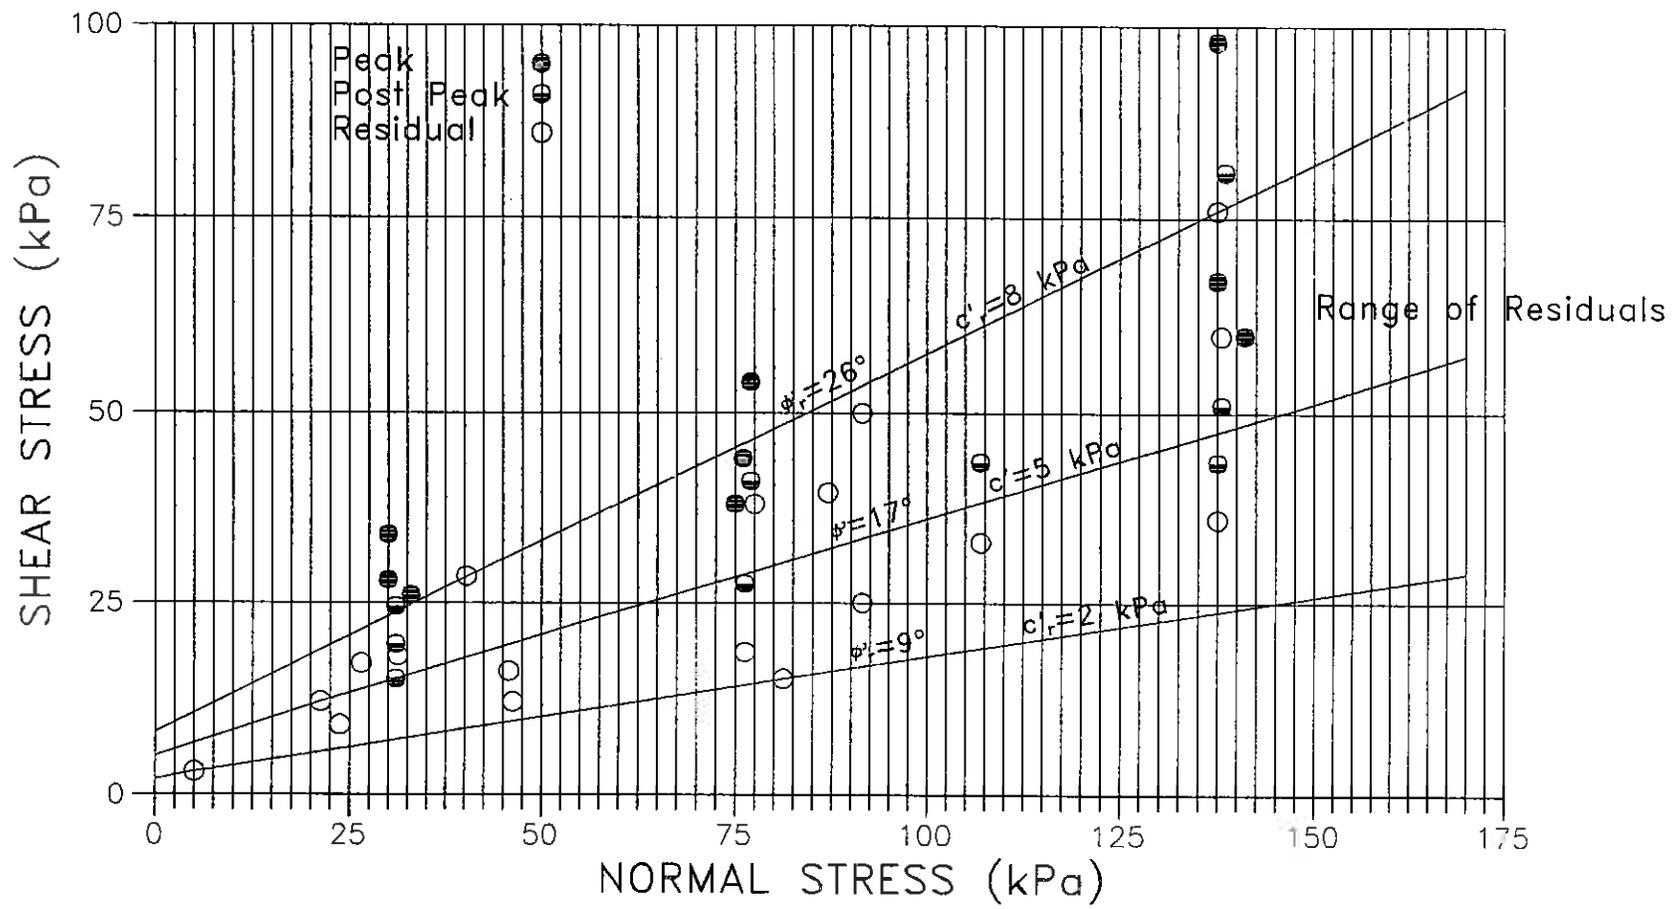
The direct shear data is based on samples from ITL Ltd. (drill holes TH-6, F1,5,3 and 16, 1987 and 1988) from the Forks National Historic Park Area.
