Basic Impact Analysis (BIA)

Construction of New Boundary Fence

Grasslands National Park

27 May 2016

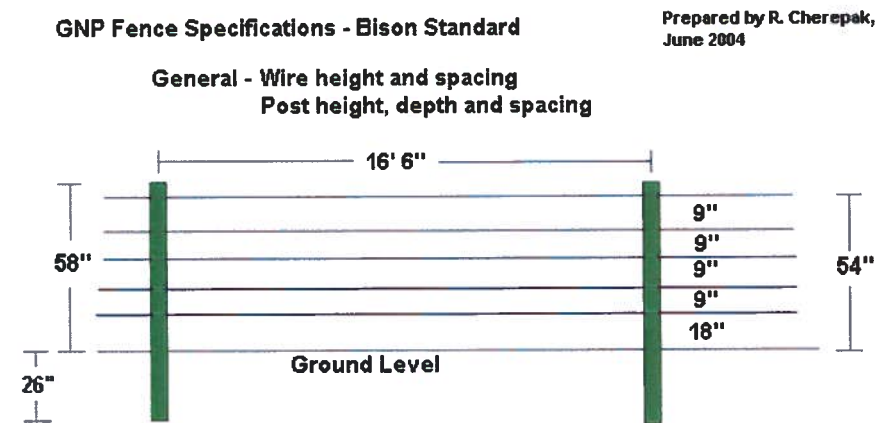
Annex II - General Fence Specifications

Note: numeric values are accurate and reflect requirement,
drawing not to scale

- *Post height is 58" (1.4732 m) above ground*
- *5 wires (top two wires and bottom wire barbless)*
- *Bottom wire 18" above ground, top wire 54" above ground*
- *Anchor posts minimum 5" (12.7 cm) diameter, placed every 1320' (402.3 m), at all direction changes, corners and gates*

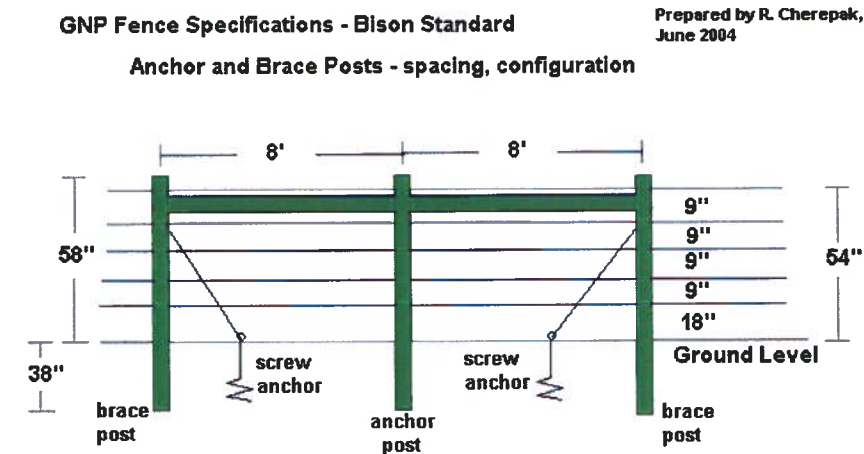
Annex III - Anchor and Brace Post Specifications

Note: numeric values are accurate and reflect requirement,
drawing not to scale

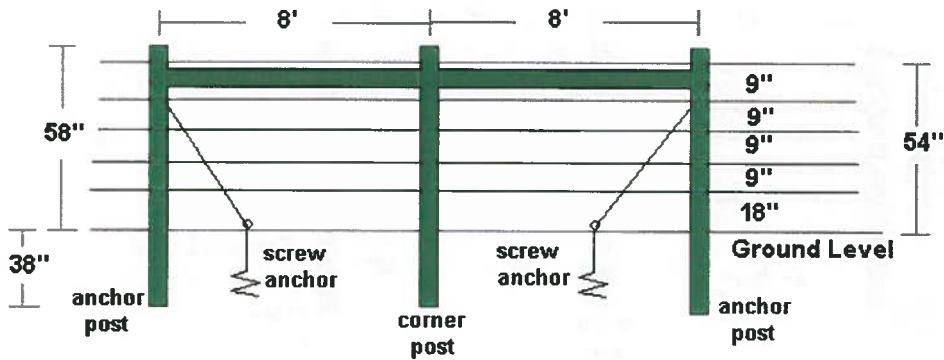
Corner Posts - anchors, spacing and configuration

side view
see next page for top view

Note: numeric values are accurate and reflect requirement,
drawing not to scale

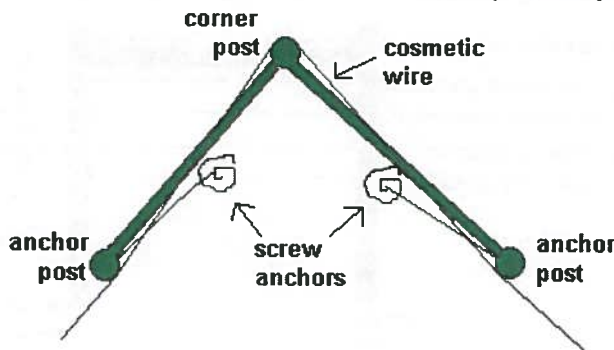
Annex V - Corner Post Specifications (Top View)

Corner Posts - anchors, spacing and configurator

top view
see previous page for side view

Note: numeric values are accurate and reflect requirement,
drawing not to scale

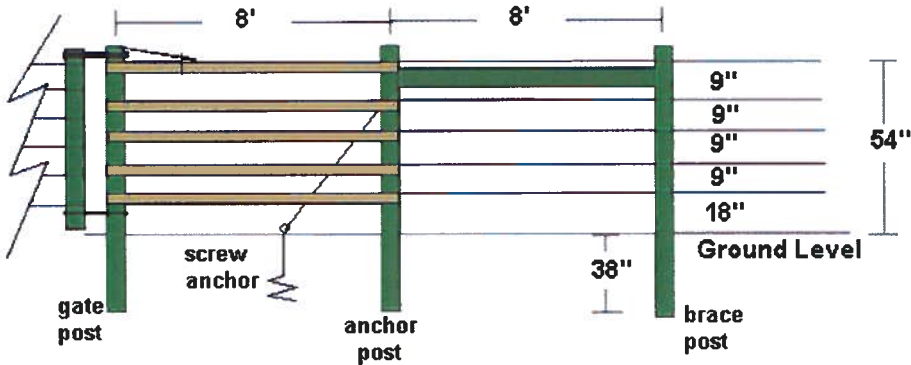
End of Fence at Wire Gate - rails, spacing and anchors

Note: numeric values are accurate and reflect requirement,
drawing not to scale

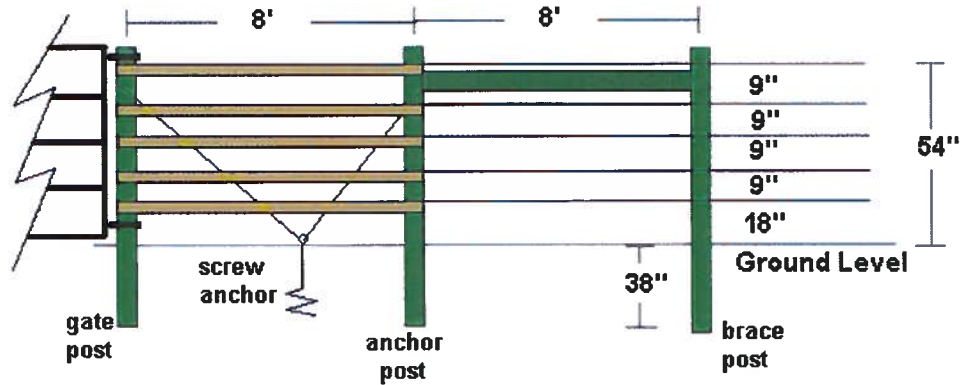
Annex VII - End of Fence at Metal Gate

End of Fence at Metal Gate - rails, spacing and anchors

Note: numeric values are accurate and reflect requirement,
drawing not to scale

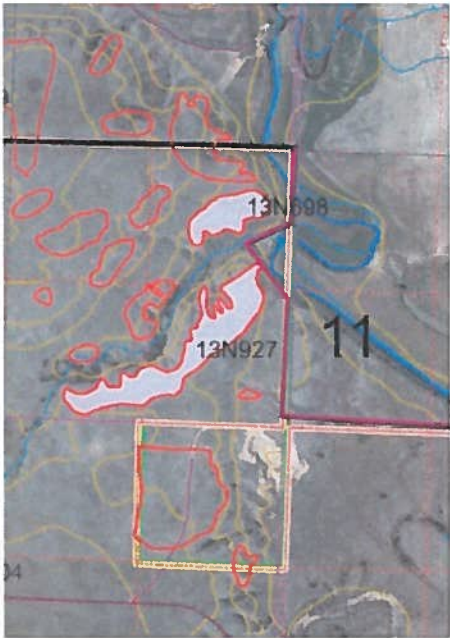
Fig. 9: Archaeological sites within 50m of fence segment #11.

There are two sites within 50m of this fence segment, which deviates from the actual boundary in order to avoid crossing the Frenchman River (Fig. 9). One site is at moderate risk of damage from fencing activities:

13N927: This site is marked by four widely-spaced tipi rings, at least five cairns and an extensive, continuous lithic scatter including flakes and cores, cobble tools and fire-cracked rock. The site extends for the length of the bluff on the south side of a coulee. The fence appears to be routed at the base of the bluff on which the site is located, but climbs to a higher elevation on the east side of the site. Any re-routing of the fence westward may cause impact to the site.

13N698: Thirteen tipi rings, two cairns and an extensive lithic scatter containing fire-cracked rock, flakes and stone tools. Some flakes are of Knife River Flint, which does not occur in local outcrops and must have been transported a considerable distance from its source in North Dakota. The site is positioned on the terrace above the valley bottom, i.e., it is at a higher elevation than the fence. Provided the fence does not deviate from its current course, the site is therefore unlikely to be impacted by fencing activities.

- 7. Sites 13N6443, 13N6444 and 13N6445 are located immediately west of fence segment #6 (Fig. 6). The fence must not be re-routed to the west in this area.*
- 8. Site 13N927 is located immediately west of fence segment #11 (Fig. 9). The fence must not be re-routed to the west in this area.*
