Parks Canada Basic Impact Analysis Johnston Canyon Trailhead Parking Lot Area Upgrades

Johnston Canyon Trailhead Parking Lot Area Upgrades

BNP-001088

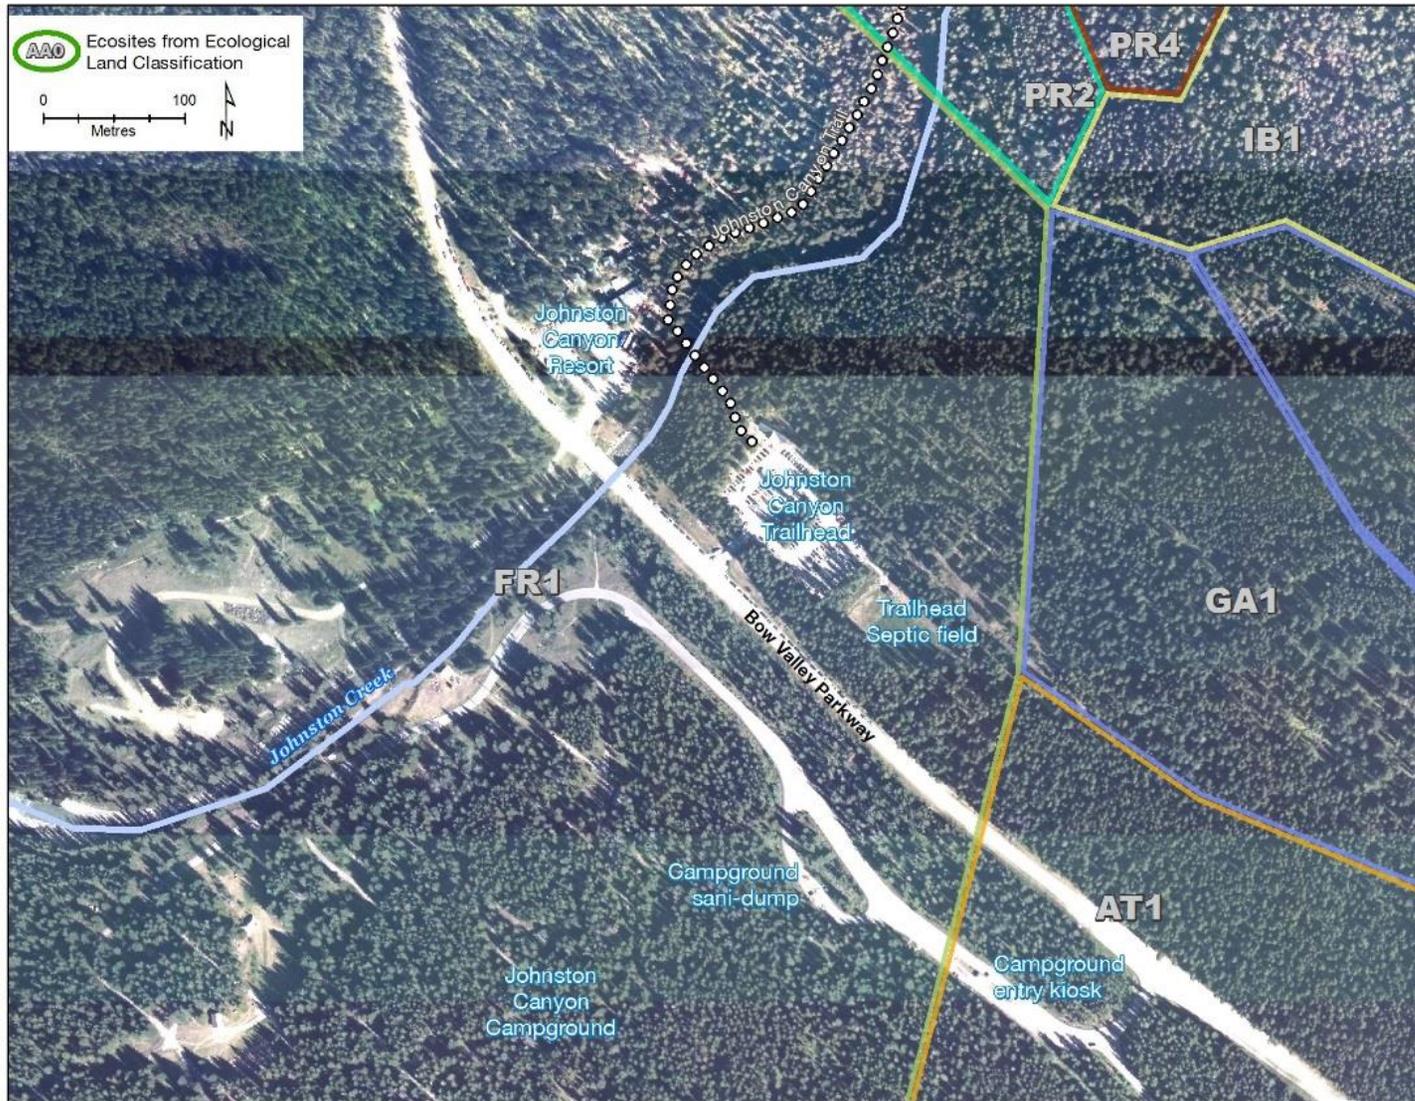
Figure 1: Overview of Existing Johnston Canyon Area Facilities

The Johnston Canyon trailhead is located in Banff National Park, Alberta off of the Bow Valley Parkway (BVP), also known as Highway 1A (Figure 1). The Johnston Canyon trail is used by people of all ages at all times of the year. It is one of the busiest trails in the park and it is busy rain or shine. The number of trail users is over 1,200 visitors per day in the busy summer months (EBA 2013). The trailhead has been operating beyond capacity and requires upgrading to meet current and projected visitor volumes. Currently, visitors that cannot be accommodated within the lot park along the shoulders of the BVP, creating a safety concern (Associated Engineering 2016). A moderate example of this is shown in the air photo in Figures 1 to 3, which was taken on a September day (i.e., not at peak time).

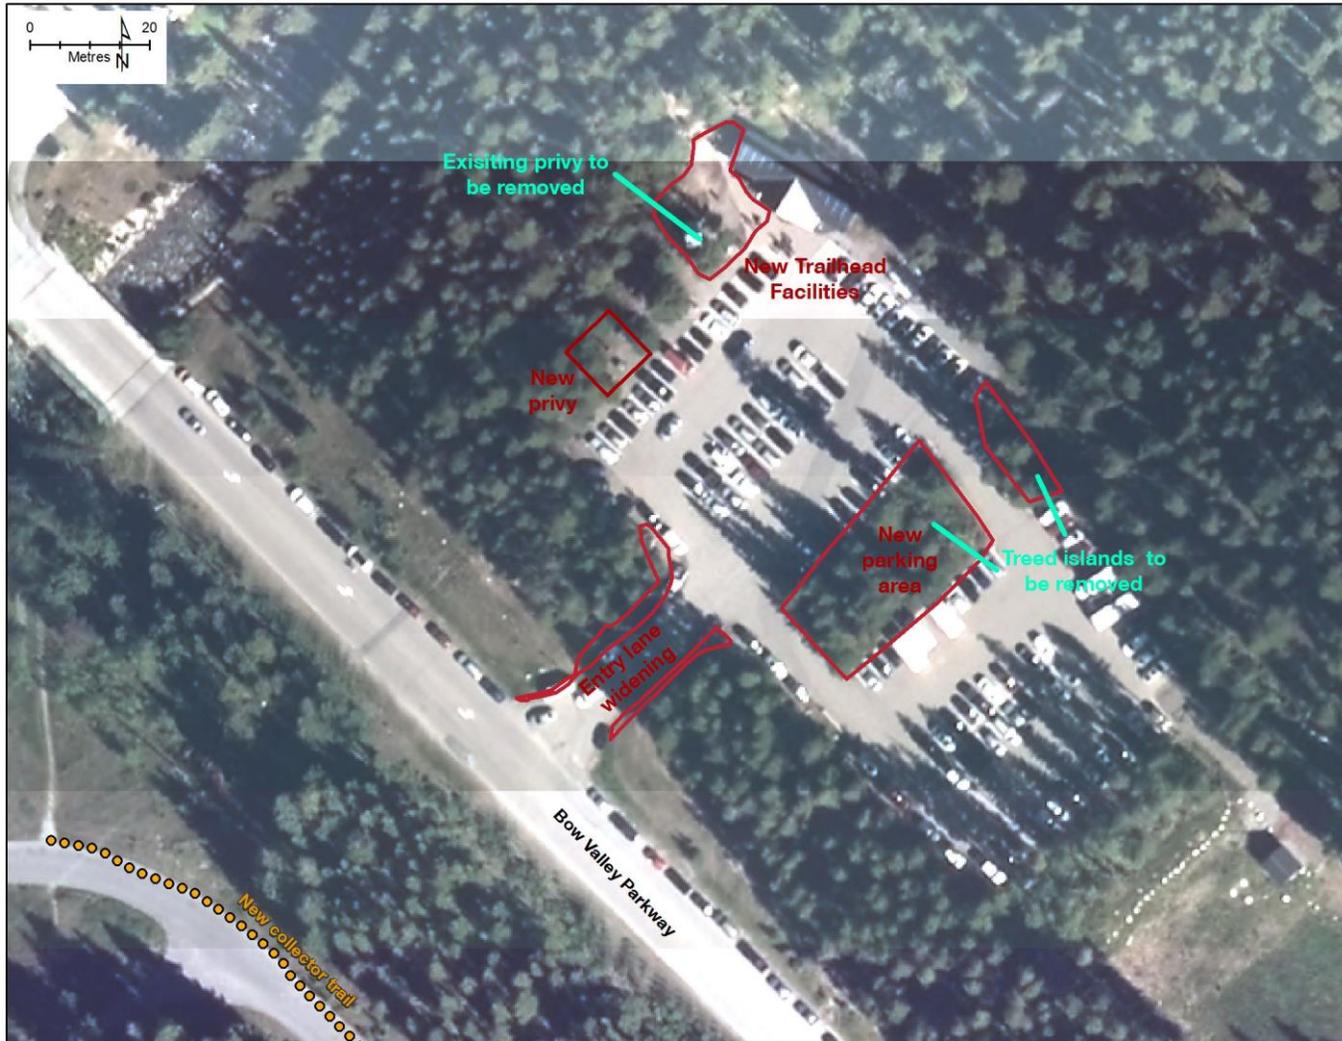
Figure 2: Johnston Canyon Trailhead Parking Upgrades

The components of the project comprise the following (see Figures 2 and 3):

- Improve parking capacity in the existing Johnston Canyon trailhead parking area, including RV and accessible parking stalls, by removing a treed island and treed node from the middle of this parking area, re-paving, re-painting stall lines and widening the parking area entry/egress lanes.

Remove current pump-out vault privy and install new pump-out vault privy at current location of picnic tables on west edge of existing parking lot (as shown in Figure 2) or adjacent to washroom building. This will comprise complete replacement with new vault and privy building. Exact location to be determined through detailed design, and will be on currently disturbed ground.
Following project completion	Post-construction monitoring
	Conduct ongoing monitoring of environmental impacts and patterns of visitor use to determine effectiveness of collector trail and BVP underpass at keeping vehicles and pedestrians off the BVP, and preventing vegetation trampling and trail shortcutting in the area.

The proposed upgrades to parking and trailhead facilities at Johnston Canyon will remain within the existing developed area of the trailhead and campground. Clearing and soil stripping requirements are summarized in Table 3 and shown in Figures 2 and 3.

- Only existing roadways and hardened areas will be used for access and equipment operation within the project site. The only exceptions include the treed islands and treed node that are to be removed and the footprints required for the proposed new trailhead facilities and privy, as shown on Figures 2 and 3.

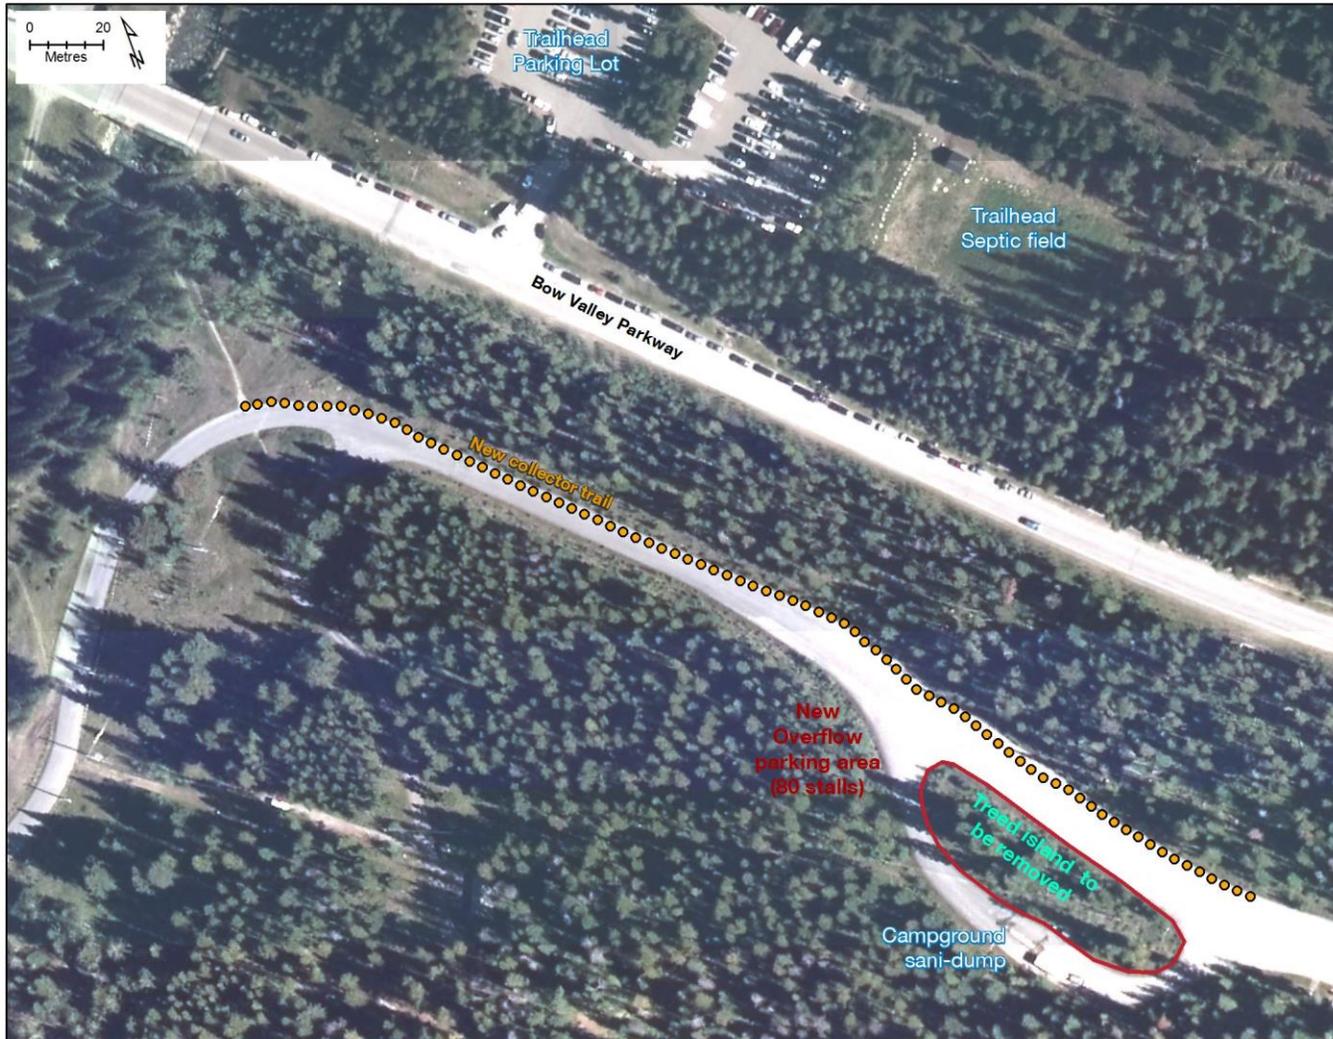
Figure 3: Proposed Overflow Parking Facilities at Johnston Canyon Campground Entry Area

- Construct a trailhead arch, new information kiosk, stamped concrete plaza, wayfinding signs and stonework seating at the trailhead.
- Create new, overflow parking capacity in the Johnston Canyon campground entry area by removing a treed island, paving and painting stall lines in this area.
- Provide a user-friendly trail connection between the new overflow parking area and the Johnston Canyon trailhead.

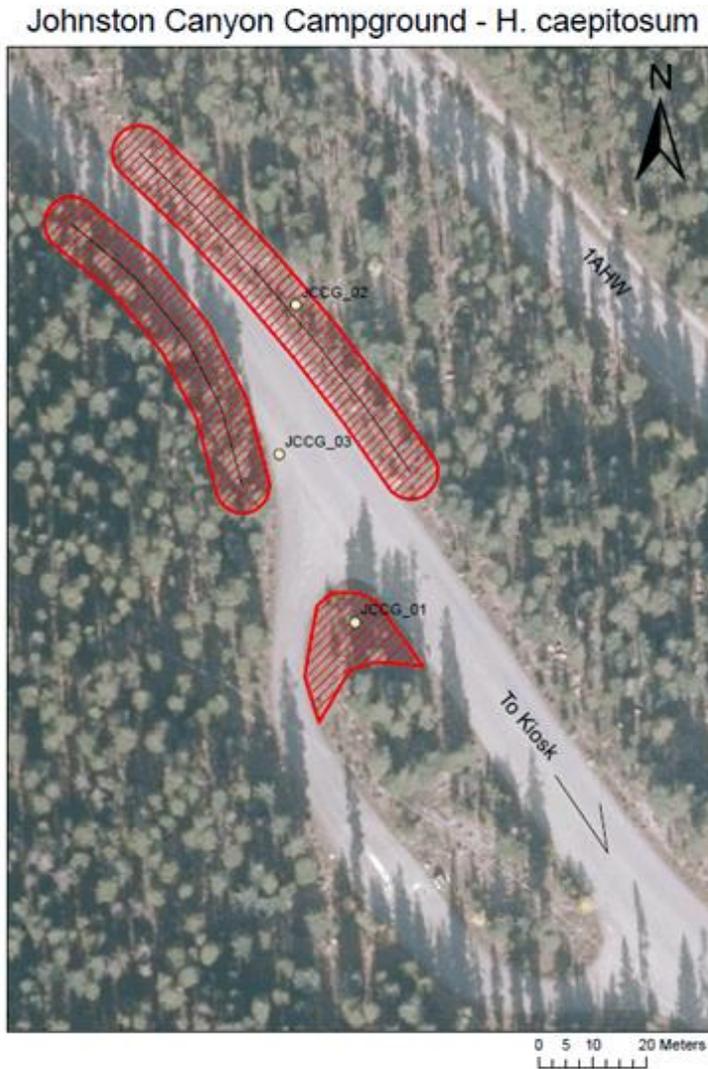
Figure 4 – Meadow Hawkweed Locations in Johnston Canyon Campground Entrance Area

Meadow hawkweed (*Hieracium caespitosum*), which is an aggressive non-native species, classified as a prohibited noxious weed species in Alberta, is known to occur in the campground entrance area (see Figure 4). The sites are located near the kiosk, originating from the island of trees located between the main road and the sani-dump location. The infestation has begun to spread across the road. This is a relatively low density area that is a good candidate for eradication and should be aggressively controlled (pers. comm. Rob Osiowy 2016).

- All construction equipment must be washed/steam cleaned prior to arrival on site to minimize risk of introducing invasive weed species.
- Special measures apply to the locations of meadow hawkweed (Figure 4):

- Ground disturbance in the locations of meadow hawkweed must be avoided.
 - When excavation is required for construction purposes, all excavated topsoil from these areas (and any subsoil that is potentially contaminated with weed seeds) must be removed from the park for disposal in compliance with provincial regulations.
