Public Works and Government Services Canada
Aircraft Fuelling System Modifications
RCMP Hanger Site - Prince Albert, SK
R.042523.006

**PHASE III ENVIRONMENTAL SITE ASSESSMENT
(EGE, 2012)**

**RCMP F Division
Phase III Environmental Site Assessment
RCMP Hangar - DFRP 14477 - PR F/266 - BU F/262
190 Airport Road - Prince Albert, Saskatchewan**

PWGSC Project No.: R.042523.005

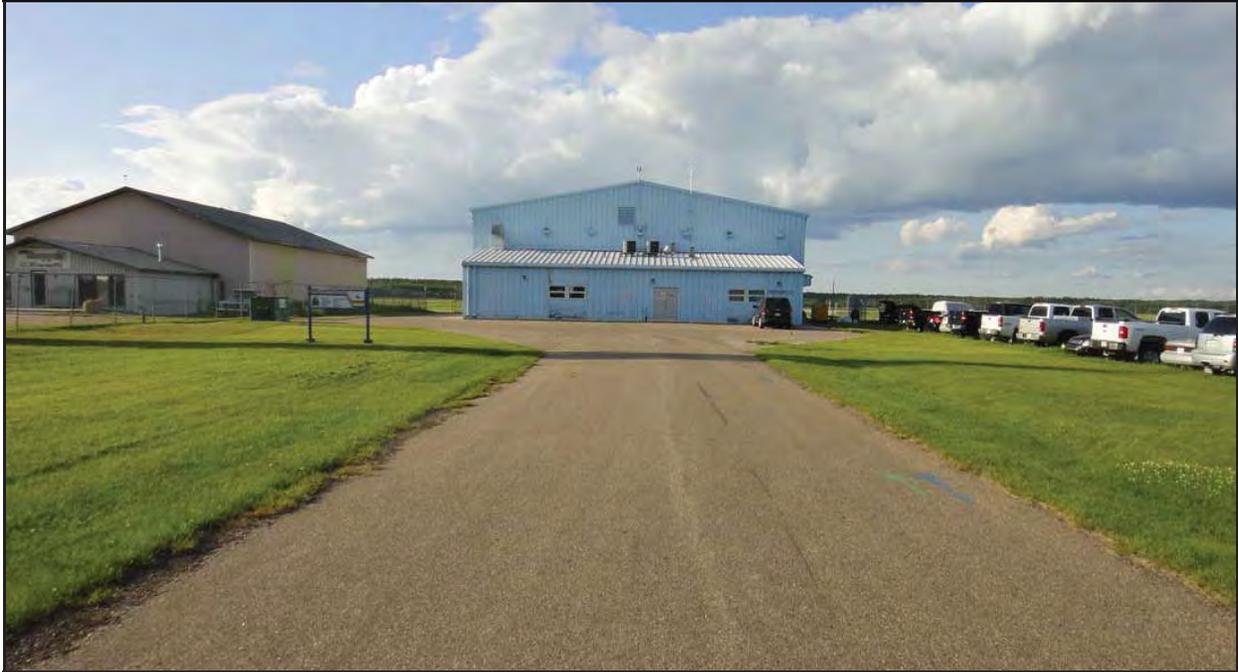
*Photo 01 - View of the south side (front) of the RCMP Hangar looking north.
The Prince Albert Shopper building is located to the west on the left side of the photograph.*

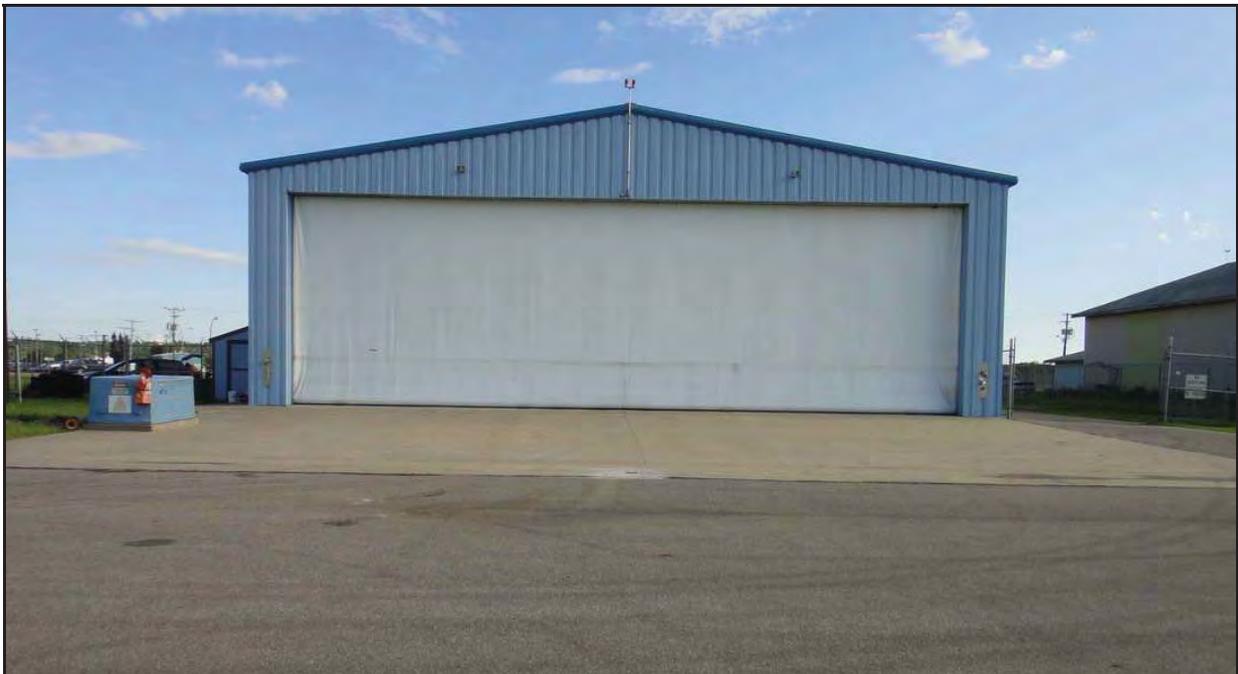
*Photo 02 - View of the north side of the RCMP Hangar looking south.
The fuel dispensing stand is visible on the concrete apron on the left side of the photograph.*

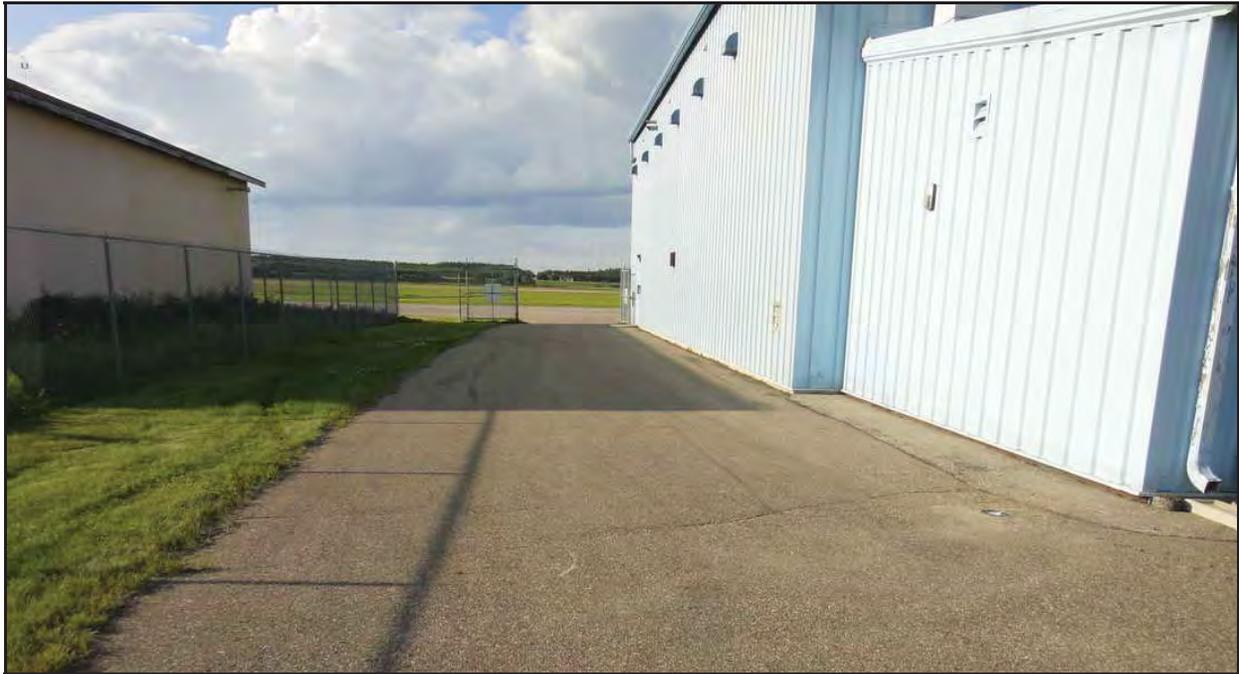
*Photo 03 - View of the west side of the RCMP Hangar looking north towards Taxiway Bravo.
The adjacent building to the left (west) is the Prince Albert Shopper.*

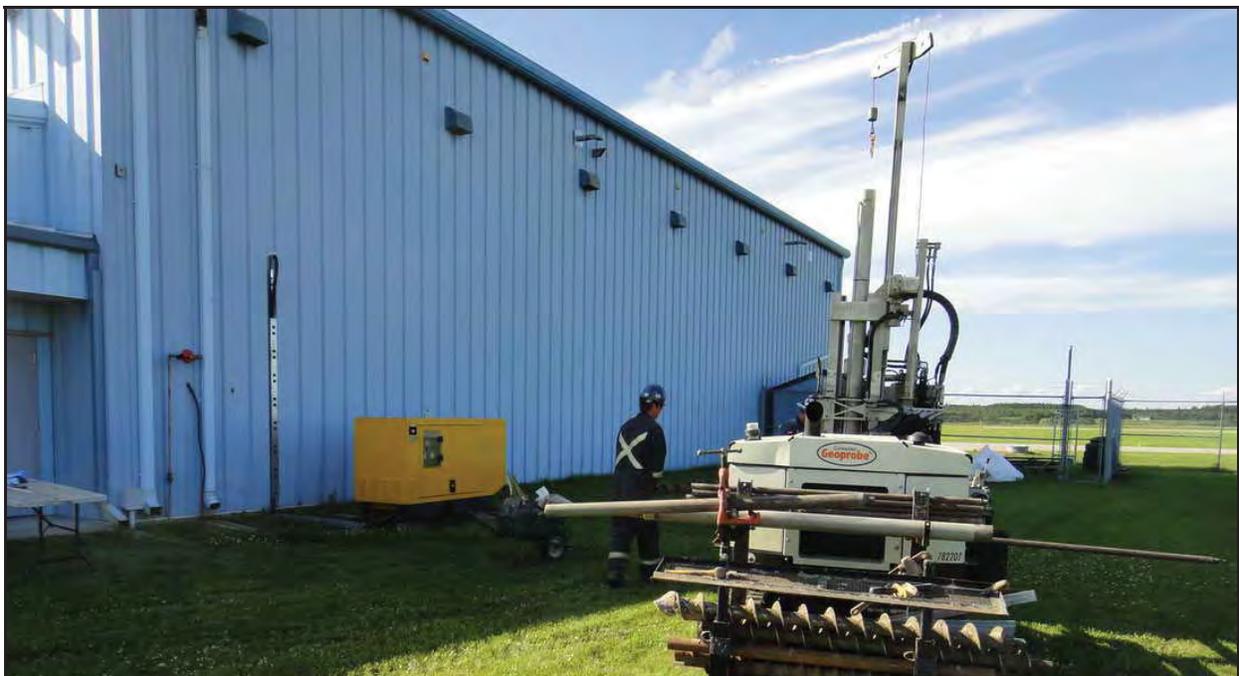
*Photo 04 - View of the east side of the RCMP Hangar looking north.
The diesel generator (yellow) on the east side of the building is also shown.*

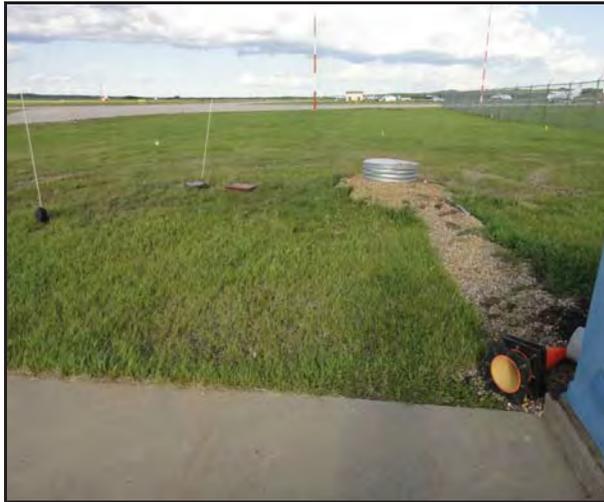
Photo 05 - UST manhole and fuel line trench leading to the fuel dispensing stand.

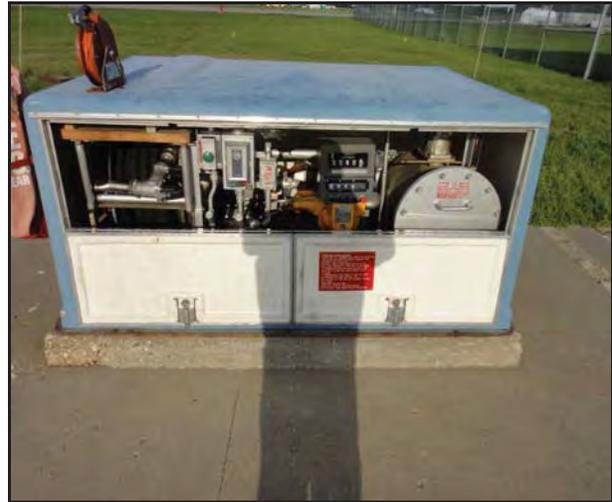
Photo 06 - Fuel dispensing stand.

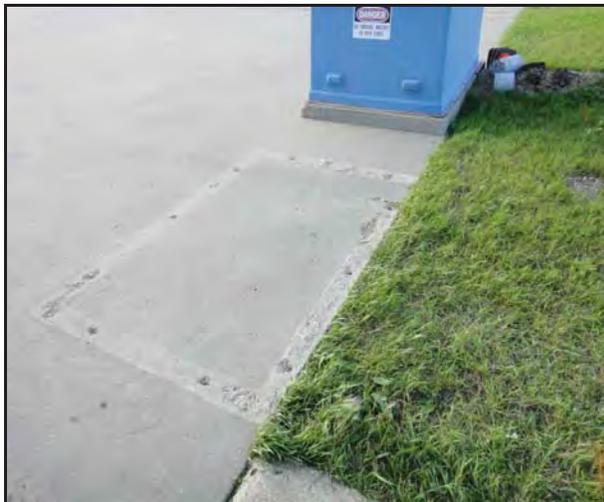
Photo 07 - Outline of former fuel dispensing stand to the south of the current stand.

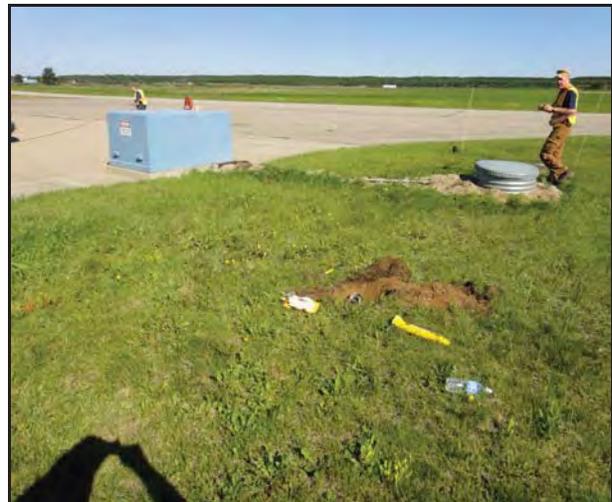
Photo 08 - View of current UST, fuel dispensing stand and existing monitoring well (MWSE).

There were no details available on the capacity, condition or contents of the suspected inactive UST, which was associated with the former fuel dispensing stand, however, the location was noted to be south of the current UST and dispensing stand. A monitoring well was observed northwest of the UST, however, there was no indication of when it was installed or details provided on the construction drawings. Based on these findings, PHH ARC recommended that a Phase II ESA be conducted at the area of the current and former USTs and fuel dispensing stand.

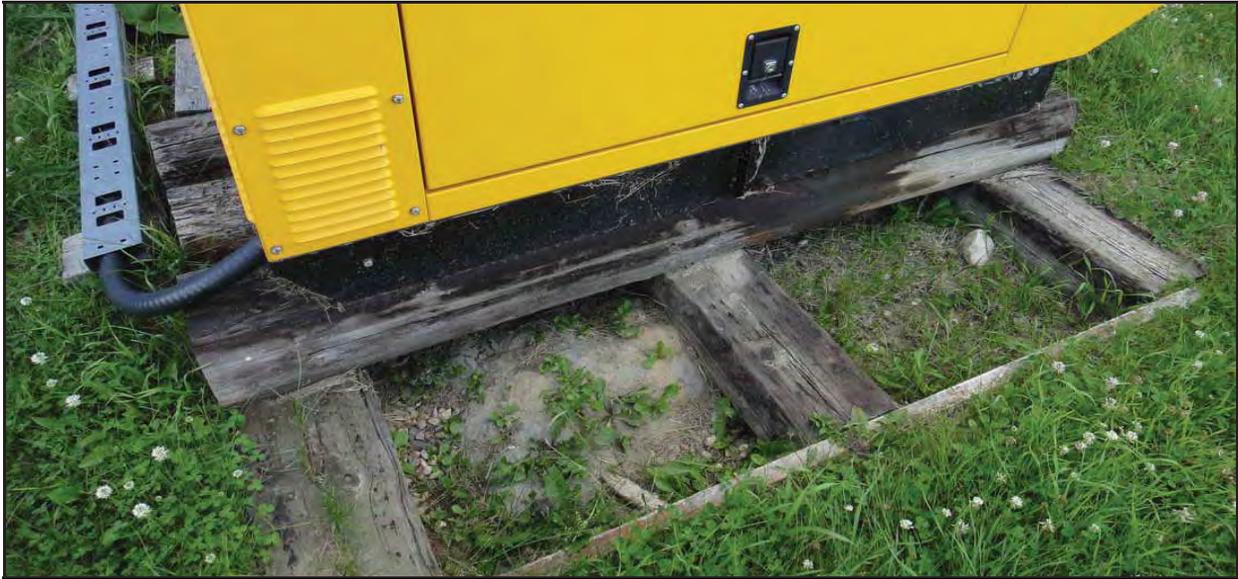
The hydrocarbon staining noted on the ground surface beneath the diesel-fired back-up generator was less than one square metre. PHH ARC recommended that secondary containment be installed beneath

Photo 09 - Stained timber cribbing and discoloured soil on the east side of the diesel generator.

the generator to mitigate the potential for further spills. There was no recommendation to conduct a subsurface investigation at the generator location.

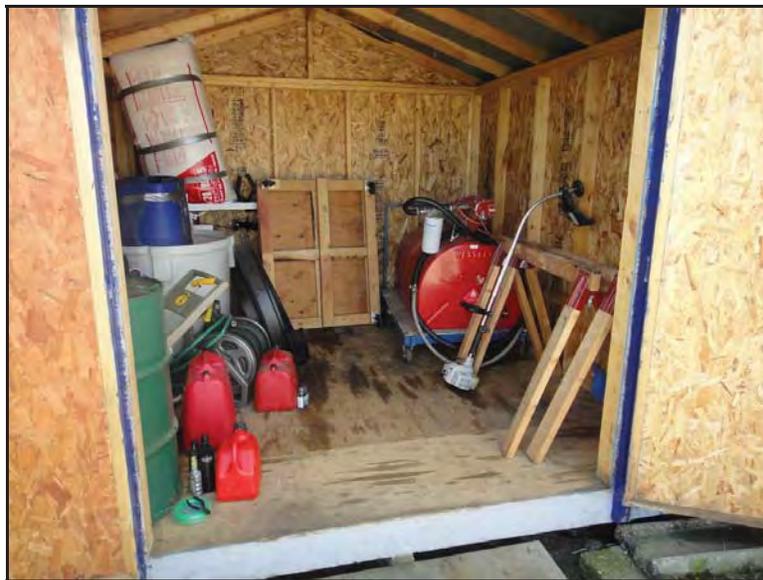
One 378 L steel single-walled AST was observed inside the storage shed on the east side of the hangar. The AST is reportedly used to collect salvageable aviation fuel from aircraft. The AST was located on a dolly for ease of movement. The storage shed has a wood floor. There was no recommendation in the Phase I ESA to conduct a subsurface investigation at the location of the storage shed.

Photo 10 - Interior of storage shed and mobile AST containing salvaged aviation fuel.

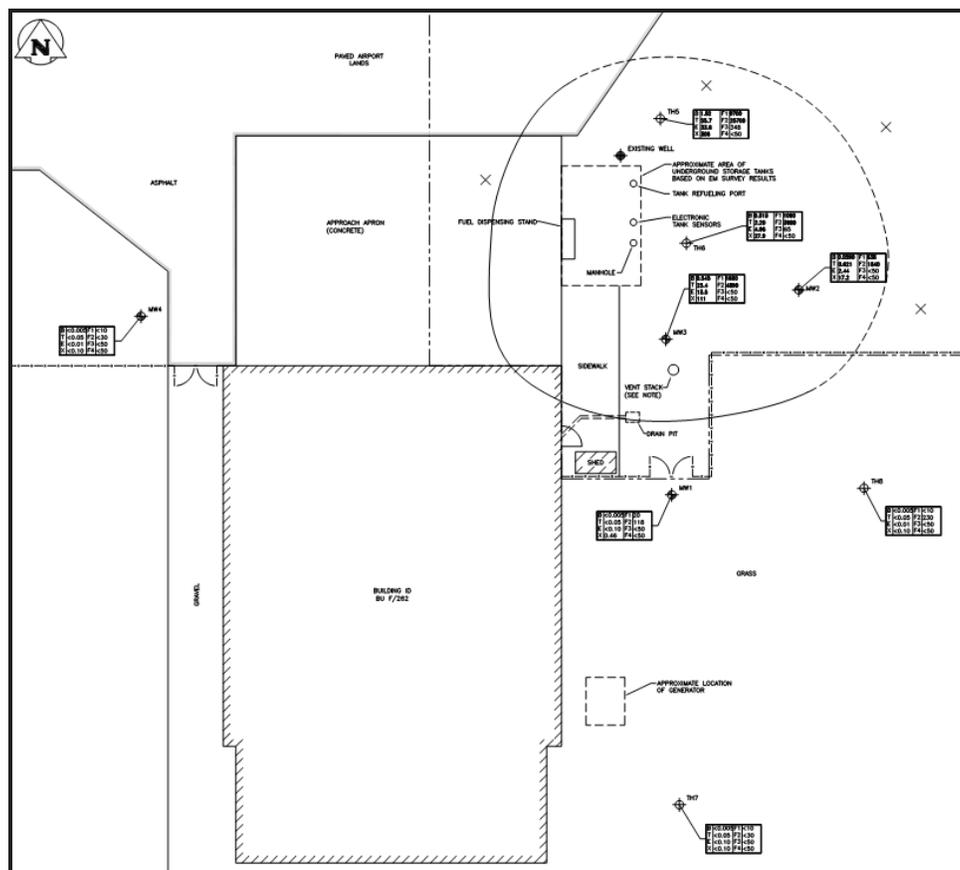
Vertical delineation of the impacted soil was not achieved, as no samples were submitted from below the impacted sand layer. Horizontal delineation was also incomplete north and east of the UST area. Therefore, the volume of impacted soil was not determined in the Phase II ESA. The location of the impacted soil was found northeast, east and southeast of the UST area. The test holes to the south and west did not report any exceedances. Plate 01 below, as taken from the Phase II ESA report, shows the location of the eight test holes and the inferred area of impacted soil.

Plate 01 - Site Plan from Phase II ESA (KGS, 2011) with test hole locations and area of impacted soil.

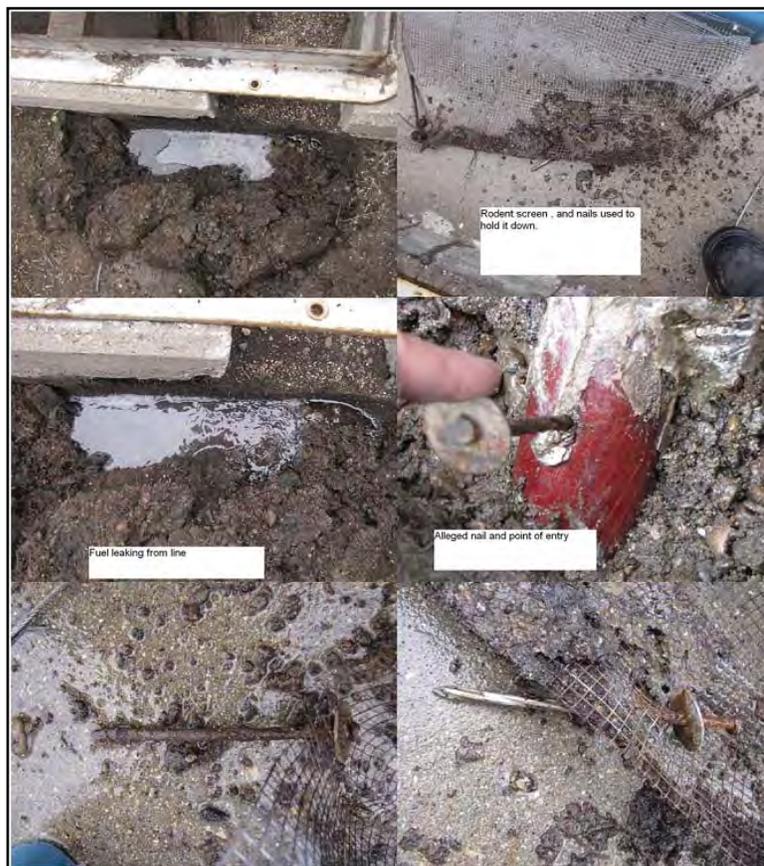
As outlined in a Leak Detection Report prepared by Cantest Solutions Inc., dated June 10, 2010 ⁽⁷⁾, a leak was identified at the bottom of the fibreglass riser pipe leading to the fuel dispensing stand, during routine testing of the lines and UST.

The leak was determined to be the result of a nail used to hold down a rodent screen, which had punctured the line. A series of photos, as included in the 2010 Leak Detection Report, are reproduced to the right, as Plate 02.

Plate 02 - Photographs taken from the 2010 Cantest Solutions Inc. - Leak Detection Report showing the nail puncture and leaking fuel line.

The line was subsequently repaired with double-walled piping in October 2010, at which time, the KGS Group also completed a soil sampling program to confirm the presence/absence of any subsurface hydrocarbon impacts from the leaking UST fuel piping that was being replaced ⁽⁸⁾. The KGS Group collected six shallow soil samples, S1 through S6, from the excavated trench where the leaking fuel pipe had been removed and replaced. Each of the samples were collected from a depth of 0.5 m below ground and were collected from between the UST access manhole and the concrete apron near the fuel dispensing stand. There was no estimate provided regarding how long the leak had occurred or how much fuel had been lost. Reconciled tank dip measurements were not available for review by the KGS Group.

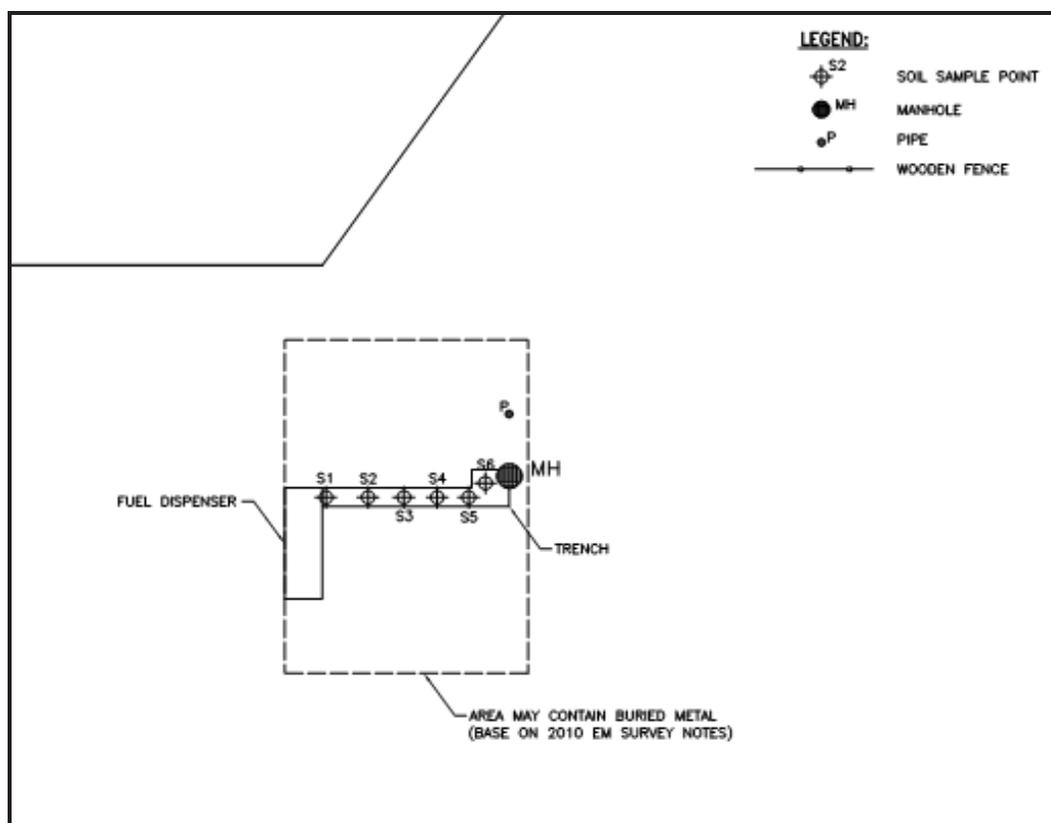
Three of the six samples, S1, S2 and S3, the three samples closest to the leak source at the fuel dispensing stand, reported PHC F2 Fraction exceedances of the CCME CWS. The sample closest to the leak, S1, also exceeded the CCME CEQG for xylenes and the CCME CWS for the PHC F1 Fraction. Plate 03 below, taken from the fuel line investigation report by the KGS Group, shows the sample locations.

Plate 03 - Site Plan from the Fuel Line Investigation report (KGS, 2011) showing sample locations.

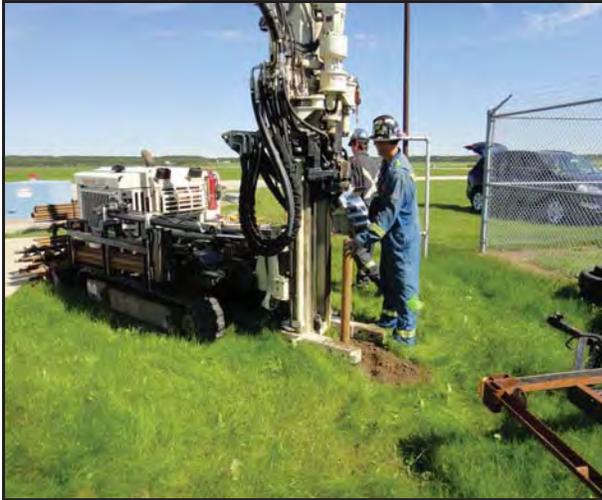
Photo 15 - View looking northeast at PA-04.

drilled to a depth of 2.25 m below ground. Test holes PA-02 and PA-04 were completed as deeper nested well installations, adjacent to test holes PA-01 and PA-03, respectively. Test holes PA-15 and PA-16 were completed adjacent to the diesel generator, which is located on the east side of the hangar, and were completed as shallow installations to assess the near surface soil quality in this area of the site. Representative photos of the drilling activities are shown below in Photos 15 and 16.

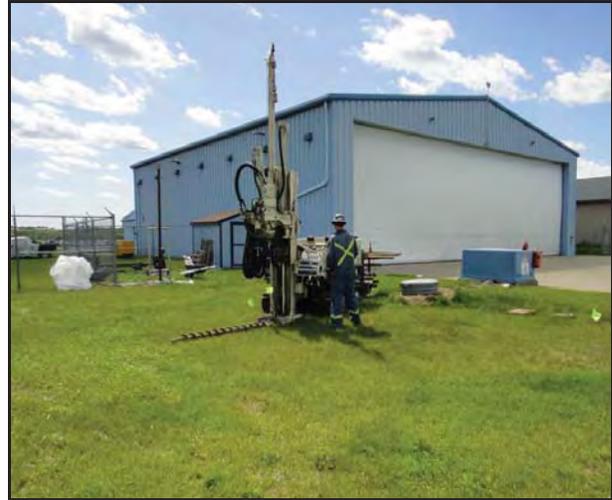
Photo 16 - View looking southwest at PA-01/02.

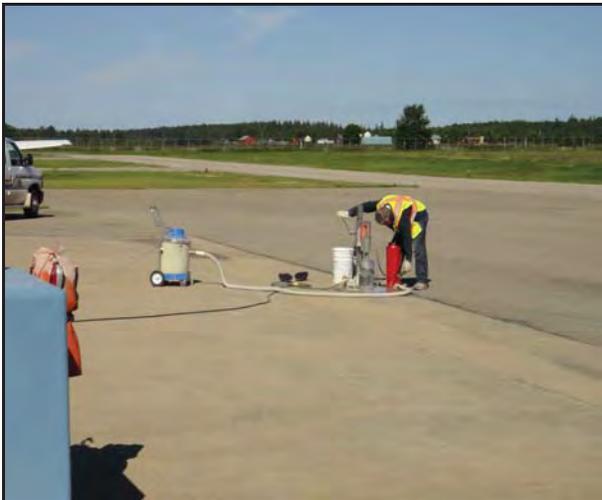
Photo 17 - Concrete coring at test hole PA-09 located north of the RCMP Hangar.

Coring was completed at test holes PA-09 and PA-10, which were located north of the hangar and within the concrete apron, and at test hole PA-11, which was located in the asphalt pavement at the southwest corner of the building. Representative photos of the coring are shown below in Photos 17 and 18.

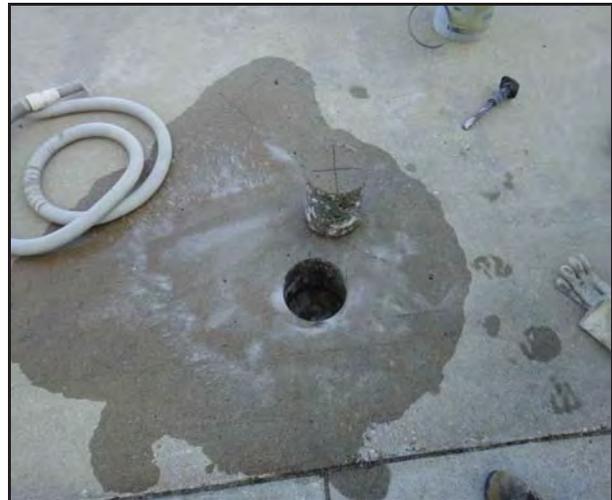
Photo 18 - Concrete core from test hole PA-10 located north of the RCMP Hangar.

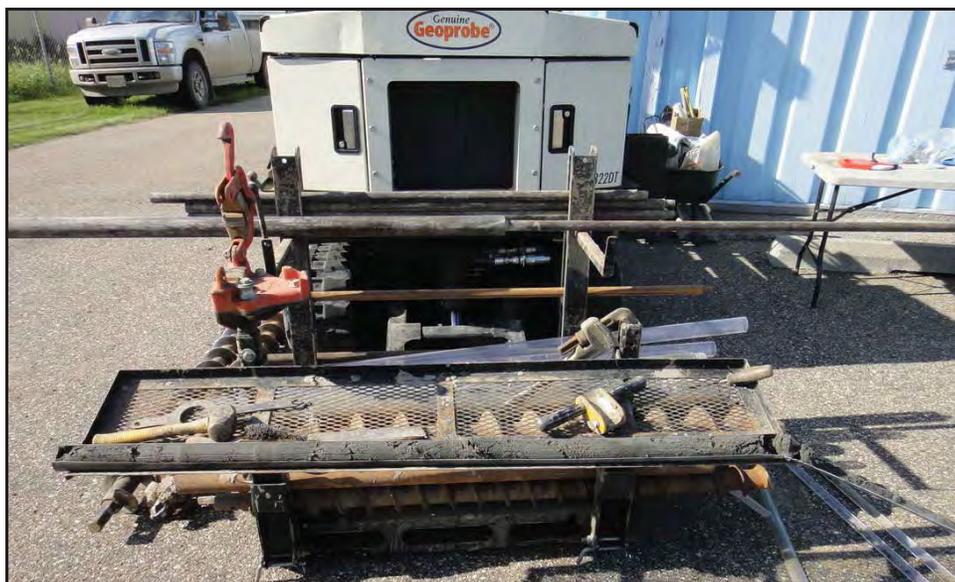
Photo 19 - Drill core tube extractor equipment and soil core ready for sampling.

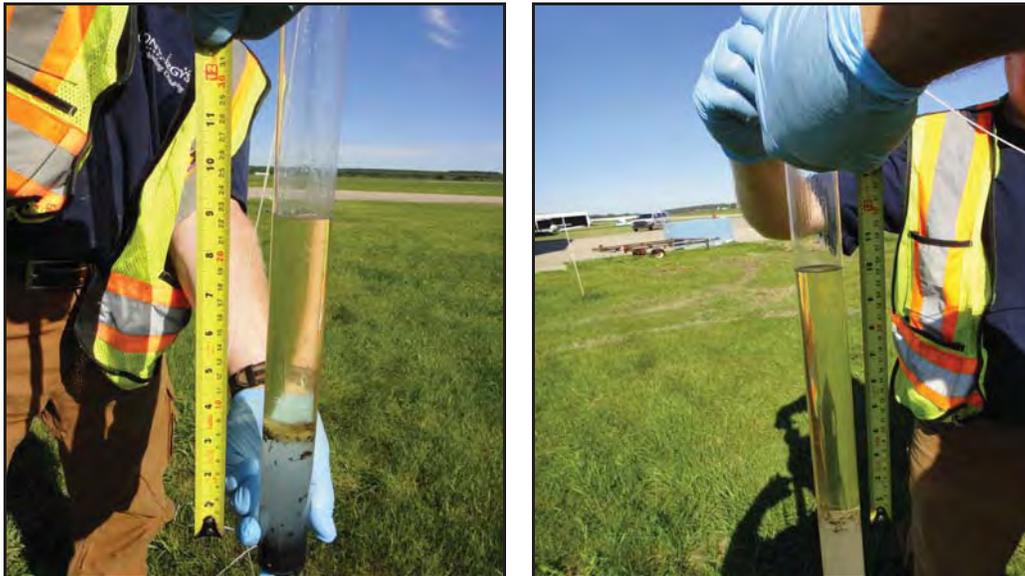
Photos 20 and 21 - LNAPL removed from monitoring wells by bailer.

Based on the presence of LNAPL on the property, immediate action is required to address the recovery of LNAPL before options can be considered for remediation or risk management of the impacted soil and groundwater. To facilitate removal of the LNAPL, it is recommended to install a minimum of two large diameter recovery wells in the central area of the LNAPL plume. These large diameter recovery wells should be at least 0.75 m in diameter and should be screened over the area of impact, from 3.0 to 4.5 m below ground. The LNAPL can then be pumped directly from the recovery wells, via a manual or automated pumping system, into temporary drums or an AST. Due to the volume of LNAPL present on site, manual bailing is not considered viable. The rate of LNAPL recovery should be monitored on a regular basis and the program adjusted, as required, to maximize the rate of recovery.

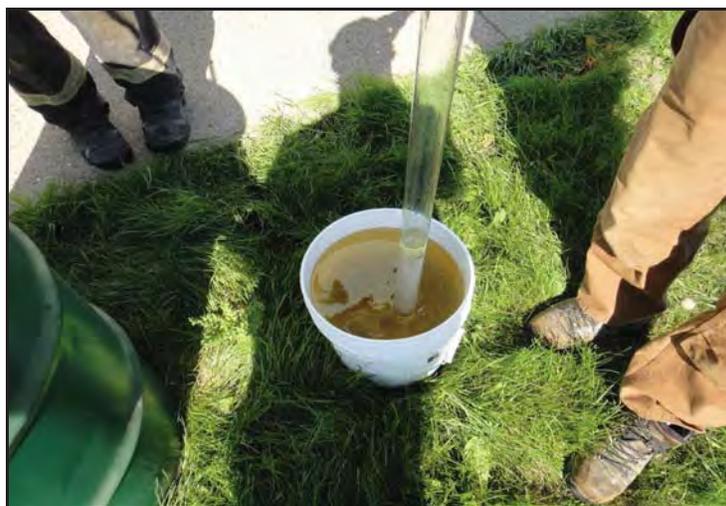
Photo 22 - Disposal of LNAPL into pail for transfer and storage in an on-site 220 litre drum.

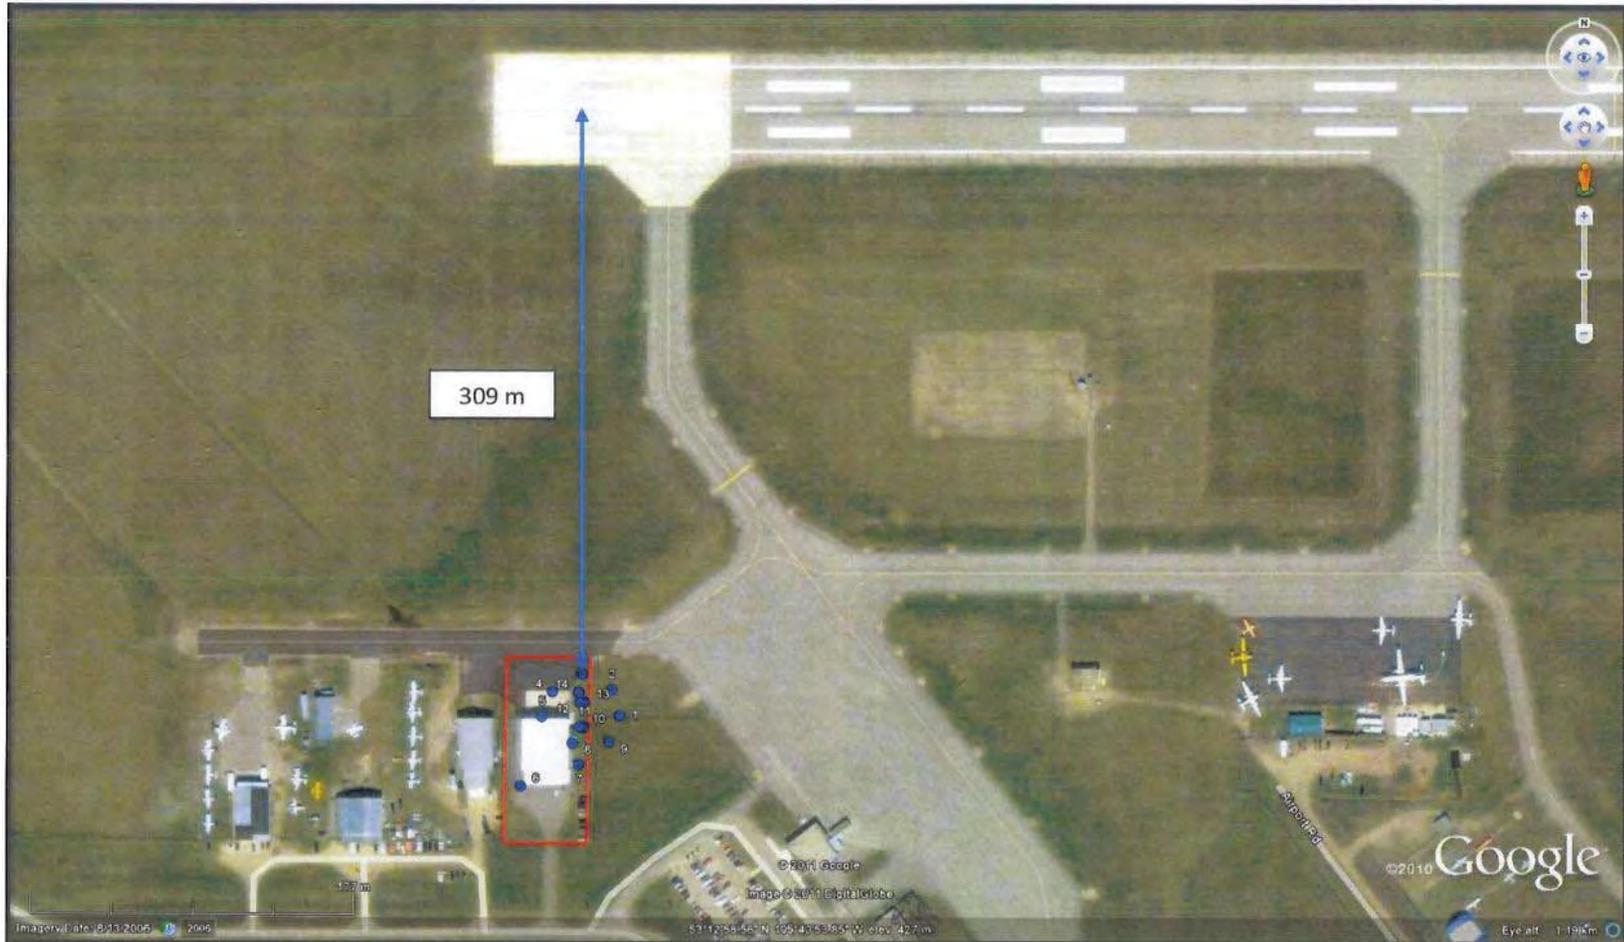
Distance from closest test hole to centreline of runway = 309 m.

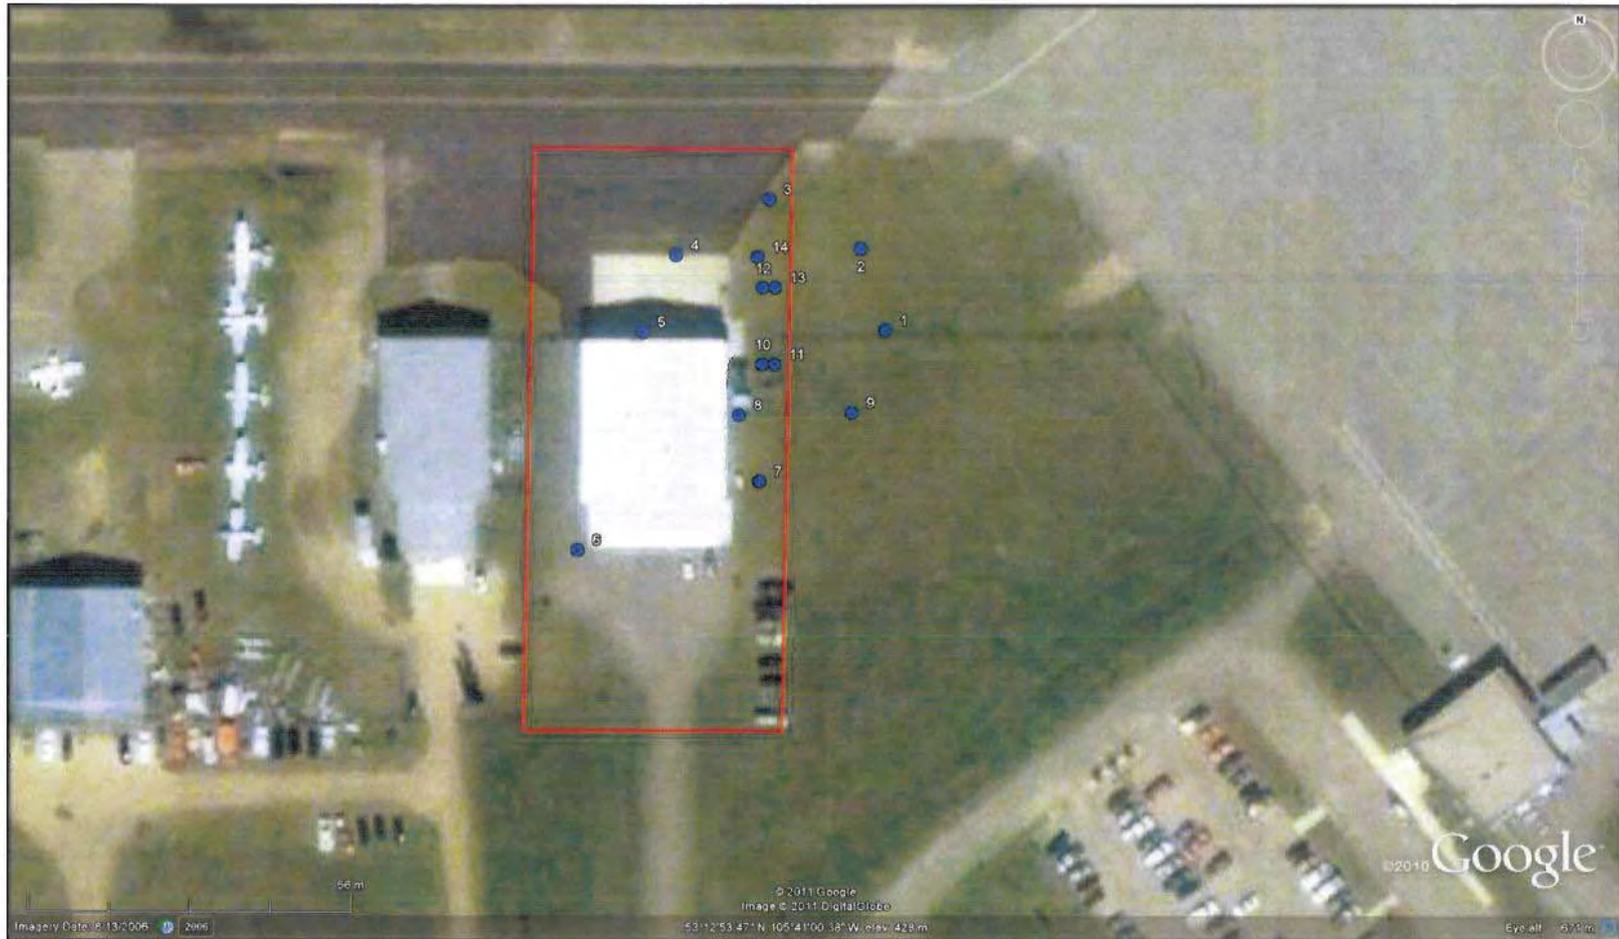
Test hole location plan. Three test holes to be located east of RCMP property (red box).

310 metres between
closest test hole (3) and
centreline of runway

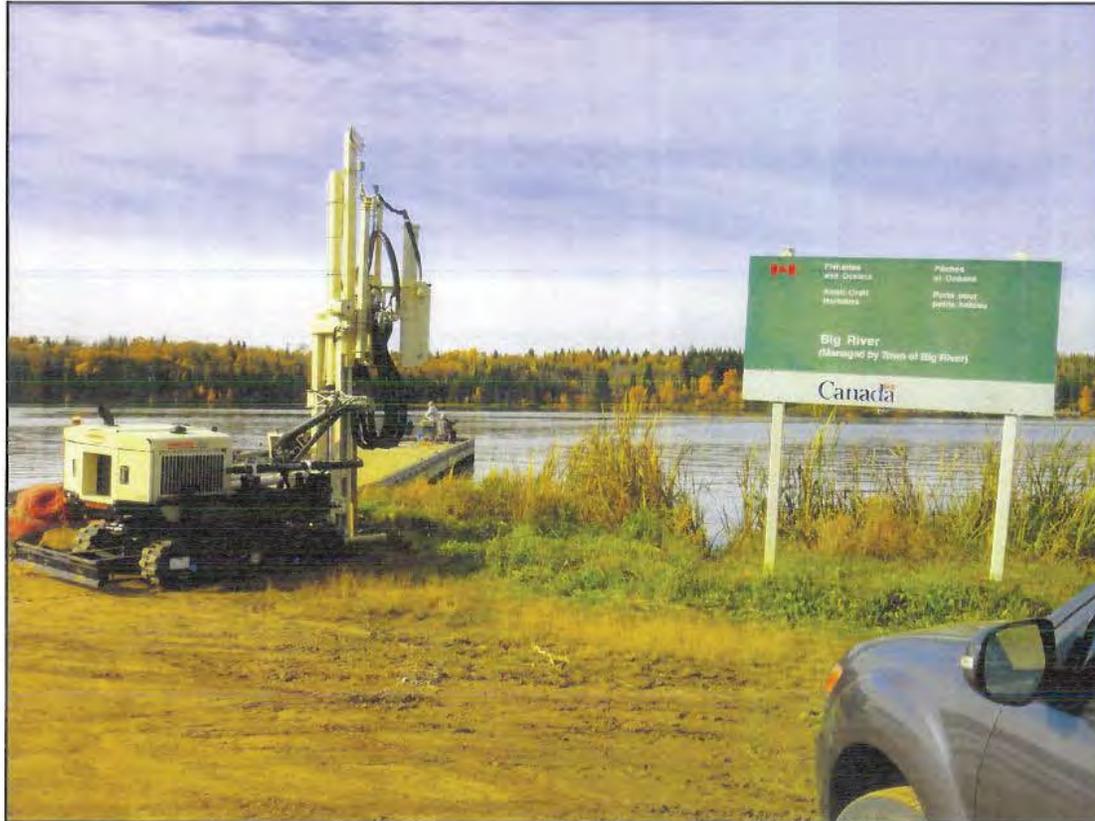
Photo of drill rig to be used at RCMP Prince Albert Hangar site investigation. Maximum boom height is 4.27 m (14 feet).

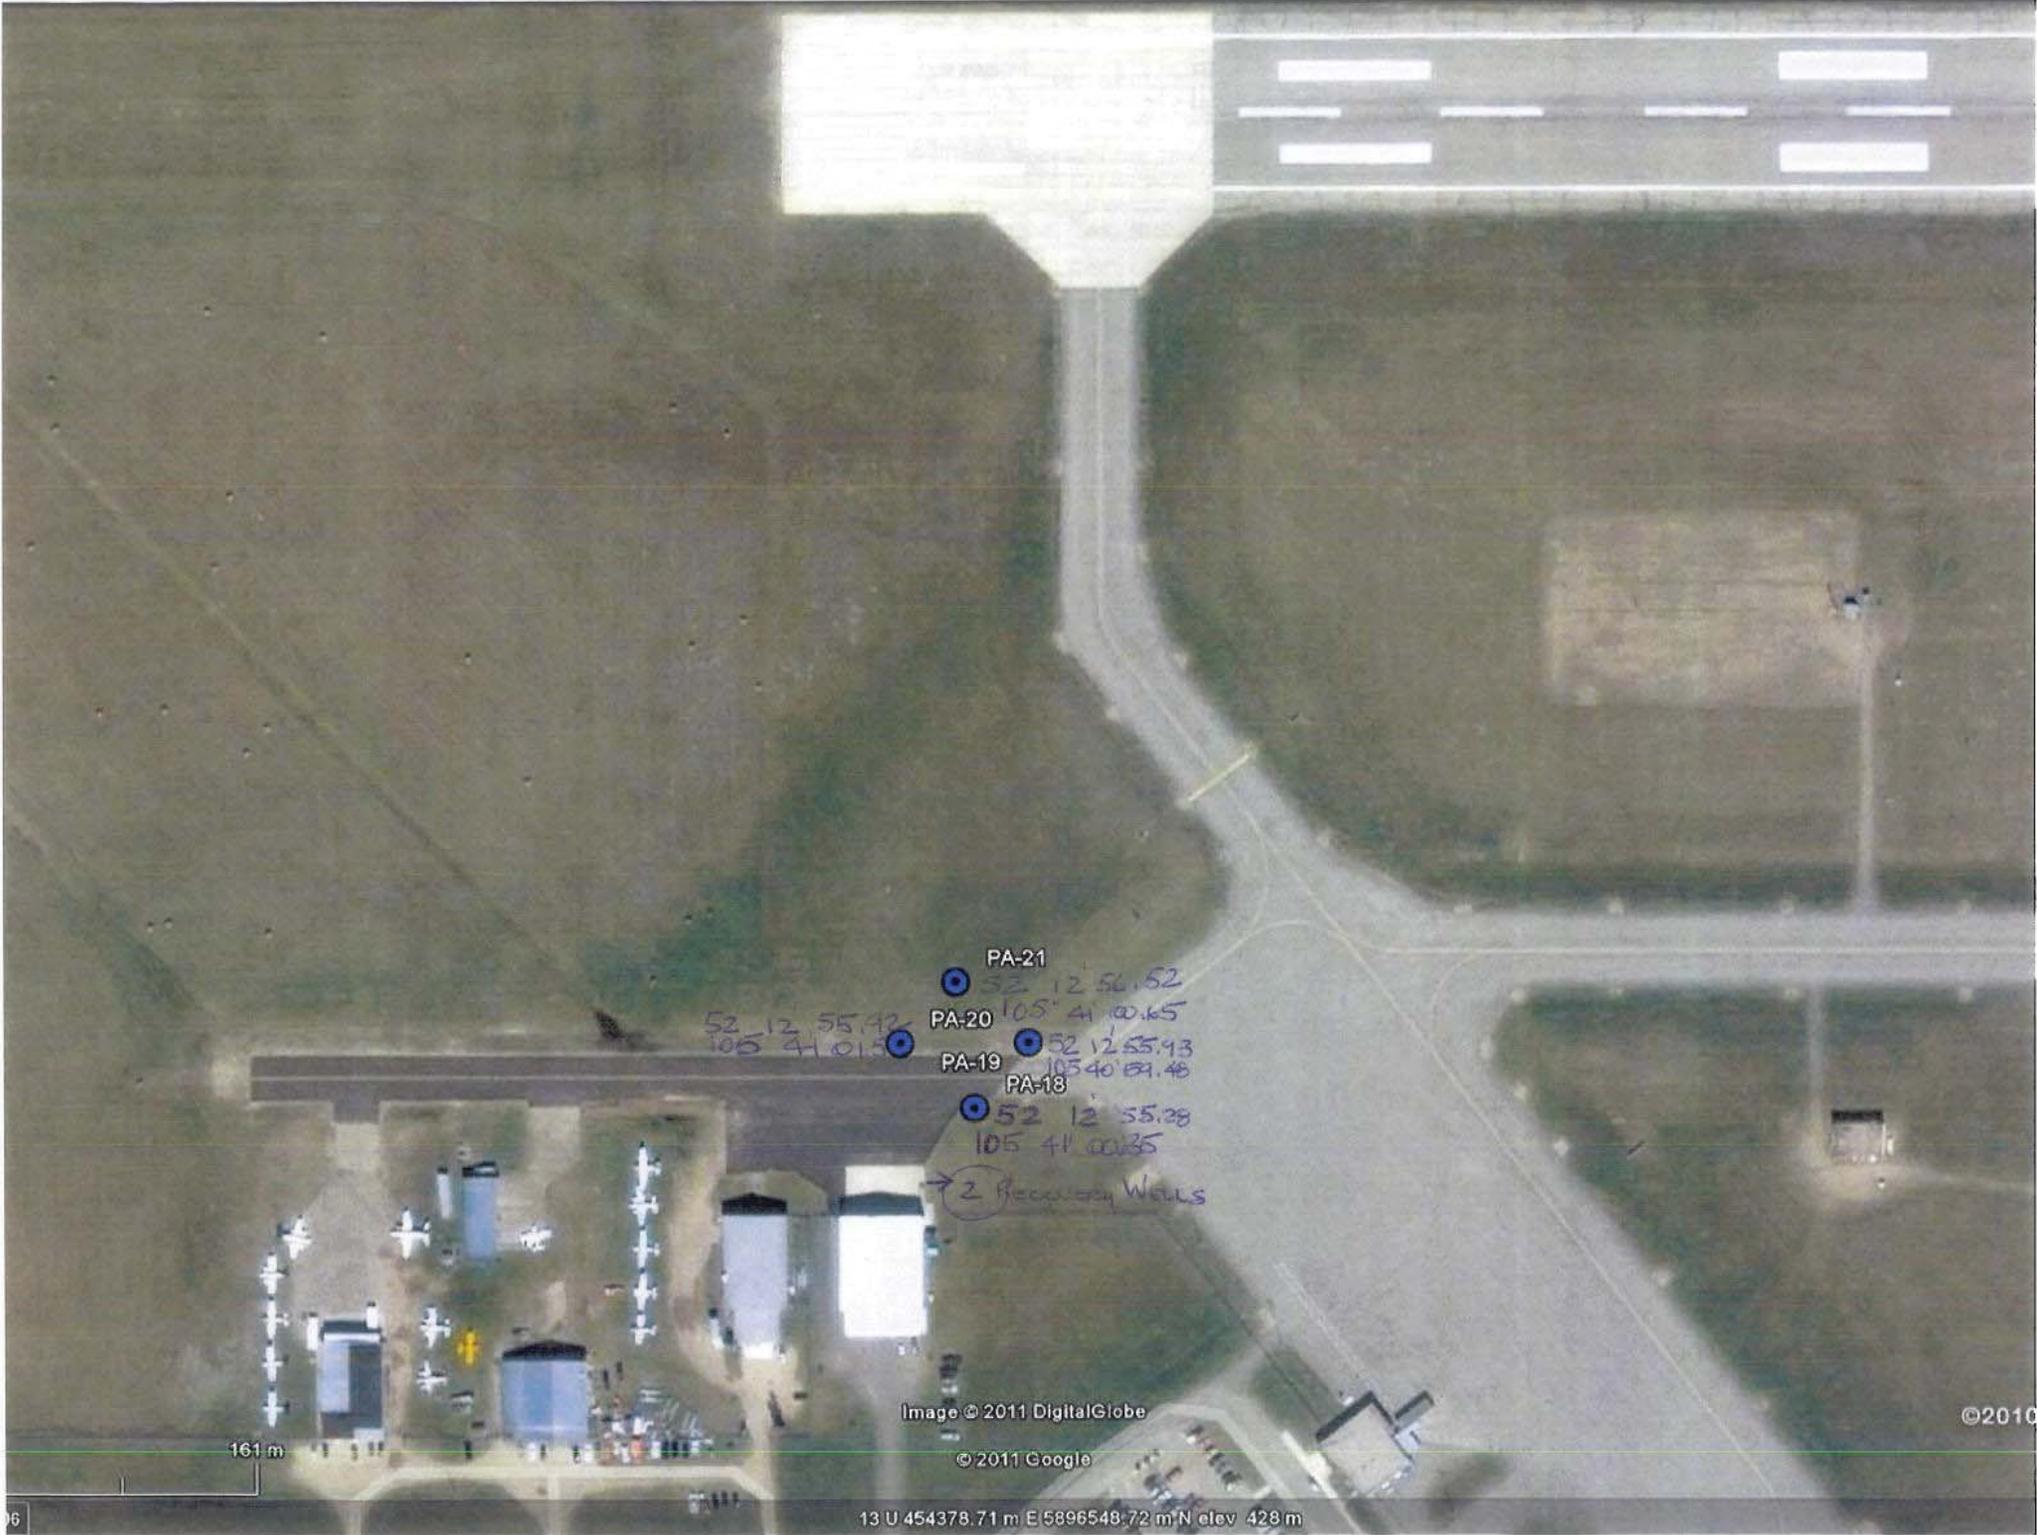
We have added two large diameter recovery wells within the area already approved for work in August. The coordinates are:

PA-21 52 12 56.52
 105 41 00.65
 PA-20 52 12 55.93
 105 40 89.48
 PA-19 PA-18
 52 12 55.38
 105 41 00.35
 → 2 Recovery Wells
