# **Geotechnical Survey and Utilities Capacity Study**

**PWGSC Reference: R.058448.002**

**DATE: FEBRUARY 26, 2013**

The geotechnical investigation was conducted to provide foundation recommendations for a future greenhouse and header house at the Morden Research Centre. A total of eight (8) testholes were drilled on the project site on November 15, 2012. The general soil stratigraphy at the site, as interpreted from the testhole logs, consists of topsoil, silty clay, sand, silt, and clay to the depths explored in the testholes. Based on the soil and groundwater conditions encountered at the testhole locations, timber or precast concrete friction piles could be used to support the structures.

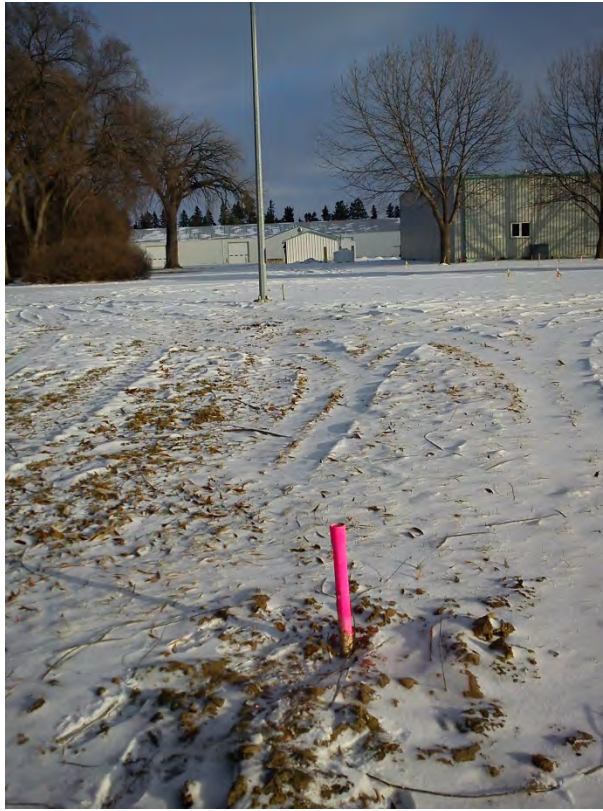
**Photo 3 - Standpipe piezometer installed in Testhole TH 04**

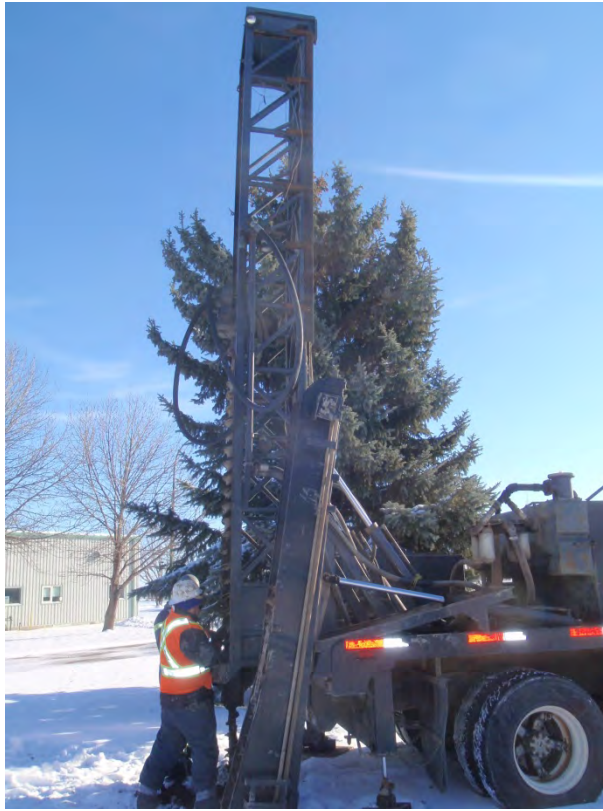
**Photo 4 - Drilling Testhole TH 08**

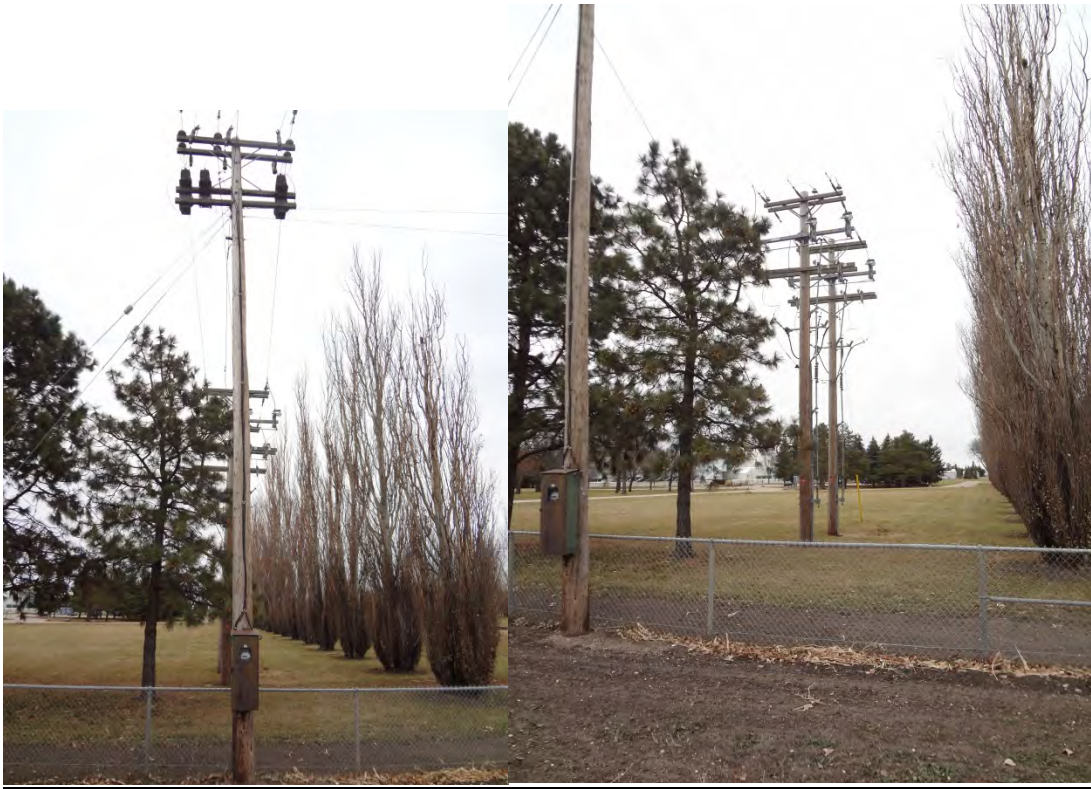
**Photo 5 - Electrical main service entrance**

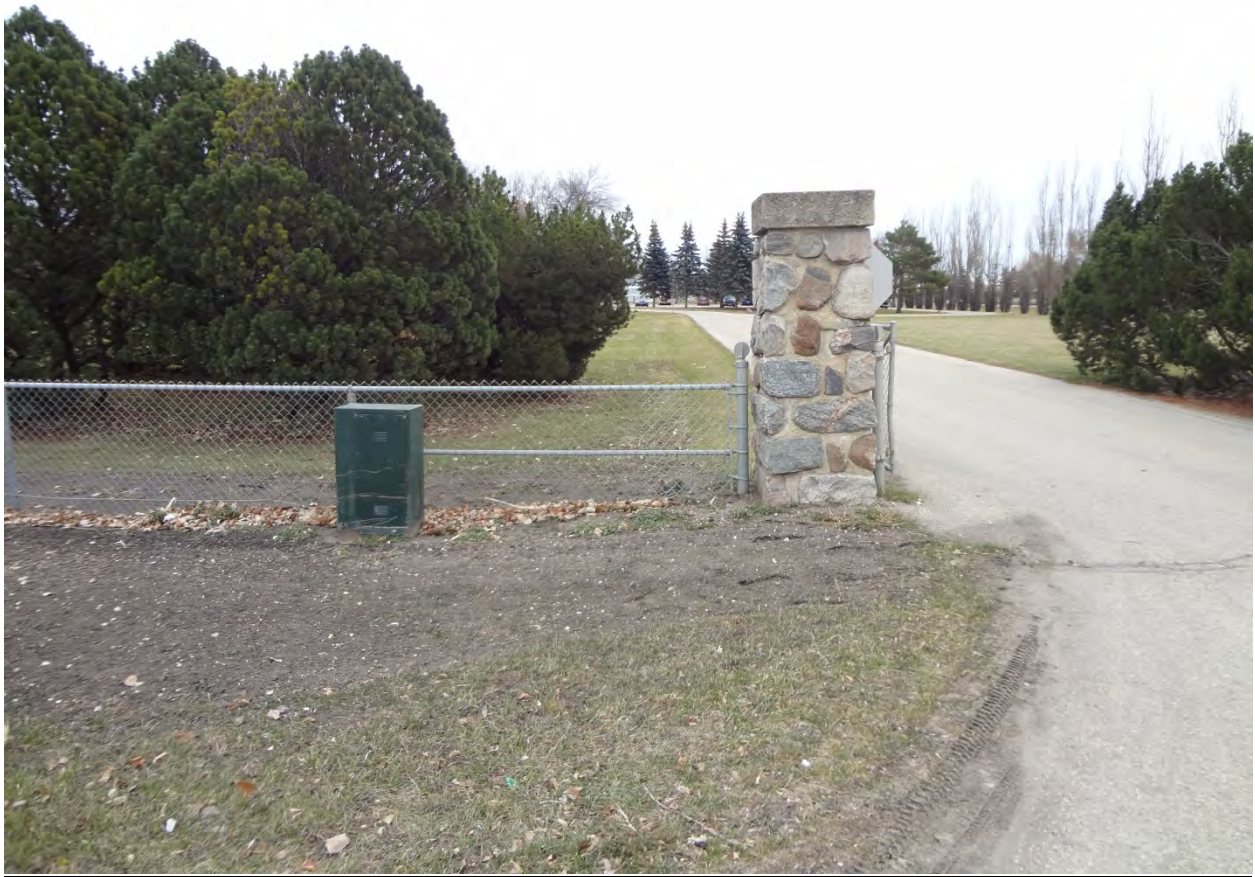
**Photo – 6 Telephone main service entrance**

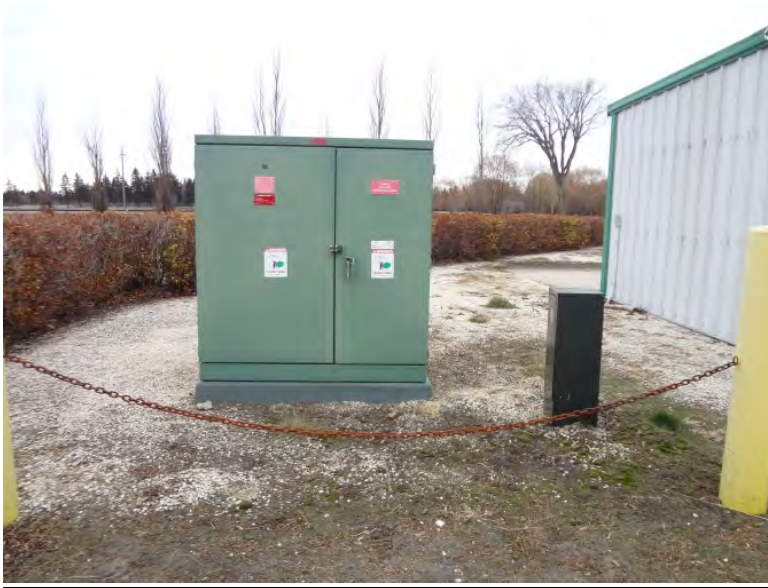
All of the customer-owned transformers, complete with their associated primary and secondary conductors, were installed in the year 2003 and appear to be in good condition.

**Photo – 7 Transformer TR#1 – 750Kva 12470-347/600V**

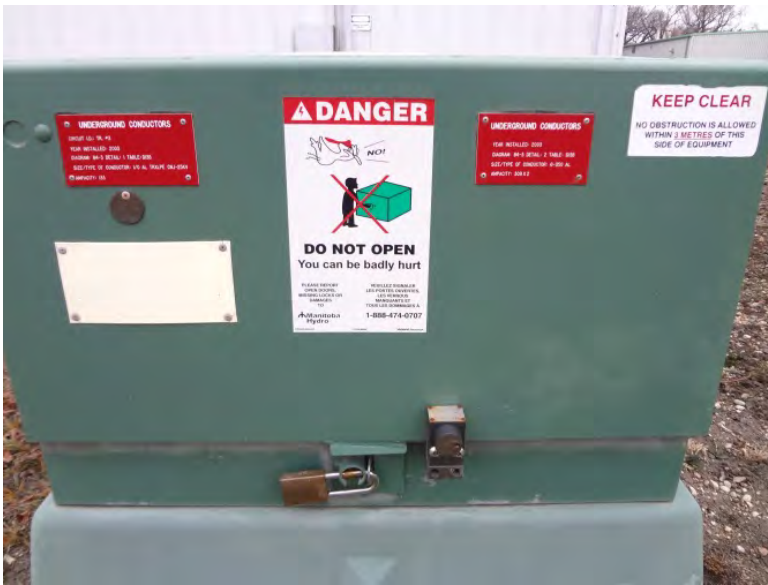
**Photo – 8 Transformer TR#2 – 300Kva 12470-347/600V**

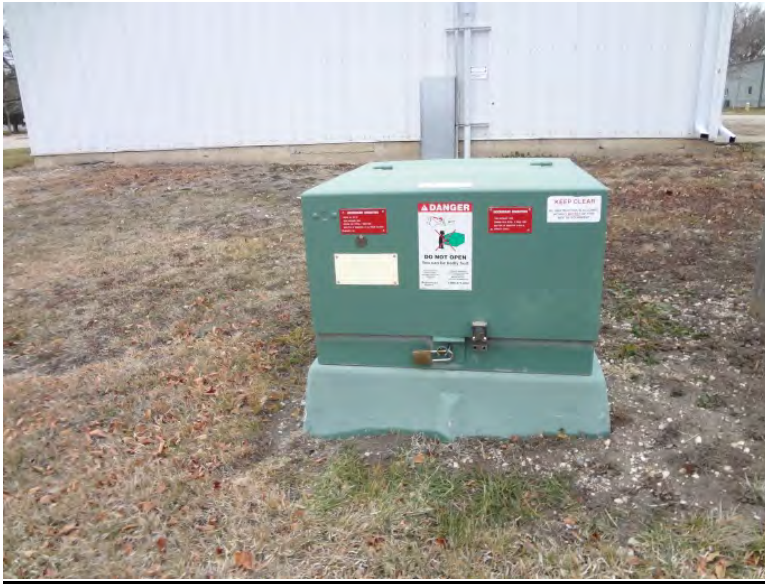
**Photo – 9 Transformer TR#4 – 50Kva 7200-347/600V (Identical to transformer TR#3)**
