APPENDIX E

Soil Treatment Facility Detail

PROJECT LOCATION:
Stringer Creek Soil Treatment Facility
Alaska Highway, BC

CLIENT NAME: PUBLIC WORKS AND GOVERNMENT SERVICES CANADA
PROJECT LOCATION: STRINGER CREEK GRAVEL PIT, KM 638.7 ALASKA HIGHWAY, B.C.
TITLE: SITE PLAN - STRINGER CREEK STF

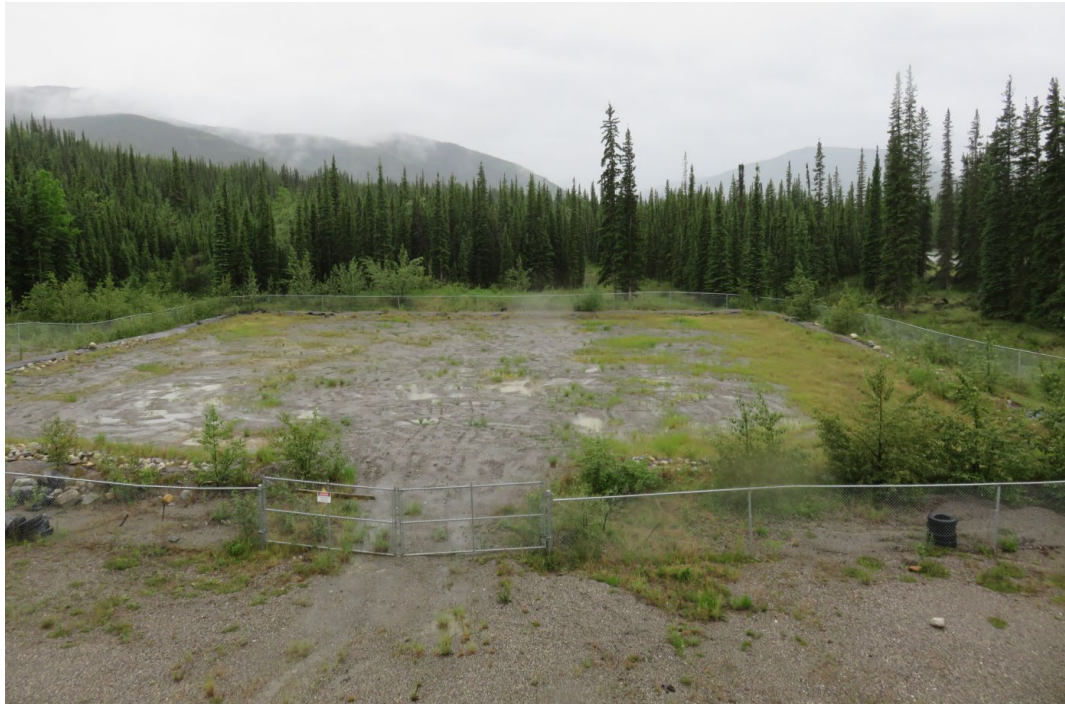
Photograph 1: View looking southwest at existing STF. Note gate and earthen ramp in foreground. Note shrubs growing along fenceline and along berms.

- 2) Any shrubs, trees or other vegetation within the fence line or directly outside and adjacent to the existing fence of the STF will require removal. All necessary precautions are to be taken to avoid further damage to the liner during the vegetation removal. A Departmental Representative must be advised of and provided an opportunity to inspection the liner during and following any vegetation removal in close proximity of the liner or within the liner footprint area.

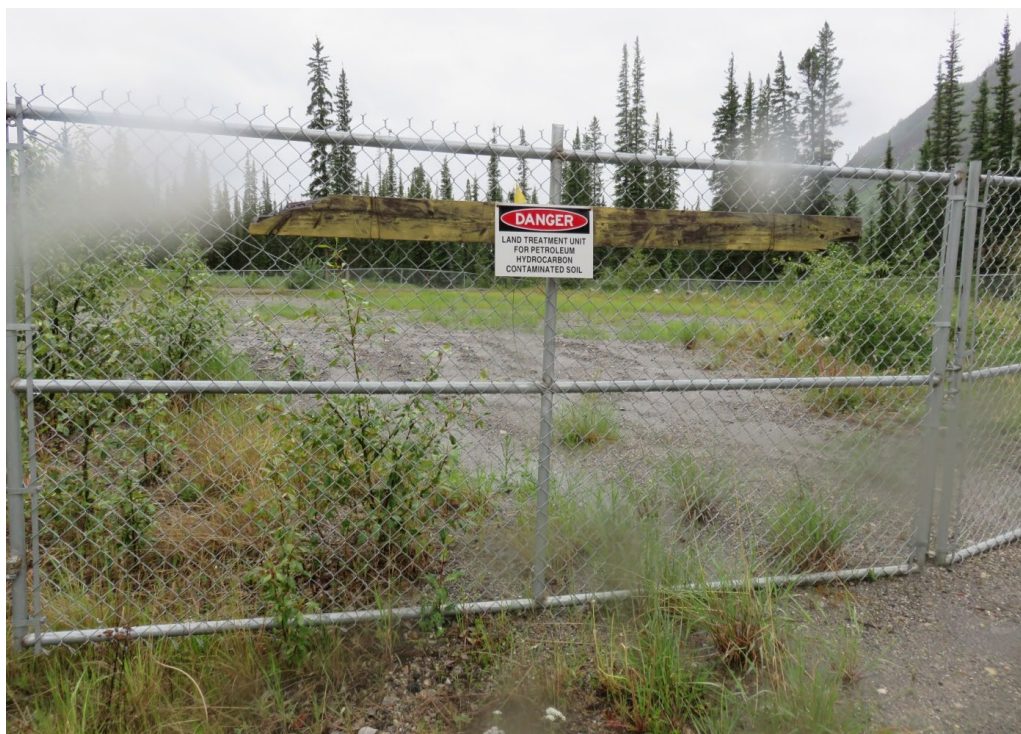
Photograph 2: View looking southwest of STF gate and earthen ramp. Note existing signage.

The existing STF appears to have a synthetic base liner and has an effective surface area of 40 m x 40 m. It is surrounded by berms with an approximate height ranging between 0.5 m to 1 m. The STF is located within a fenced compound with a lockable gate and signage at its east side. An earthen ramp extends from the top of the berm through the gate to the east and provides access to the STF for heavy equipment.

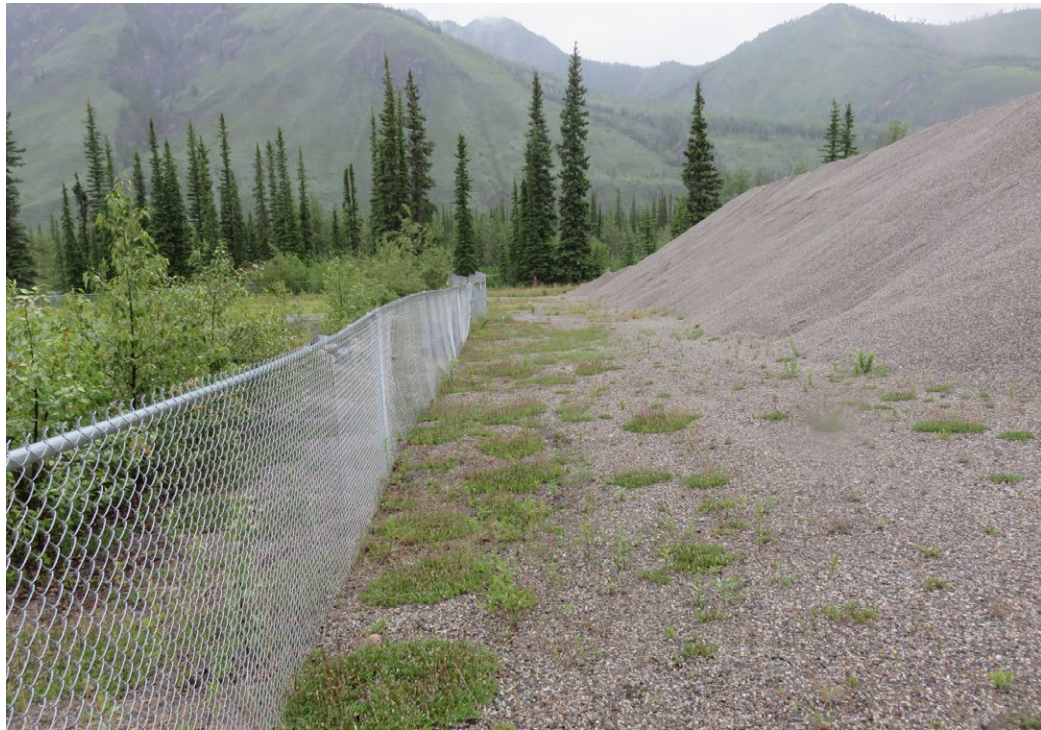
Photograph 3: View of looking northwest along northeast STF fenceline. Note gravel pile in photograph right.

- 5) Access constraints to the STF for heavy equipment and soil staging from Toad River must be considered and confirmed by the Contractor. Note that existing gravel piles located adjacent to the SFT will not be relocated.

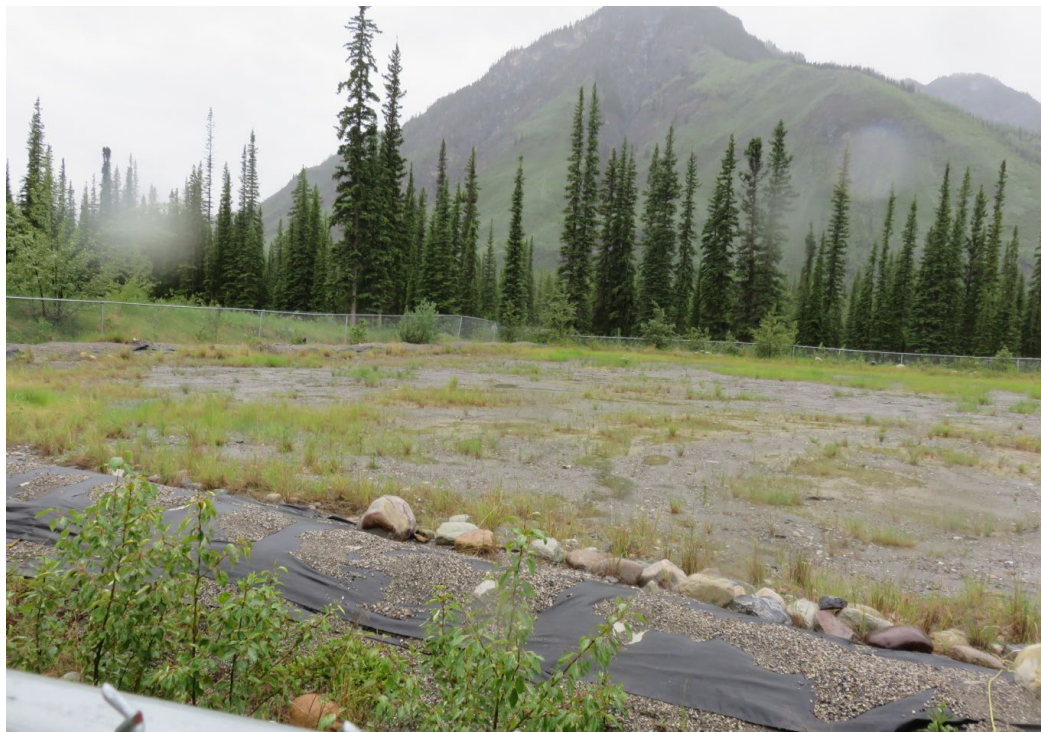
Photograph 4: View looking west across STF.

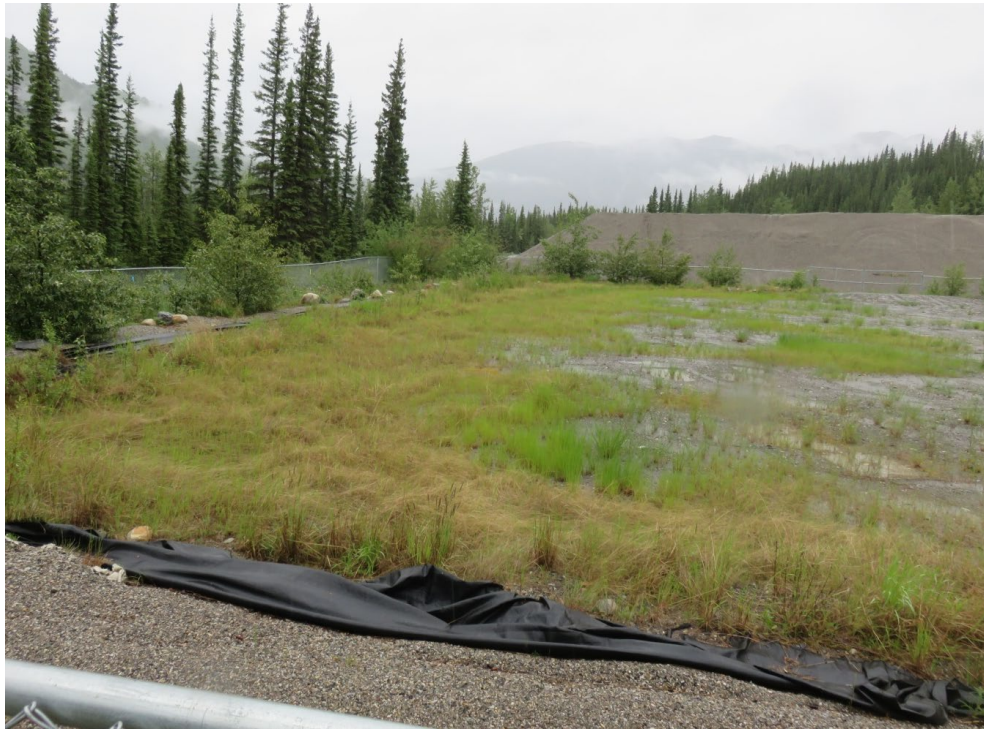
Photograph 5: View looking northeast of STF from west corner.

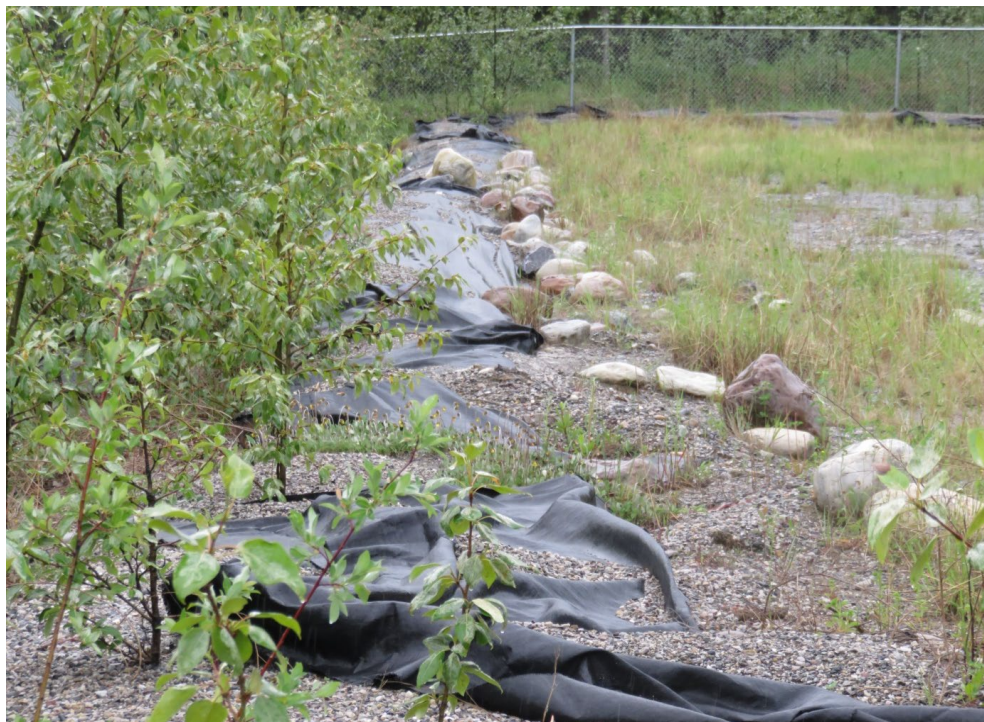
Photograph 6: View of typical berm construction at STF. Exposed liner on berm is woven material, and may extend below STF.

- 3) The contractor is to inspect and repair the existing liner (e.g., patching) as required for any holes, tears or rips in the existing liner (as identified by a Departmental Representative or the Contractor) prior to placement of soil any additional within the STF. A Departmental Representative must be advised of and provided an opportunity to inspection any liner repairs prior to use of the STF for receiving soil.

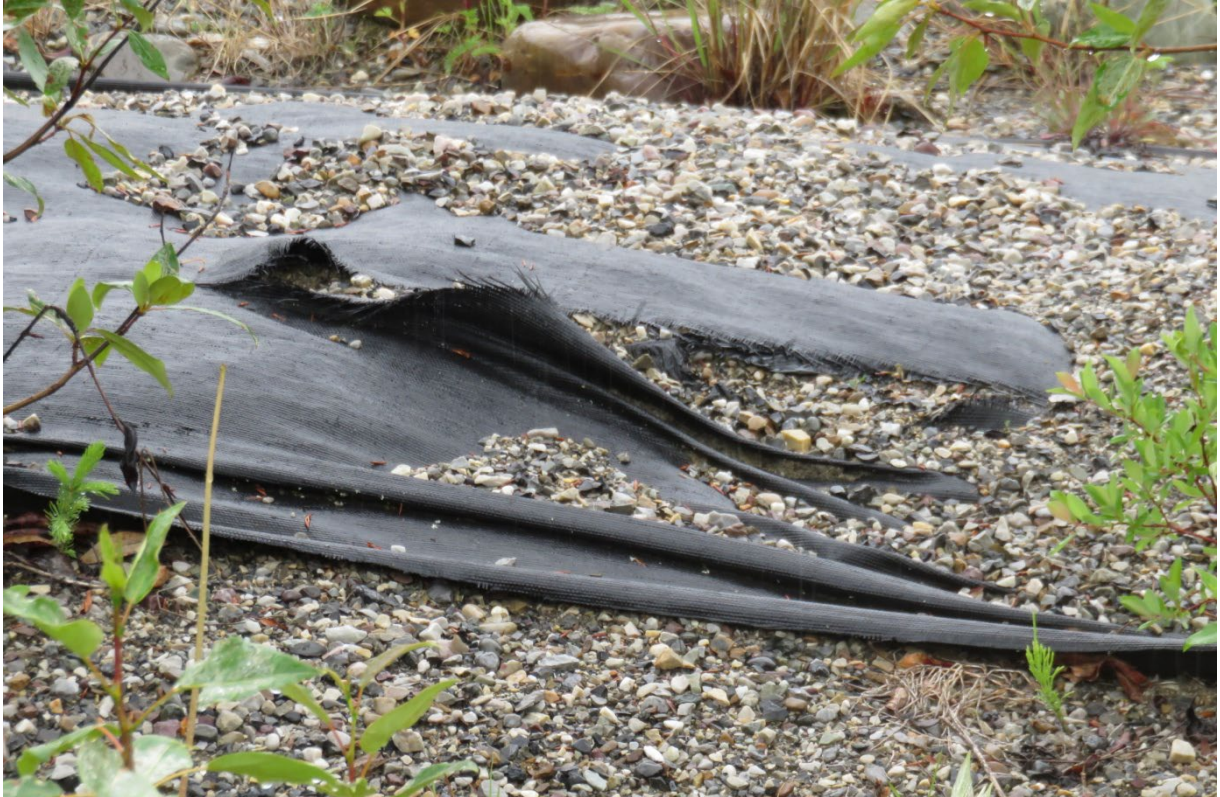
Photograph 7: Close up of suspect (woven) liner.
