ISSUED FOR TENDER

Parks Canada Agency
 763 - Waterton Boundary Fence Rehabilitation
Fence Access Routes

Boundary Fence Rehabilitation Project
 Location: Waterton Lakes National Park, AB

Environmental Alignment Sheet

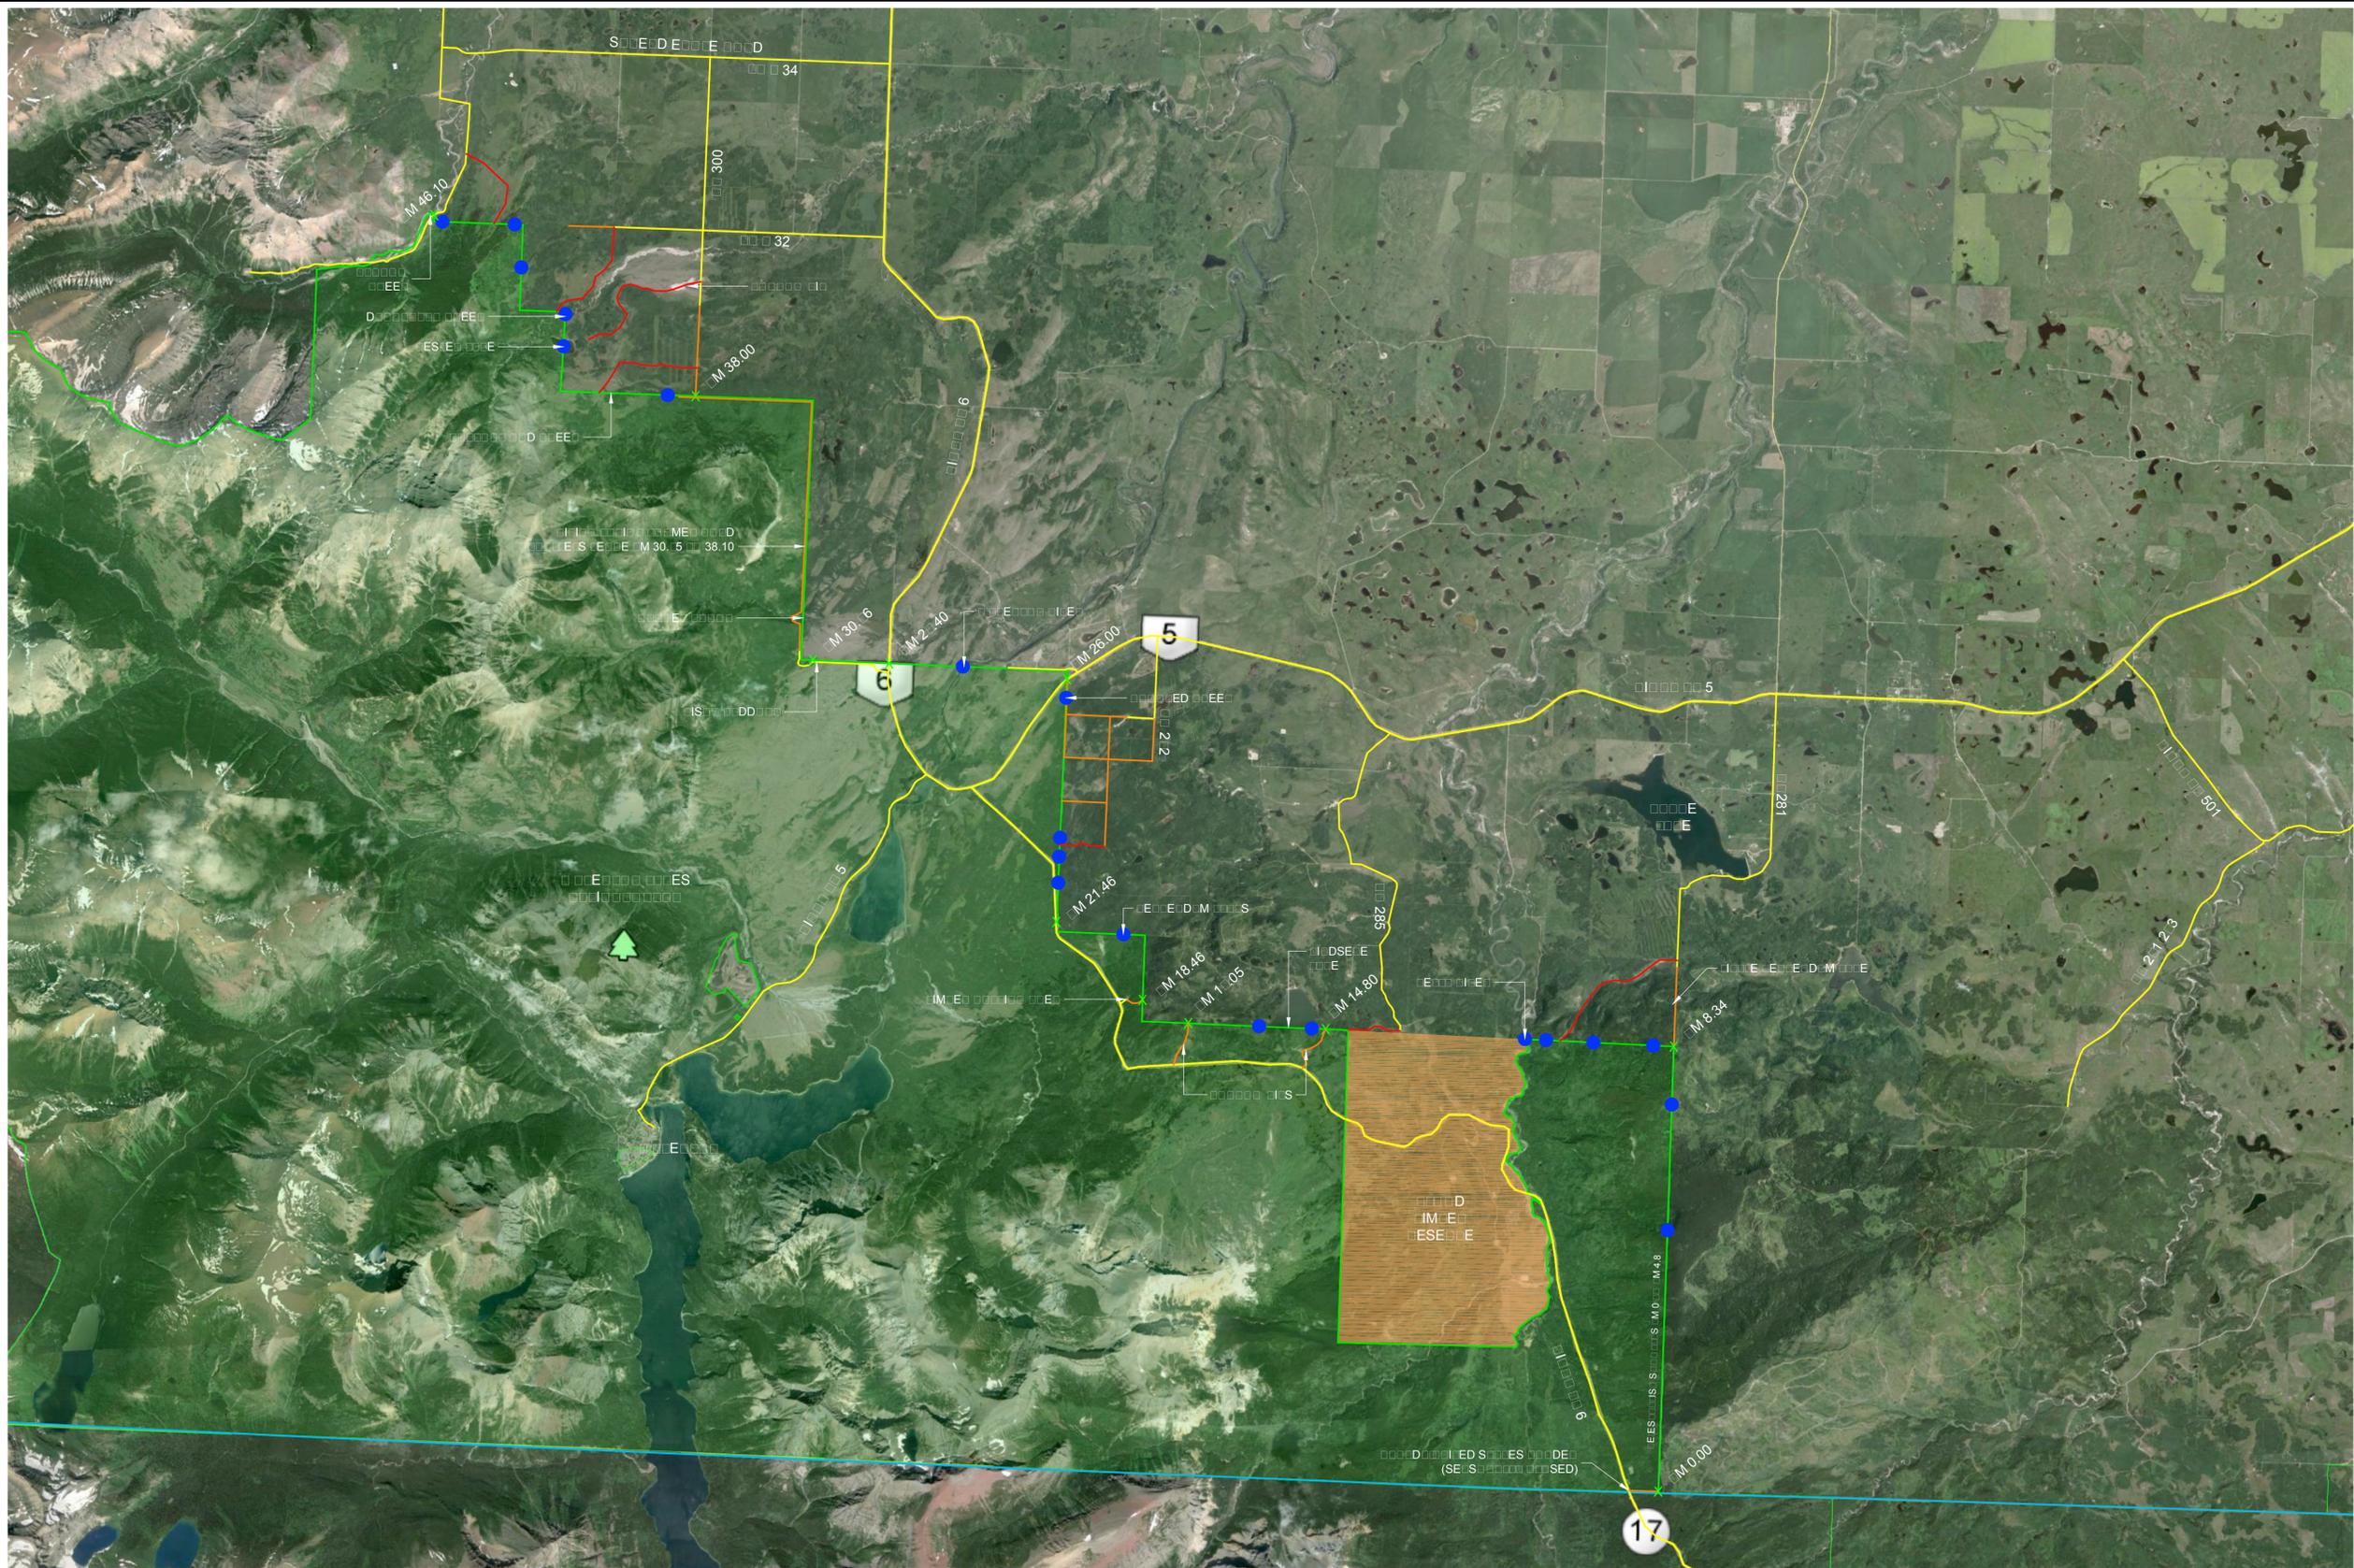
AECOM Project # 60485867
G0001

THIS DRAWING IS FOR ILLUSTRATIVE PURPOSES ONLY, AND HAS BEEN PREPARED BASED ON PUBLICLY AVAILABLE INFORMATION.

ROUTES AS SHOWN ARE CONTINGENT ON MAKING APPROPRIATE ARRANGEMENTS WITH LAND OWNERS, ROAD AUTHORITIES, AND OTHER GOVERNING BODIES AS APPLICABLE. SOME ROUTES AS SHOWN MAY NOT BE ACCEPTABLE.

KNOWN ACCESS POINTS ARE ROUTES THAT HAVE BEEN USED FOR PERIODIC ONGOING NON-MECHANICAL FENCE MAINTENANCE THAT PASS ONLY THROUGH PUBLIC LANDS. THERE IS EVIDENCE OF OTHER PRIVATE ACCESS POINTS BEING USED DURING PAST EXTENSIVE BRUSHING/FENCING ACTIVITIES THAT USED MECHANICAL EQUIPMENT.

NON-PASSABLE OBSTACLES TO MECHANICAL EQUIPMENT ARE MAJOR FEATURES SUCH AS RIVERS, CREEKS, LAKES, STEEP SLOPES, LARGE WETLANDS, AND SO FORTH WITHOUT A PRE-EXISTING SHOOFLY WITHIN THE PARK BOUNDARY. THESE POINTS ARE FOR GUIDANCE ONLY, AS SOME MECHANICAL EQUIPMENT MAY BE CAPABLE OF WORKING THROUGH THESE AREAS, WHILE OTHER EQUIPMENT MAY FIND ADDITIONAL AREAS CHALLENGING THAT HAVE NOT BEEN EXPLICITLY LABELED.

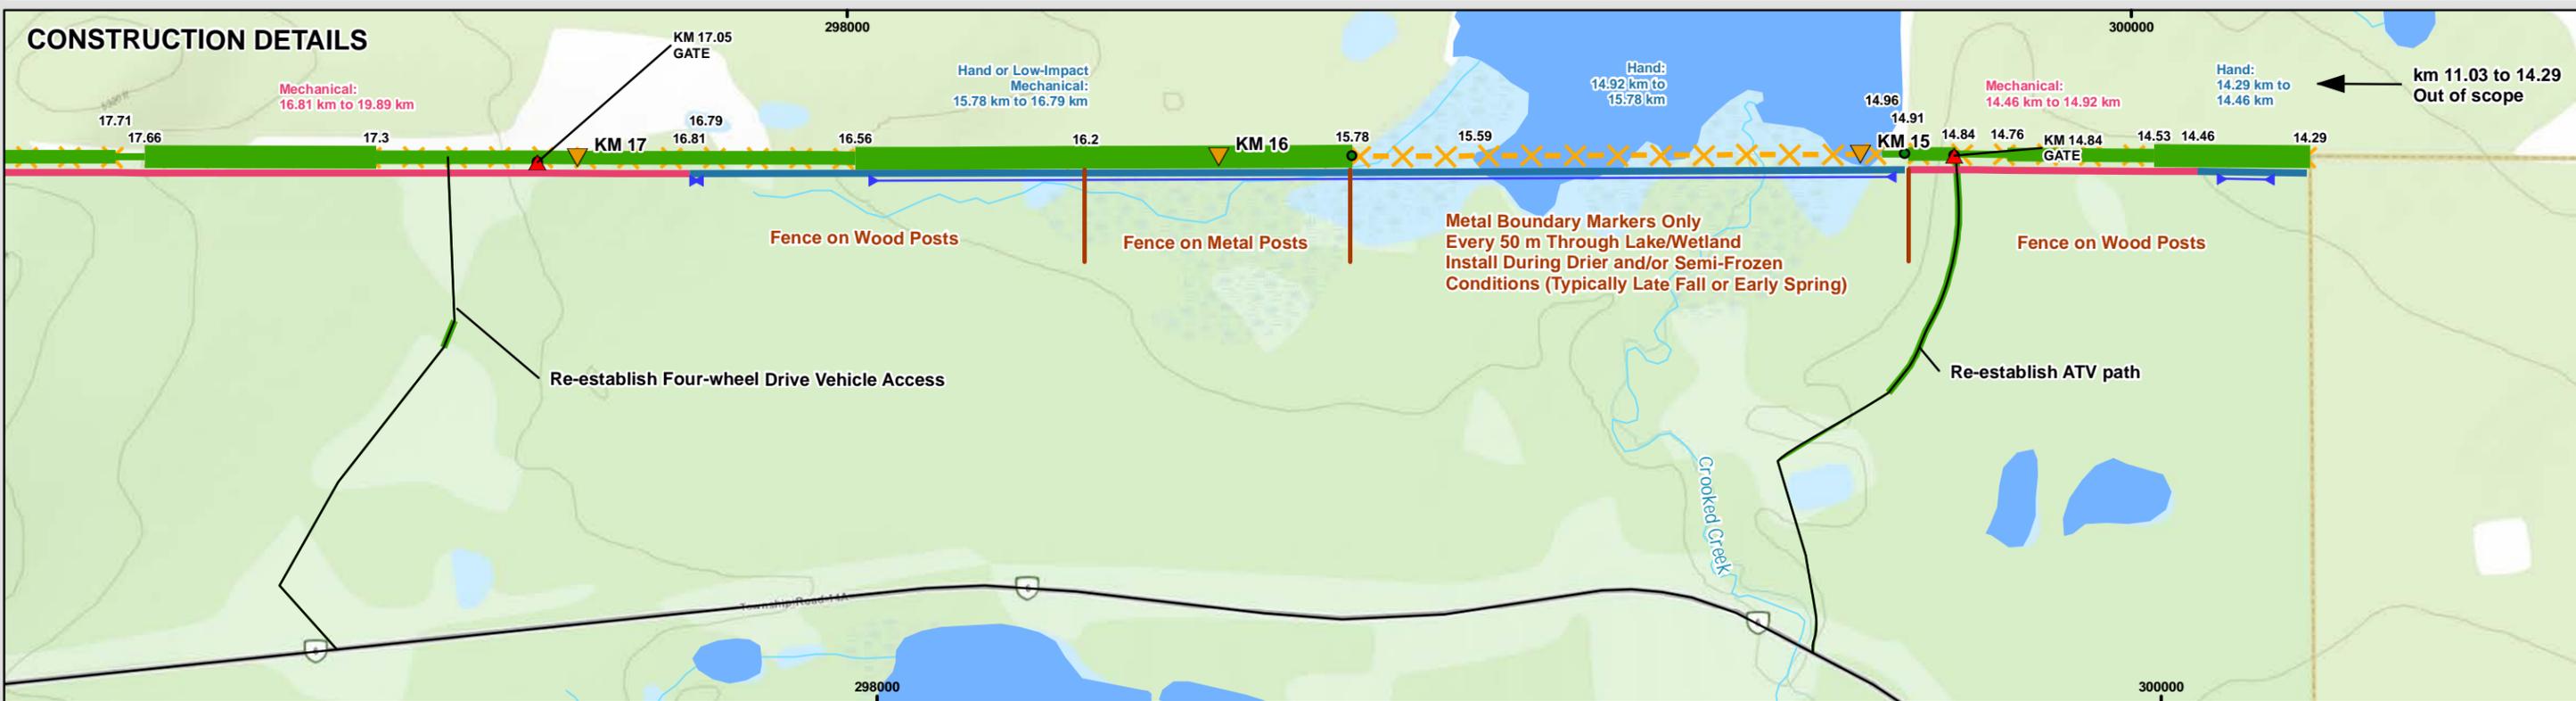
CONSTRUCTION DETAILS

- Archaeological sites and buffers are not indicated. Locations of the 3 known areas along the fence alignment will be provided to the successful contractor only.
- Migratory Bird Restricted Activity Period (Apr 01 – Aug 31) No Brushing
- Minimize traffic in areas of archaeological significance to avoid rutting of ground surface

- Follow and re-establish existing shoofly routes only (ATV-width). Moderate brushing and minor earthwork may be required where stumping has occurred. Do not disturb previously untouched ground or forest
- Information is for guidance only and work is to be done in accordance with the Best Management Practices.

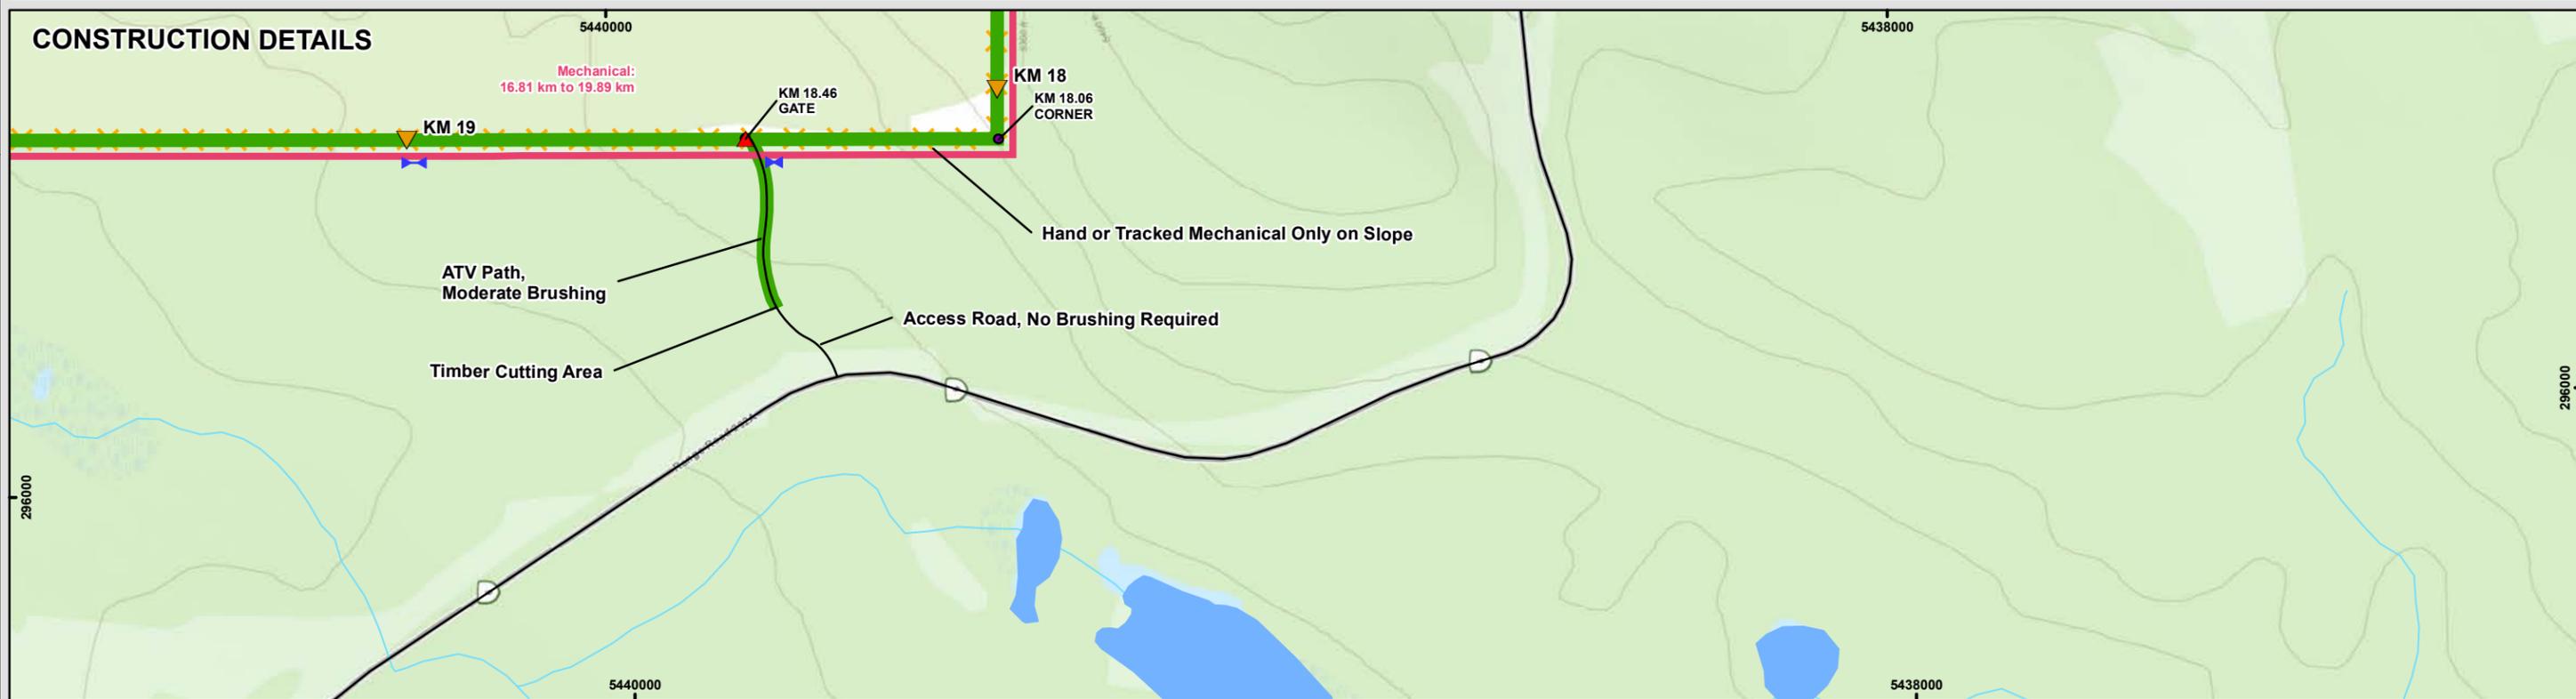
CONSTRUCTION DETAILS

- Brushing Condition**
- Moderate
 - ↔ Wetland (Observed)
- Notes**
- Archaeological sites and buffers are not indicated. Locations of the 3 known areas along the fence alignment will be provided to the successful contractor only.
 - Migratory Bird Restricted Activity Period (Apr 01 – Aug 31) No Brushing

- Minimize traffic in areas of archaeological significance to avoid rutting of ground surface
- Follow and re-establish existing shoofly routes only (ATV-width). Moderate brushing and minor earthwork may be required where slumping has occurred. Do not disturb previously untouched ground or forest
- Information is for guidance only and work is to be done in accordance with the Best Management Practices.

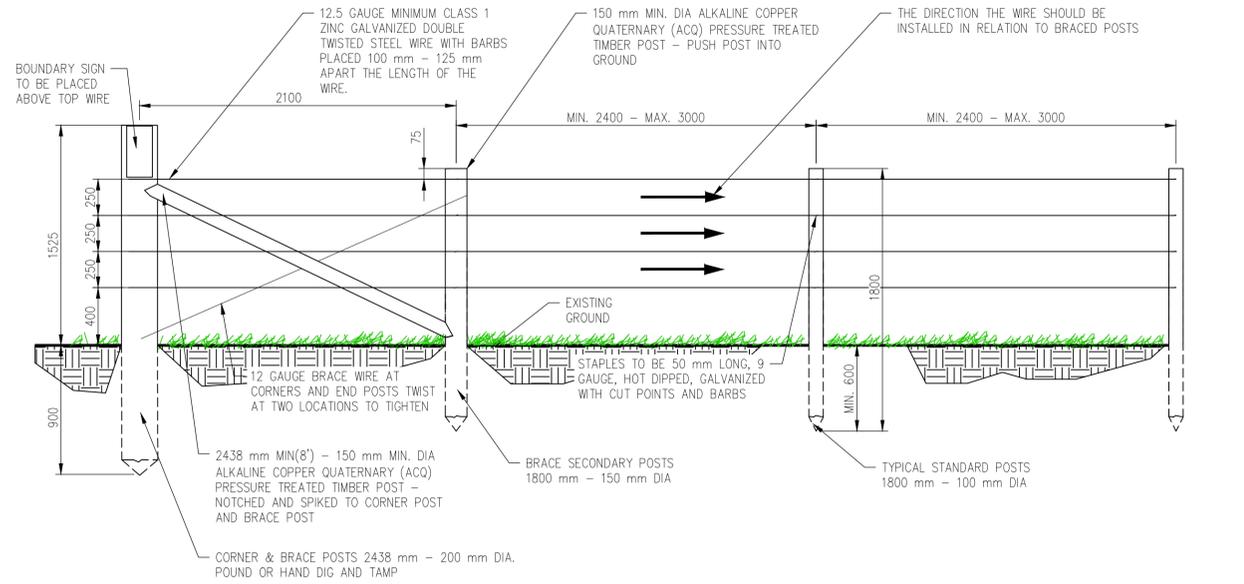
ELEVATION – TIMBER POST 4 STRAND BARBED WIRE FENCE
SCALE : 1:25

- NOTES:**
- START WIRE AT A CORNER POST WITH BRACING
 - CONTRACTOR TO ENSURE SUPPORT SECURED TO CORNER POST TO SATISFACTION OF THE DEPARTMENTAL REPRESENTATIVE
 - EVERY 100 L.M. USE AN 2438 mm (8') POST, KEEPING 375 mm ABOVE TOP WIRE FOR INSTALLATION OF A PARK BOUNDARY SIGN
 - EXISTING POSTS TO REMAIN IN PLACE IF SUITABLE. REPOUND AND REALIGN IF LEANING AND REAPPLY WIRE. CONTRACTOR RESPONSIBLE FOR DISPOSAL OF EXISTING FENCING MATERIALS OFF SITE, EXCLUDING SOUND POSTS.

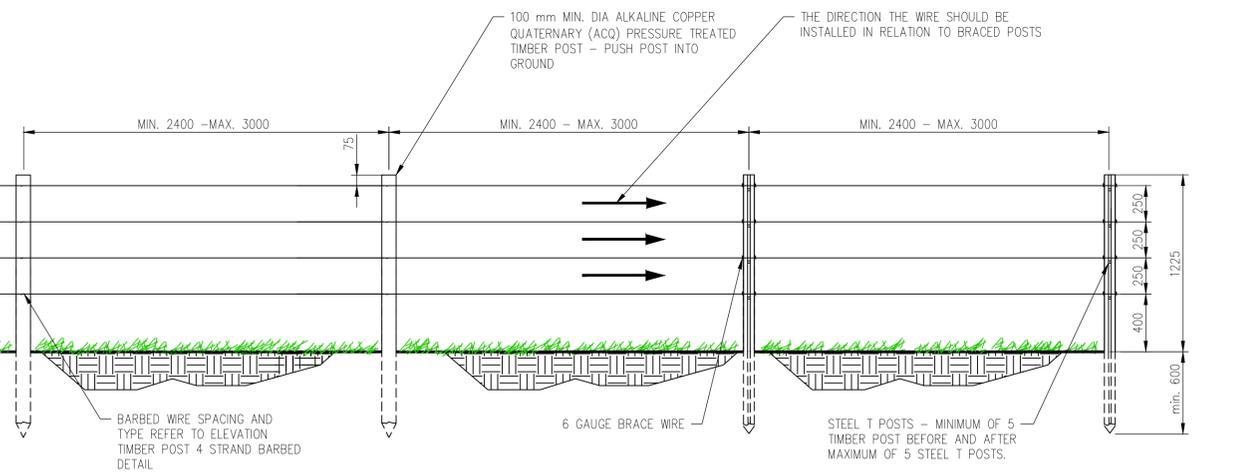
ELEVATION – TIMBER POST TO STEEL T-POSTS TRANSITION 4 STRAND BARBED WIRE FENCE
SCALE : 1:25

- NOTES:**
- STEEL POSTS SHOULD ONLY BE USED IN SECTIONS WHERE WOOD POSTS ARE NOT ABLE TO BE PUSHED INTO THE GROUND OR UNLESS OTHERWISE SPECIFIED.

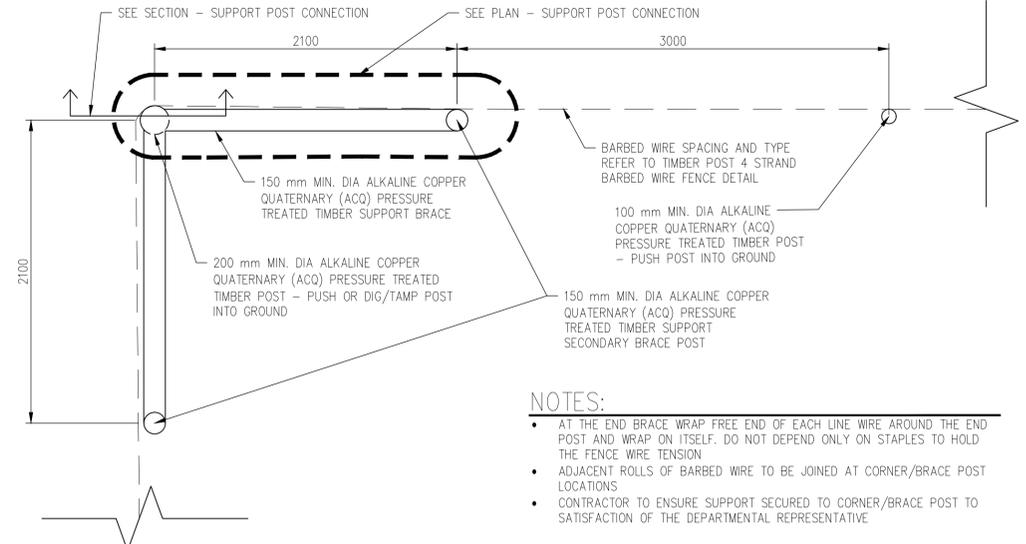
PLAN – TIMBER POST 4 STRAND BARBED FENCE CORNER
SCALE : 1:25

- NOTES:**
- AT THE END BRACE WRAP FREE END OF EACH LINE WIRE AROUND THE END POST AND WRAP ON ITSELF. DO NOT DEPEND ONLY ON STAPLES TO HOLD THE FENCE WIRE TENSION
 - ADJACENT ROLLS OF BARBED WIRE TO BE JOINED AT CORNER/BRACE POST LOCATIONS
 - CONTRACTOR TO ENSURE SUPPORT SECURED TO CORNER/BRACE POST TO SATISFACTION OF THE DEPARTMENTAL REPRESENTATIVE

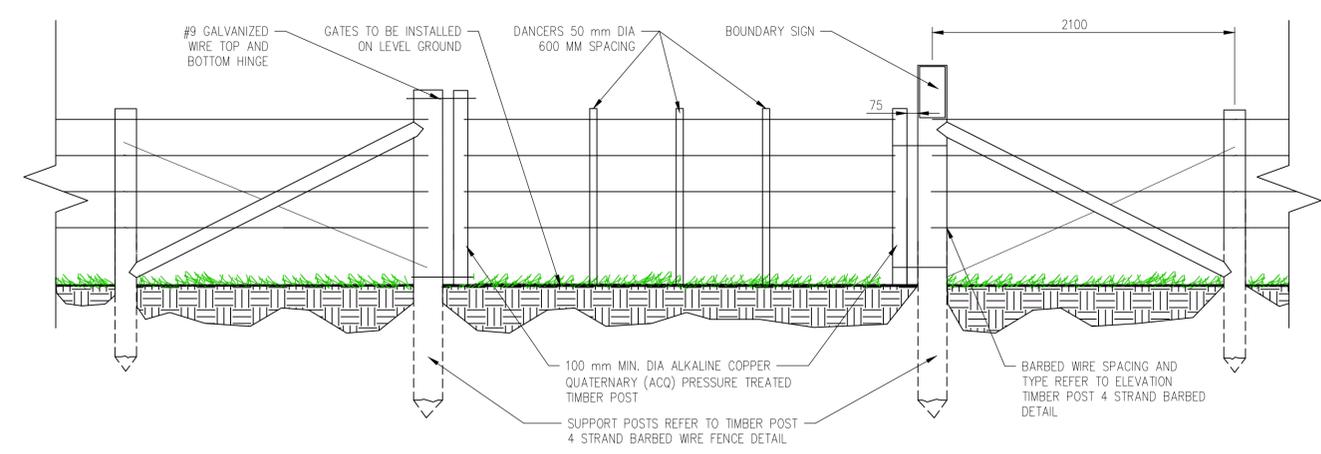
ELEVATION – TIMBER 4 STRAND BARBED WIRE GATE
 SCALE : 1:25

- NOTES:
- WIDTH OF GATE IS TYPICALLY BETWEEN 4 TO 5 m (MATCH EXISTING GATE WIDTH)
 - INSTALL A BOUNDARY SIGN AT EVERY GATE

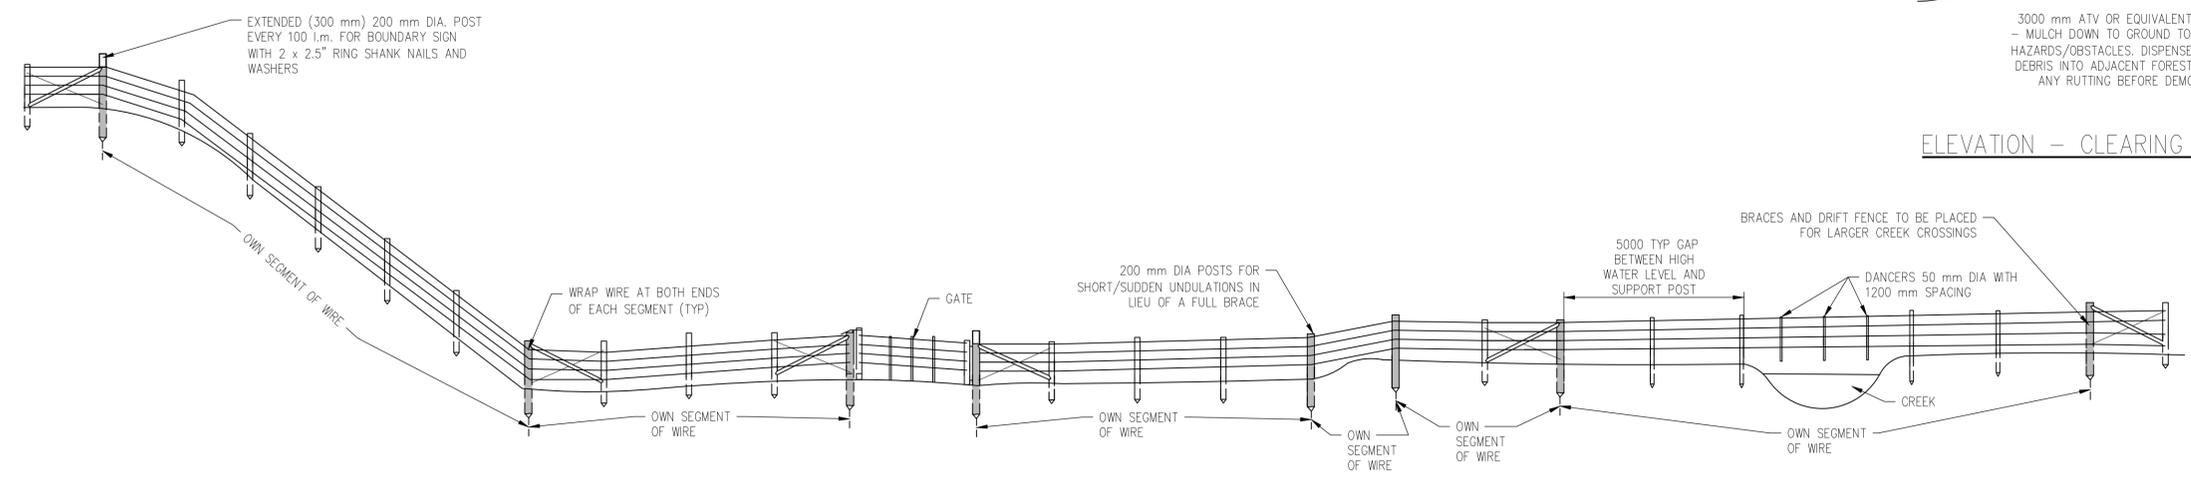
ELEVATION – TYPICAL CONDITIONS AND HOW/WHERE TO USE BRACES
 SCALE : 1:100

- NOTES:
- THE BOUNDARY SIGN TO BE INSTALLED WITHOUT INTERFERING WITH THE TOP WIRE.
