PUBLIC WORKS AND GOVERNMENT SERVICES  
CANADA  
WILMER MARSH UNIT COLUMBIA NWA  
WILMER, BRITISH COLUMBIA

REMEDIATION TENDER SPECIFICATION

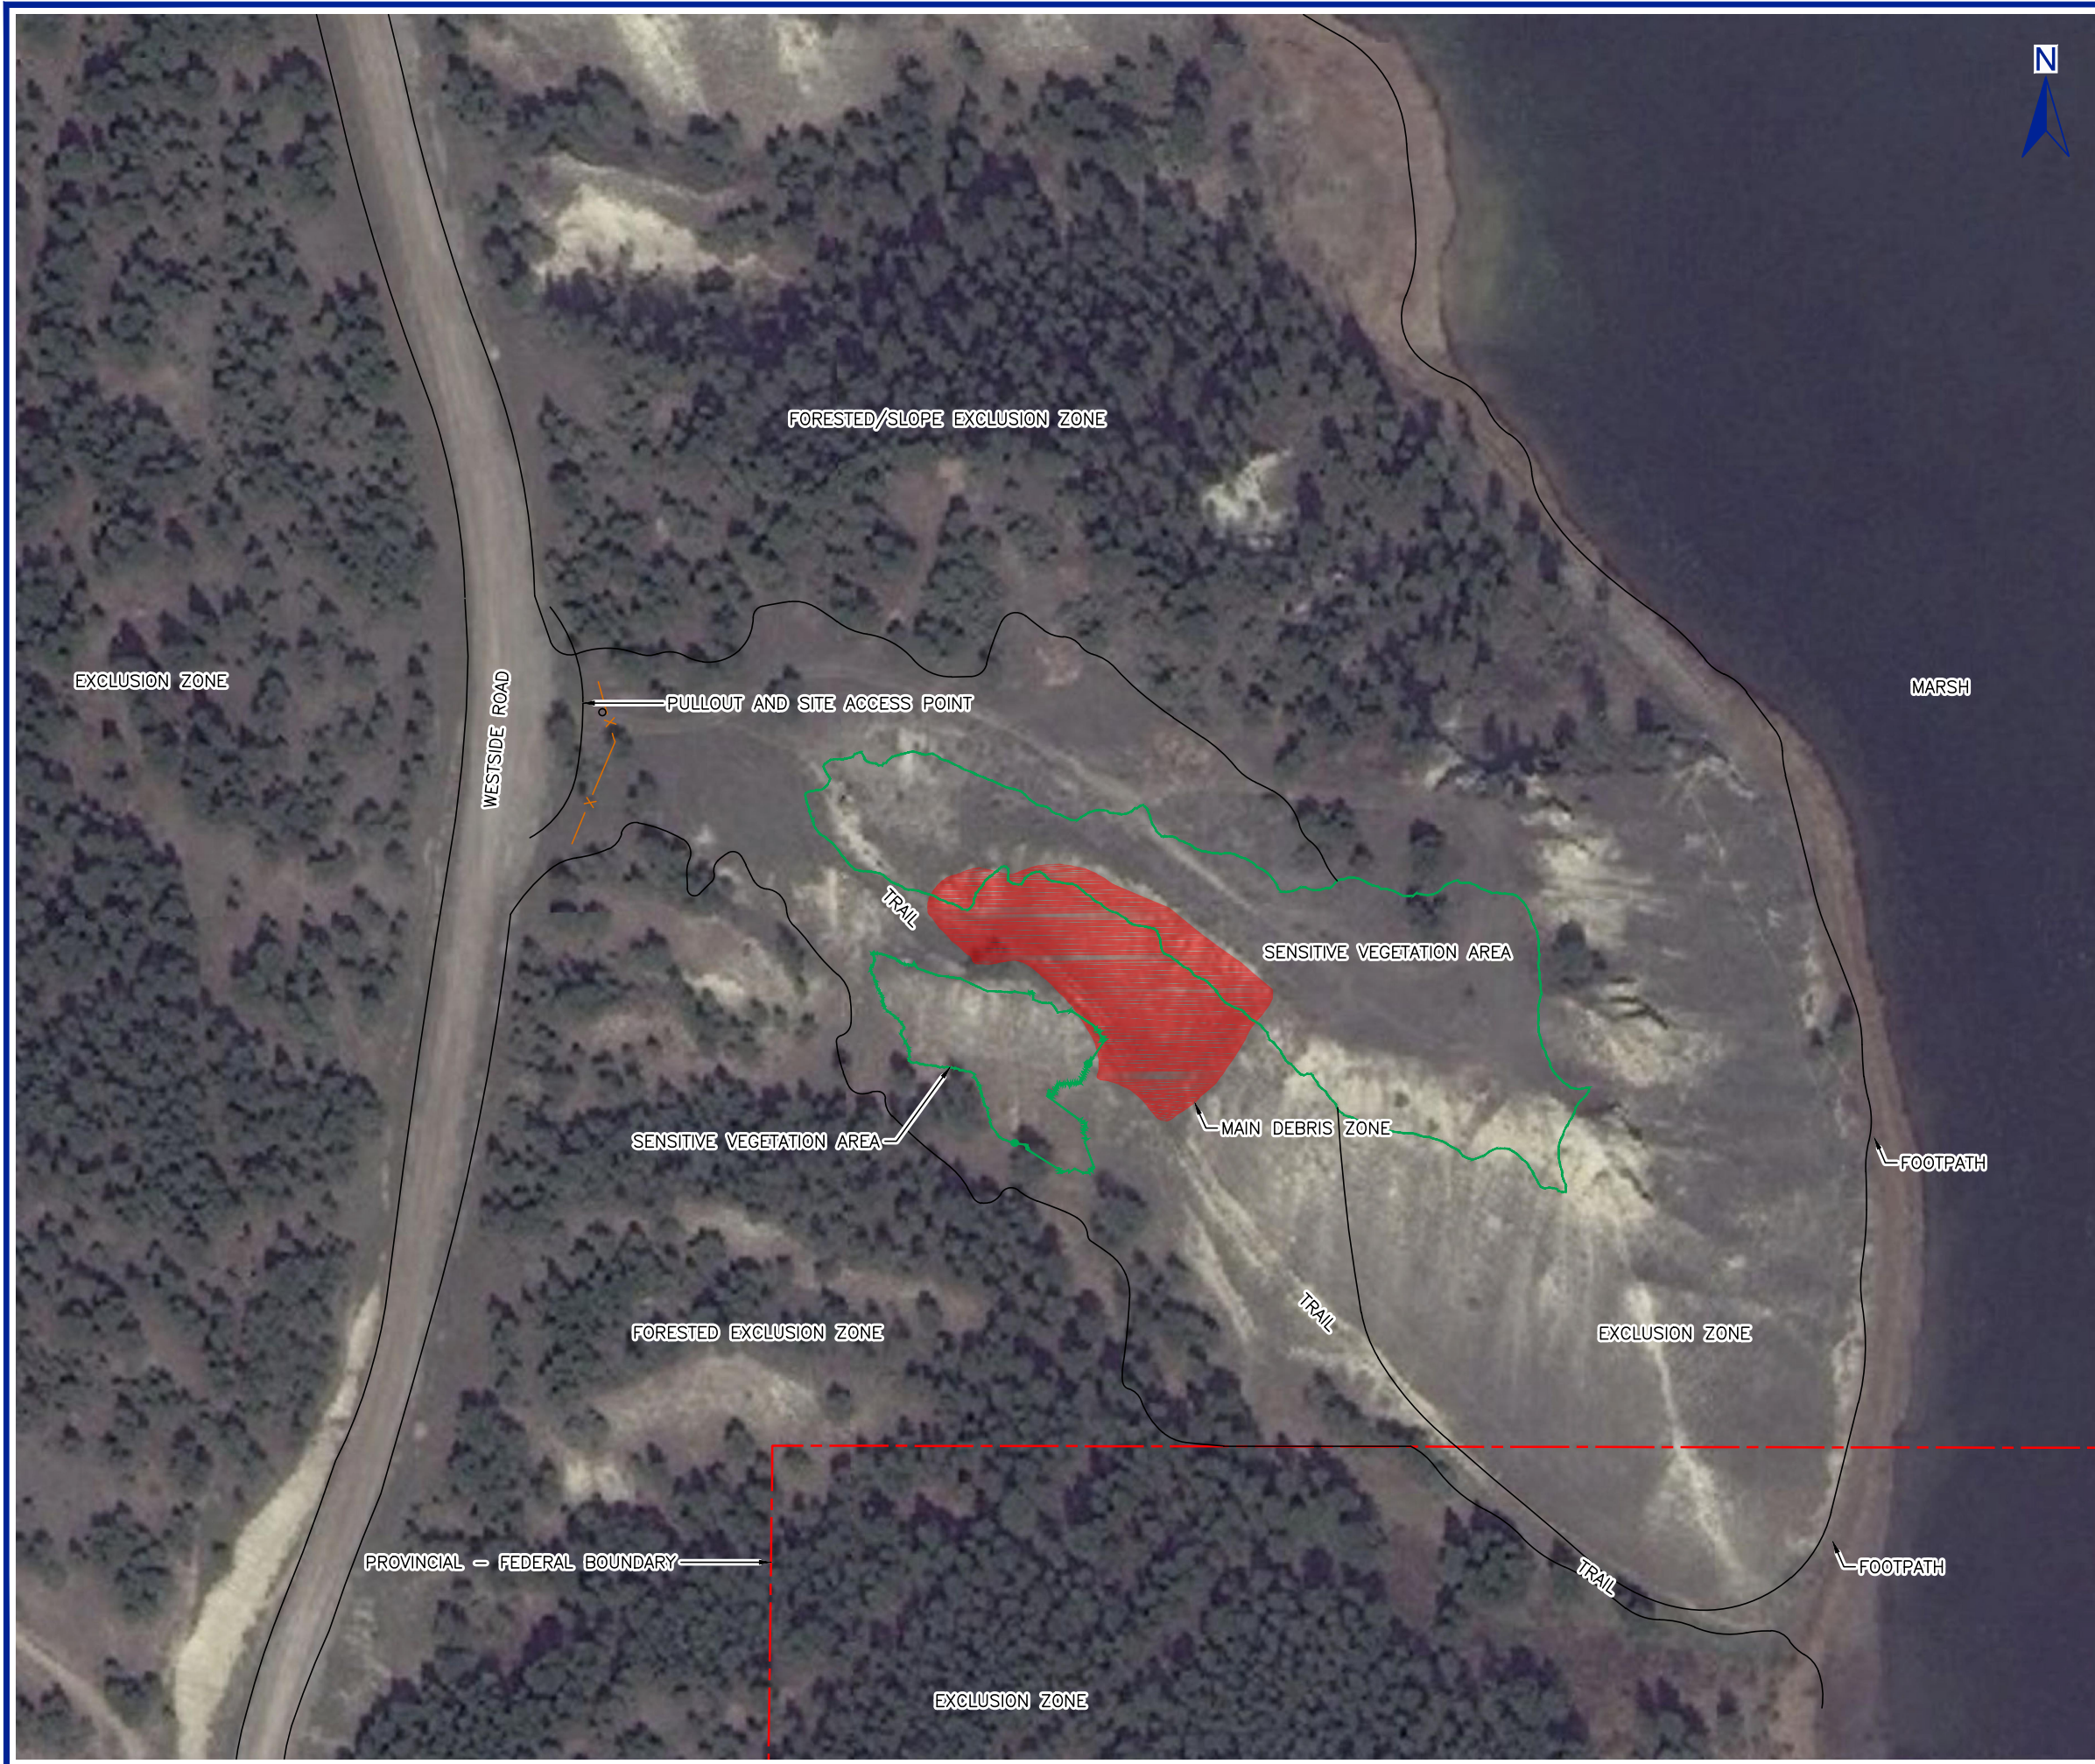
Date: August 23, 2016	Drawing No.
Project No. 219.05112.00013	<b>2</b>

**SITE LAYOUT**

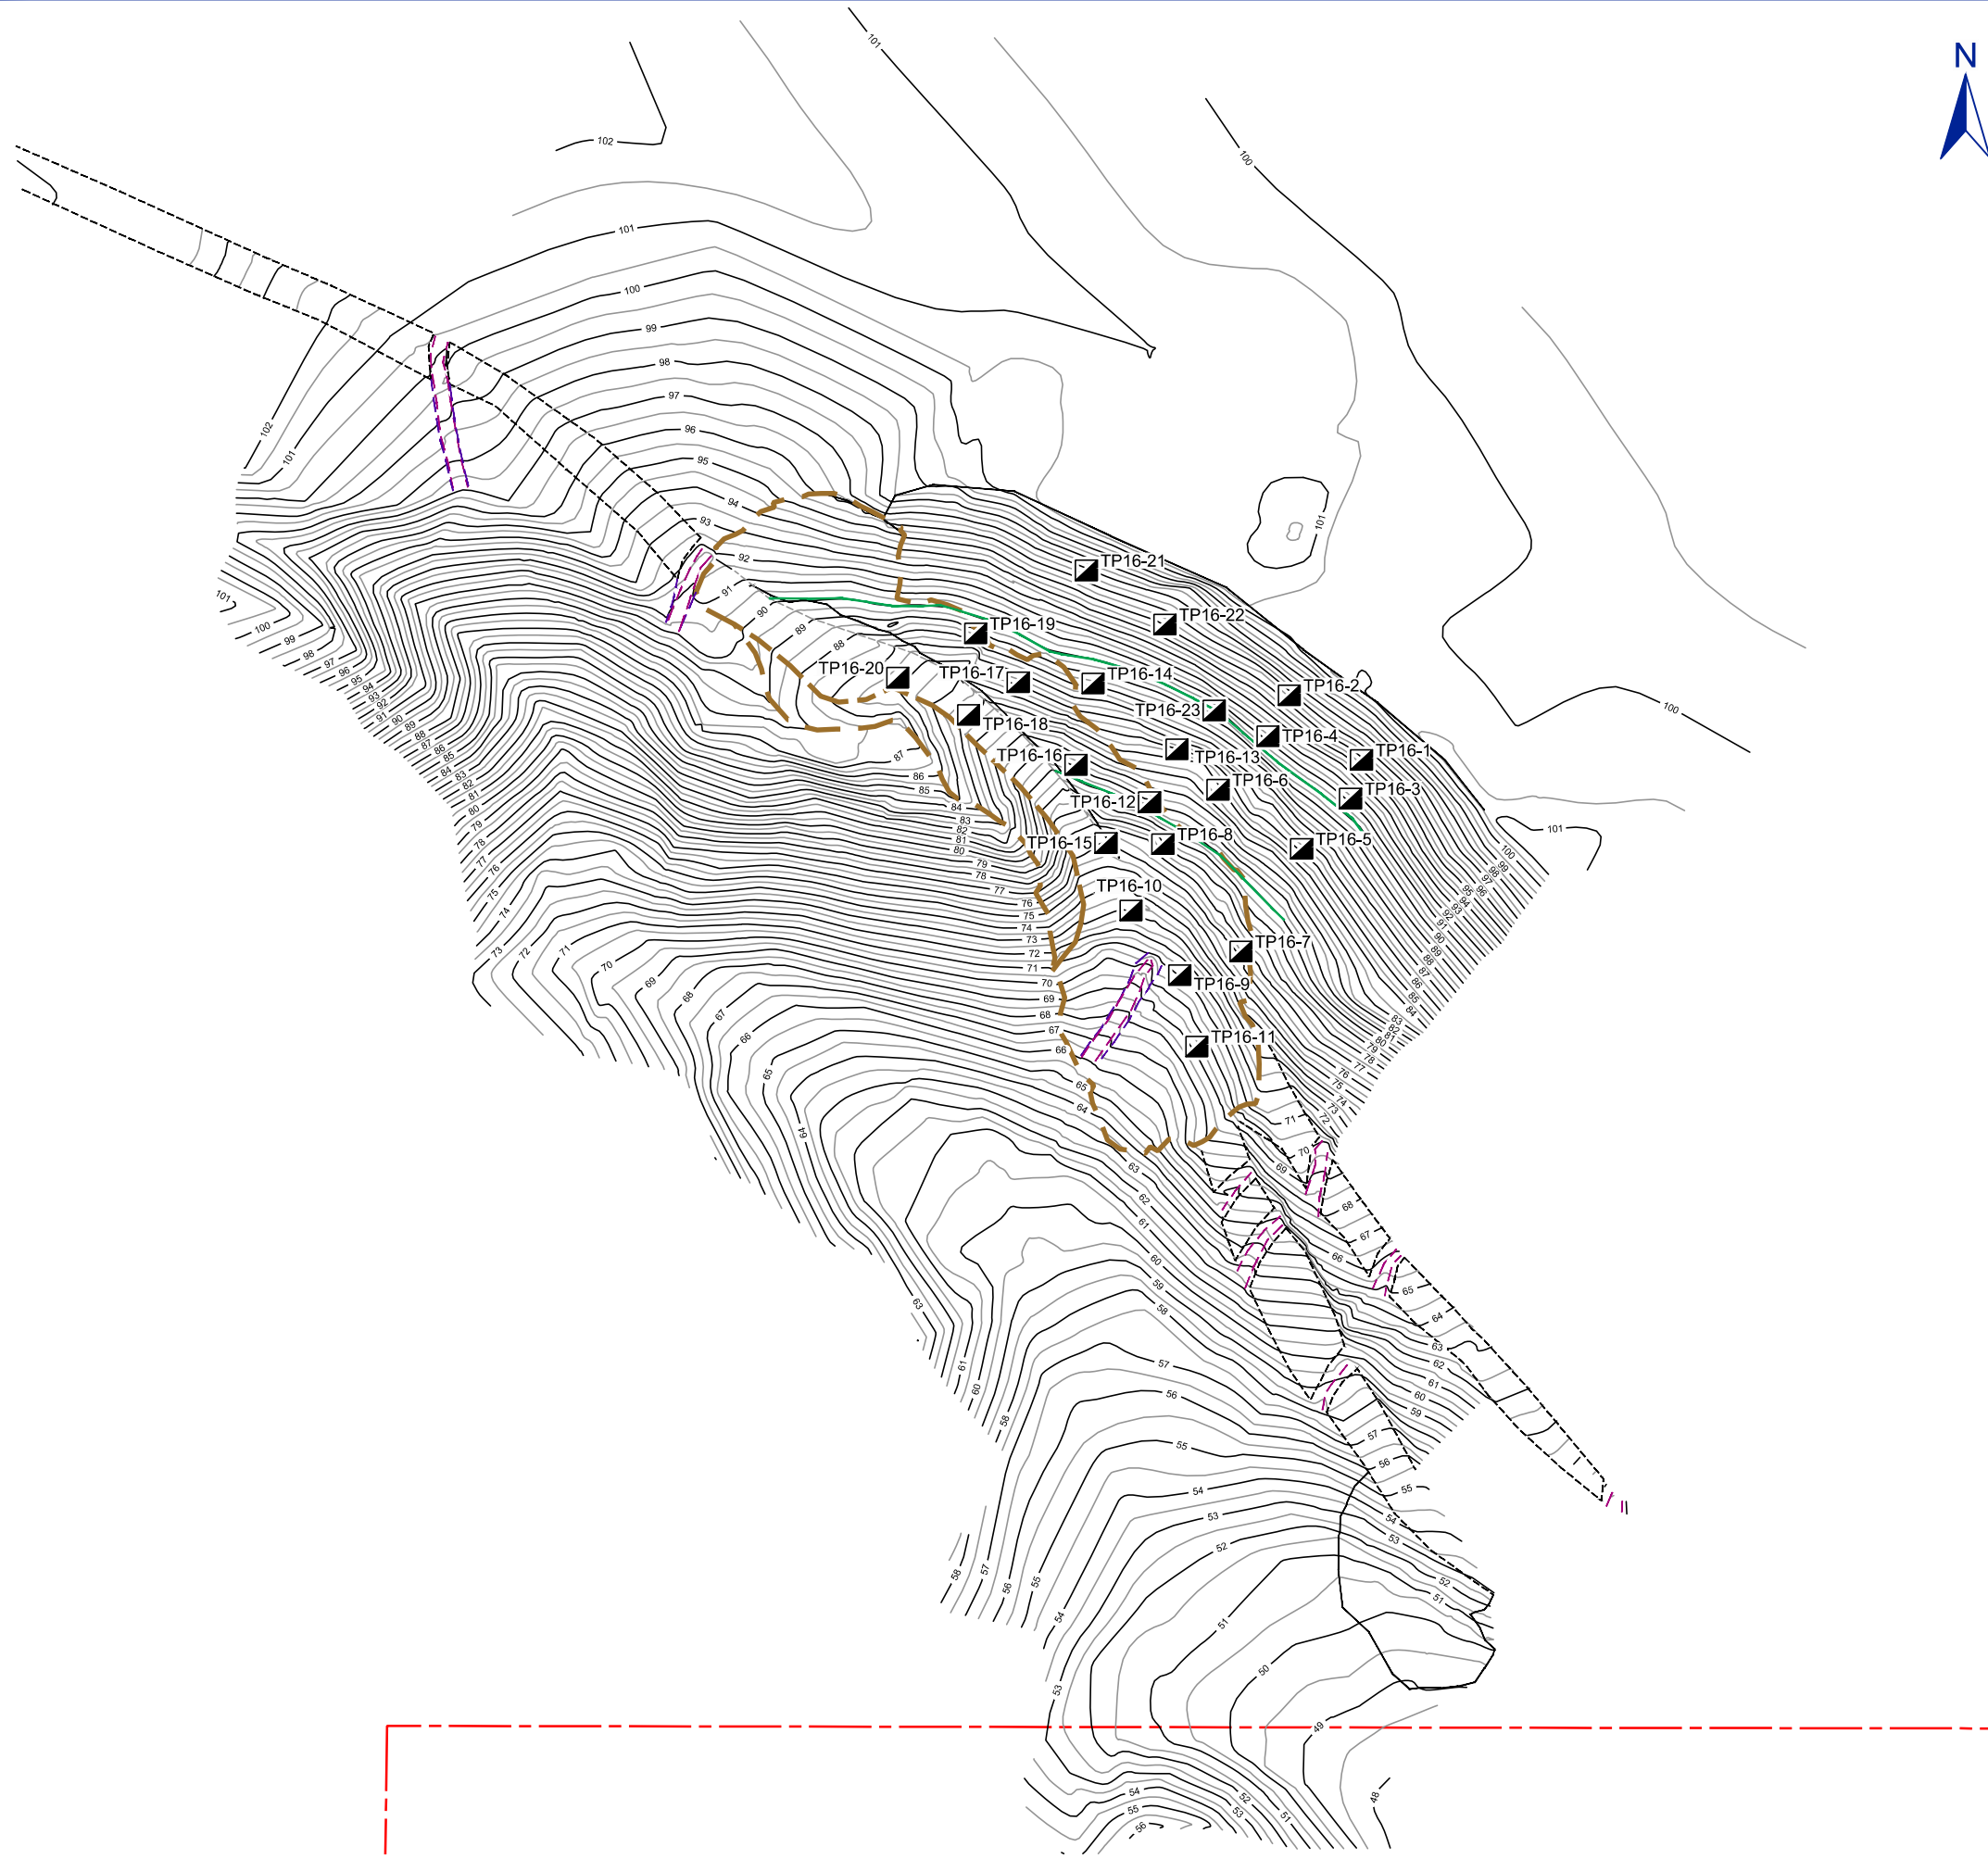
Date: August 23, 2016	Drawing No. <b>3</b>
Project No. 219.05112.00013

**TOPOGRAPHIC LAYOUT OF REMEDIATION AREAS**

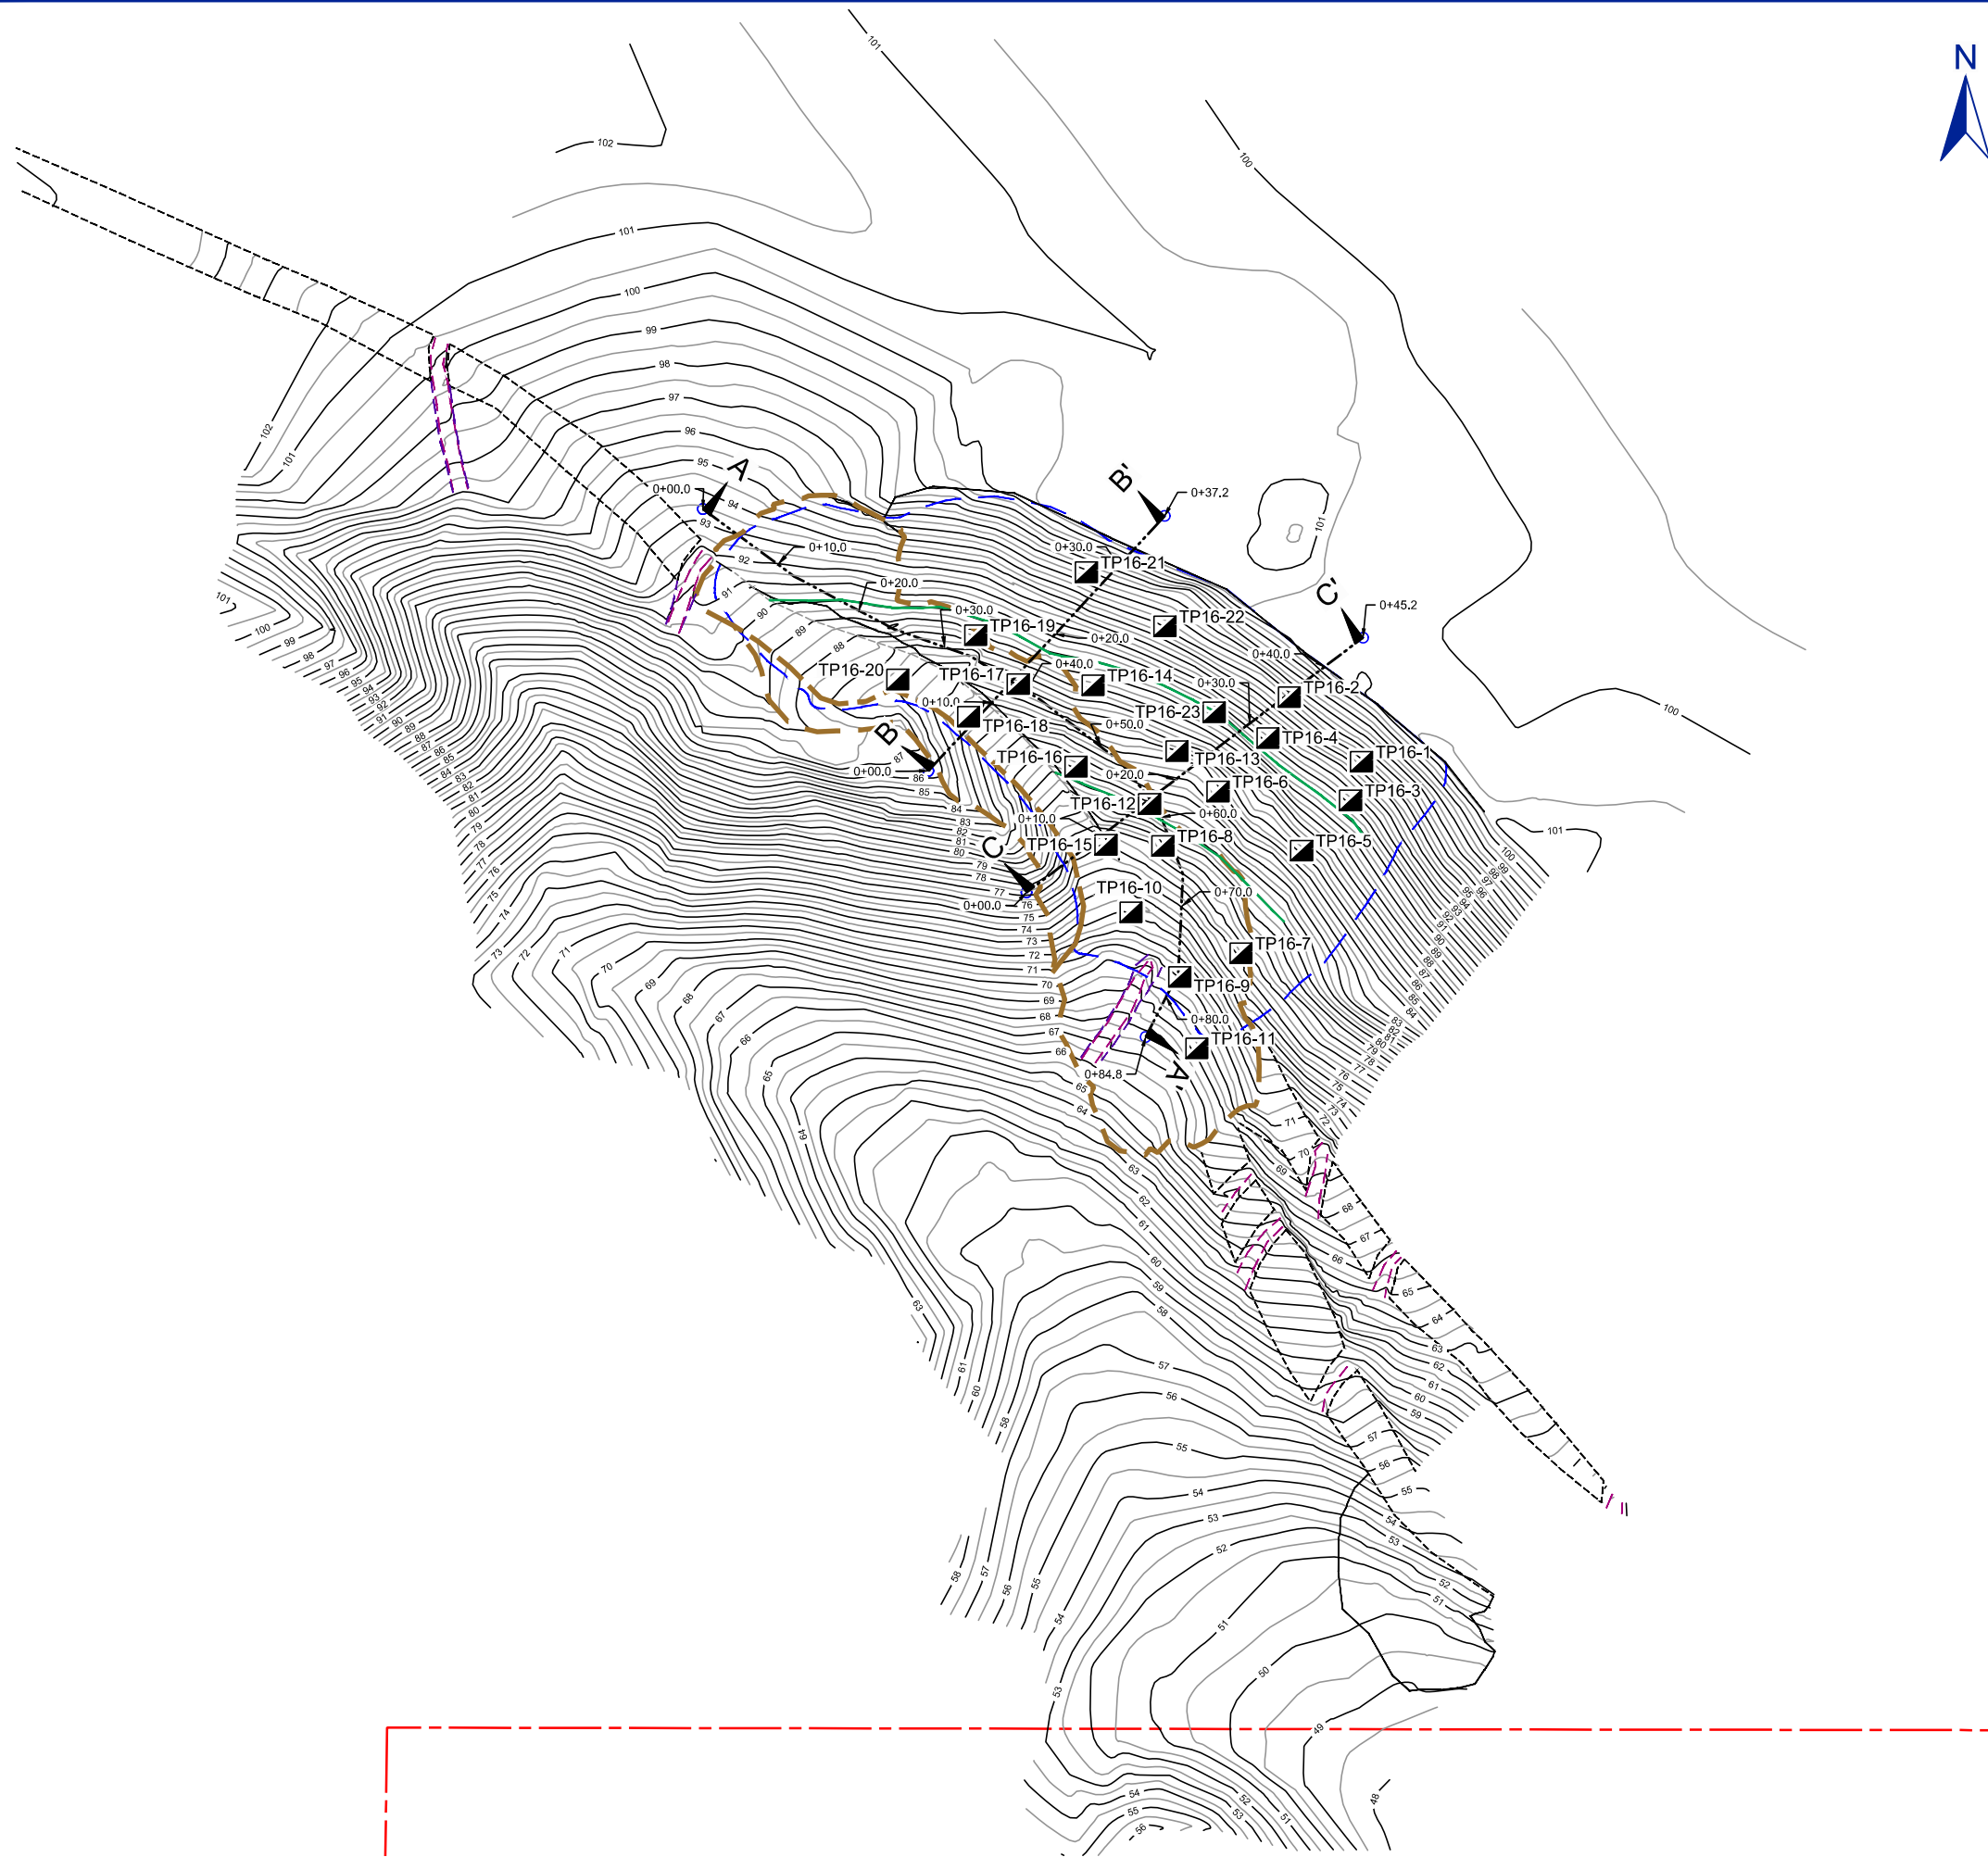
Date: August 23, 2016	Drawing No. 4
Project No. 219.05112.00013

**IMPACTED AREA OF SOIL & DEBRIS TO BE REMEDIATED**

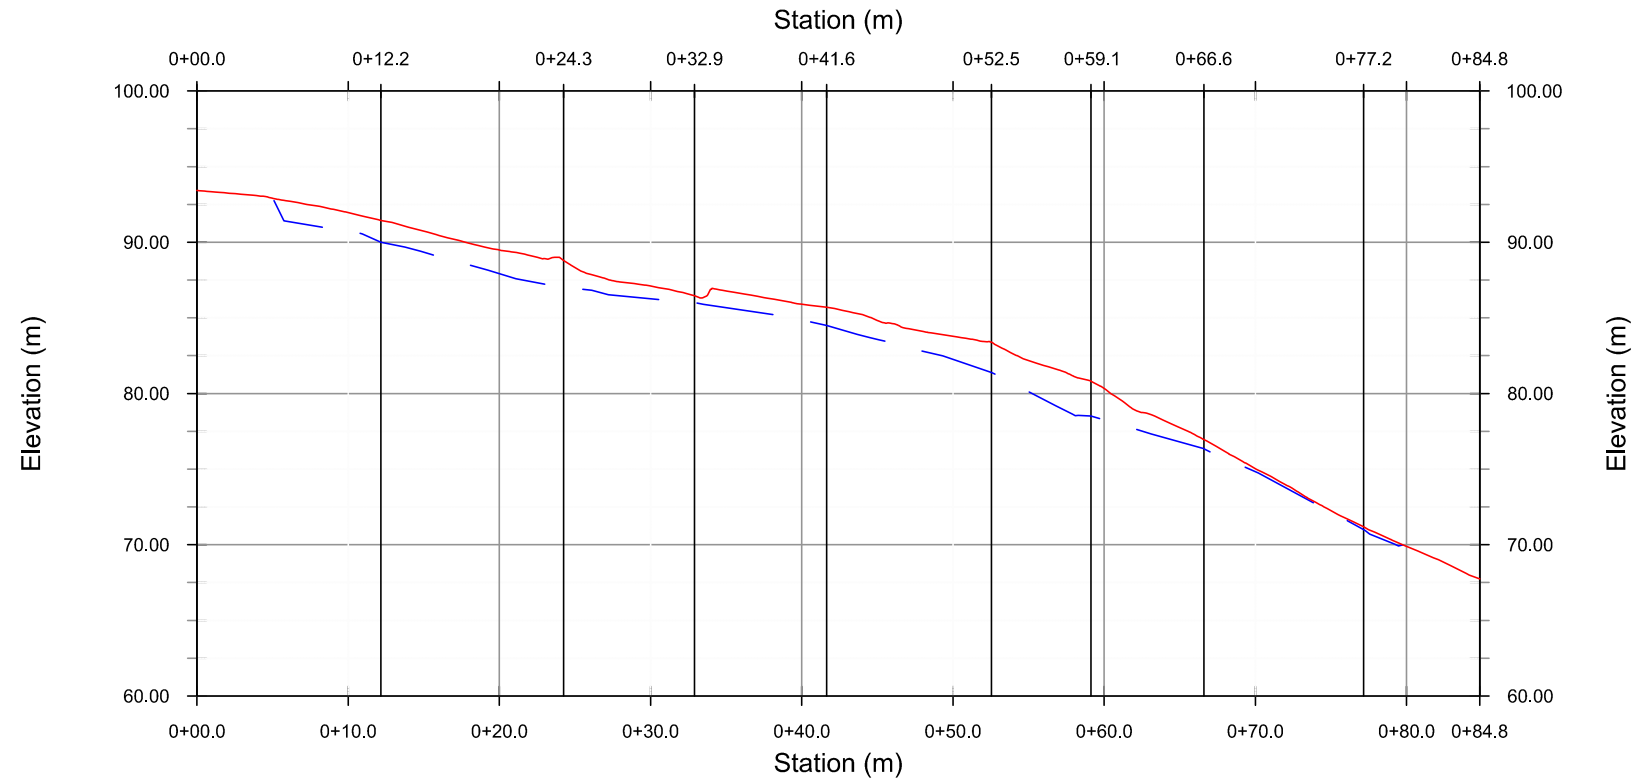
**PROFILE VIEW OF A - A'**

**EXISTING GROUND SURFACE AND PROPOSED AREA OF IMPACTED SOIL AND DEBRIS PROFILE VIEWS IN MAIN DEBRIS ZONE**
