**Geotechnical Investigation
Wind Turbine Installation
Green Island, NL**

Department of Fisheries and Oceans
P.O. Box 5667
St. John's, NL
A1C 5X1

April 1, 2016

Amec Foster Wheeler Project No. TF1611038

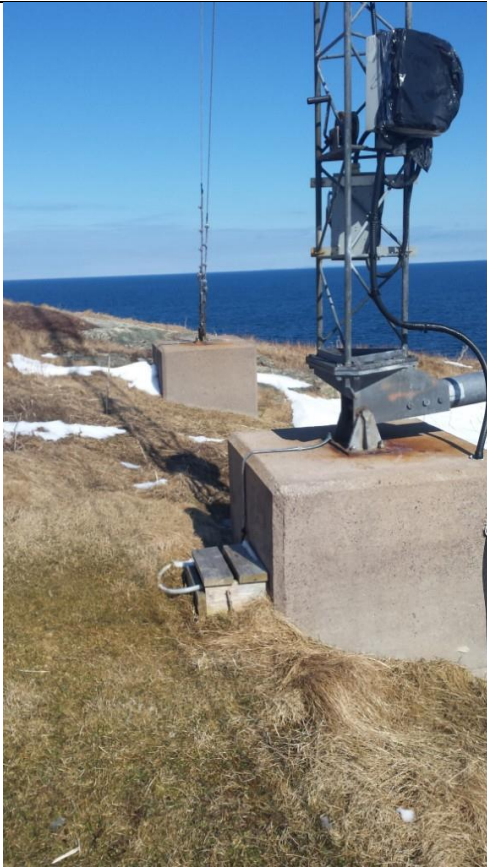
**Photo 1: Existing Turbine & Concrete Support Blocking.
Existing Turbine to be decommissioned and replaced with Turbine 14-01.**

Turbine 14-01 is planned to be constructed at the location of the existing 18.3 m turbine after it has been decommissioned. The existing turbine is supported by concrete blocking at its hub in addition to four (4) concrete anchor blocks. Each block is ~1.5 x 1.5 m and appear to be in reasonable condition with no observable cracking or weathering. It is understood that the existing blocking may be used to support Turbine 14-01 if minimal damage is incurred during decommissioning efforts. The ground within the immediate area within the existing turbine has been levelled during previous construction. Topography outside of its footprint is sloped and generally up-gradient toward to W-NW.

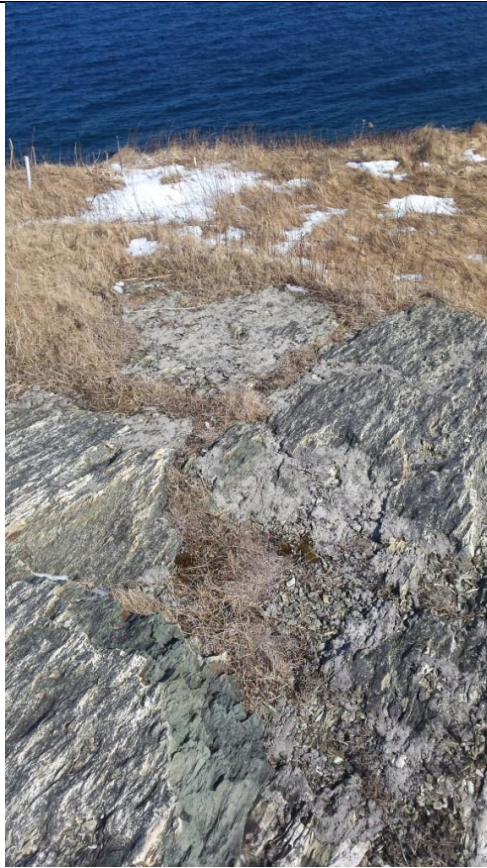
Photo 3: Outcrop A – near proposed location of Turbine 14-01. Located adjacent to east anchor block. Note close spacing of joints / cleavage planes with some surface fracturing.

Three (3) areas of exposed bedrock were observed near the proposed location of Turbine 14-01. The first (termed Outcrop A) is adjacent to the existing east anchor block; the second (Outcrop B) is ~3 m W of the existing west anchor block. Outcrop C is located ~ 10 m SE of the existing tower.

The exposure at Outcrop A was ~ 4 x 4 m in size and described as green-grey siliceous siltstone. Evidence of slight to moderate surface weathering and iron oxide staining was noted on exposed surfaces. The rock mass was jointed two (2) prominent joint sets generally striking NW-SE. Both sets were dipping near vertical and had extremely close to close joint spacing (10 - 80 mm). Extremely close to very close spaced (10 mm - 50 mm) cleavage planes generally trending toward the NE-SW were also observed on the surface of the outcrop. The bedrock surface exhibited some fracturing due to the joint / cleavage patterns and their spacing. Bedding plane orientation was not determined due to insufficient exposure.

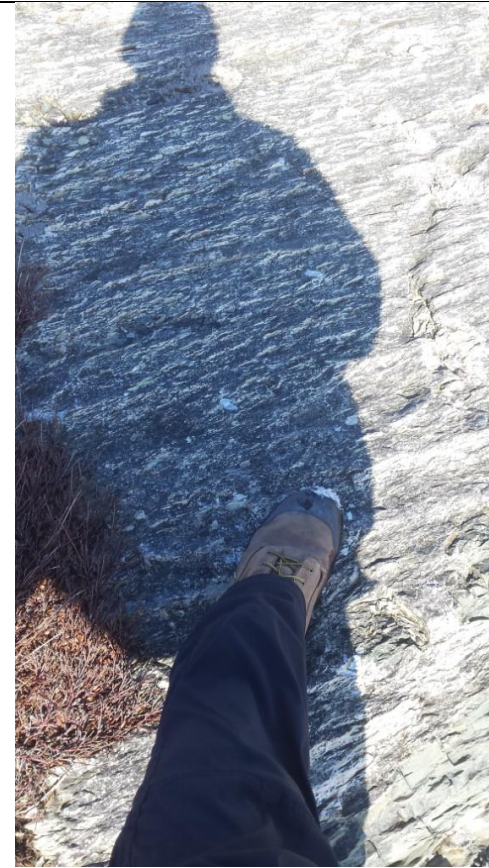
Photo 4: Alternate view of Outcrop A.

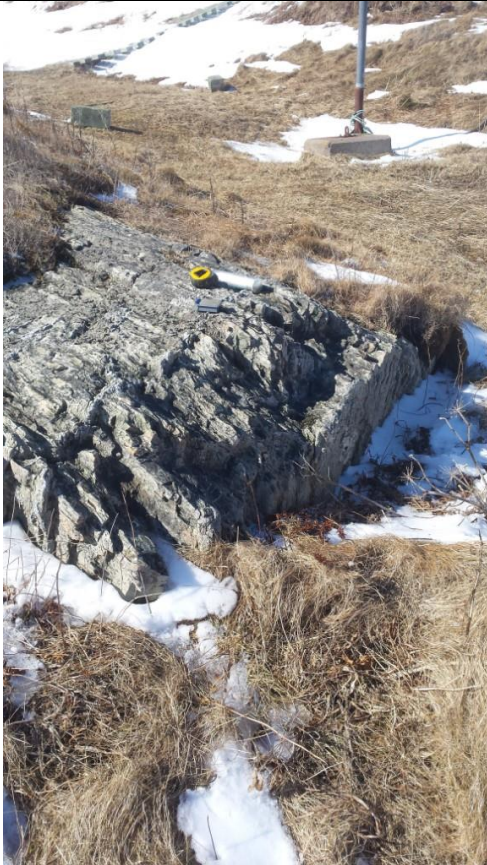
Photo 5: Outcrop B – near proposed location of Turbine 14-01. Located ~ 3 m west of the existing west anchor block. Note close spacing of joints / cleavage planes with some surface fracturing.

Outcrop B was ~ 3 x 2 m in size and described as green-grey siliceous siltstone. Evidence of slight to moderate surface weathering and iron oxide staining was noted on exposed surfaces. Trace to some moss / lichen growth was observed on the bedrock surface. Quartz veins spaced 30 - 50 mm apart and trending N-S were also noted. The rock mass was jointed two (2) prominent joint sets generally striking NW-SE. Both sets were dipping near vertical and had very close to close joint spacing (20 - 100 mm). Extremely close to very close spaced (10 mm - 50 mm) cleavage planes generally trending toward the NE-SW were also observed on the surface of the outcrop. The bedrock surface exhibited some fracturing due to the joint / cleavage patterns and their spacing. Bedding plane orientation was not determined due to insufficient exposure.

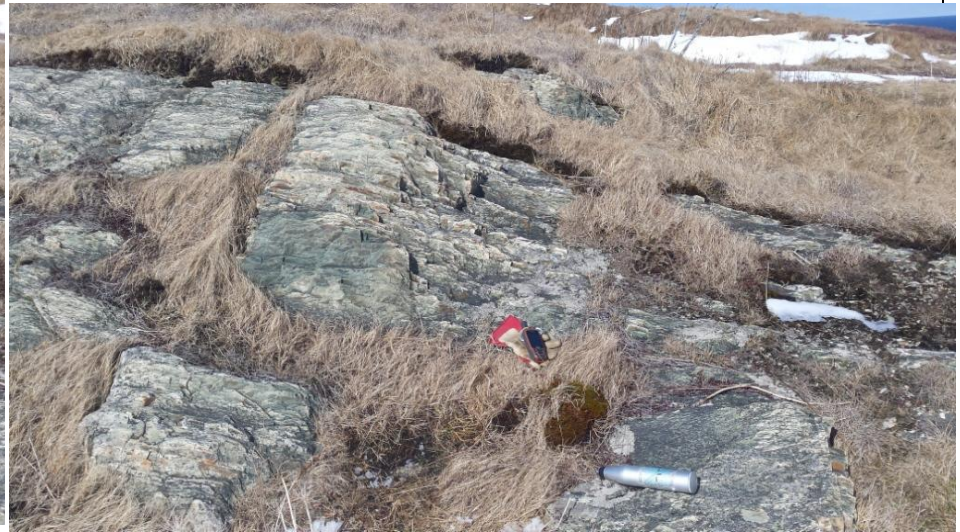
Photo 8: Alternate view of Outcrop C.

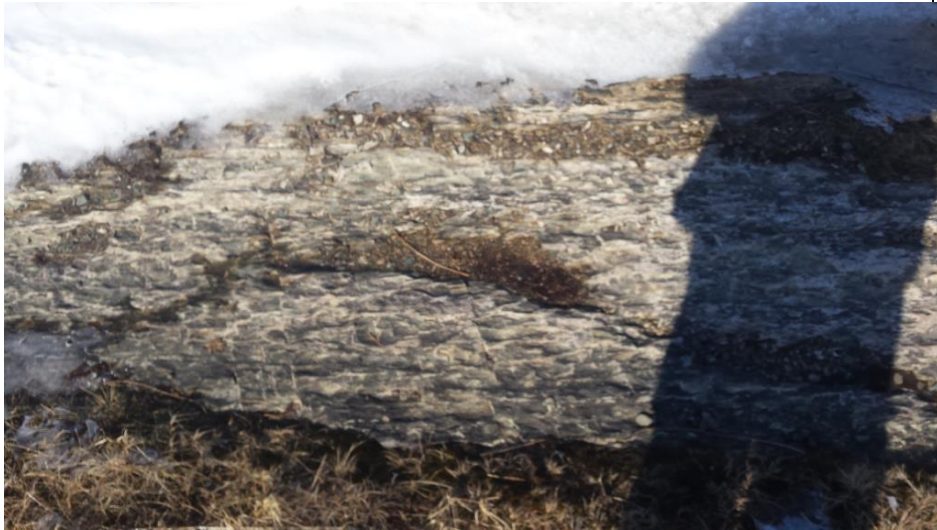
Photo 11: Outcrop D – near approximate location of Turbine 14-02. Note close spacing of joints / cleavage planes with some surface fracturing.

One (1) bedrock outcrop (Outcrop D) was noted near the approximate location of Turbine 14-02. The exposure was ~ 6 x 2 m in size and described as green-grey siliceous siltstone. Evidence of slight to moderate surface weathering and trace iron oxide staining was noted on exposed surfaces. The rock mass was jointed with near-vertical, very close to close spaced joints (20 mm - 100 mm). Extremely close to close spaced (5 mm - 20 mm) cleavage planes generally trending toward the NE-SW were also observed on the surface of the outcrop. Bedding plane orientation was not determined due to insufficient exposure. Refer to Table 5.4 for a summary of observations recorded at Outcrop D.

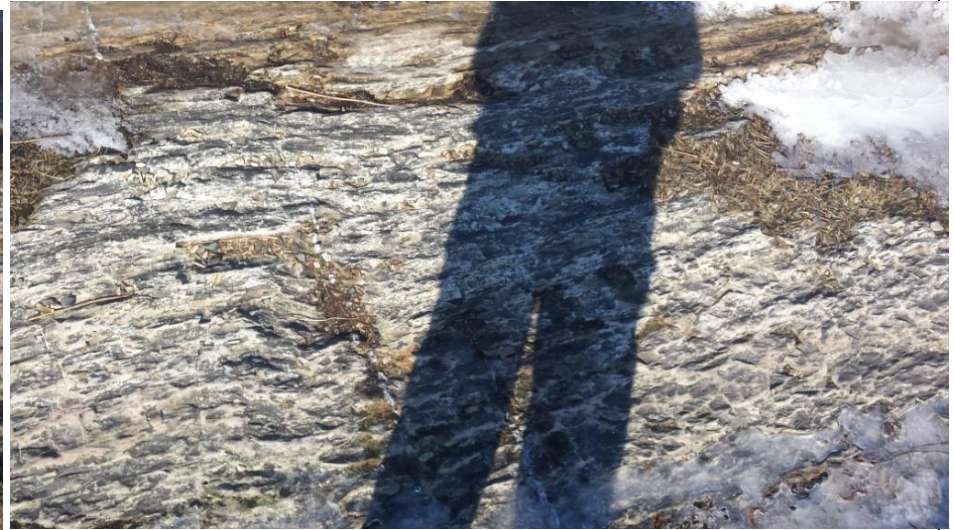
Photo 12: Alternate view of Outcrop D.

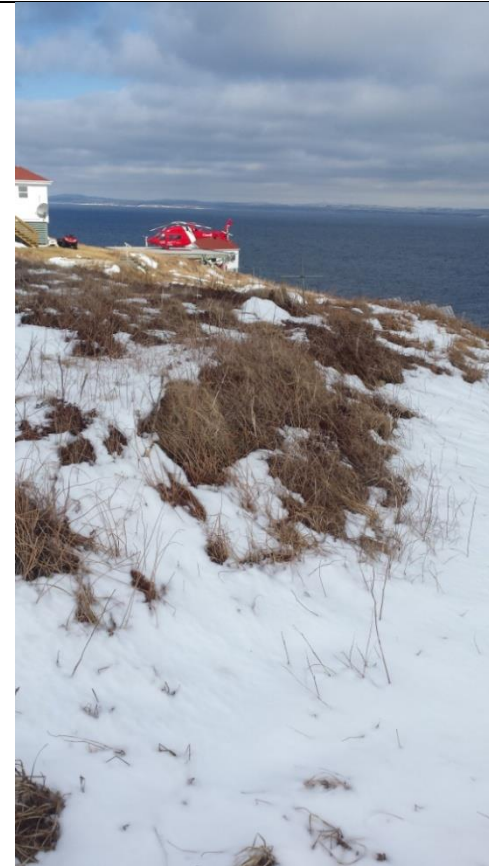
Photo 14: View of concealed bedrock ridge ~ 20 N-NW of approximate location of Turbine 14-03.

The proposed location of Turbine 14-03 is approximately 60 m W-SW of the staff house (see Drawing 1, Appendix A). Existing topography is generally flat with up-gradient topography toward the W-NW. Bedrock was not exposed within the immediate vicinity. An apparent concealed bedrock ridge (with poorly exposed bedrock at the base ridge) was observed approximately 20 m toward the N-NW.

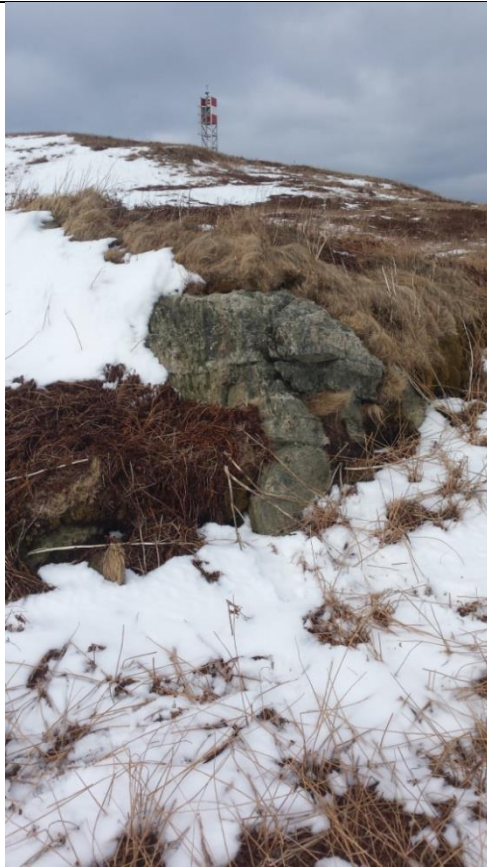
Photo 15: Outcrop E located ~ 50 m W-SW of approximate location of Turbine 14-03. Some fracturing from joint patterns.

The exposure at Outcrop E was ~ 1.5 x 1.5 m in size and described as green-grey siliceous siltstone. Evidence of slight to moderate surface weathering and iron oxide staining was noted on exposed surfaces. The rock mass was jointed two (2) prominent joint sets striking E-W and NE-SW. Both sets were dipping near vertical and had very close to close joint spacing (30 – 100 mm).

The bedrock surface exhibited some fracturing due to joint patterns and their spacing. Bedding plane orientation was not determined due to insufficient exposure.

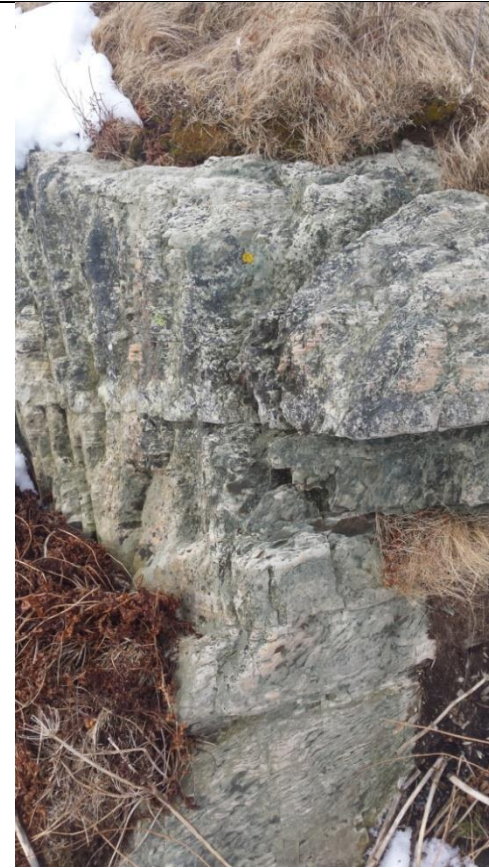
Photo 16: Alternate view of Outcrop E.

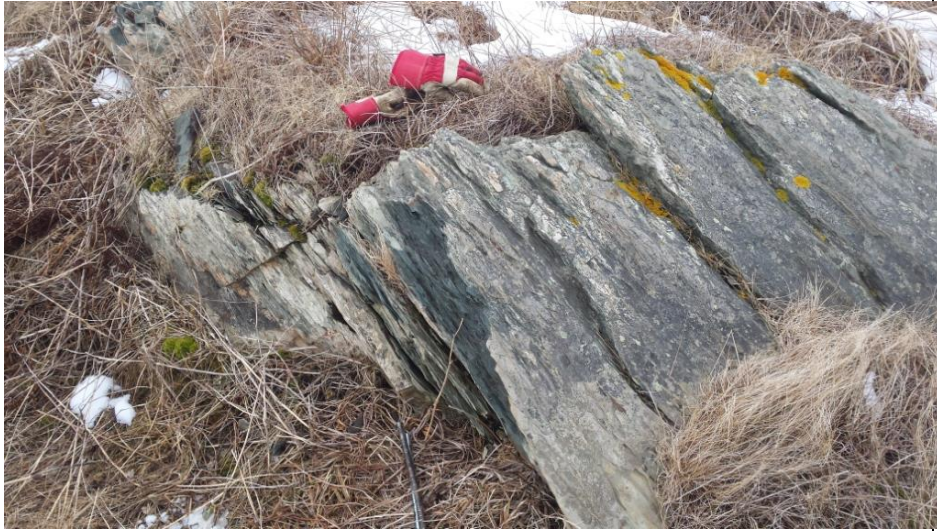
Photo 17: Outcrop F located ~ 35 m NE of approximate location of Turbine 14-03. Note close spacing of cleavage planes with some surface fracturing.

Outcrop F was ~ 1 x 4 m in size and described as green-grey siliceous siltstone and shale. Moderate surface weathering was noted on exposed surfaces. Approximately 40% of the outcrop was comprised of shale that is fractured, brittle and exhibits very close spaced cleavage planes that generally trend E-W with a near-vertical dip. Bedding plane orientation was not determined due to insufficient exposure.

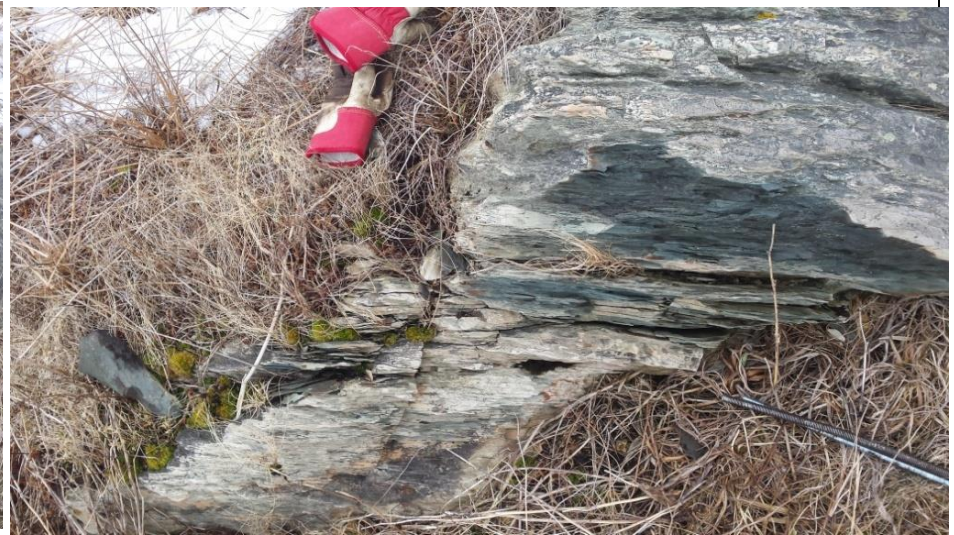
Photo 18: Alternate view of Outcrop F.

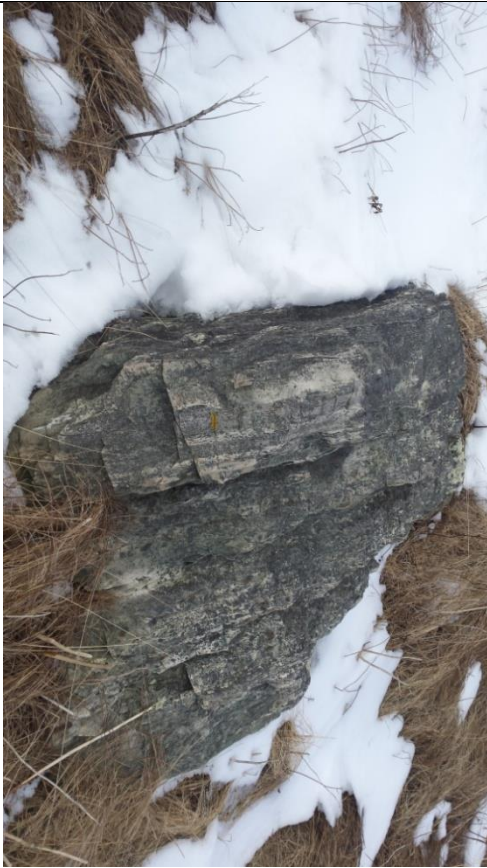
Photo 21: Outcrop G located ~ 30 m NE of approximate location of Turbine 14-04. One dominant joint set striking E-W with near vertical dip.

The exposure at Outcrop G was ~ 1 x 1 m in size and described as green-grey siliceous siltstone. Evidence of slight to moderate surface weathering was noted on exposed surfaces. The rock mass exhibited one (1) dominant joint set striking E-W with a near vertical dip with very close to close spacing (20 - 100 mm). Bedding plane orientation was not determined due to insufficient exposure.

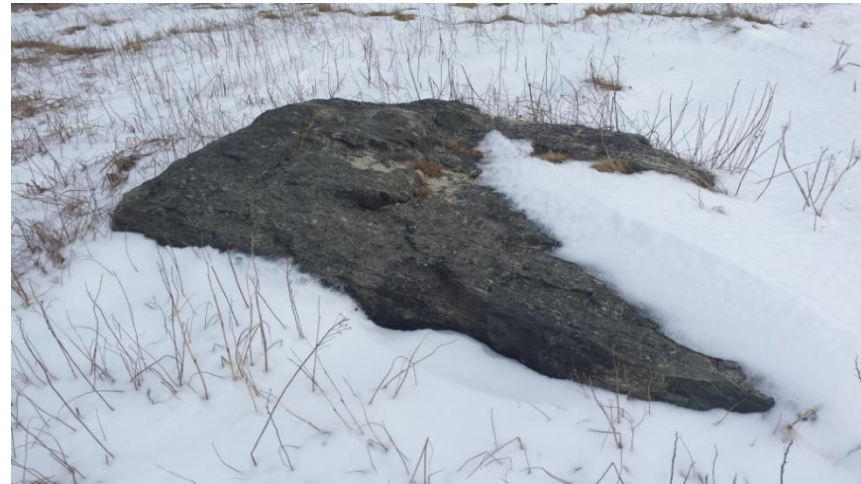
Photo 22: Alternate view of Outcrop G.

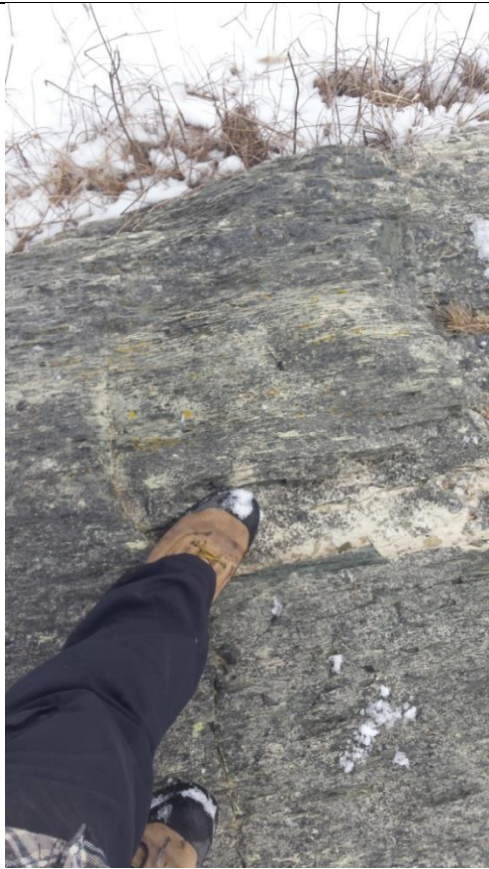
Photo 25: Outcrop H located ~ 25 m NE of approximate location of Turbine 14-05 exhibiting close spaced jointing and cleavage planes.

Outcrop H was ~ 3 x 3 m in size and described as green-grey siliceous siltstone. Slight to moderate surface weathering was noted on exposed surfaces. The rock mass exhibited one (1) dominant joint set striking E-W with a near vertical dip with very close to close spacing (50 - 100 mm). Very close to close spaced (20 mm - 120 mm) cleavage planes generally trending toward the N-S dipping near vertical were also observed on the surface of the outcrop. Bedding plane orientation was not determined due to insufficient exposure.

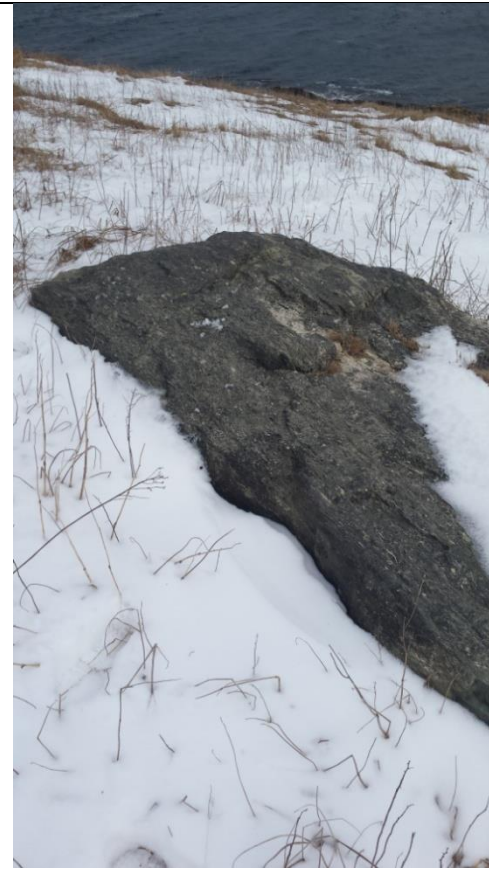
Photo 26: Alternate view of Outcrop H.

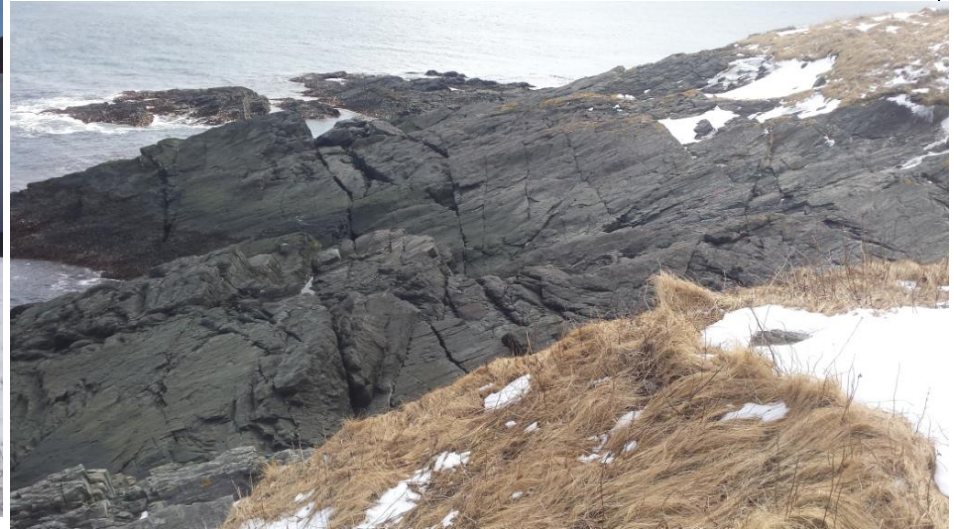
Photo 28: View of exposed bedrock along south shoreline.
