**Geotechnical Investigation, Cape  
Spear Access Road, Cape Spear  
National Historic Site, NL**

**Final Report**

**File No: 133347329**

June 13, 2016

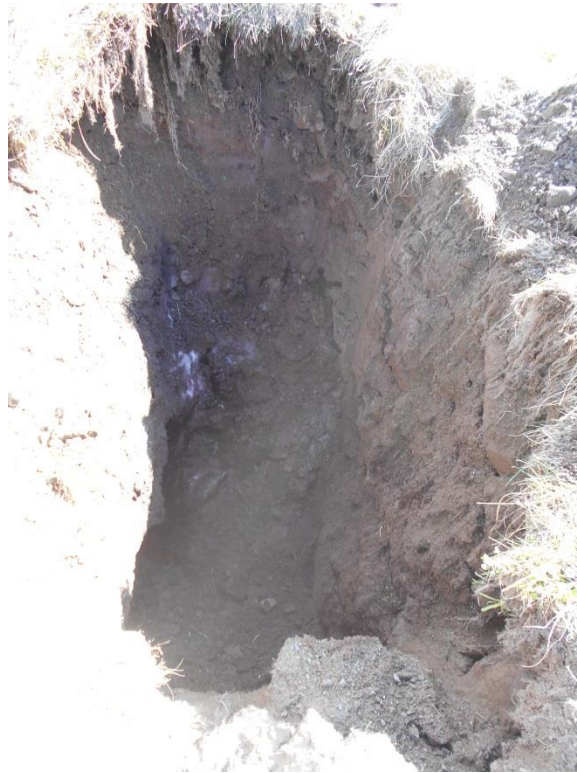
**Test Pit TP-01**

Surficial layers of organic soils including sod, rootmat and/or topsoil were encountered at all test pit locations. The combined thickness of the organic soils ranged from 0.1 m to 0.3 m. Grass, roots, rootlets, occasional gravel and asphalt were encountered within the organic layers.

A layer of black, peat/organic materials with strong organic odour was encountered at TP-01, TP-02 and TP-03 locations underlying the upper fill and/or gravel and sand layer. The thickness of the peat/organic materials ranged from 0.1 m to 0.2 m.

A layer of gravel and sand was encountered at TP-01 to TP-04 at depths ranged from 0.1 m to 0.5 m below the existing ground surface. The thickness was varied from 0.4 m to 0.7 m. Based on our visual observations, the materials can be described as brown to grey, gravel with sand and silt (GP-GM) with trace rootlets, tree debris, occasional to some cobbles and some to frequent boulders. Organic materials were observed throughout the layer. Slight to strong organic odour was encountered at the bottom of the layer. In terms of relative density, based on direct inspection in the test pit and excavator performance, this fill layer can be generally classified as loose to compact.

At the time of the investigation, groundwater seepage was encountered at test pit locations, TP-01, TP-02, TP-03 and TP-05. Based on our observations during test pit excavations, slow to rapid water seepage was observed through fill and/or silty sand with gravel at depths ranging from 0.3 m to 1.5 m below the ground surface.

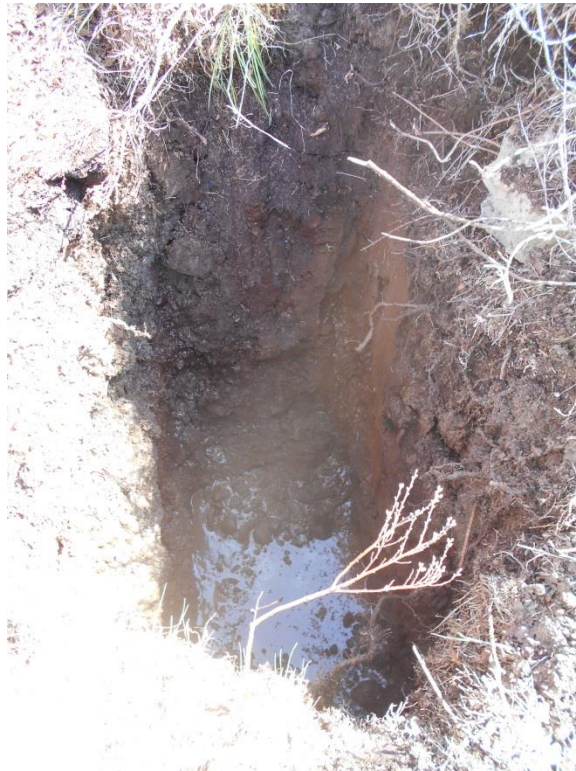
**Test Pit TP-02**

A layer of asphalt was encountered below the organic layer at TP-04 and in the organic layer at TP-02. The thickness of the asphalt was approximately 0.1 m.

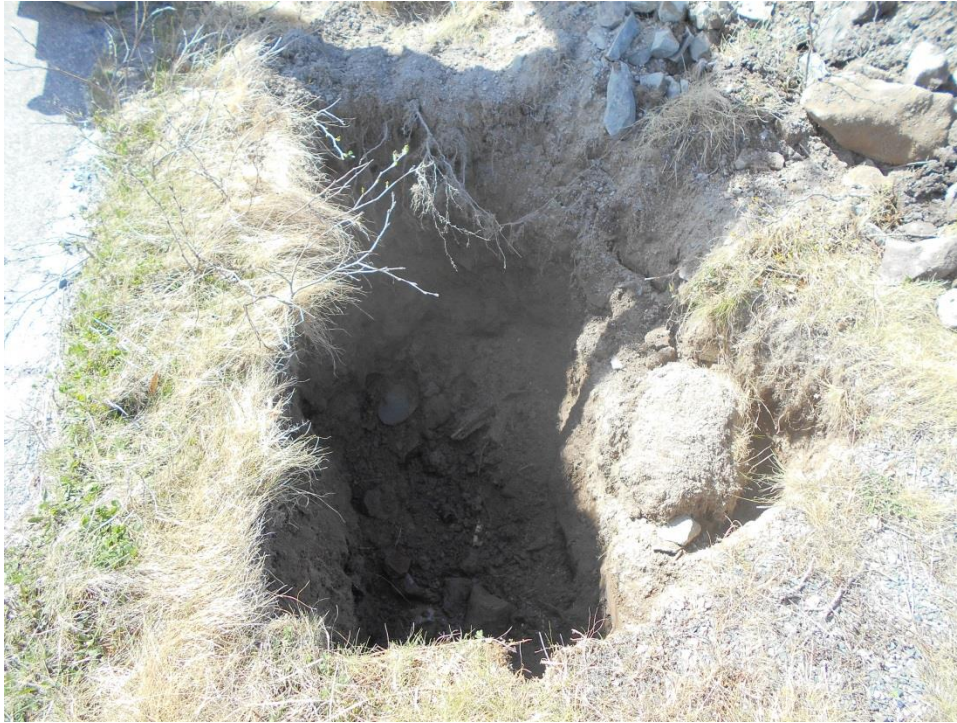
**Test Pit TP-03**

All test pits were excavated refusal on probable/inferred bedrock at depths ranging from 0.1 m to 1.8 m below the ground surface, except TP-03, which was terminated at 1.5 m depth due to presence of a probable abandoned underground utility. Upon completion, the test pits were backfilled with the excavated material and nominally compacted using the excavator bucket. Once Stantec has departed the site, it is the responsibility of the Owner to address any potential hazards due to settlement of backfilled materials.

Rockfill was encountered at TP-03 at a depth of 0.3 m and extended to 0.5 m below the existing ground surface. Based on our visual observations, the rockfill is described as 100 mm minus blasted rock with sand and gravel. In terms of relative density, based on direct inspection in the test pits and excavator performance, the rockfill can be generally classified as loose.

A 0.5 m and 0.2 m thick layer of sand and gravel was encountered at TP-03 and TP-09 at a depth of 1.0 m and 0.2 m respectively. Based on our visual observations, the materials can be described as brown to grey, sand with silt and gravel (SP-SM) to silty sand with gravel (SM) with occasional to some cobbles. Black organic soil materials and debris (e.g. glass, metal pieces etc.) were encountered at TP-09. In terms of relative density, based on direct inspection in the
