Parks Canada Basic Impact Analysis

Lighthouse Access Road Recapitalization, Cape Spear Lighthouse National Historic Site

CAPE SPEAR NHS LIGHTHOUSE ACCESS ROAD RECAPITALIZATION

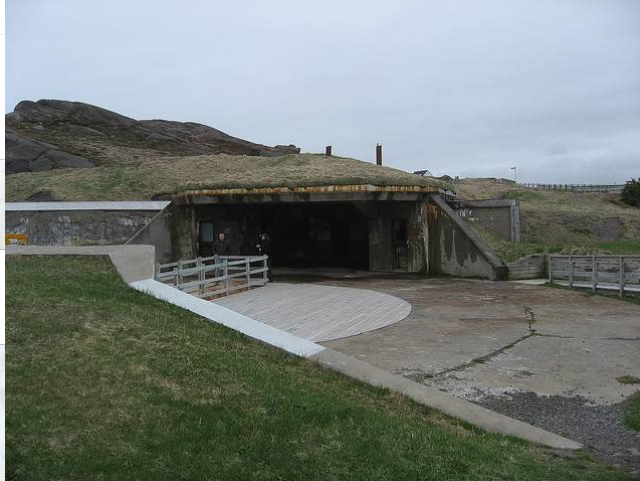
Figure 5. WWII bunker behind gun emplacement n° 2.

The World War II Battery consists of a number of interconnected components including concrete bunkers, two gun emplacements, two large 10 inches 30 ton gun barrels, ready room, magazine and connecting trenches (figs. 5-13). It is situated below the lighthouse at the outermost tip of the cape. Near the current parking lot lies the battery plotting room and above the battery are the remains of concrete foundations for a radar hut, antenna platform and search light platform. An extensive complex of barracks, administrative buildings and other structures were located at the base of the ridge (figs. 14-16). Most of the buildings were of temporary construction and, with the exception of the battery complex, were removed after the war. Evidence of these temporary structures still exist. The land in the area used for barracks and administrative structures had been built-up and later graded. As a result their former location is visible by changed vegetation patterns, with the exception of the area now occupied by the visitor parking lot. Similarly, altered vegetation and soil compaction indicate where interconnecting roads, walkways and the water line were located. Other evidence of Fort Cape Spear includes a memorial cross located near the tip of the peninsula and remnants of barbed wire and wire spools that are found intermittently throughout the western half of the site (CIS 1999, p. 10). Few changes have also been made to the site (for the convenience of tourists) in the second half of the 20th century which had an impact upon the gun emplacements. A raised board walk has been placed to one side and one of the gun emplacements is now covered with a wooden deck as a safety precaution and for its use as a stage for summer performances (figs. 5, 7, 13).

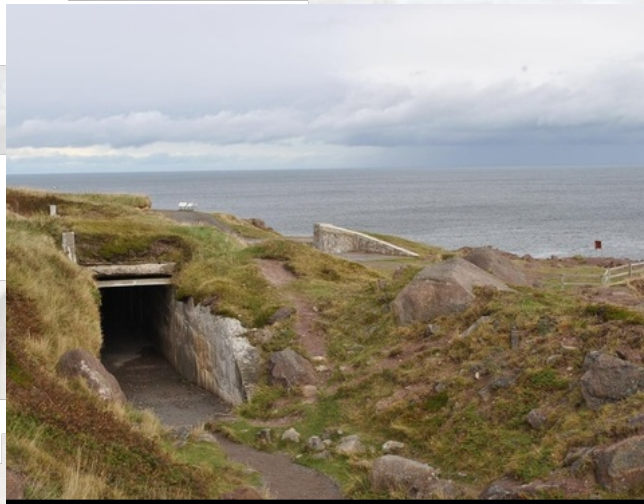
Figure 6. Cape Spear WWII bunker.

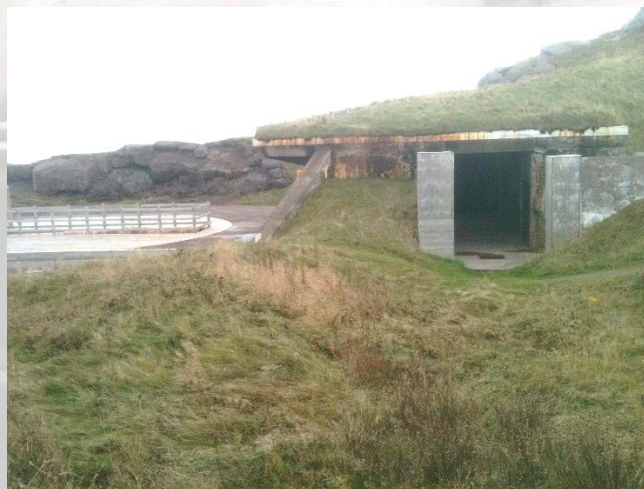
Figure 7. WWII bunker behind gun emplacement n° 2.

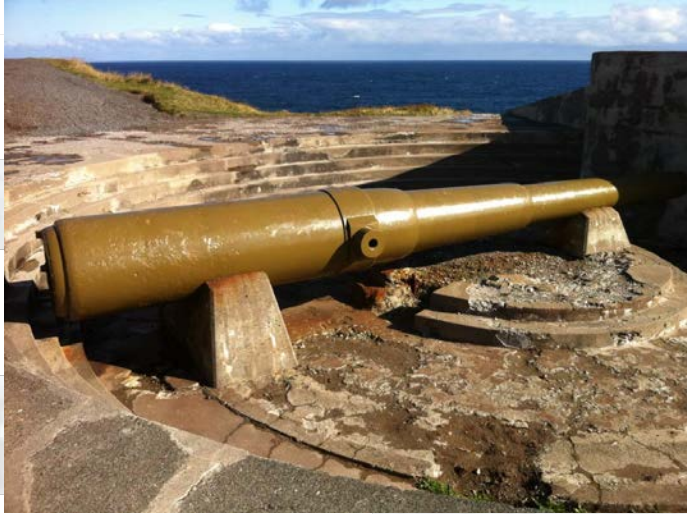
Figure 8. WWII bunker. Gun emplacement n° 1.

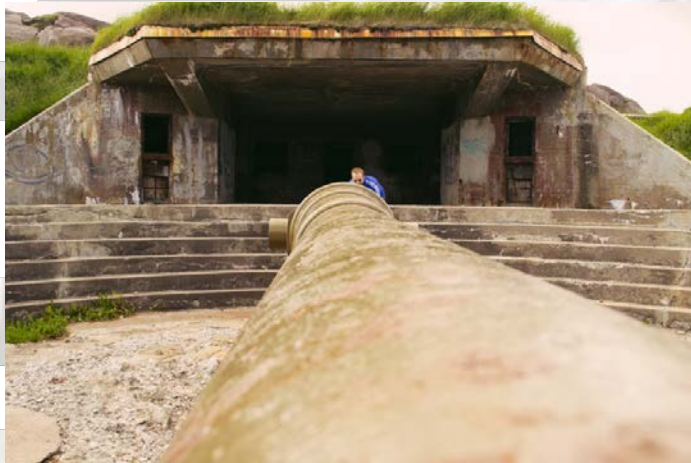
Figure 9. WWII bunker. Gun emplacement n° 1.

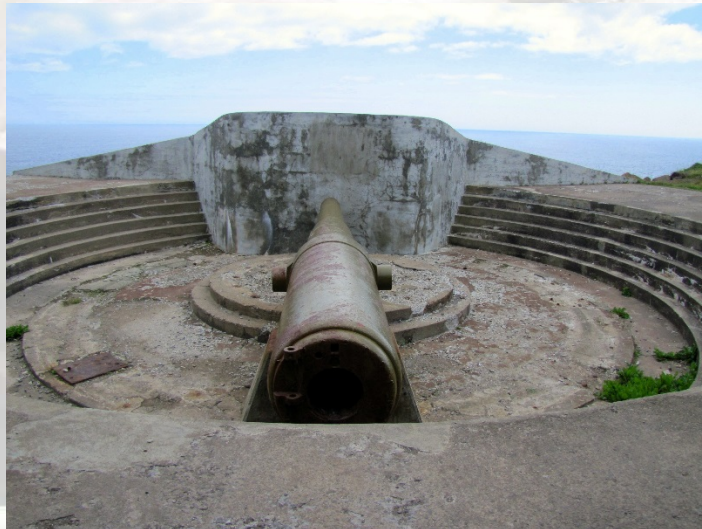
Figure 10. WWII bunker. Gun emplacement n° 1.

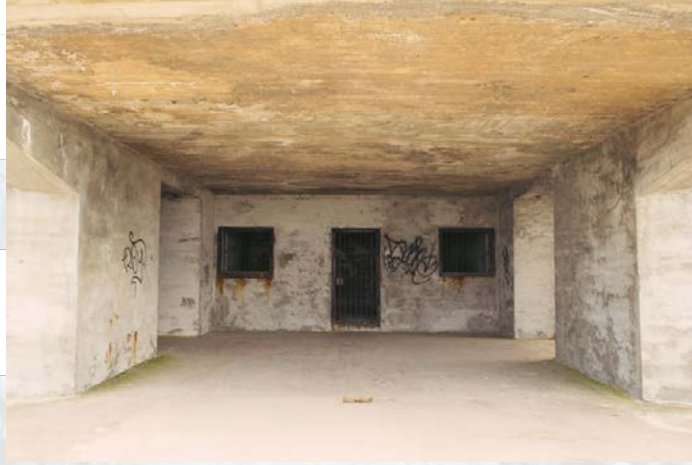
Figure 11. WWII bunker. Crew shelter behind gun emplacement n° 1.

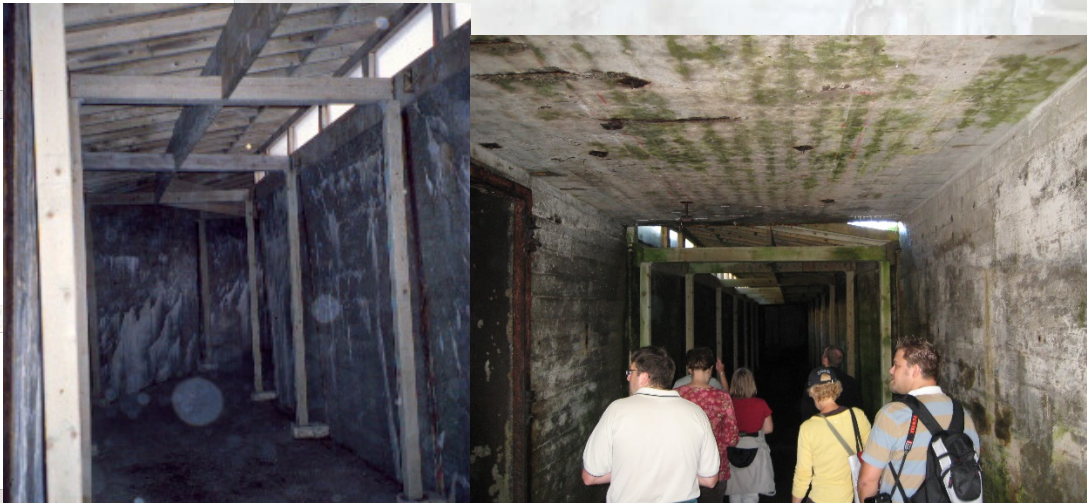
Figure 12. WWII bunker. Corridors that lead to the ammunition storage rooms.

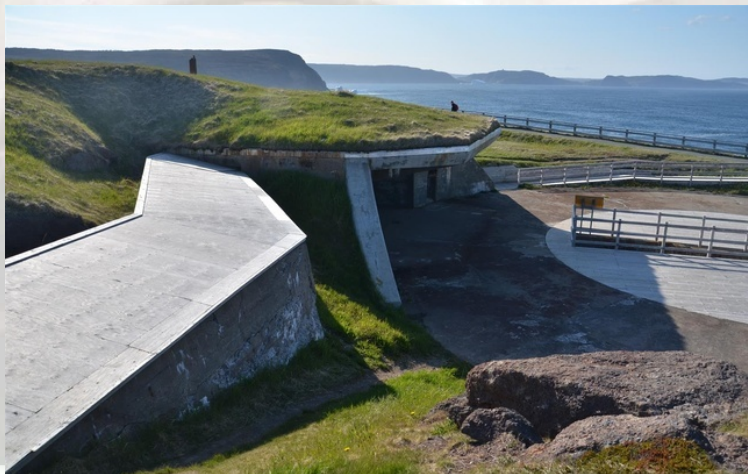
Figure 13. WWII bunker behind gun emplacement n° 2.

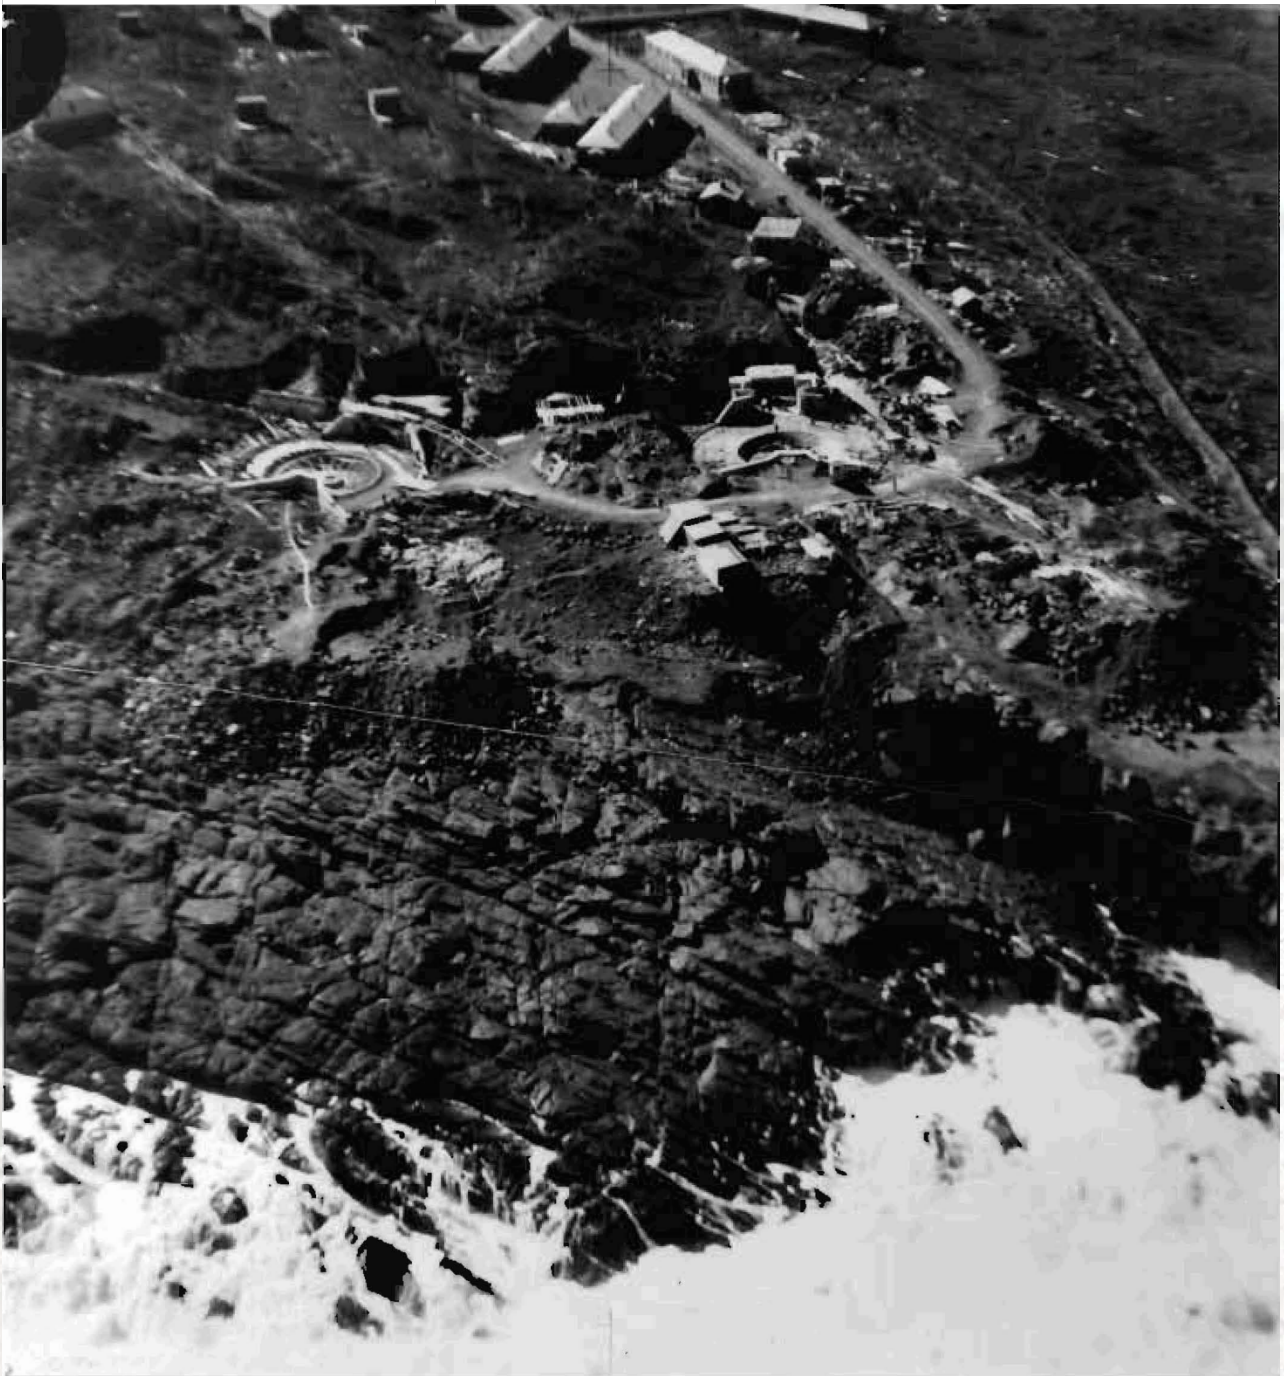
Figure 15. Aerial view of gun battery at Fort Cape Spear under construction in 1941. From Mosquin 2002, fig. 9. (*Parks Canada Atlantic Region Photograph Collection*).

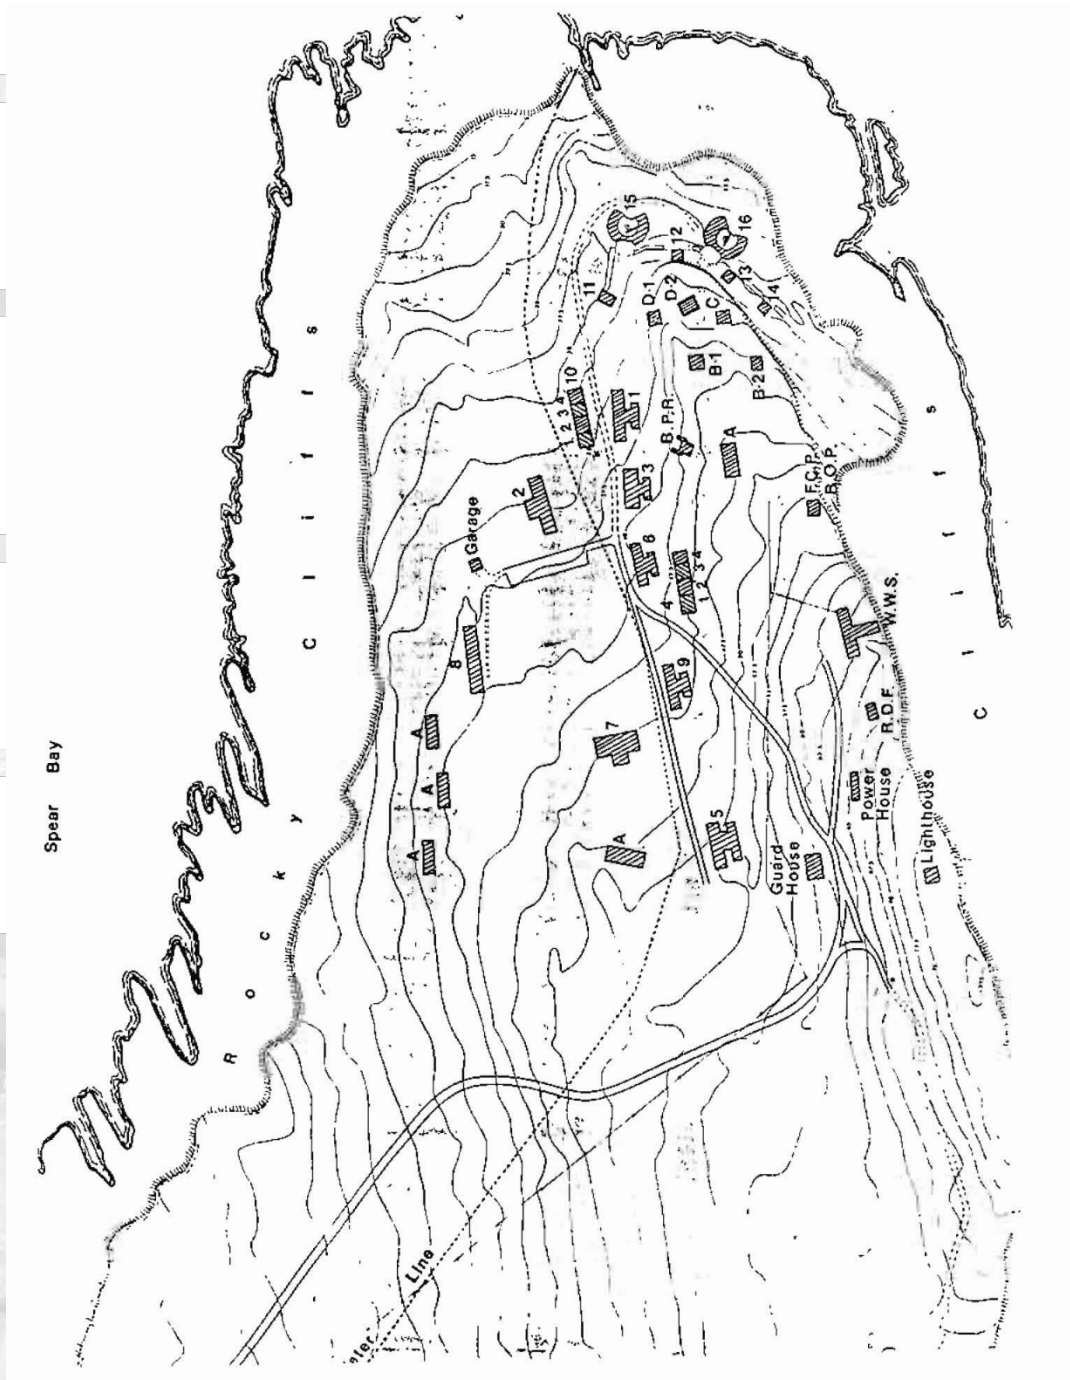
Figure 16. Map of Cape Spear showing all the buildings that were part of Fort Cape Spear. The gun emplacements are indicated by 15 and 16; the ammunition rooms which are linked by covered corridor to the emplacements are numbers 11-14. The battery plotting room is indicated B.P.R. From Mosquin 2002, fig. 10. (*Indian and Northern Affairs, Parks Canada and Atlantic Region Planning, "Cape Spear National Historic Park" n.d.*)
